QIKIQ15 BAFFIN REGION DEW LINE SITE MONITORING

2017 CAM-5 Monitoring Report

Report Number: 1530908-3000-R3-V4

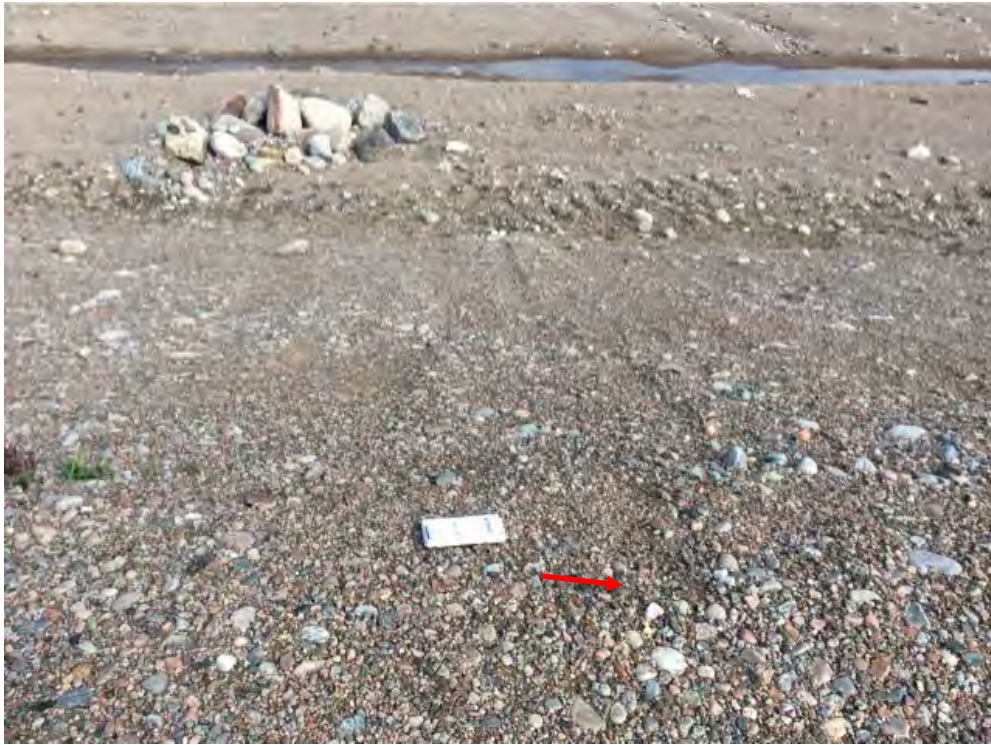
Photo 107: Non-Hazardous Waste Landfill- East slope, Feature L-Self-armouring erosion, facing northeast (Acceptable) (CAM5_Photo19.jpg)

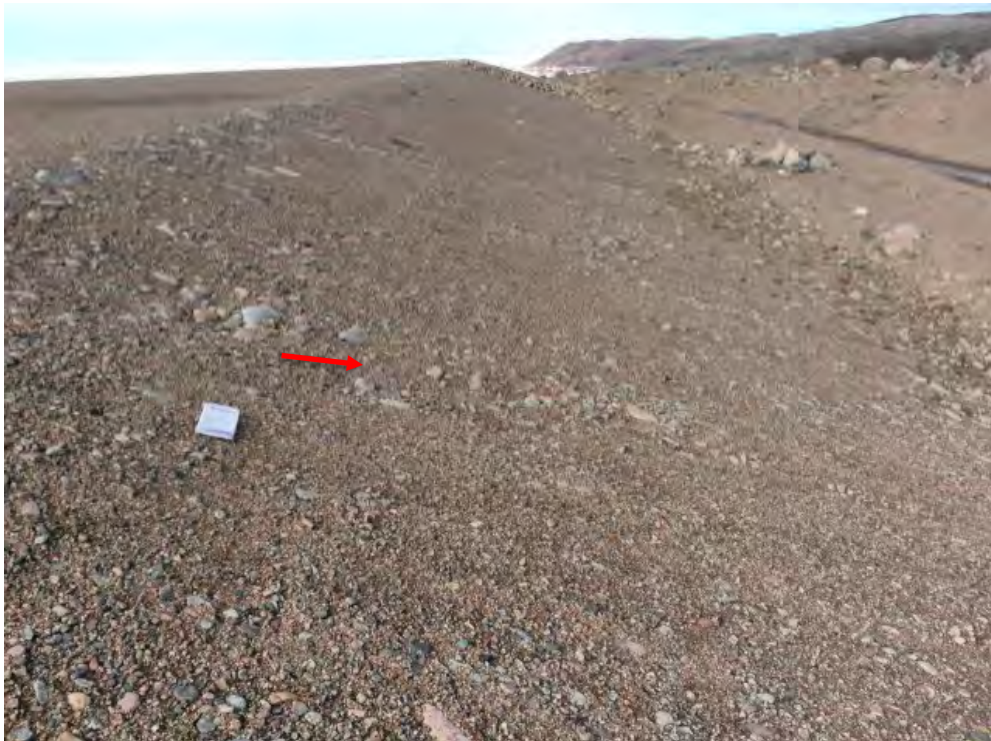
Photo 108: Non-Hazardous Waste Landfill- East slope, Feature L-Self-armouring erosion, facing northwest (Acceptable) (CAM5_Photo18.jpg)

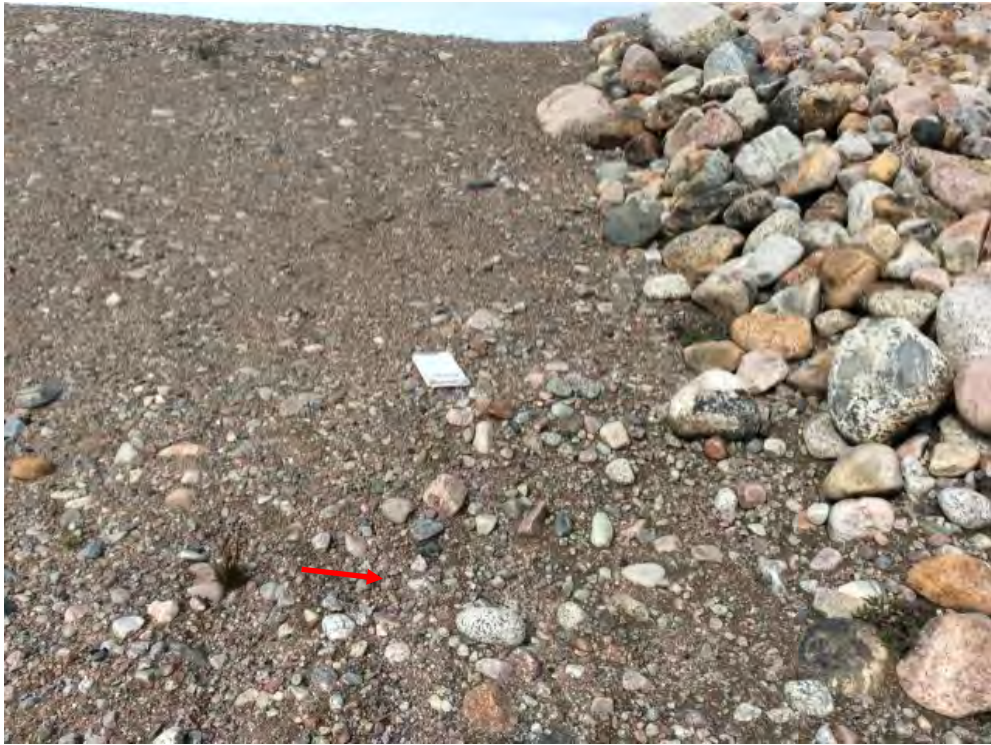
Photo 109: Non-Hazardous Waste Landfill- South slope, Feature M-Settlement, facing north (CAM5_Photo14.jpg)

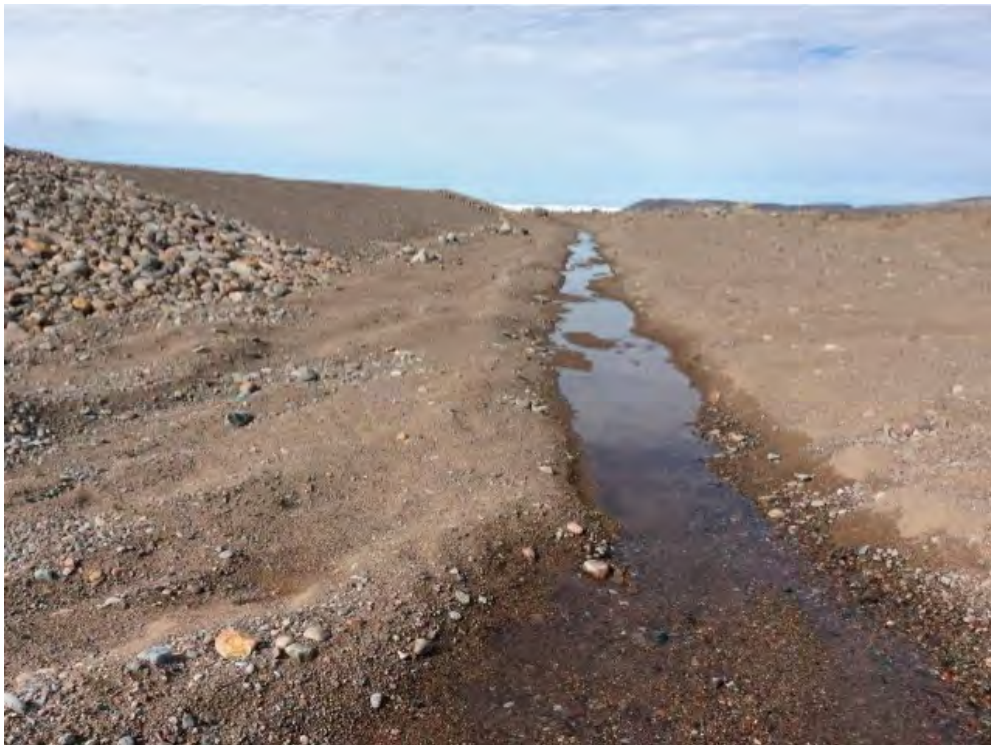
Photo 110: Non-Hazardous Waste Landfill- East toe, Feature N- Ponded water, facing northwest (Acceptable) (CAM5_Photo11.jpg)

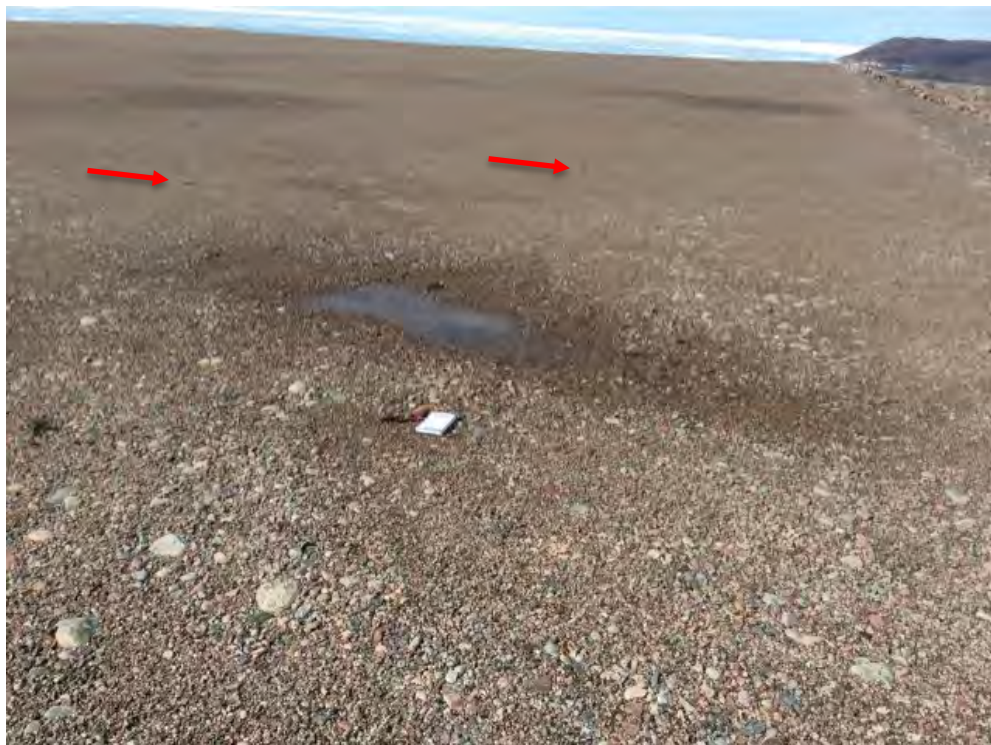
Photo 111: Non-Hazardous Waste Landfill- Southeast corner, Feature O-Sparse vegetation, facing north (Acceptable) (CAM5_Photo13.jpg)

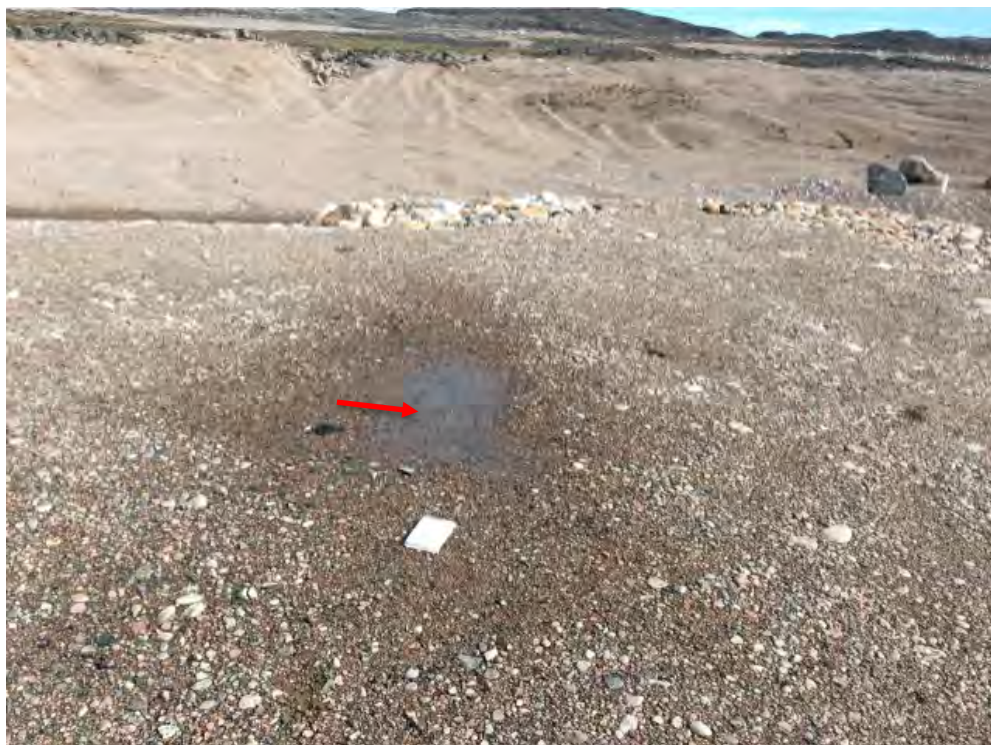
Photo 112: Non-Hazardous Waste Landfill- South east corner, Feature P-Ponded Water, facing east (Acceptable) (CAM5_Photo16.jpg)

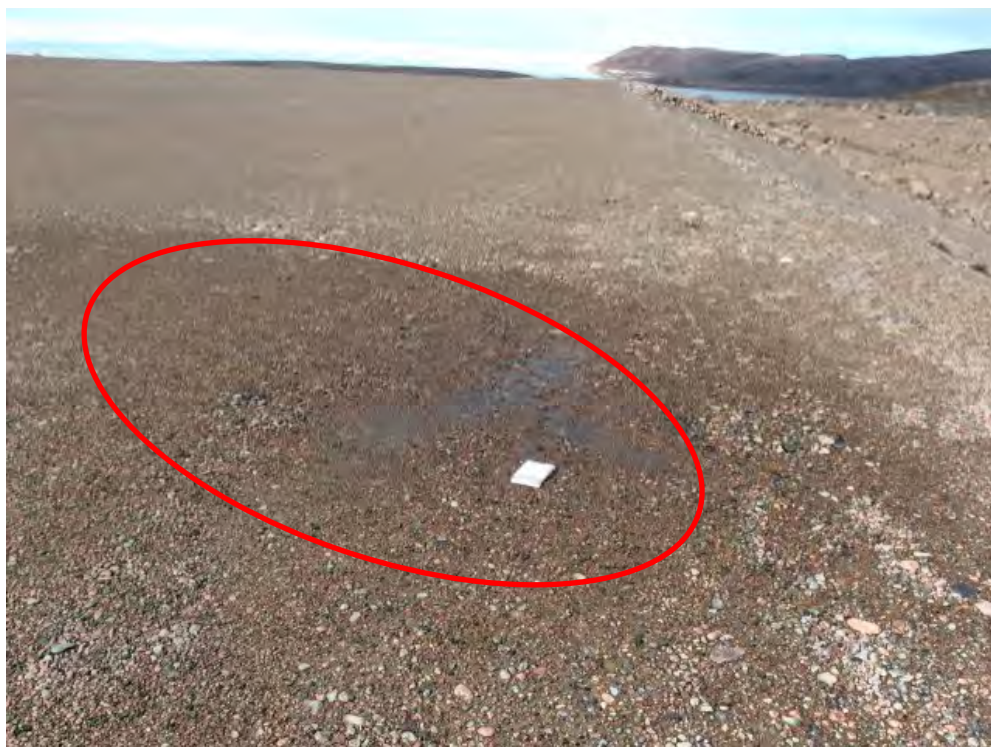
Photo 113: Non-Hazardous Waste Landfill- Cover surface, Feature P-Pond water and wet area, facing north (Acceptable) (CAM5_Photo17.jpg)

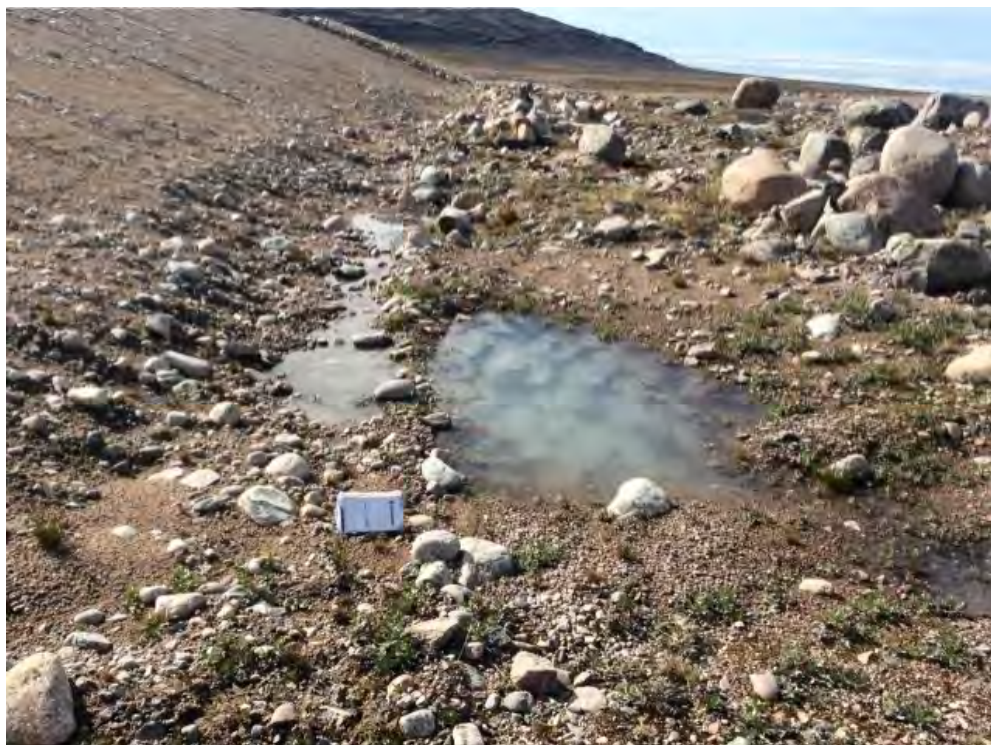
Photo 114: Non-Hazardous Waste Landfill- North toe, Feature Q-Ponded water, facing southwest (Acceptable) (CAM5_Photo23.jpg)

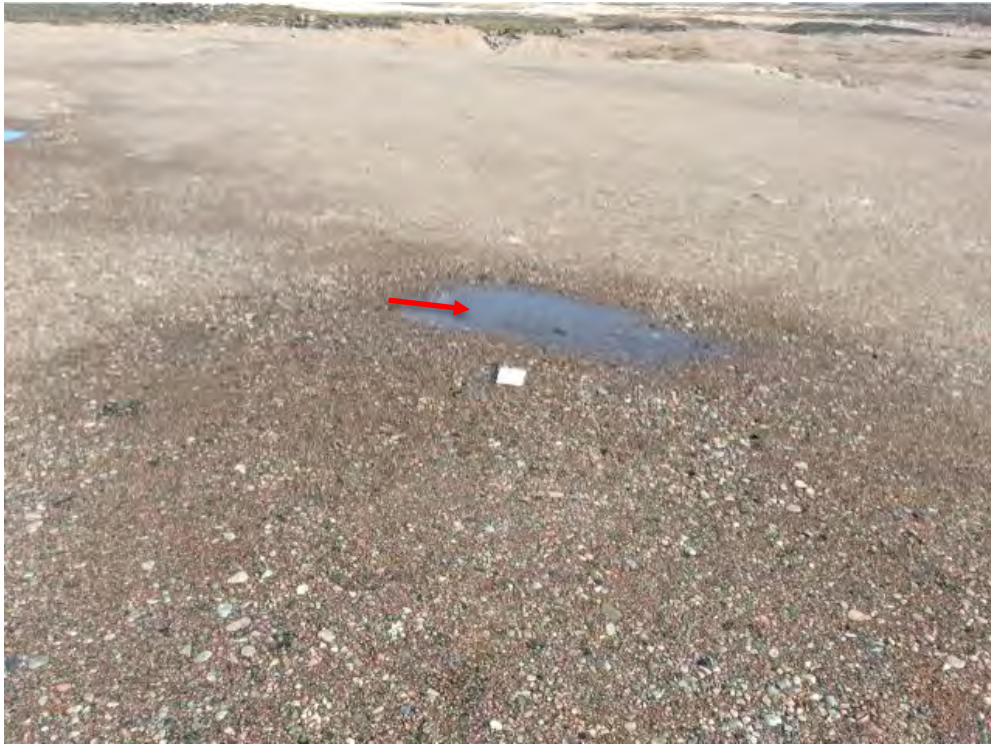
Photo 115: Non-Hazardous Waste Landfill- Cover surface, Feature P-Ponded water, facing east (Acceptable) (CAM5_Photo29.jpg)

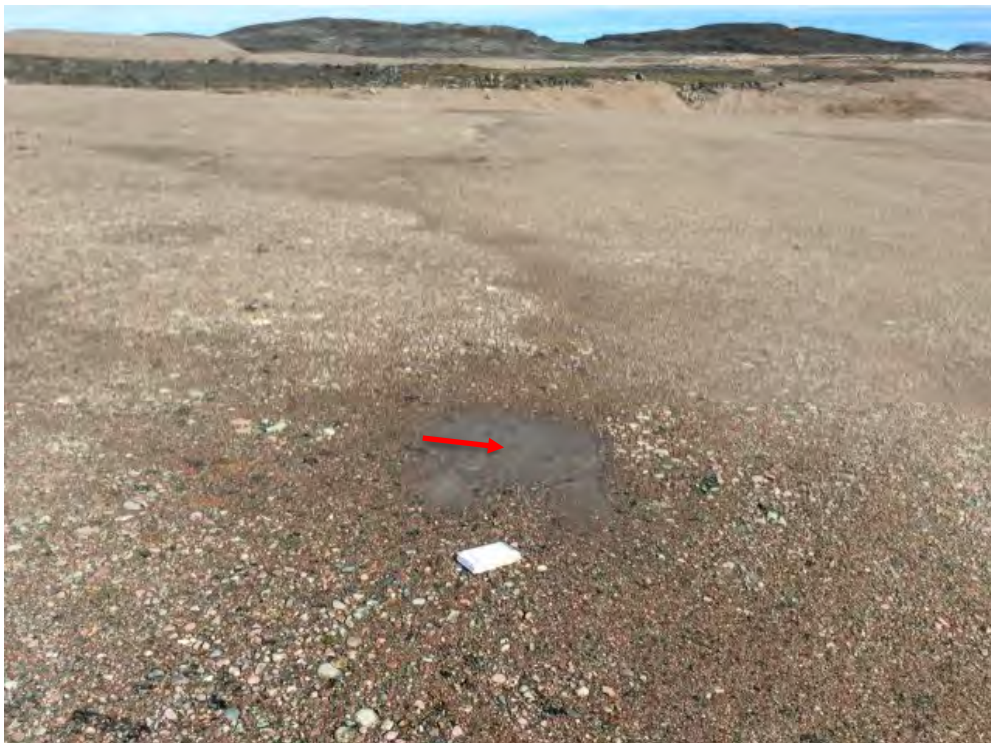
Photo 116: Non-Hazardous Waste Landfill- Cover surface, Feature P -Ponded water, facing east (Acceptable) (CAM5_Photo30.jpg)

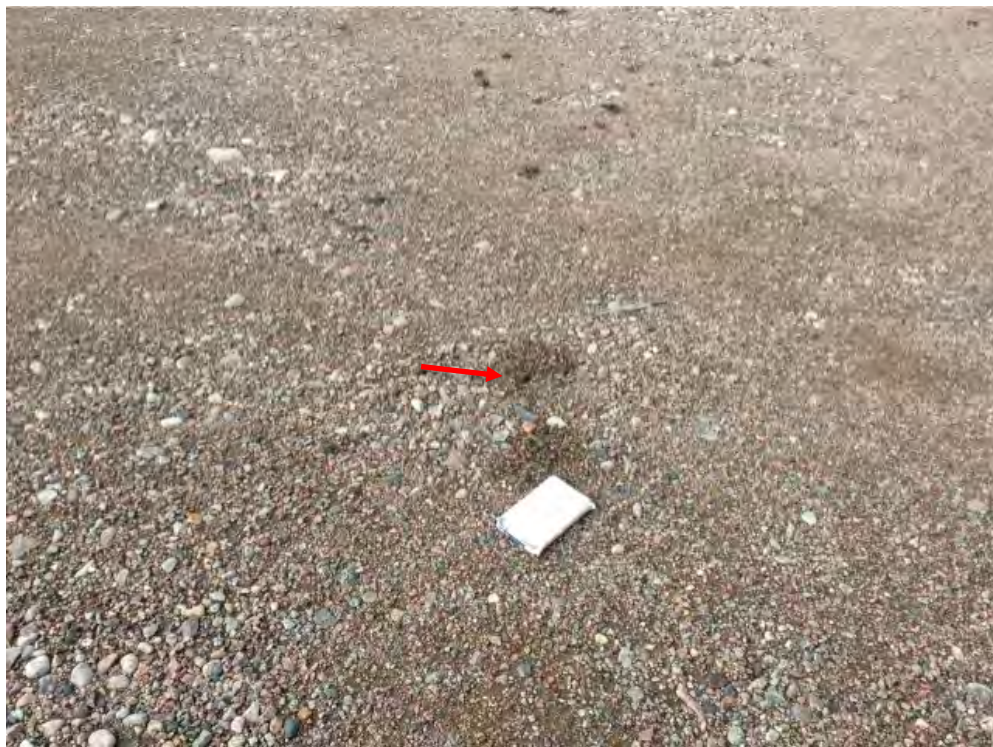
Photo 143: USAF & Asbestos Landfill- South central crest, Feature B-Small hydrocarbon stain, facing northwest (Acceptable) (CAM5_Photo40.jpg)

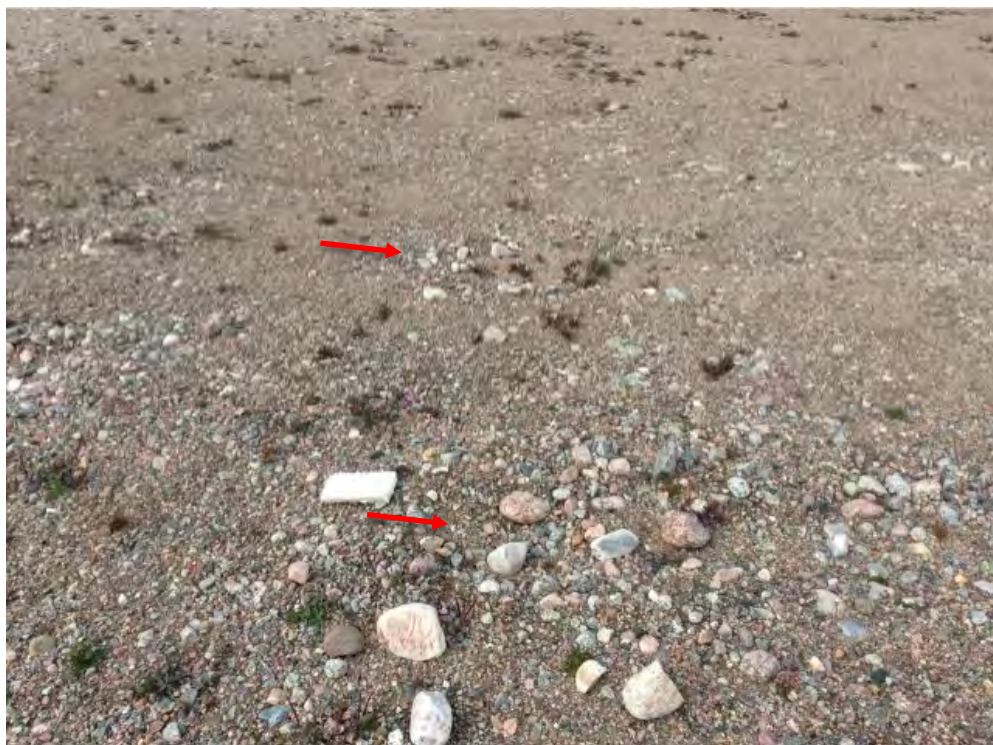
Photo 144: USAF & Asbestos Landfill- West crest surface, Feature C-Minor settlement, facing northwest (Acceptable) (CAM5_Photo44.jpg)

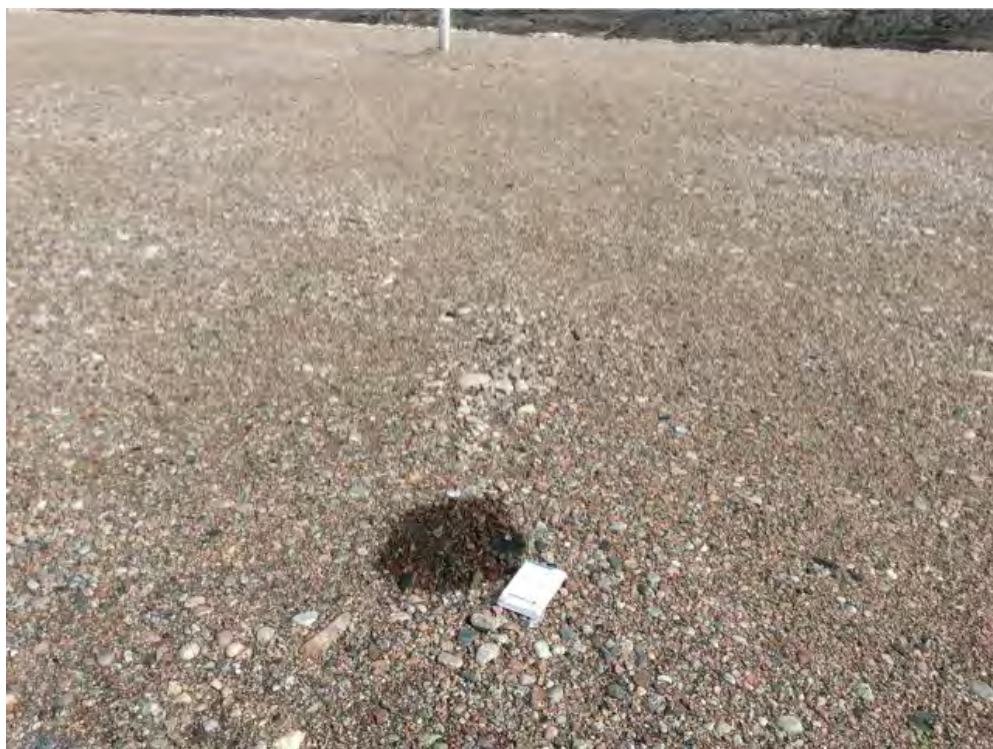
Photo 185: Tier II Disposal Facility- Central crest surface, Feature C-Possible hydrocarbon stain, facing northeast (Acceptable) (CAM5_Photo8.jpg)

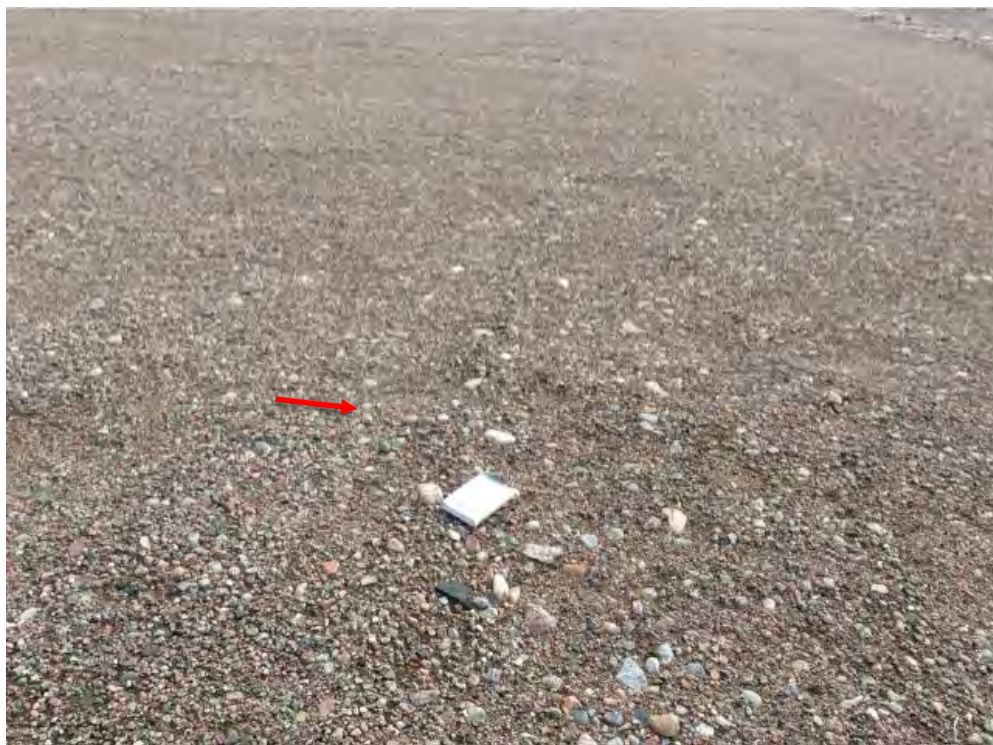
Photo 186: Tier II Disposal Facility- Cover surface, Feature D-Settlement, facing southeast (CAM5_Photo3.jpg)
