WATER LICENCE INSPECTION FORM

Licensee		Licensee Representative	
CIRNAC Contaminated Sites		Benoit Lefebvre/Dany Roy/Ken Gauthier	
Licence No. / Expiry		Representative's Title	
1BR-MTH1722			
Land / Other Authorizations		Land / Other Authorizations	
LUP N2017U0002			
Date of Inspection		Inspector	
27 July 2018		Baba Pedersen	
Activities Inspected			
<input checked="" type="checkbox"/> Camp	<input type="checkbox"/> Drilling	<input type="checkbox"/> Mining	<input type="checkbox"/> Construction
<input type="checkbox"/> Roads/Hauling	<input type="checkbox"/> Other:	<input type="checkbox"/> Other:	<input checked="" type="checkbox"/> Reclamation
			<input checked="" type="checkbox"/> Fuel Storage

PHOTO LOG

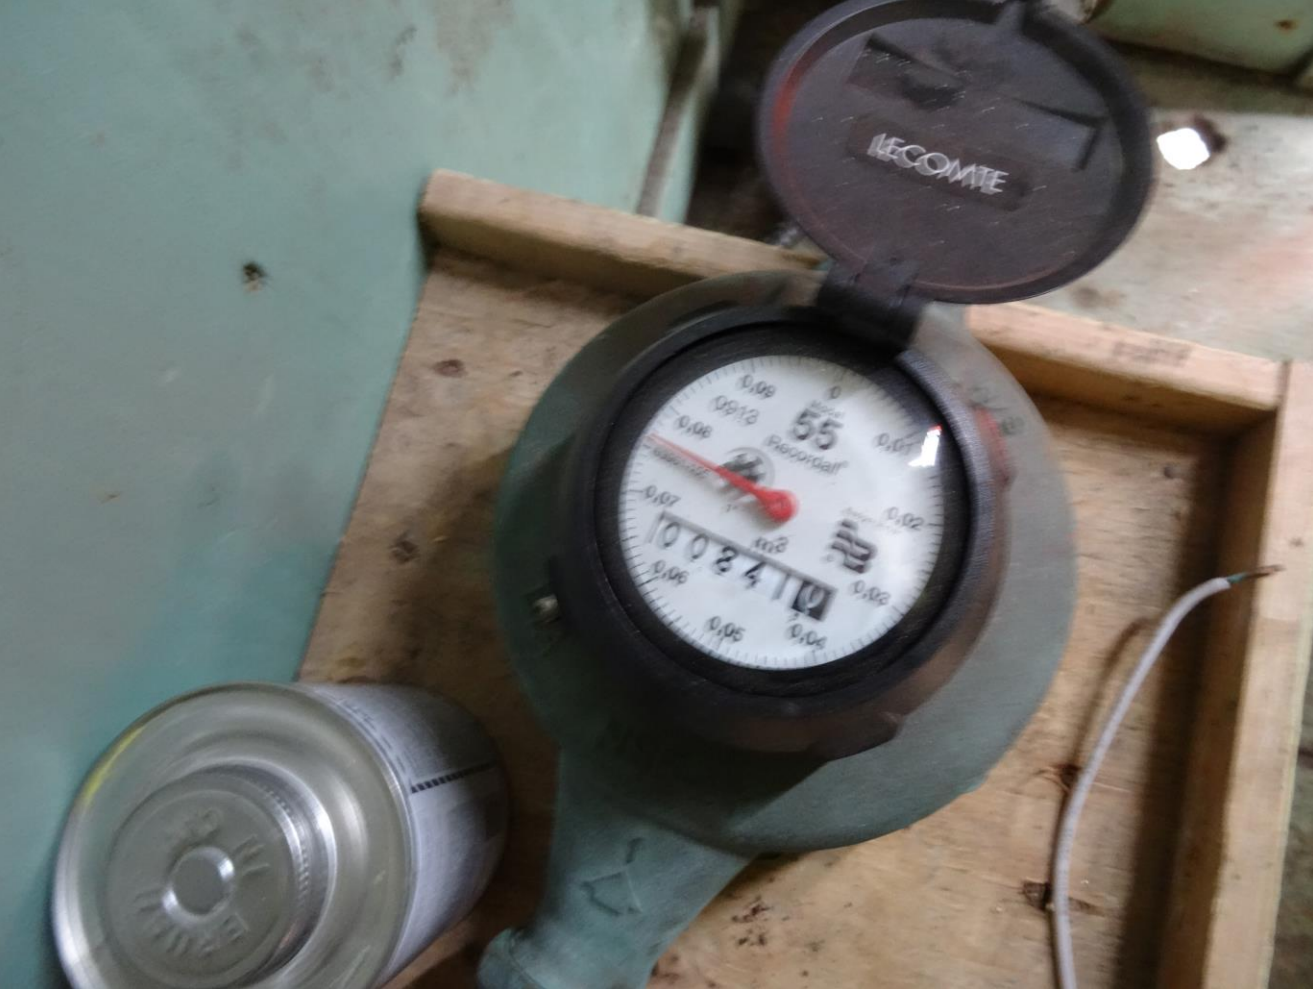
Photo 2

Description: Raw Water Flow Meter inside Sea Can Container

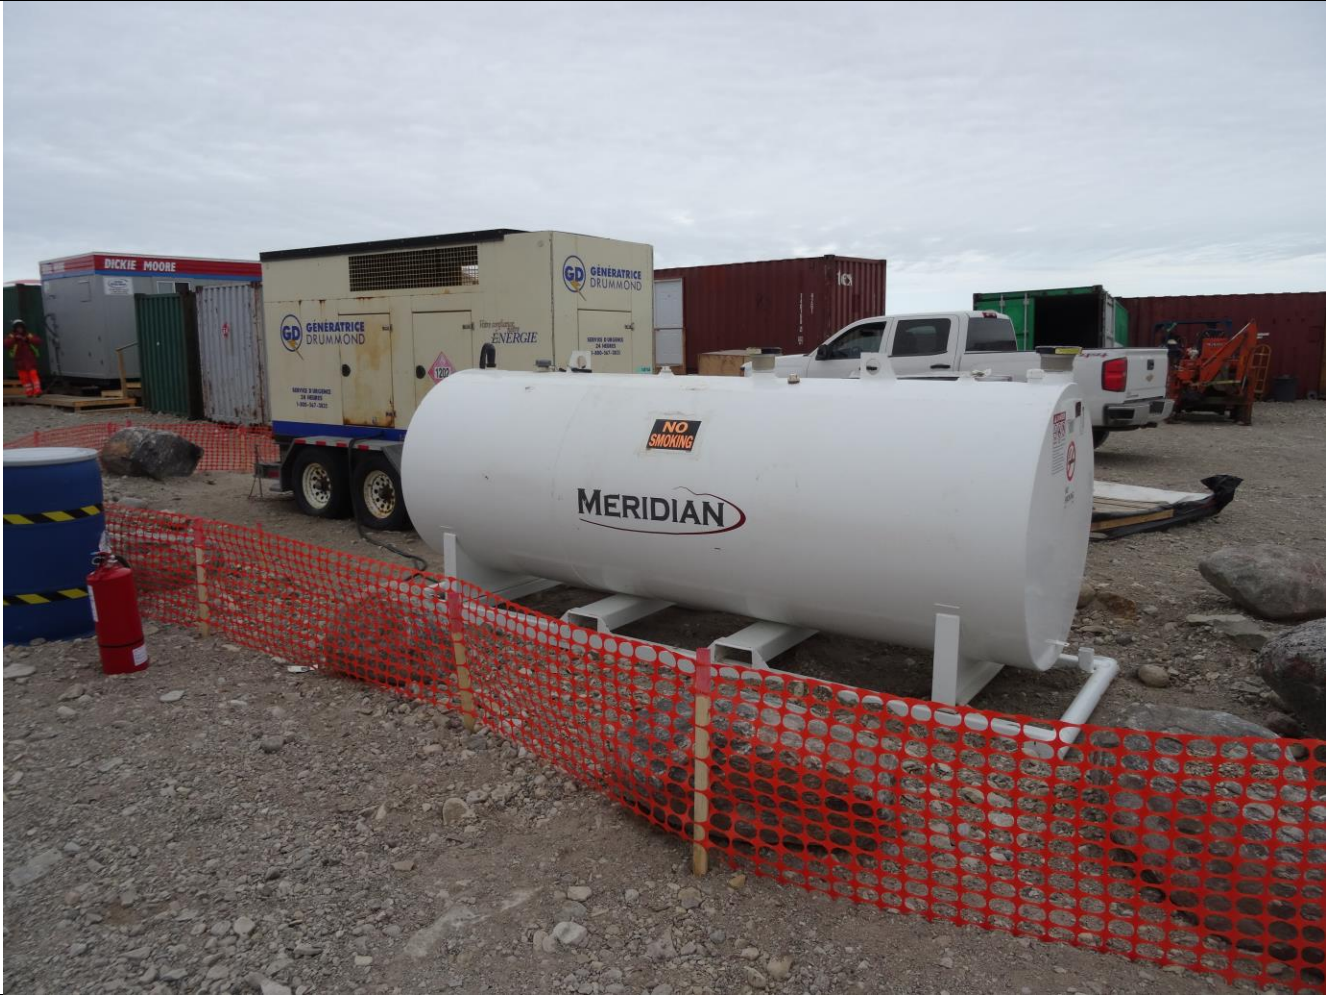
Photo 9

Description: Double Walled Fuel Tank and Camp Generator

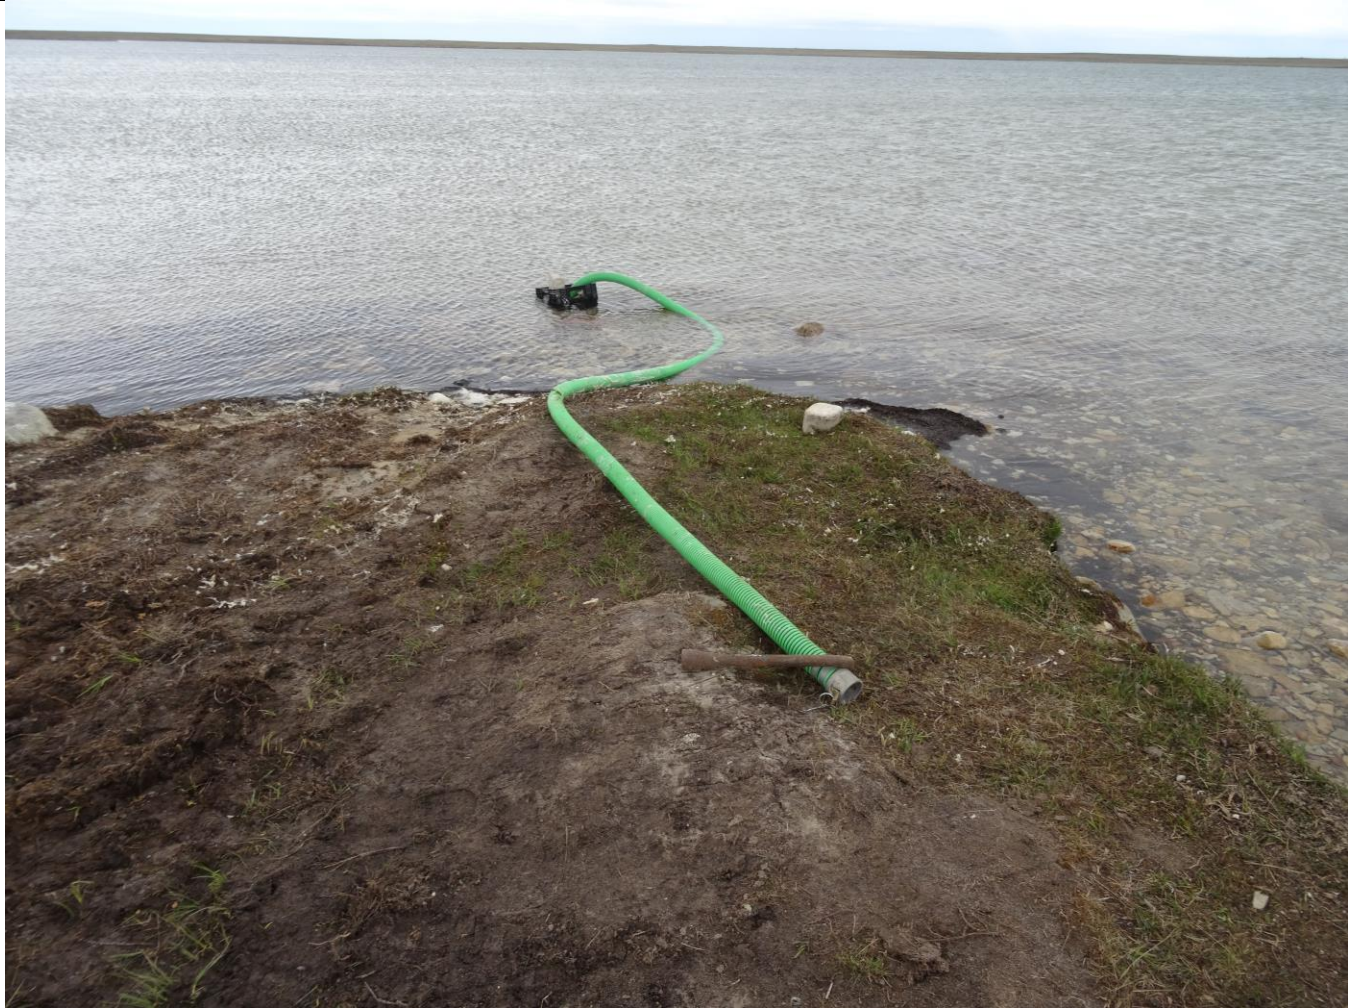
Photo 10

Description: Raw Water Intake Hose at Water Lake – NO SIGNAGE

SECTION 3	<input type="checkbox"/> Comments	<input type="checkbox"/> Non-Compliance with Act or Licence	<input checked="" type="checkbox"/> Action Required
This was a very easy Inspection, the entire Camp and Operation are very well run and meet almost all the Terms and Conditions of both the Water License and the Land Use Permit. The only exception was 7. There was NO SIGNAGE indicating where the Raw Water Intake Area was. Appropriate Signage must be placed and a Photo of such must be emailed to the Inspector as soon as complete.

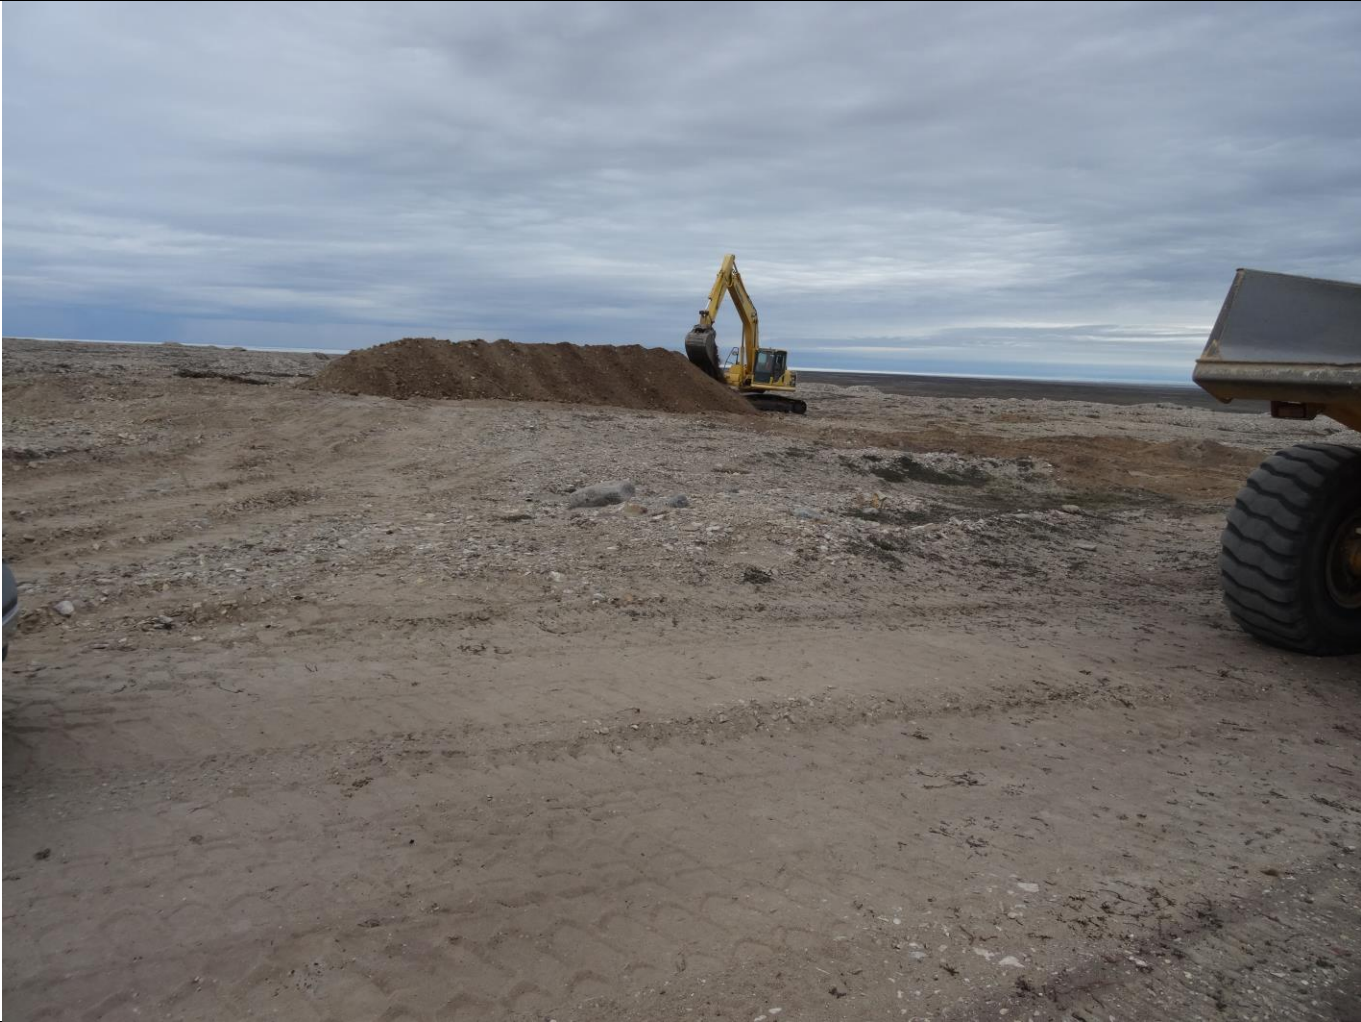
Photo 11

Description: Borrow Area 15

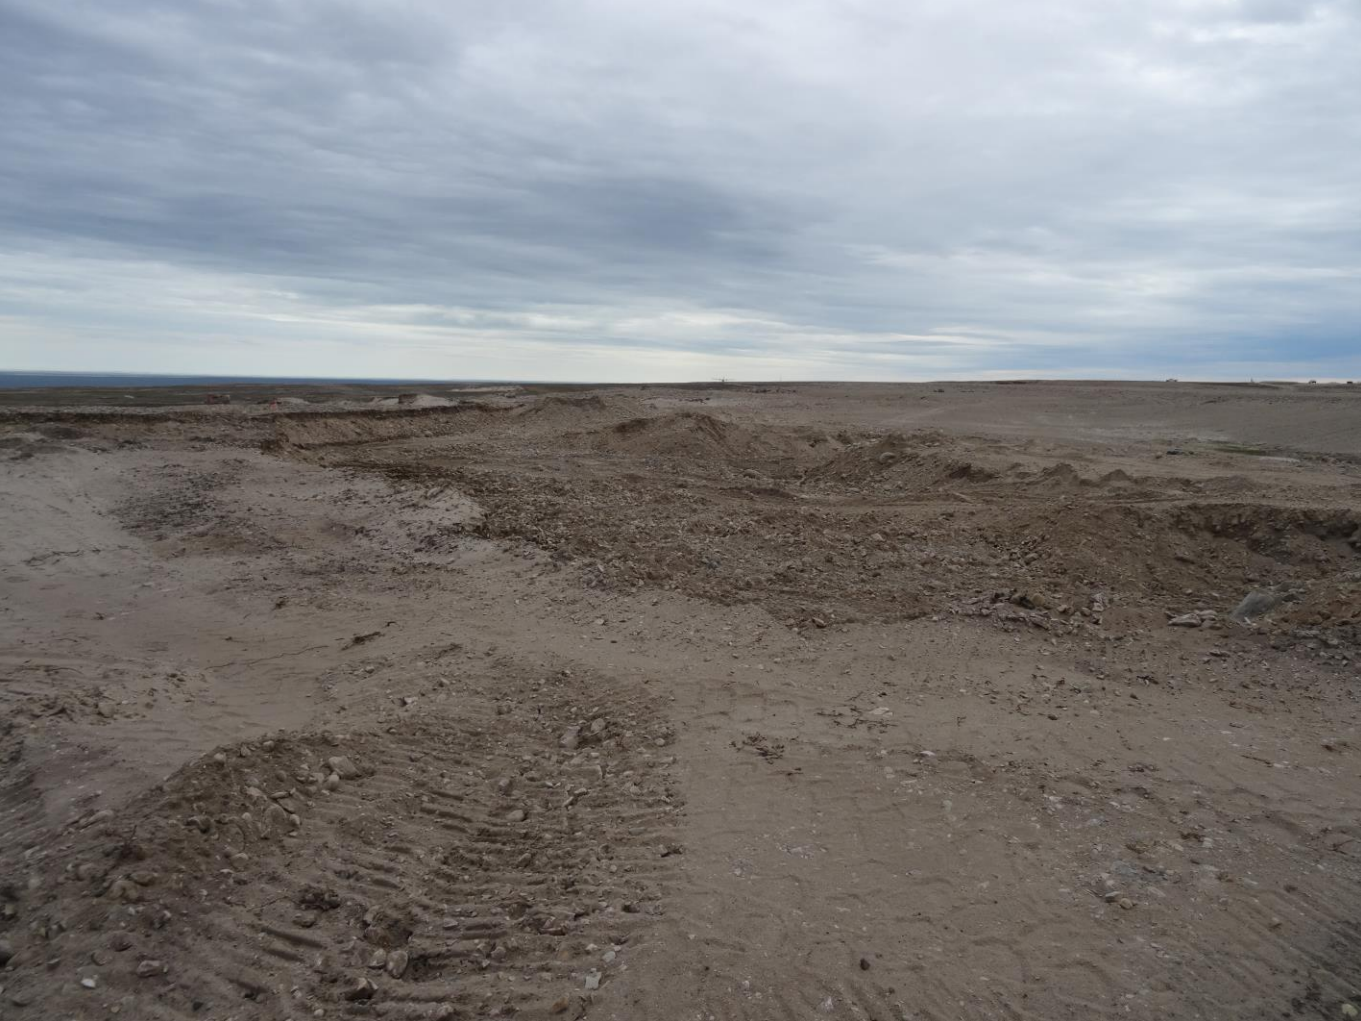
Photo 12

Description: Borrow Area 15
