**RE: CAM-C (Matheson Point) Remediation Project: 2018 Annual
Report for Water Licence No: 1BR-MTH1722**

NWB Annual Report

Project Name: CAM-C (Matheson Point) Site Remediation

WATER LICENCE INSPECTION FORM

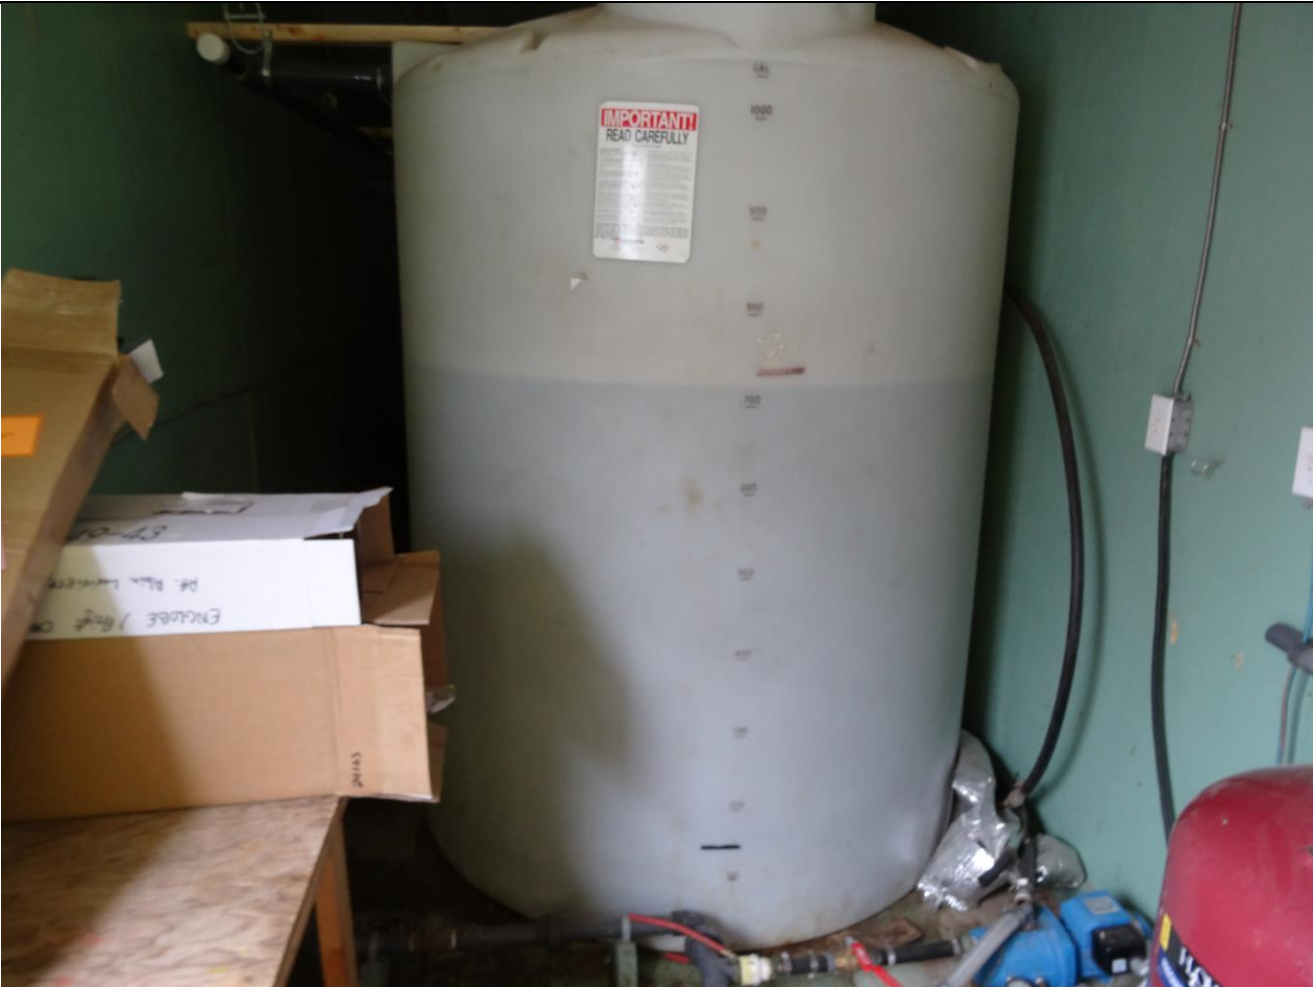
Photo 1

Description: Raw Water Storage Tank – 1 of 5 inside Sea Can Container

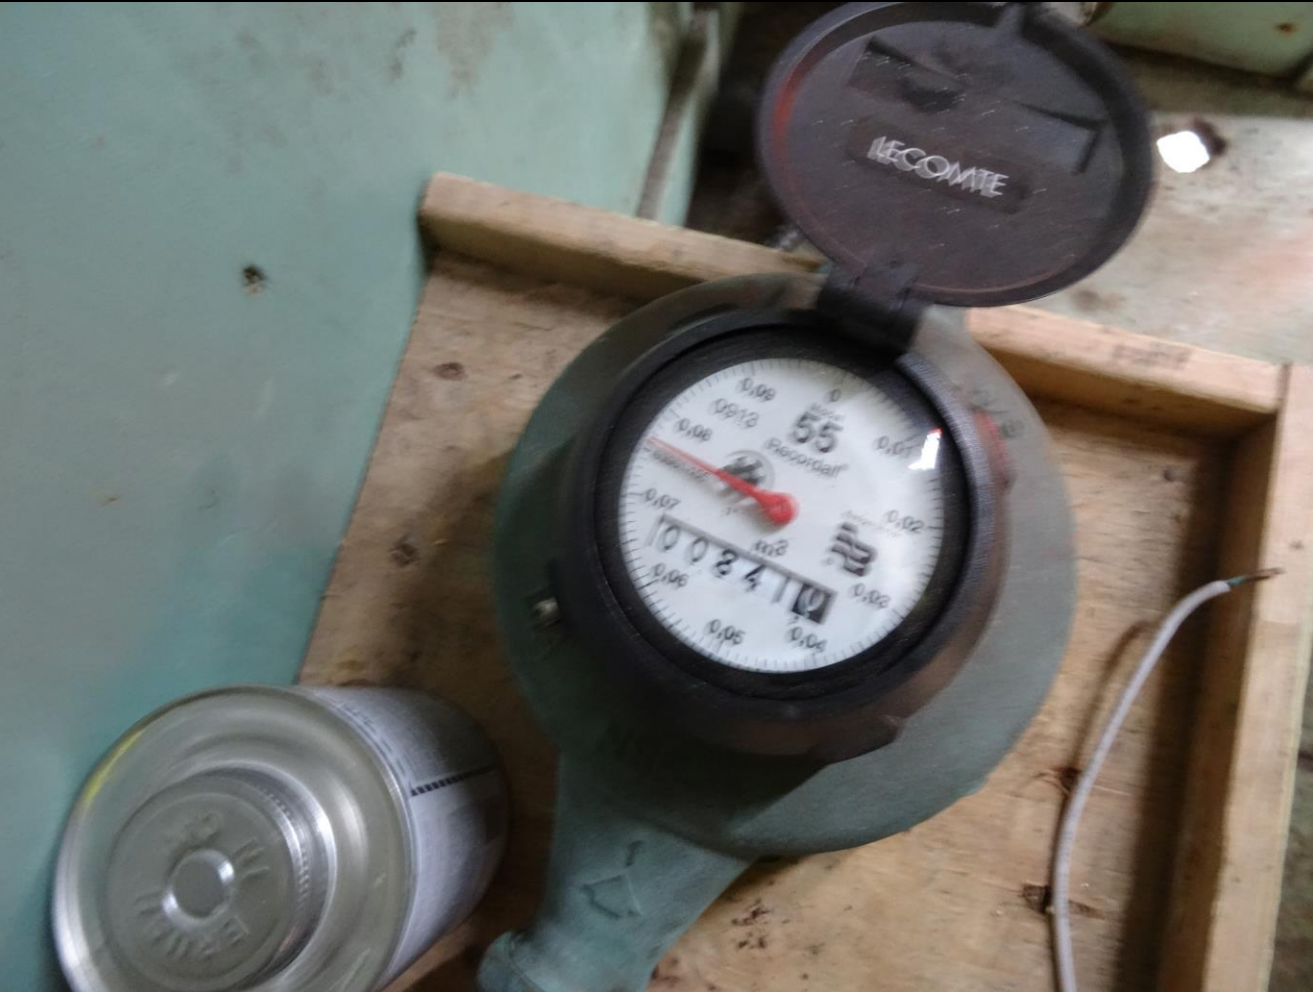
Photo 2

Description: Raw Water Flow Meter inside Sea Can Container

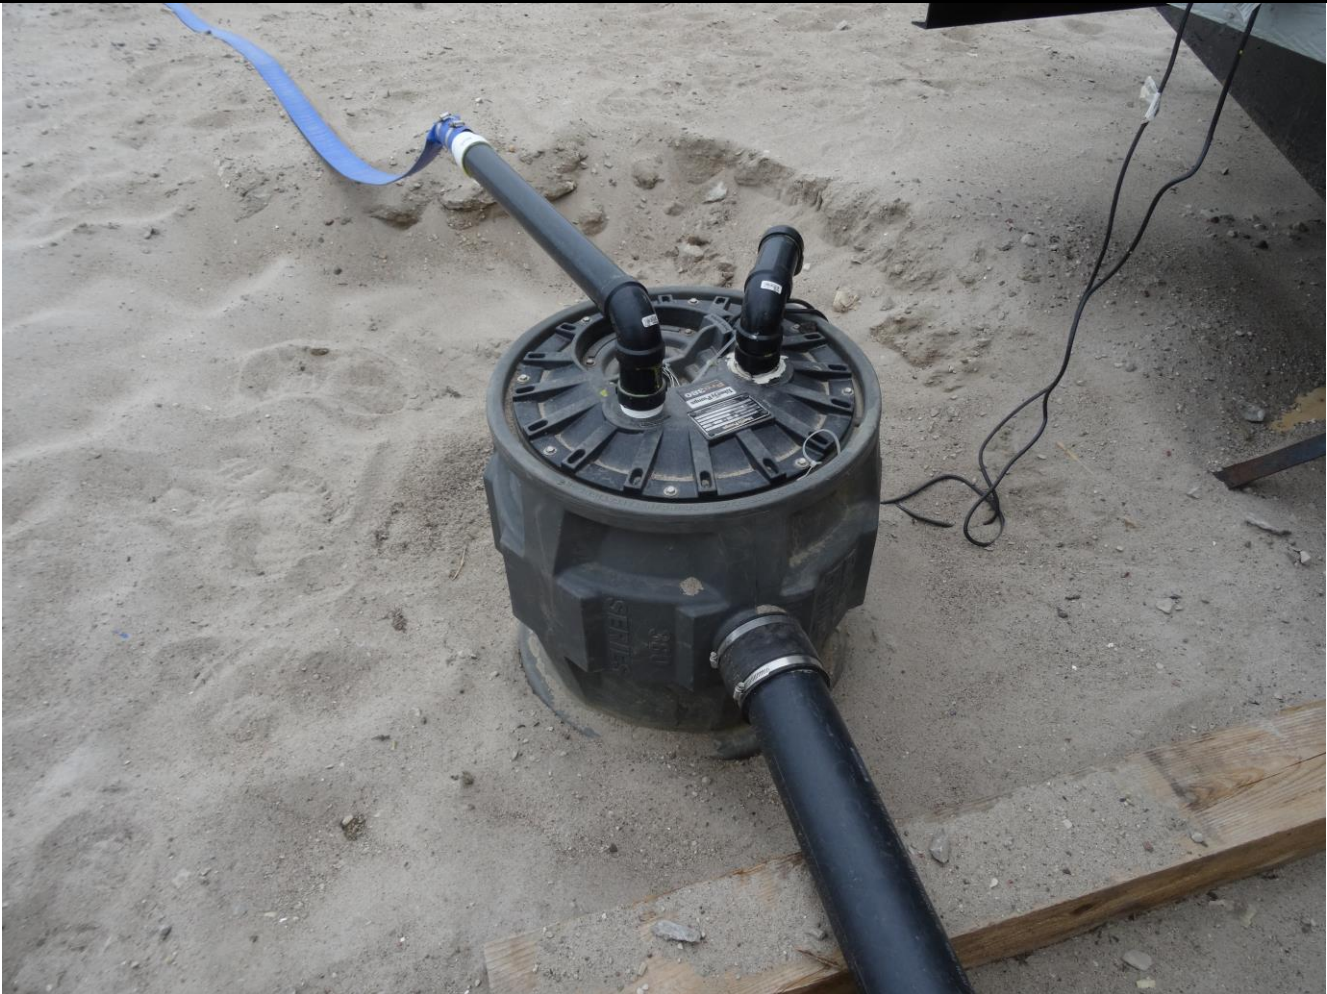
Photo 3

Description: Grey/Black Water Pump/Mulcher

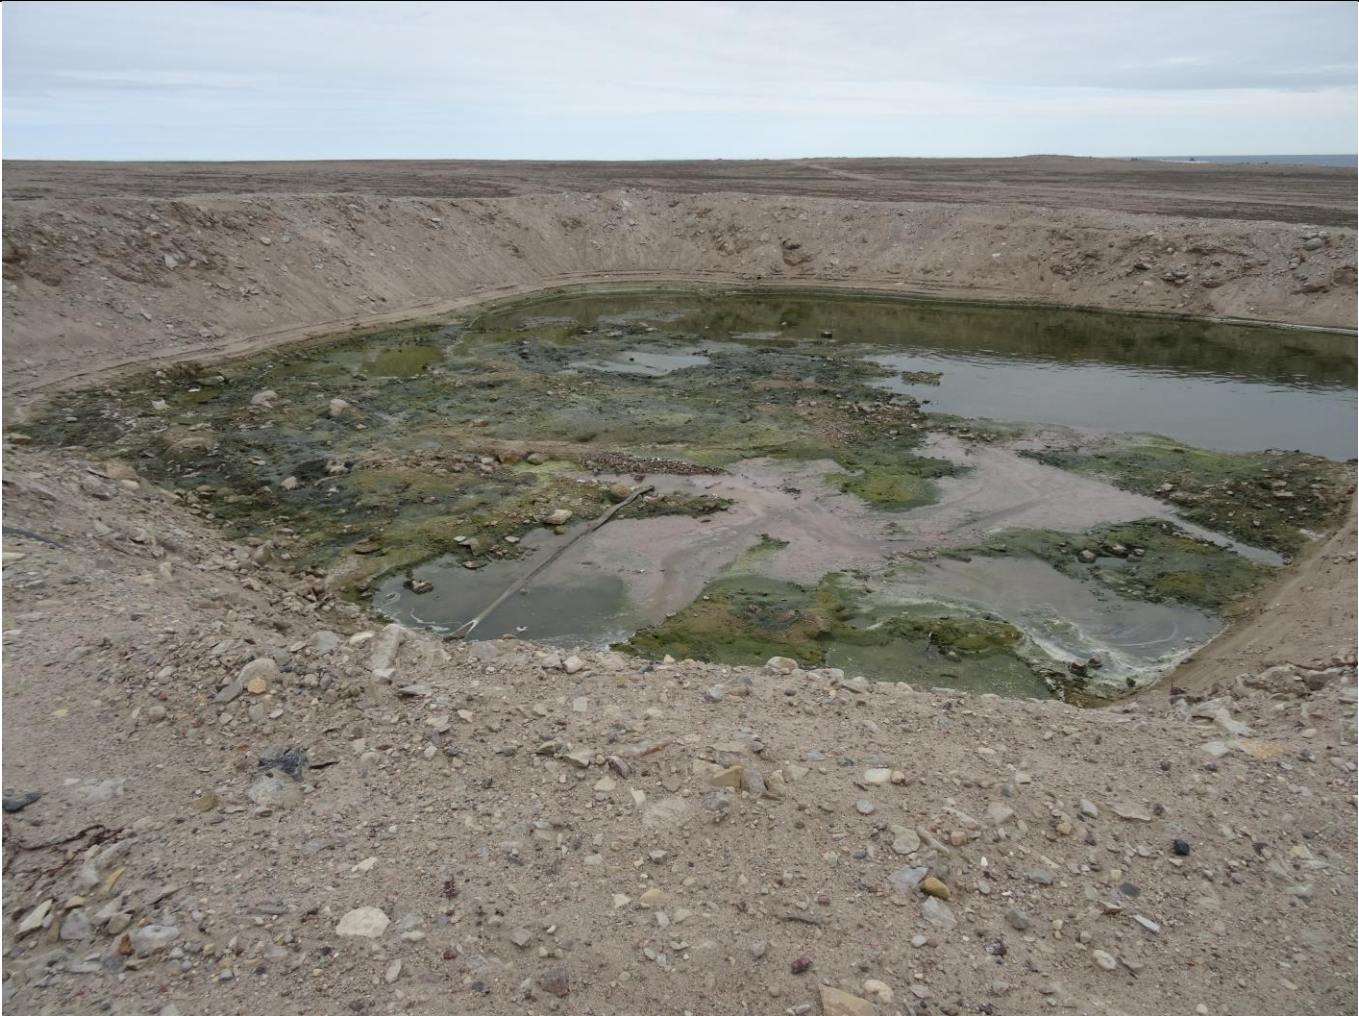
Photo 4

Description: Sewage Lagoon/Sump

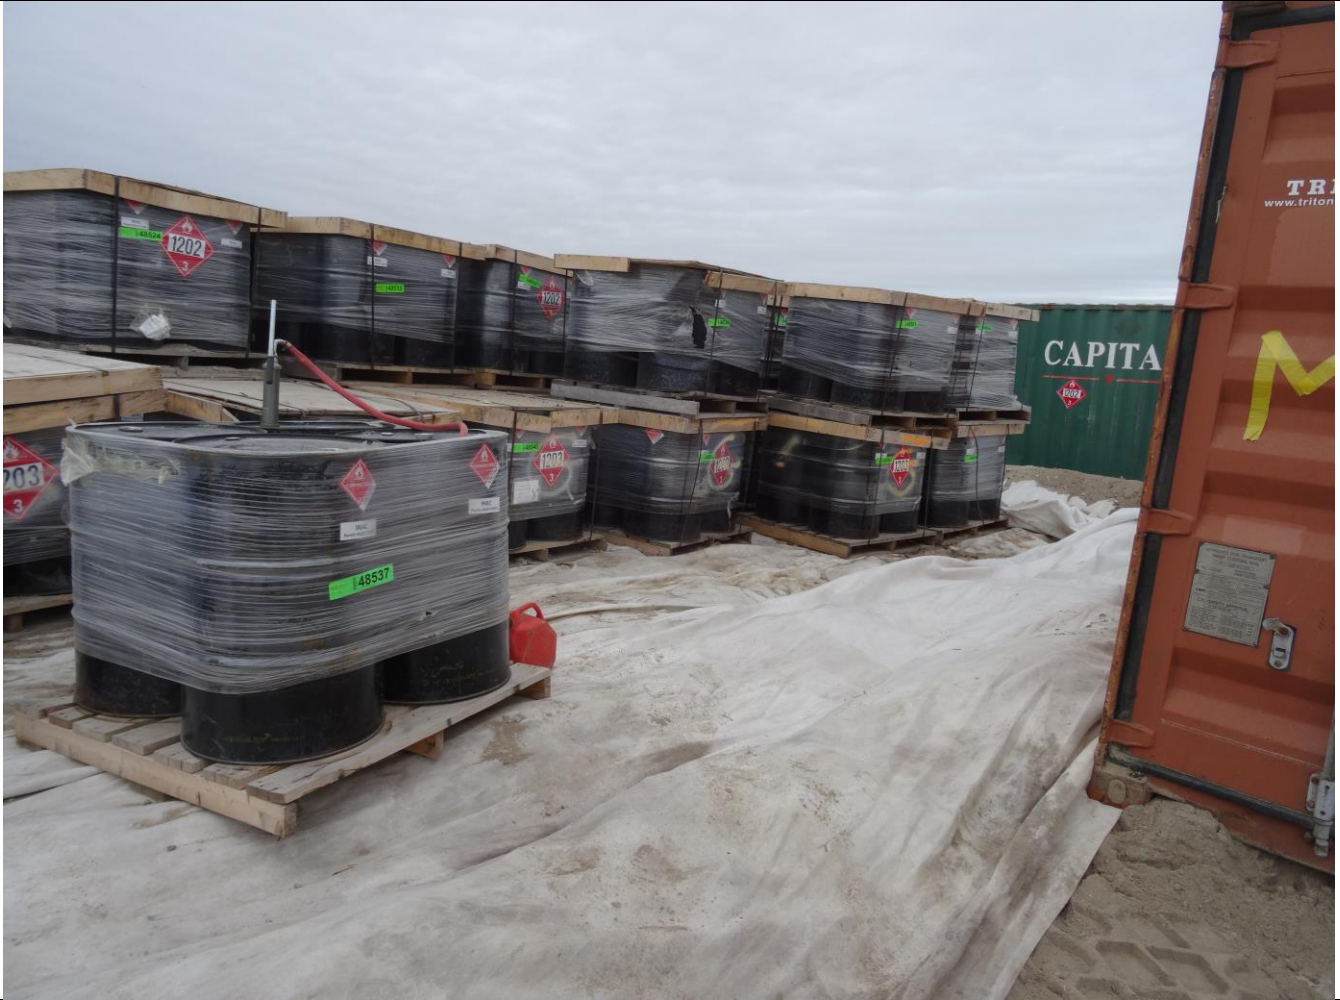
Photo 5

Description: Drummed Fuel Storage Area - Lined

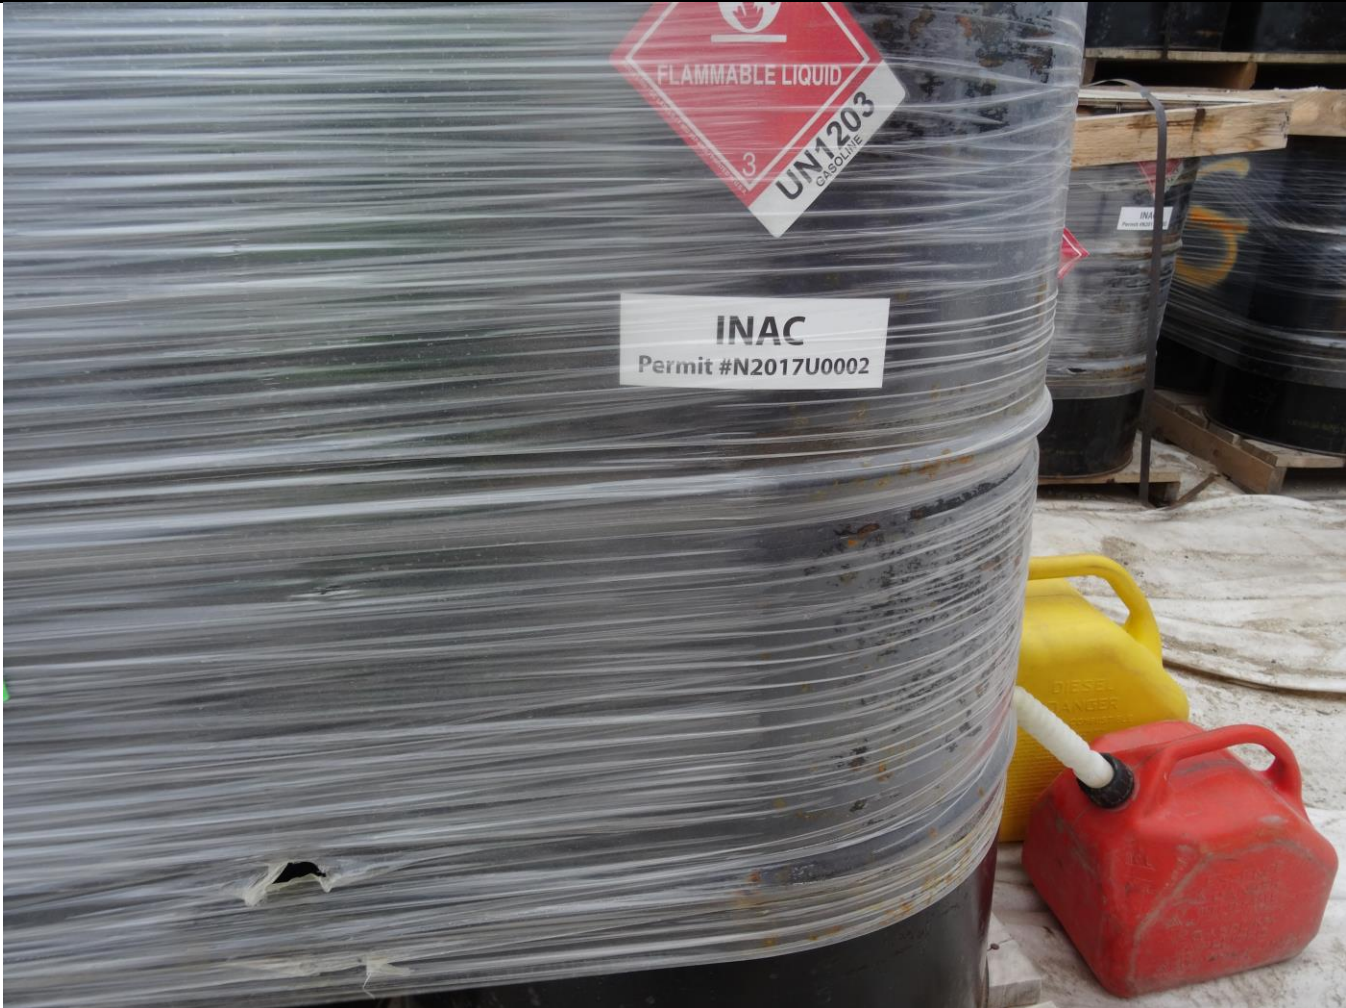
Photo 6

Description: LUP # Affixed to Every Drum of Fuel- Very Nice

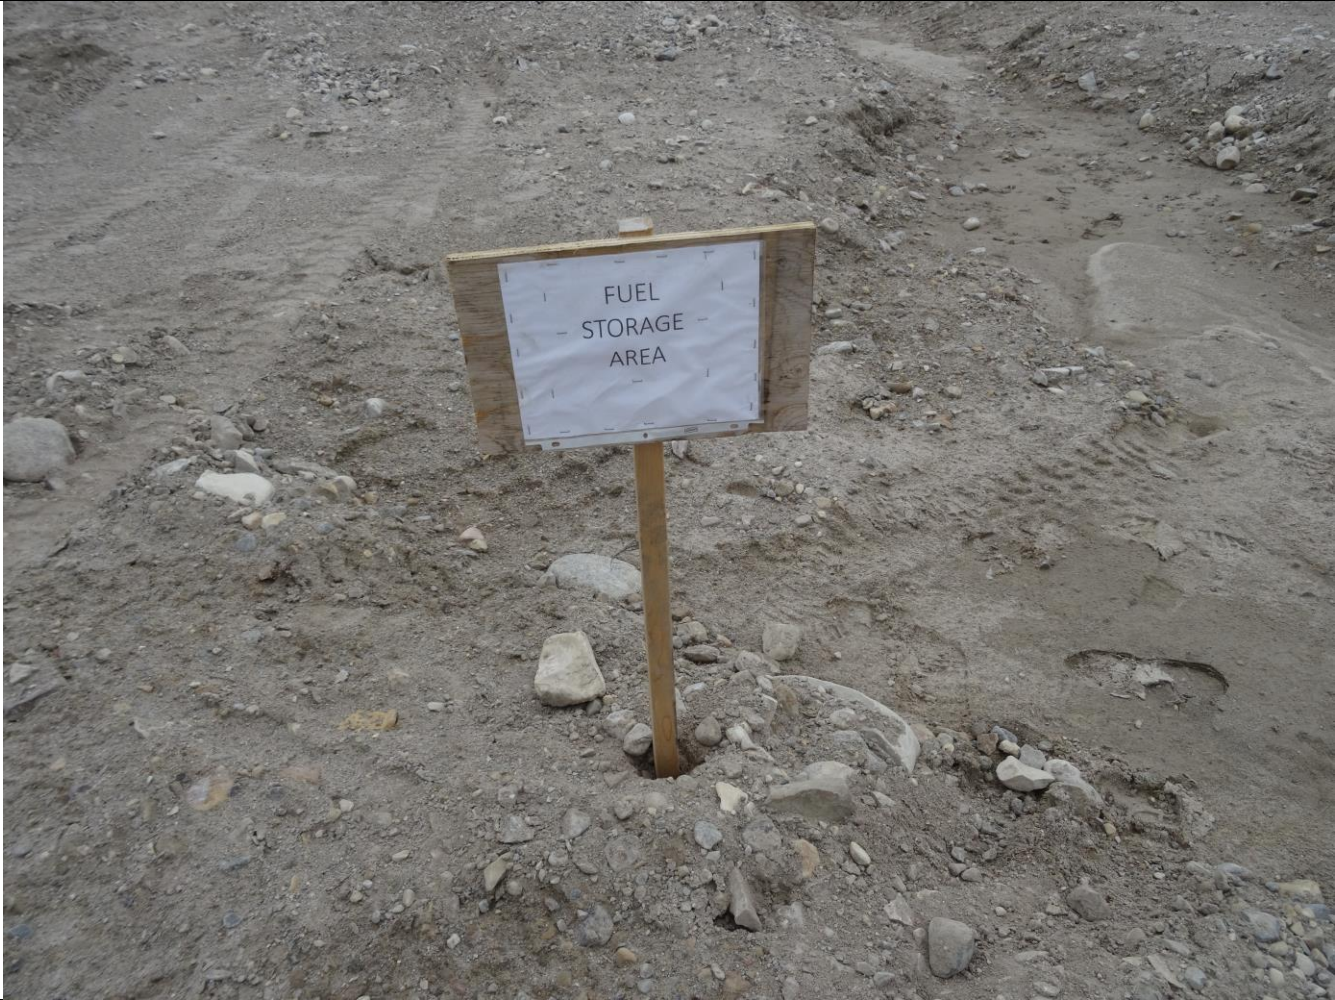
Photo 7

Description: Fuel Storage Area Signage – Very Nice

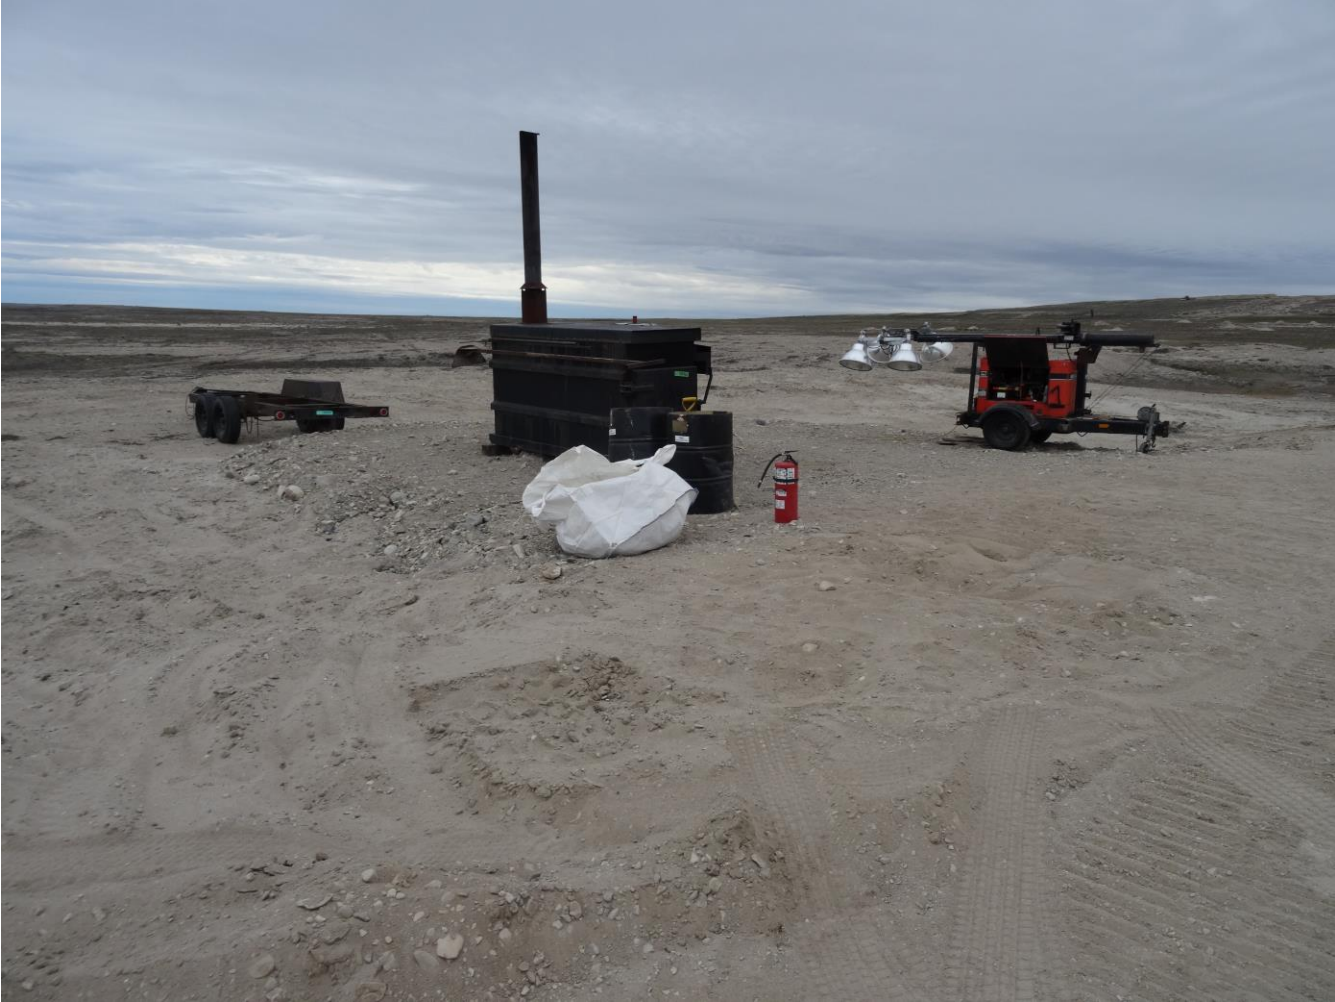
Photo 8

Description: Incinerator

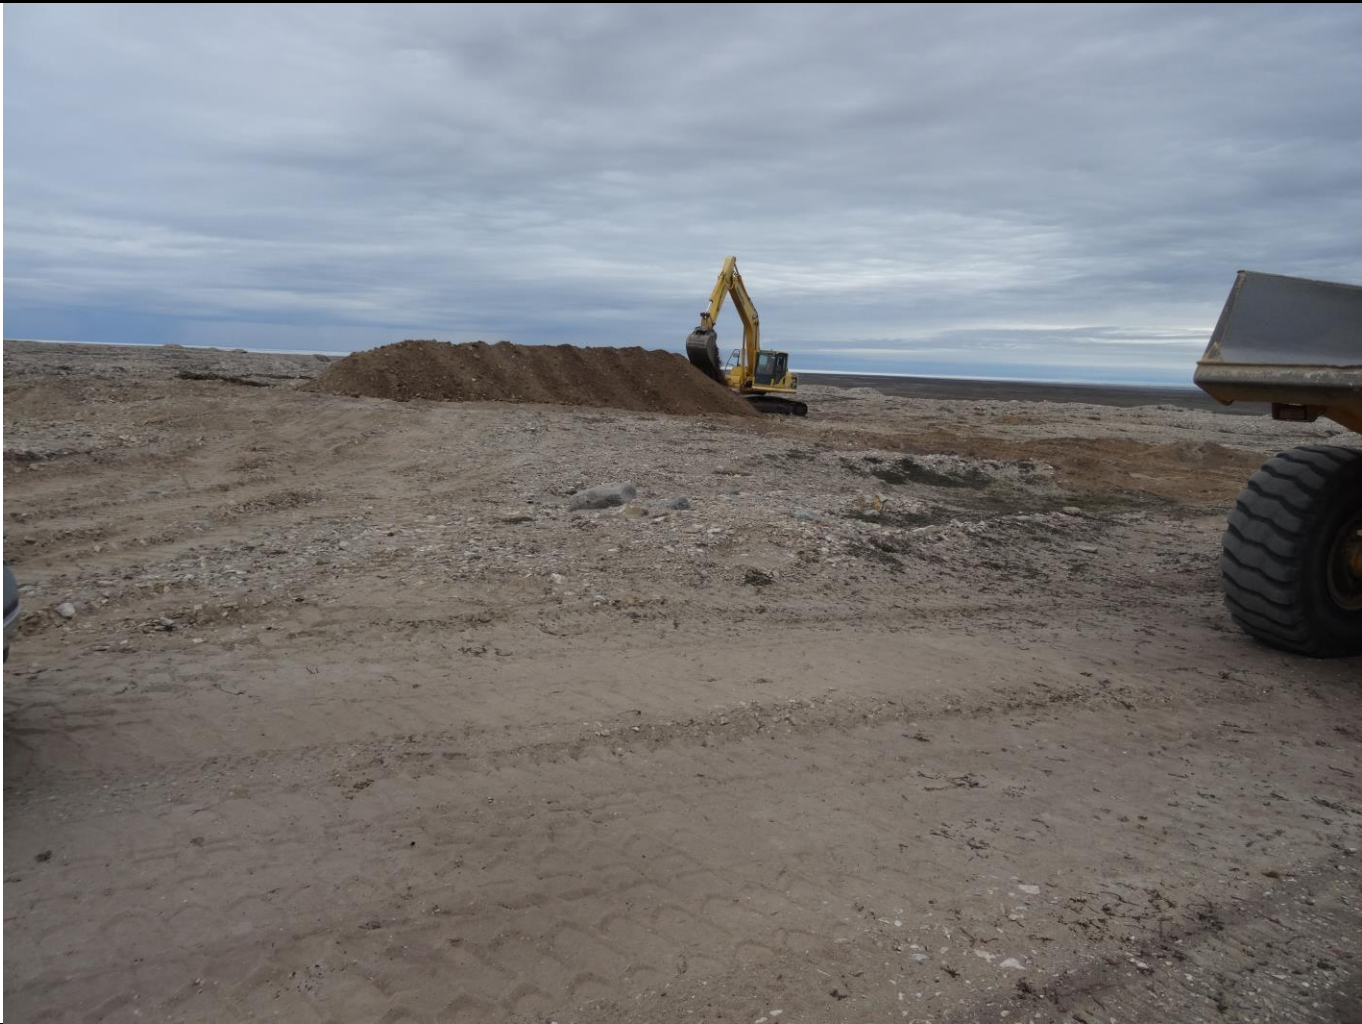
Photo 11

Description: Borrow Area 15

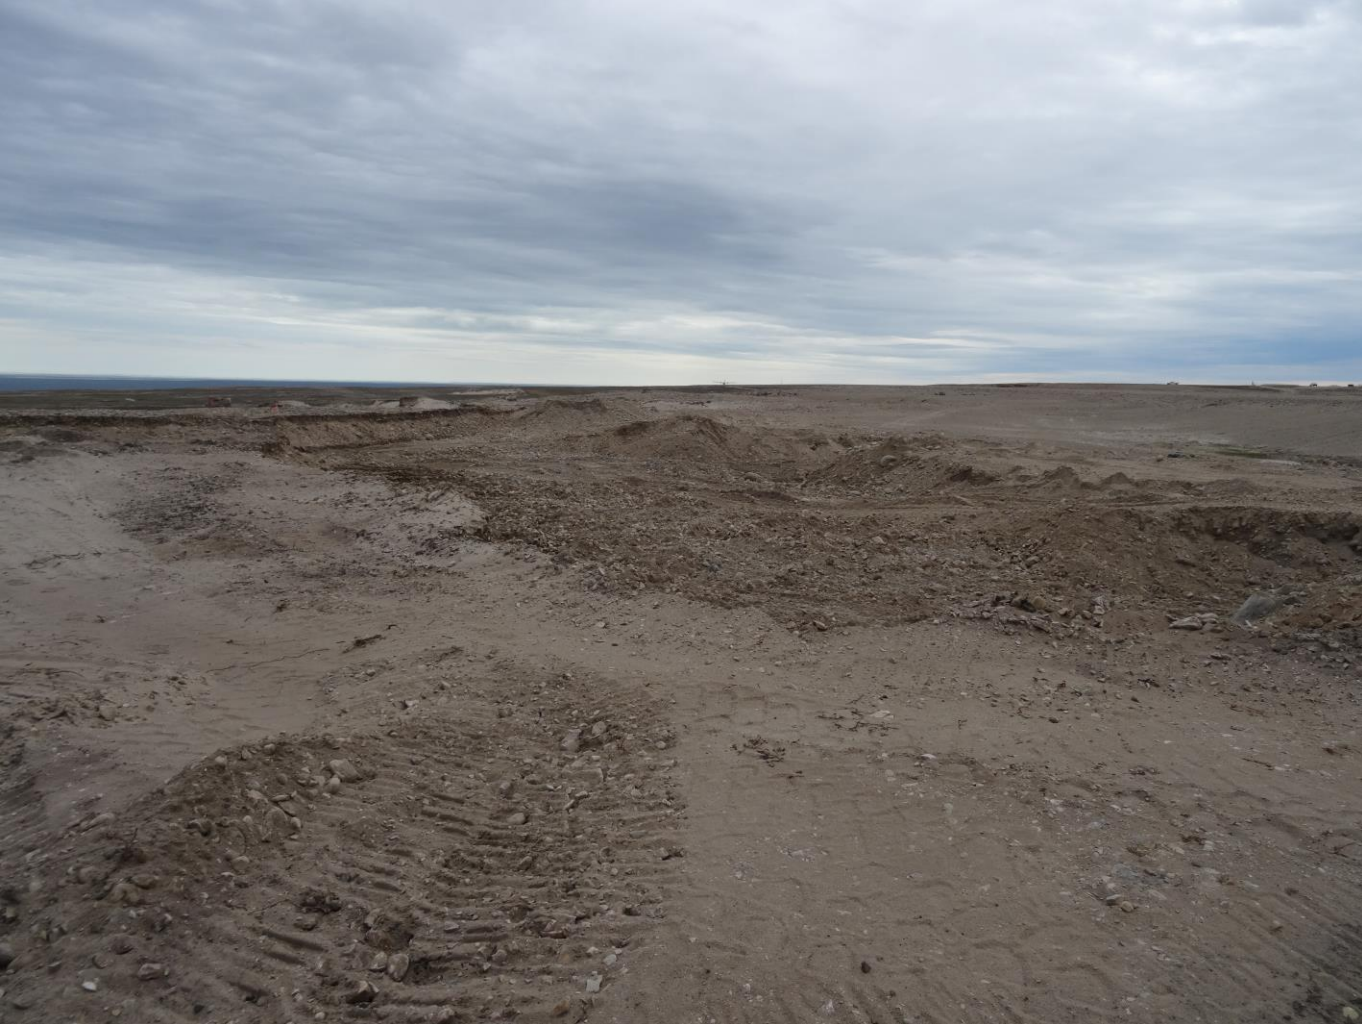
Photo 12

Description: Borrow Area 15

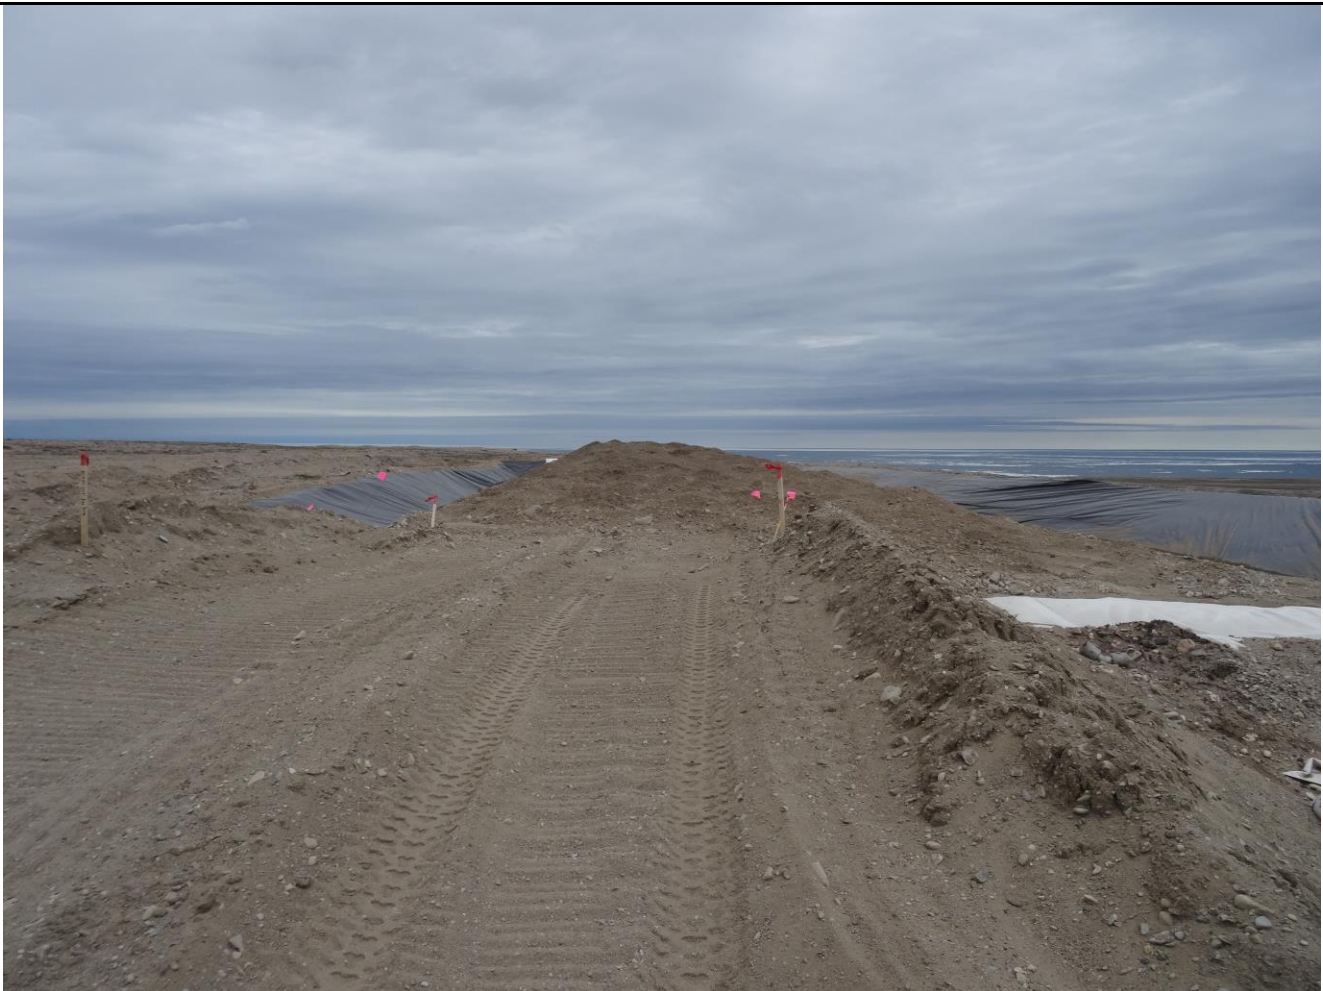
Description: Land Farm Treatment Area – Lined and Bermed

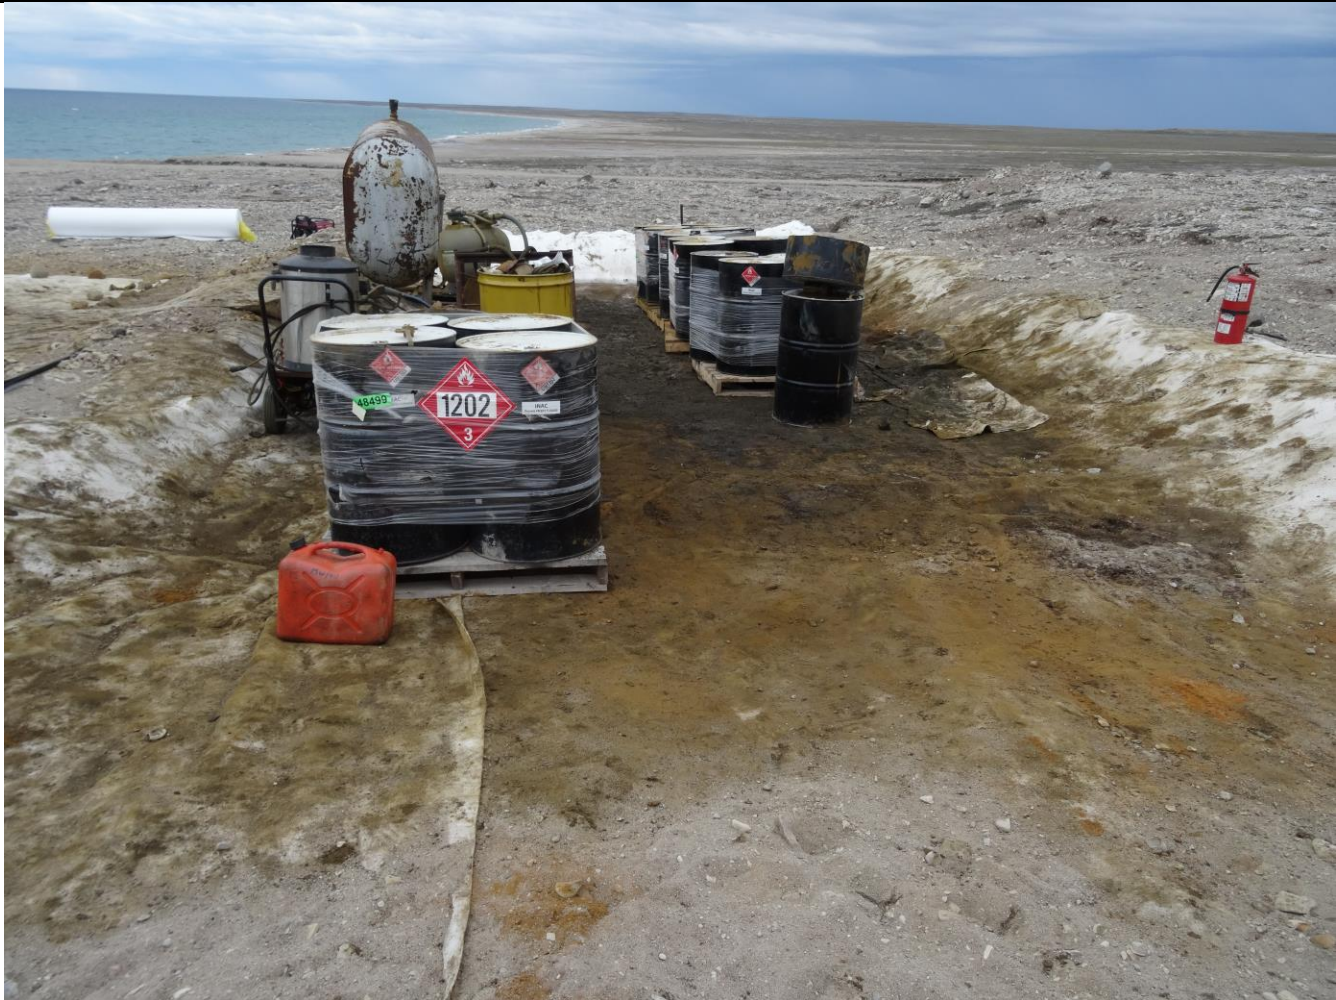
Description: Barrel Processing Area – Lined and Bermed
