WATER LICENCE INSPECTION FORM

Licensee		Licensee Representative	
Department of Indigenous and Northern Affairs Canada (INAC) Box 100 Iqaluit, Nunavut X0AOHO		Jessie Hoyt – Environmental Engineer- PWGSC Allen MacGarvie –Stantec Brandon MacKay- Englobe Kimberly Krug- Stantec	
Licence No. / Expiry		Representative's Title	
1BR-NIR1419		Environmental Engineer	
Land / Other Authorizations		Land / Other Authorizations	
N2013U0015		Nil	
Date of Inspection		Inspector	
June 22,2016		A.Keim	
Activities Inspected			
<input type="checkbox"/> Camp <input type="checkbox"/> Drilling <input type="checkbox"/> Mining <input type="checkbox"/> Construction <input checked="" type="checkbox"/> Reclamation <input type="checkbox"/> Fuel Storage <input type="checkbox"/> Roads/Hauling <input type="checkbox"/> Other: Water Discharge <input type="checkbox"/> Other: Municipal

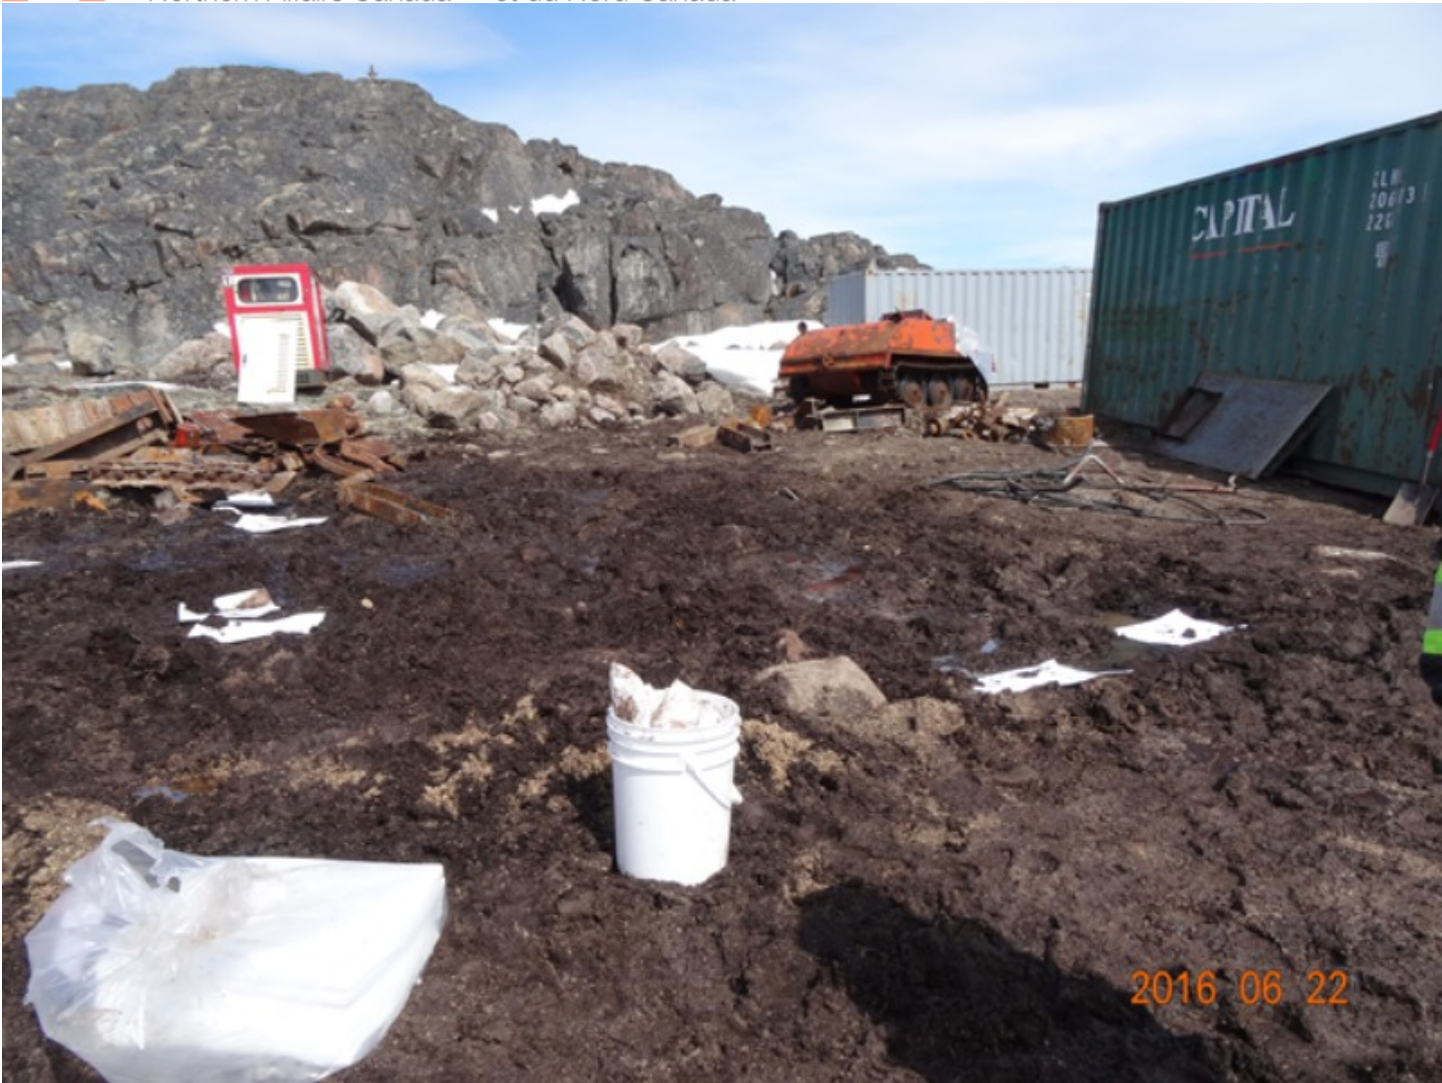
Figure 1- Small spill of hydraulic fluid on site

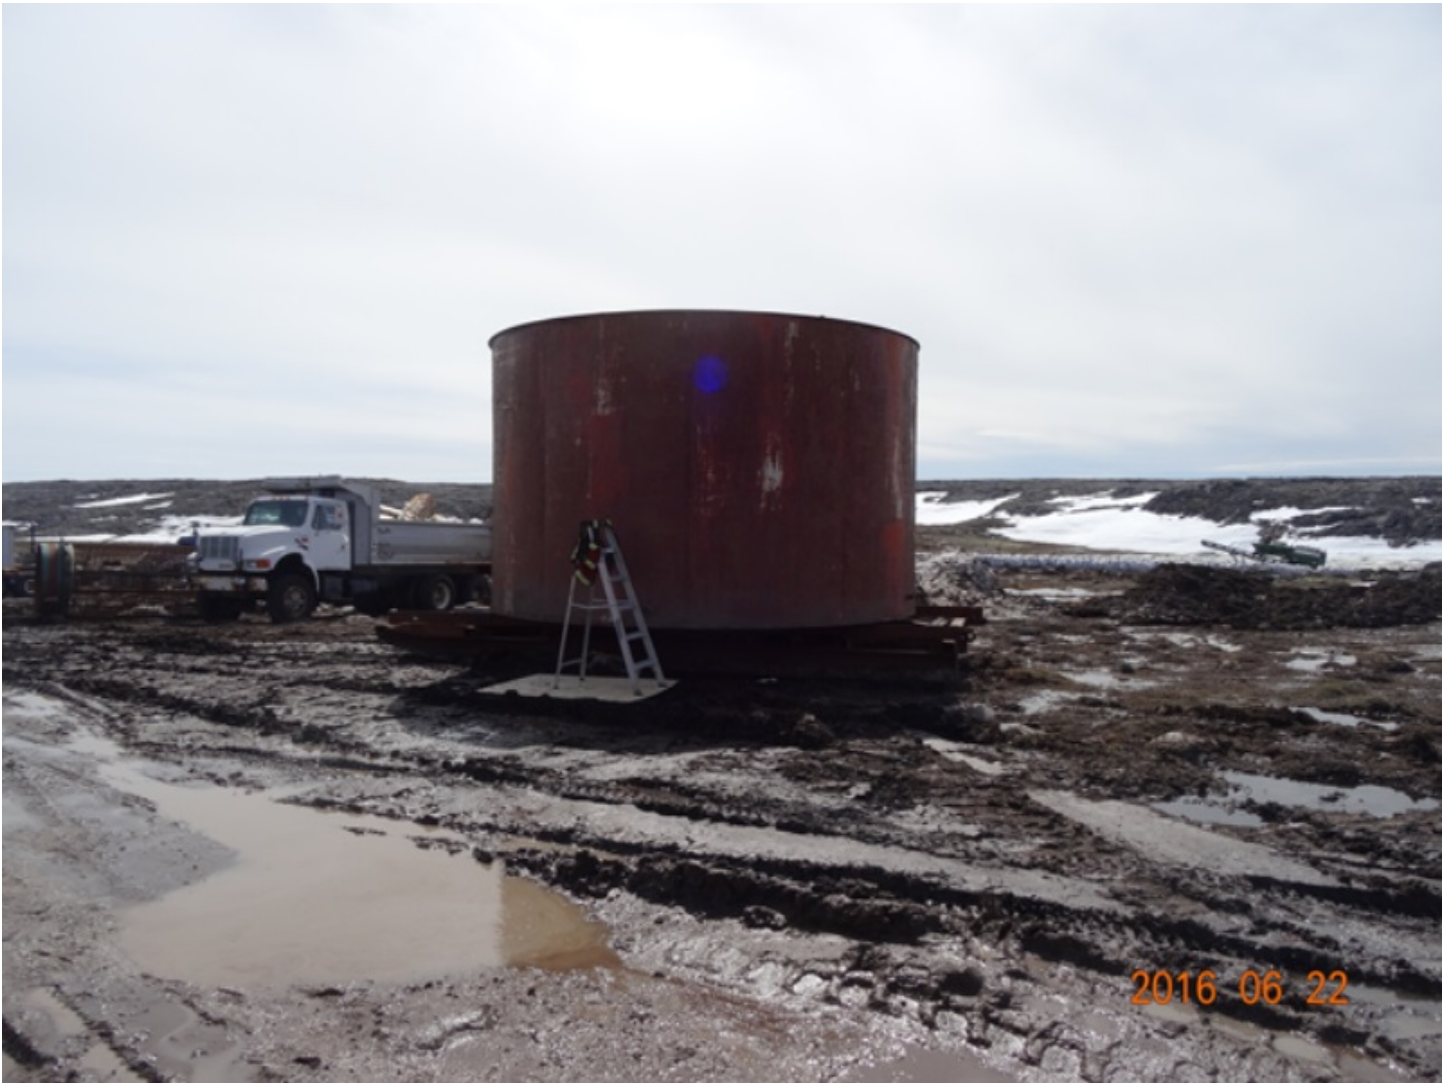
Figure 2 One of the two bulk fuel storage tanks on site

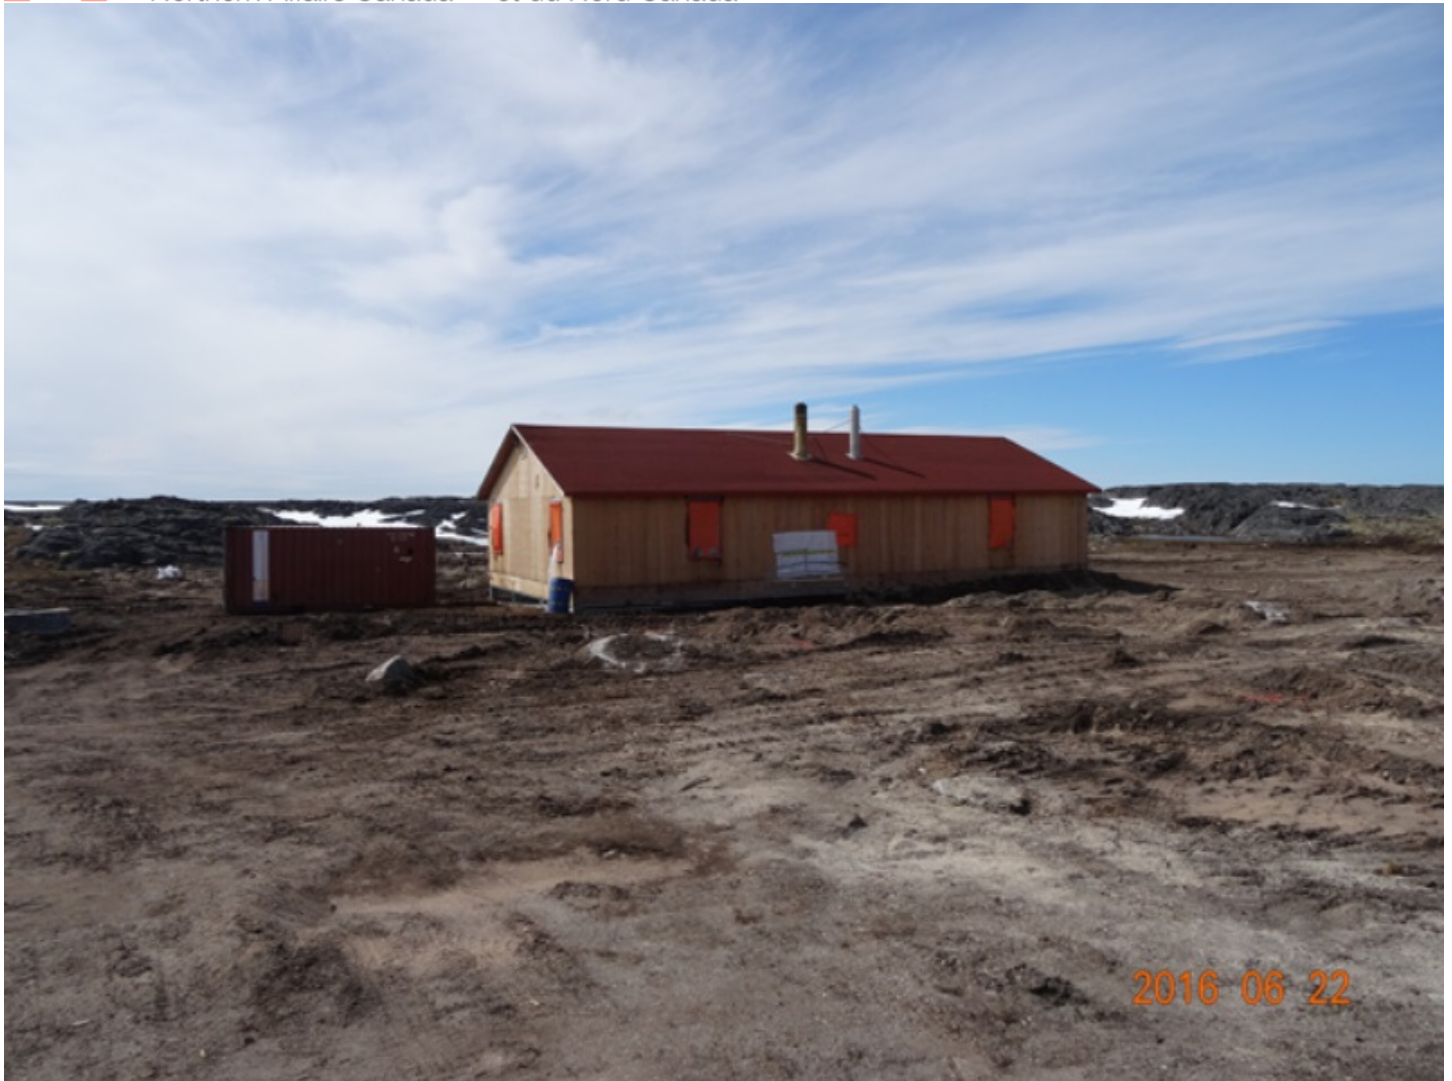
Figure 3- Building on site, to be dismantled

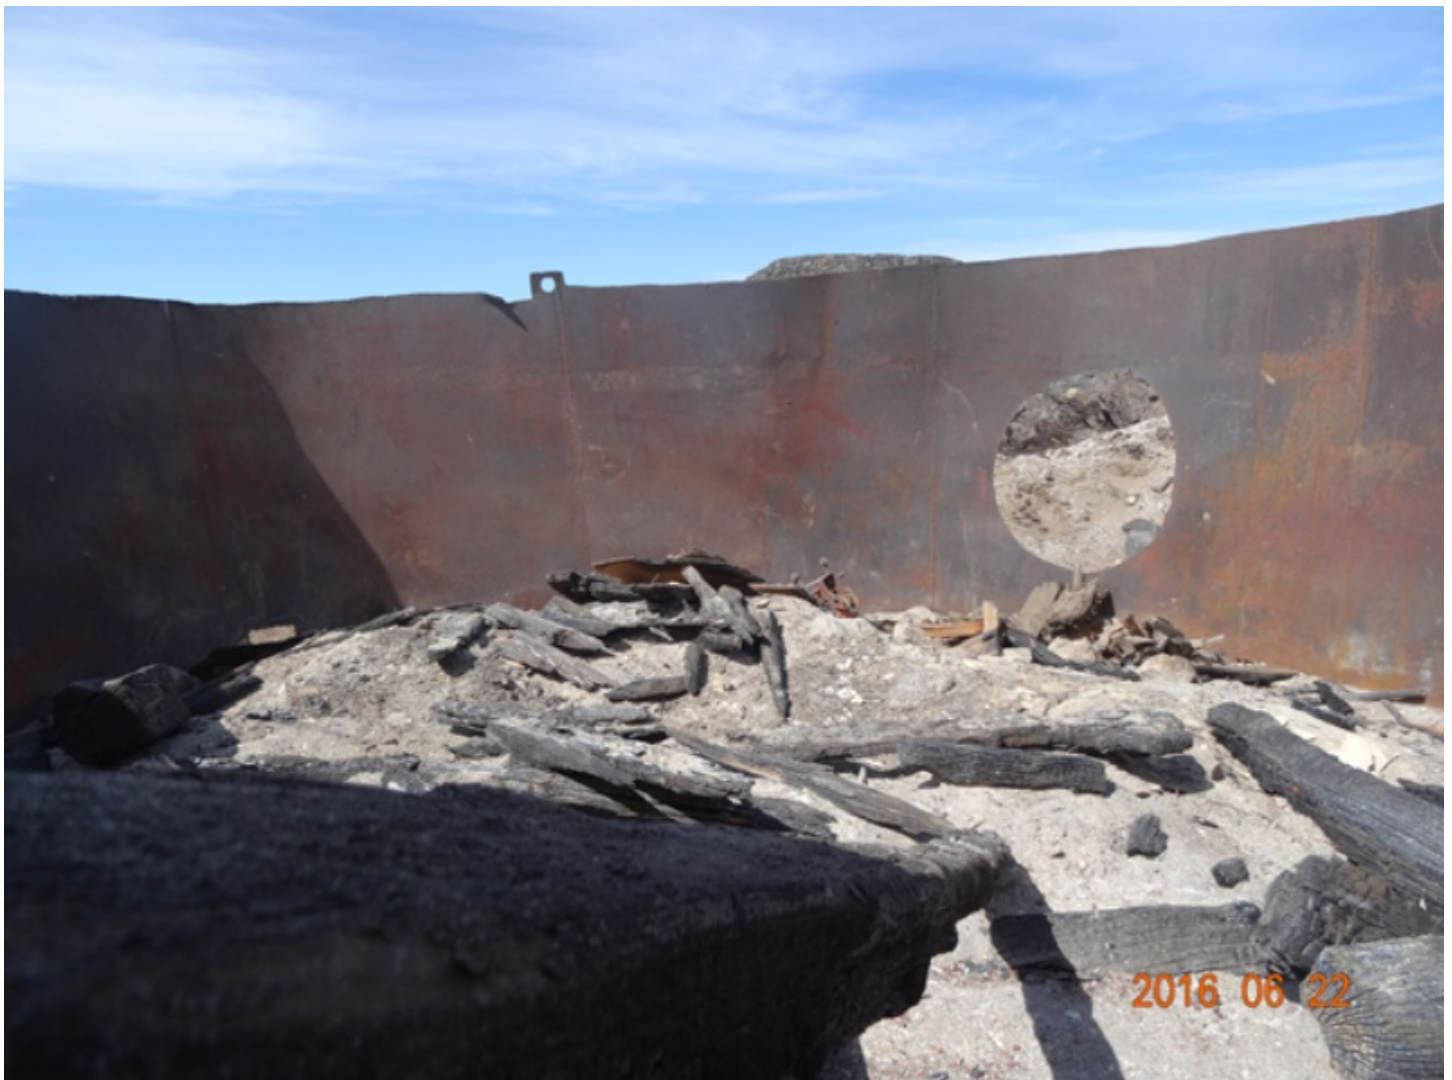
Figure 4 Burn bin for clean wood

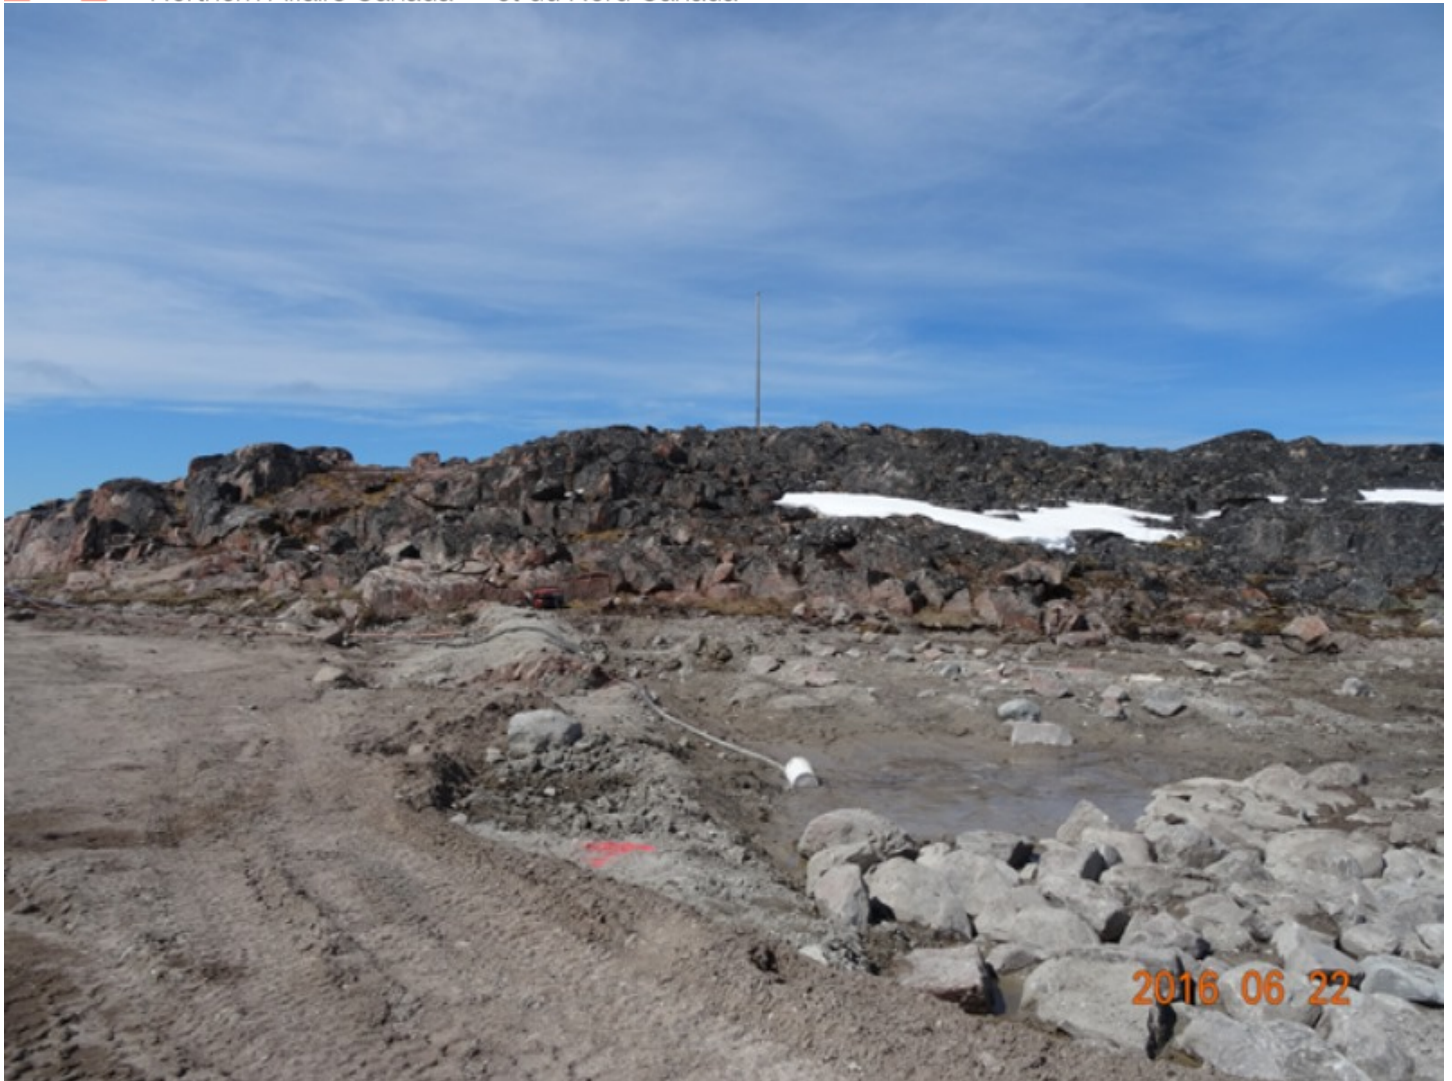
Figure 5 From site of main camp looking back to shoreline. water accumulation from freshet

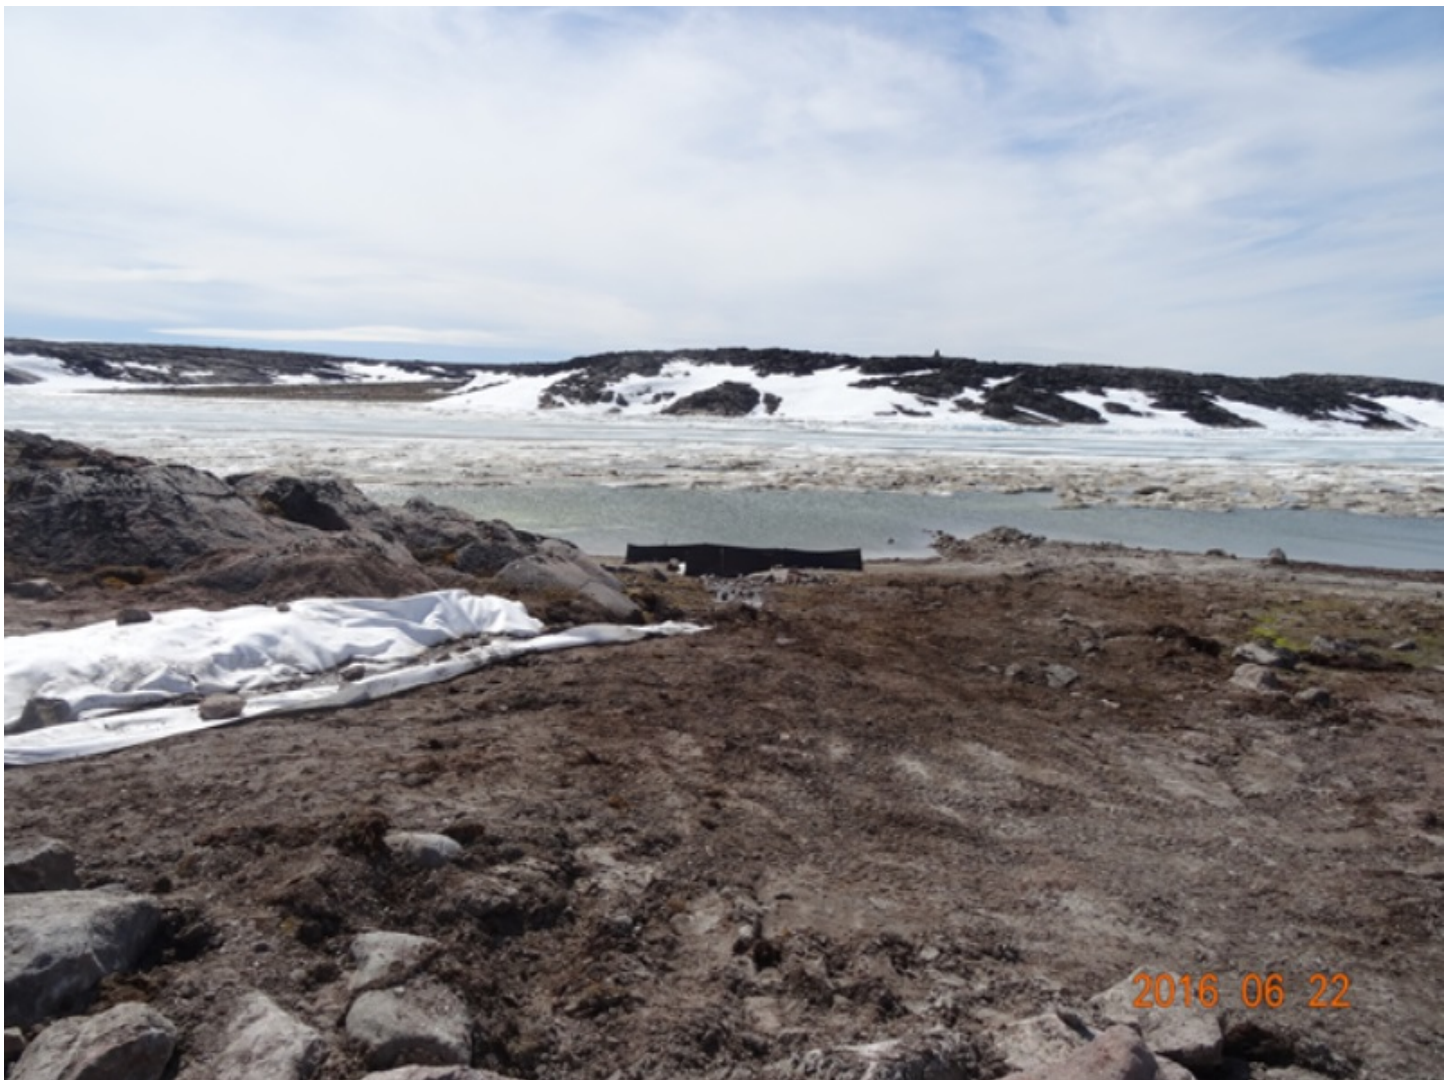
One other issue identified by the PWGS representative as well as by the Stantec representative to the Inspector during the Inspection was the issue over mitigations put in place to address possible erosion and sedimentation down gradient from the Hydrocarbon contamination clean up location above the sea-lift beach area. .

1. From the main camp location down gradient to the beach head impacted soils have been removed. The area has been back filled and regraded however there remains concern over the possibility that surface flow may carry fine cover material down grade and this may in turn affect the stability of the excavation and sediment buildup on the beach. Measures to reduce the flow and to slow run off have been put in place by the Licensee and are to be monitored to ensure their effectiveness.

Figure 6 Beach head and on site erosion control measures

The Inspector notes that the monitoring of erosion/ sedimentation or surface water management is not included within the Water Management plan for the site or as a specific condition of the license. It is recommended that monitoring of the mitigations form part of the long term monitoring program/ license for the site so as to identify and avoid the deposit of materials beyond the beach head and into the Marine environment.

It is recommended that the Licensee monitor next year’s Freshet to monitor the success of the measures put in place.

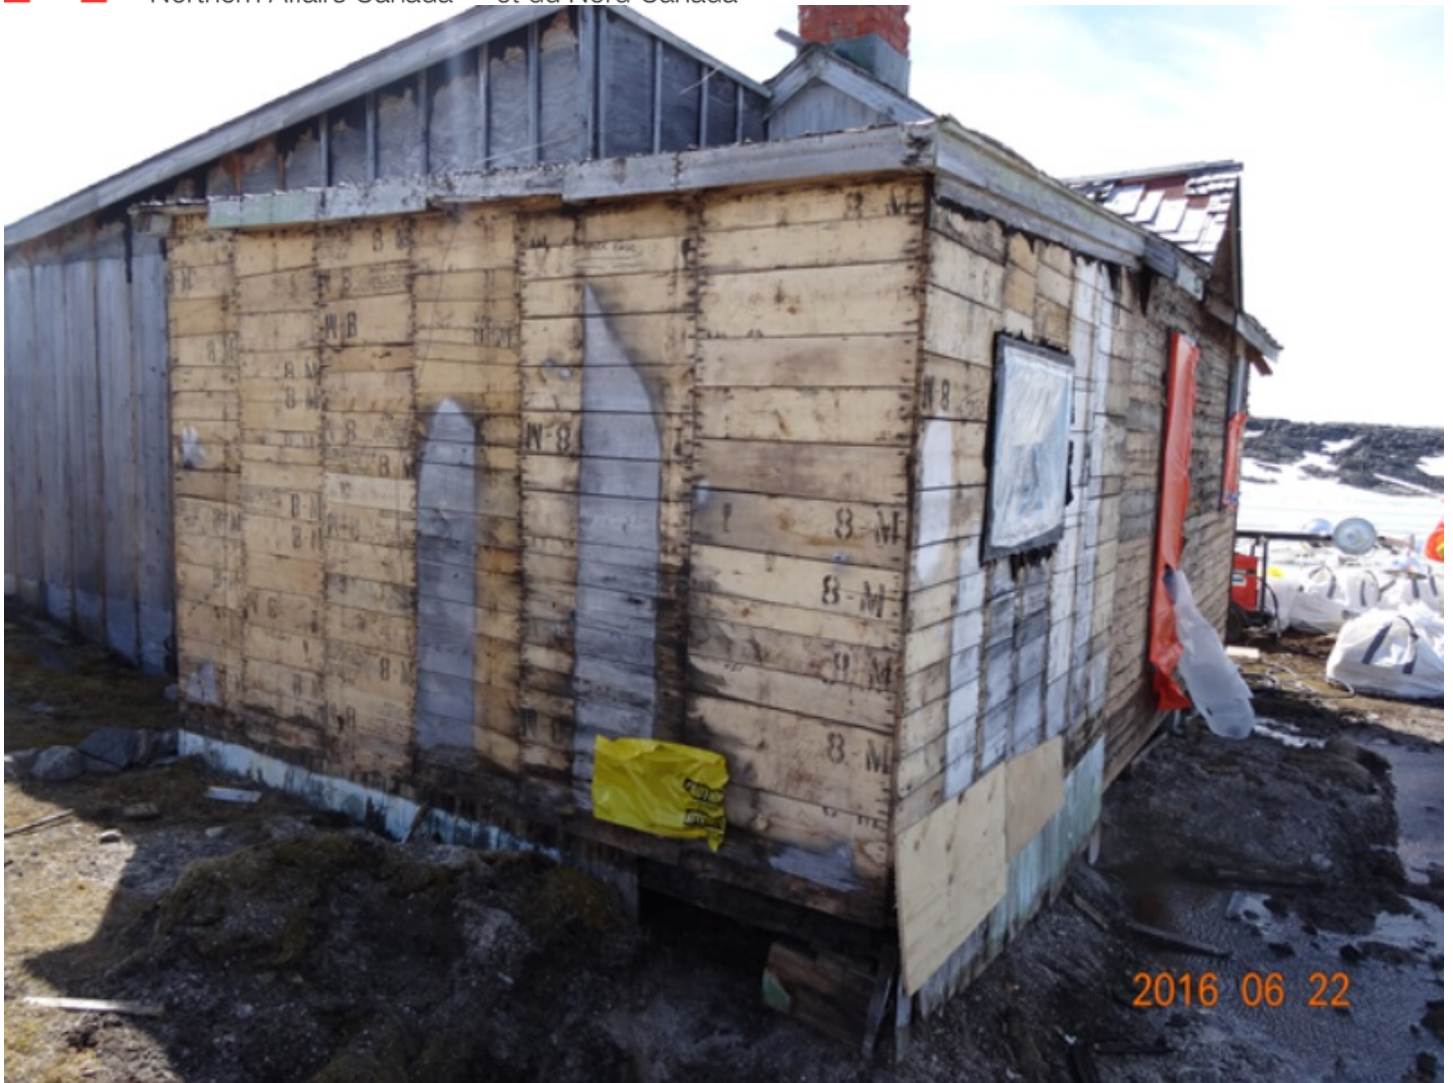
Figure 7 Old residence for cleaners/cooks

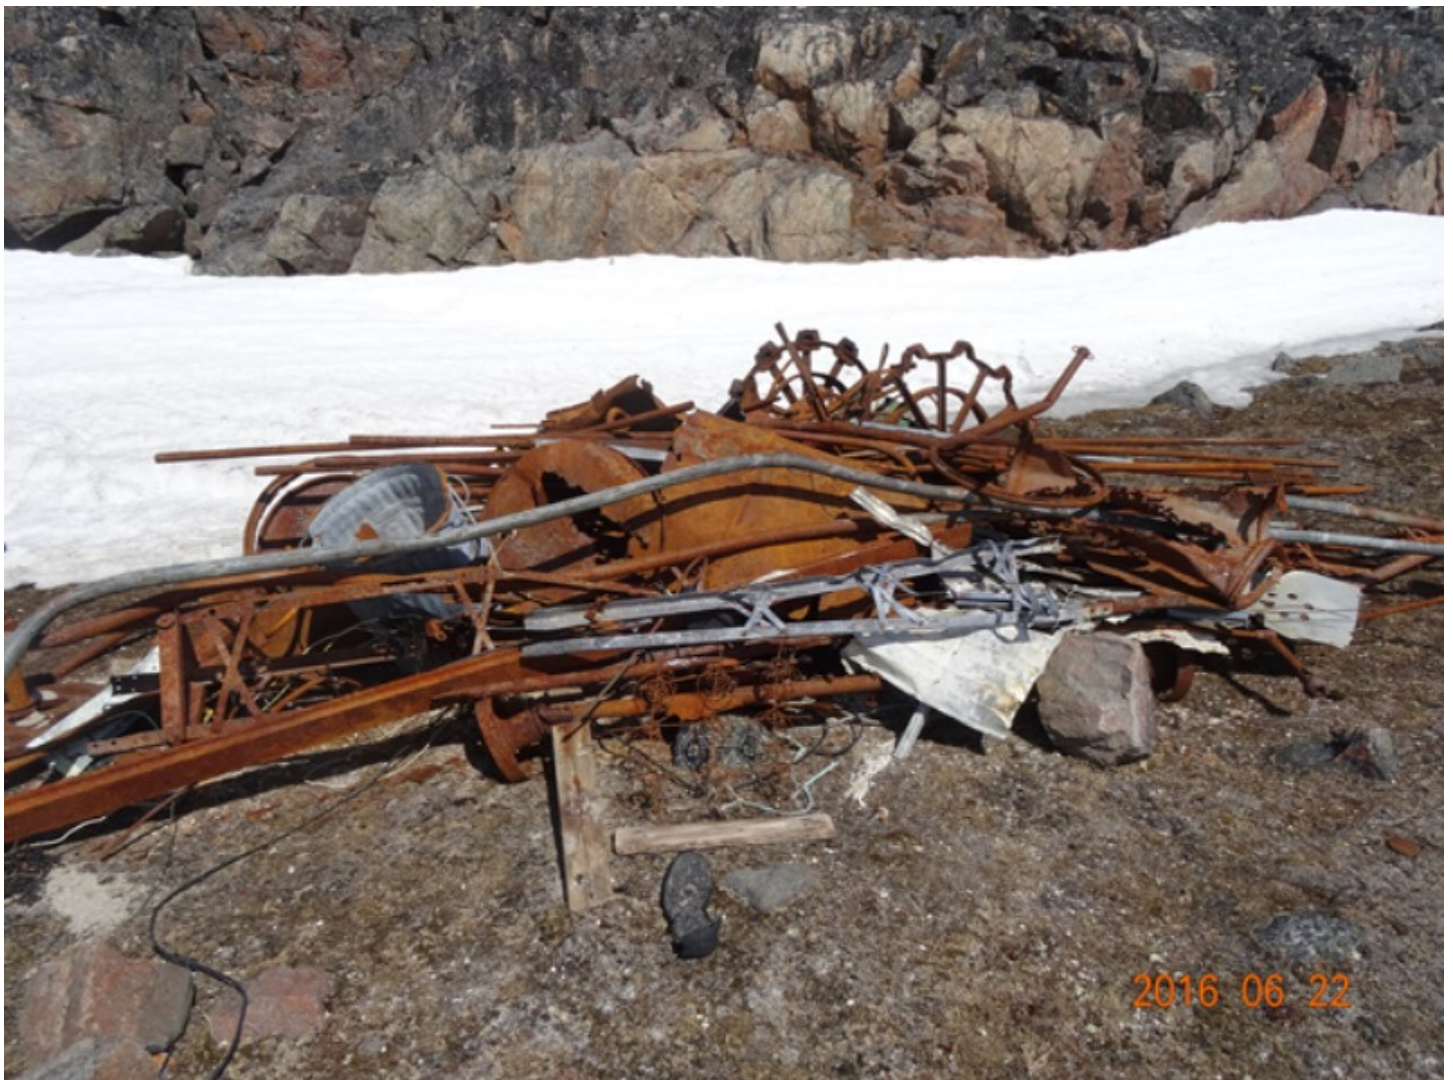
Figure 8 Scrap metal and debris to be cur and bagged

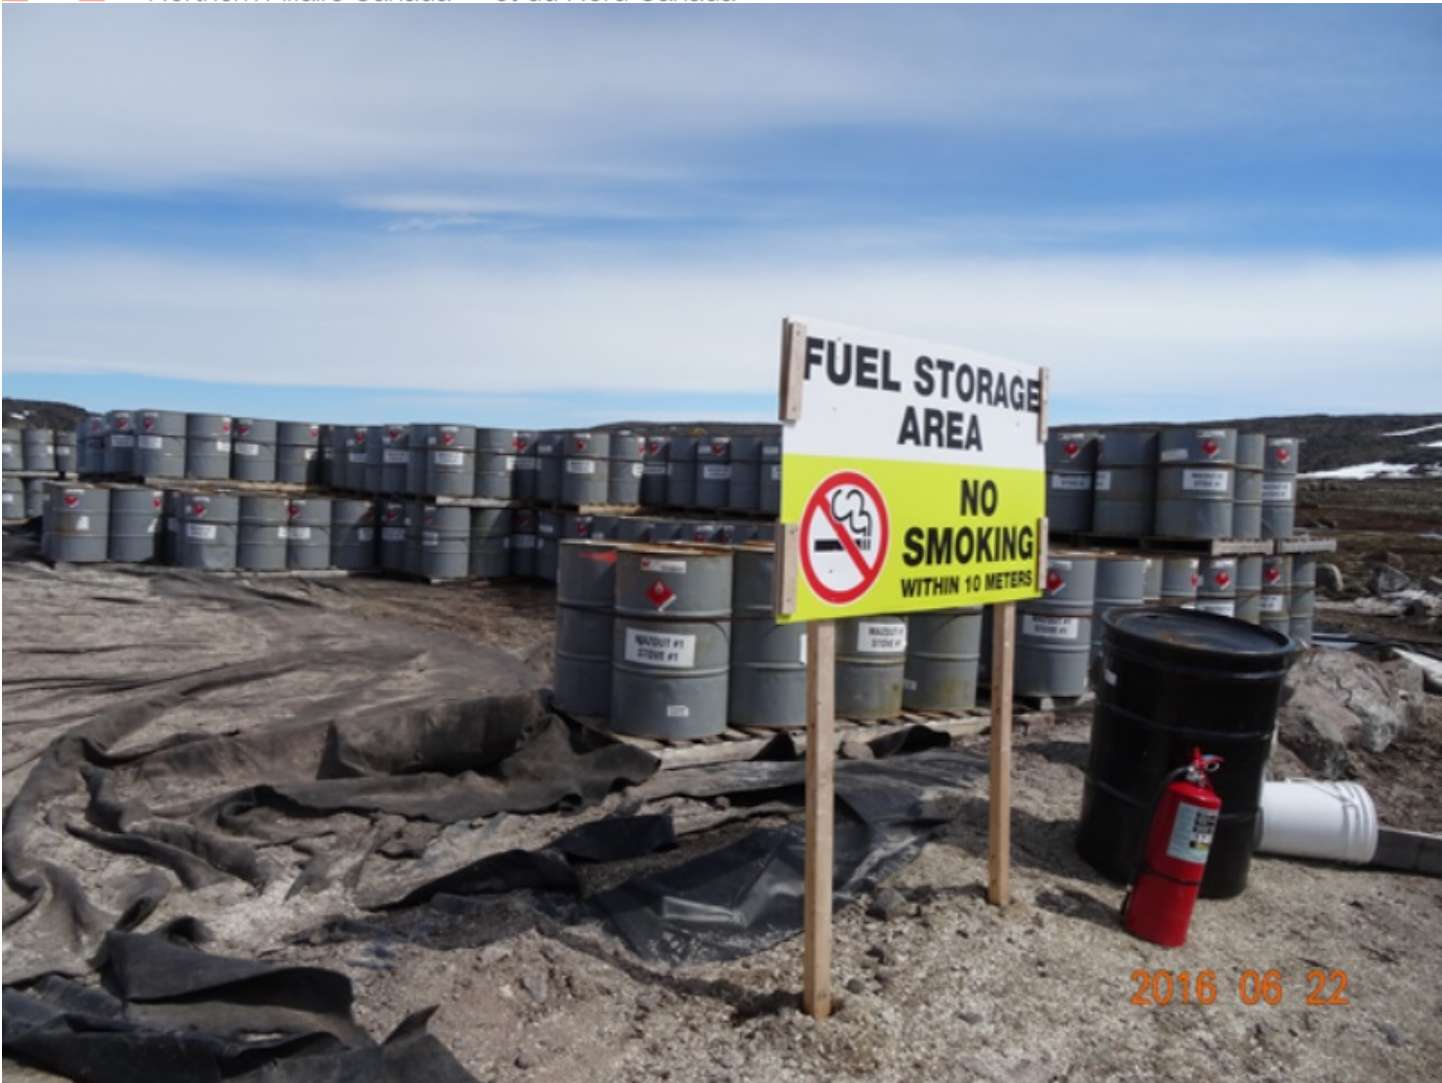
Figure 9 Drum fuel storage area

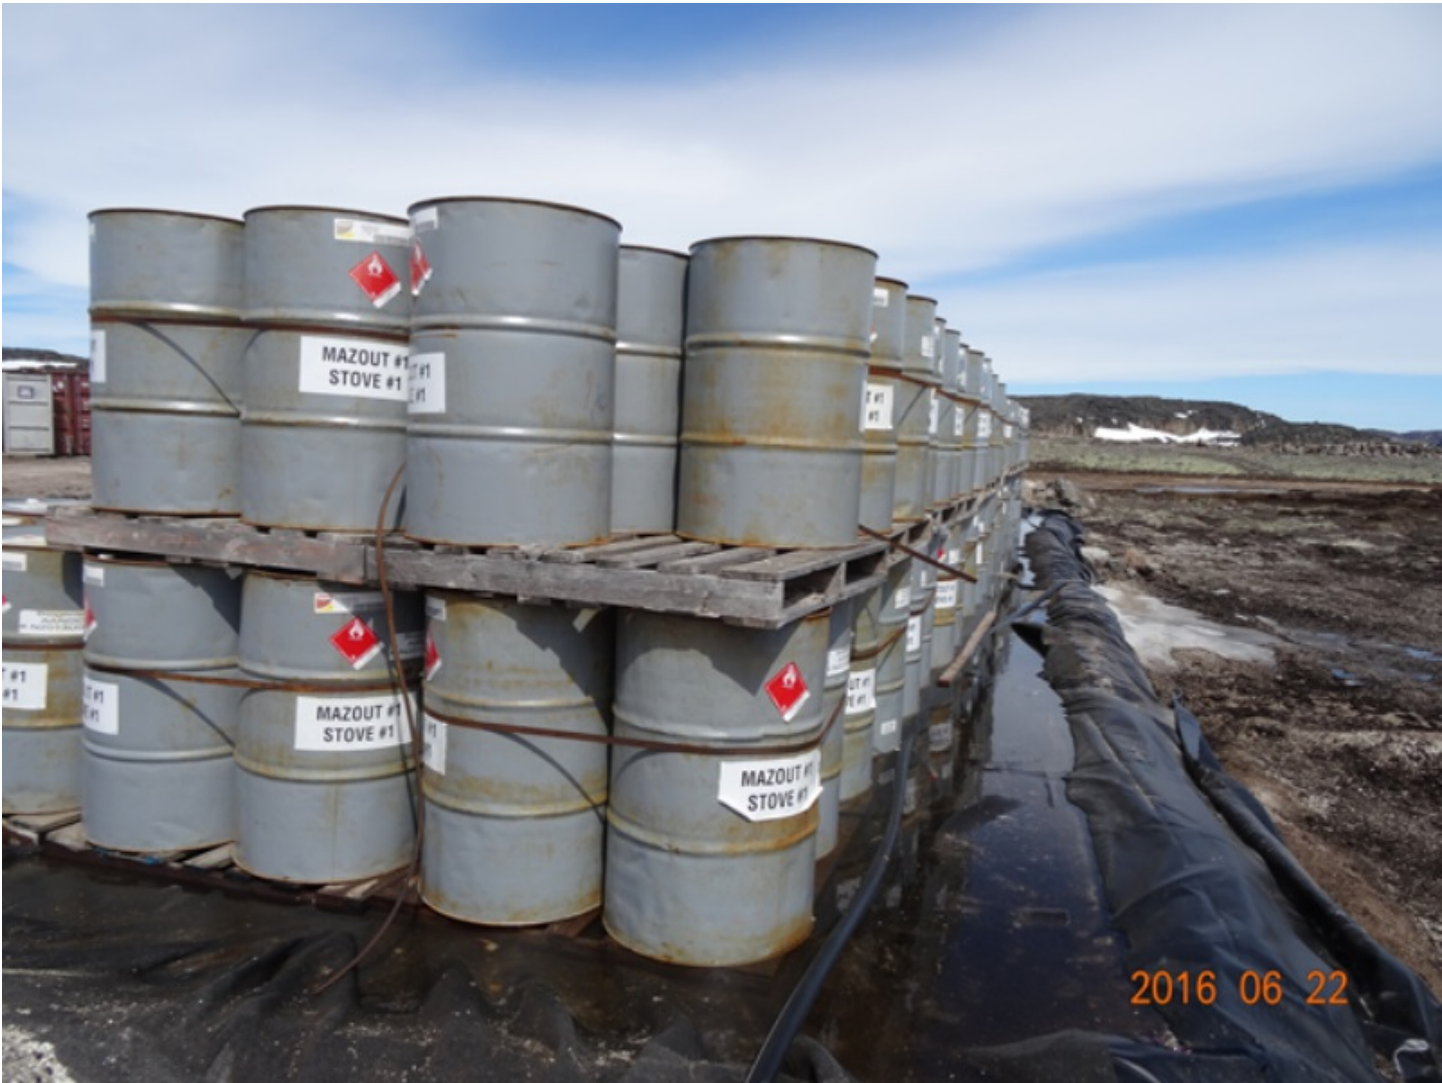
Figure 10 drum fuel storage

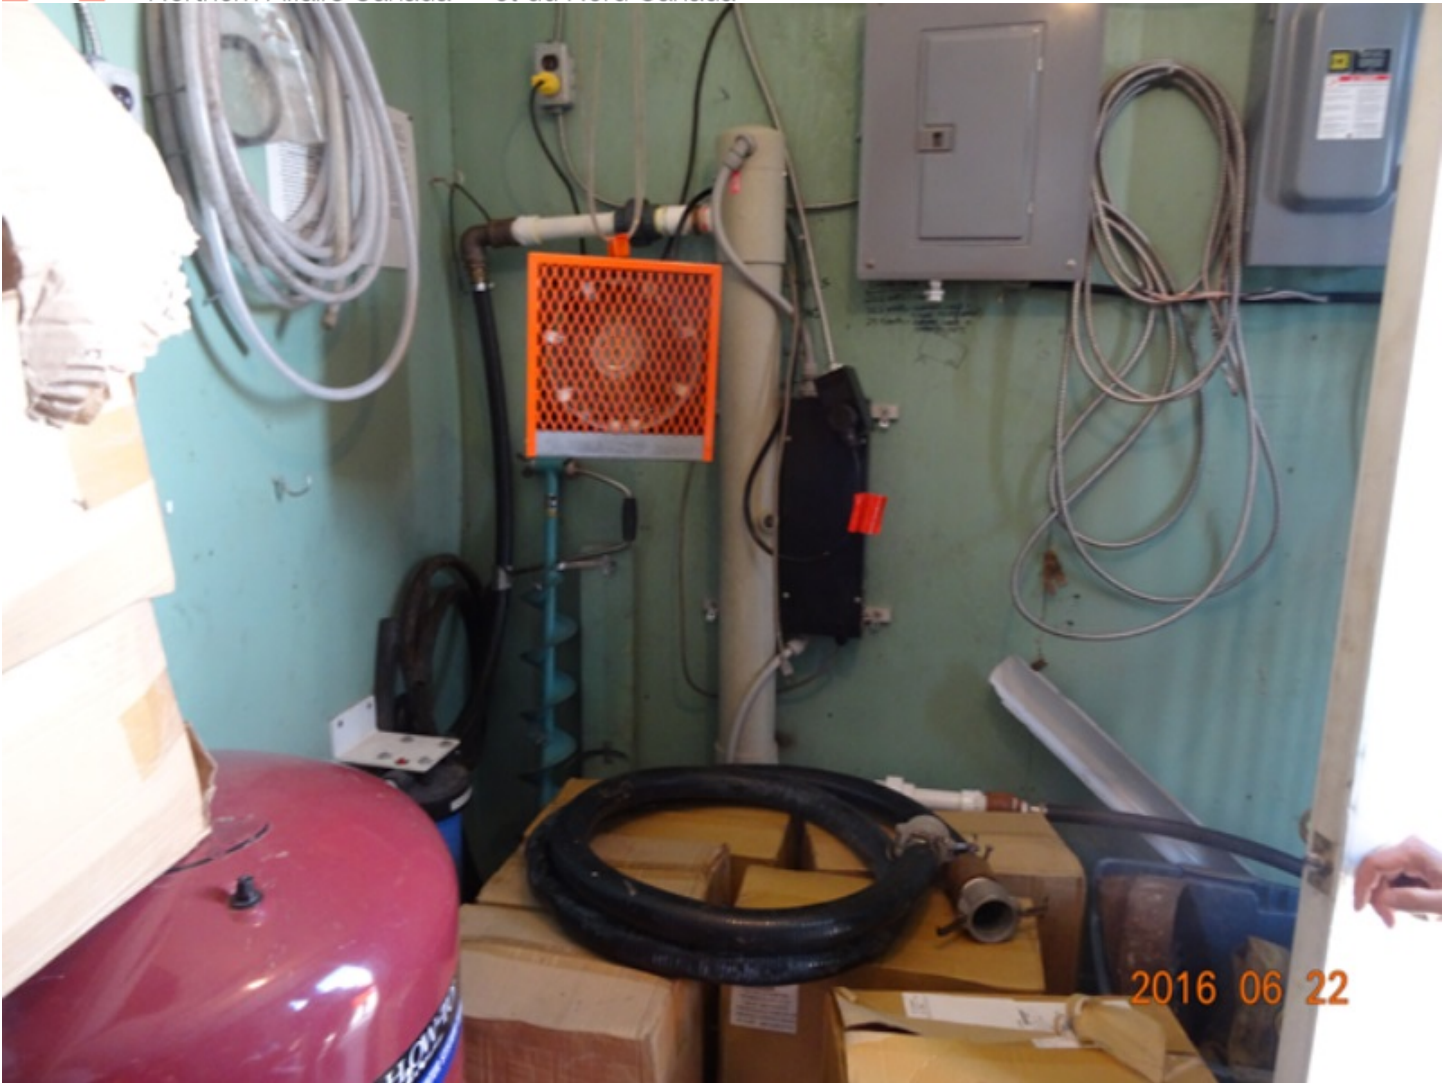
Figure 11 Sand filters and UV water treatment

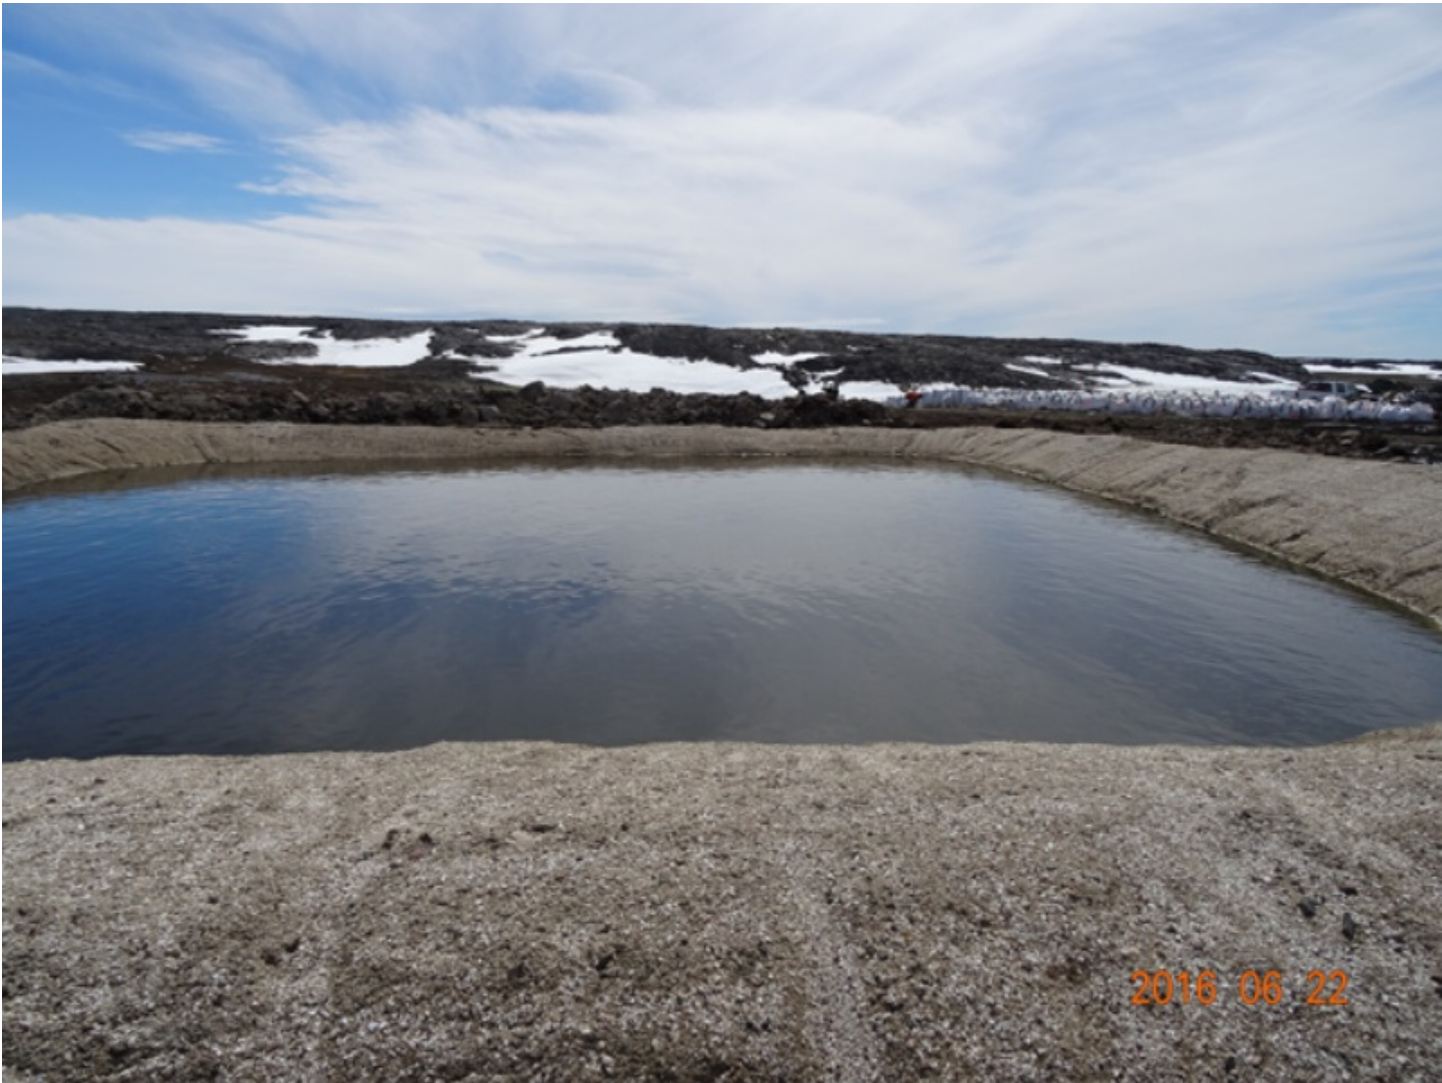
Figure 12 Lagoon

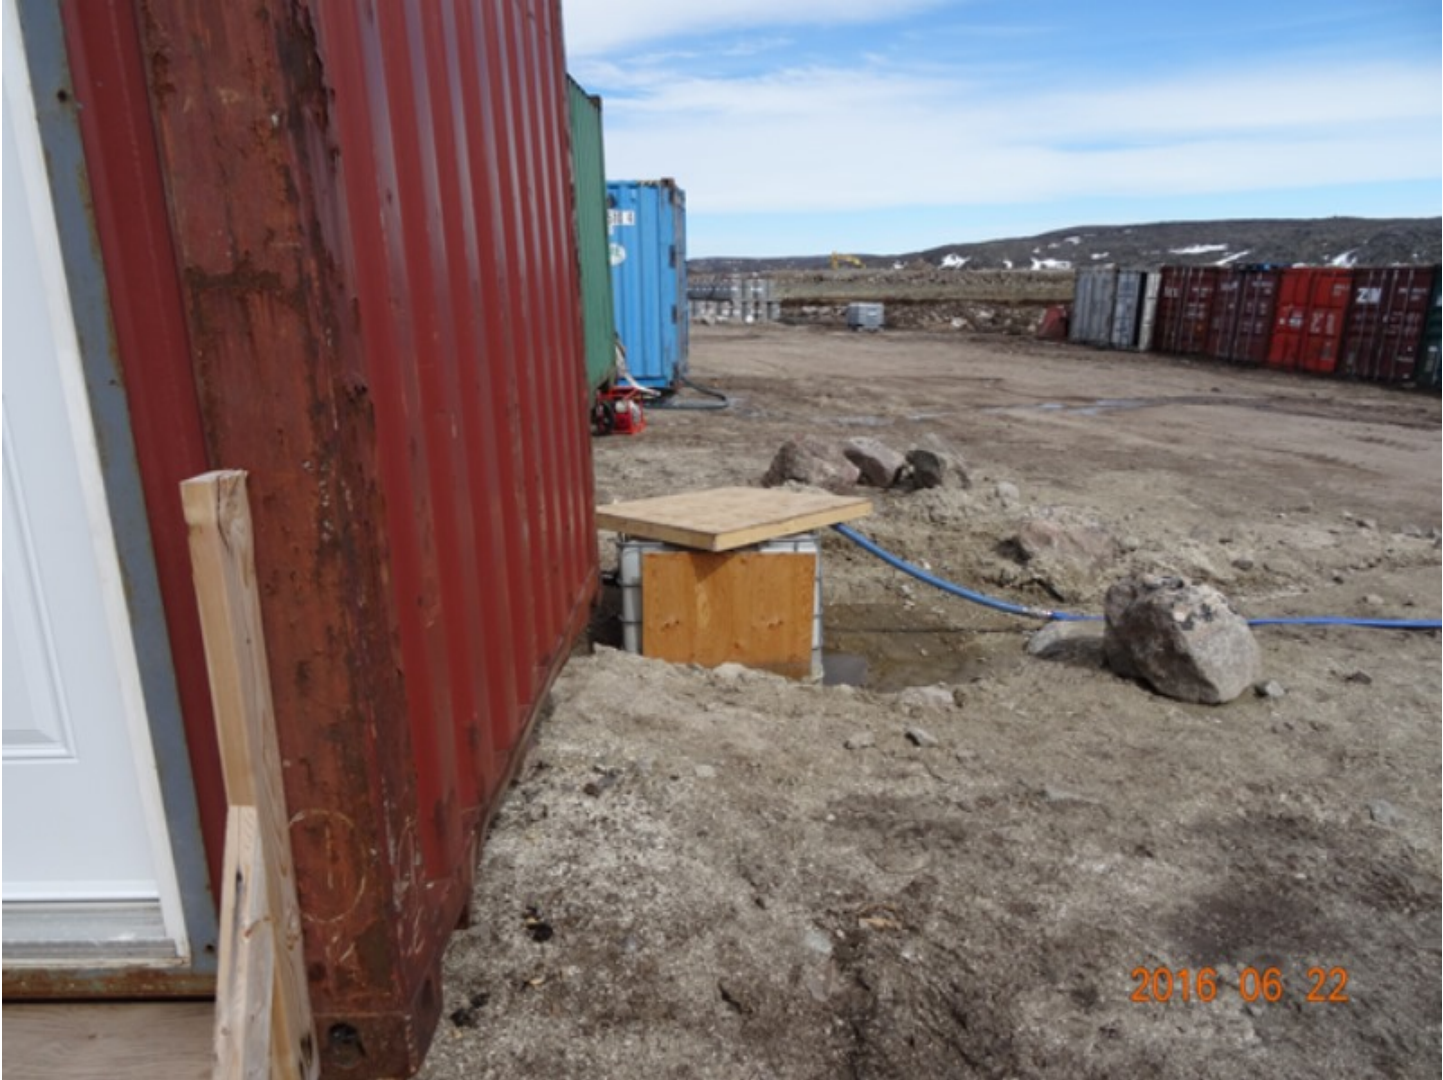
Figure 13 wastewater collection point for discharge to lagoon.
