Water Licence Inspection Report

Authorization	Representative
Nunatta Environmental Services	Jim Wilson
Authorization No. / Expiry	Representative's Title
1BR-NUN1828	Vice President
Activities Inspected	
<input type="checkbox"/> Camp, Commercial <input type="checkbox"/> Drilling <input type="checkbox"/> Mining <input type="checkbox"/> Construction <input type="checkbox"/> Reclamation <input type="checkbox"/> Fuel Storage <input type="checkbox"/> Roads/Hauling <input type="checkbox"/> Winter Hauling <input type="checkbox"/> Camp, Private <input checked="" type="checkbox"/> Other

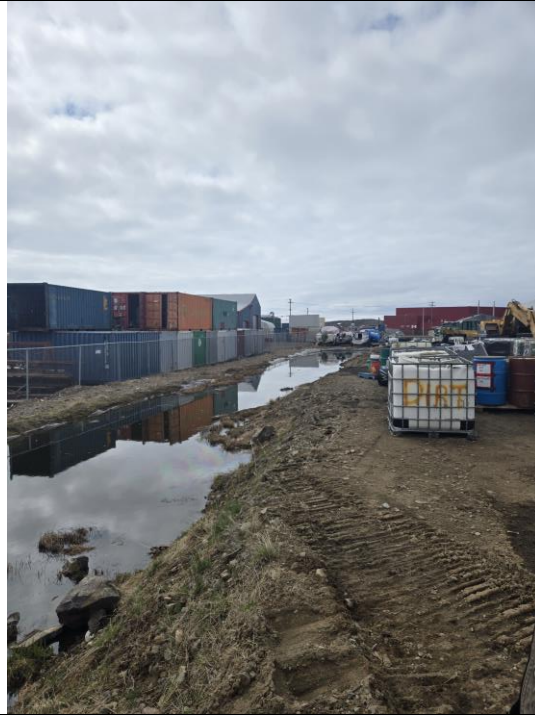
Photo No. 1	
Photo	Click or tap here to enter text.

During the inspection, Nunatta Environmental was in the middle of sorting hazardous waste throughout the facility. While there was no evidence of water leaking/overflowing from the first cell, the Inspector was concerned about the amount of water that has accumulated within the cell and the amount of freeboard left.

Description: Photo of cell with melt water along the edge of the cell being contained within the berm. Photo facing West towards the main road.

The Licensee must monitor the water levels in Cell #1 and ensure that no water exits the cell prior to being treated.

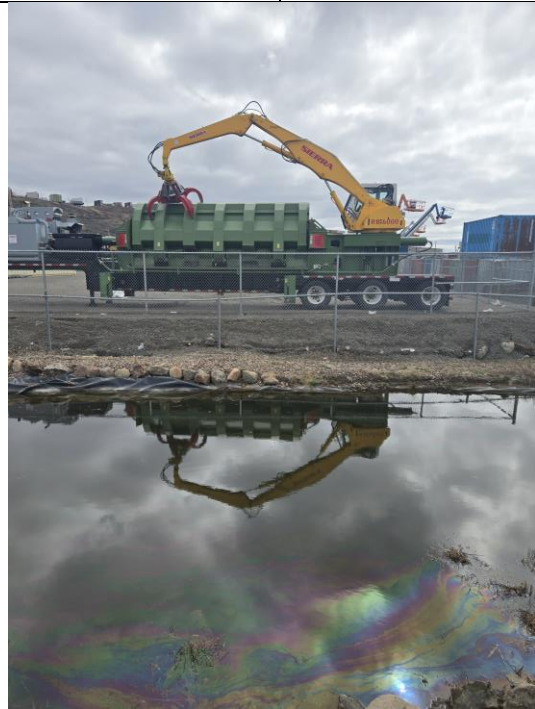
Photo No. 2	
Photo	Click or tap here to enter text.

Description: Photo of same cell with water being contained. Sheening in the water was observed during the inspection.

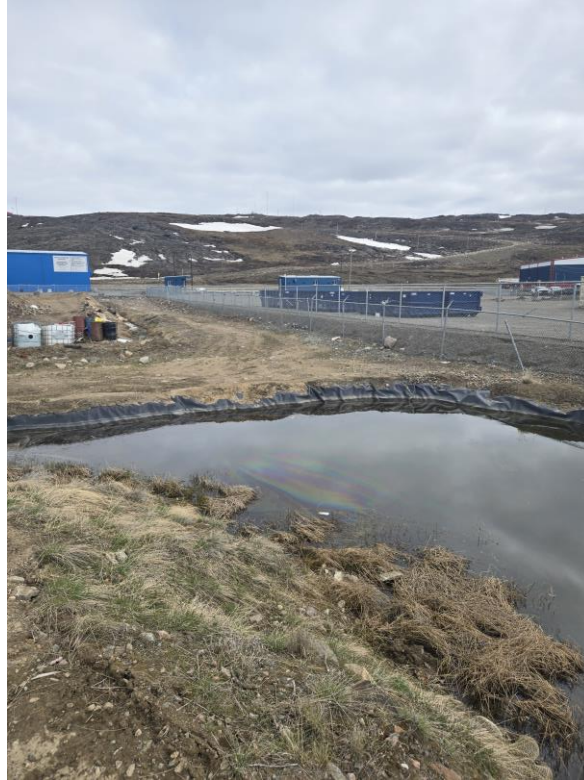
Photo No. 3

Photo of the other end of the cell, more seen observed during the inspection.

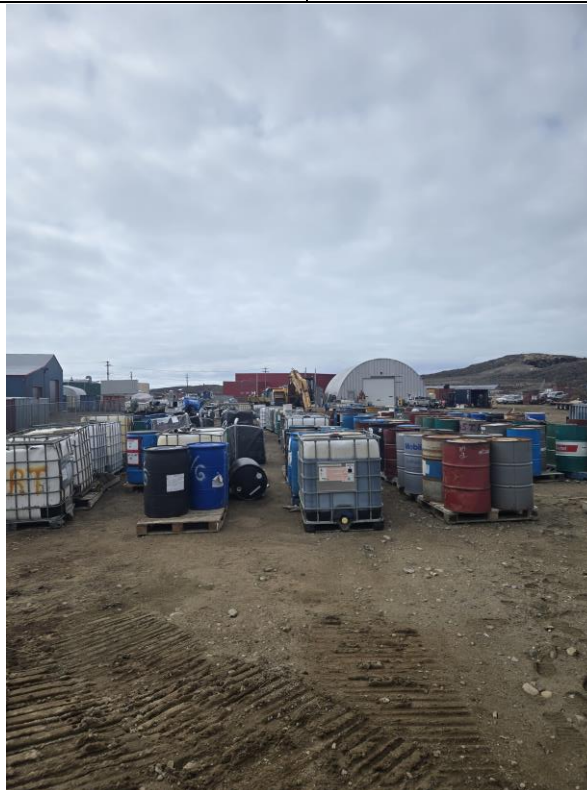
Photo No. 4

Photo of first cell where hazardous waste is received and sorted.

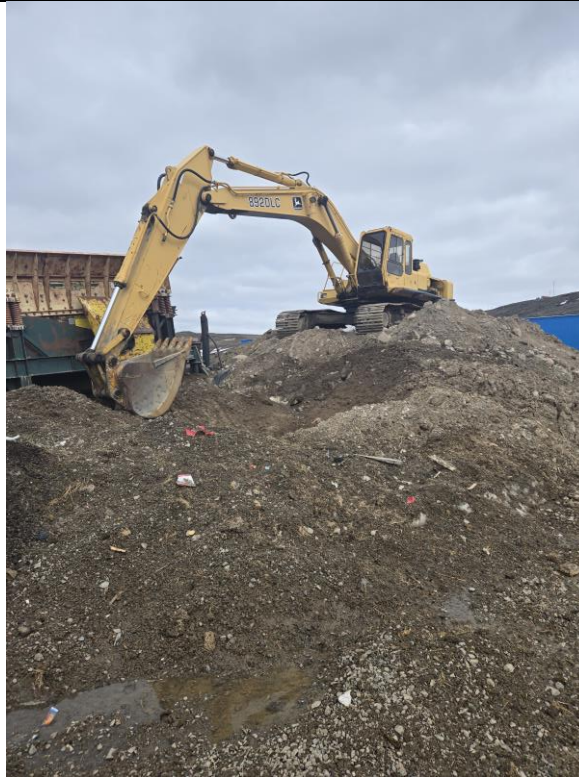
Photo No. 5

Contaminated soil is received at the landfarm where it will be treated prior to being used for a variety of projects.

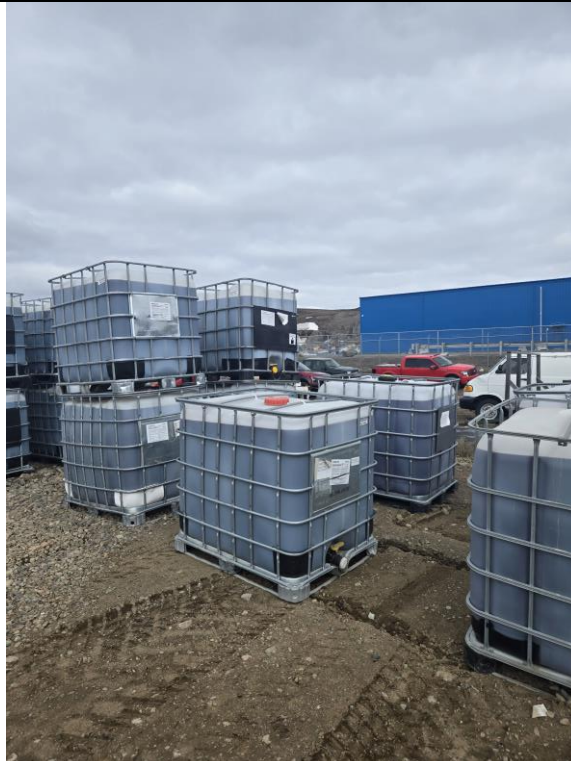
Photo No. 6

Used oil from the Iqaluit Power Plant is being stored at the landfarm prior to being sent South to a disposal facility.

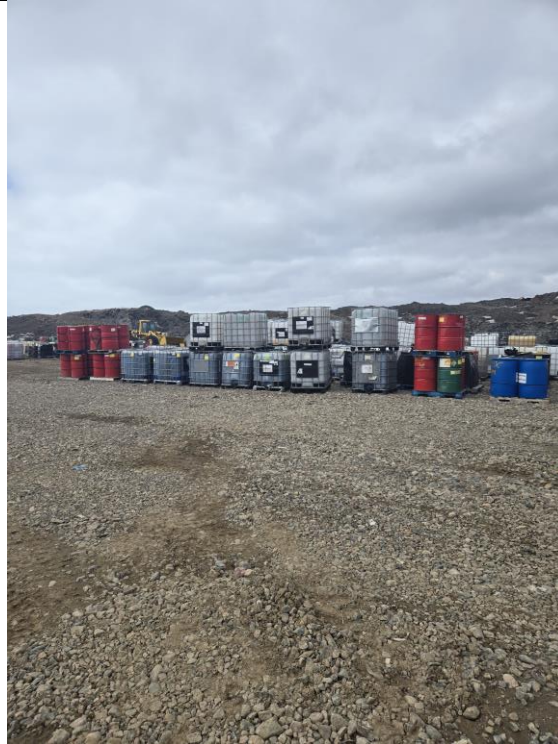
Photo No. 7

Used oil from the Iqaluit Power Plant is being stored at the landfarm prior to being sent South to a disposal facility.

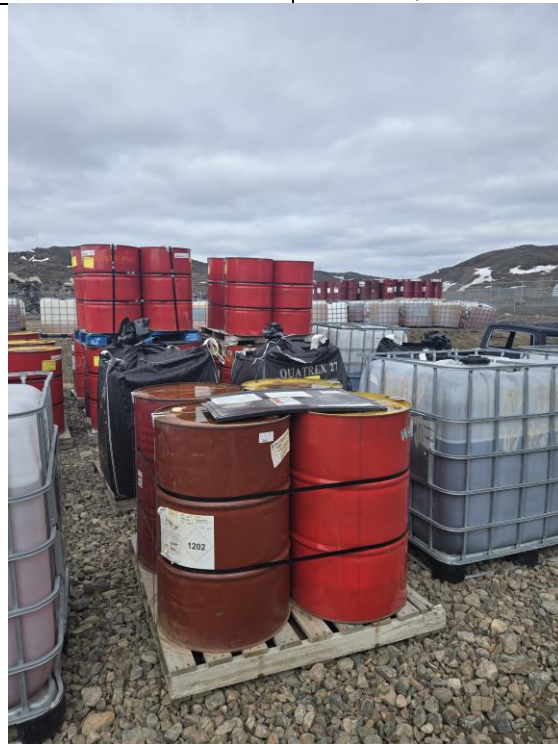
Photo No. 8

Used oil from the Iqaluit Power Plant is being stored at the landfarm prior to being sent South to a disposal facility.

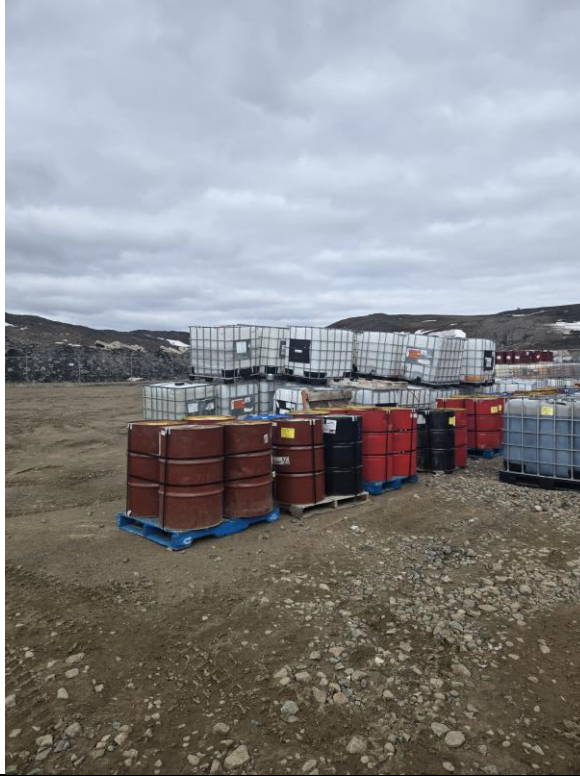
Photo No. 9

Used oil from the Iqaluit Power Plant is being stored at the landfarm prior to being sent South to a disposal facility.

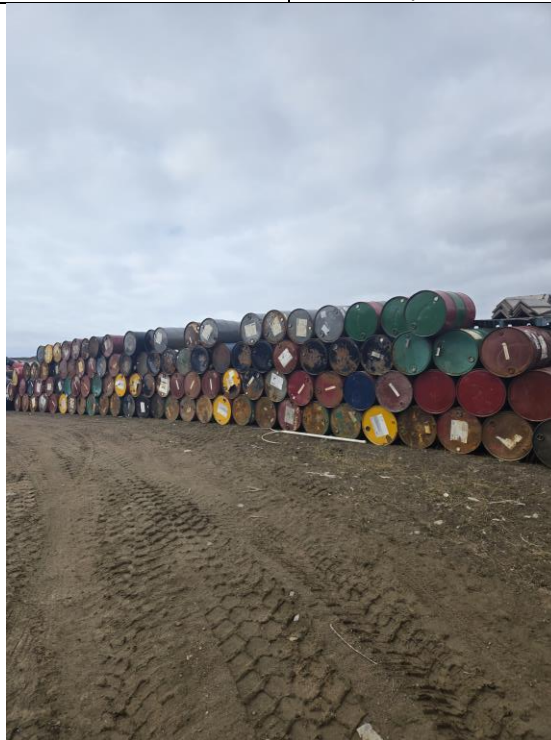
Photo No. 10

Empty fuel drums were observed within the landfarm facility.

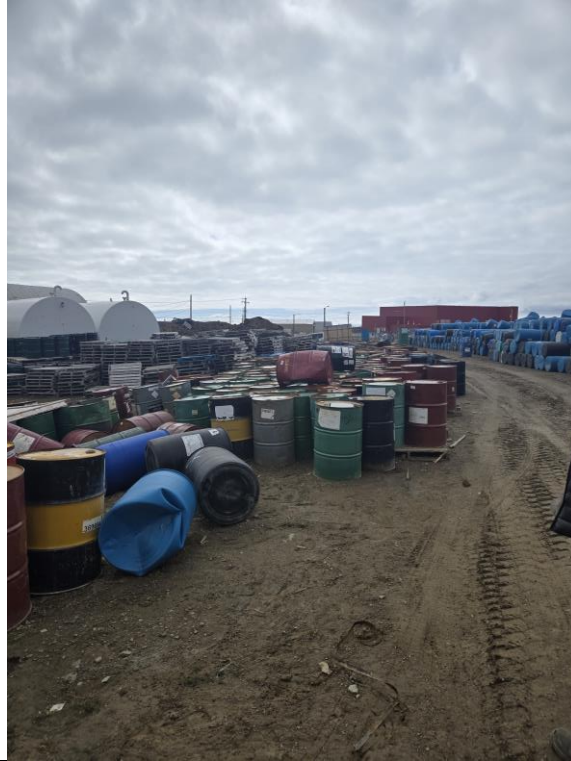
Photo No. 11

Empty fuel drums were observed within the landfarm facility.
