APPENDIX II

PHOTOS

PHOTOGRAPHIC RECORDS

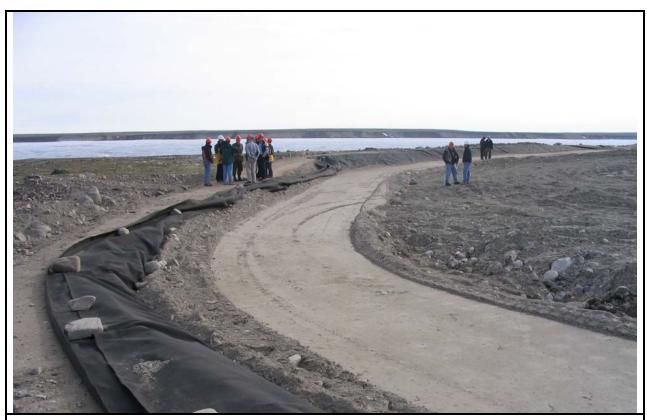
Photo 1: Landfarm berm.

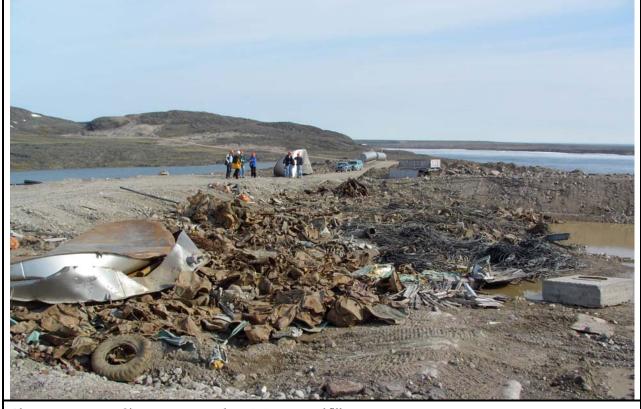
Photo 2: Lower Site Non-Hazardous Waste Landfill.

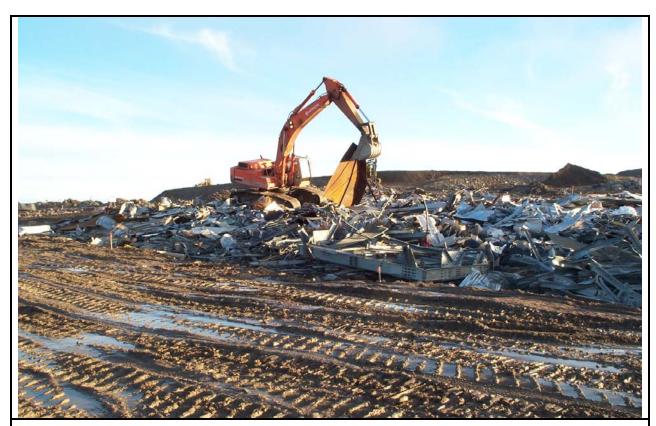
Photo 3: Upper Site Non-Hazardous Waste Landfill.

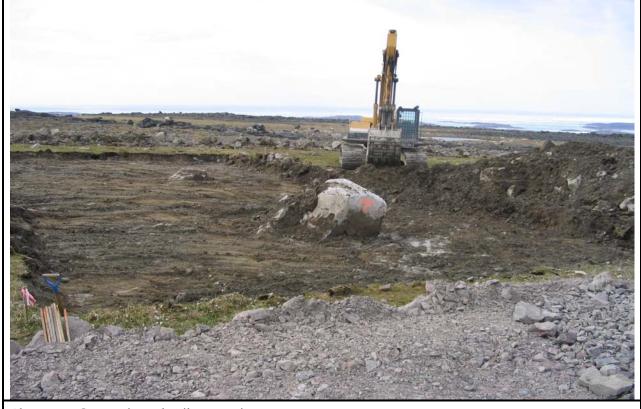
Photo 4: Contaminated soil excavation.

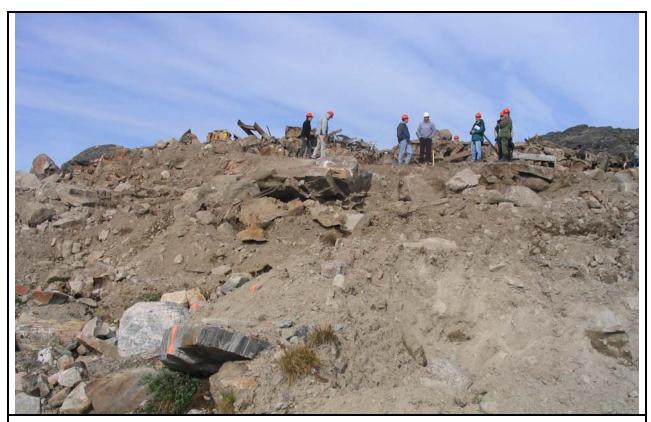
Photo 5: Upper Site Landfill excavation.

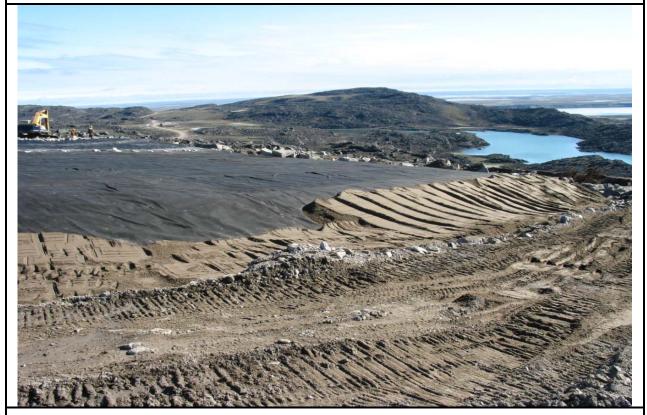
Photo 6: Liner and cover at the Upper Site Landfill.
