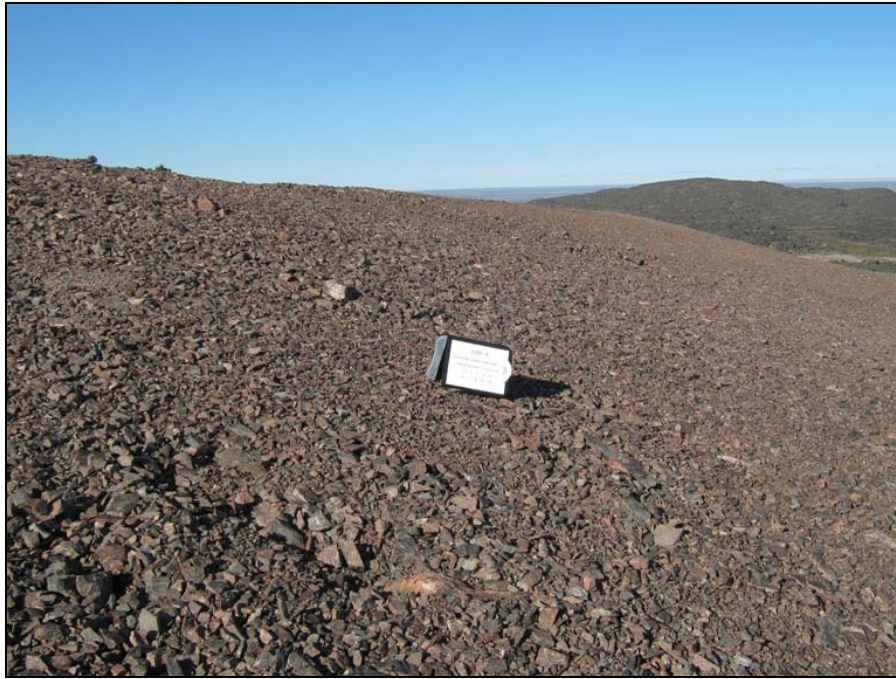
Photograph SNH-1A. Southwest corner at the toe, facing northeast. ↑

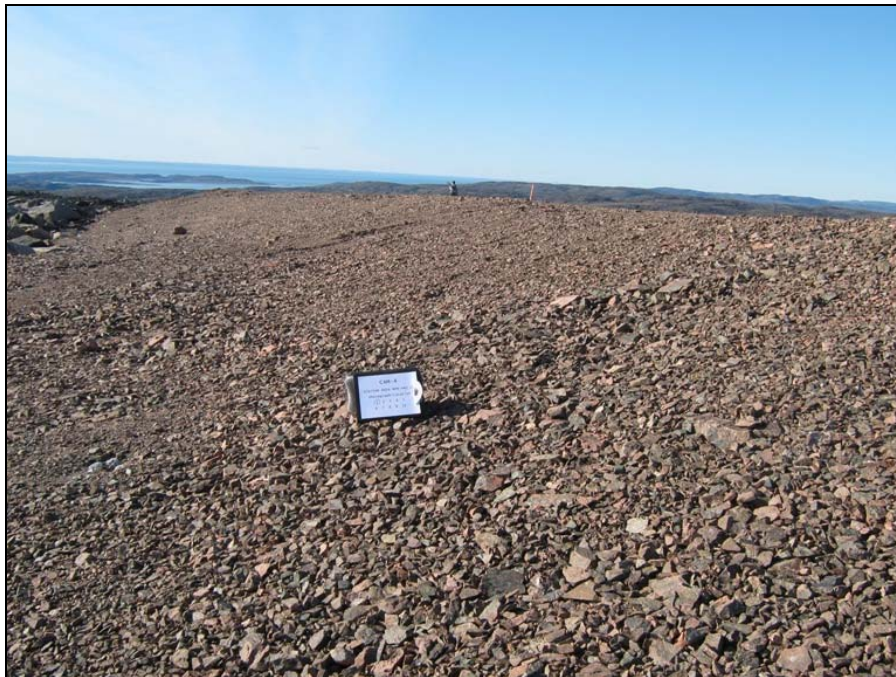
Photograph SNH-1B. Southwest corner at the toe, facing north. ↑

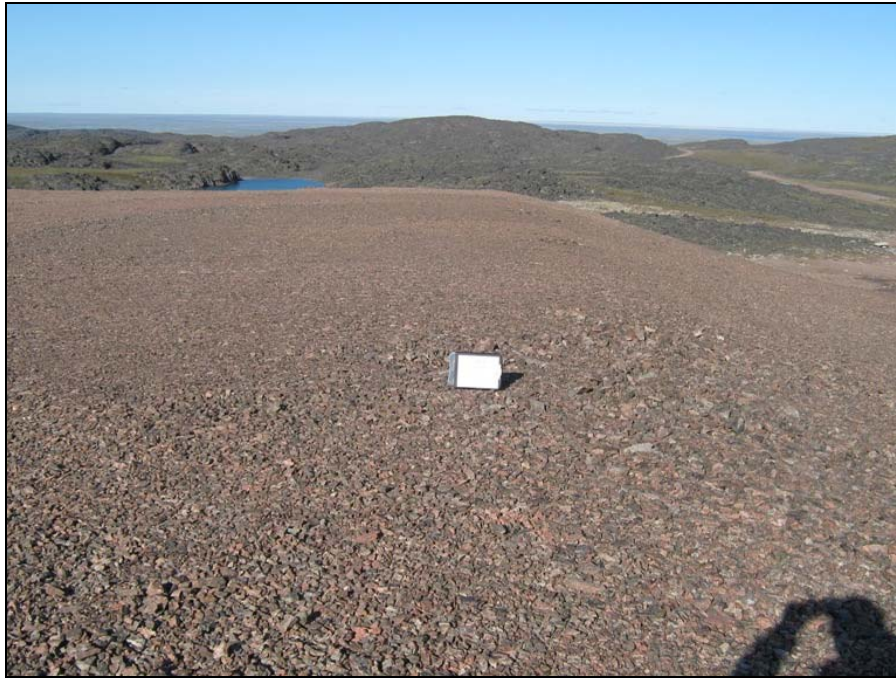
Photograph SNH-2A. Southwest corner at the crest facing northeast. Some tire tracks from a vehicle that tried to drive up onto the landfill near clipboard. ↑

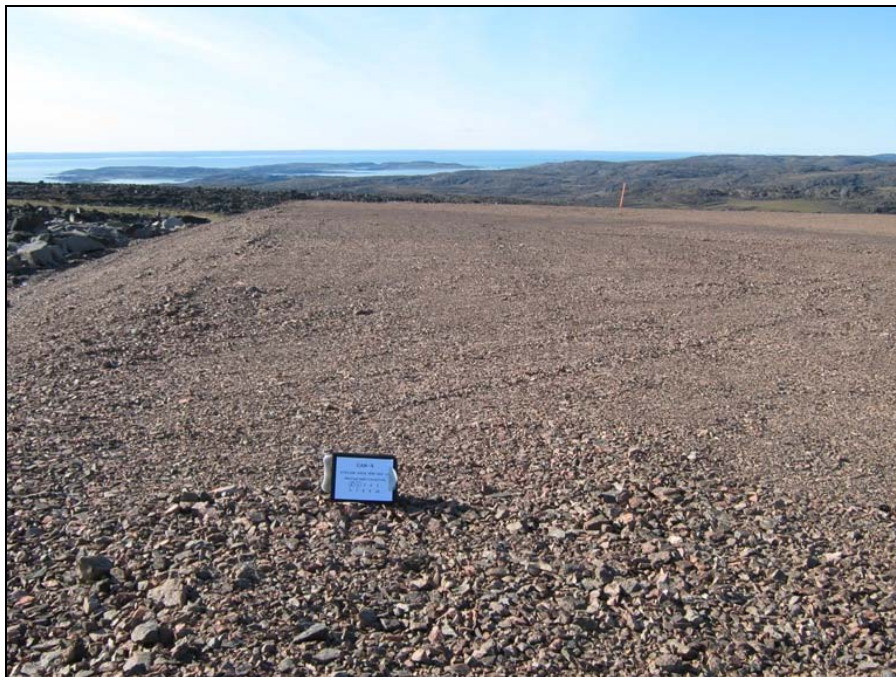
Photograph SNH-2B. Southwest corner at the crest, facing north. ↑

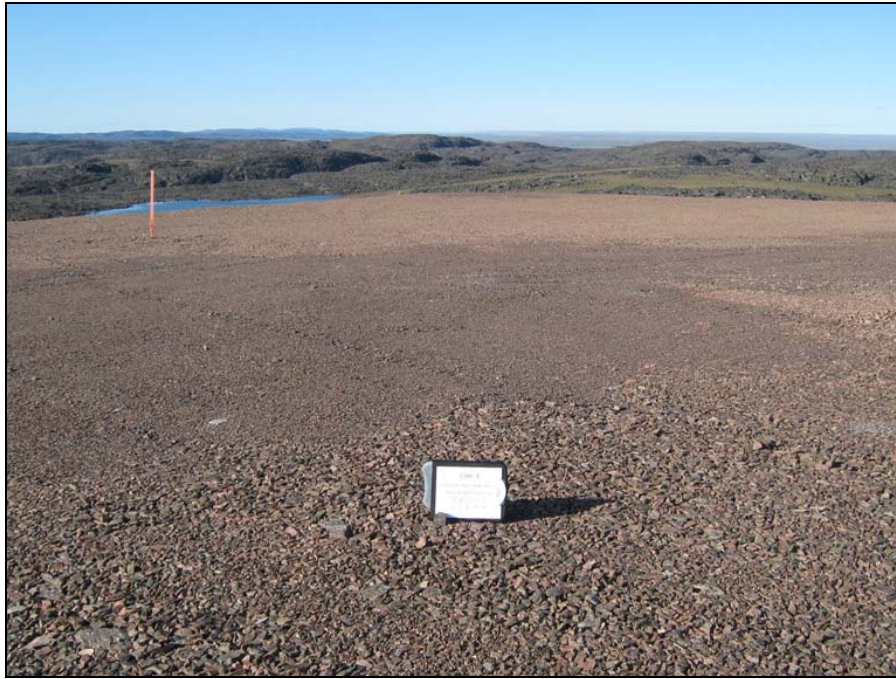
Photograph SNH-3A. Facing northeast over landfill surface. ↑

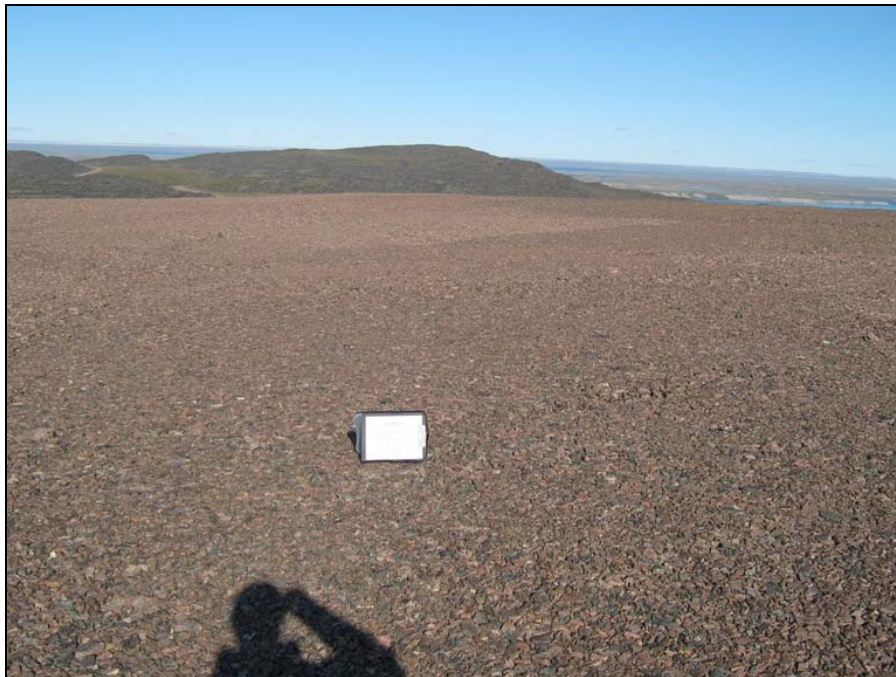
Photograph SNH-3B. Facing southeast over landfill top. ↑

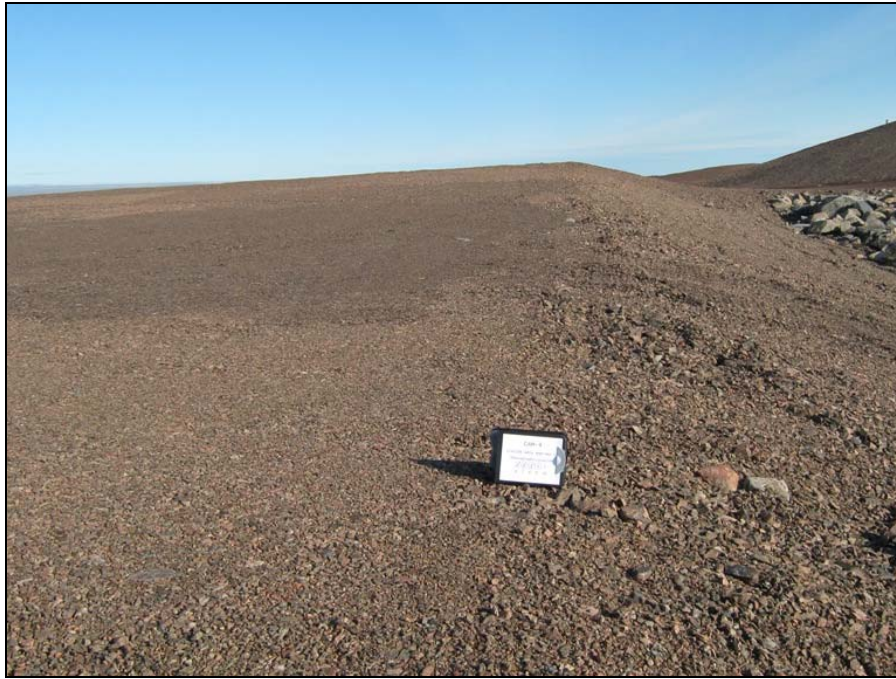
Photograph SNH-4A. Northwest corner crest, facing south. ↑

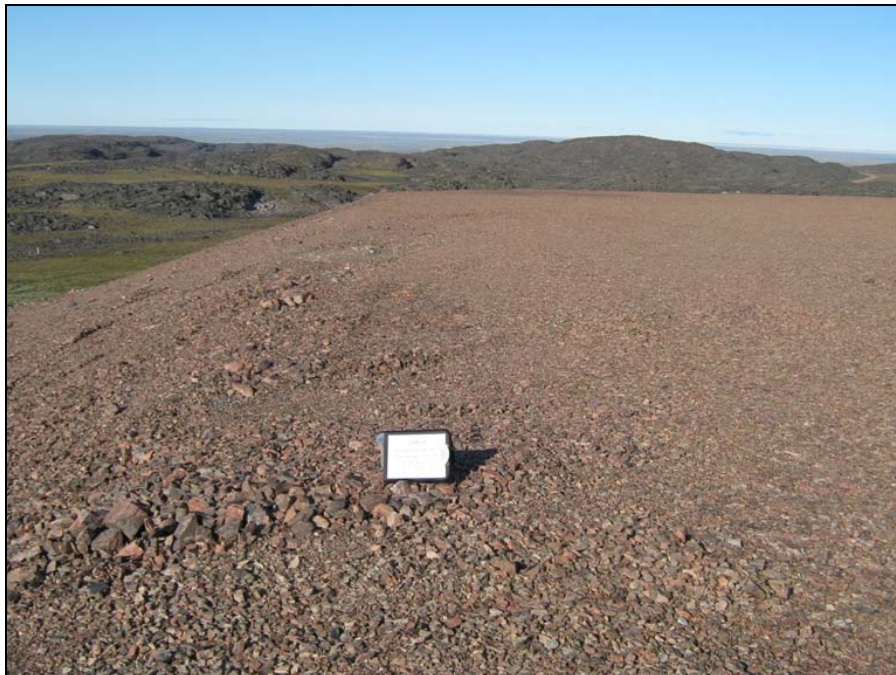
Photograph SNH-4B. Northwest corner crest, facing east. ↑

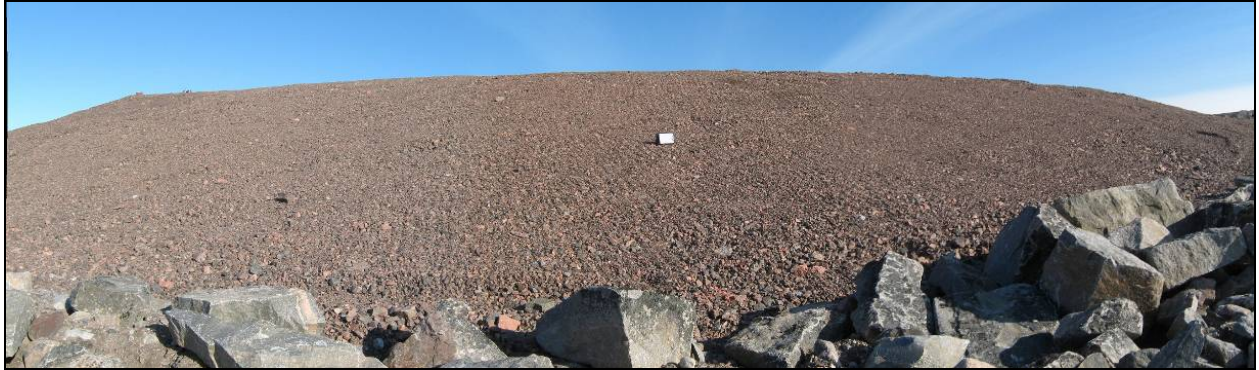
Photograph SNH-5. Panoramic of the north slope. ↑

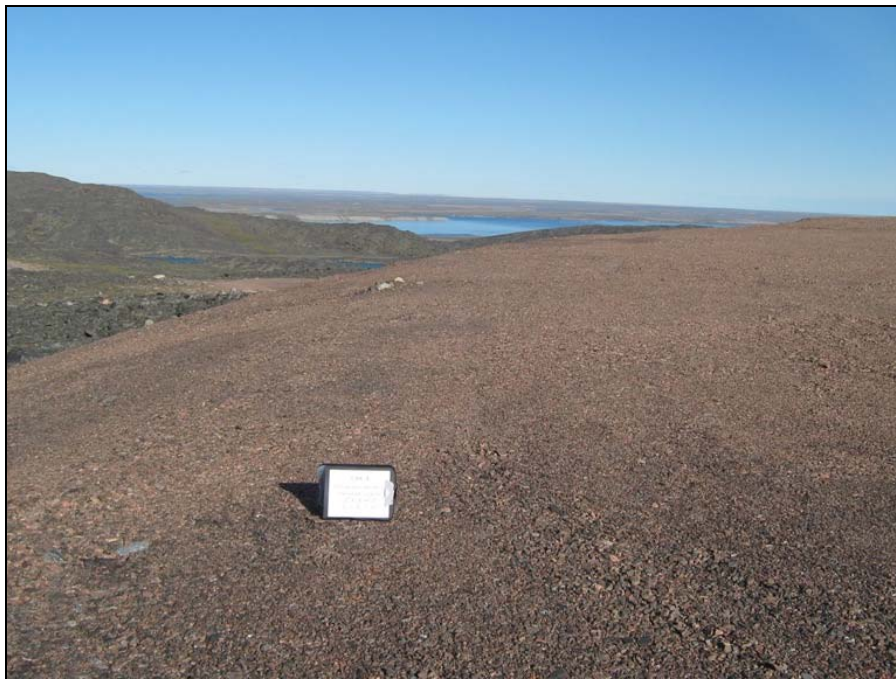
Photograph SNH-6A. Northeast corner facing south. ↑

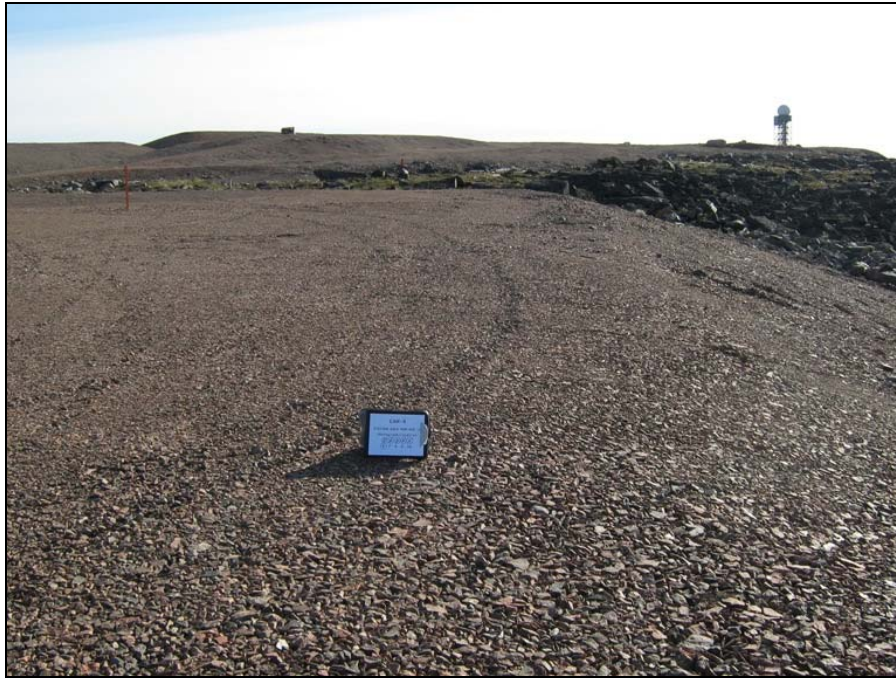
Photograph SNH-6B. Northeast corner facing west. ↑

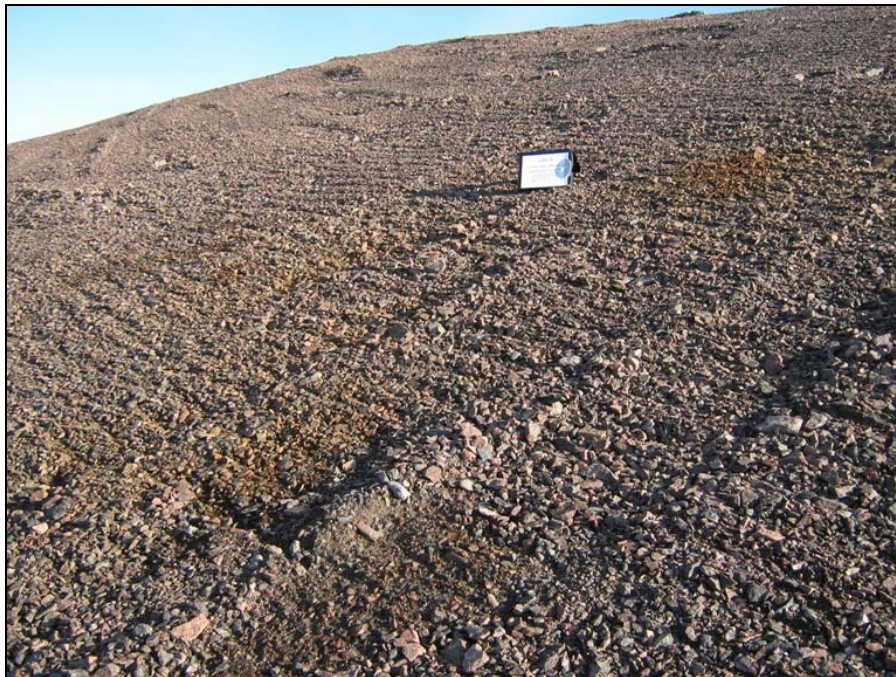
Photograph SNH-7A. Facing slope. Some seepage and orange staining over 10m x 10m area on lower half of east slope, towards the northeast corner toe. ↑

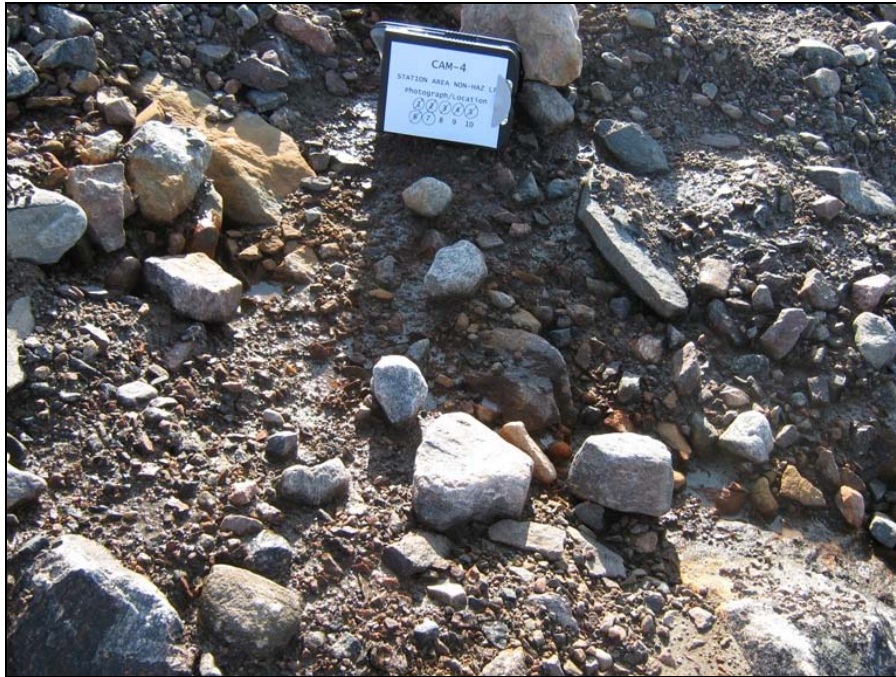
Photograph SNH-7B. Toe of slope near northeast corner. Orange staining and seepage discharging onto rocks at toe of landfill. Down-slope of photo SNH-12. ↑

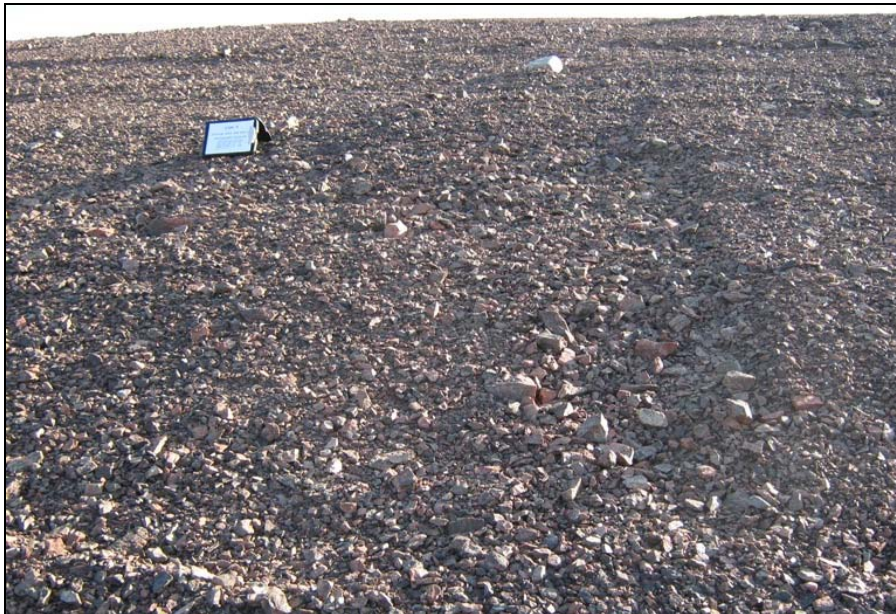
Photograph SNH-8. East slope. Area of possible minor erosion with gullies about 0.5m wide and less than 0.1m deep that appear to be self healing with larger rock in cover fill. ↑

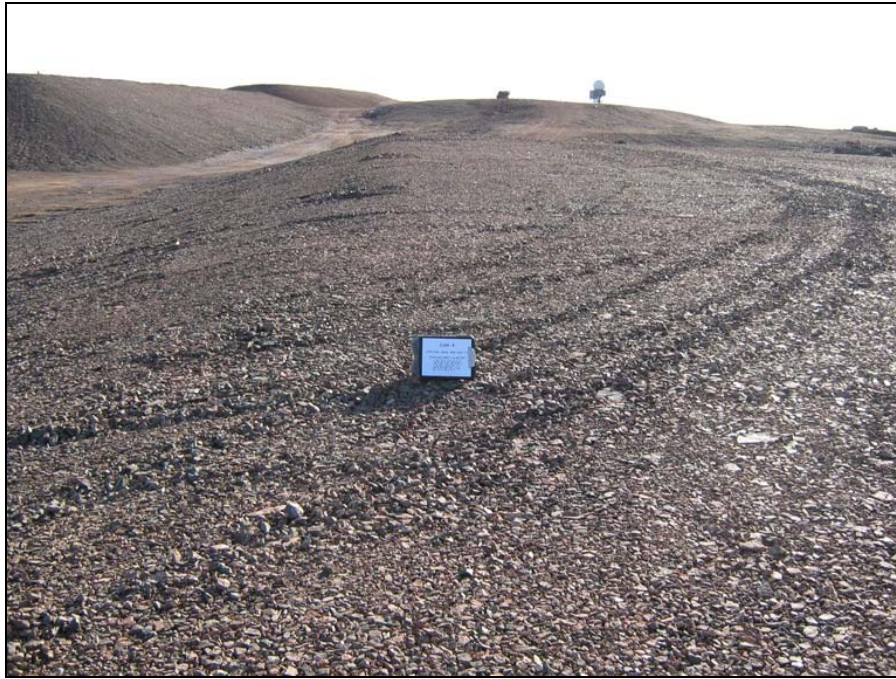
Photograph SNH-9A. Facing west along south crest. ↑

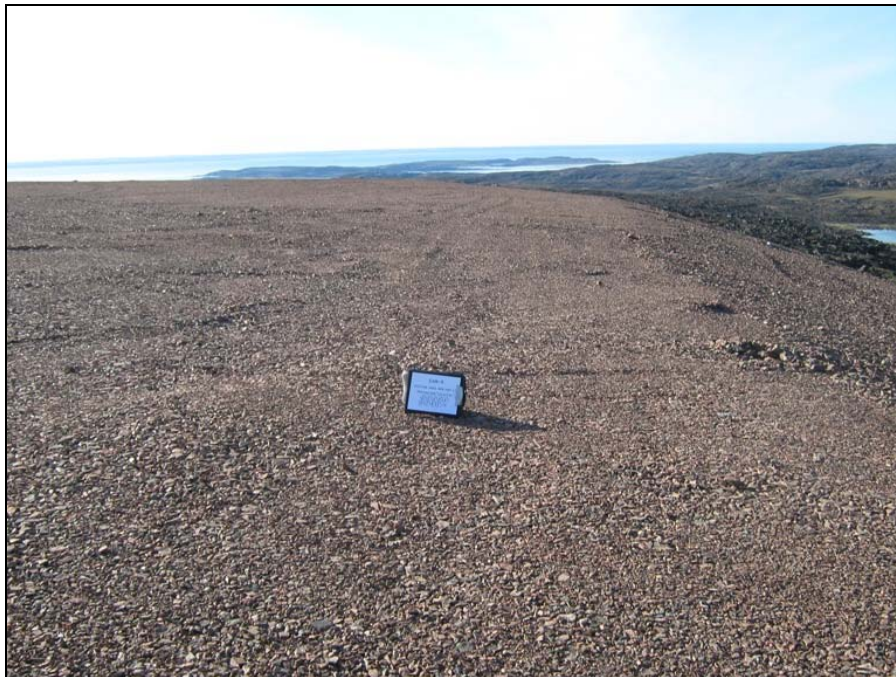
Photograph SNH-9B. Facing north along east crest. Some tire tracks but no damage. ↑

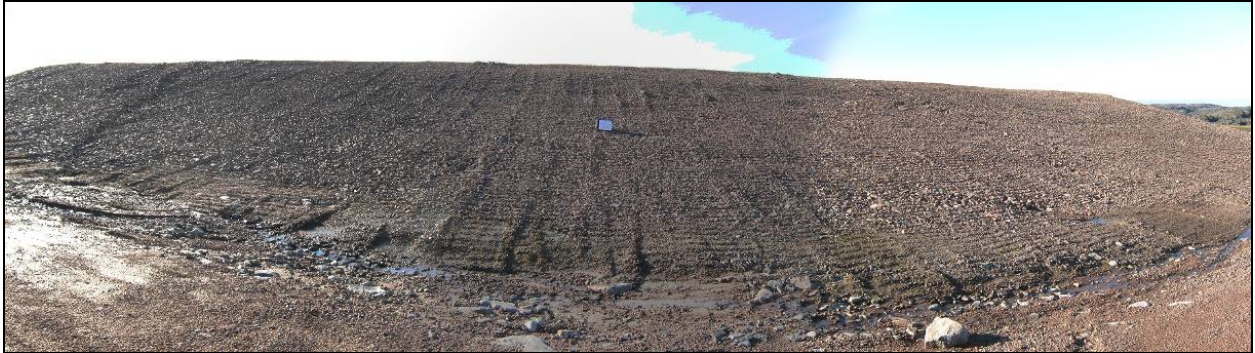
Photograph SNH-10. Panoramic of the south face. Some seepage and drainage along road at toe.
No staining. ↑
