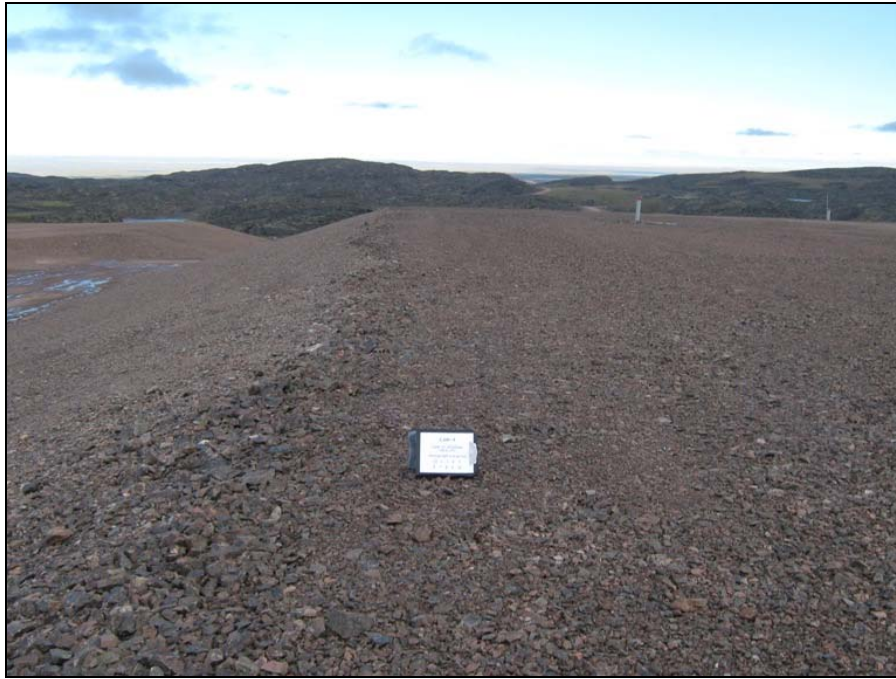
**Photograph TII-1A.** Northwest corner of landfill facing east along crest. ↑

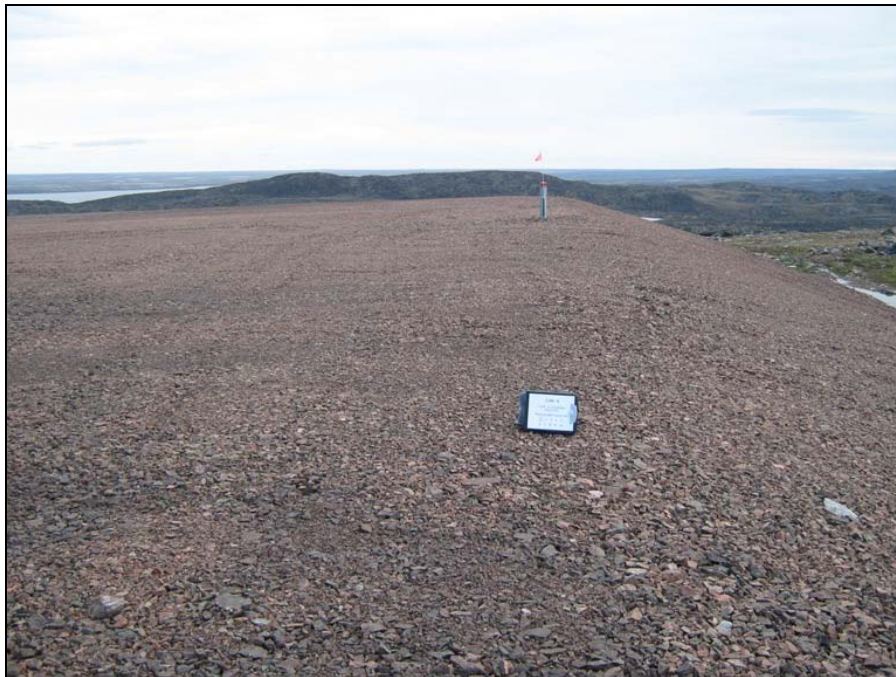
**Photograph TII-1B.** Northwest corner of landfill facing south along crest. ↑

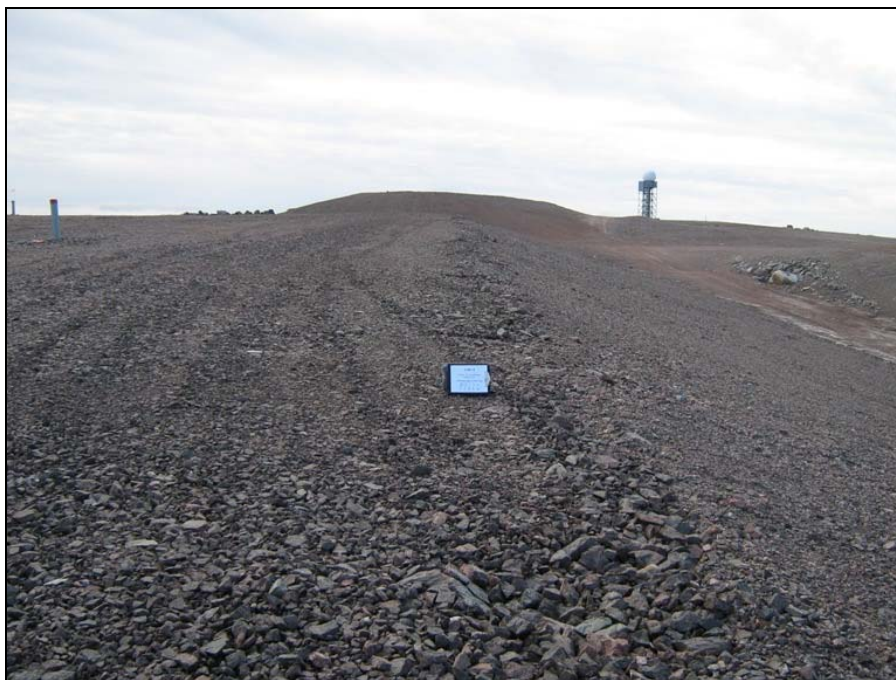
**Photograph TII-2A.** Northeast corner of landfill facing west. ↑

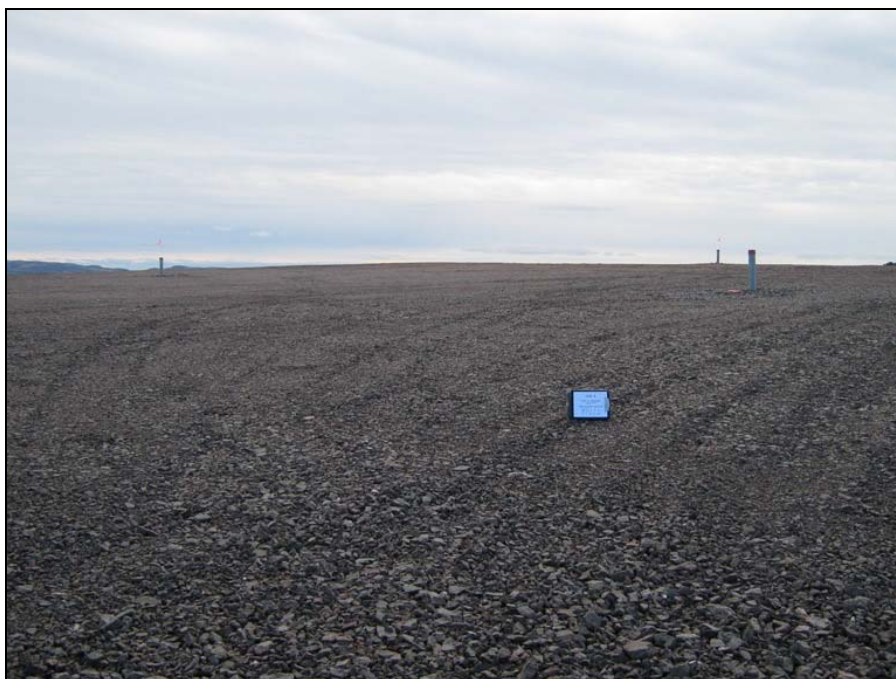
**Photograph TII-2B.** Northeast corner of landfill facing southwest. ↑

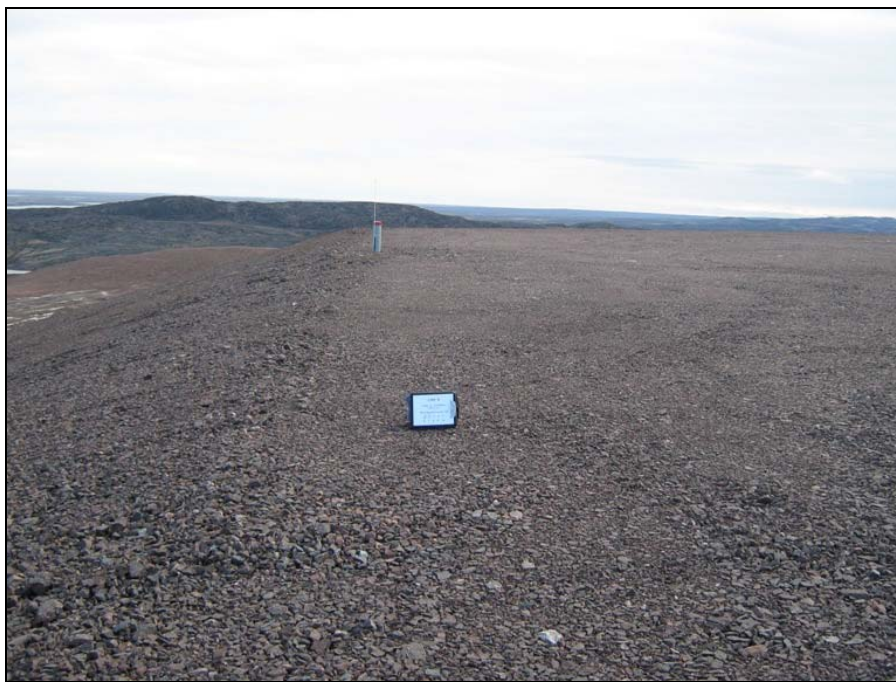
**Photograph TII-2C.** Northeast corner of landfill facing south. ↑

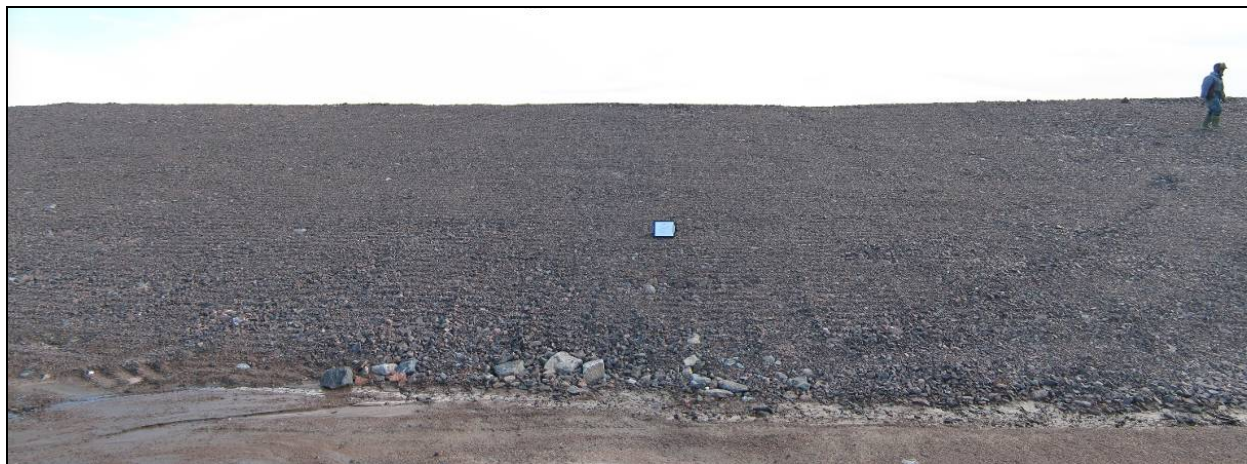
**Photograph TII-3.** Panoramic photo of the north slope. ↑

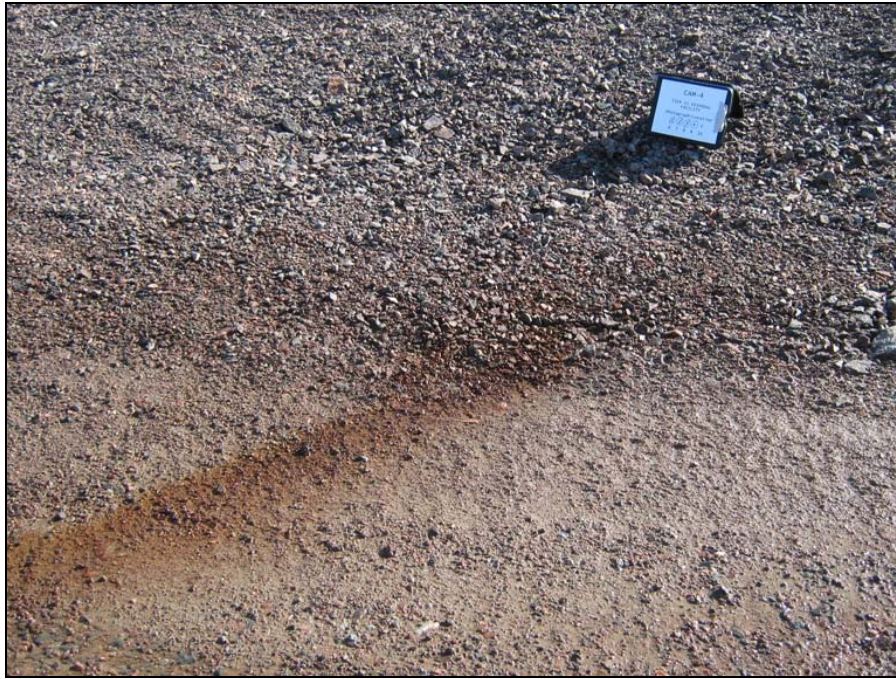
**Photograph TII-4A.** At the northeast toe. Some seepage with orange staining. Some water drainage along the road at the toe. ↑

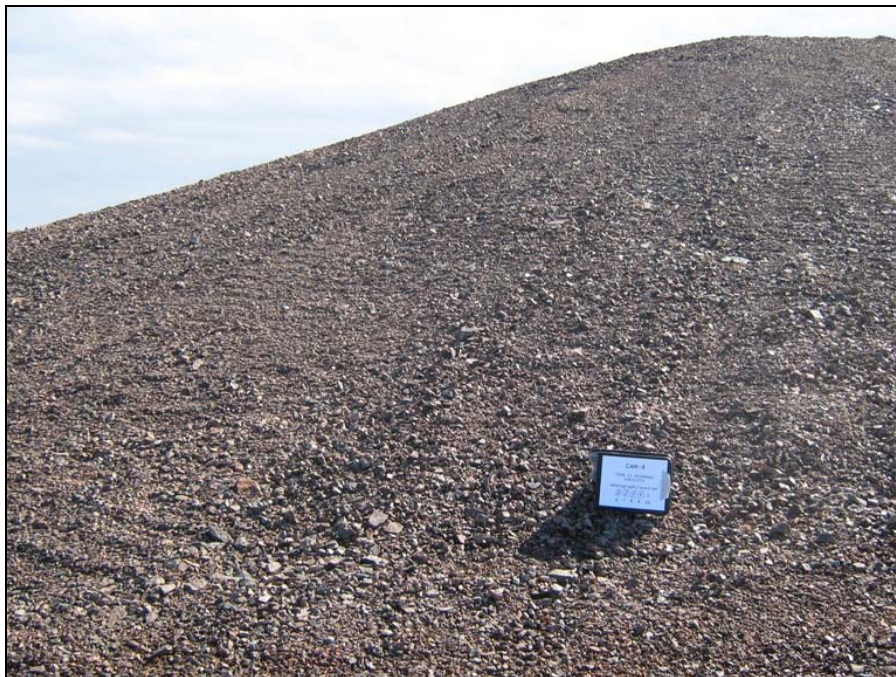
**Photograph TII-4B.** Northeast corner and toe. ↑

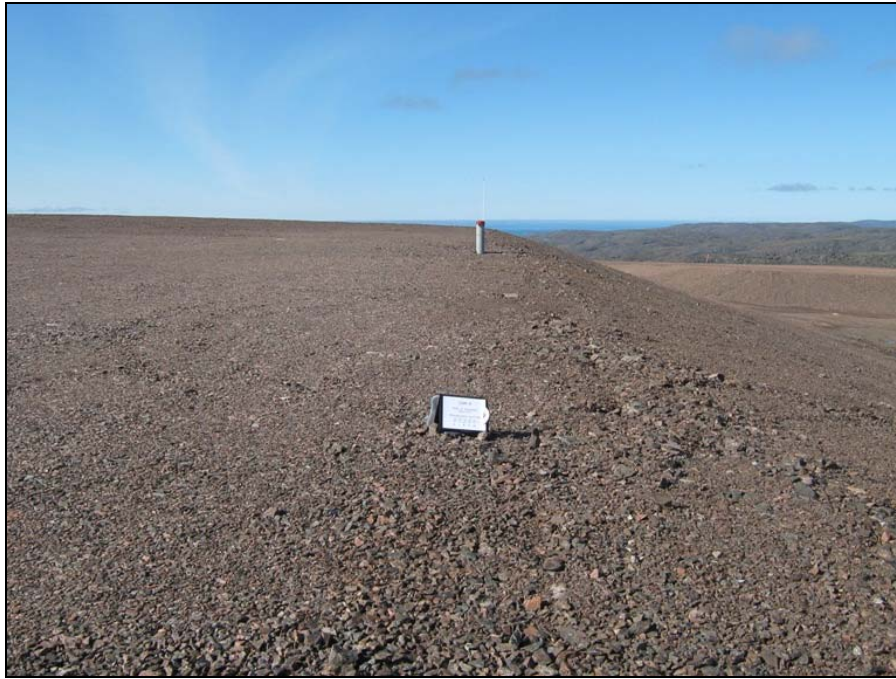
**Photograph TII-5A.** Southeast crest facing north. ↑

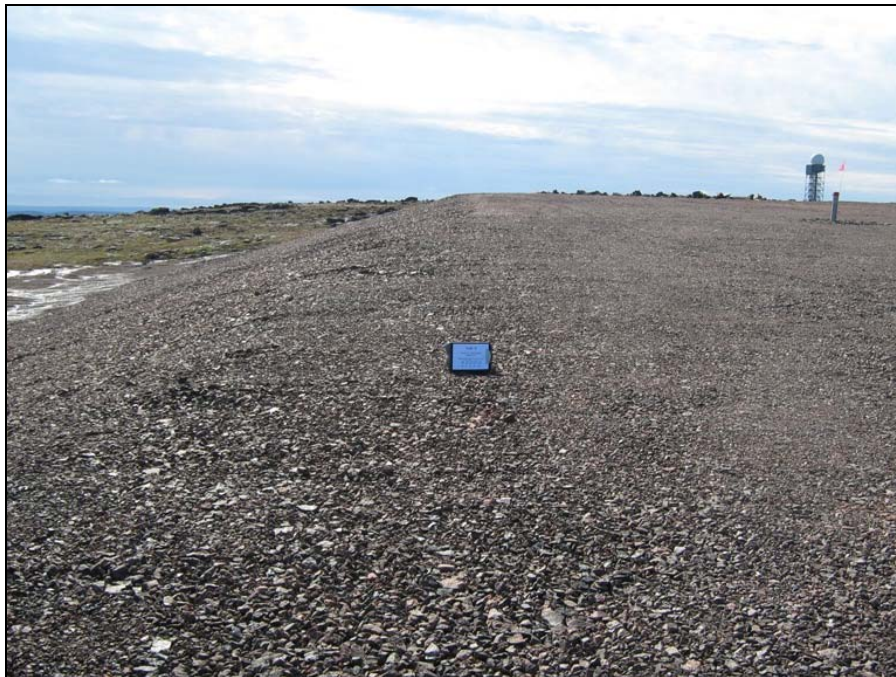
**Photograph TII-5B.** Southeast crest facing west. Some coarse rockfill along crest edge but there does not appear to be tension cracks. ↑

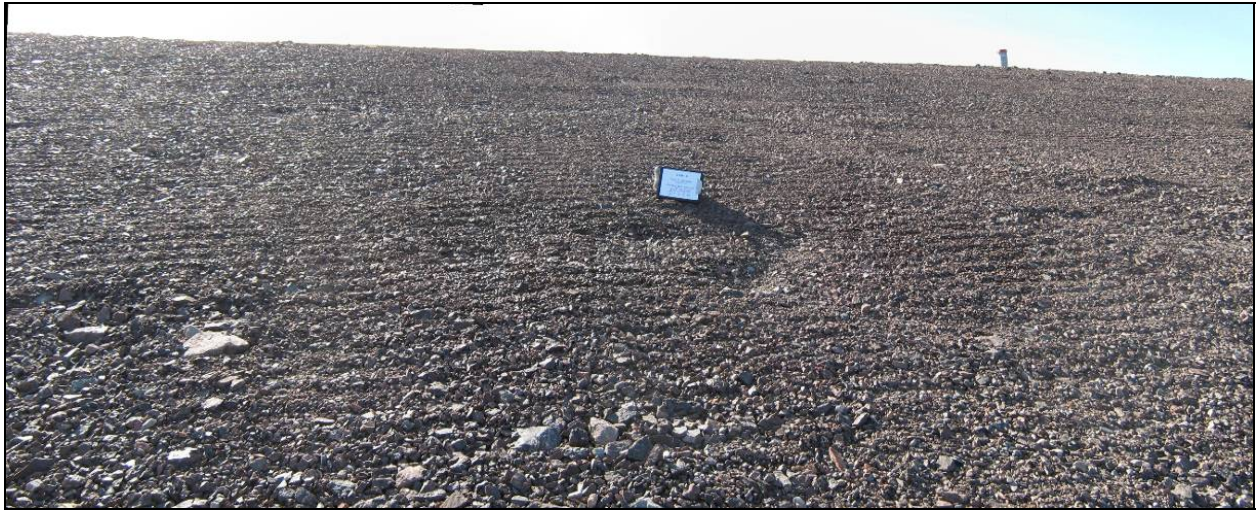
**Photograph TII-6.** Panoramic photo of the southeast slope. Some water seeping out of slope face. No staining. ↑

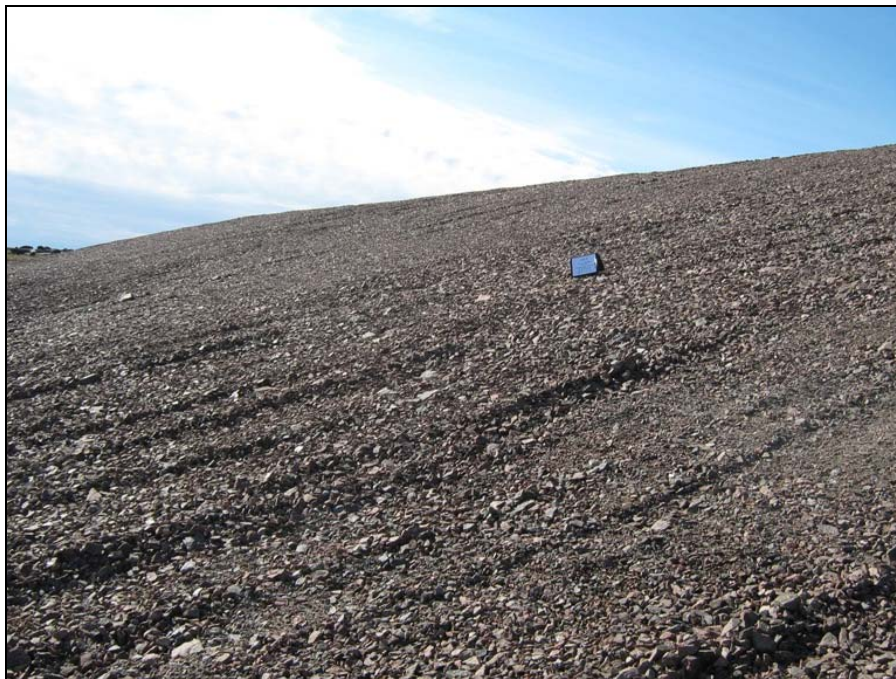
**Photograph TII-7.** South slope from southeast toe facing west. Some seepage from south slope and minor ponding at toe. No staining. ↑

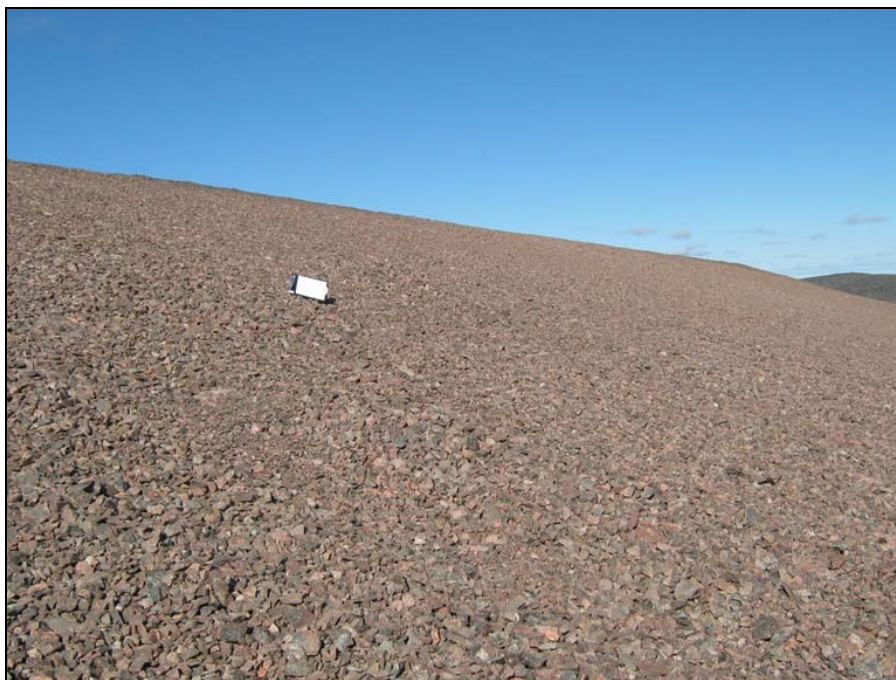
**Photograph TII-8.** South slope from southwest toe facing east. ↑

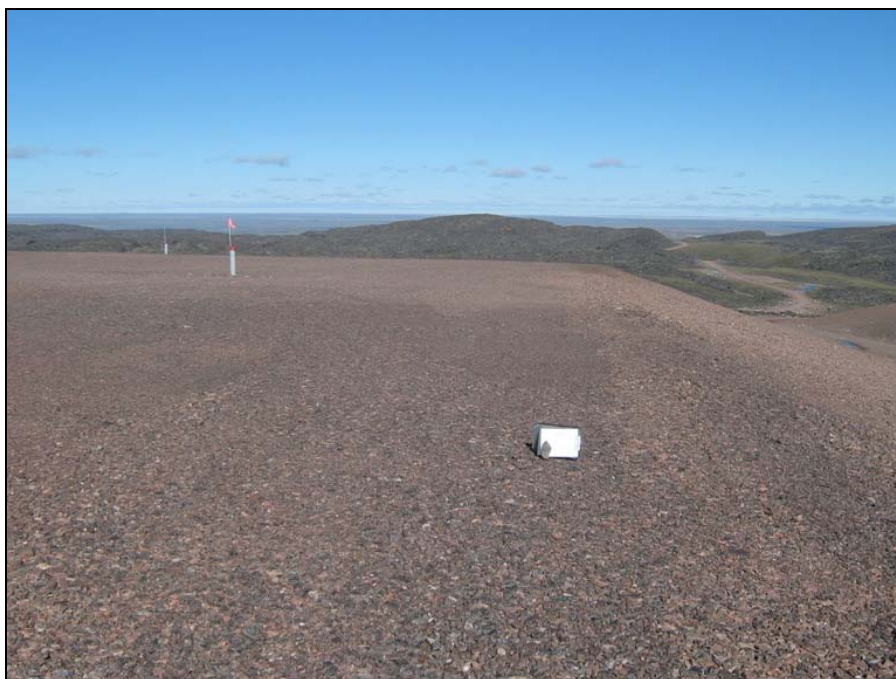
**Photograph TII-9A.** Facing east along crest from the southwest corner of the landfill. ↑

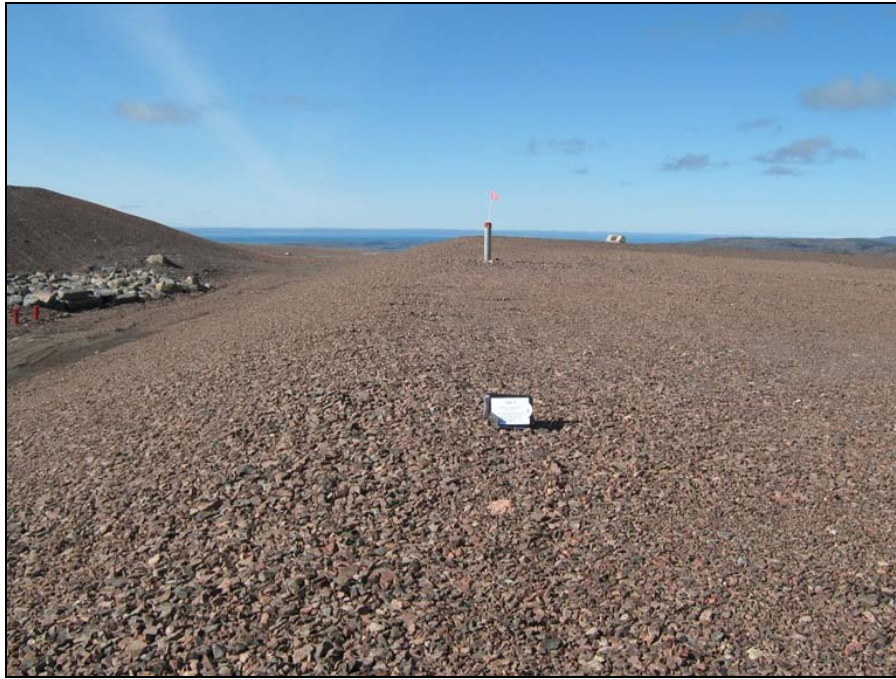
**Photograph TII-9B.** Facing north along crest from the southwest corner of the landfill. Some ponded water along toe. No staining. ↑

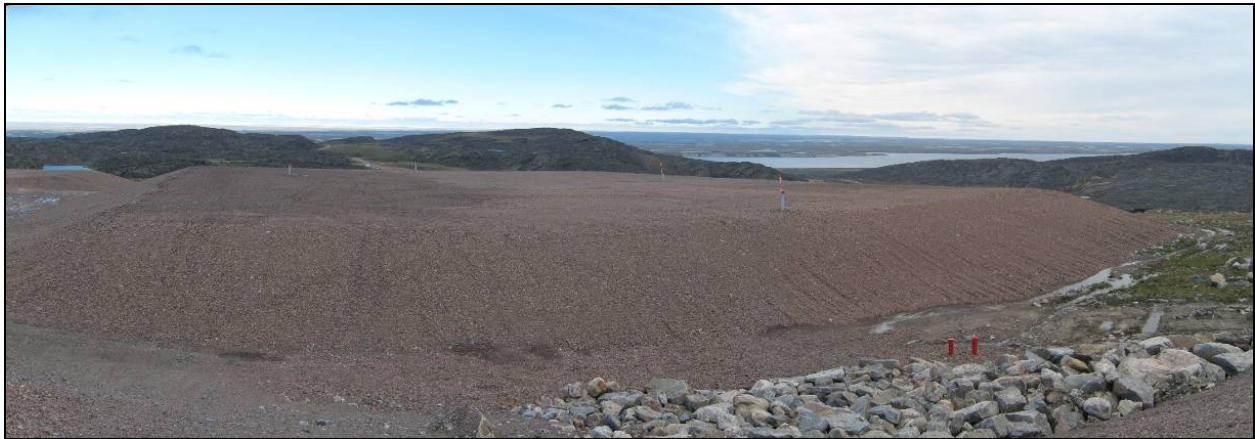
**Photograph TII-10.** Panoramic photo of Tier II landfill facing east from raised gravel pad. ↑
