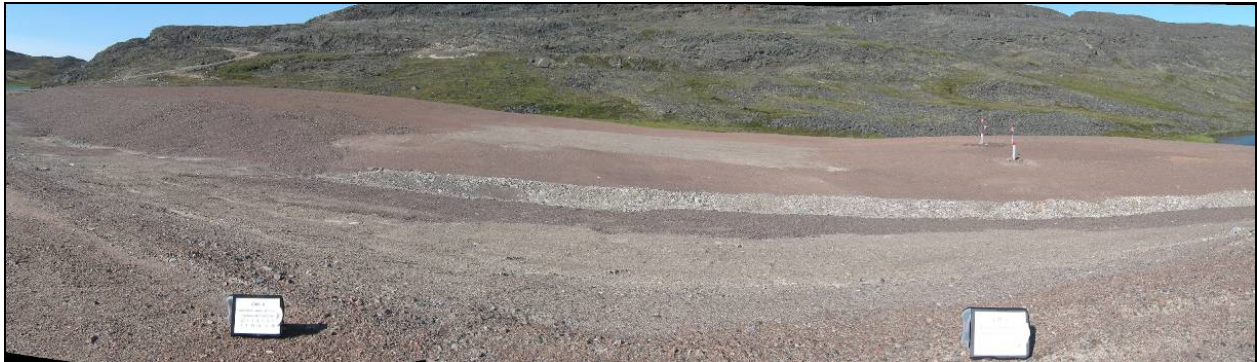
**Photograph LSL-1.** Panoramic photo of landfill from regraded hill near MW-20 ↑

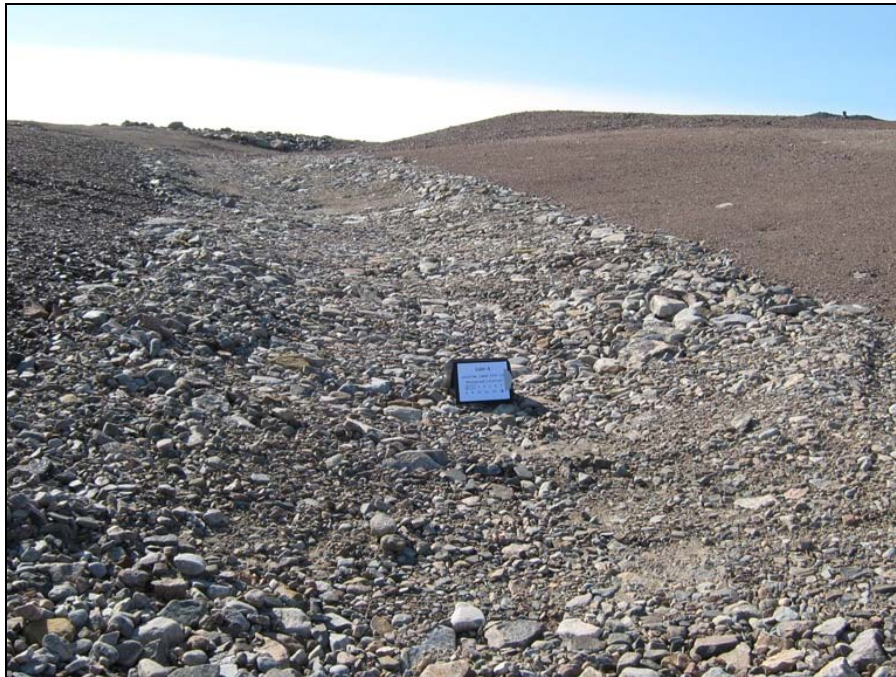
**Photograph LSL-2A.** Looking west, upstream, along the rip-rap lined drainage channel. ↑

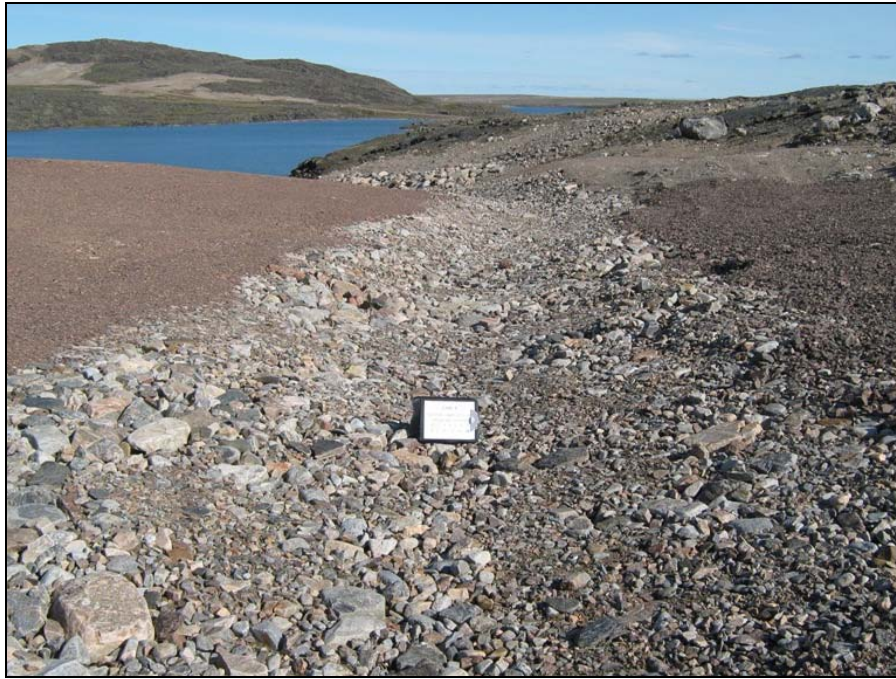
**Photograph LSL-2B.** Facing east, downstream, along the rip-rap lined drainage channel. ↑

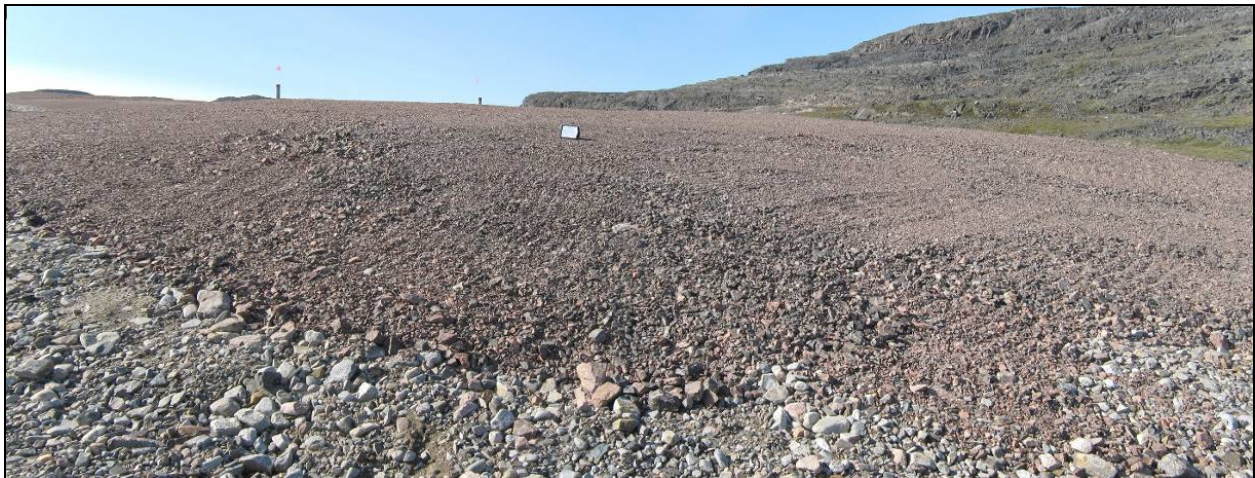
**Photograph LSL-3.** Panoramic photo of the southeast end of the landfill from the toe of the landfill near the rip-rap drainage channel outlet. ↑

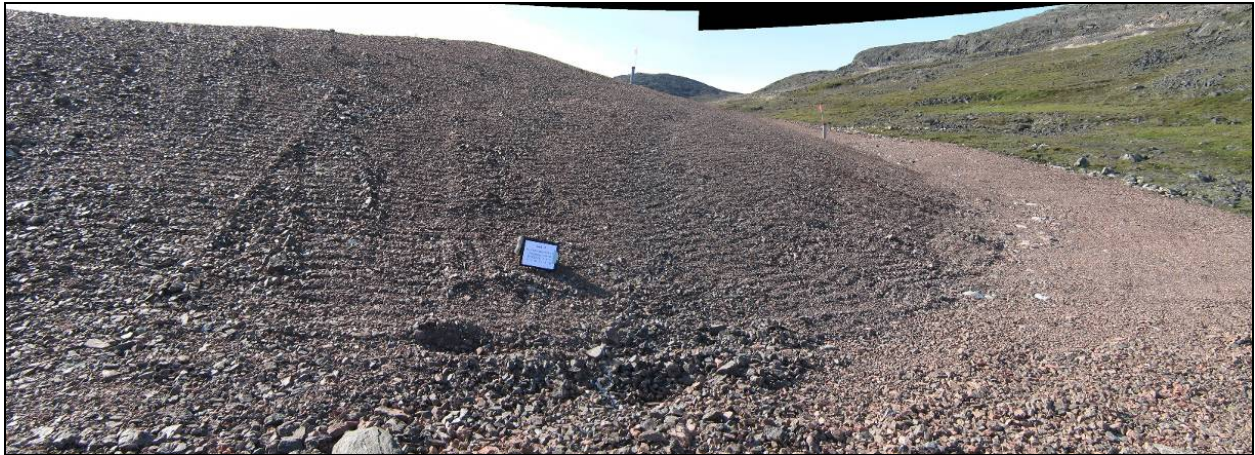
**Photograph LSL-4.** Panoramic photo facing west to the northeast corner of the landfill. ↑

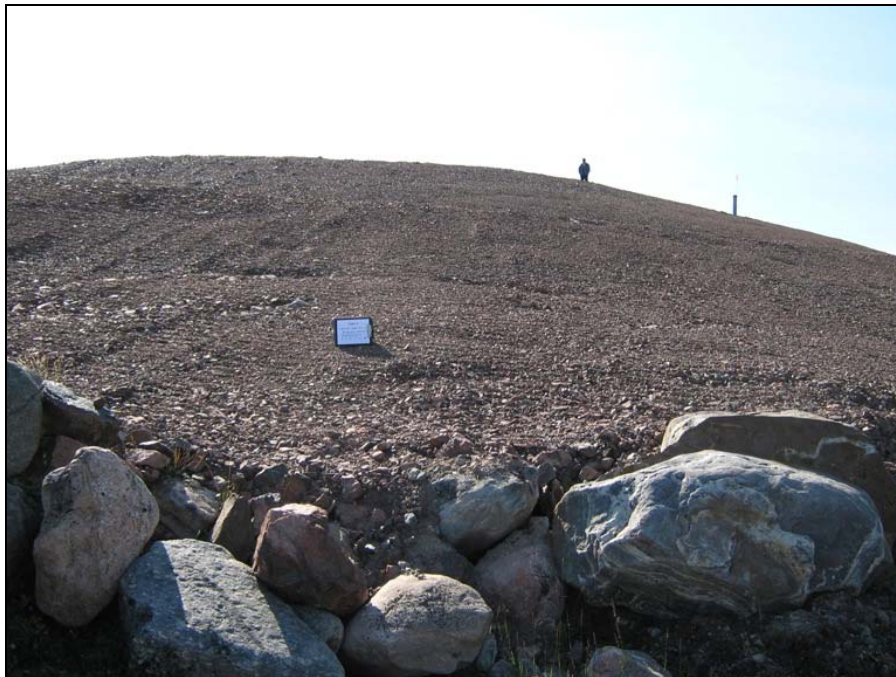
**Photograph LSL-5.** View of the northeast corner slope from near MW-17, facing southwest. ↑

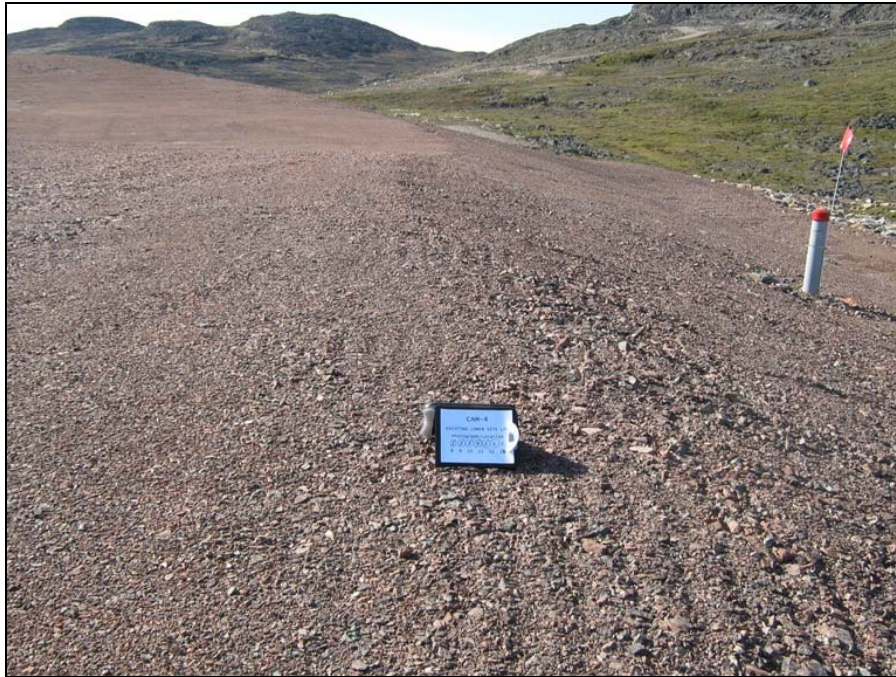
**Photograph LSL-6.** Facing west long the north crest. Some seepage from lower half of north face. No staining observed. ↑

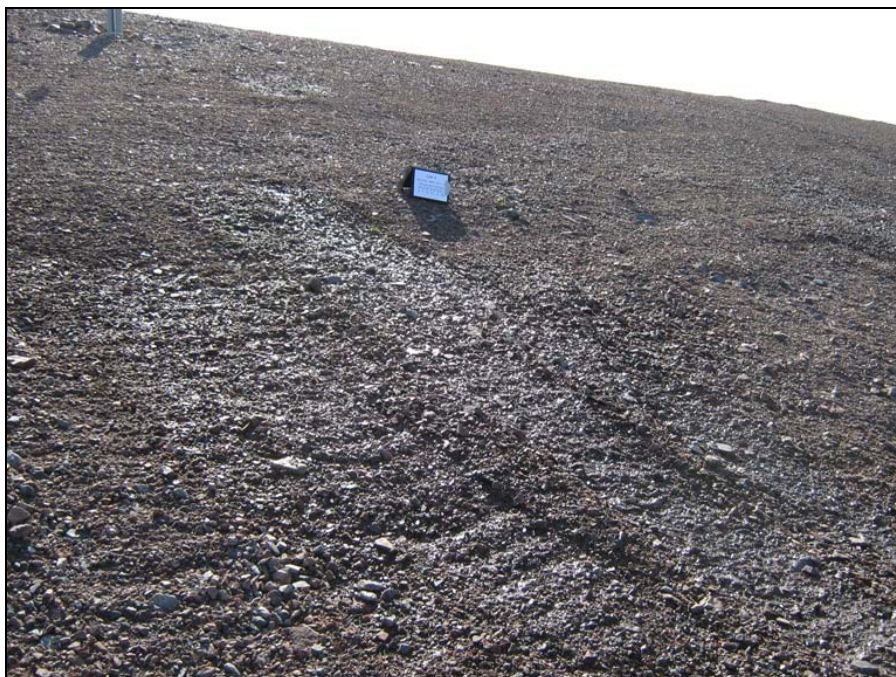
**Photograph LSL-7.** Facing southwest to the north slope near thermistors. Seepage from lower half of slope, with no staining observed. Very small tufts of grass/vegetation observed. ↑

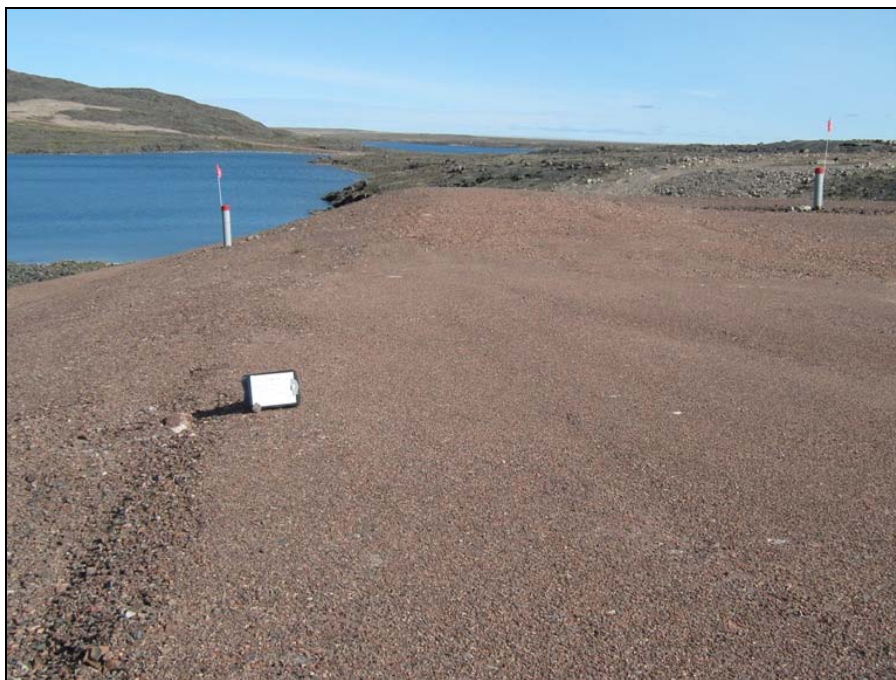
**Photograph LSL-8.** Facing east along the north crest near thermistors. ↑

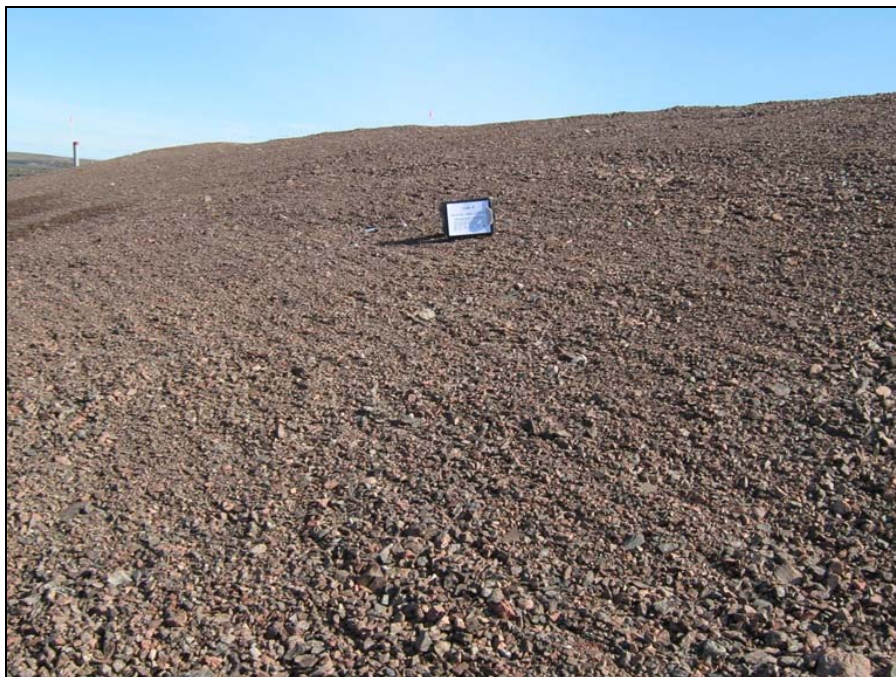
**Photograph LSL-9.** Facing southeast to slope. ↑

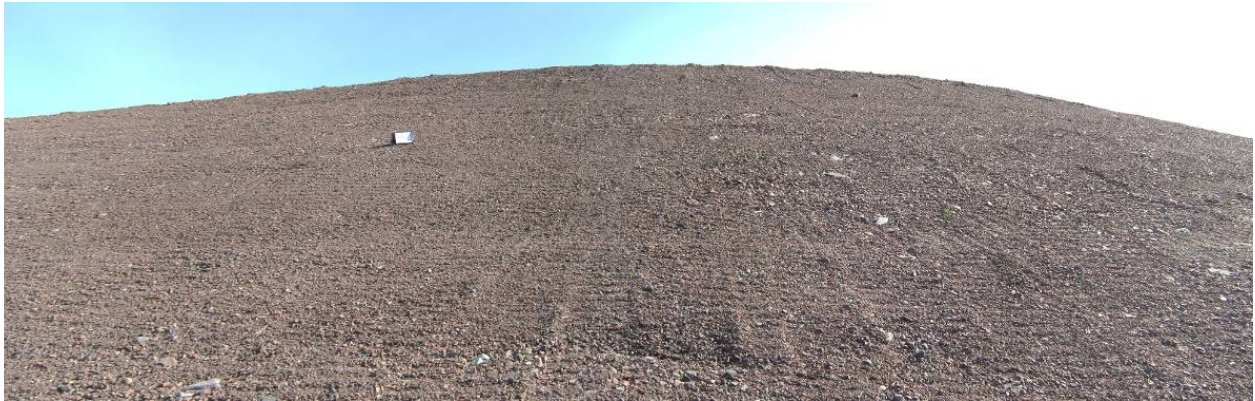
**Photograph LSL-10.** Panoramic photo facing southeast to the north slope at northwest end. Minor erosion of fines but self armouring. ↑

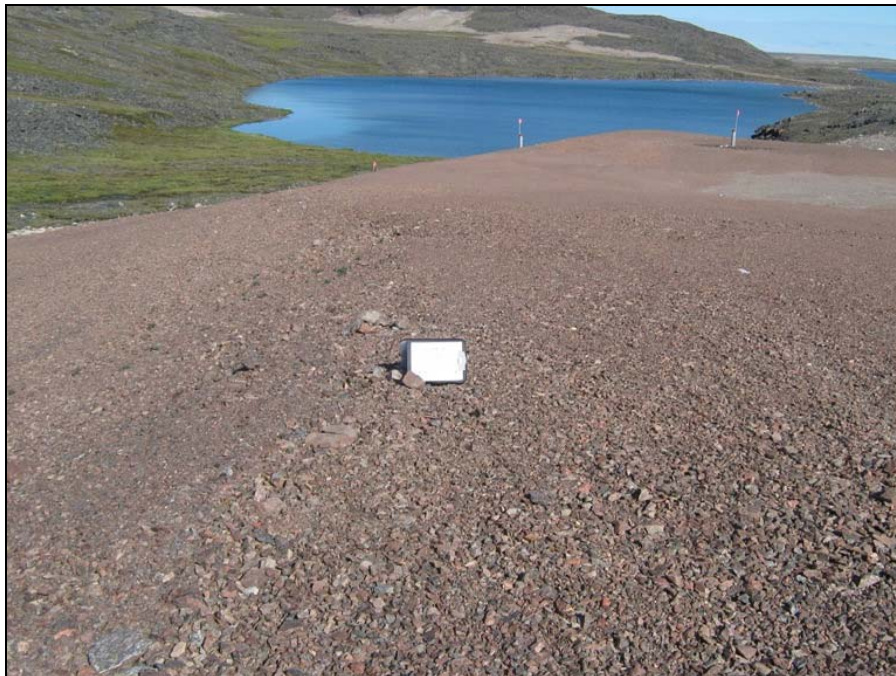
**Photograph LSL-11A.** Facing east along northwest crest. ↑

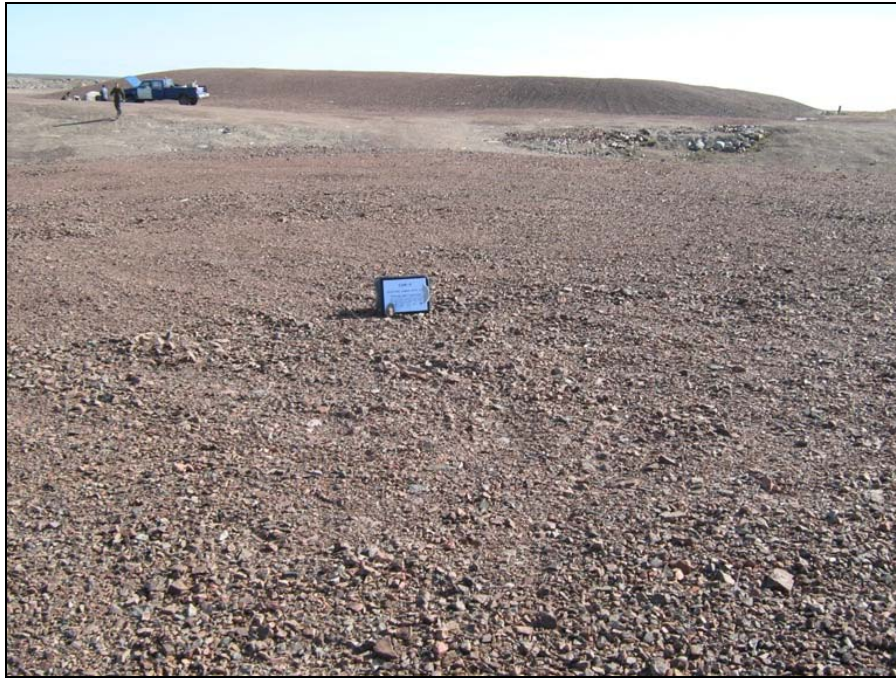
**Photograph LSL-11B.** Facing south over the landfill from the northwest crest. ↑

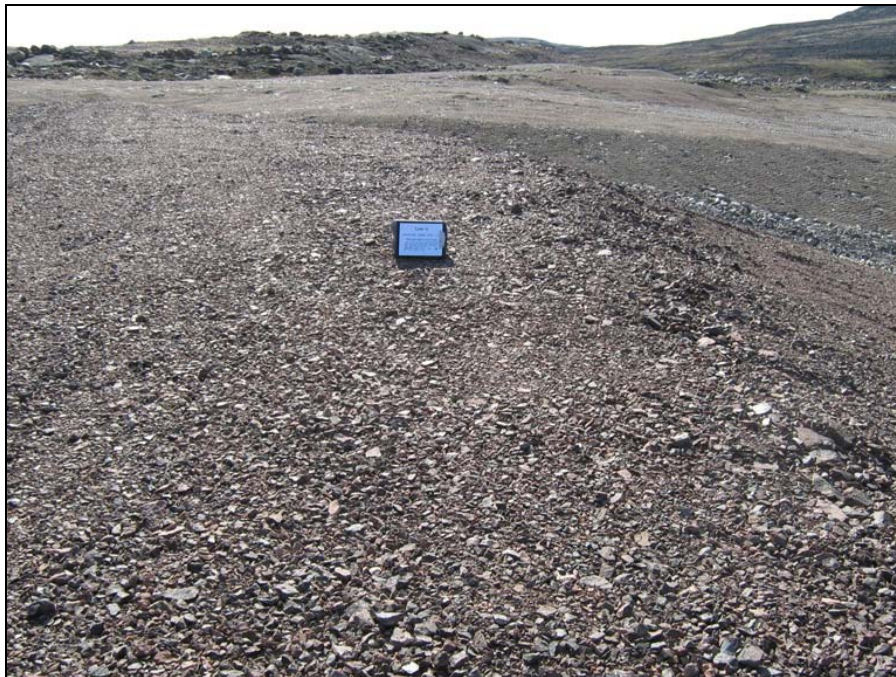
**Photograph LSL-11C.** Facing west along the northwest crest. ↑

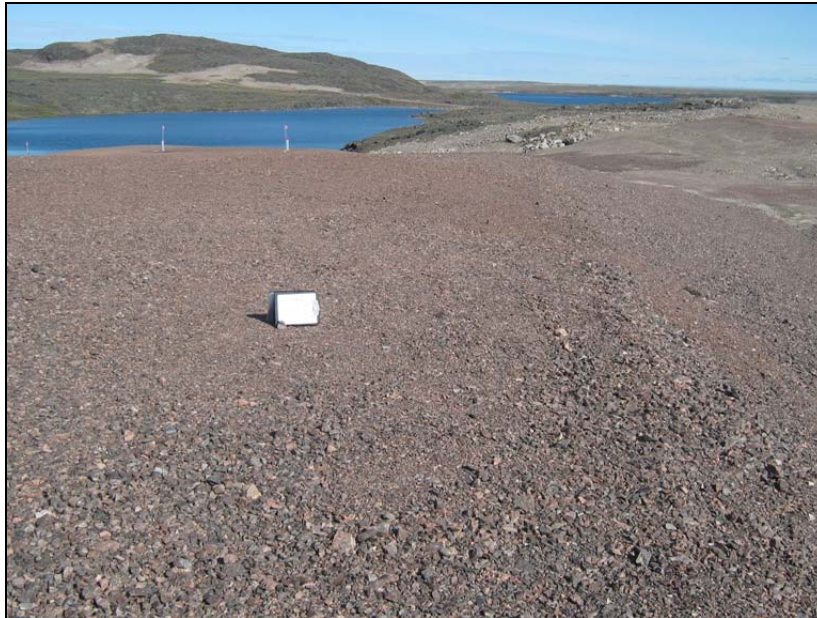
**Photograph LSL-12.** Facing east along crest at the southwest corner. ↑

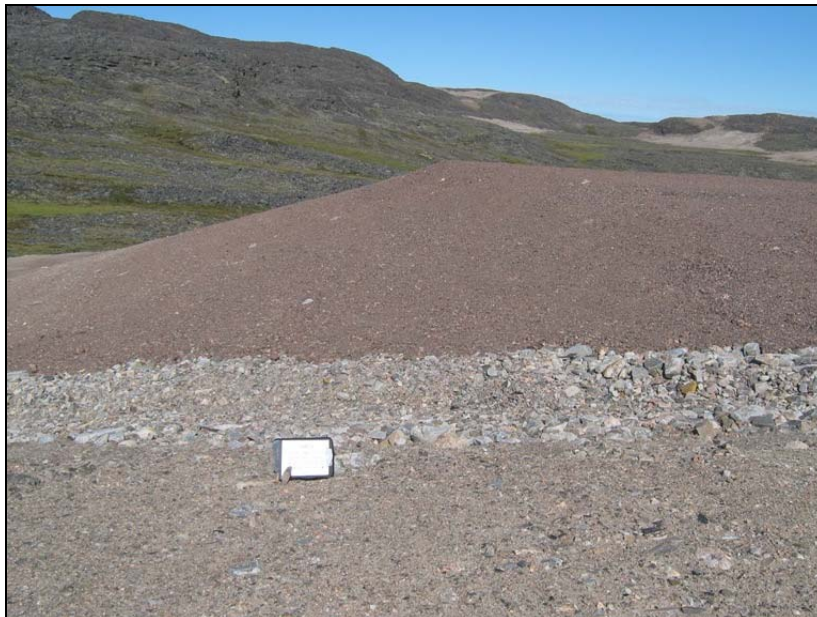
**Photograph LSL-13.** Facing northeast to the west slope and rip-rap lined drainage ditch at the toe of the landfill. ↑
