**THE COLLECTION OF LANDFILL  
MONITORING DATA AT THE FORMER  
CAM-4 DEW LINE SITE**

Kugaaruk, Nunavut

**FINAL REPORT – 2011 SEASON**

**DEFENCE CONSTRUCTION CANADA**

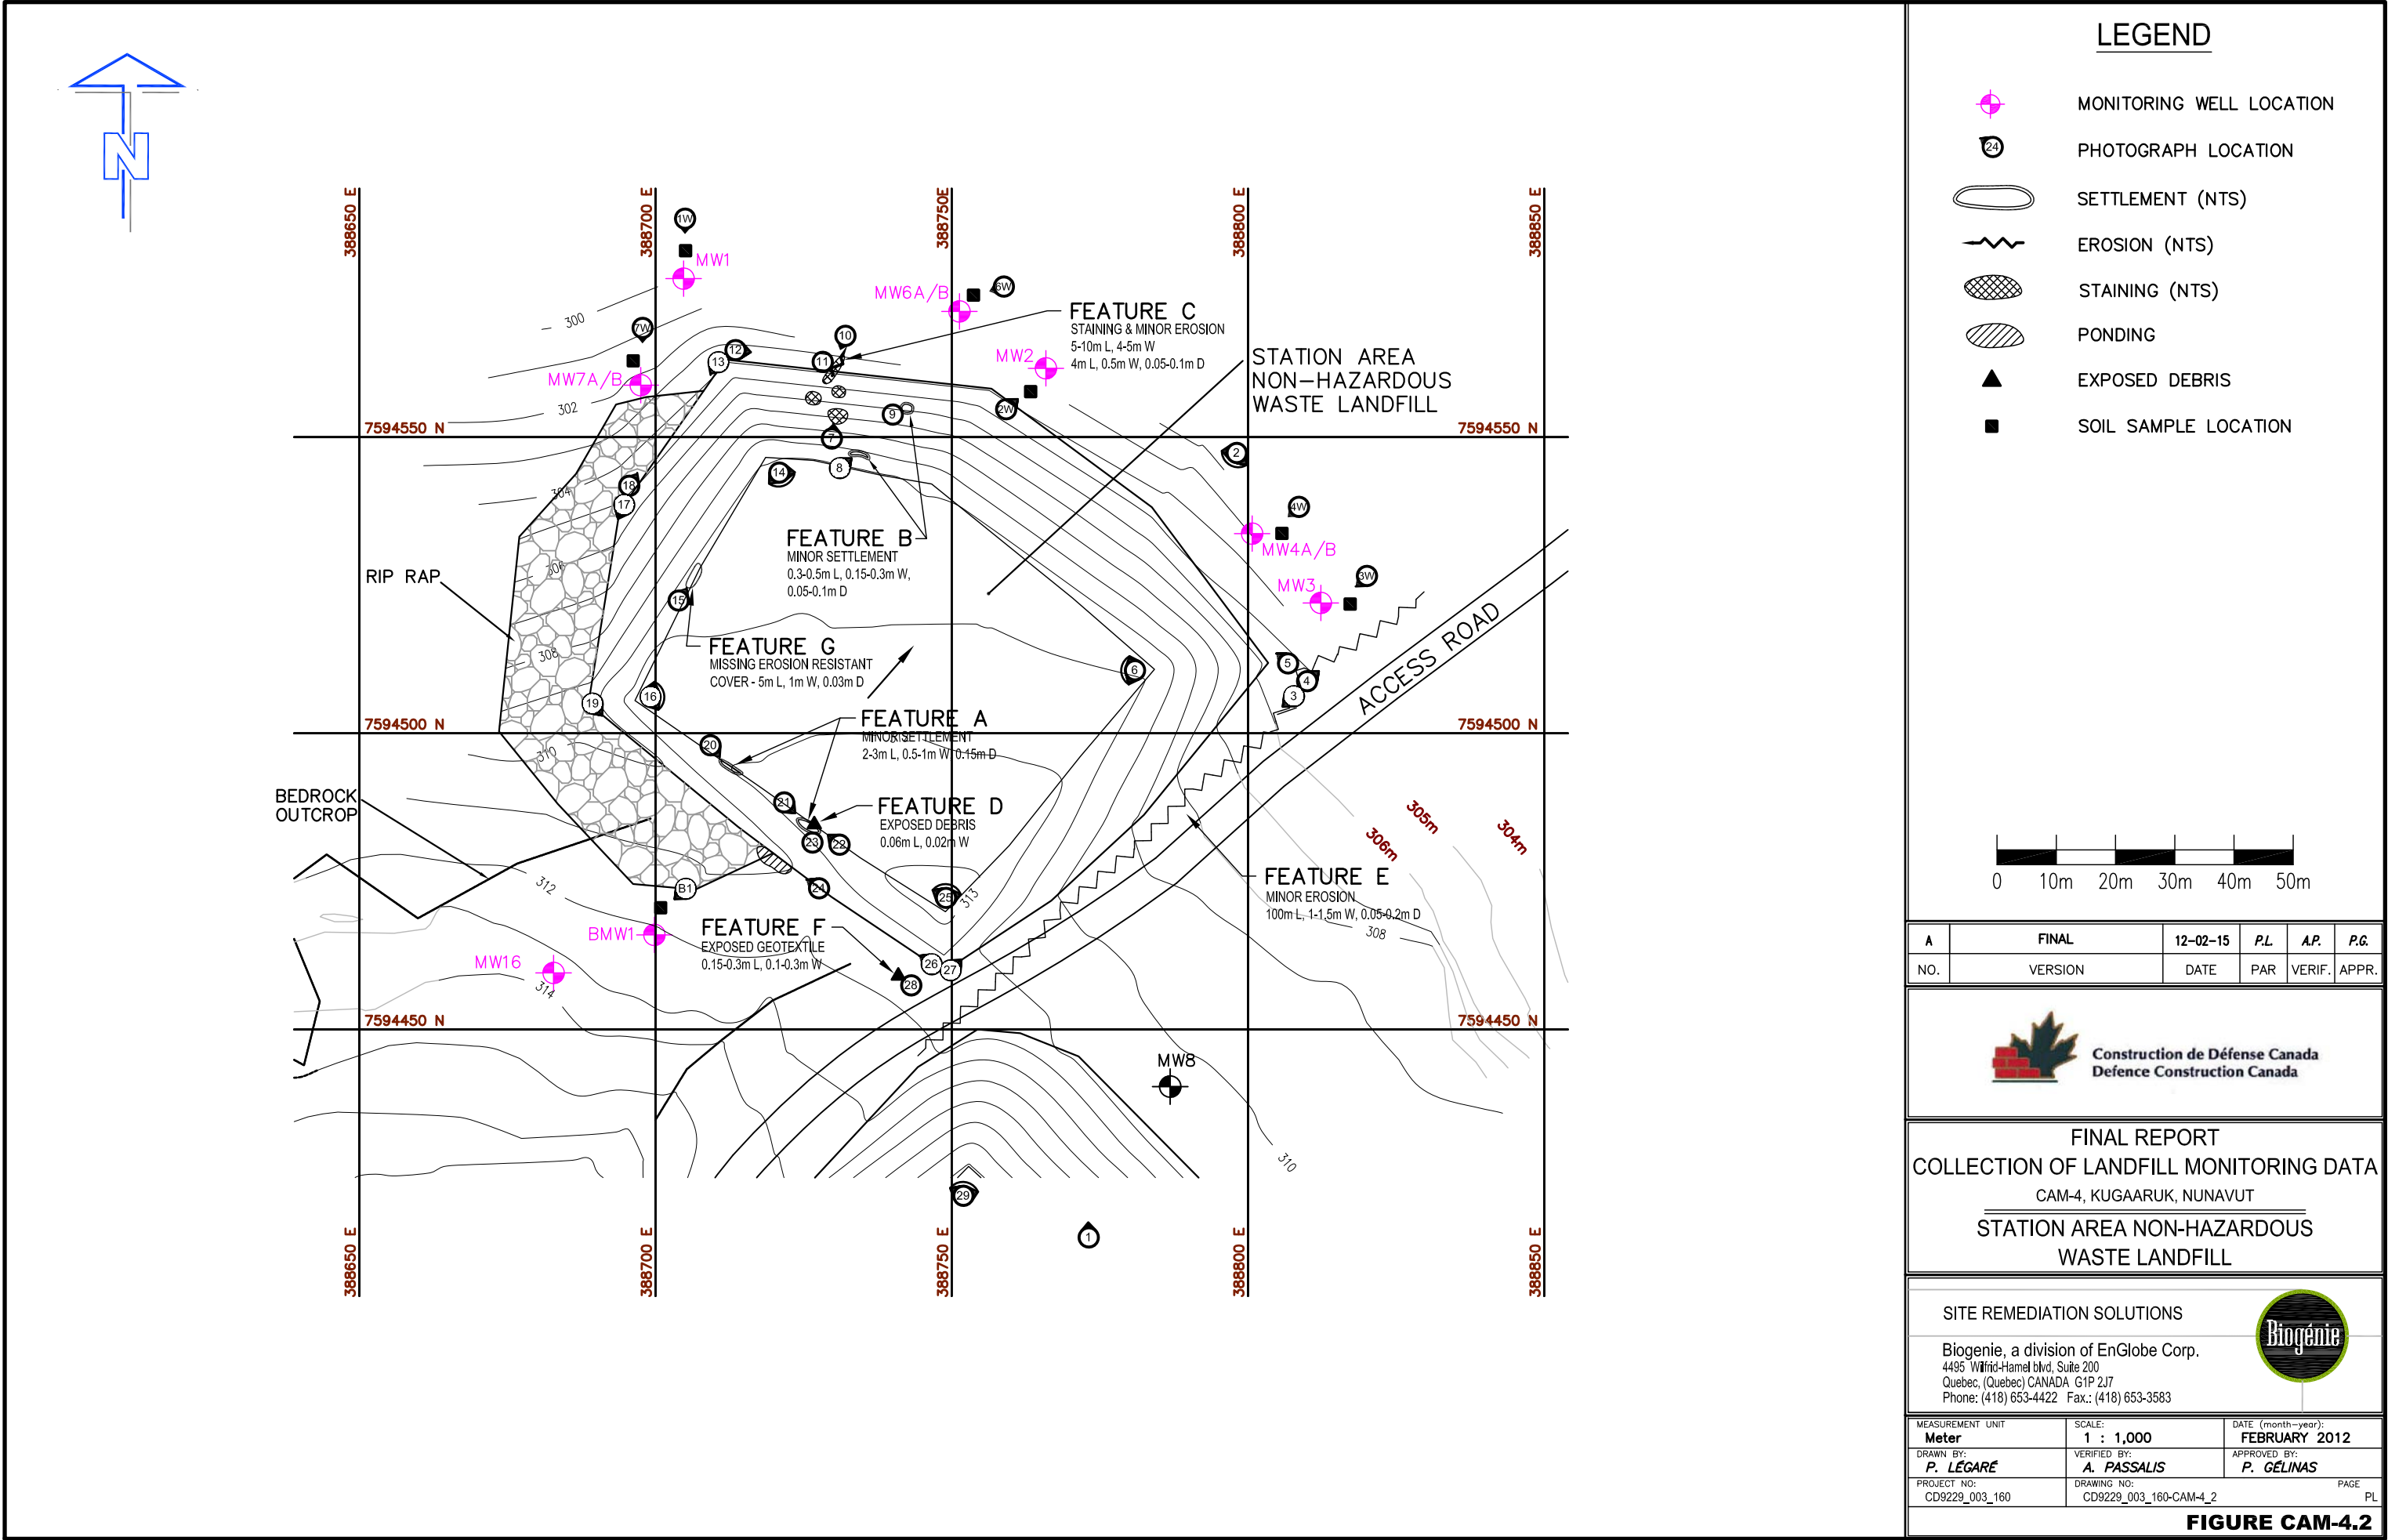
The Location Plan for the SA NHWLF has been completed as per the ToR and is included in the following page as Figure CAM-4.2.

| Checklist Item | Present (Yes/No) | Location | Length | Width | Depth | Extent | Description | Photographic Record | Severity Rating | Additional Comments |
|---|---|---|---|---|---|---|---|---|---|---|
| Erosion | Yes | FEATURE C<br>See Figure CAM-4.2 (northwest corner slope / toe)<br><b>NEW OBS.</b> | 4 m | 0.5 m | 0.05 - 0.1 m | Isolated | Minor erosion | SNH-10, 11 | Acceptable | Associated with rust coloured staining. |
| Staining | Yes | FEATURE C<br>See Figure CAM-4.2 (northwest corner slope) | 5-10 m | 4-5 m | N/A | Isolated (<1%) | Discontinuous areas of rust-coloured staining | SNH-7, 10, 11 | Acceptable | Stained areas on northwest sideslope. No seepage noted at time of inspection. |
| | | FEATURE G<br>See Figure CAM-4.2 (northwest crest)<br><b>NEW OBS.</b> | 5 m | 1 m | 0.03 m | Isolated | Missing erosion resistant cover material | SNH-15 | Acceptable | Located on northwest crest. |

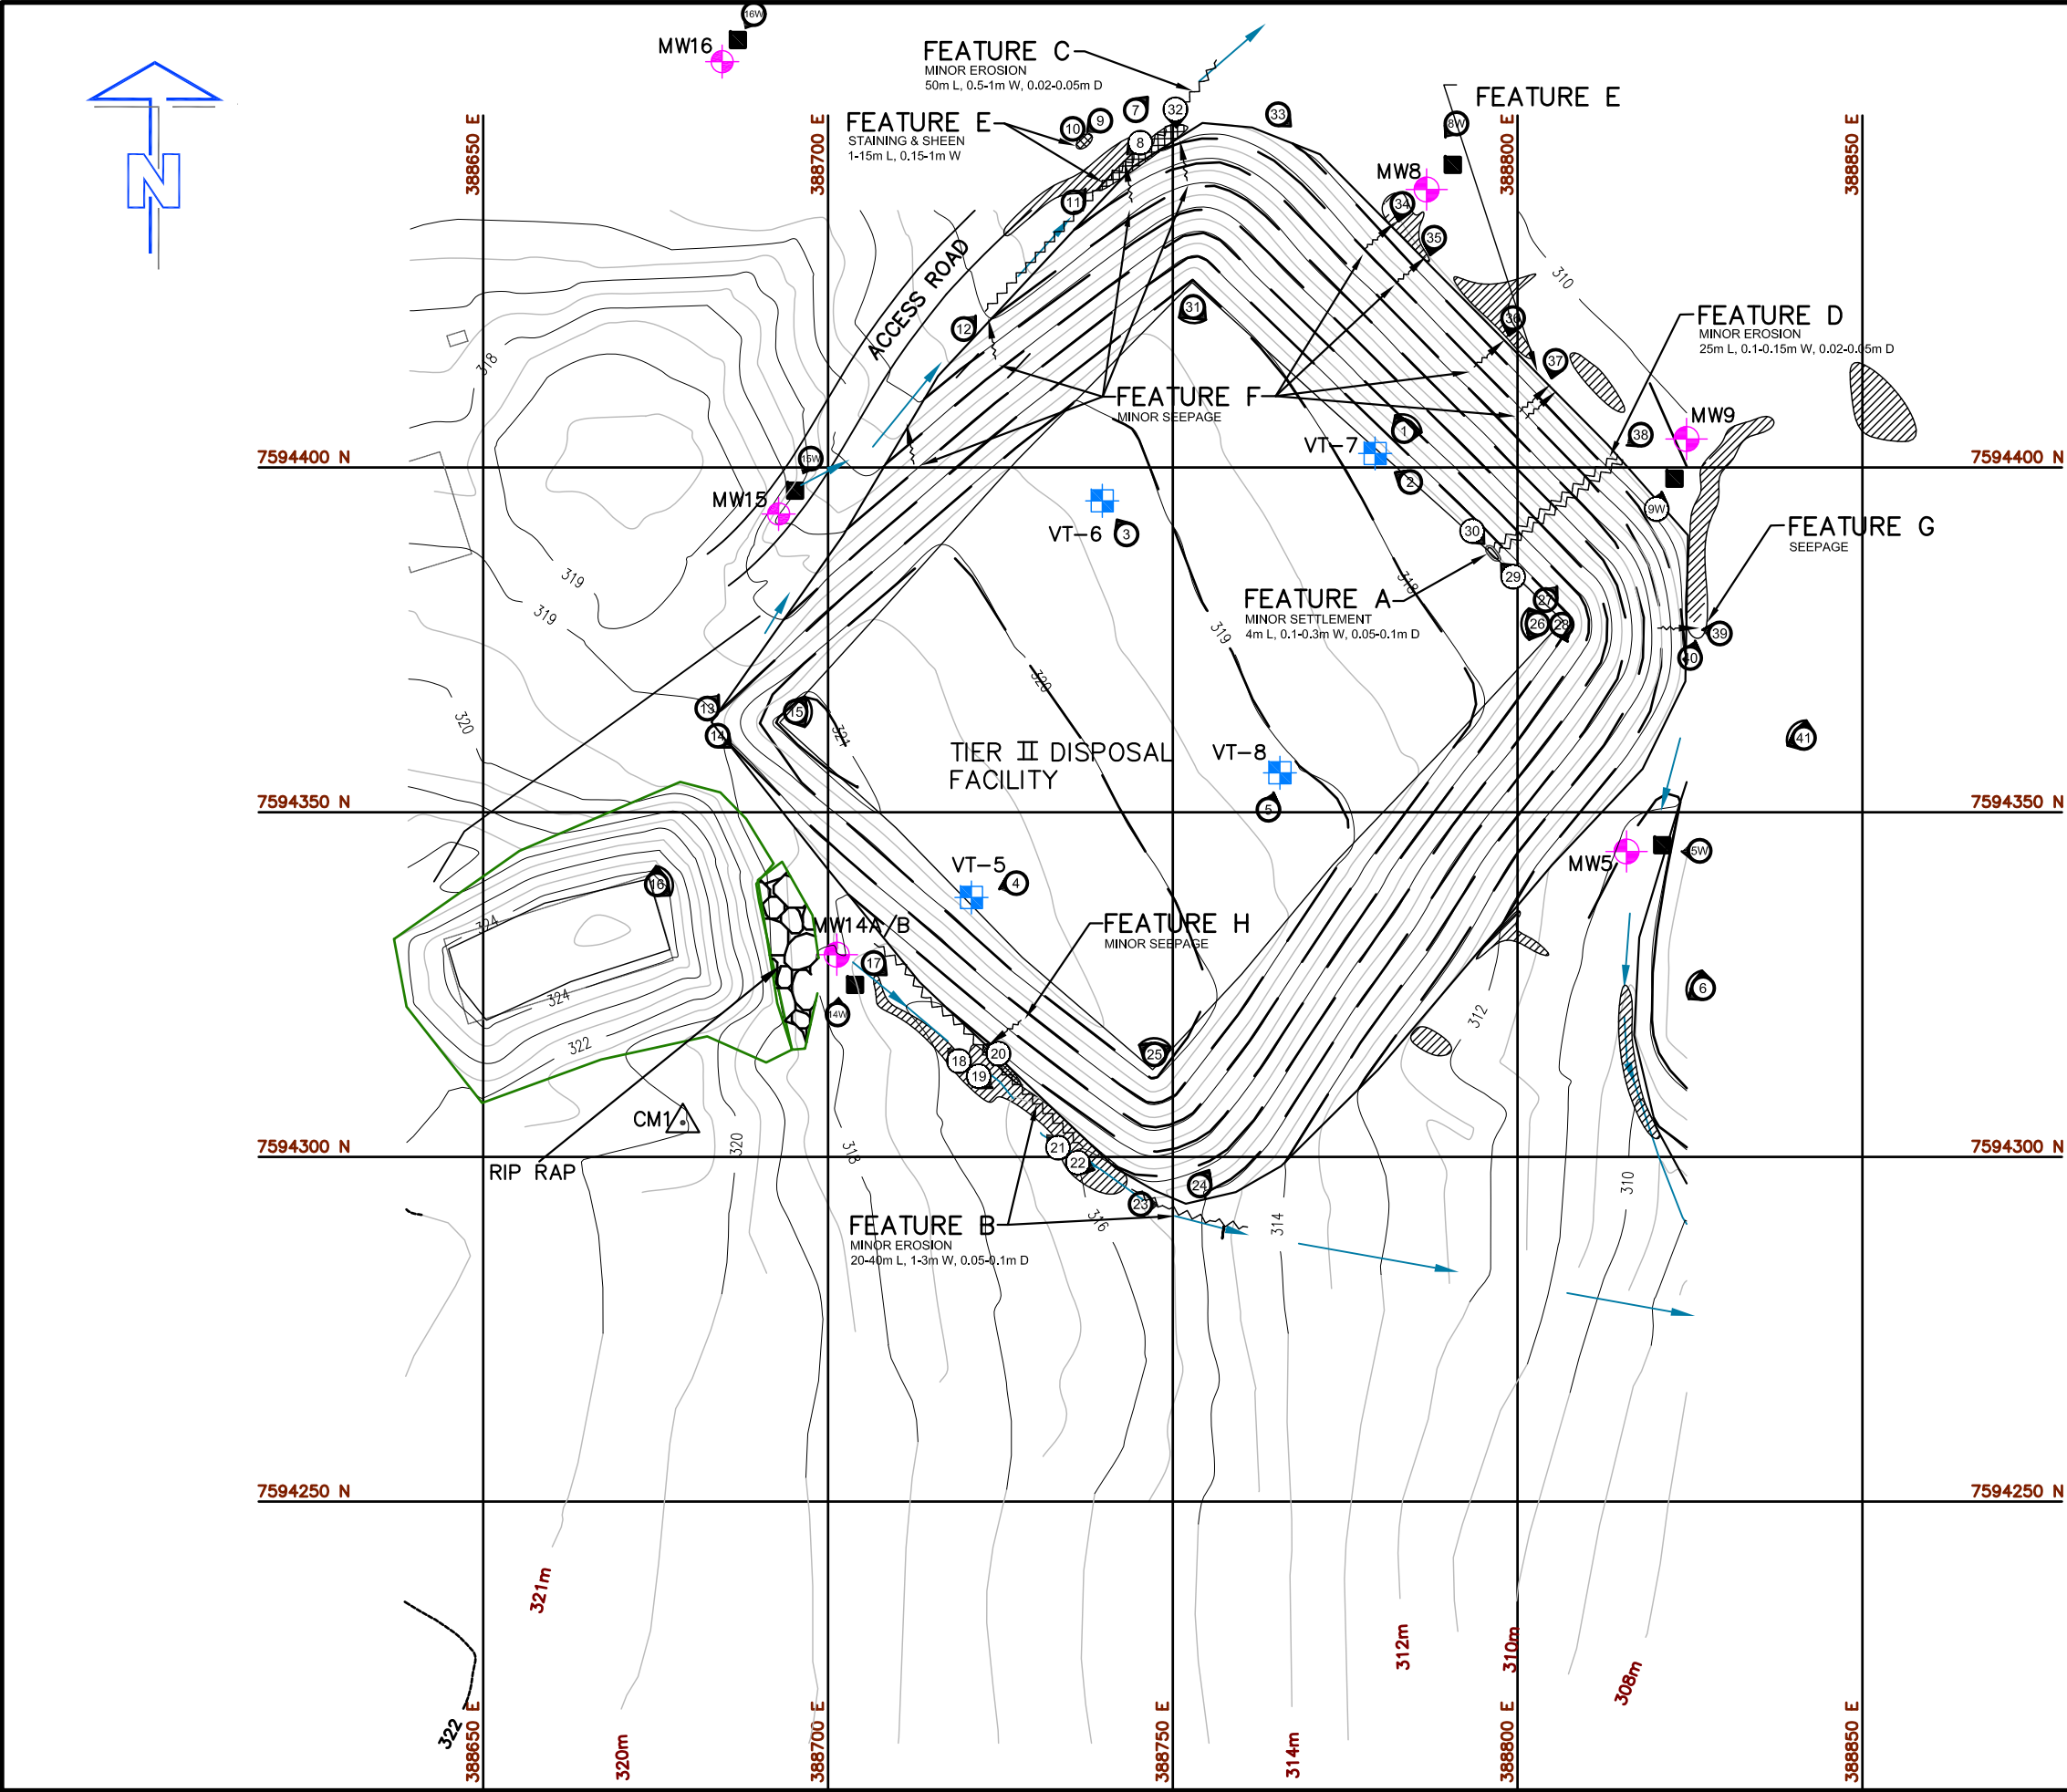
The Location Plan for the Tier II Disposal Facility has been completed as per the ToR and is included in the following page as Figure CAM-4.3.

| Checklist Item | Present (Yes/No) | Location | Length | Width | Depth | Extent | Description | Photographic Record | Severity Rating | Additional Comments |
|---|---|---|---|---|---|---|---|---|---|---|
| Staining | Yes | FEATURE E<br>See Figure CAM-4.3 (northwest toe) | 1-15 m | 0.15-1 m | Unknown | Isolated | Minor staining and sheen noted in roadway and along seepage path | TII-8-11, 32 | Acceptable | Minor rust-coloured staining associated with seepage point along northwest toe of facility. Sheen associated with staining in majority of locations. |
| Seepage Points | Yes | FEATURE F<br>See Figure CAM-4.3 (northwest and northeast toes) | 0.5 m | 0.1 - 0.5 m | N/A | Isolated | Discrete points of seepage along toe of slopes | TII-8, 12, 32, 34-37 | Acceptable | Localized ponding associated with seepage along toe of slope. Wetted area and minor seepage observed on lower slope. |
| | | FEATURE G<br>See Figure CAM-4.3 (east toe) | 0.5 - 1.0 m | 0.2 m | N/A | Isolated | Seepage along toe of slope | TII-39, 40 | Acceptable | Localized seepage. No staining observed. |
| | | FEATURE H<br>See Figure CAM-4.3 (southwest toe)<br><b>(NEW OBS.)</b> | 0.5 m | 0.15 m | N/A | Isolated | Minor seepage along toe of slope | TII-20 | Acceptable | Localized seepage. Rust coloured staining and sheen noted for 10 m downgradient. |
