**REMEDIAL ACTION PLAN
FOR PELLY LAKE FORMER AIRSTRIP
AND FUEL CACHE SITE
PELLY LAKE, NUNAVUT**

Project Number: 220515

14 December 2023

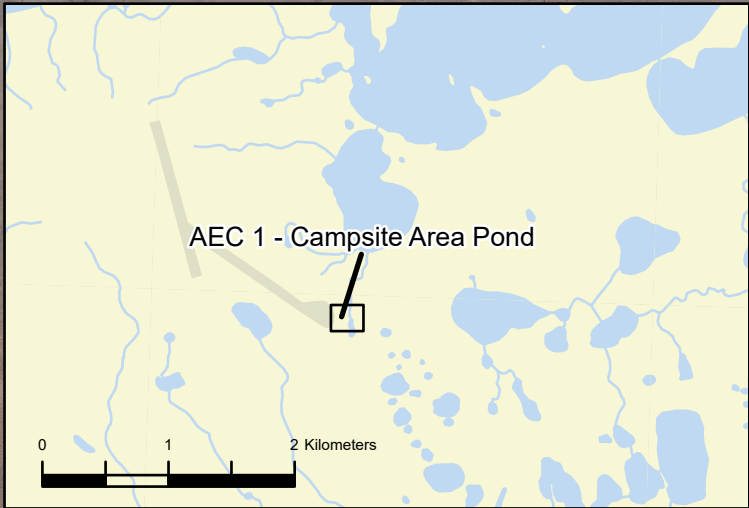
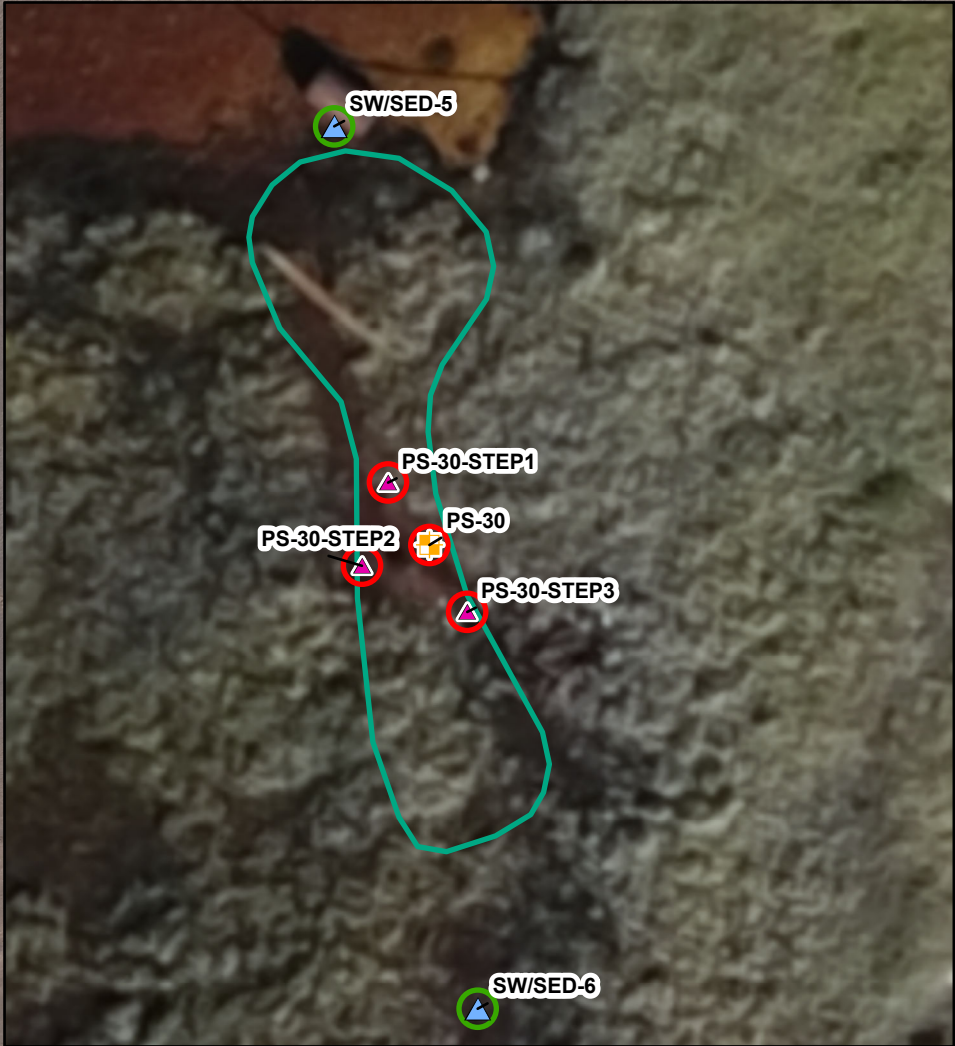
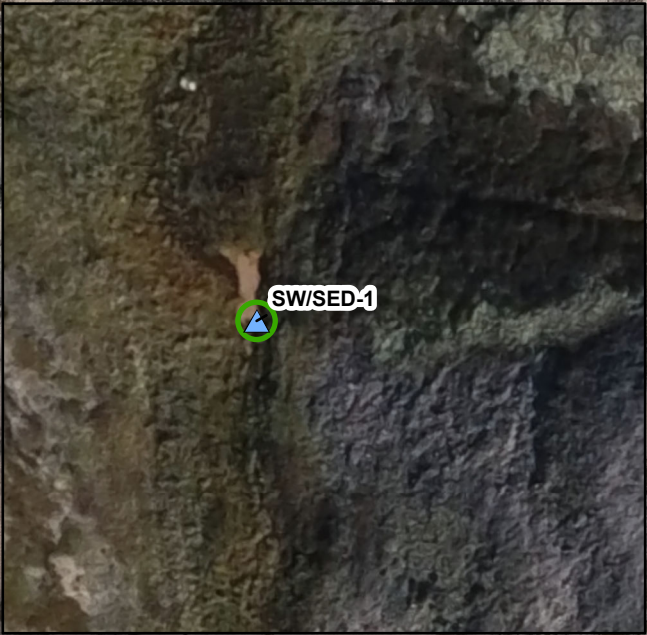
SW/SED-1 North of AEC 1

COC	Unit	PS30	PS30 – STEP 1	PS30 – STEP 2	PS30 – STEP 3	SED5	SED6	PW3	PW5
Lead (Pb)	mg/kg	4385	1740	7540	2720	60.2	14.8	0.97	0.95

COC	Unit	SED1	SED 2	SED 3	SED 4
Lead (Pb)	mg/kg	0.84	1.26	3.53	3.62

As described in the ROA (BluMetric, 2023), impacted sediment will be removed and disposed of off site. This was the preferred outcome in both the ROA (BluMetric, 2023) and the community engagement sessions. Due to the relatively small volume of impacted sediment, the sediment will be removed by hand and placed into suitable containers or drums and removed off site opportunistically during the summer Year 1. Any remaining drums or containers will be removed during the winter/early spring of Year 2 along with the non-hazardous debris. Removing the sediment by hand will decrease the need for heavy machinery, allowing for a simpler logistical approach and a decrease in the carbon footprint of this remediation strategy.

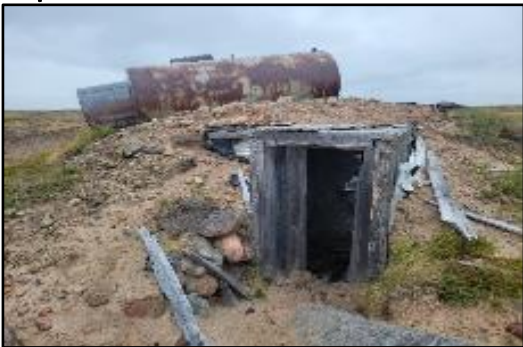
ITEM	Surface Debris	APEC	Description	Inventory – Hazardous	Inventory – Non-hazardous
1	Campsite Food Cache

1	Constructed of wood and metal (walls, ceiling, roof and floors) and built into the mound of soil with the entrance facing west. The walls consist of unpainted boards and are lined with sheet metal. The wood and metal is not painted. The roof appears to have been covered in black tar paper in poor condition (partially buried in the gravel to the side of the structure). There appears to be a sheet of plywood lying in front of the structure that may have been the door. The floor has collapsed exposing bare earth, and the structure itself has partially collapsed). There are three tanks on the roof. Area: 9 m² Volume: 20.9 m³ Adjusted volume without void space: 8.7 m³	Liquid and Drum/Tank Residues – 0.3 m ³ Total: 0.3 m³	Plywood and boards 4 m ³ Metal debris 2 m ³ Tar paper 1.3 m ³ Three tanks, cut up 1.4 m ³ Total: 8.7 m³

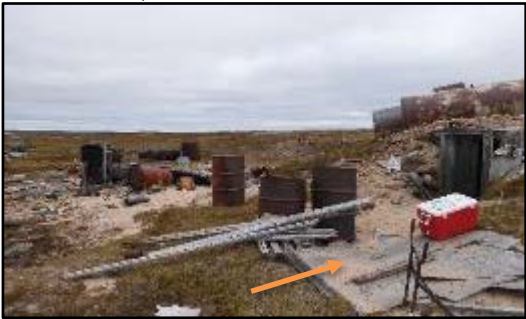
2	Immediately West of the Food Cache

1	No structure remains. Wooden debris, a metal structure, household items, and empty barrels (approximately 7) remain in this area. Area: 15 m² Volume: 15.1 m³ Adjusted volume without void space: 13.75 m³	none	Wood debris 13 m ³ Metal Debris 0.39 m ³ Household items 0.25 m ³ Empty barrels, crushed 0.11 m ³ Total: 13.75 m³
3	Northwest of the Food Cache

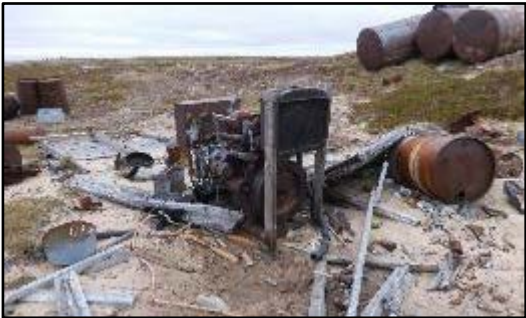
1	No structure remains. Wooden debris, an old generator, a battery, rubber hose, household items, soda cans, and overturned empty barrels (approximately 6) are present in this area. Area: 54 m² Volume: 41.1 m³ Adjusted volume without void space: 14.1 m³	Car batteries (3 units) 0.10 m ³ Total: 0.10 m³	Cylinders (Two 0.8 m ³ tanks, two 0.5 m ³ tank, and two 0.002 m ³ tank) 2.6 m ³ Machine parts and generator 1.4 m ³ Wood debris 9.9 m ³ Empty barrels, crushed 0.09 m ³ Total: 14 m³
4	West of the Food Cache

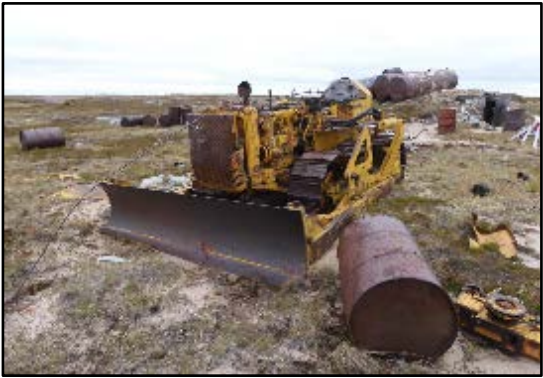
1	No structure remains. CAT bulldozer and metal debris (including approximately two empty barrels) remain in this area. Area: 25 m² Volume: 26 m³ Adjusted volume without void space*: 17.58 m³ <small>*void space estimated at 2/3 of volume for equipment</small>	Possible liquids inside bulldozer 10 L Assumed lead-based paint, estimated thickness 0.01 m. Total Liquids: 0.01 m³ Total Paint: 0.25 m³	Empty barrels, crushed 0.031 m ³ Steel debris 0.6 m ³ CAT bulldozer, dismantled 16.7 m ³ Total: 17.3 m³

Two large items will be left on-site, the D4 bulldozer and the old turbine on a steel cart. These items will be inspected for any remaining fuels/liquids within the equipment and the paint will be tested for lead and PCBs. If there are any liquids within the large equipment, they will be drained and removed off-site for hazardous waste disposal. If the paint contains lead or PCBs, it will be removed from the equipment following approved methodology and removed off site for disposal as hazardous waste.

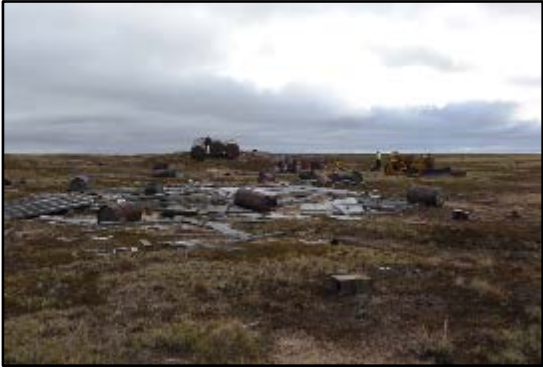
ITEM	Surface Debris	APEC	Description	Inventory – Hazardous	Inventory – Non-hazardous
5	North of the Food Cache – 1

1	<p>No structure remains. Wooden debris, household items, glass bottles, and overturned empty barrels (approximately 13) are present in this area.</p> <p>Area: 54 m² Volume: 7.6 m³ Adjusted volume without void space: 5.2 m³</p>	none	<p>Wooden debris, household items, glass bottles = 5 m³ Empty barrels, crushed 0.2 m³</p> <p>Total: 5.2 m³</p>
6	North of the Food Cache – 2

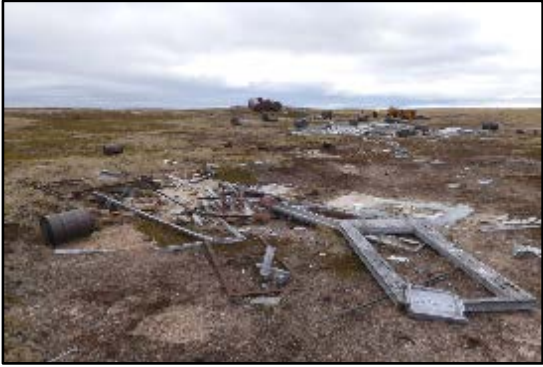
1	<p>No structure remains. Wooden debris, household items, glass bottles, and overturned empty barrels (approximately 2) are present in this area.</p> <p>Area: 54 m² Volume: 17 m³ Adjusted volume without void space: 16.63 m³</p>	none	<p>Cylinders (Two 0.8 m³ tanks, two 0.5 m³ tank, and two 0.002 m³ tank) 2.6 m³ Metal debris 4 m³ Wood debris 10 m³ Empty barrels, crushed 0.03 m³</p> <p>Total: 16.63 m³</p>

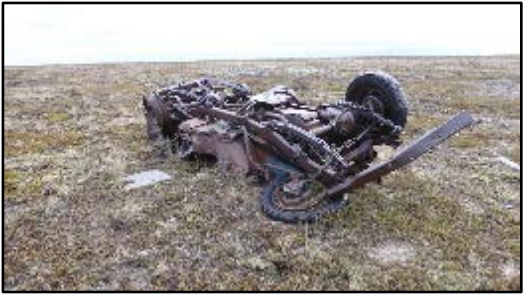
7	Southeast of the Food Cache

1	<p>Debris from overturned Jeep remain in this area.</p> <p>Area: 10 m² Volume: 4.9 m³ Adjusted volume without void space: 3.3 m³</p> <p><small>*void space estimated at 2/3 of volume for equipment</small></p>	<p>Possible liquids inside Jeep 10 L</p> <p>Total: 0.01 m³</p>	<p>Jeep debris 3.3 m³</p> <p>Total: 3.3 m³</p>
8	Site#1 Fuel Cache (South Pile)

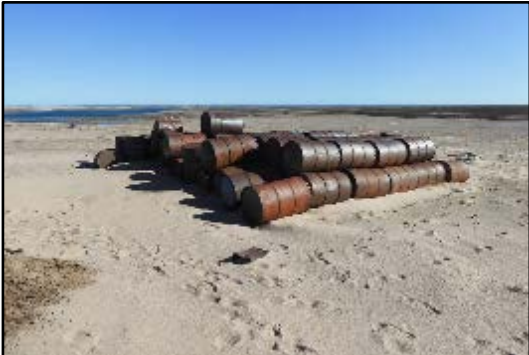
2	<p>111 barrels (unlabeled and empty) in the large cache, and approximately 44 more barrels scattered in surrounding areas to the south, southeast and southwest.</p> <p>Area: 60 m² (for the cache), plus 22 m² for the scattered barrels Volume: 22.8 m³ (for the cache), plus 9 m³ for the scattered barrels Adjusted volume without void space: 2.3 m³ and 0.9 m³</p>	none	<p>155 empty fuel barrels, crushed 3.2 m³</p> <p>Total: 3.2 m³</p>

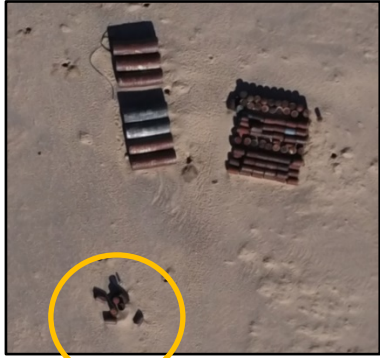
ITEM	Surface Debris	APEC	Description	Inventory – Hazardous	Inventory – Non-hazardous
13	Site#1 Drum Pile (S)

2	6 barrels (unlabeled and empty) in a small cache. Area: 3 m² Volume: 1.2 m³ Adjusted volume without void space: 0.09 m³	None	6 empty fuel barrels, crushed 0.09 m ³ Total: 0.09 m³
14	Site#2 Fuel Cache

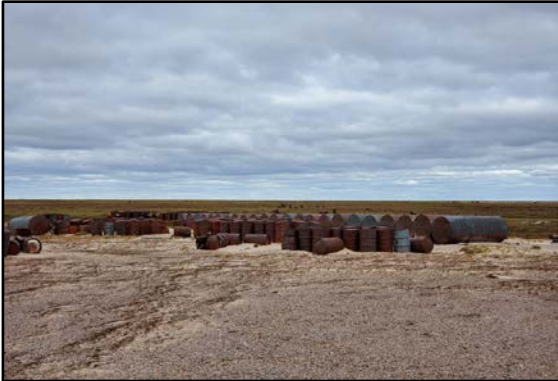
3	352 barrels, 26 tanks, plus another 9 barrels scattered to the south, and 23 scattered to the north, 32 toward the airstrip to the northeast and 1 to the east. One tank sample (approximately 15 cm liquid present, sample T1) and two barrel samples (samples B1 and B2) were collected in this area. Sample B2 had a very high concentration of F2 and is assumed to be fuel (location presented on Figure 7). B1 and T1 did not contain fuel and are assumed to be mostly water. Total tanks: 26 Total barrels: 417 Area: 156 m² (tanks) plus 208.5 m² (barrels) Volume: 118.2 m³ (tanks) plus 85.5 m³ (barrels) Adjusted volume without void space: 11.8 m³ (tanks) plus 8.6 m³ barrels	205 L of fuel present in 1 barrel (B2). Liquid and drum/tank residues – 2.8 m ³ Total Liquid and drum/tank residues: 3.0 m³	417 empty barrels, crushed 8.6 m ³ metal 1 full barrel (Contents: diluted fuel/water) 205 L liquid 26 empty tanks: 11.8 m ³ (metal) 1 tank (Contents: diluted fuel/water) 140 L liquid Total Liquid: 0.345 m³ Total Debris: 20.4 m³

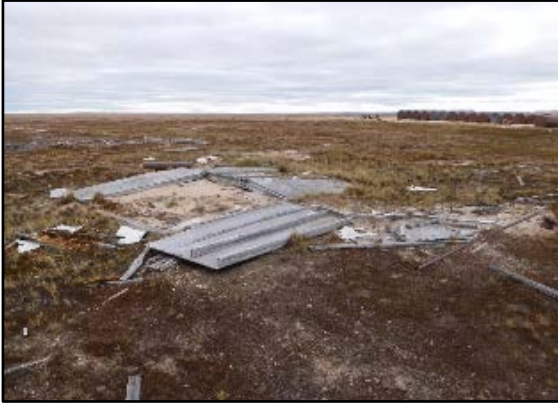
15	East of Site#2 Fuel Cache

3	No structure remains. Wooden and metal debris, household items, and broken glass are present in this area. Three samples were collected for analysis of Asbestos Containing Materials (ACM) from the surfaces of the collapsed building and were negative for ACM (samples A01a, A01b, and A01c). Area: 54 m² Volume: 12.1 m³ Adjusted volume without void space: 11.7 m³	none	Two empty barrels 0.03 m ³ Steel framing 2 m ³ Metal Debris 0.7 m ³ Wood debris 2 m ³ Tubing 7 m ³ Total: 11.7 m³
16	Southwest of Site#2 Fuel Cache

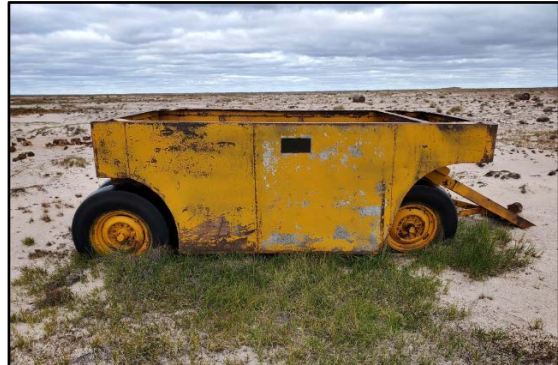
3	Metal cart. Area: 12 m² Volume: 18 m³ Adjusted volume without void space: 12.12 m³	Assumed lead-based paint, estimated 0.01 m thick. Total Paint: 0.12 m³	Steel cart 12 m ³ Total: 12 m³

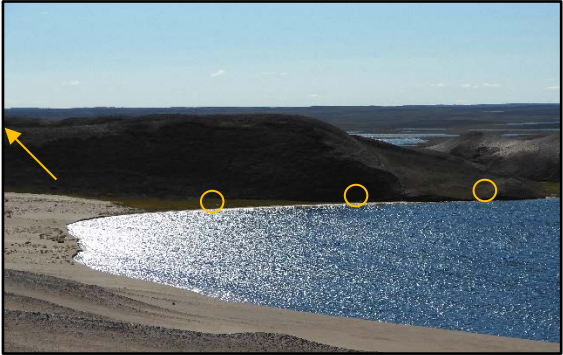
ITEM	Surface Debris	APEC	Description	Inventory – Hazardous	Inventory – Non-hazardous
17	Drinking Water Lake

4	15 barrels (unlabeled and empty) scattered around the shoreline and above the banks of Drinking Water Lake Area: 7.5 m ² Volume: 3.1 m ³ Adjusted volume without void space: 0.23 m ³	none	15 empty fuel barrels 0.23 m ³ Total: 0.23 m ³
18	Landing Lakes

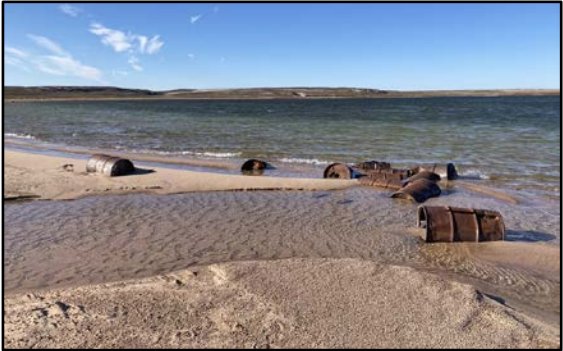
5	27 barrels and 1 x 1,000 L tank (unlabeled and empty) scattered around the shoreline and to the southwest of the Landing Lakes Area Area: 18 m ² Volume: 5.5 m ³ (barrels) plus 4.5 m ³ (tank) Adjusted volume without void space: 0.87 m ³	Liquid and drum/tank residues – 0.1 m ³ Total: 0.1 m ³	27 emptybarrels 0.42 m ³ 1 empty tank 0.45 m ³ Total: 0.87 m ³
19	Empty Fuel Drums throughout the site	N/A	Empty fuel drums throughout the site	Liquid and drum/tank residues – 1.3 m ³ Total: 1.3 m ³	N/A
	Total Volume Estimates			Total Debris: 0.10 m ³ Total Paint: 0.52 m ³ Total Liquids and Drum/Tank Residues: 6.64 m ³	Total (debris): 172.77 m ³ Total (liquid): 0.345 m ³
