**Project No: Water Use License 1BR-QIK0712 2011 Annual Report**

**Regarding: FOX-5, Qikiqtarjuaq DEW Line Site**

# PHOTOGRAPHIC LOG

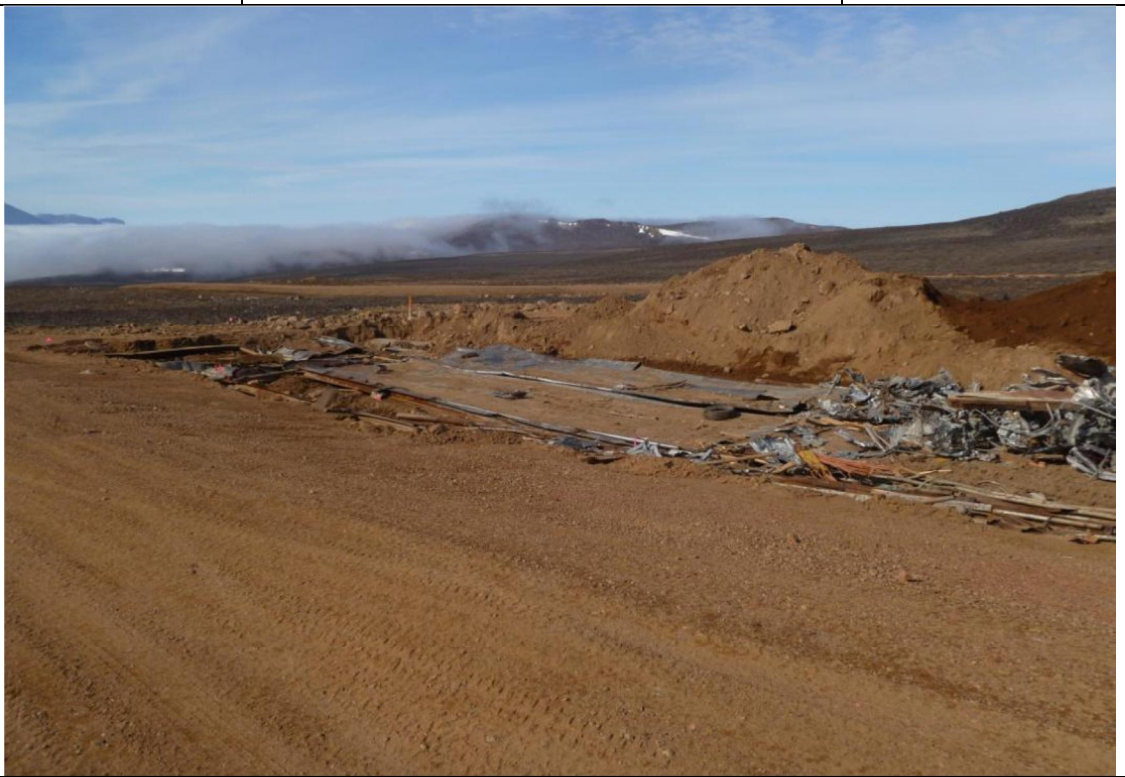
**Photo No.**  
1

**Description:**  
Debris being placed within the NHWL cell.

- A new cell at the Non-Hazardous Waste Landfill (NHWL) at the Middle Site was completed in 2011. The original facility was designed with the central berm shared between the NHWL and the Tier II Disposal Facility. The design of the new cell for disposal of the 2011 debris consisted of excavating a 60 m by 12 m area in the existing NHWL cap to a depth of 0.6 m. Construction began on Aug. 6, 2011. The non-hazardous debris generated from the collection of site debris, additional demolition activities and buried debris excavation were transported to this cell for disposal. The average depth of waste was approximately 0.3 m. Construction of the cap commenced after the final lift of intermediate fill over the debris was completed.

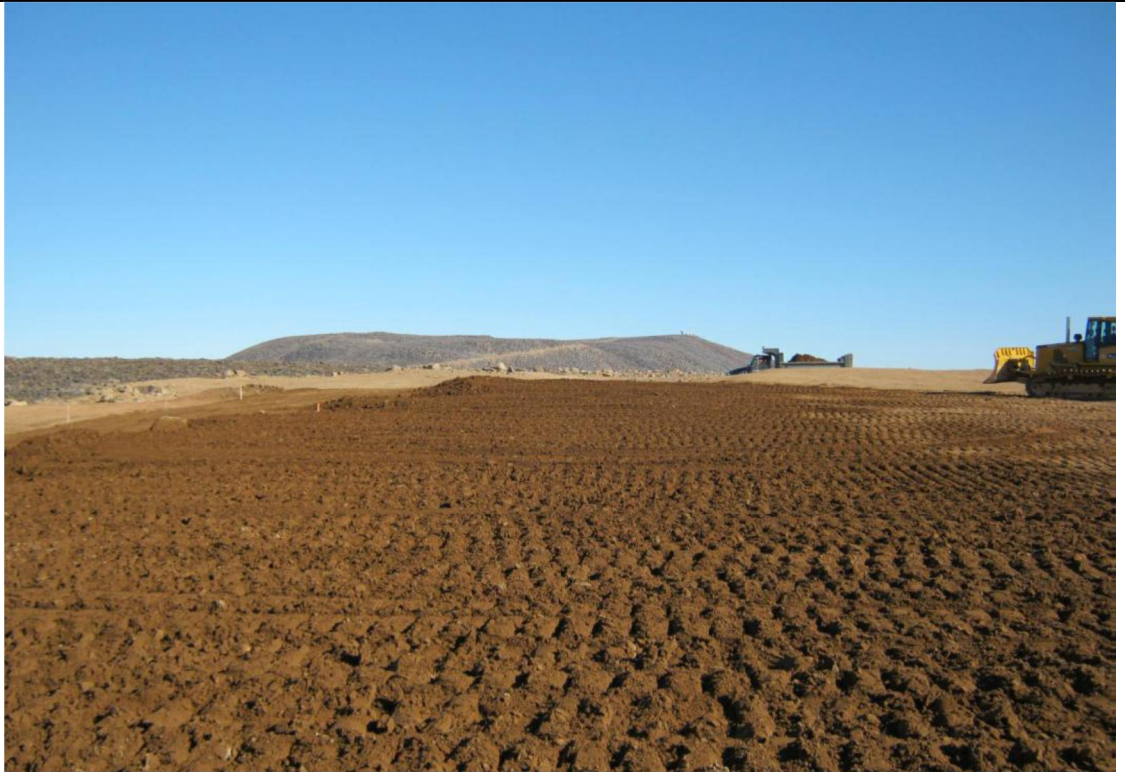
**Photo No.**  
2

**Description:**  
Final lift of granular fill cover at the NHWL.

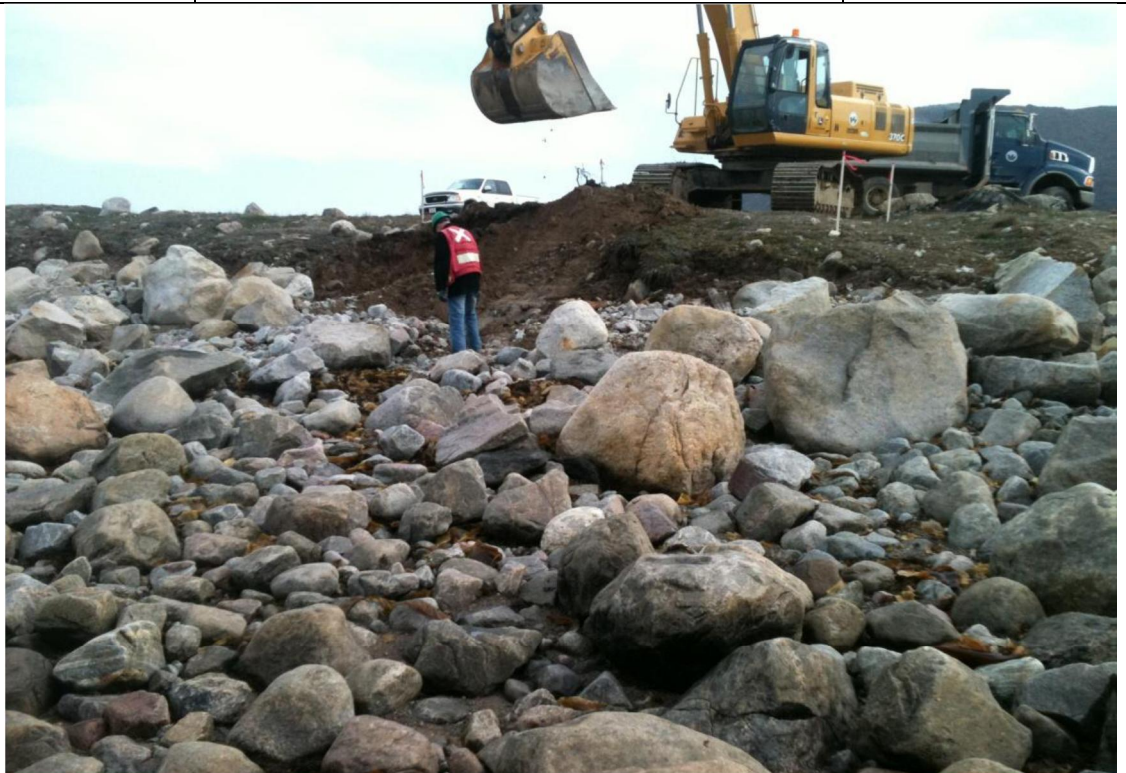
**Photo No.**  
3

**Description:**  
Excavation of Airstrip Landfill West

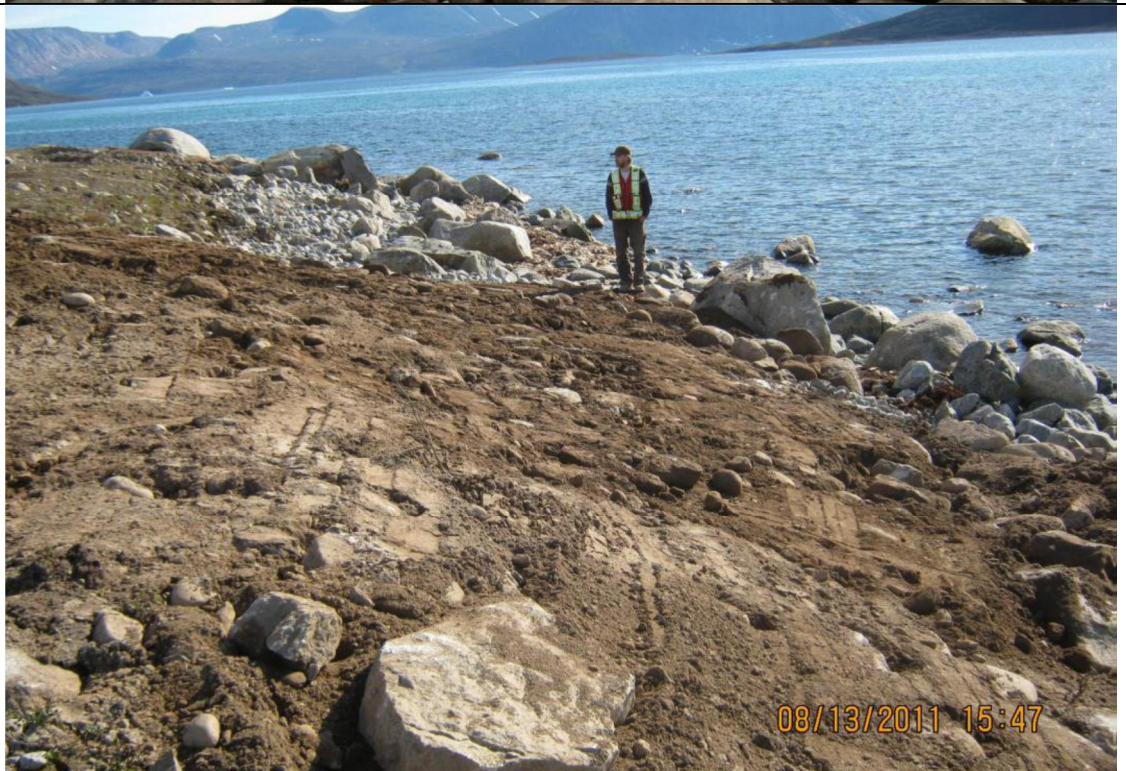
**Photo No.**  
4

**Description:**  
Airstrip Landfill West, backfilled.

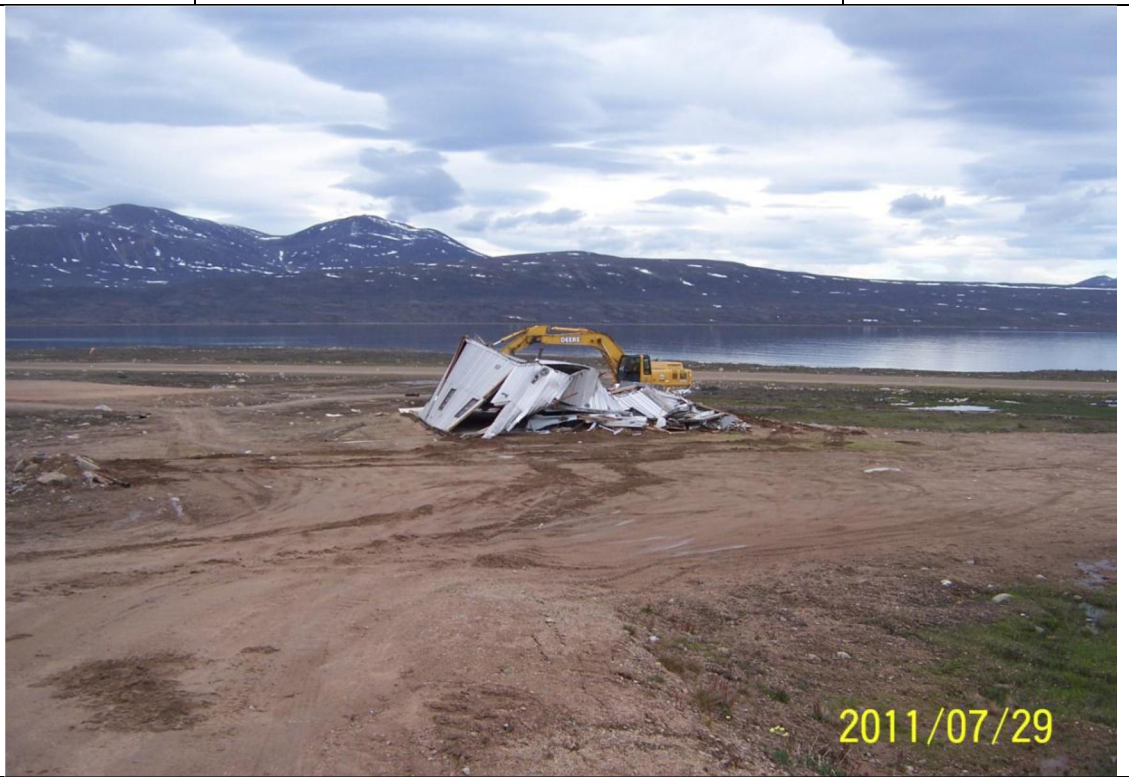
**Photo No.**  
5

**Description:**  
Demolition of the Heated Vehicle Storage Building.

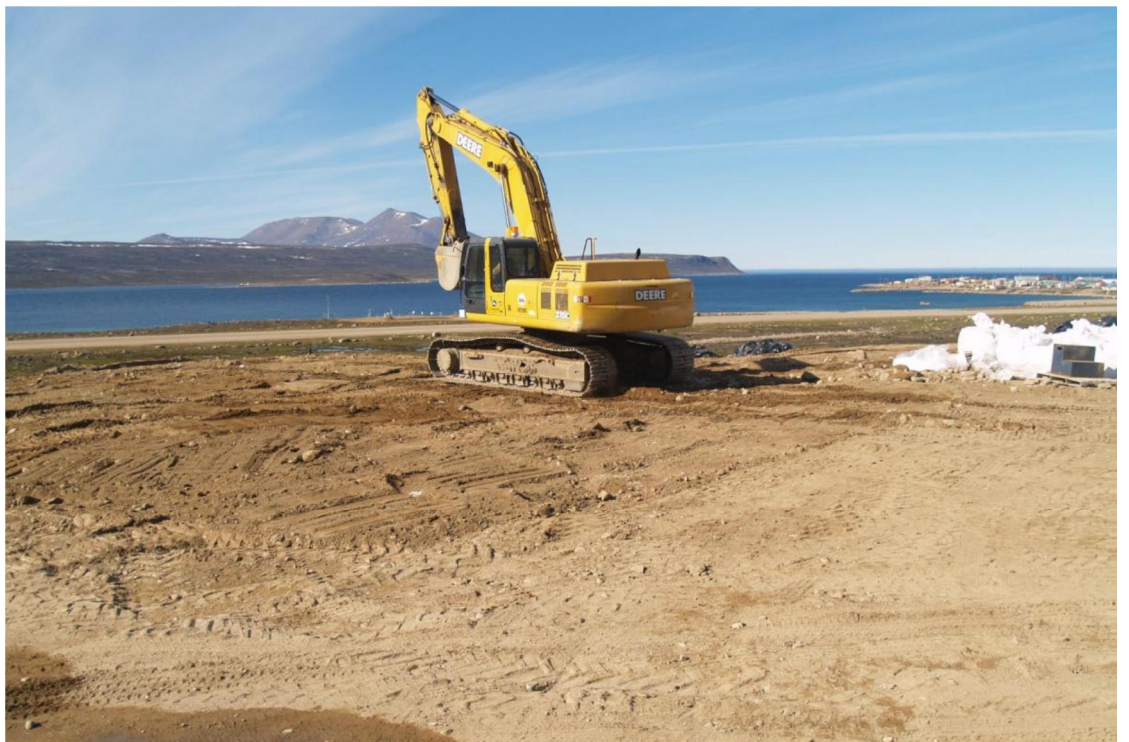
**Photo No.**  
6

**Description:**  
Final grading at the former Heated Vehicle Storage Building.

- Contaminated soil from beneath the heated vehicle storage building was excavated, placed within soil bags and moved to the beach landing area for transport off-site.
