April 21, 2009

Project Number: 0171-146-01-08

**Re: Modification to Water Use License 1BR-QIK0712: FOX-5, Qikiqtarjuaq DEW Line Site**

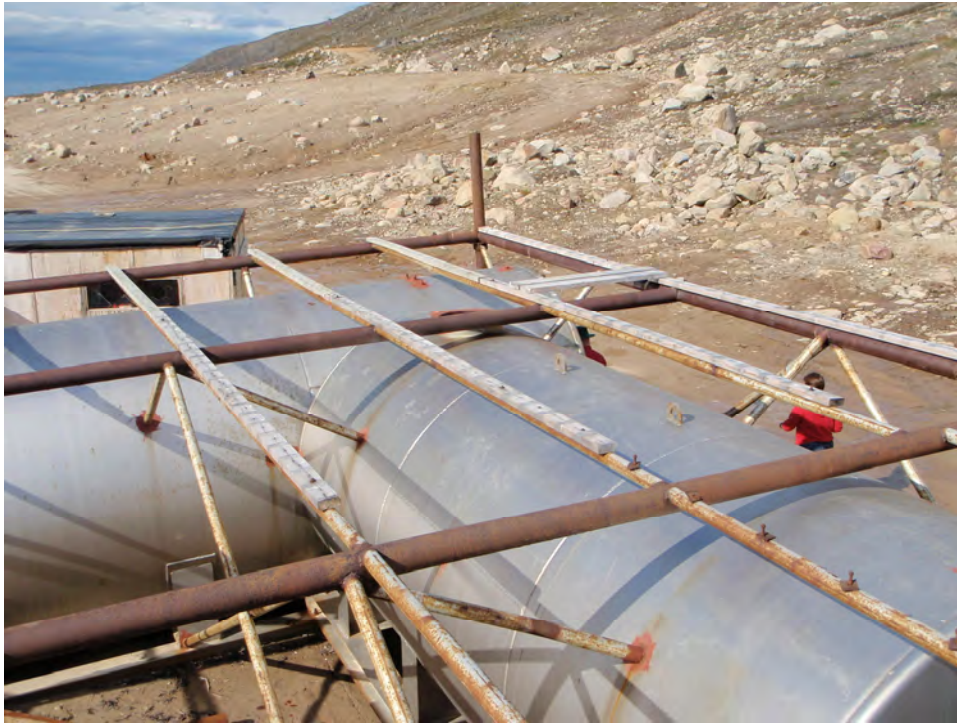
**Photograph 1.** Clamming raft/barge - Beach Area ↑

- Dismantling of the clam-diving platform/barge structure, which consists primarily of four former DEW Line fuel tanks, and cutting of the tanks into suitable sized components to facilitate disposal.
- Loading, transport and disposal of the clam diving platform/barge to the Middle Site Non-Hazardous Waste Landfill, or containerization of the structure components if leachability testing completed by July 20, 2009 indicates the paint on the tanks to be hazardous.

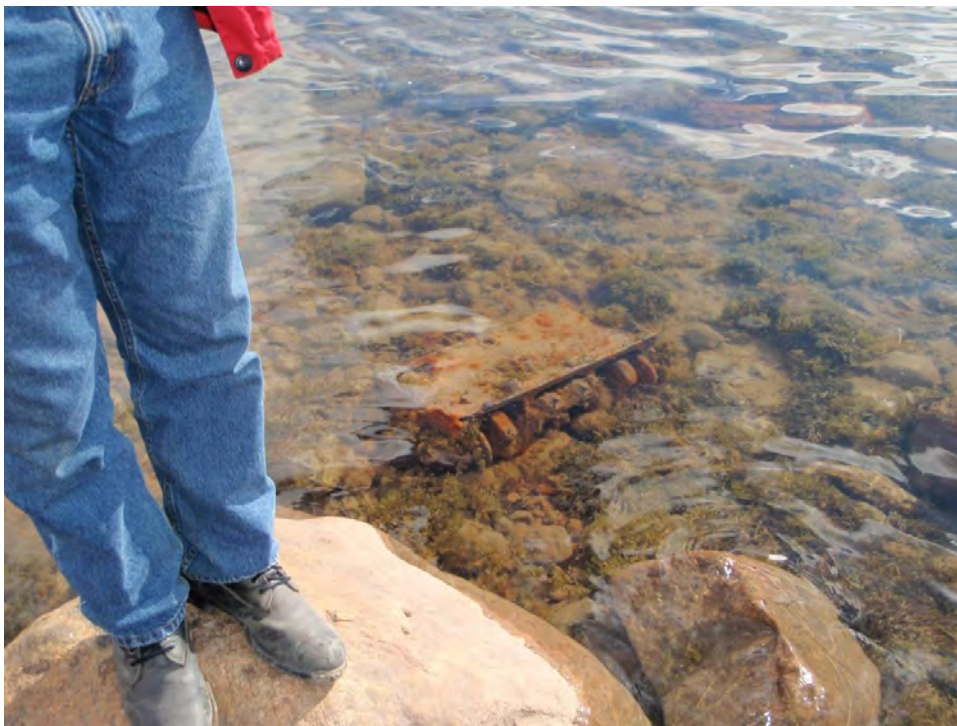
**Photograph 2.** Debris in water - Airstrip Landfill ↑

- Collection and disposal of surface and submerged non-hazardous debris along the toe of the Airstrip Landfill – West.
- Full excavation of the landfill lobe including physical separation of soil and debris.
- Transport and disposal of excavated non-hazardous soils and debris to the Middle Site Non-Hazardous Waste Landfill.
- Containerization and secure storage of any Tier II Contaminated Soil and hazardous soil and debris identified during this portion of the work.
- Backfilling of excavated area with local borrow material, including rip-rap, to match surrounding terrain.

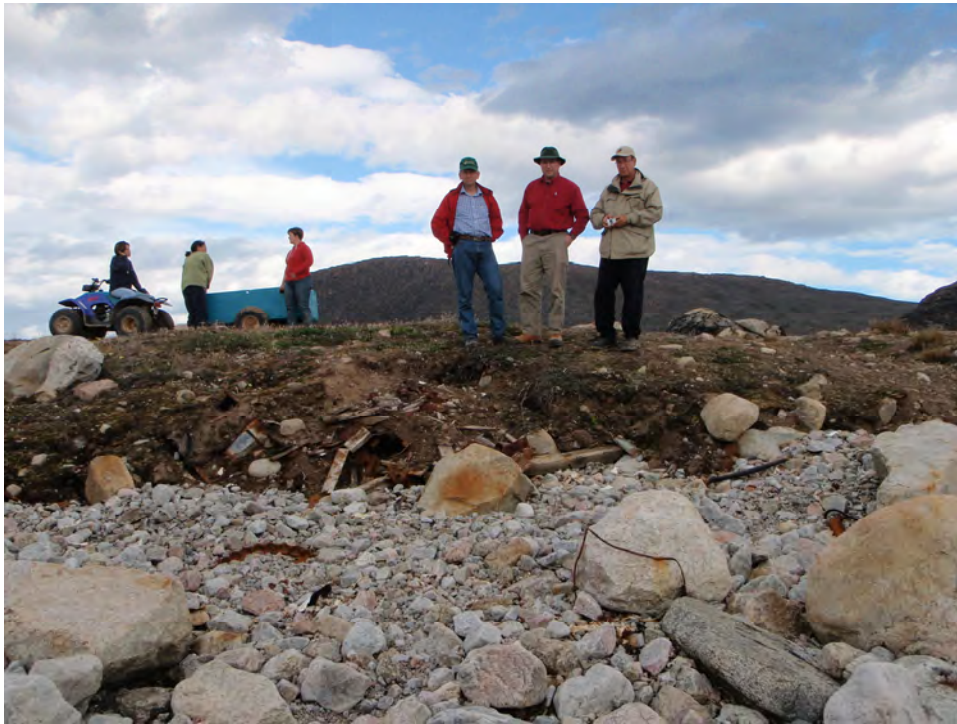
**Photograph 3.** Exposed landfill lobe - Airstrip Landfill ↑

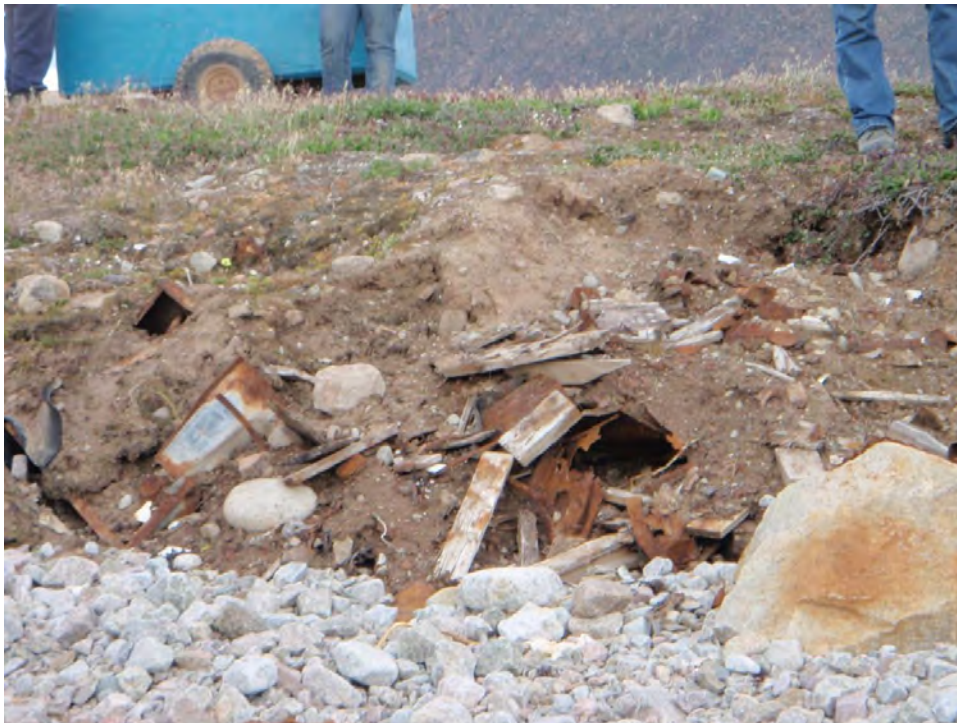
**Photograph 4.** Exposed landfill lobe - Airstrip Landfill ↑

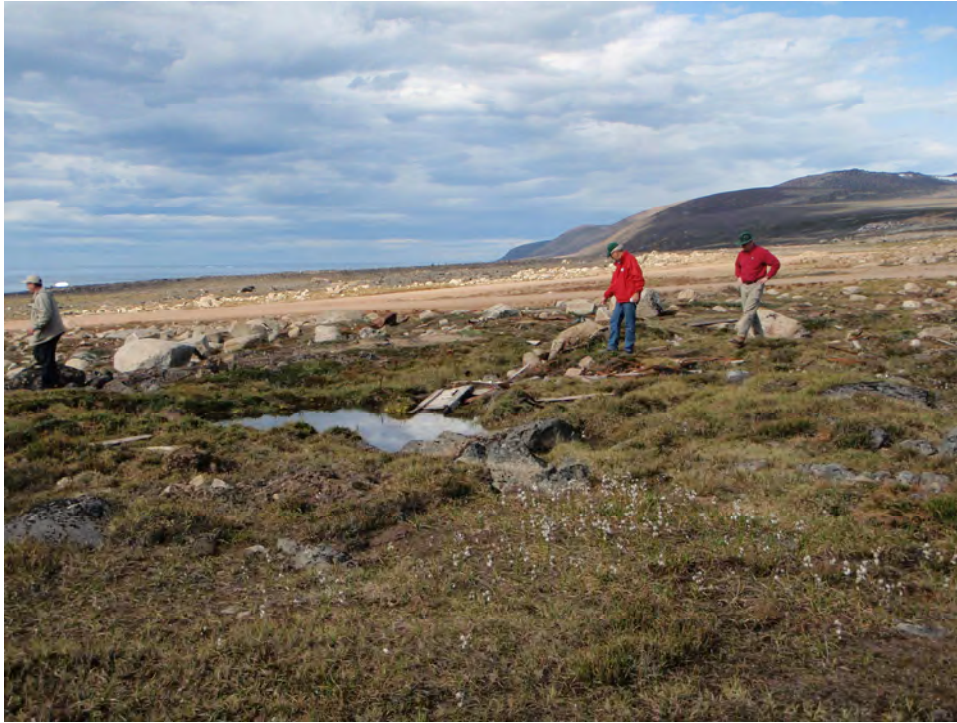
**Photograph 5.** Surface debris area - Reservoir Road ↑

- Collection and disposal of surface and partially buried non-hazardous debris to the Middle Site Non-Hazardous Waste Landfill.

- Containerization and secure storage of any hazardous debris identified during this portion of the work.
- Reshaping areas where partially buried debris was removed.

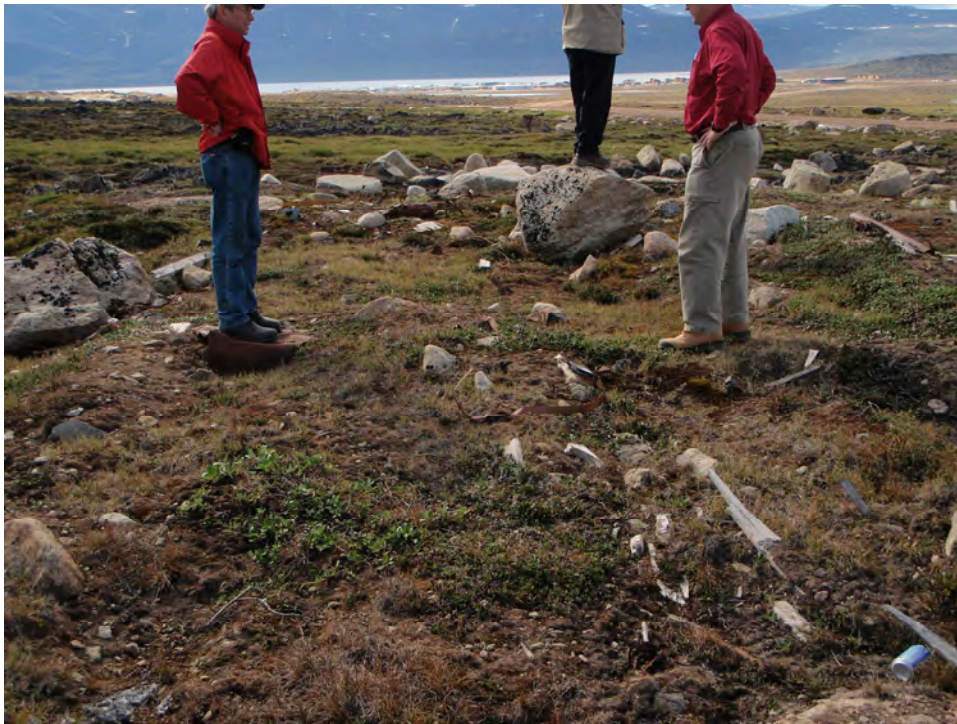
**Photograph 6.** Partially buried debris - Reservoir Road ↑

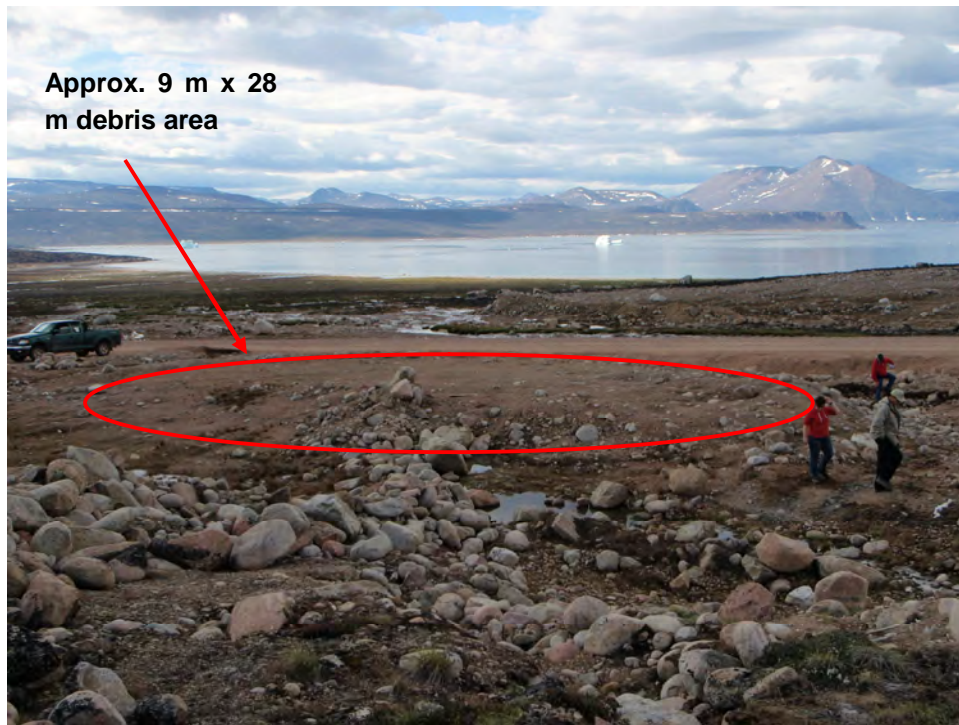
**Photograph 7.** Partially buried debris area - Community Borrow ↑

- Removal and disposal of surface debris and partially buried non-hazardous debris to the Middle Site Non-Hazardous Waste Landfill.
- Transport and disposal of excavated non-hazardous debris to the Middle Site Non-Hazardous Waste Landfill.
- Containerization and secure storage of any Tier II Contaminated Soil or hazardous soil and debris identified during this portion of the work.
- Facilitate soil testing in stained areas or in areas where hazardous debris is found.

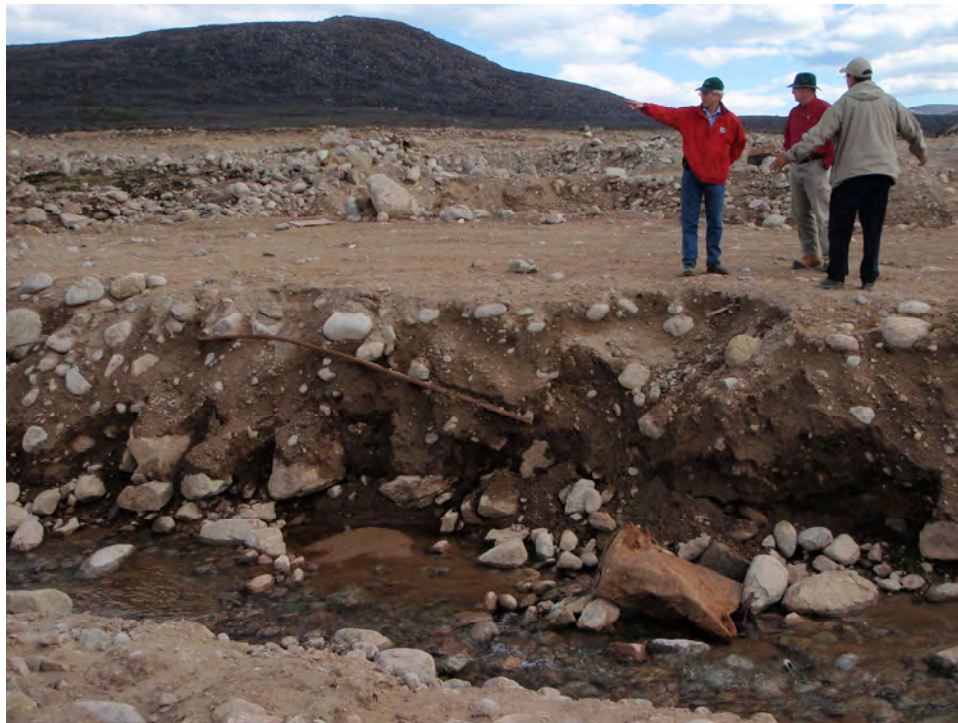
**Photograph 8.** Partially buried debris - Reservoir Road ↑

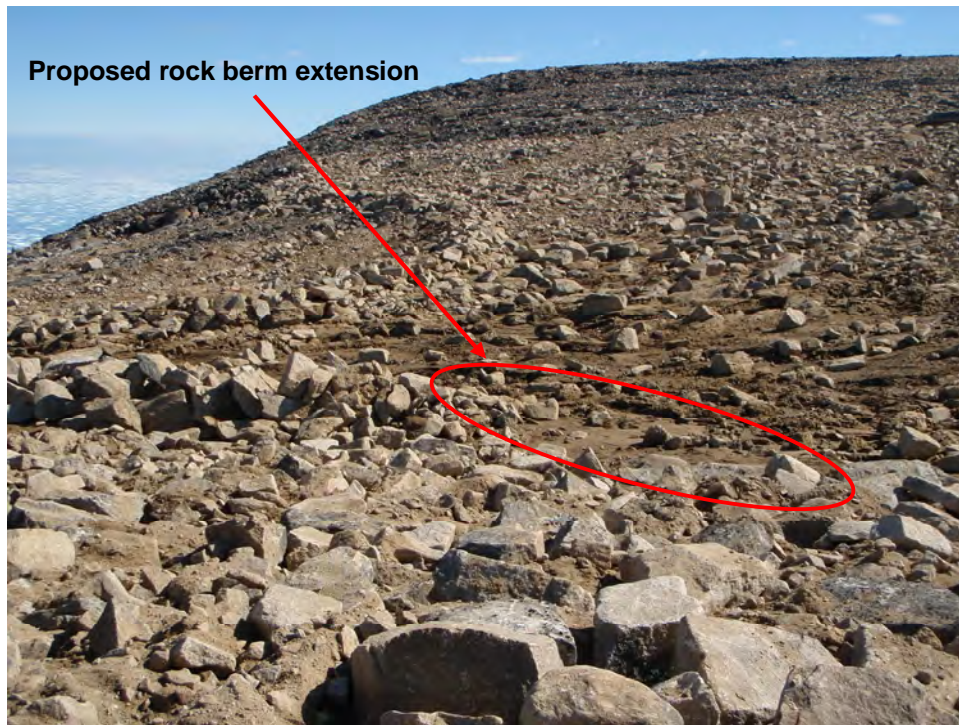
**Photograph 9.** Water diversion work, south side - Main Landfill ↑

- Placement of rock rip-rap material to provide a 10 to 15 metre extension to the existing rock berm on the southeast side of the Main Landfill.
- Relocation of approximately 5 m of rock rip-rap materials to close the channel along the northwest side of the Main Landfill and open the channel slightly further west.

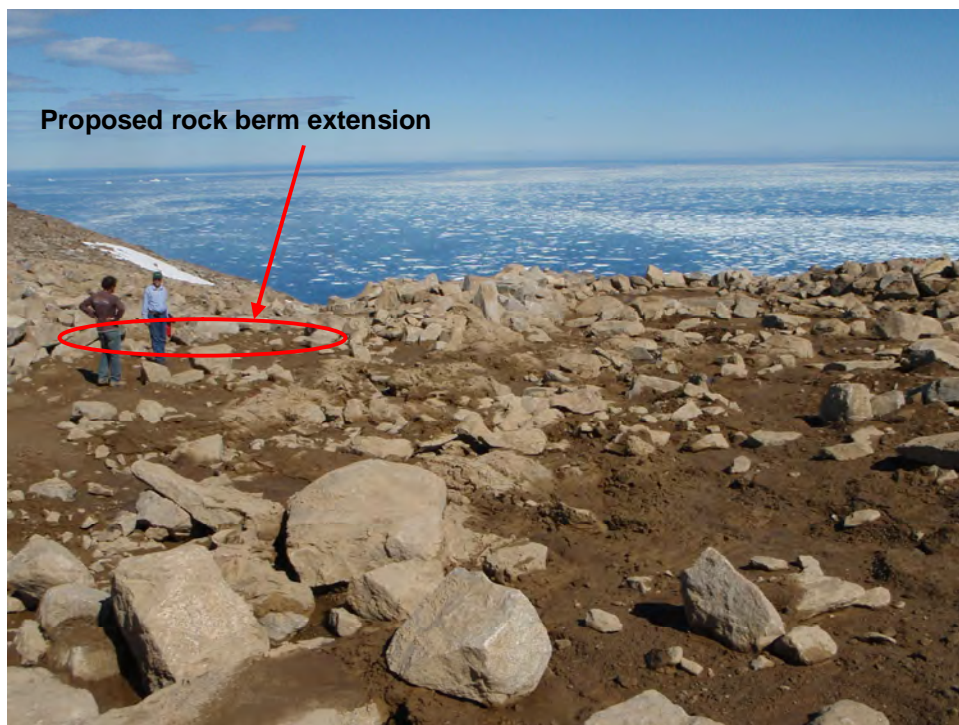
**Photograph 10.** Water diversion work, south side - Main Landfill ↑

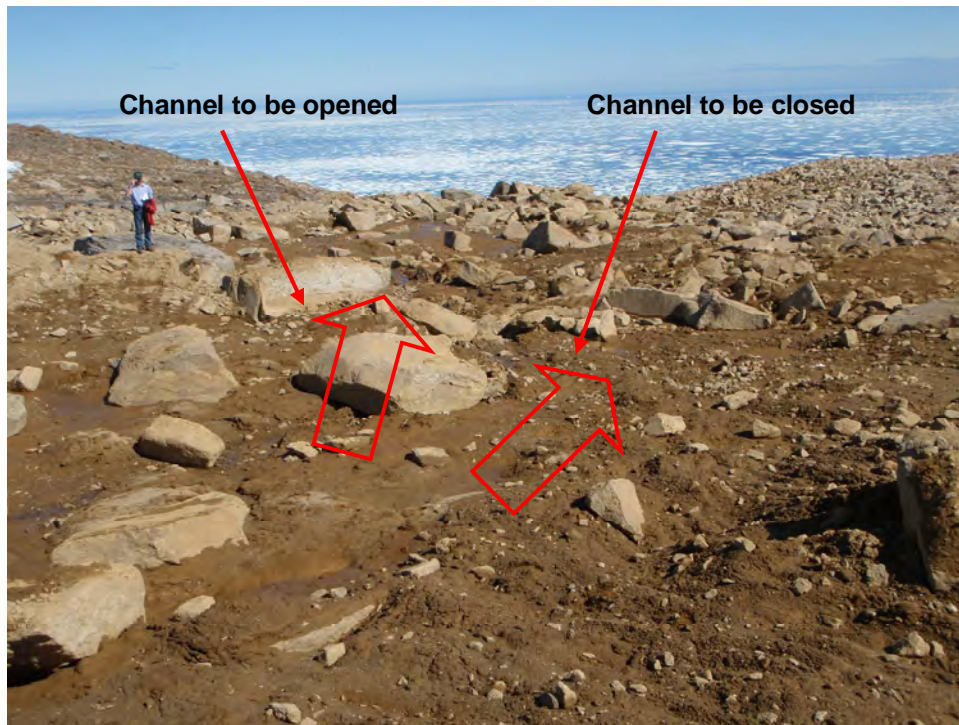
**Photograph 11.** Water diversion work, north side - Main Landfill ↑

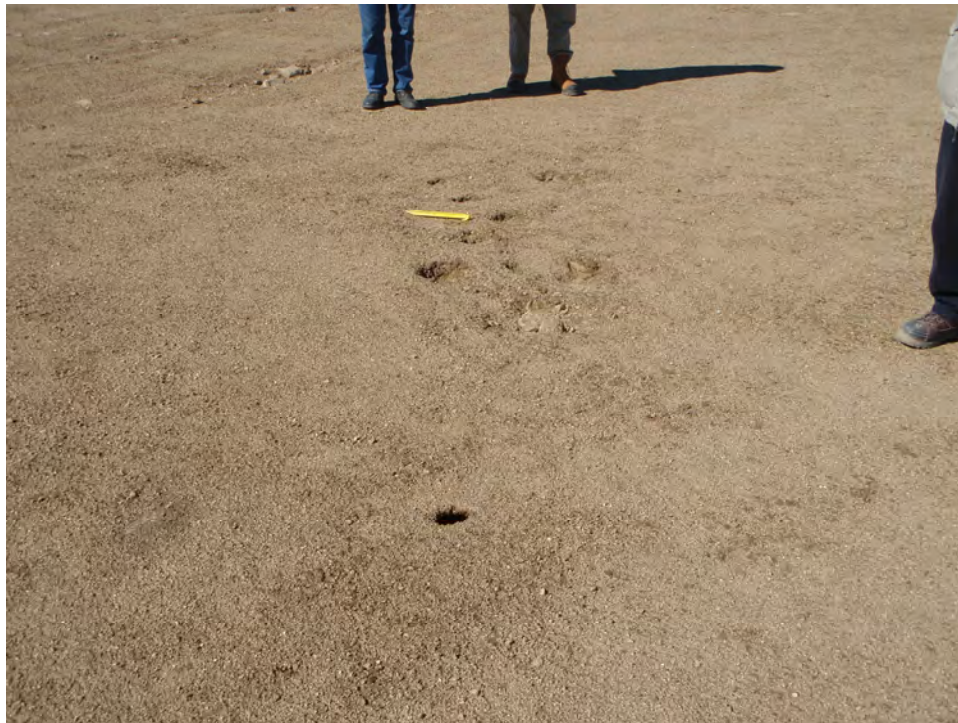
**Photograph 12.** Settlement pockets - Station Area Non-Hazardous Landfill ↑

- Regrading the portion of the landfill surface showing settlement with additional Type 2 Granular Fill.
