**Remedial Action Plan**  
**Former Navigational Aid and Weather Station**  
**Radio Island, Nunavut**

**Indian and Northern Affairs Canada**  
**Iqaluit, Nunavut**

**Public Works and Government Services Canada**  
**Environmental Services, Western Region**  
**1000, 9700 Jasper Avenue**  
**Edmonton, Alberta, T5J 4E2**

**December 2005**

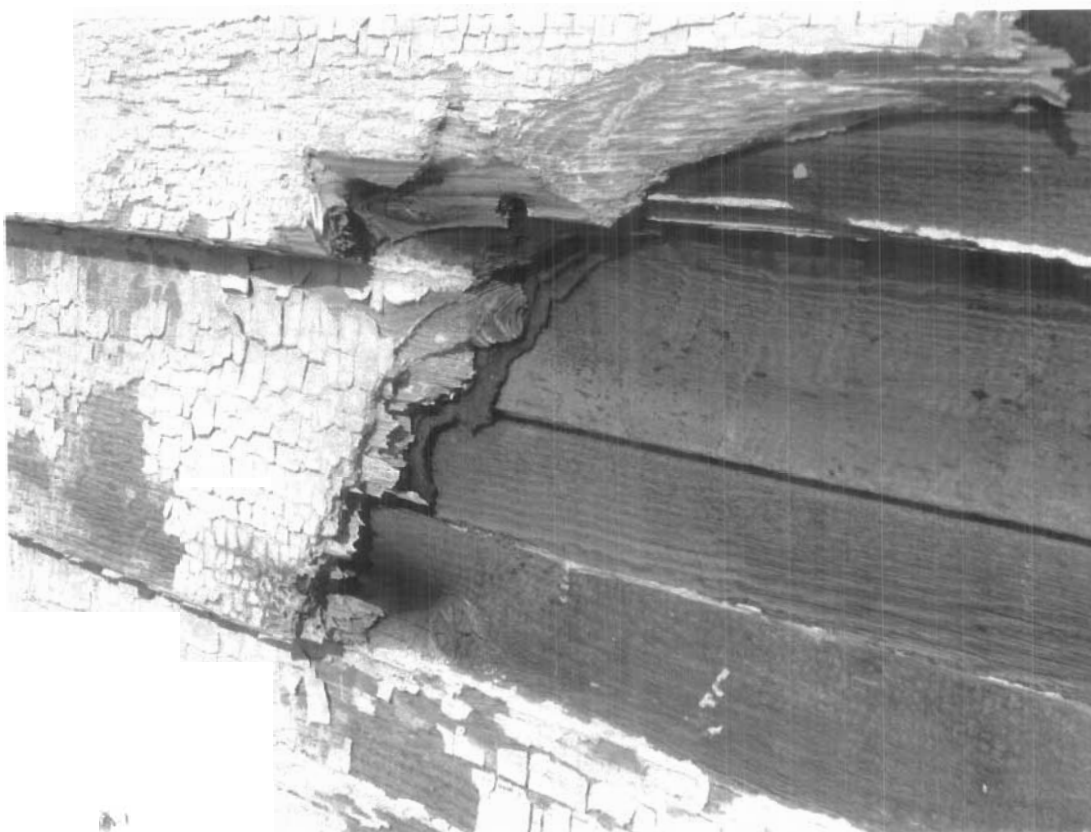
Close-up of Lead based pain on Winch Shed

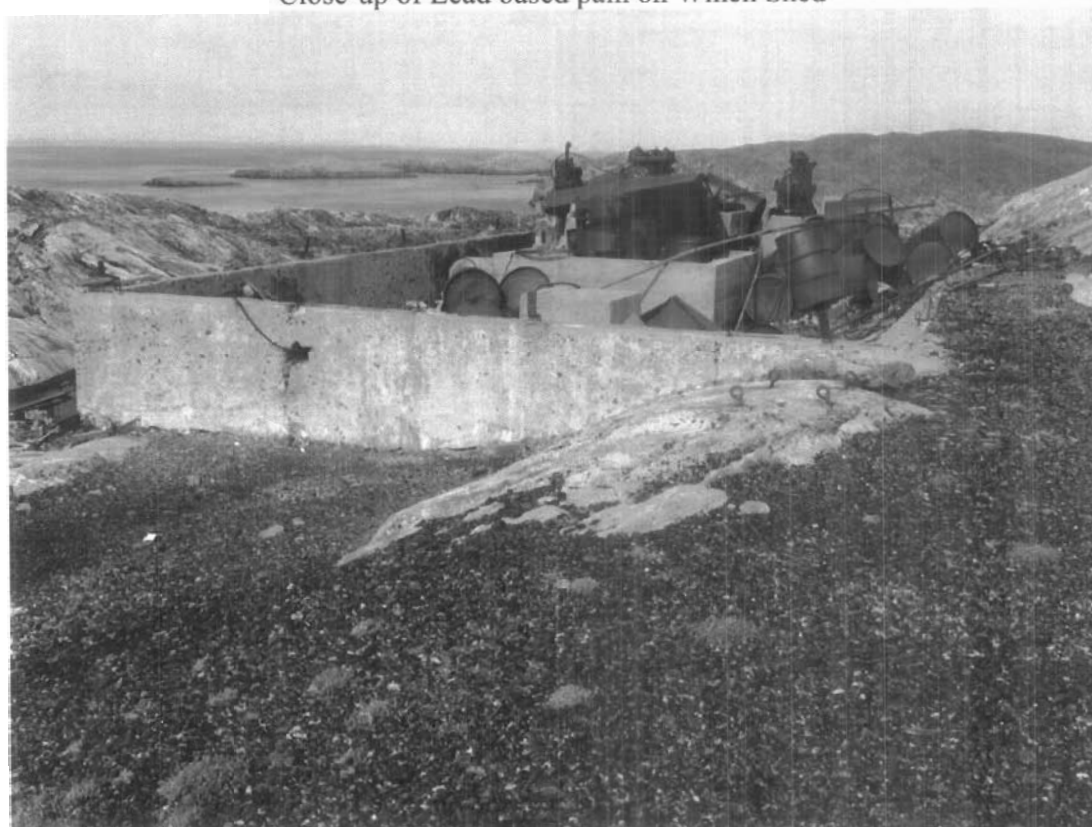
View of Generator Building Foundation and Debris

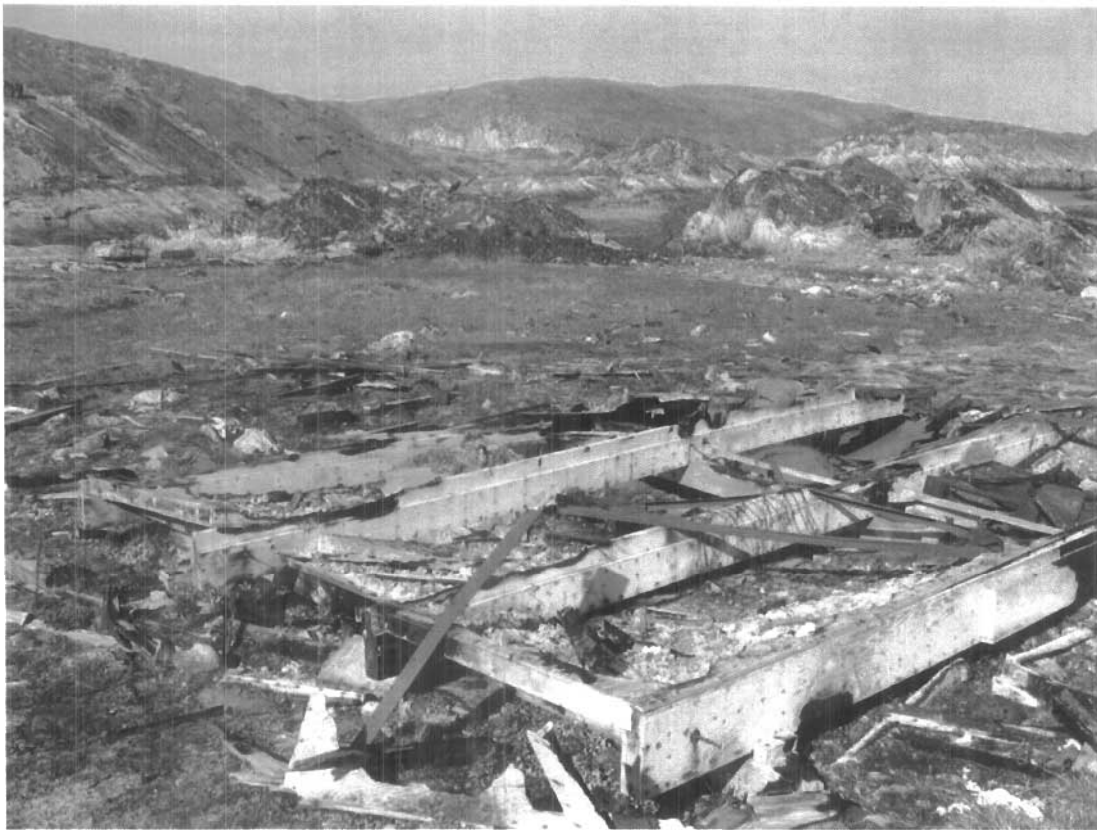
View of Beach Hut (Burnt)

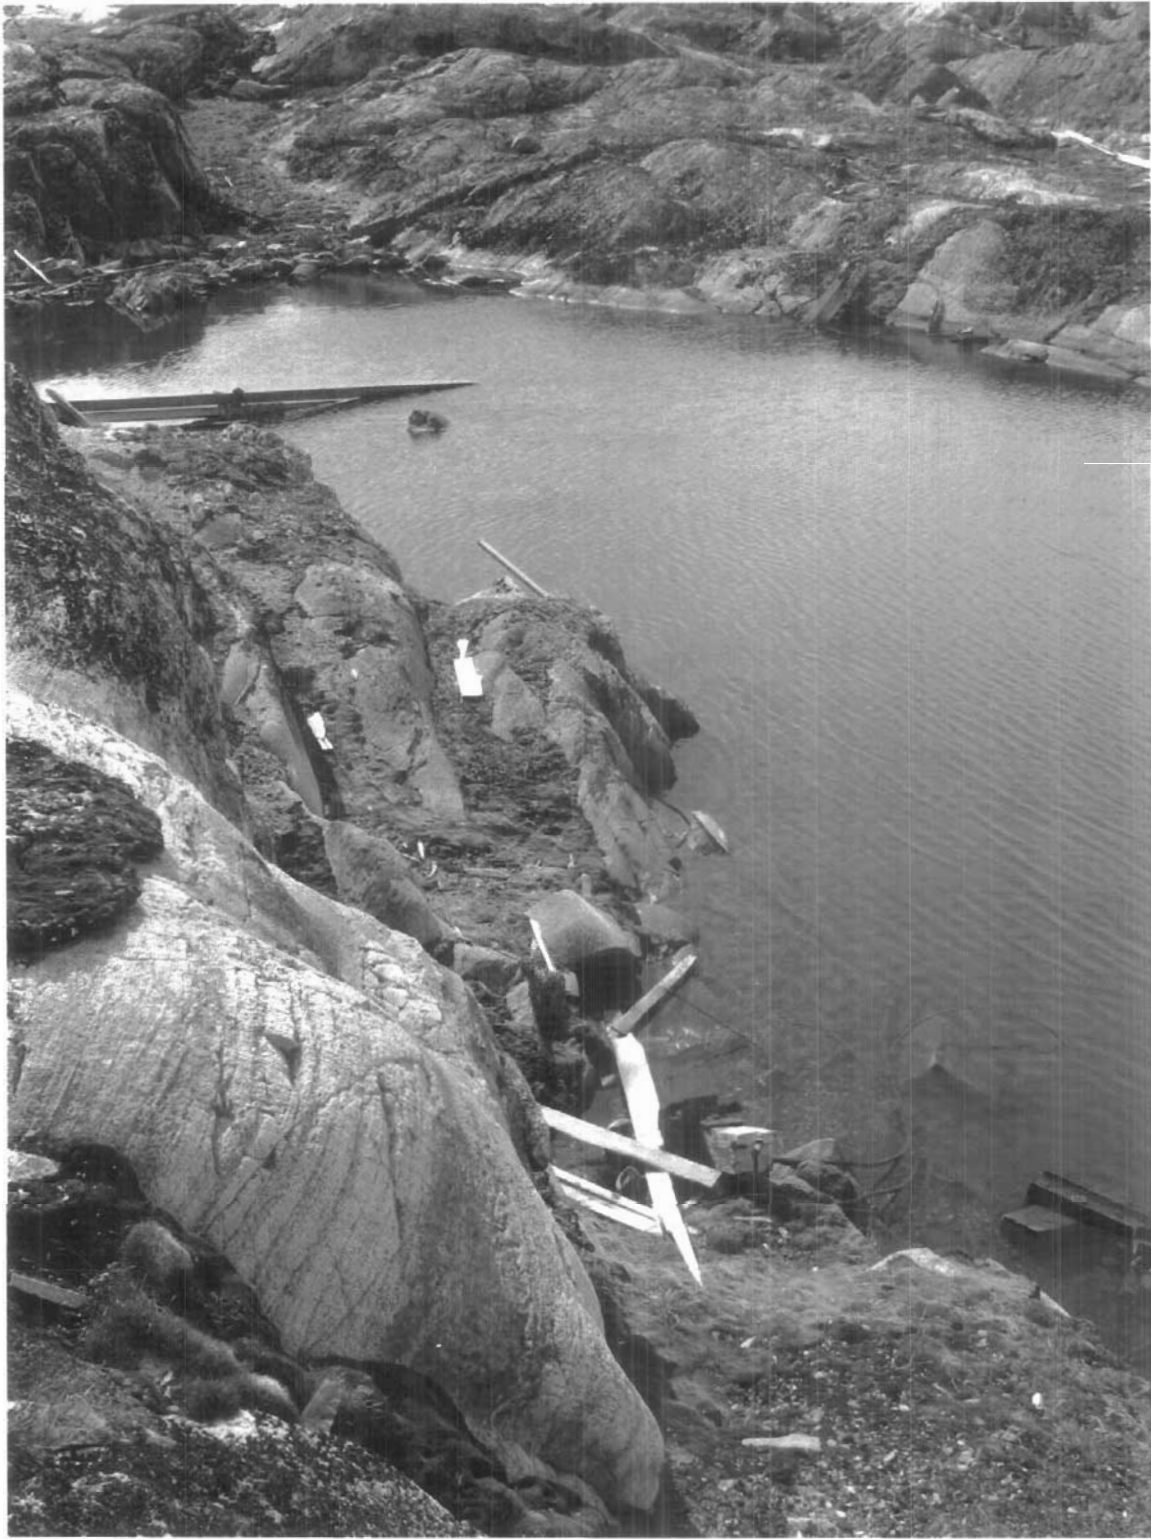
View of man-made Pond and Debris west of Main House
