**WATER LICENCE INSPECTION FORM**☒ Original
☐ Follow-Up Report

On July 4th, 2019 Crown Indigenous Relations and Northern Affairs Canada's Water Resource Officer, Jakob VOISEY completed a compliance inspection of the Government of Nunavut's Land farm (photo 1) - Water Licence No. 1BR-RAN0914. The following report was produced with the findings of that inspection.

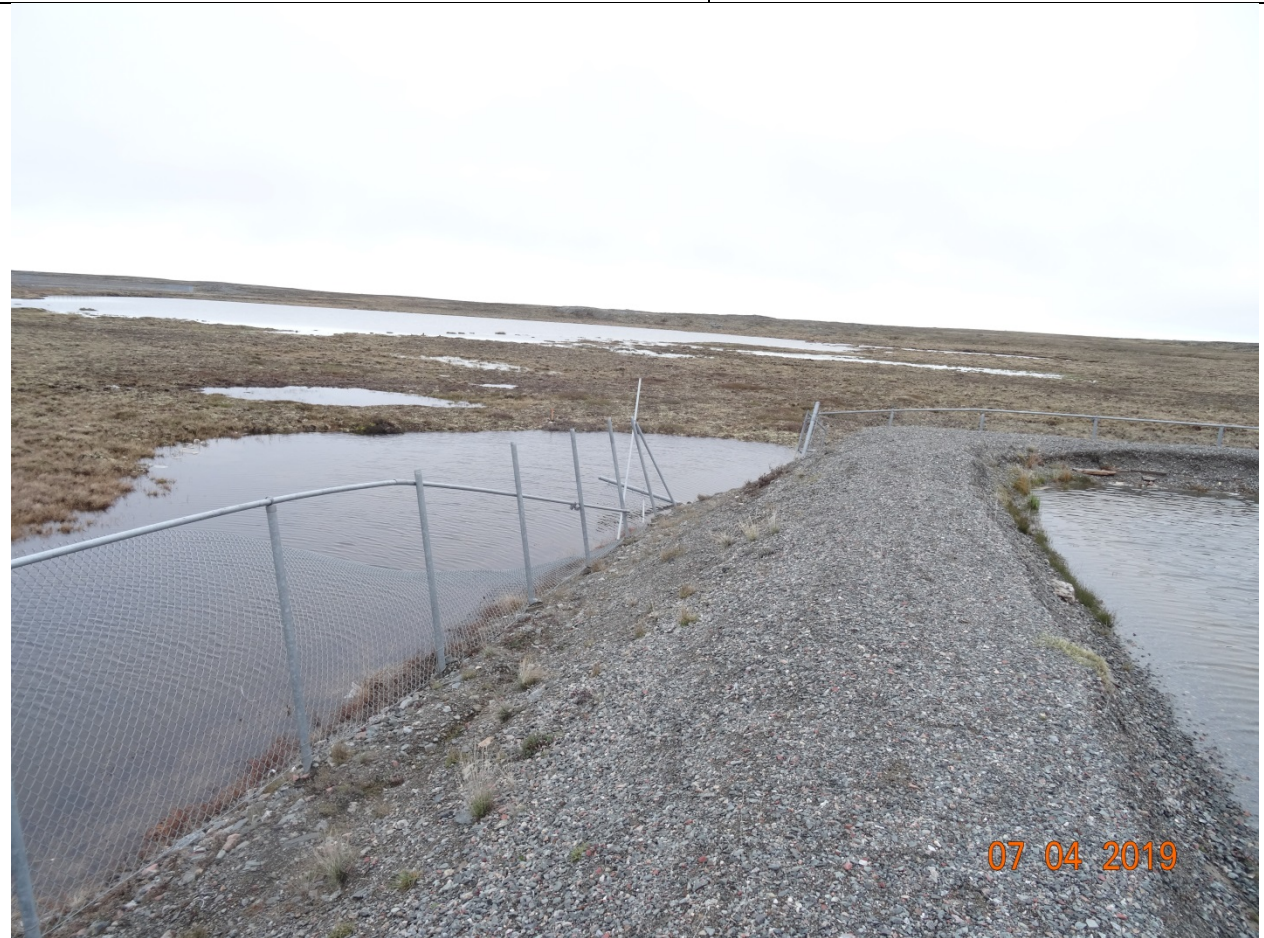
1. The facility's water licence is currently expired as of November 1, 2014.
2. The facility appears to require maintenance. The southern corner of the land farms fencing has fallen down, and also the containment berms are slouching and cracked along the inner and outer faces of the berm (Photo 1).
3. Water surrounds the facility on the northwest and south sides (Photo 2).
4. The containment area is filled with deep pools of water. A hose is noted in the water (Photo 3).
5. The HDPE liner appears to be damaged/ripped (Photos 4-6).
6. Erosion on the banks of the containment berms (Photo 7).

Broken fencing on South side of Rankin Inlet landfarm.

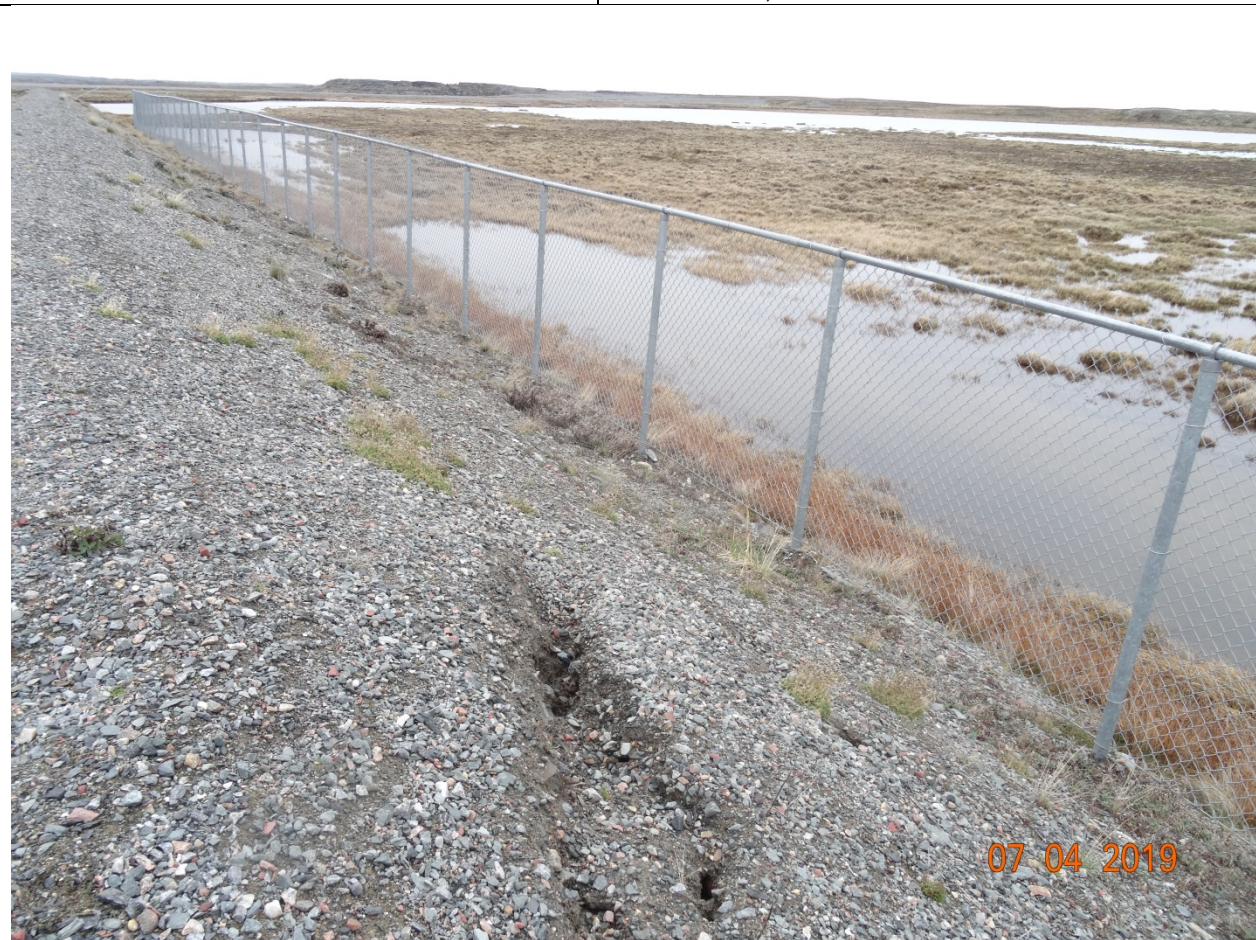
Photo 7

Erosion on bank of containment berm.
