**WATER LICENCE INSPECTION FORM**☒ Original
☐ Follow-Up Report

On July 5, 2022 an inspection of the Government of Nunavut Petroleum Product Division's Rankin Inlet Landfarm was conducted by Crown Indigenous Relations and Northern Affairs Canada (CIRNAC), Water Resource Officer K. Amsel (Inspector).

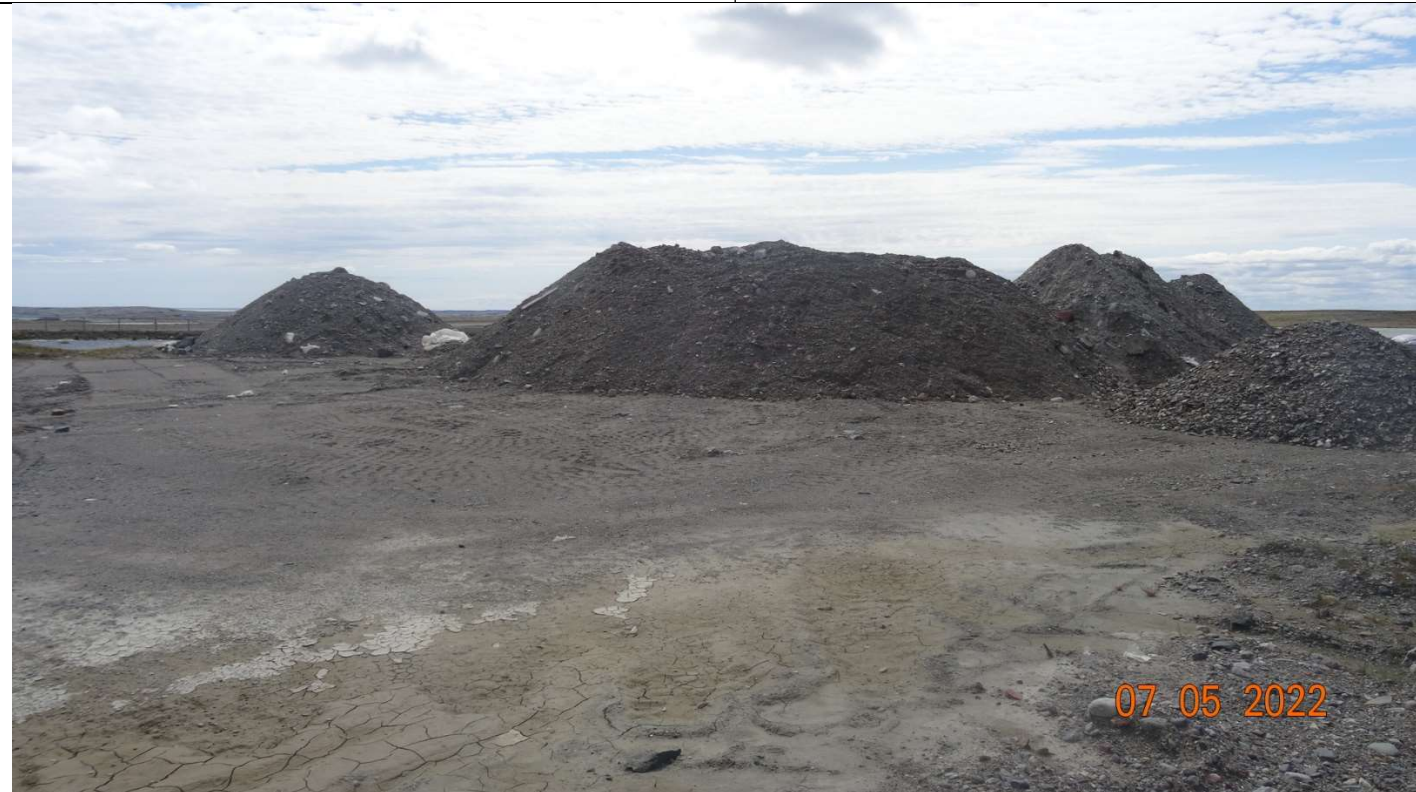
- The Landfarm has several piles of soil on a pad within the Landfarm. (photo 1) The Representative indicated that;
 - Soil on the South side of the Landfarm and on the West or rear of Landfarm are over 5 years old and will be screened this year, then remediated.

Piles of soil in Landfarm. Photo taken near entrance on East side facing West. Pile on left ready for remediation this year, piles in forefront and right will be turned this year.

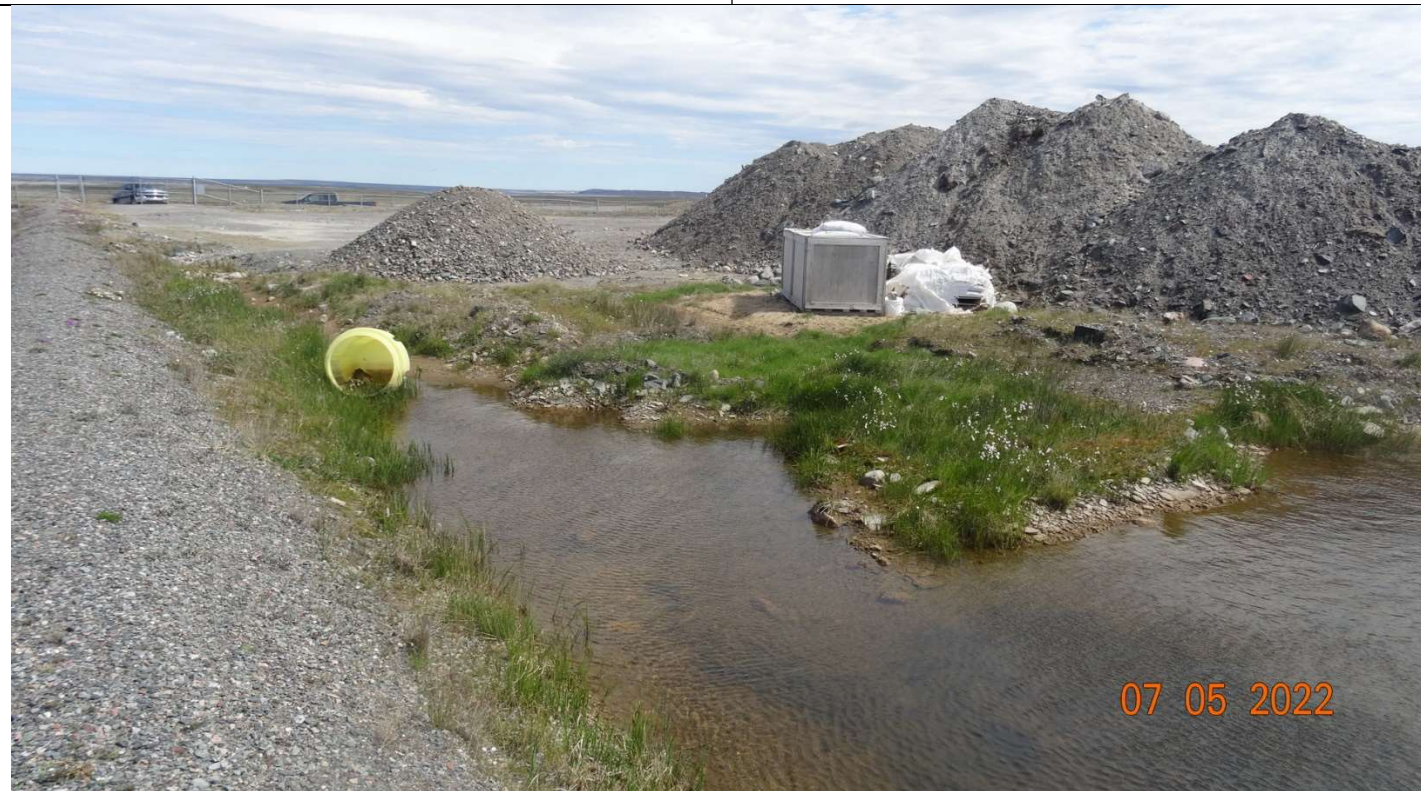
Photo 2

- Soil on the North side is from 2021 and will be turned over this year.
- A crate and pallet of fertilizer are near the West side of the Landfarm amongst piles of soil, as well as an empty spill kit located at N 62° 49' 50.3" W 92° 10' 22.9". (photo 2)

Fertilizer in crate and on pallet on right, empty spill kit on left. Photo on North side of Landfarm, facing East.

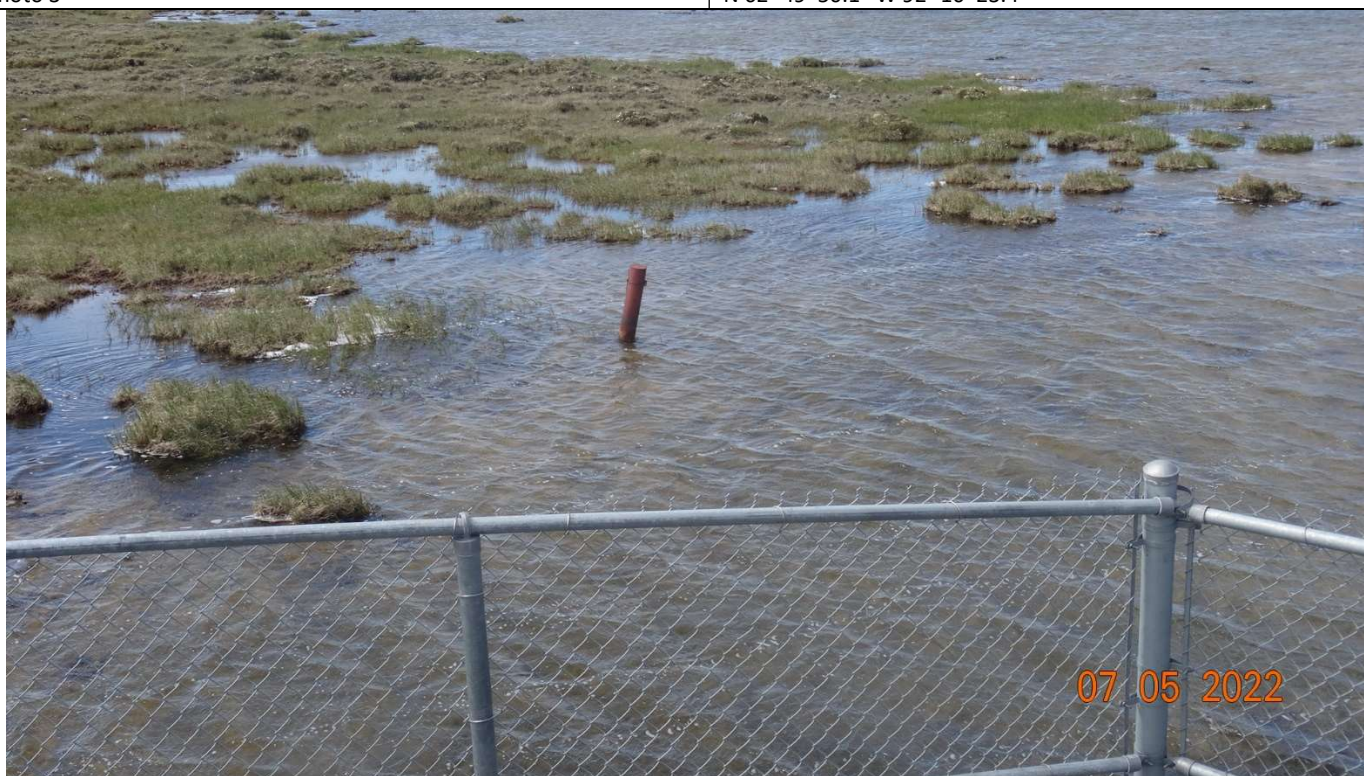
Photo 3

- There are no signs displayed at the sampling wells near the Landfarm as required under the licence Part B Item 3.
 - The sampling well on the West side of the structure is at N 62° 49' 50.1" W 92° 10' 23.4". (photo 3)

Sampling well on the West side of Landfarm. Photo taken on North-West corner.

- Removal of garbage in the Landfarm
- Installation of signage at monitoring points as per Part B Item 3
- Repair of fencing surrounding the Landfarm
- Covering the liner with sand
- Submit to the Inspector a plan to conduct an assessment of the Landfarm to Complete the Landfarm Integrity Assessment

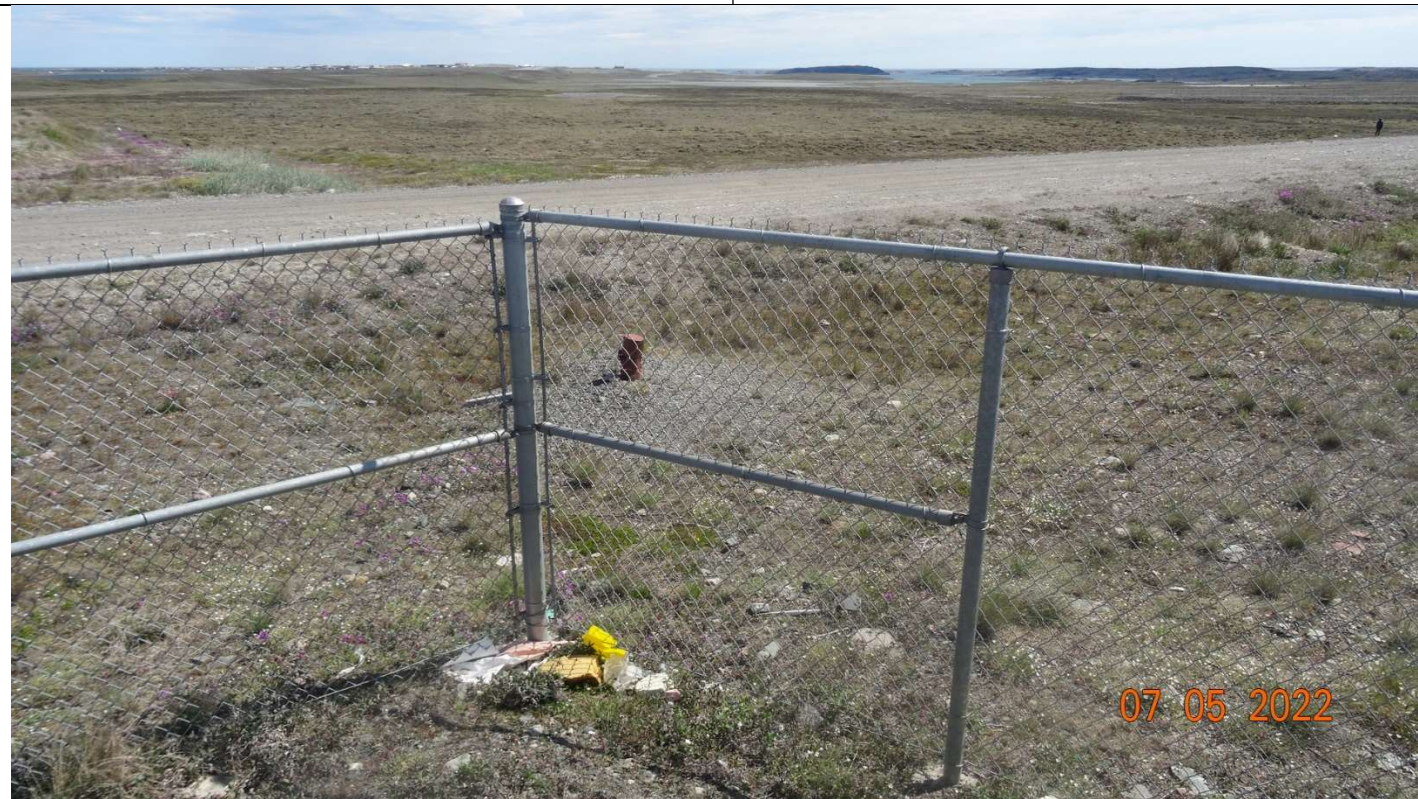
Photo 4

Sampling well on the Sout-East side of Landfarm.

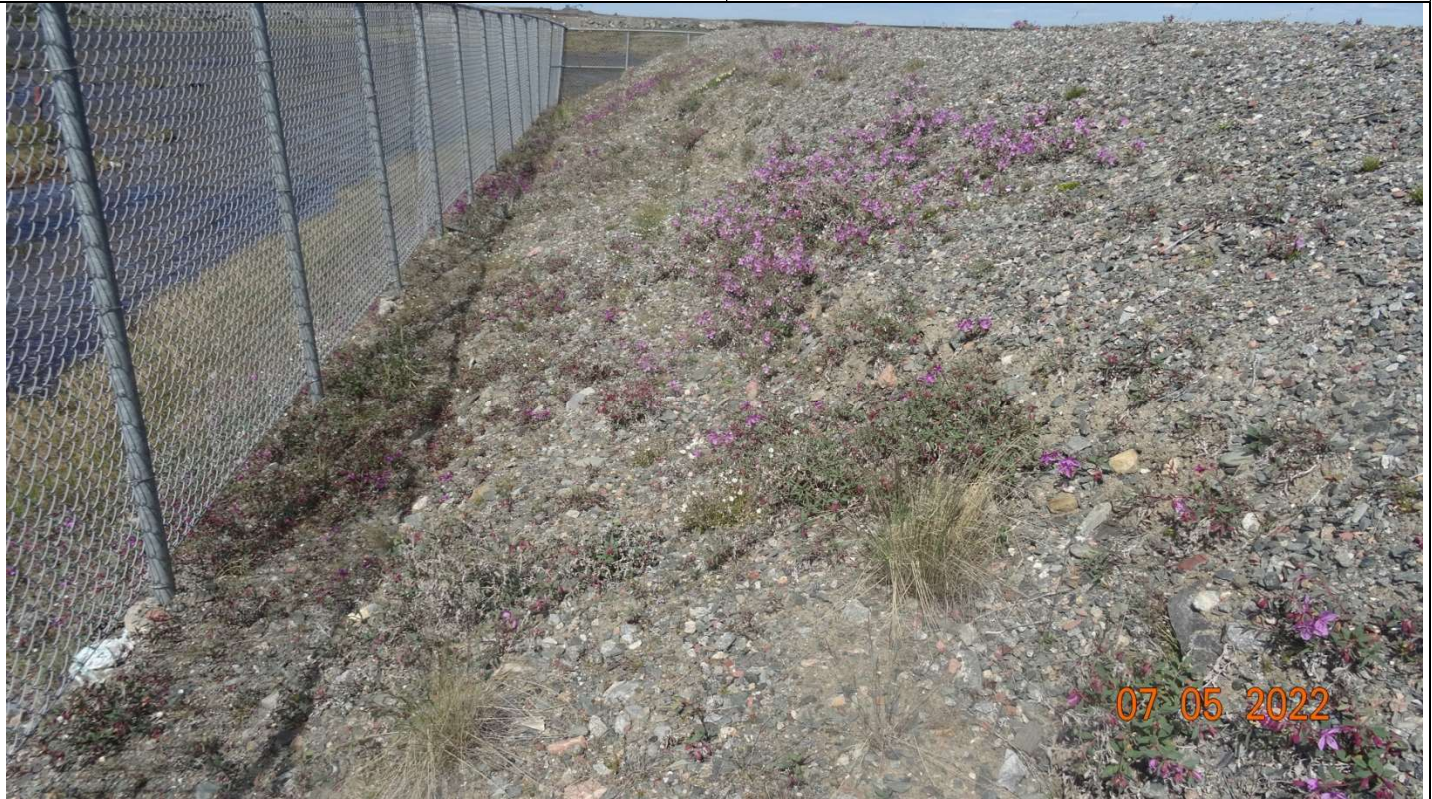
Photo 5

- The sampling well on the East side of the structure is at N 62° 49' 48.7" W 92° 10' 19.1". (photo 4)
- The berms of the Landfarm are slumping on the West and South sides which is of concern to the Inspector. The Inspector believes that water ponding near the toe of the berm and steep berm walls are contributing factors. These concerns were noted in the 2020 inspection (Appendix A) and appear to not have been addressed. The cracks noted in the 2020 inspection appear to have naturally filled in. (photo 5)

Slouching on West berm of Landfarm

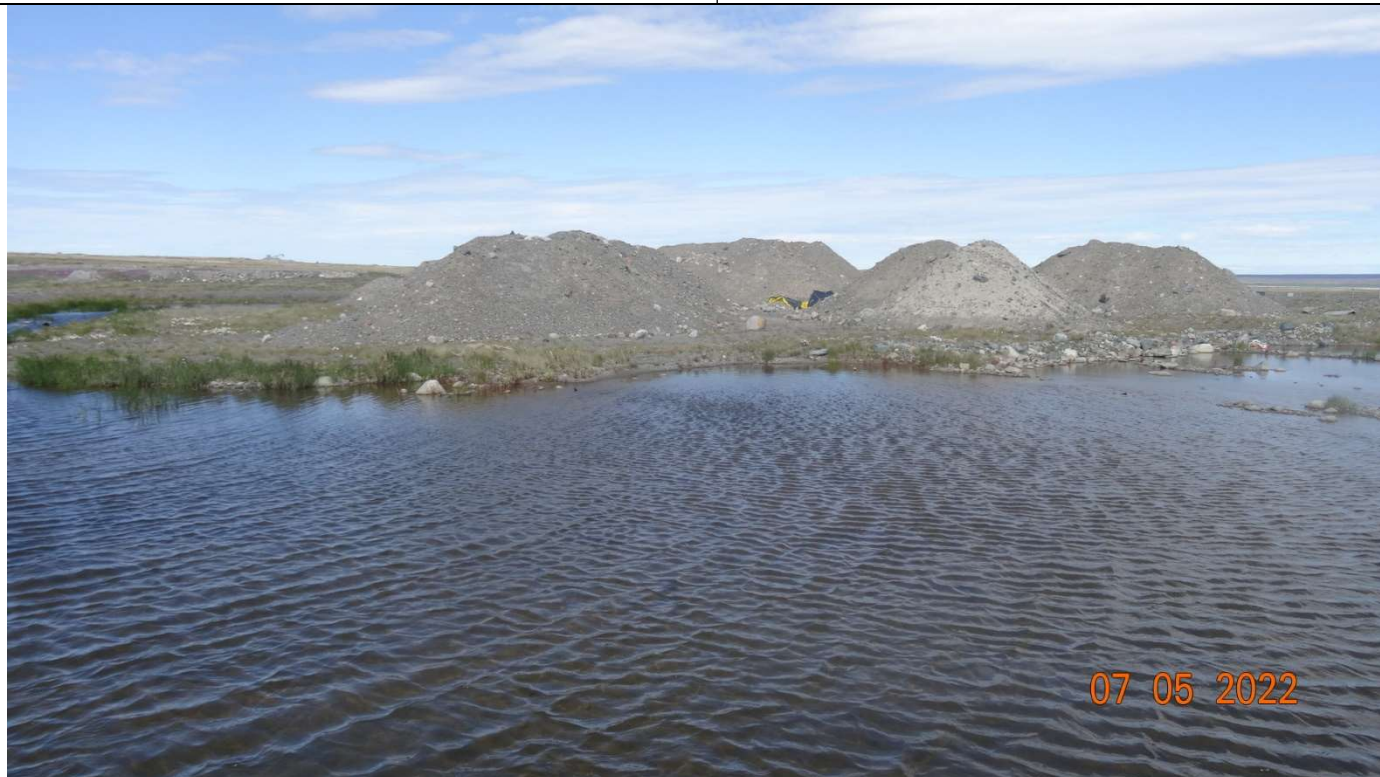
Photo 6

- Representative stated that the pad in the Landfarm will be expanded to the walls of the berm on the West and North side to allow for more usable room inside the Landfarm. Water surrounds the pad inside the landfarm. (photo 6)

Pad constructed inside the Landfarm. Open water in left background in photo will be filled in as part of construction activities. Photo taken on South side of Landfarm facing North.

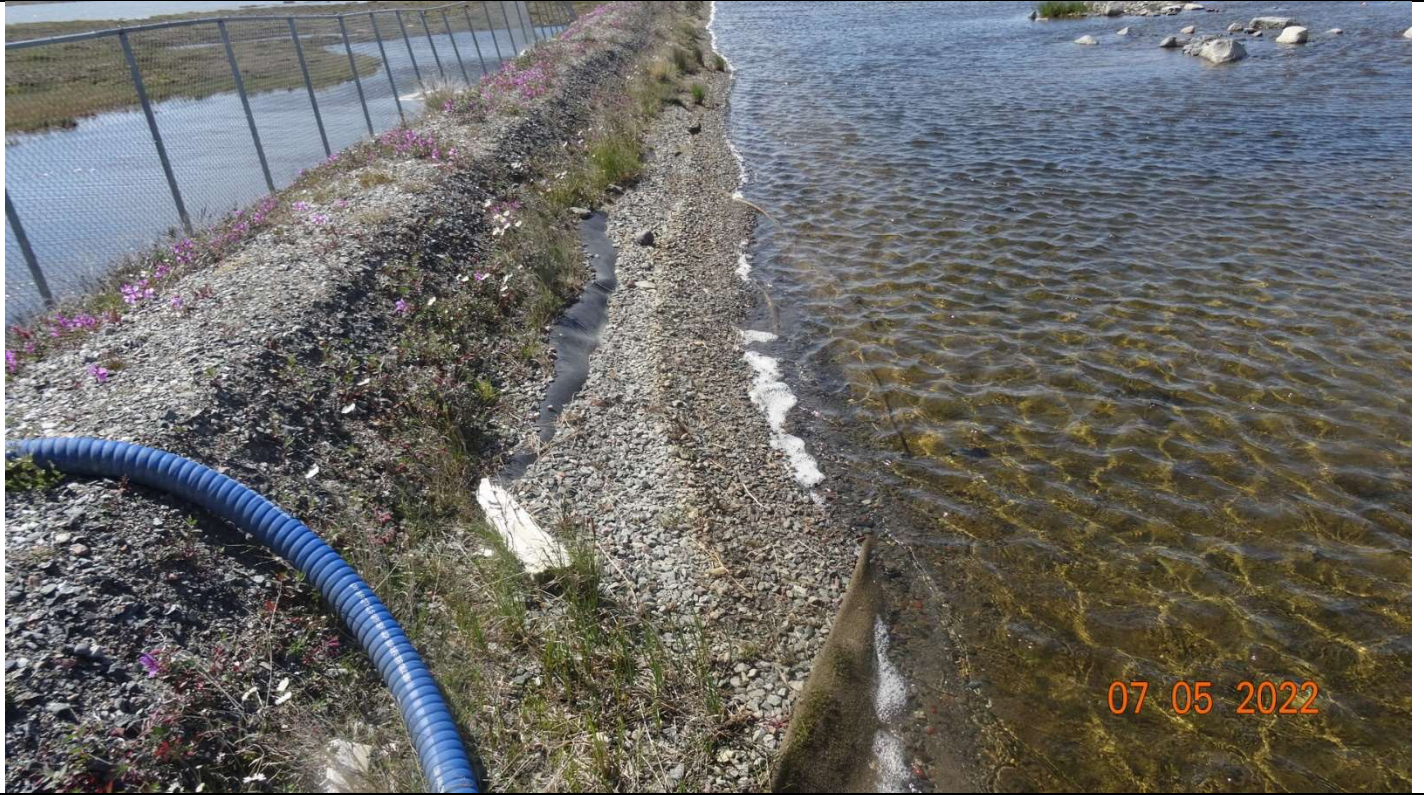
Photo 7

- On the South side of the Landfarm, a brown felt-like membrane and black plastic-like membrane are exposed and are a concern

to the Inspector. Similar issues were noted in the 2020 Inspection (Appendix A). (photo 7).

Exposed liner in Landfarm. Photo on South berm of Landfarm.

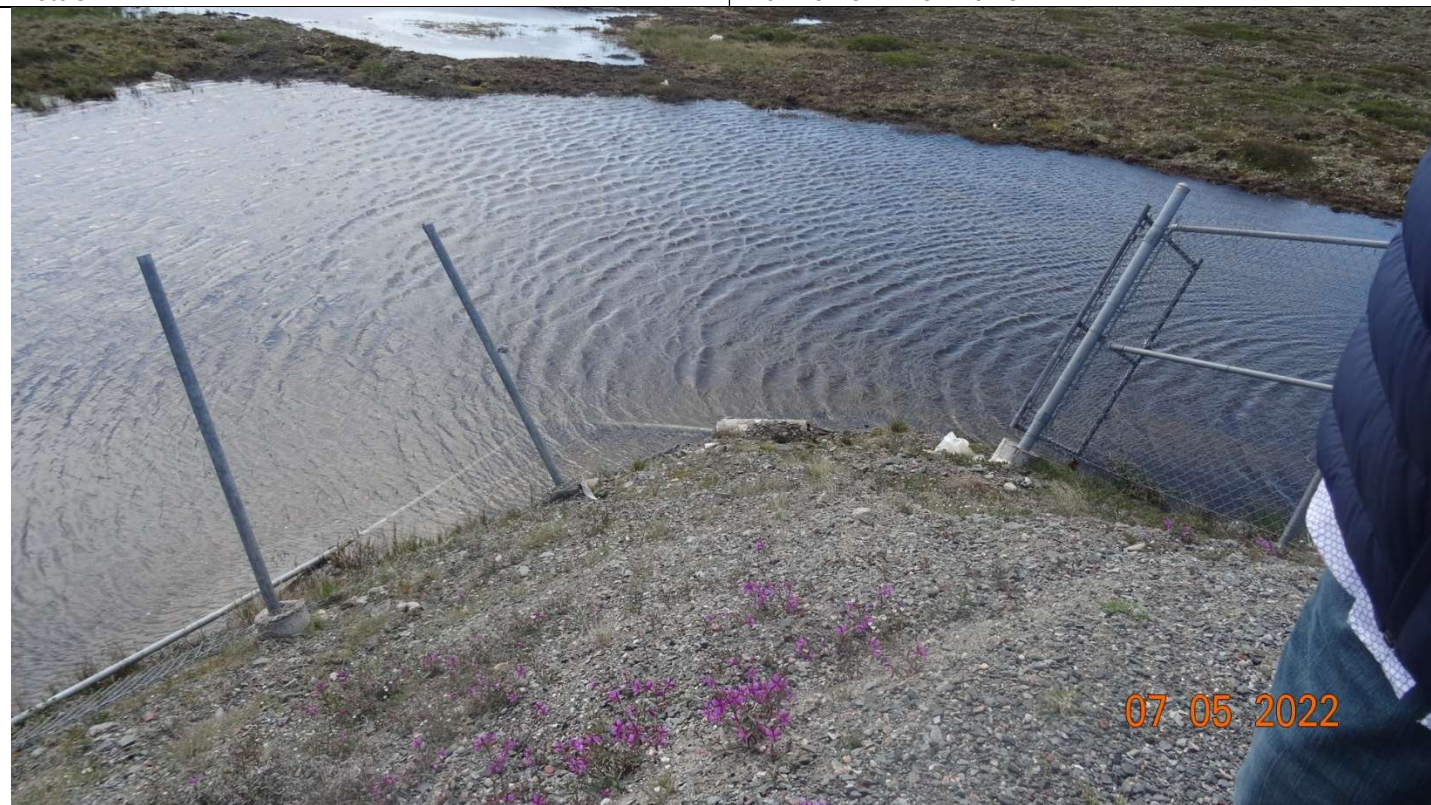
Photo 8

8. The water within the Landfarm is high with a freeboard estimated at 50cm. Representative stated that a discharge is planned later in the summer to remove excess water.
9. Fencing on the South-West corner of the Landfarm is damaged and falling down. This concern was noted during the 2020 inspection (Appendix A) and appears to have not been addressed. (photo 8)
10. Representative stated that an addition to the existing Landfarm is planned for 2023 on the South side of the Landfarm. (photo 9)
11. The Representative informed the Inspector that as part of the summer operations a local contractor was to repair the fencing, and would be engaged to repair some of the concerns mentioned by the Inspector.

Damaged fence in South-West corner.

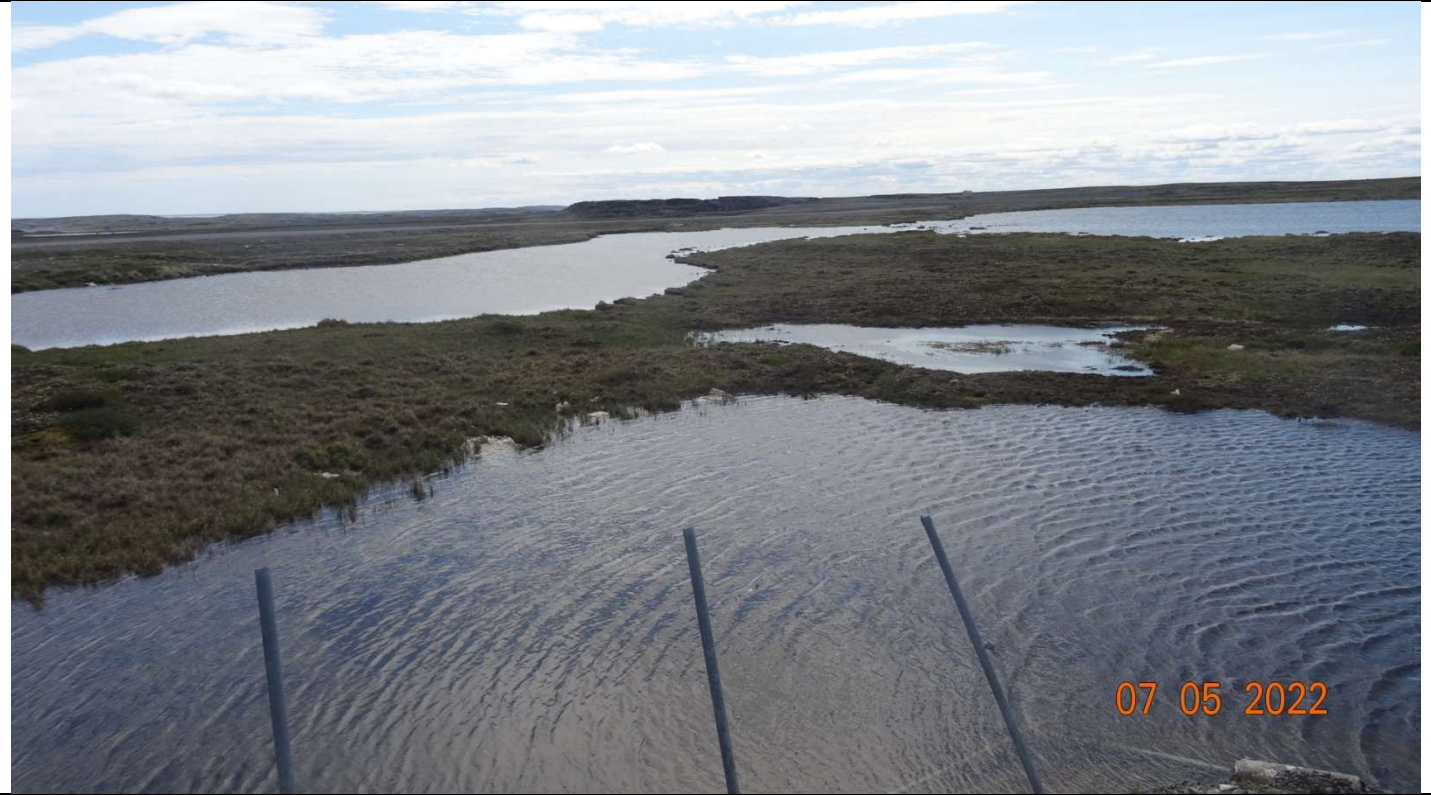
Photo 9

Planned are for Landfarm expansion on South side of existing Landfarm.

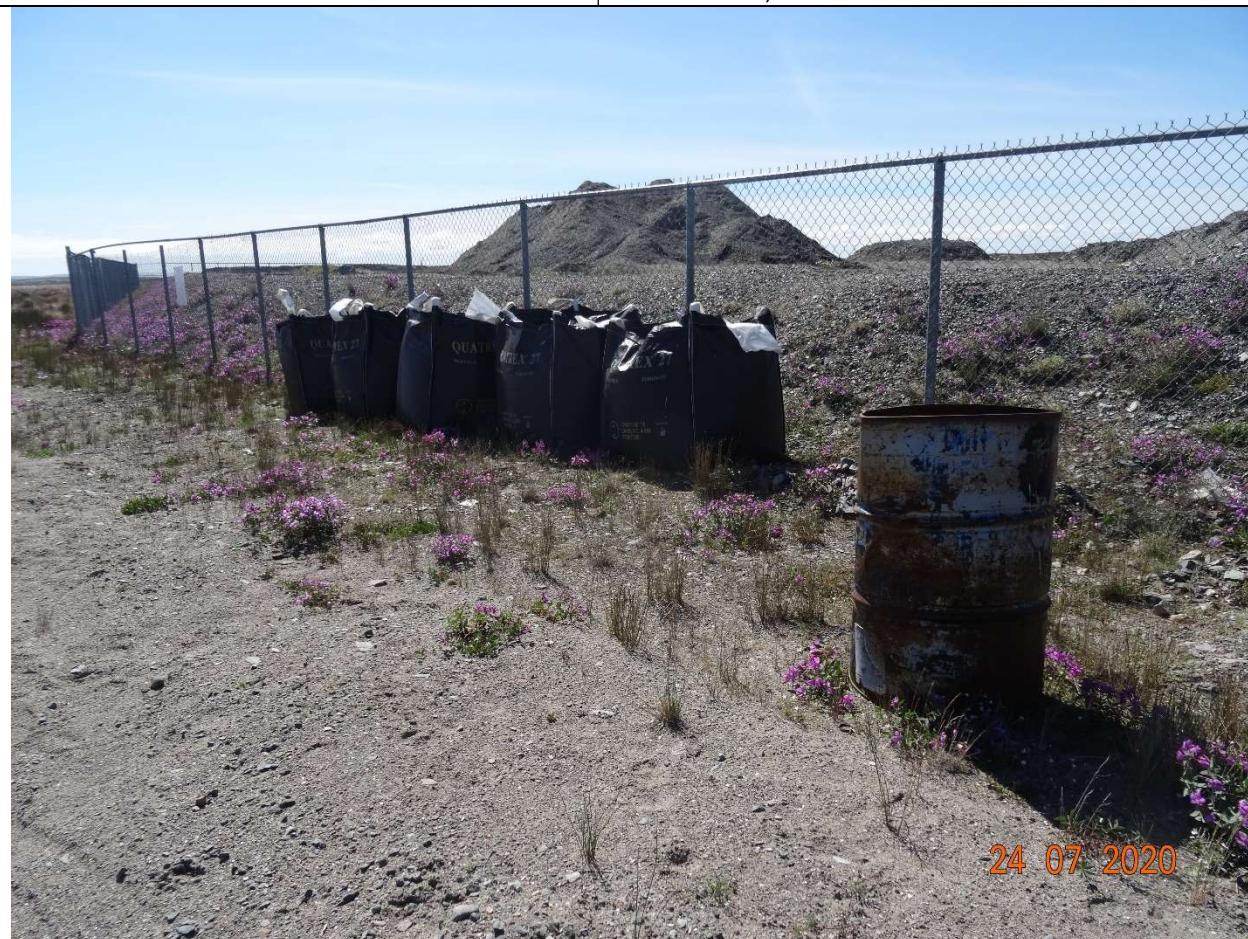
Photo 2

3. There are five Quartex bags located outside of the facility filled with unknown materials (photo 2). Signs have been put up at the facility explaining that unauthorized dumping is not permitted (photo 3).

Five Quartex bags filled with material outside the facility.

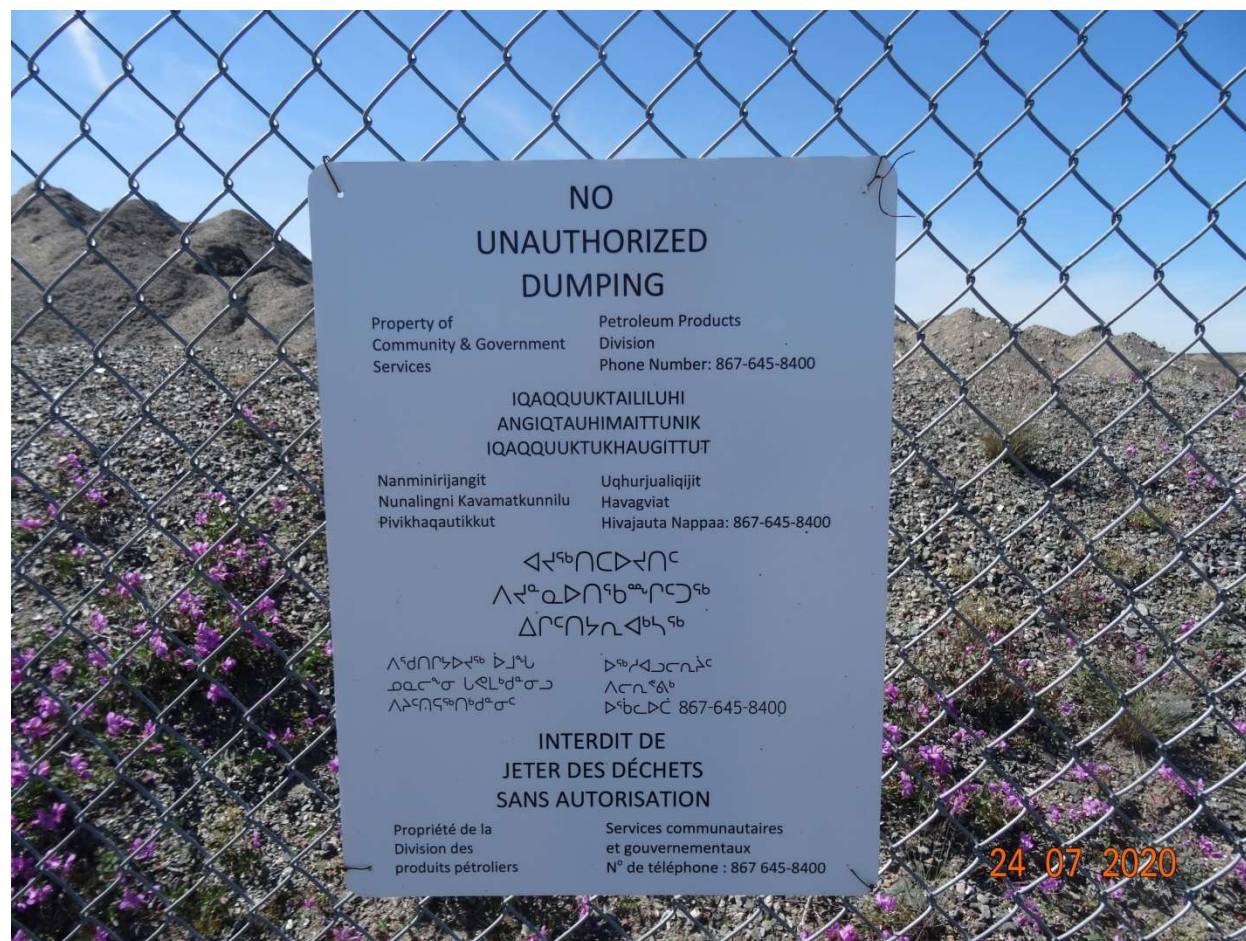
Photo 3

Signage outside of facility.

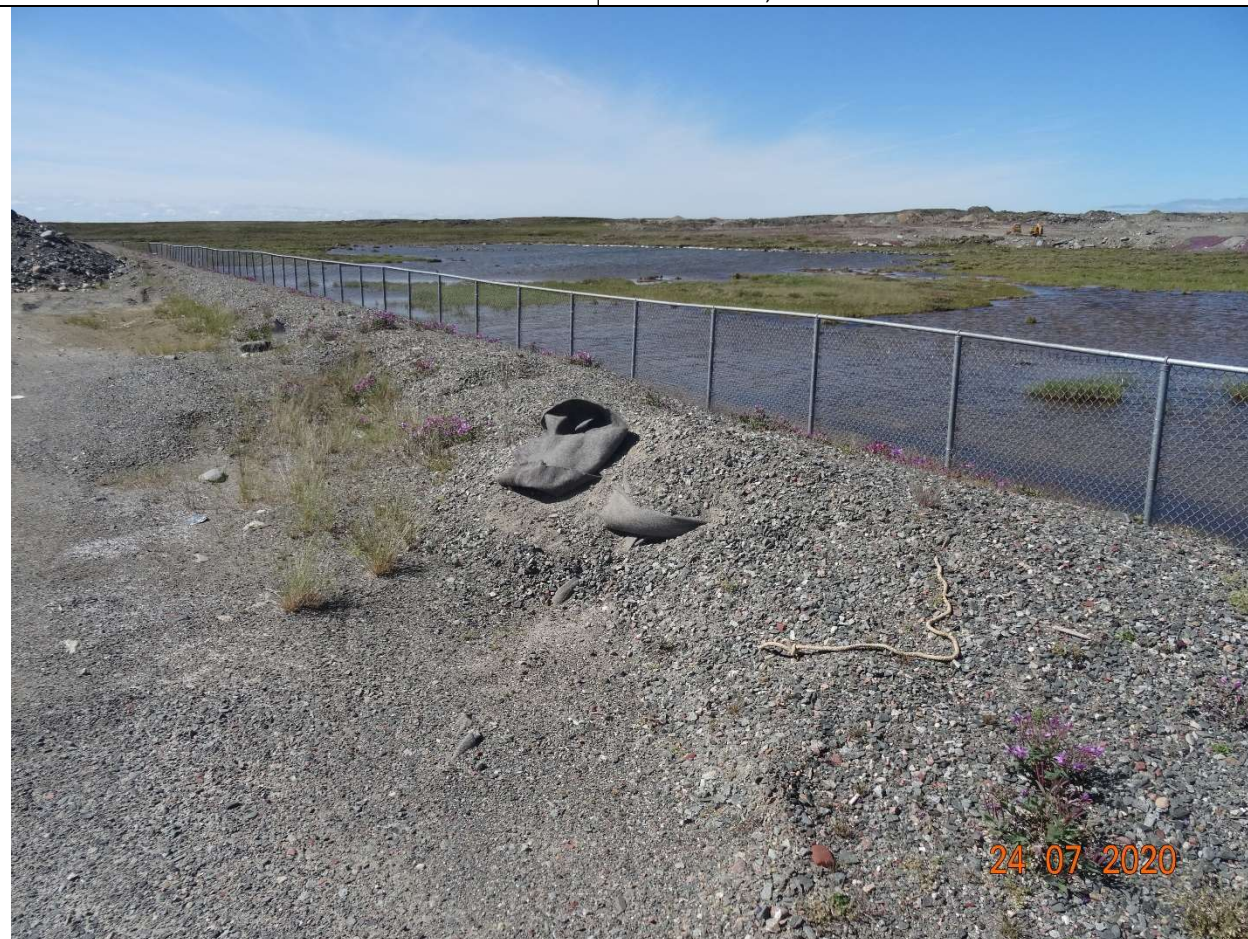
Photo 4

4. In multiple places around the facility the HDPE liner appears to be damaged (photo 4).
5. There is garbage and debris located inside and around the facility (photo 5-10). A hose is also noted by on of the pools of water (photo 11).

HDPE liner appears to be damaged.

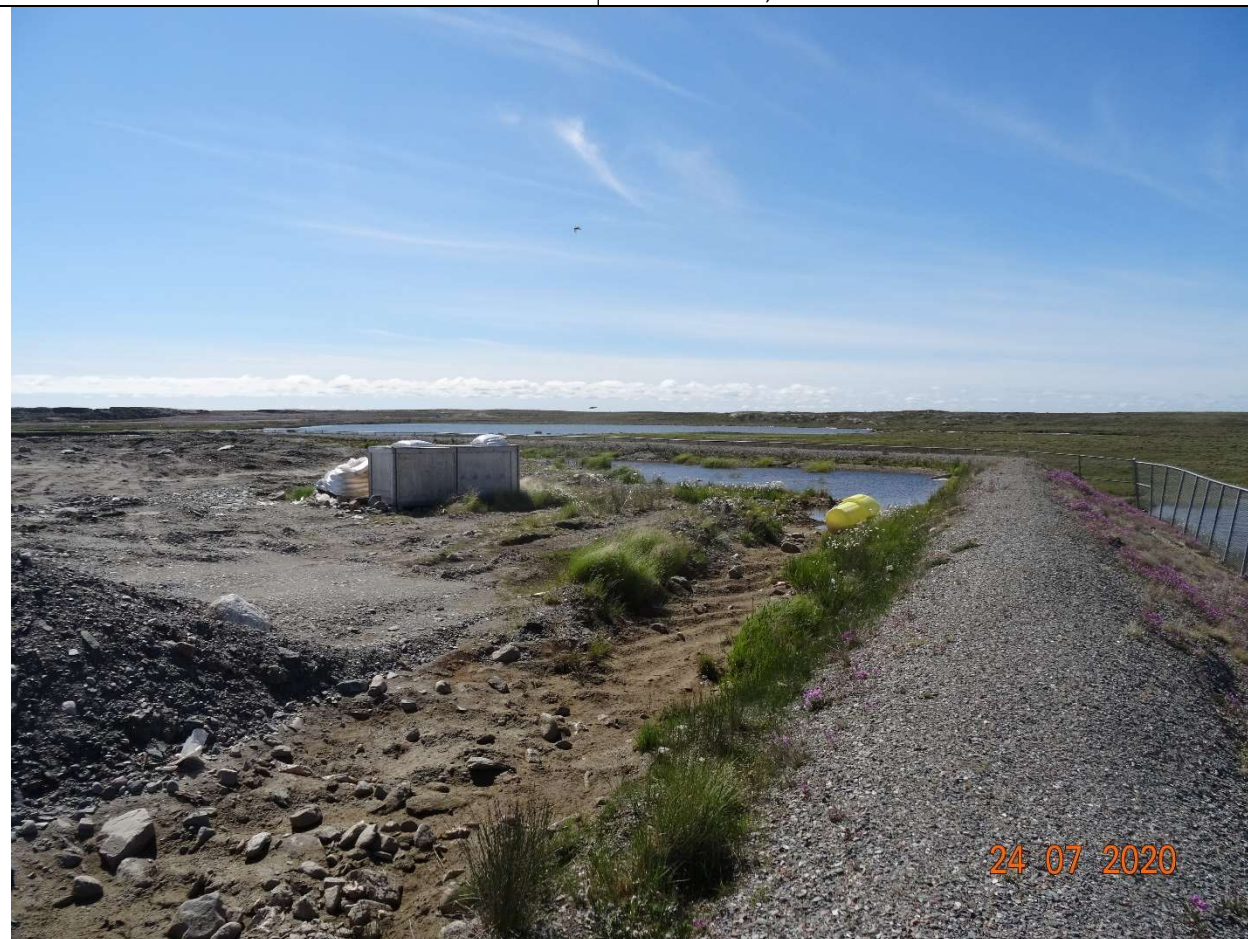
Photo 5

Water ponded inside facility, also a plastic barrel noted inside.

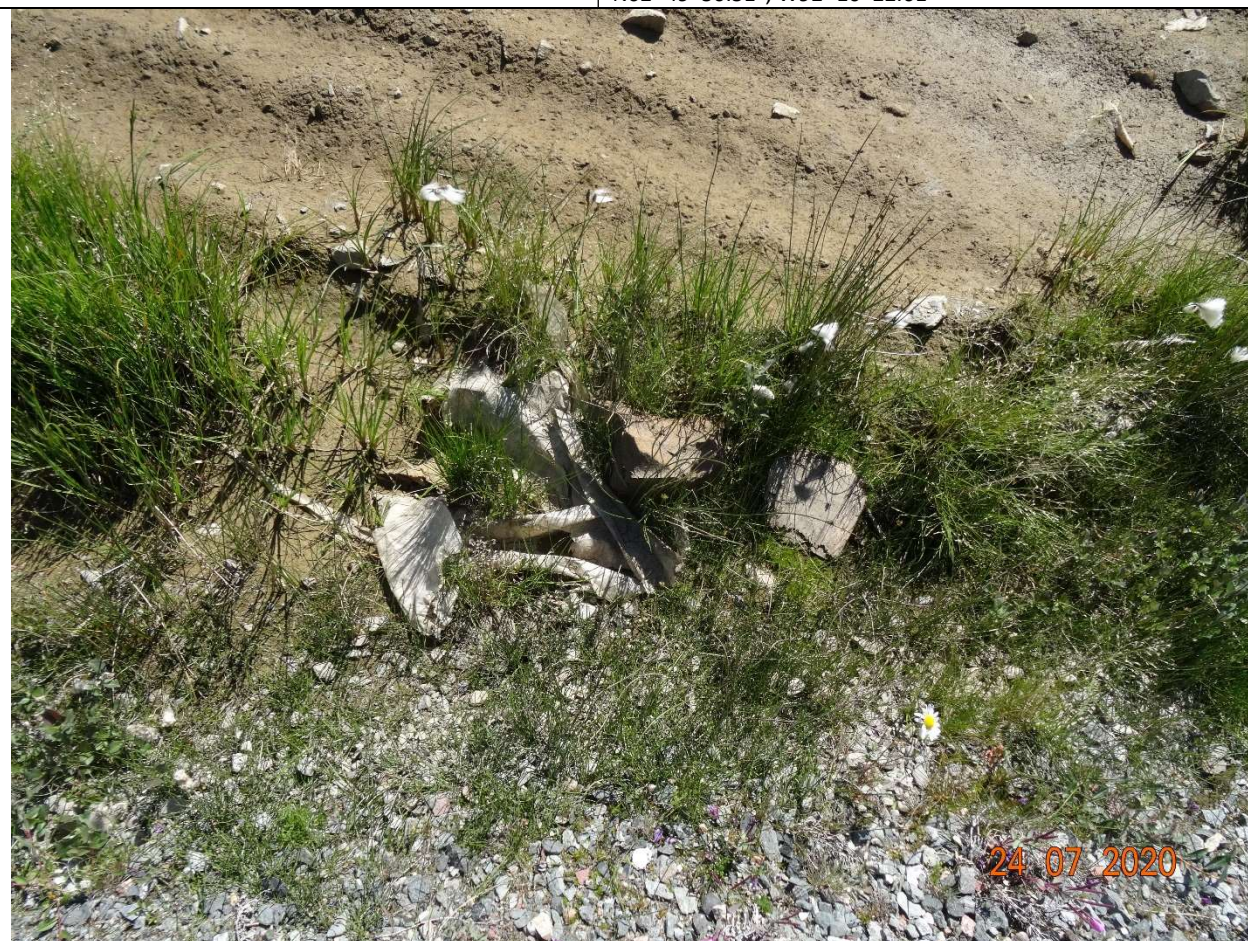
Photo 6

Garbage and debris located inside of facility.

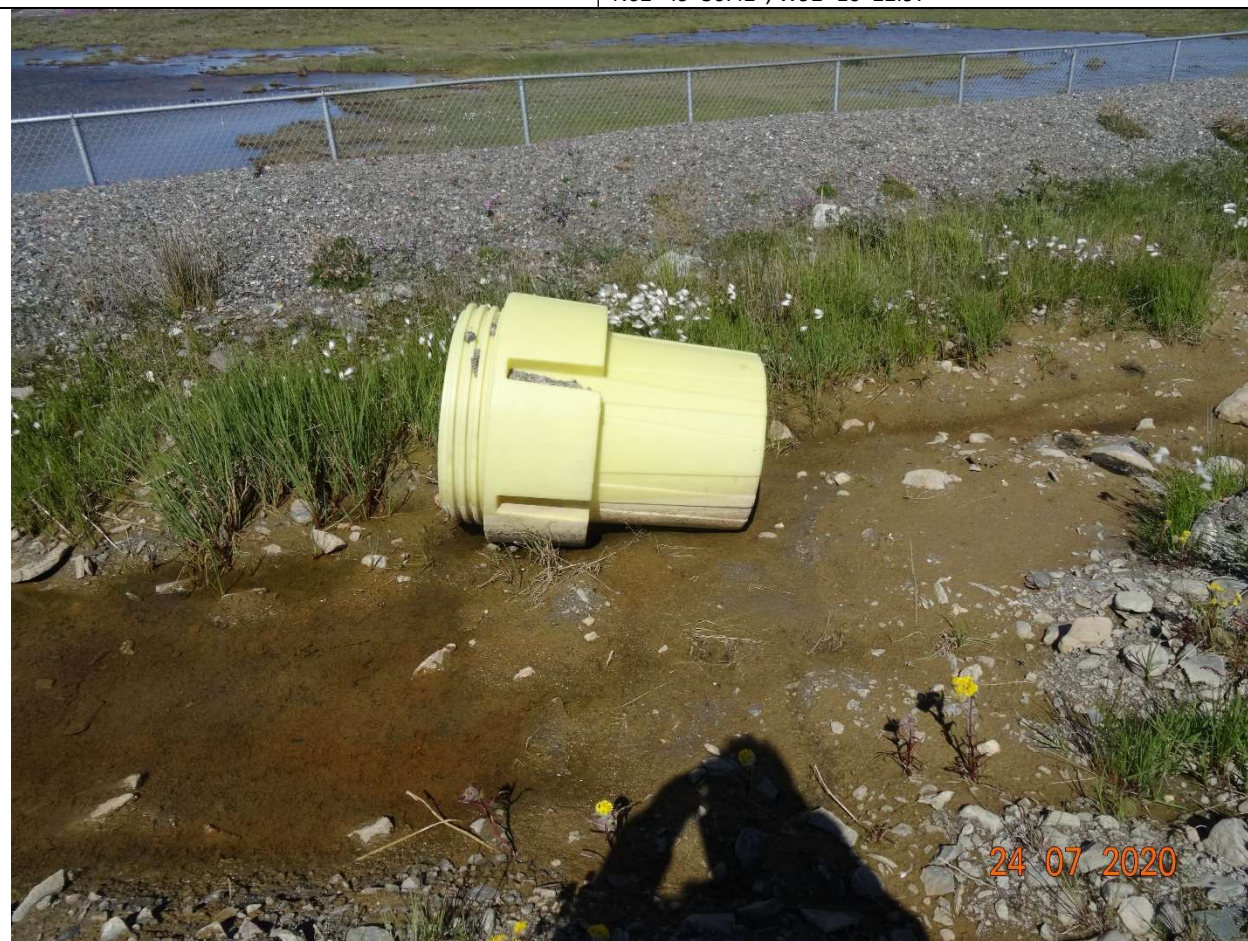
Photo 7

Plastic barrel located inside of facility.

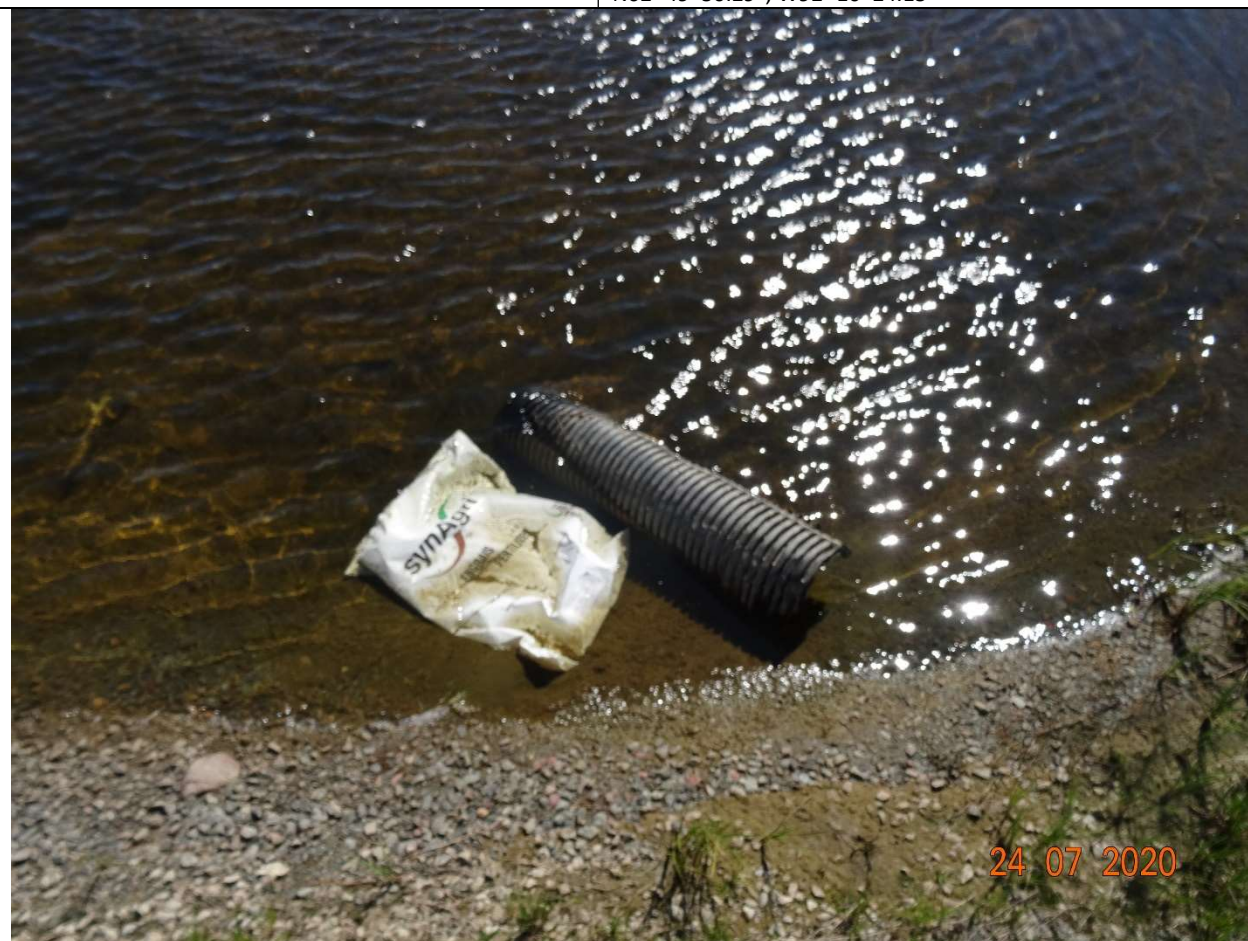
Photo 8

Garbage and debris located inside of facility

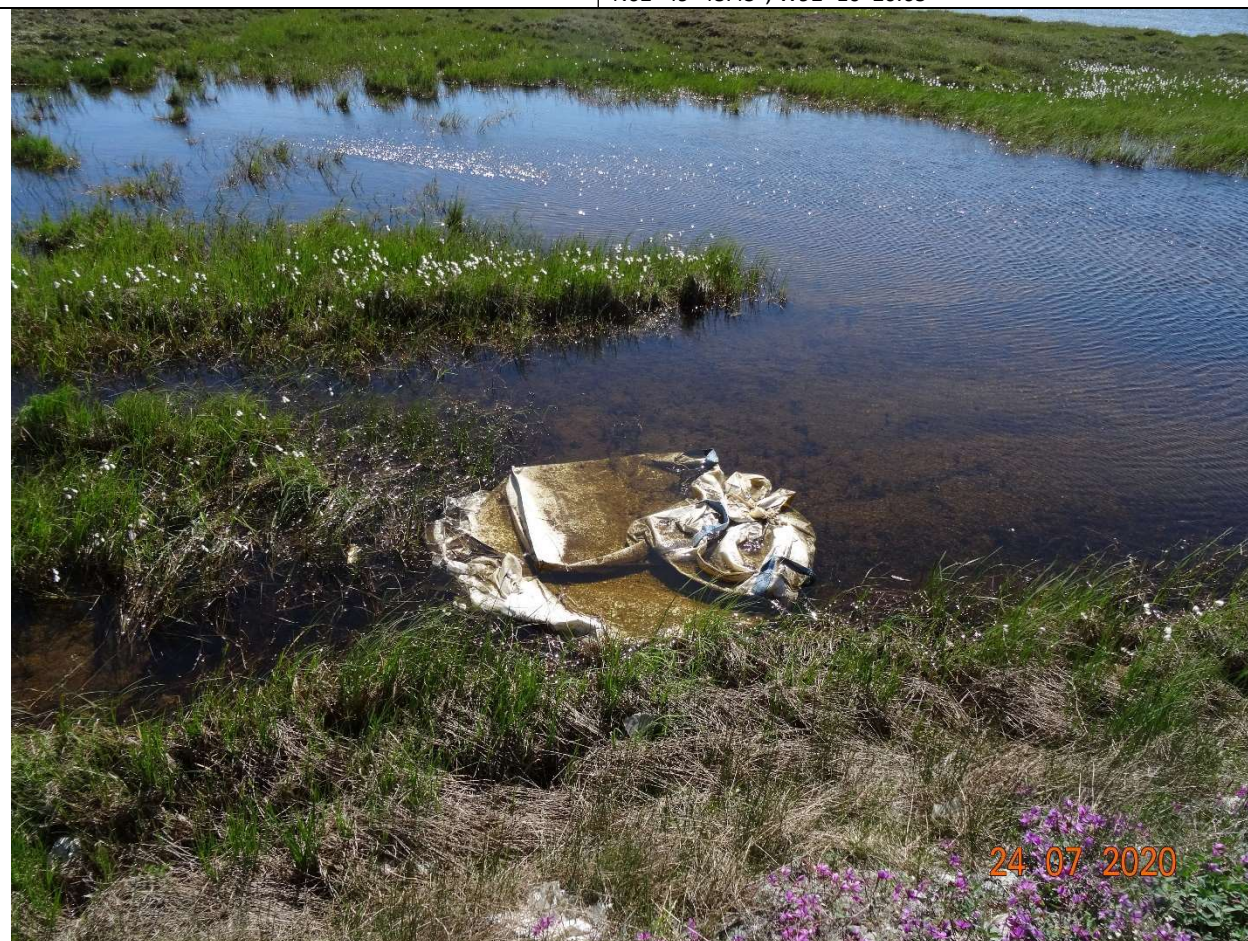
Photo 9

Quartex bag located outside of facility.

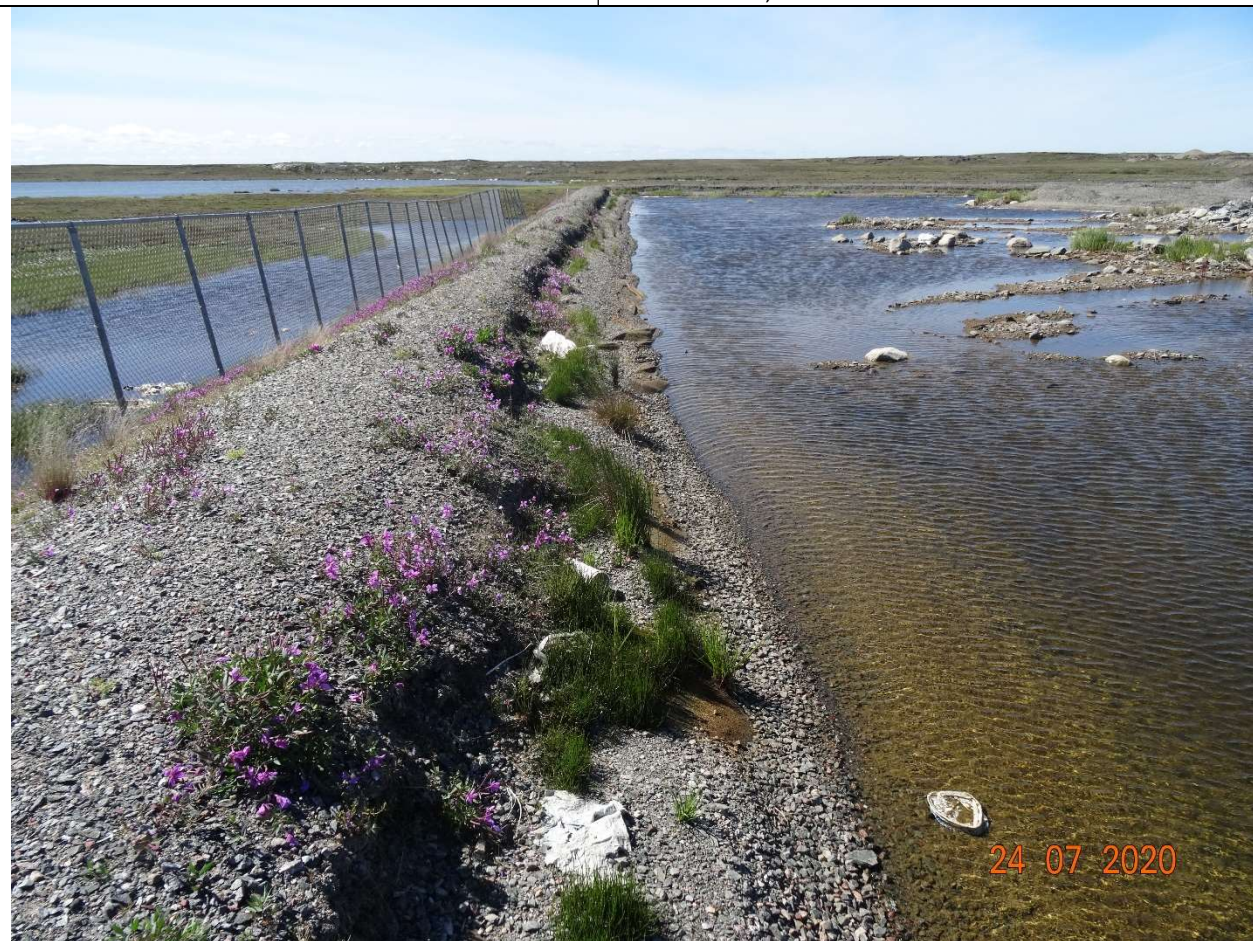
Photo 10

Water ponded inside facility, garbage/debris located inside facility.

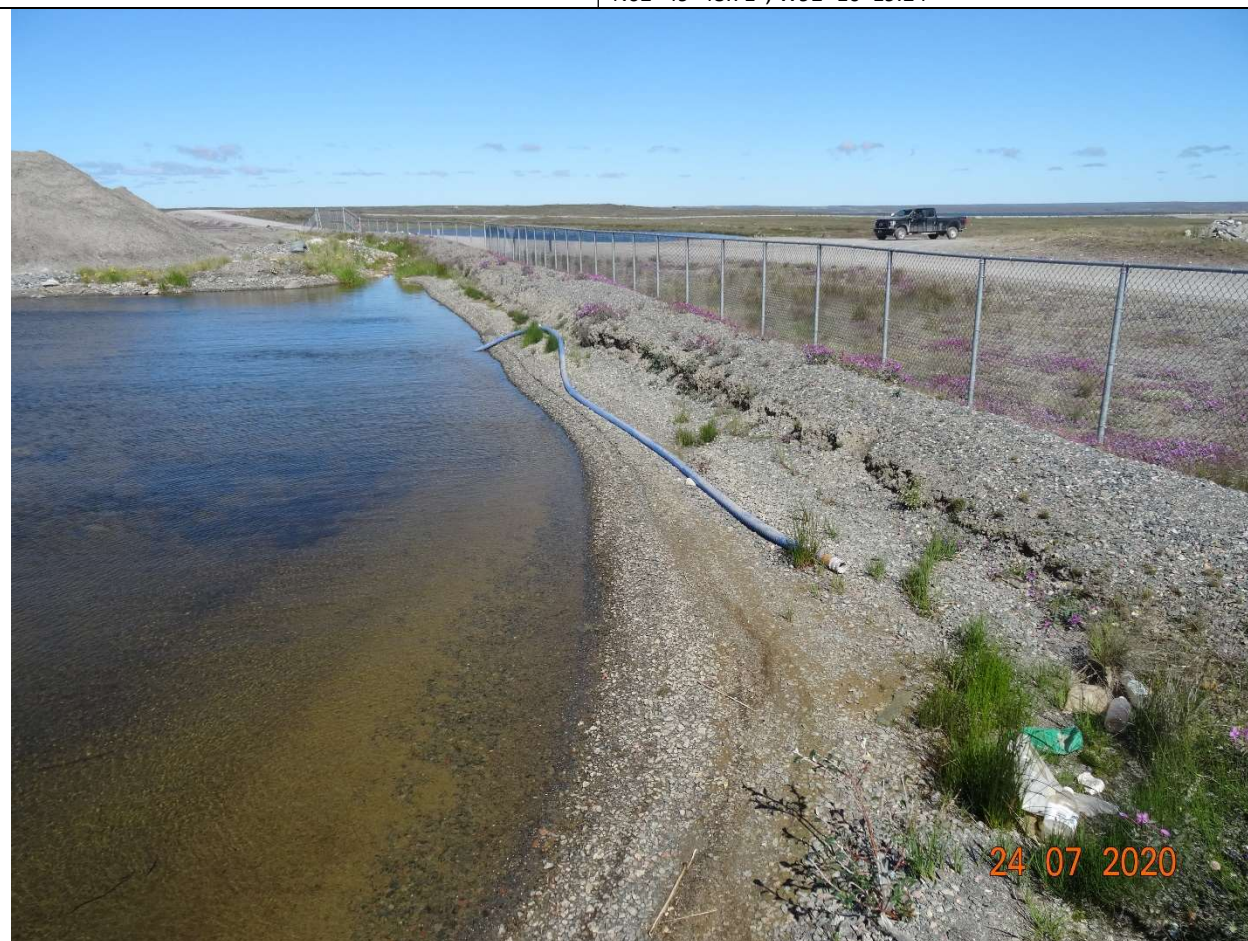
Photo 11

Water hose and garbage/debris located inside facility.
