**WATER LICENCE INSPECTION FORM**☒ Original
☐ Follow-Up Report

On July 5, 2022 an inspection of the Government of Nunavut Petroleum Product Division's Rankin Inlet Landfarm was conducted by Crown Indigenous Relations and Northern Affairs Canada (CIRNAC), Water Resource Officer K. Amsel (Inspector).

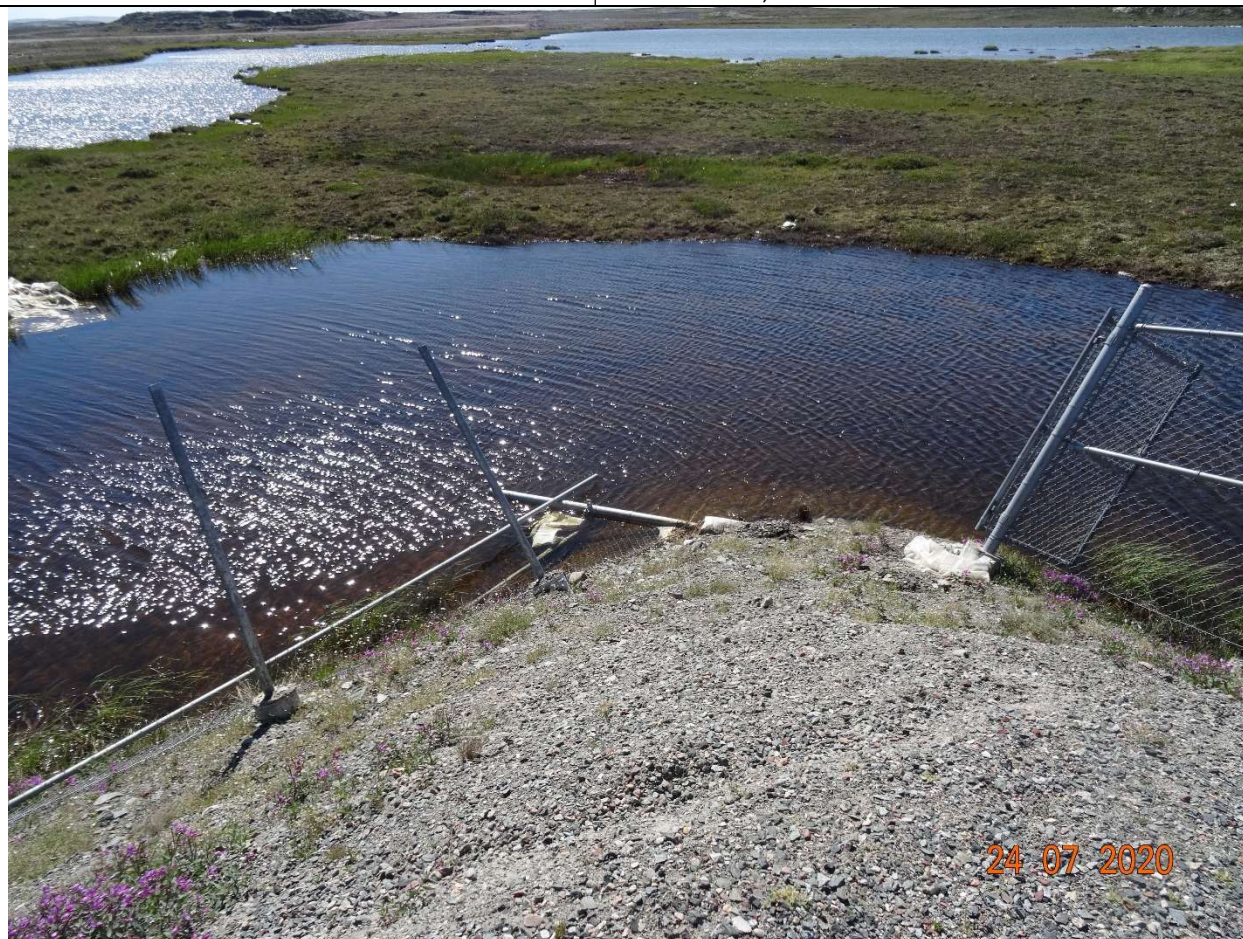
Photo 12

6. The water level inside the facility is high. The southern corner of the facility's fencing has fallen down (photo 12) and the berm wall in this corner is lower. The majority of the water in the facility sits against this berm wall.

Broken fencing.

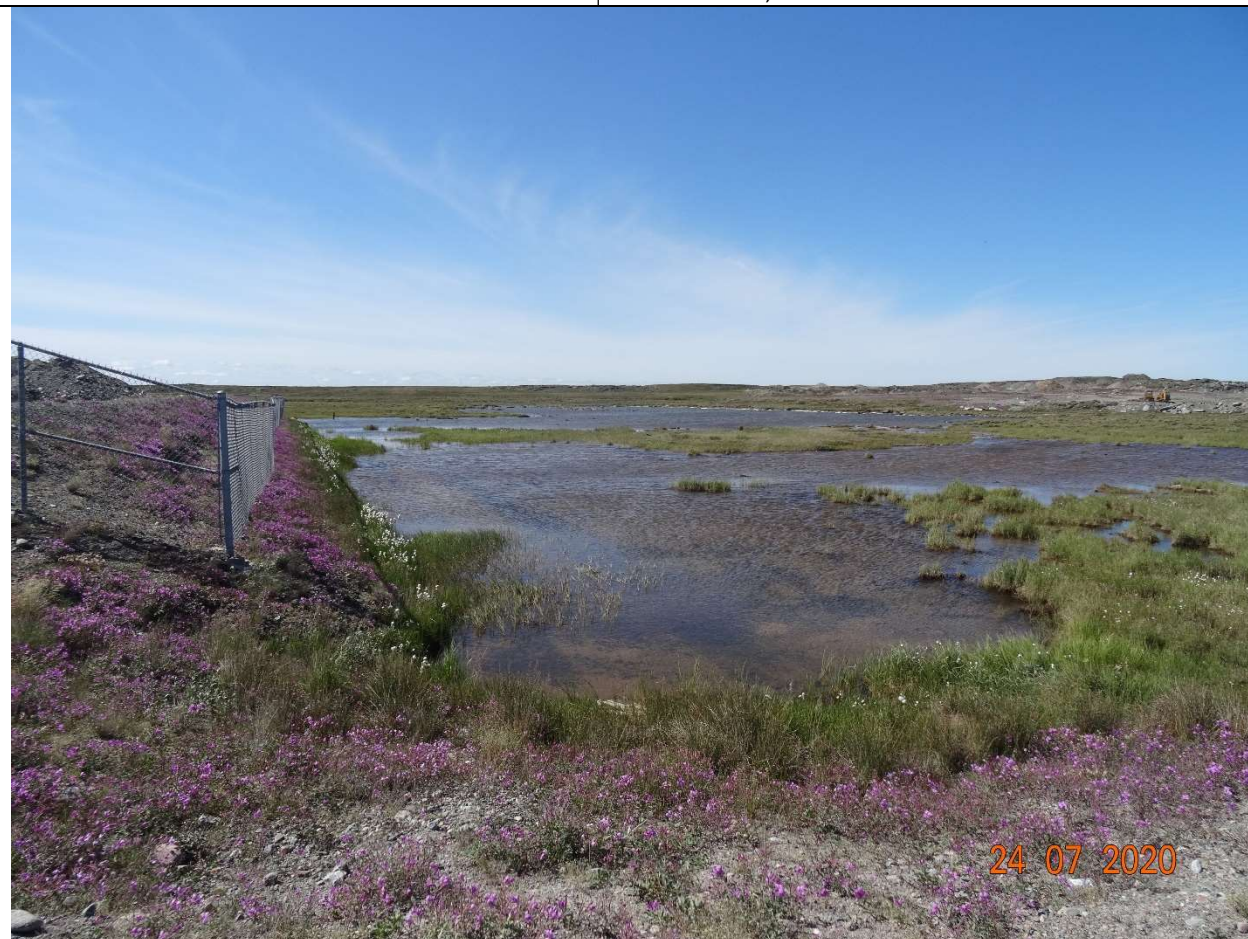
Photo 13

7. No culverts are noted along the road adjacent to the facility. The facility is surrounded with water and not well drained due to the road (photo 13-14).

Water surrounding facility.

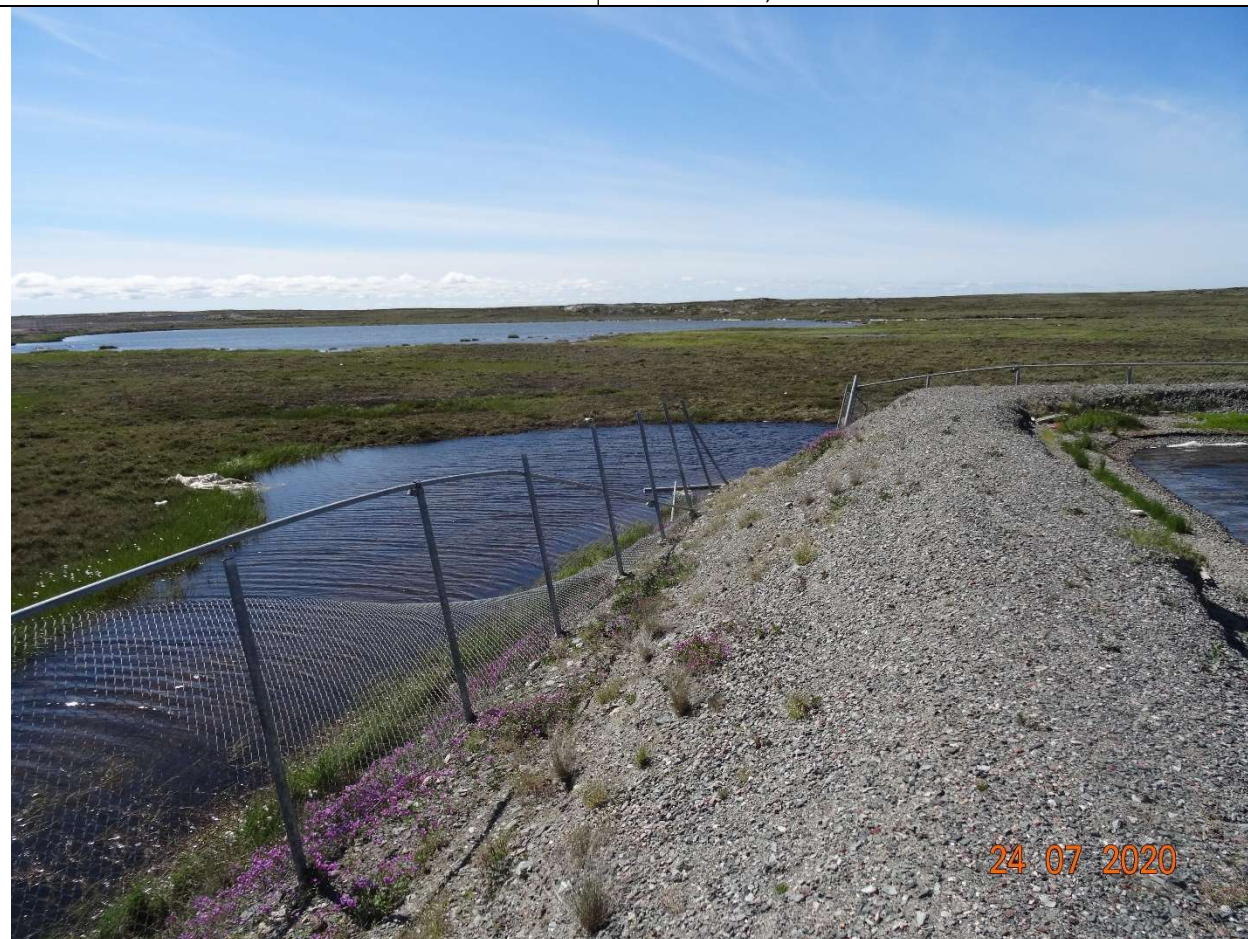
Photo 14

Broken fencing and pond of water outside facility.
