#### II. REMEDIATION

# C. S1/S4 Buildings Area

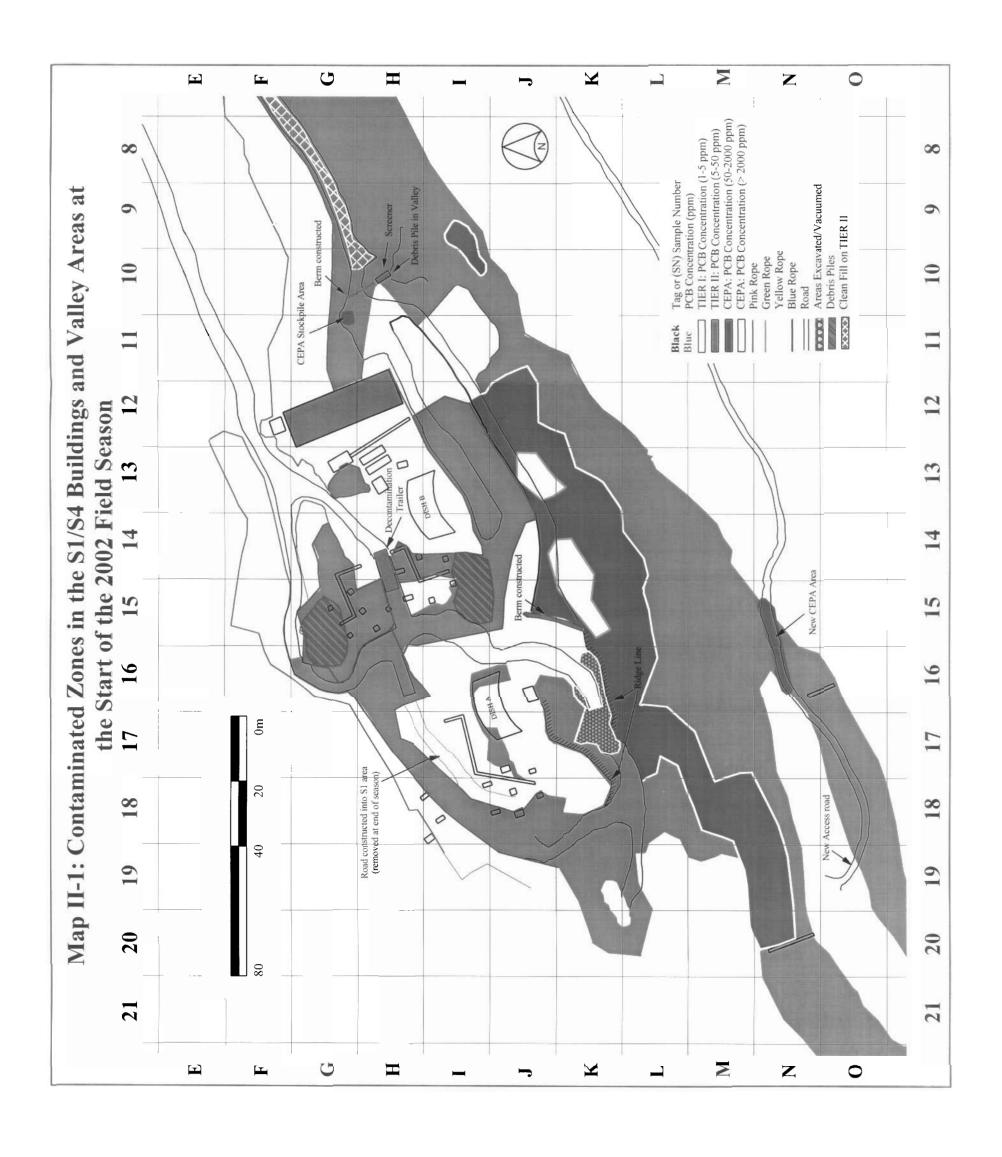
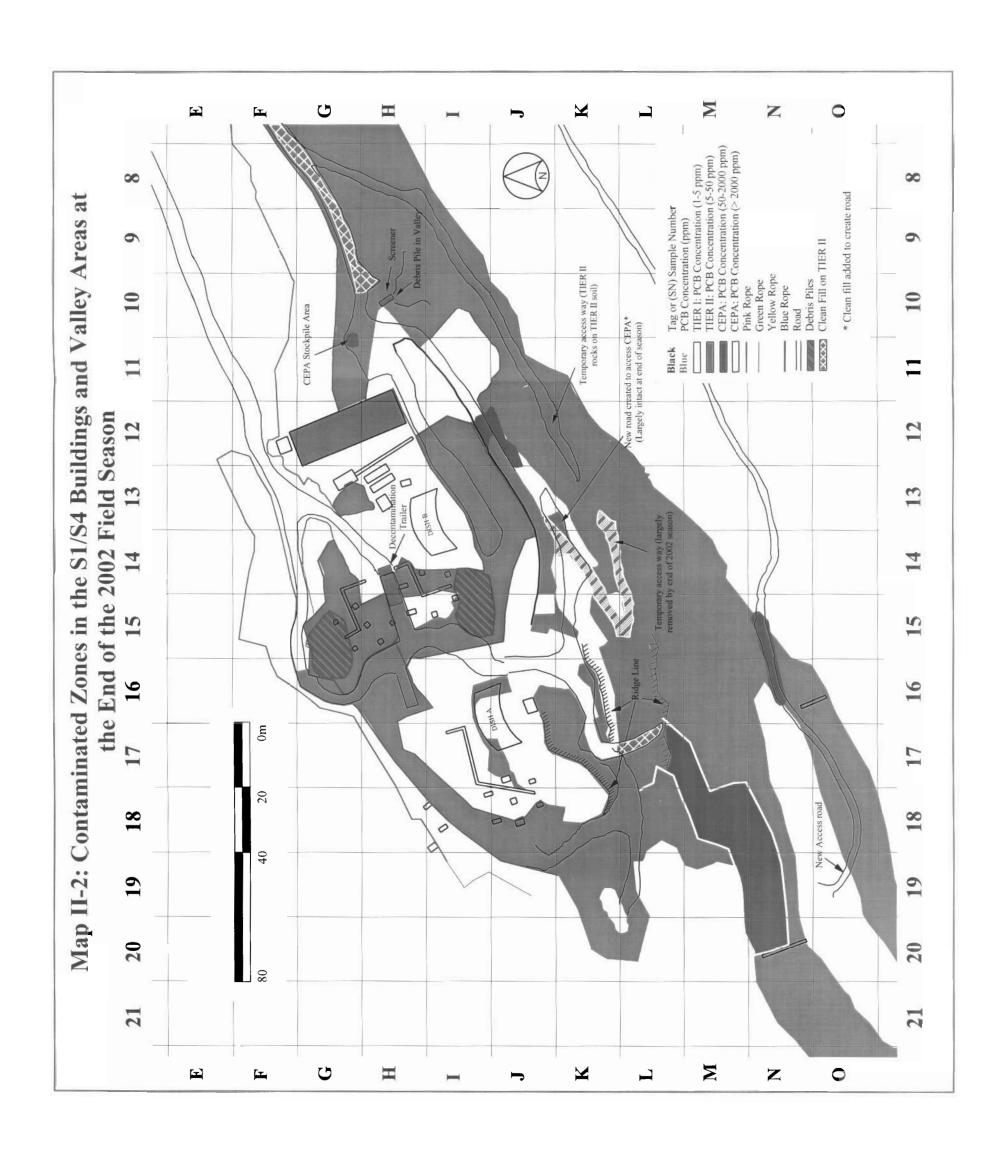
Most of the remaining contaminated soil was removed from the S1/S4 Buildings and Valley Areas this year. Map II-2 shows the extent of remediation and contamination at the end of the excavation work this year. Table II-1 contains the sample dates and sample numbers, a description of sampling locations and PCB concentrations of soil samples taken in and around the S1/S4 area for the 2002 season.

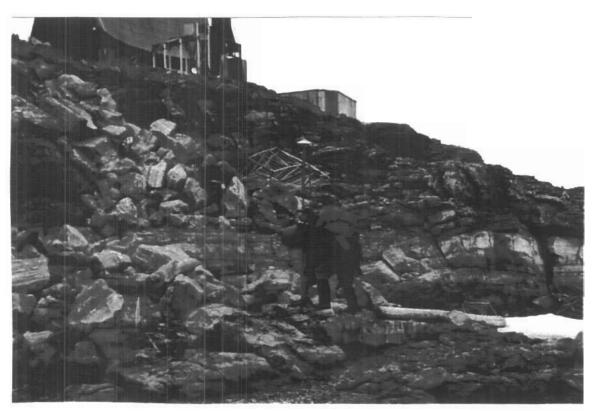
Photograph II-1: Using the GPS System in the S1/S4 Valley and Buildings Area

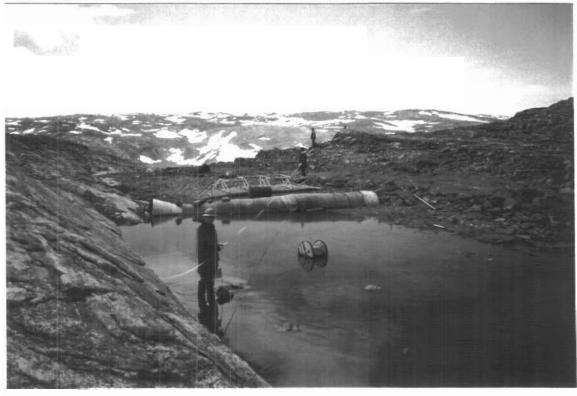
Photograph II-2: Placing Flags at the Corners of the Quadrants in the S1/S4 Valley

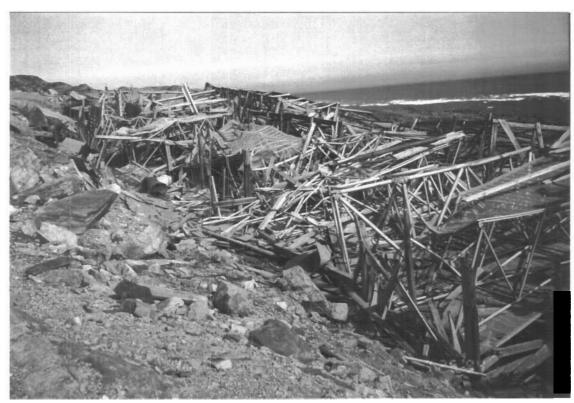
Vacuuming was required all along the ridge (grids K15, 16 and 17), and access was provided by the construction of new roads. Smaller rocks were removed from the ridge areas using manual excavation by a team of workers. Work in these areas progressed much faster than normal as a result of the unusually dry and fog free weather (Photographs II-3 and II-4).

Photograph II-3: Beside the Road Between the S1/S4 Valley and Buildings S2 and S4 in 1994

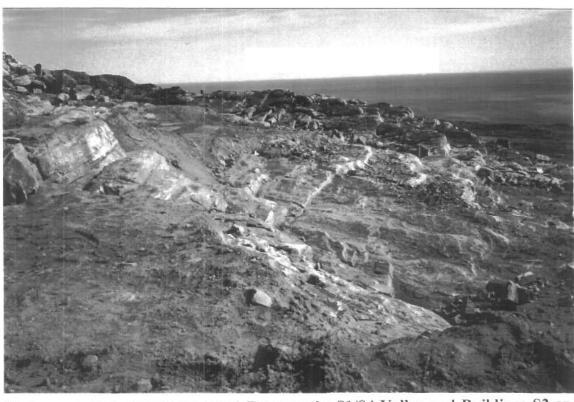
Photograph II-4: Beside the Road Between the S1/S4 Valley and Buildings S2 and S4 in 2002 After Excavation of CEPA Material

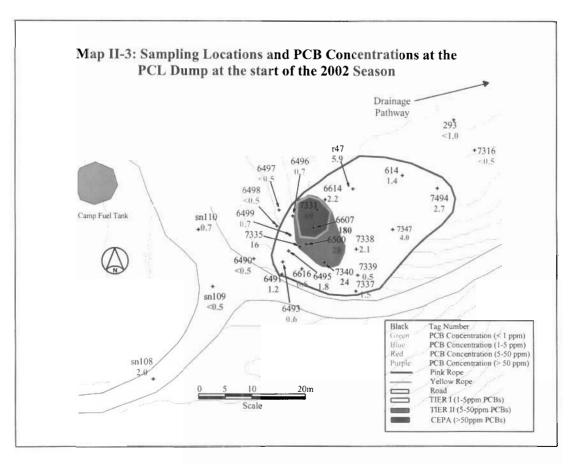
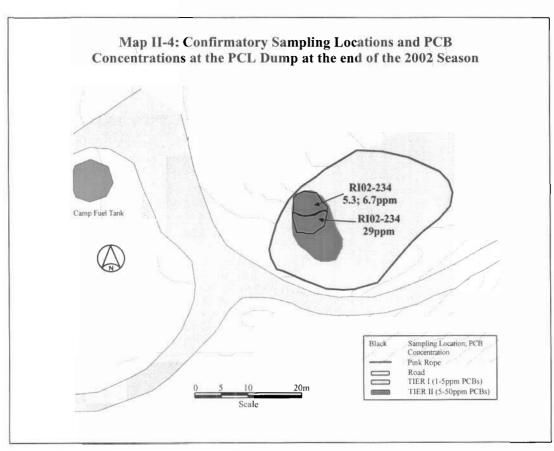
This dump was originally established by PCL during the construction of the North Warning SRR Station in the late eighties. Small amounts of camp debris were added to one side of the dump in 1997 and 1998. The material was moved and shredded into the new landfill just across the road in 1999. The area was re-sampled in 1999 and two samples were found to contain PCBs at levels above 50 ppm (69 and 180 ppm). This finding was reported to Environment Canada. In 2000, 13 were collected in order to determine the extent of the CEPA contamination. None of the samples taken in 2000 contained > 50 ppm PCBs. Map II-3 shows the PCB contaminant level boundaries at the start of this year.

The CEPA soil was excavated this year. Excavation was to a depth of approximately 30 cm. The soil and remaining ground was very muddy. Two composite confirmatory samples were taken from the excavated area. RI02-033 from the SW portion gave a result of 29 ppm PCBs and RI02-034 from the NE portion gave a result of 6.0 from duplicate analyses. Therefore further excavation was not required. The volume of CEPA soil excavated was estimated as 15 m<sup>3</sup>. Map II-4 shows the remaining contaminant levels at the end of the season.

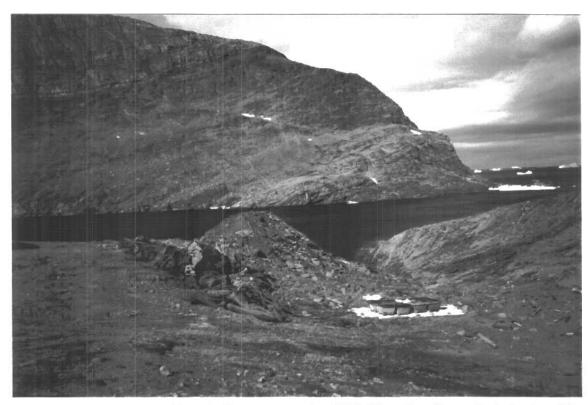
Most of the debris in the dump was removed in 1999 and 2001. Partial excavation was also carried out on a second smaller dump near the main beach dump. This year a small amount of debris was removed from both dumps. The remaining debris in the main dump was in the permafrost and will be excavated as it thaws next year. The dump was delineated in 2001 and areas contaminated at the Tier II and Tier I level identified. No further analysis were deemed necessary this year.

Photograph II-5: The Beach Dump Area in 2002 Showing Some Debris Awaiting Transport to the Non-Hazardous Landfill and Spill Trays Set Out to Receive Oil From Leaky Barrels if Required.
