BAF-5 Resolution Island

Maintenance Assessment Report (AECOM, 2014)

Public Works and Government Services Canada

BAF-5, Resolution Island Maintenance Assessment Report

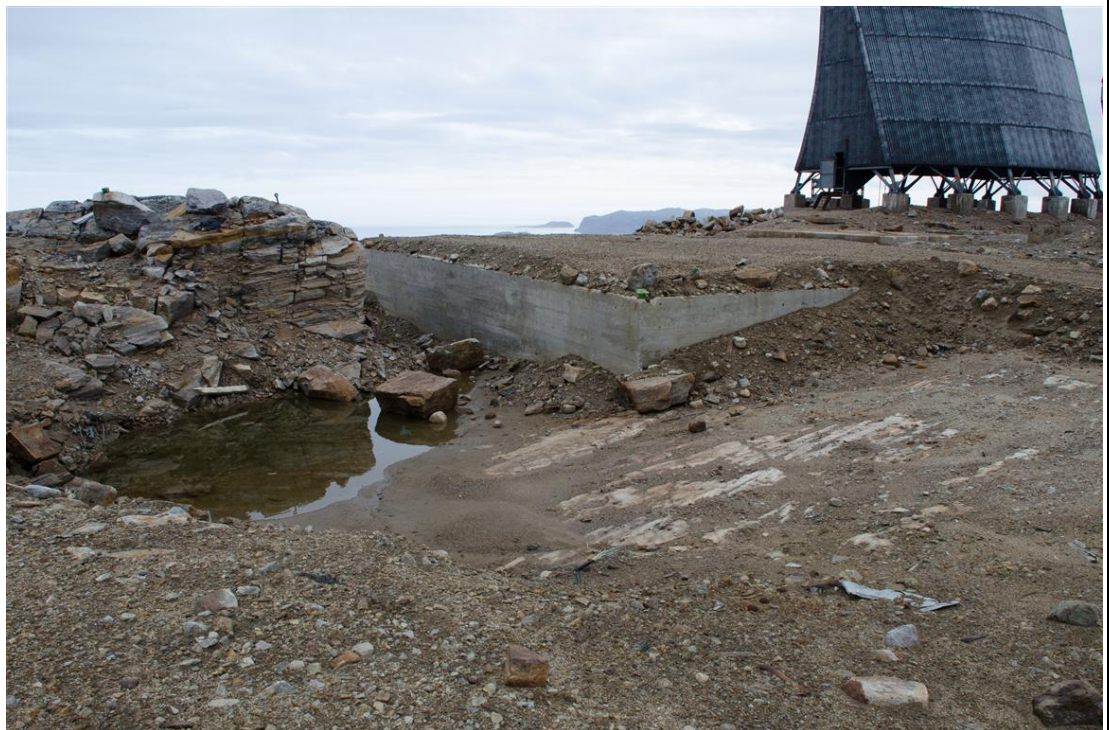
Looking south towards drainage between rock and concrete foundation near billboard antenna, taken near the south toe of the west portion of the landfill.

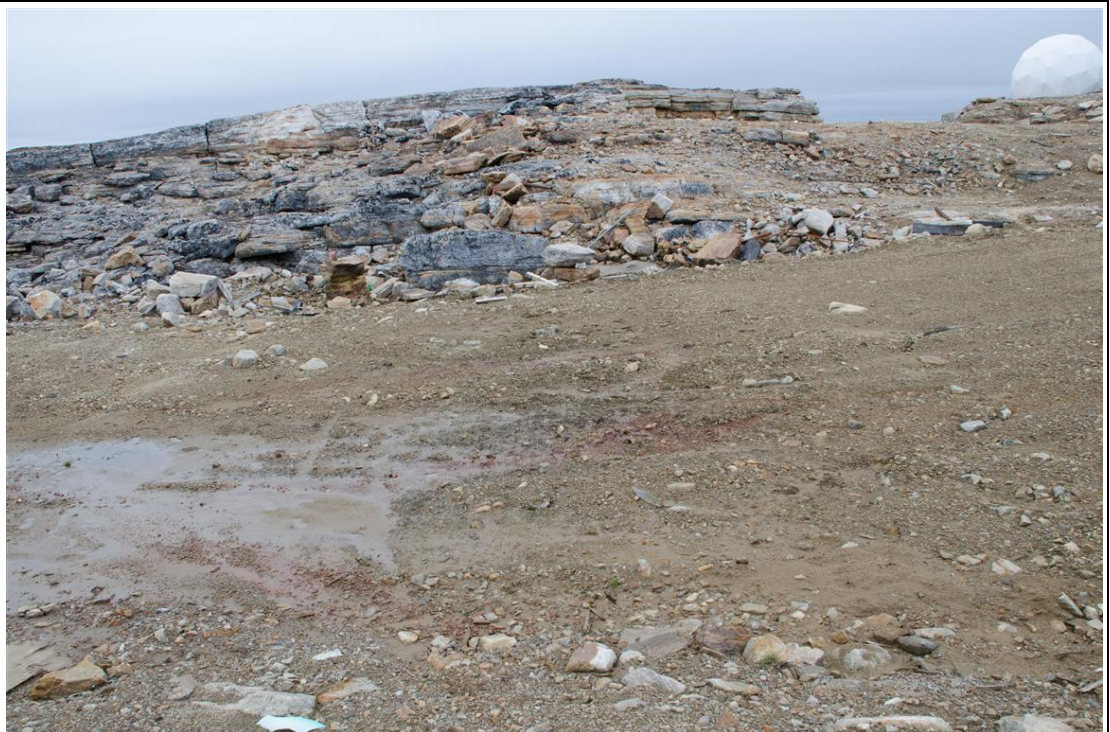
Looking north at west landfill toe with area of staining and poor drainage, taken near the southwest landfill toe.

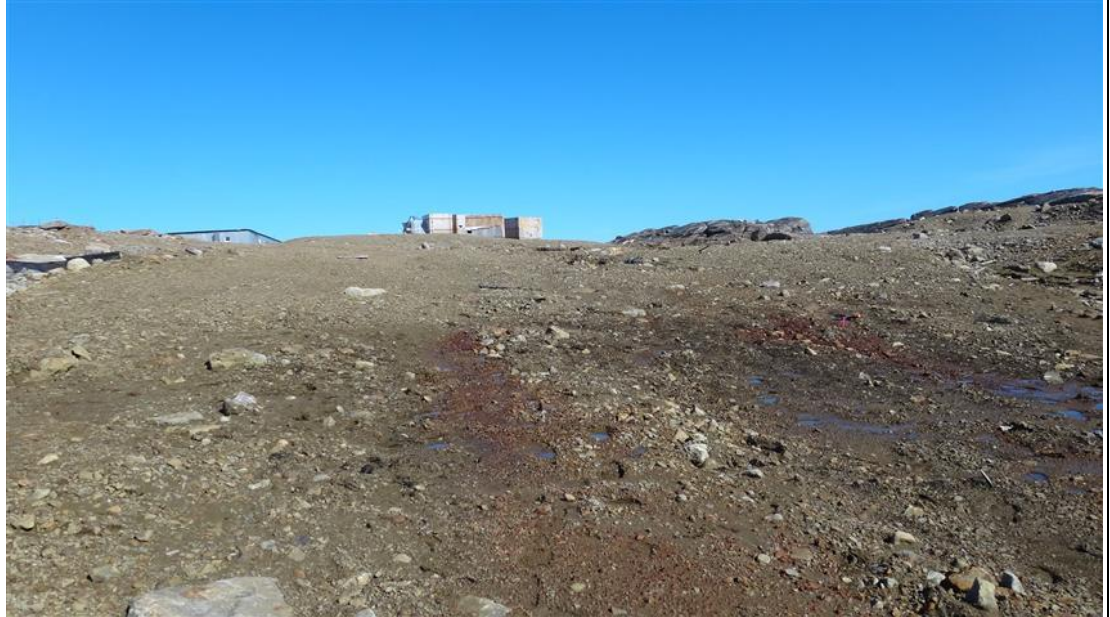
Looking east at west landfill toe with area of staining and poor drainage.

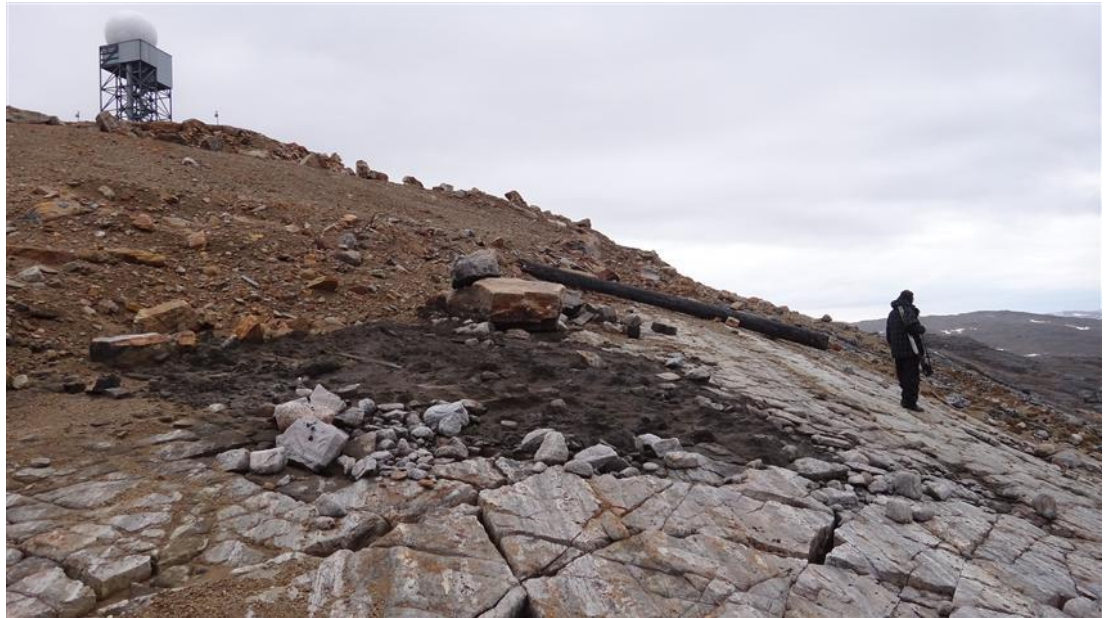
Looking west along toe of north-most portion of North Slope Dump. POL stain visible adjacent to edge of fill

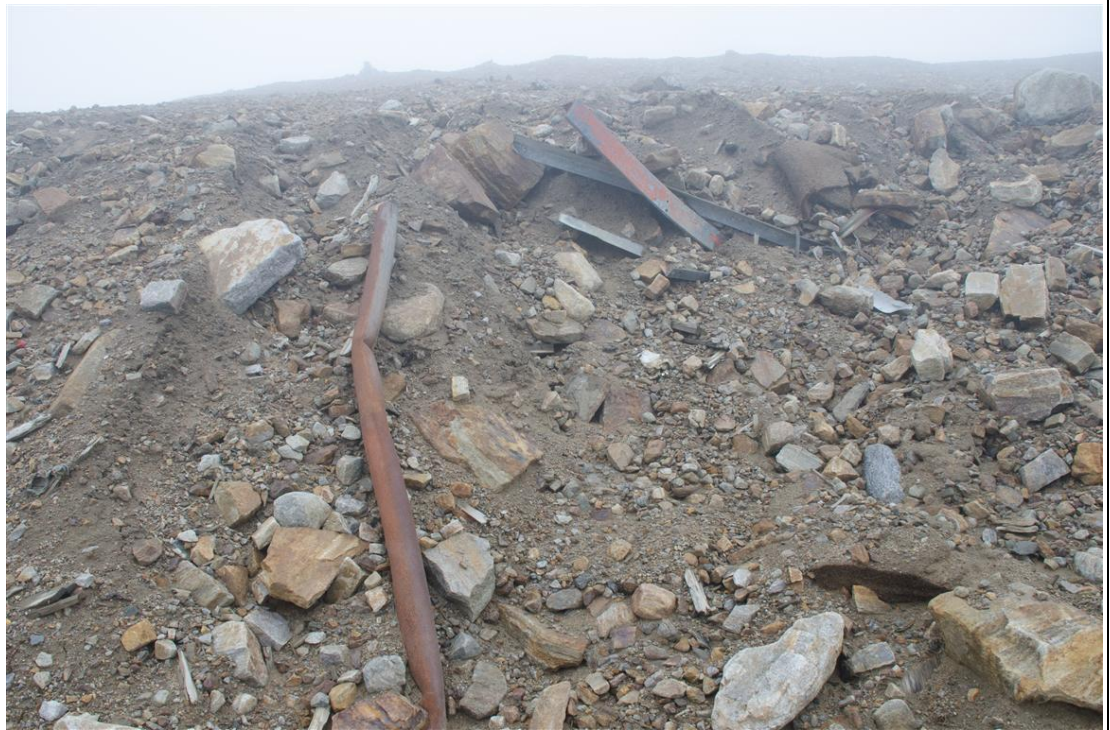
Evidence of erosion, settlement and subsequent slope failure in central section of North Slope Dump (WP#078)

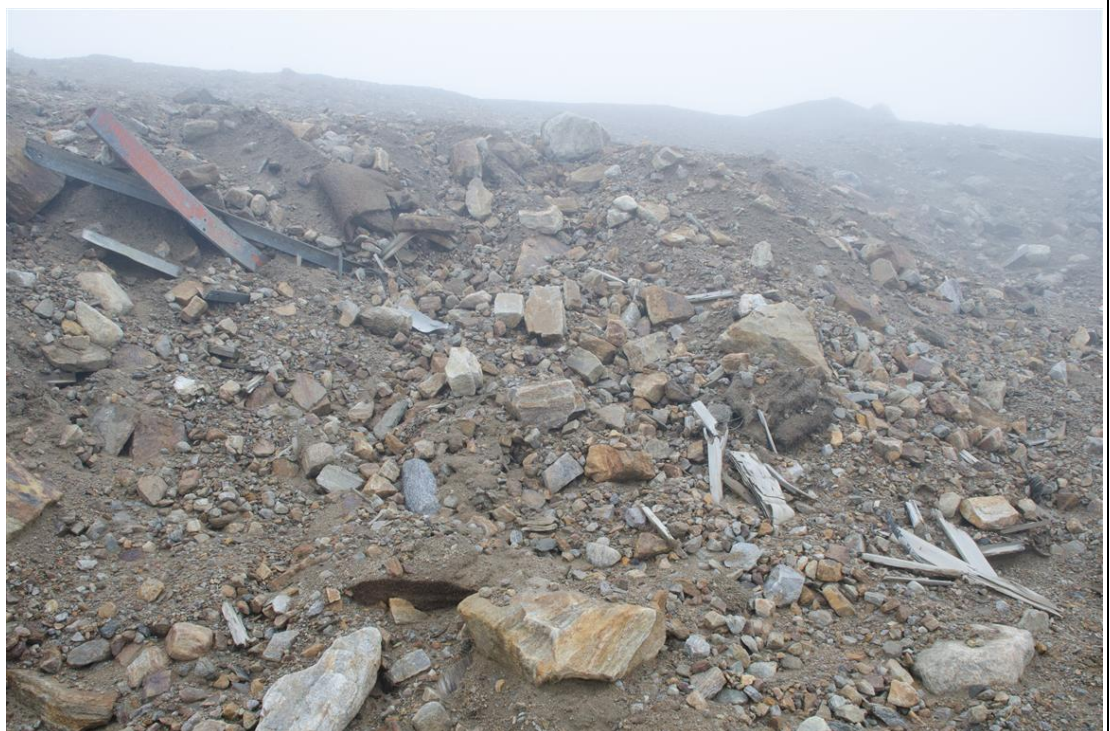
Evidence of erosion, settlement and subsequent slope failure in central section of North Slope Dump (WP#078)

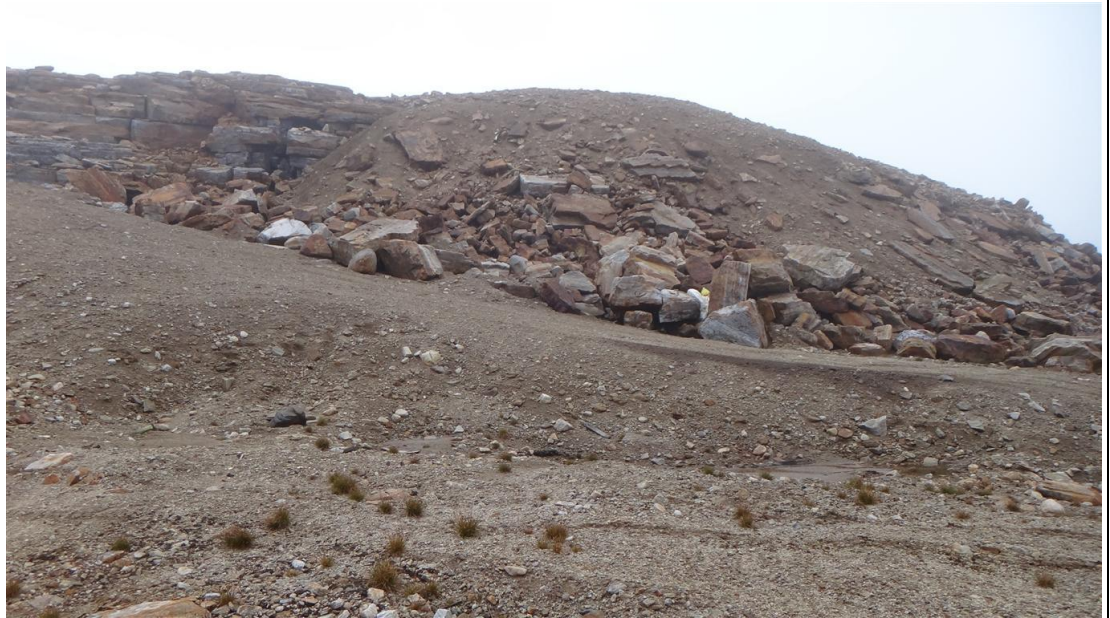
Looking southwest at SRR Construction Landfill. Staining visible on photo right.

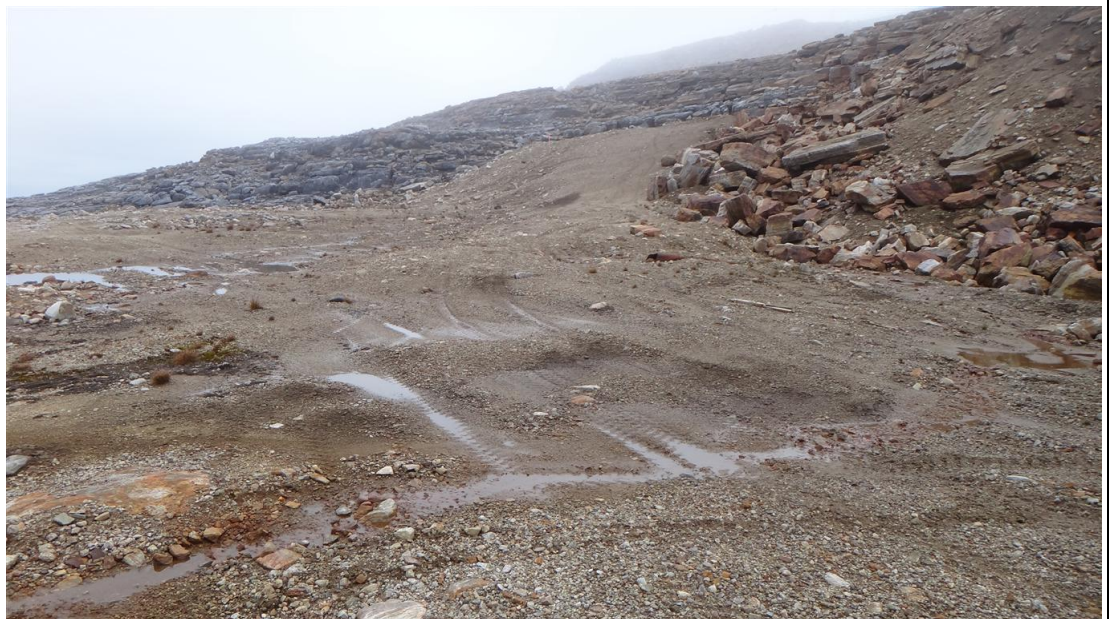
Looking southeast at ramp portion of SRR Construction Landfill. Note staining throughout the disturbed area.

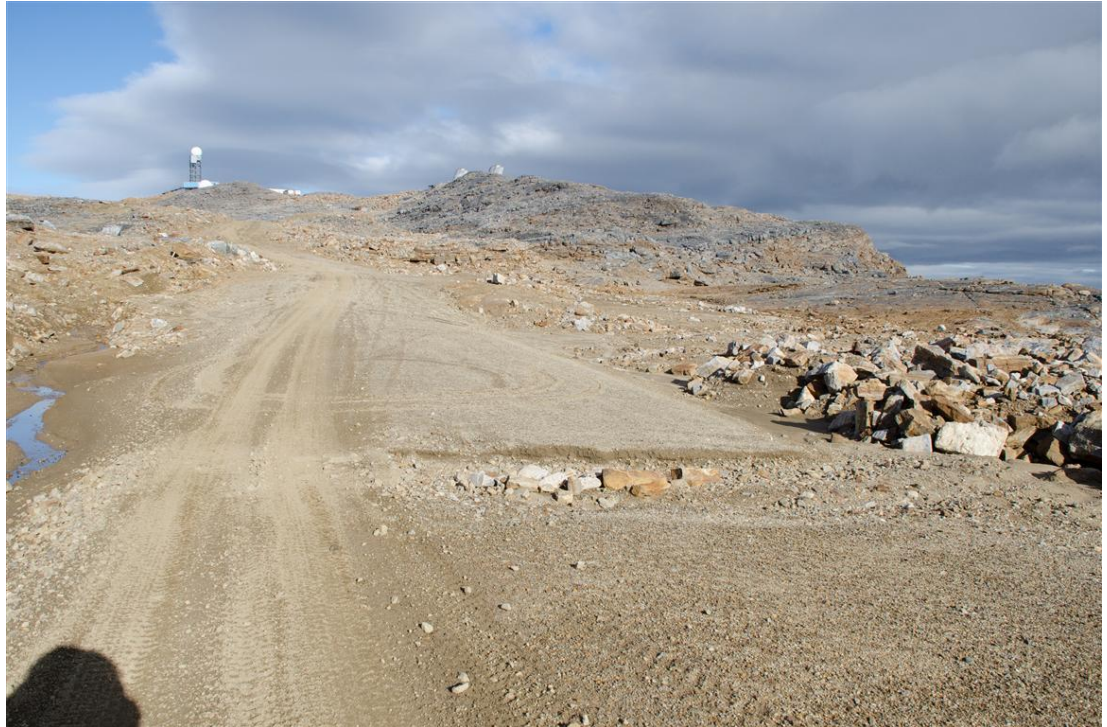
Road Section 1: Looking northeast at road washout/settlement located along road west of Tier II Disposal Facility. Repair could consist of additional fill or grading.

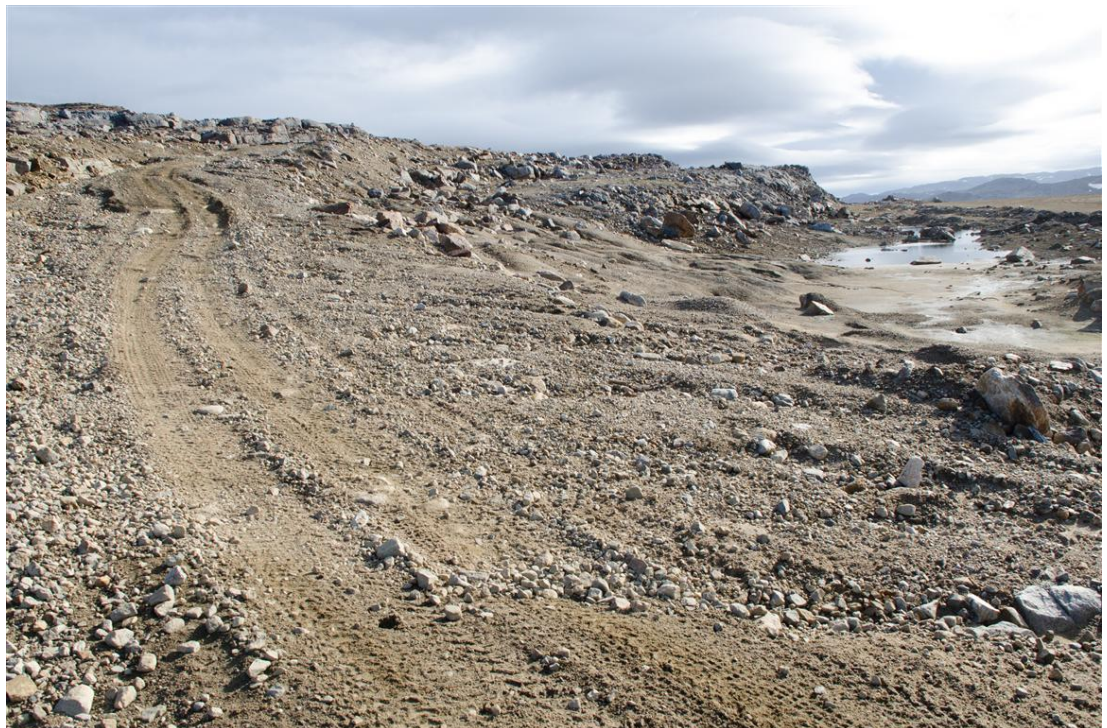
Road Section 1: Looking south at major erosion, drainage channels and slope failure located on the portion of Road Section 1 closest to the Airstrip. Additional fill and compaction required in this area.

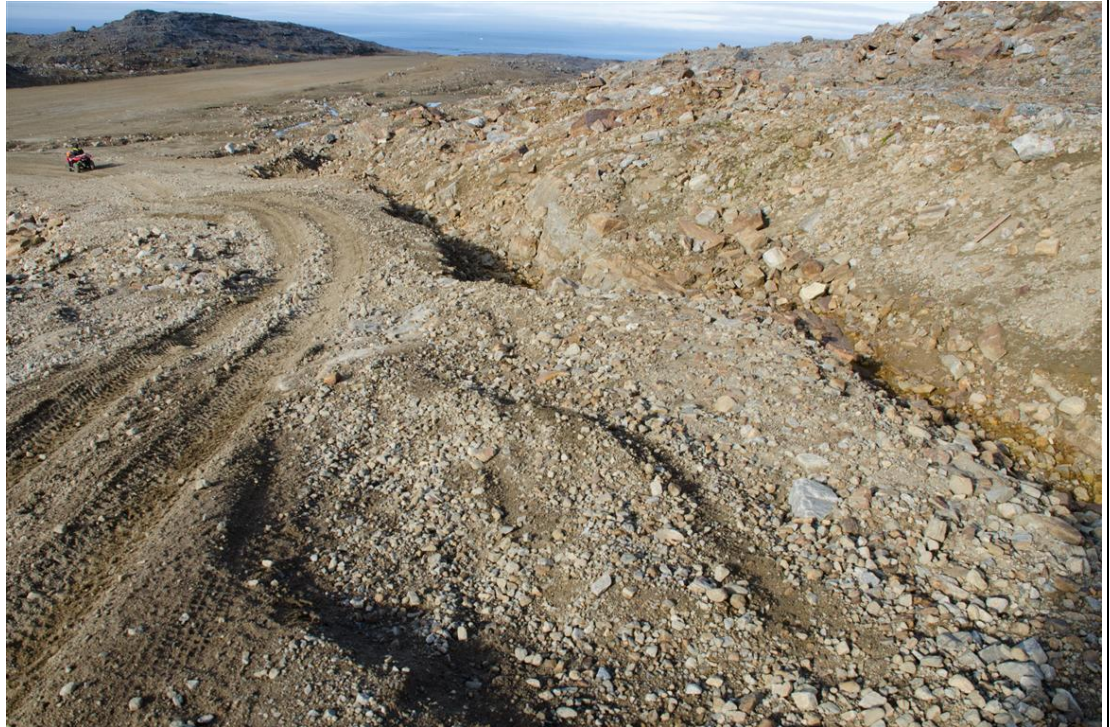
Road Section 1: Looking north at major erosion, drainage channels and slope failure located on the portion of Road Section 1 closest to the Airstrip. Additional fill and compaction required in this area.

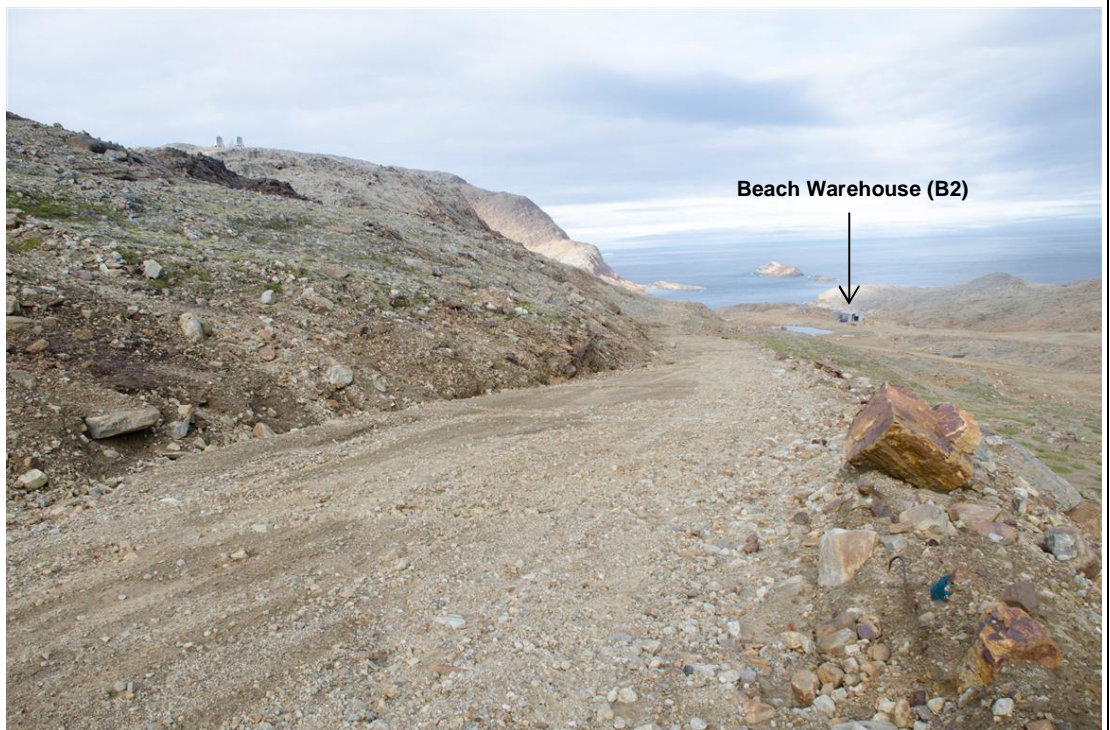
Road Section 3: Typical condition of Road Section 3 between Freshwater Lake and the beach Area. Minor erosion channels/rills throughout.
