III. SITE INVESTIGATIONS

B. Tier II Landfill

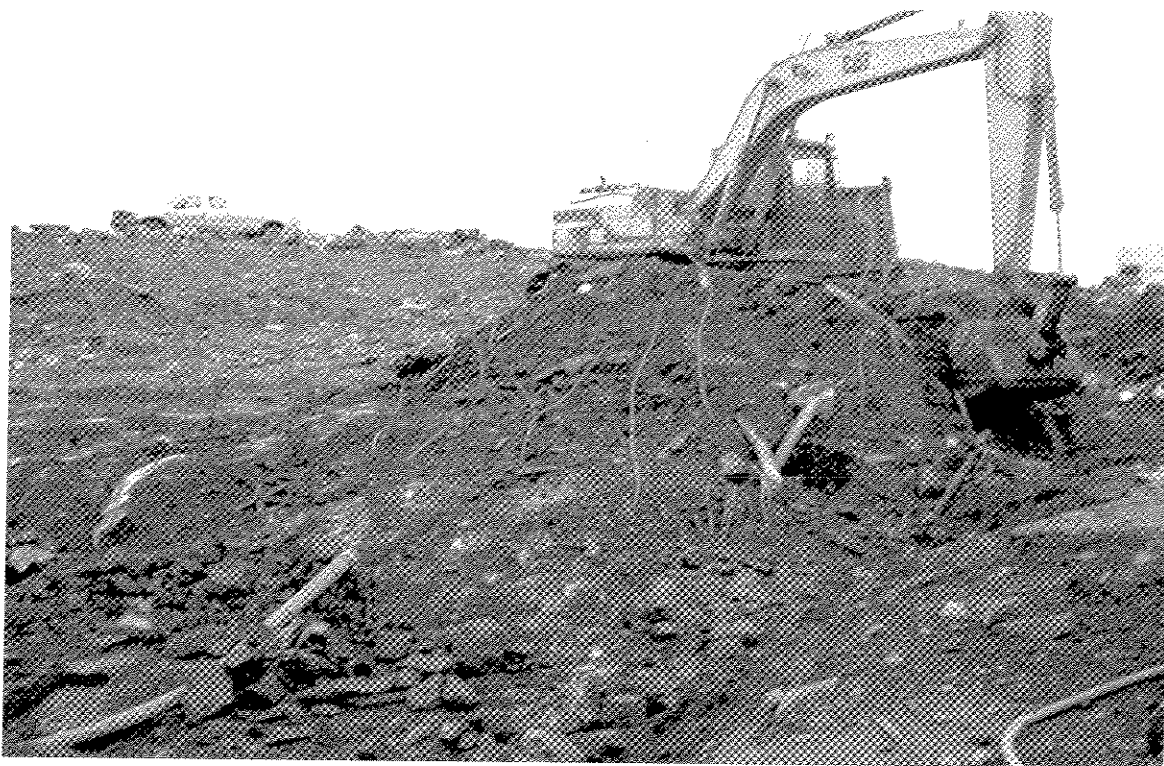
Photograph II-21: Excavating Metal Contaminated Soils at the Beach Dump

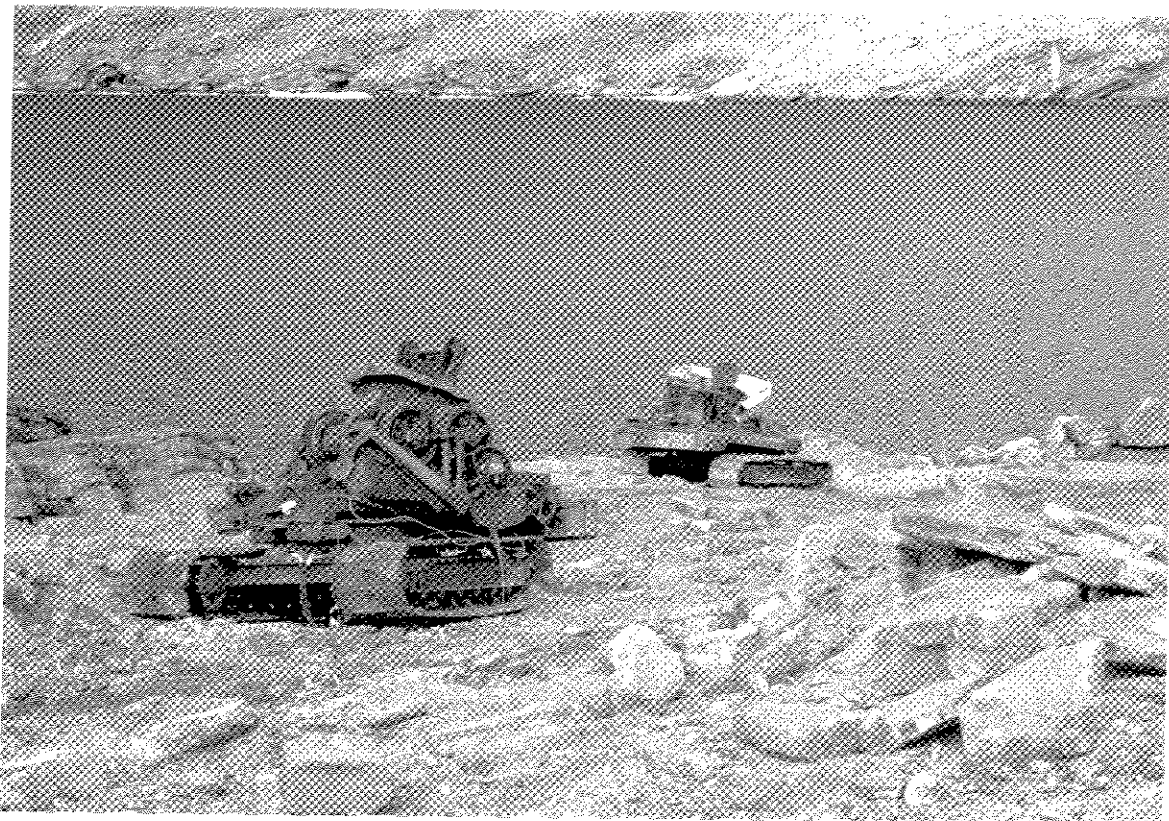
Photograph II-22: Two Large Old Pieces of Equipment Were All that Remained at the Main Beach Dump After Contaminated Soil Was Excavated to Bedrock

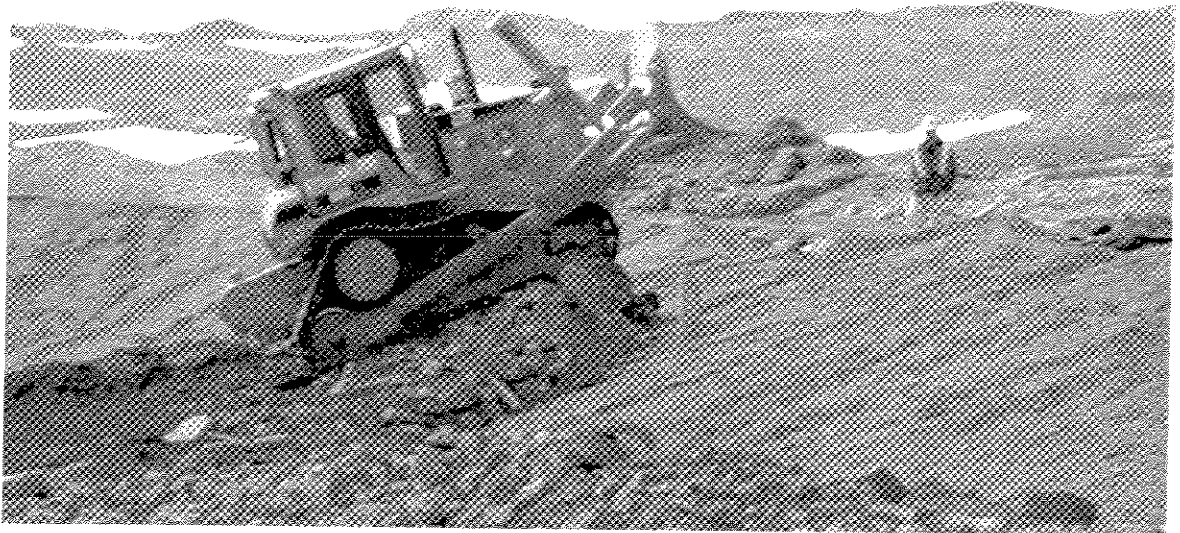
Photograph III-1: Soil was Transported From the Various Tier II Contaminated Areas and Placed Within the Lined Area of the Tier II Landfill

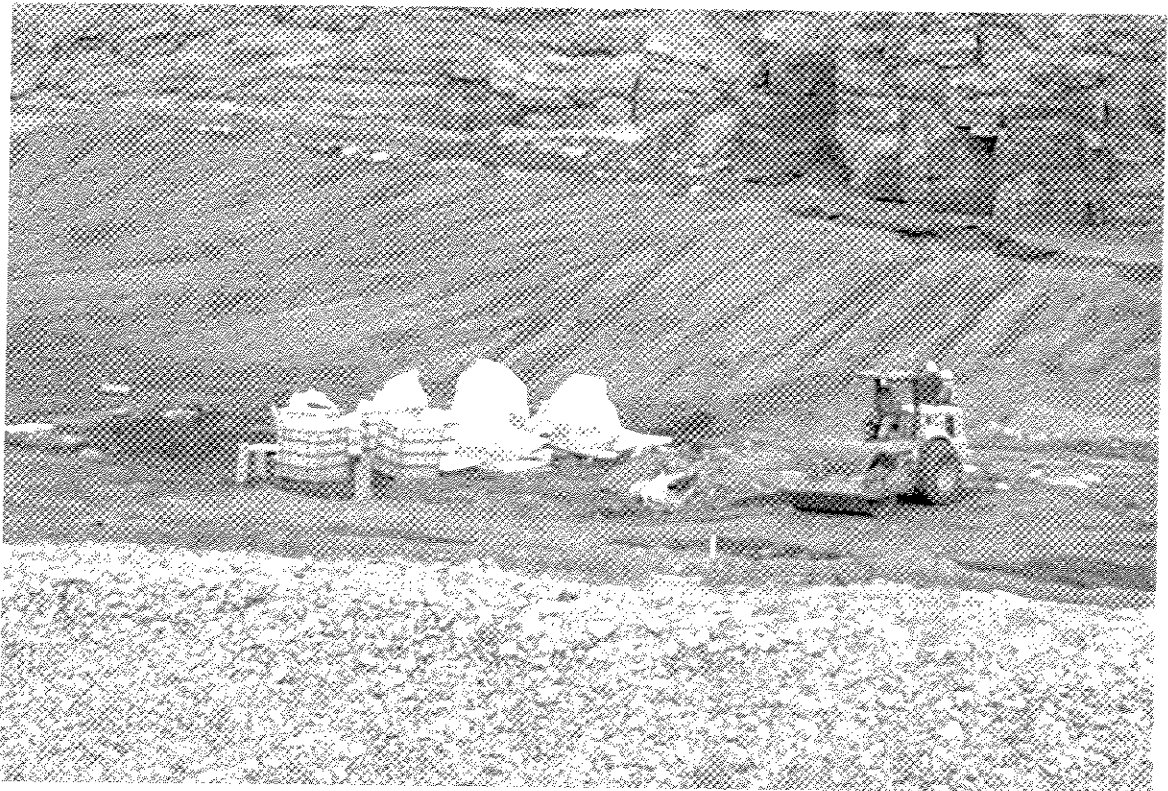
Photograph III-2: Soil Was Placed in Lifts in the Landfill and Compacted: Metal Contaminated Soils Previously Stored in Wooden Boxes Were Placed in the Landfill

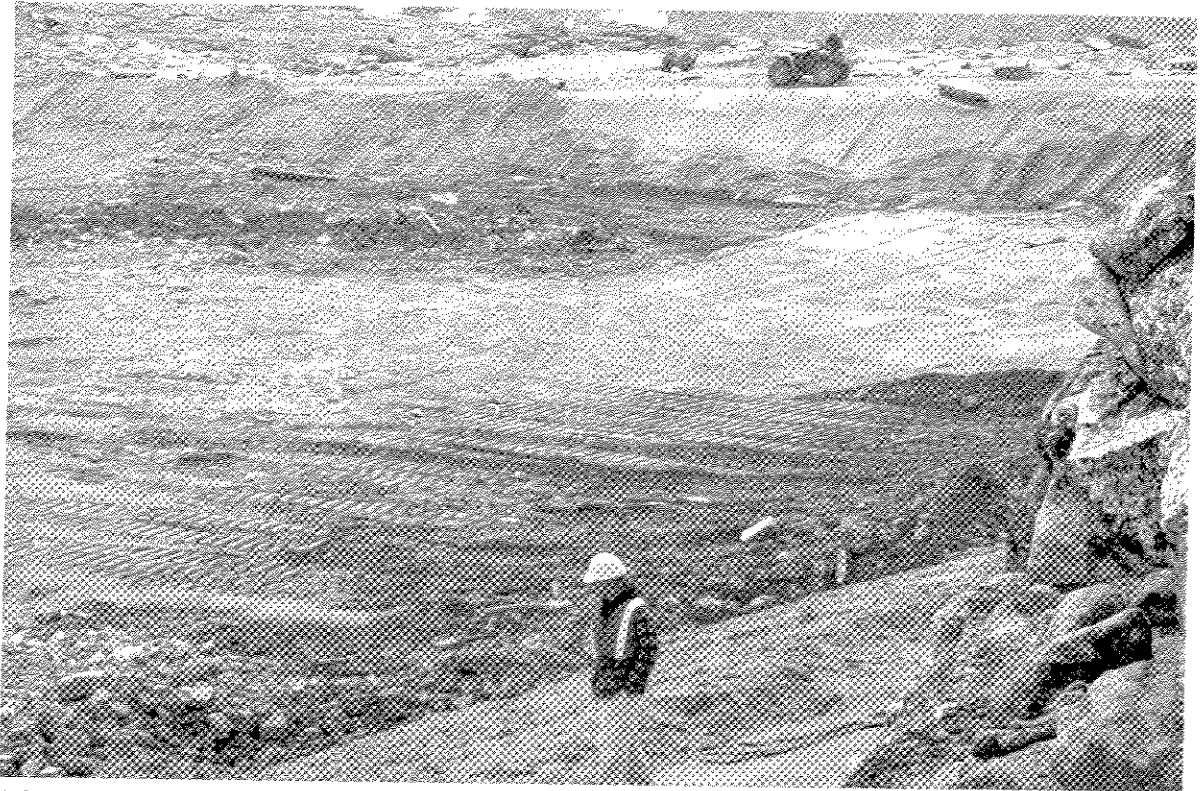
Photograph III-3: Contaminated Soil was Added to the Landfill in Lifts and Compacted

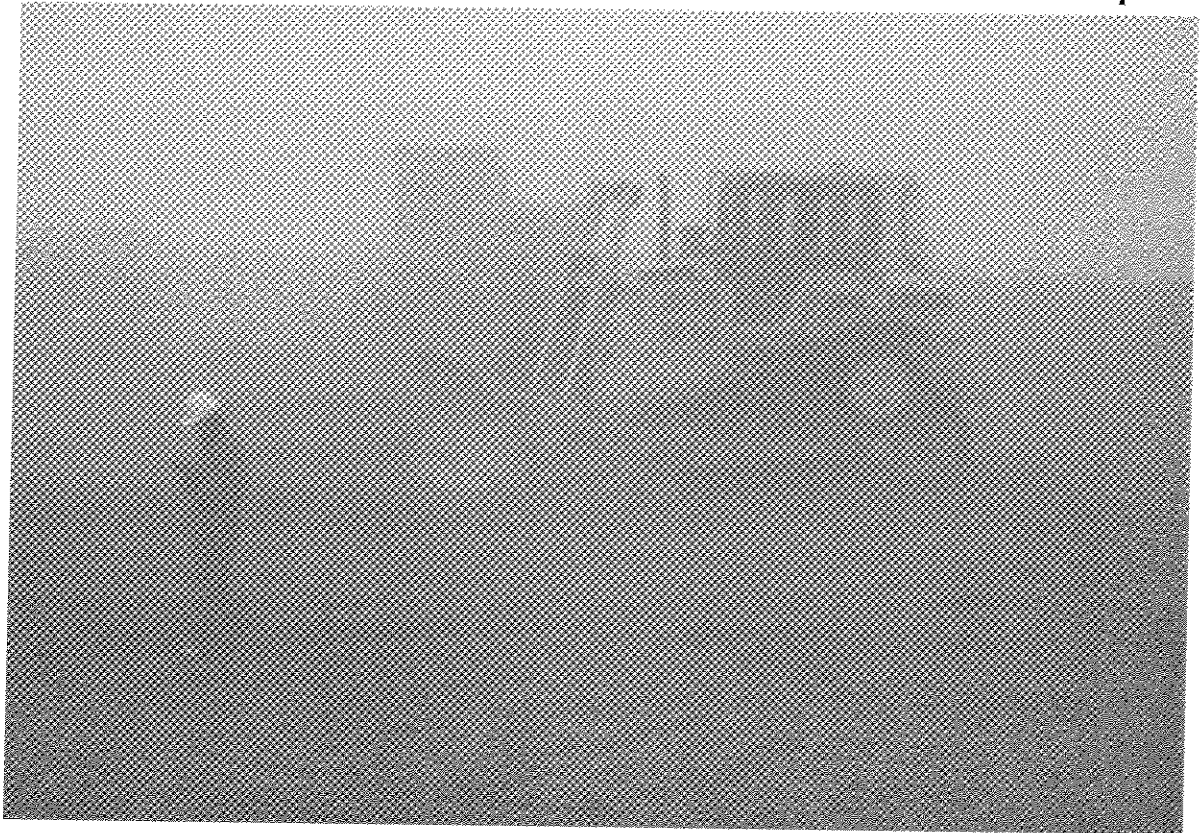
Photograph III-4: Constructing the Landfill in Foggy Conditions
