## **E. PCL Dump**

### *1. Background*

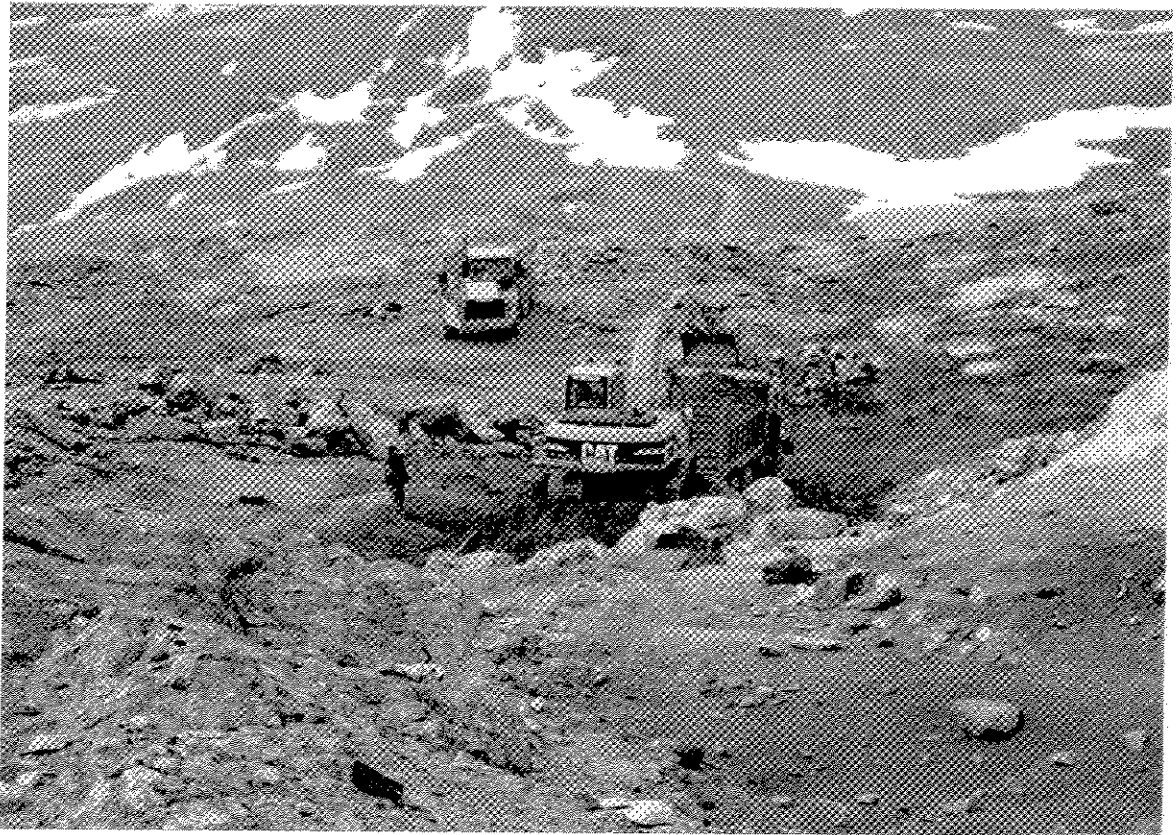
**Photograph II-11: Placing Stockpiled Tier II Soil Into Trucks That Transported It to the Tier II Landfill**

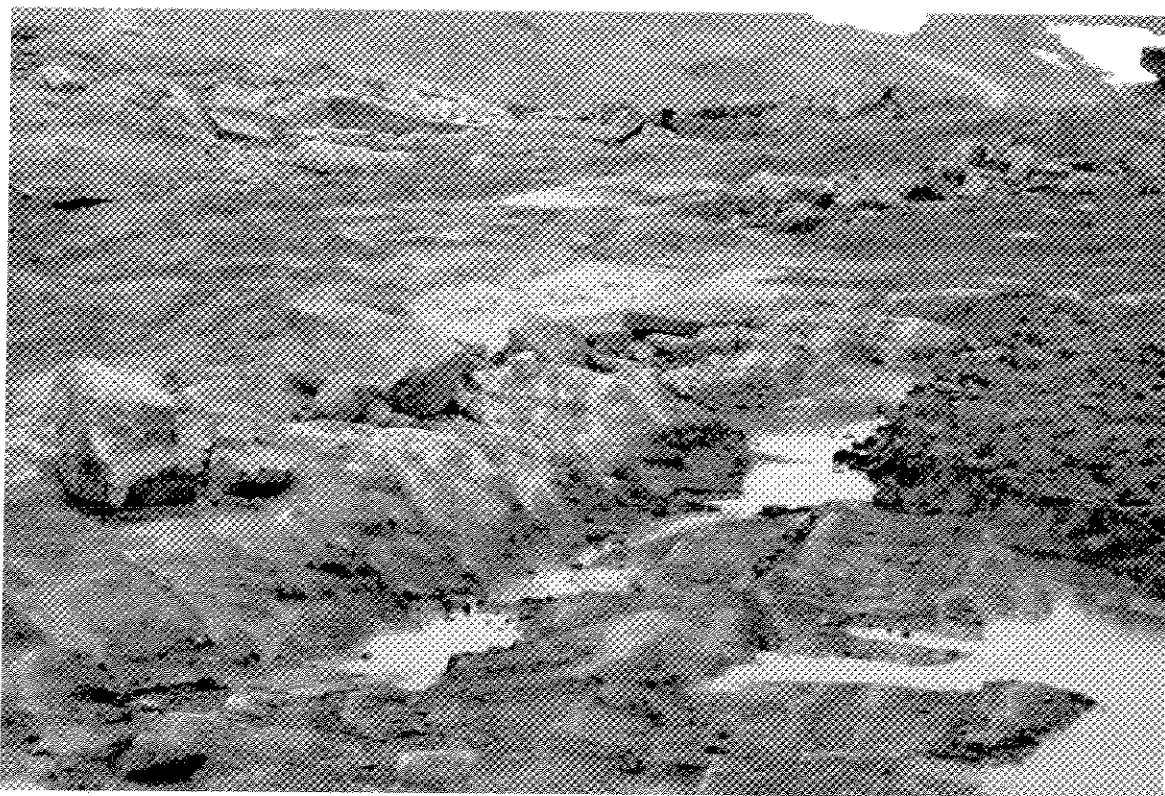
**Photograph II-13: The End of the S1/S4 Valley After Removal of all Tier II and Tier I PCB Contaminated Soil: The Barrier Is Just Visible in the Background**

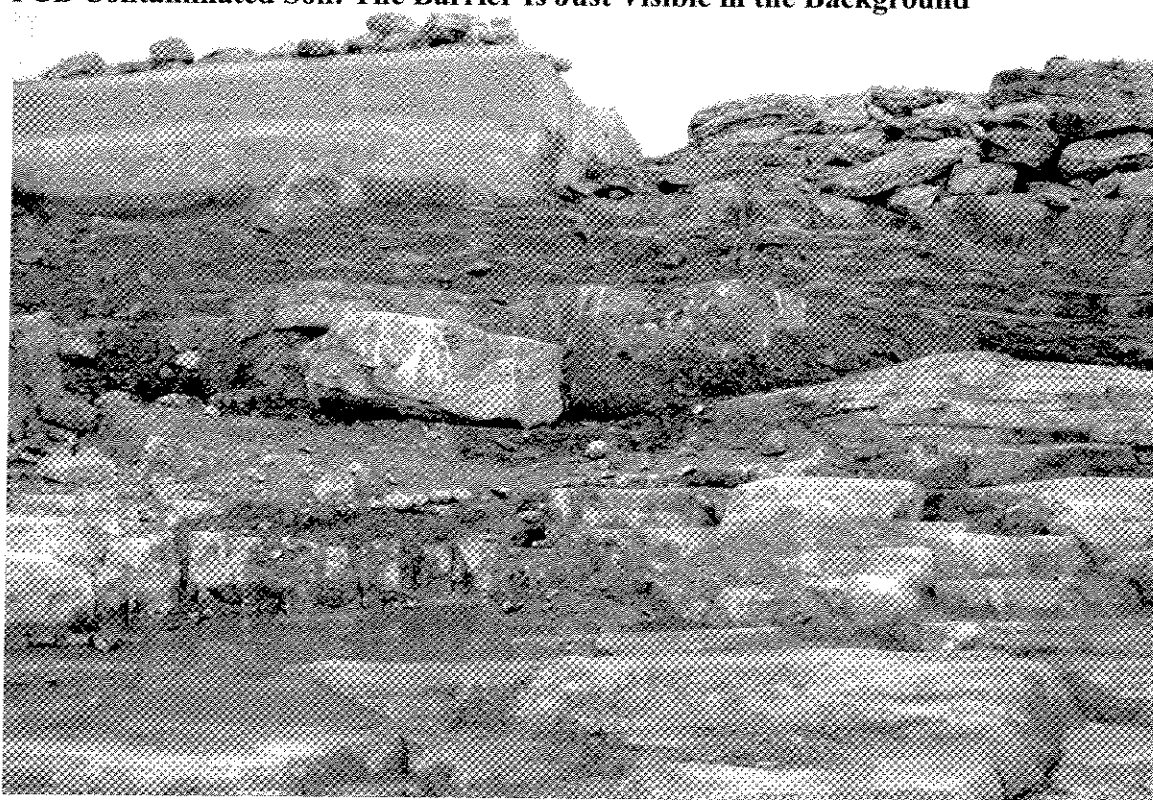
**Photograph II-14: Most of the S1/S4 Buildings Area was Scraped to Bedrock in Removing Tier II and Tier I Soils**

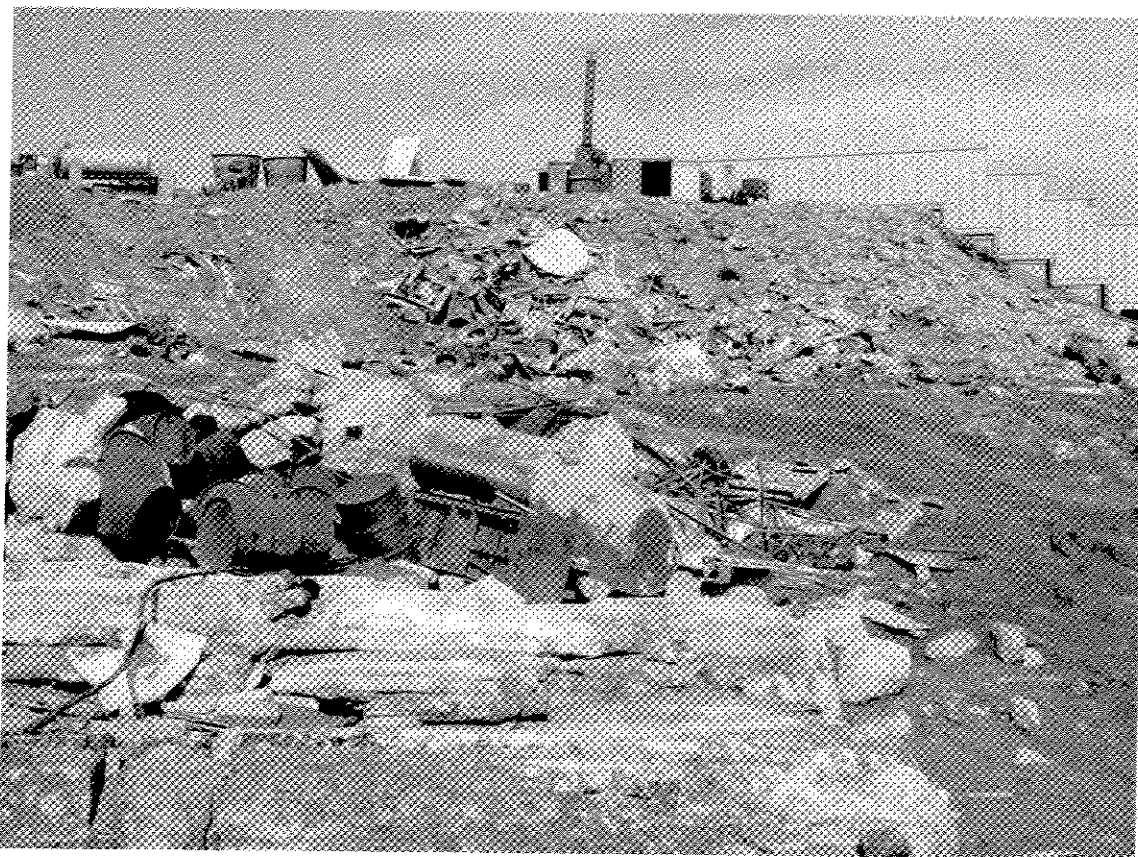
The PCL dump was roped off to define the Tier I and Tier II contaminated areas. Additional sampling was required to re-establish the Tier I and Tier II boundaries at this location. Map II-5 shows the delineated area as established in 2002 and the additional sampling points. Table II-3 gives the PCB levels found in the nine samples taken. All Tier I and Tier 2 soil were then excavated from the PCL dump and its drainage pathway. The contamination in this pathway runs all the way to the cliff edge, and concerns were raised regarding the stability of the cliff face with an excavator at its edge. Excavation was, therefore, terminated 20 metres from the cliff edge where the terrain became quite rocky. All excavations in the dump and its drainage pathway were to bedrock and therefore no confirmatory testing was necessary (Photograph II-16).
