F. North Slope Dump

G. DND Helipad

H. Maintenance Dump

I. Beach Dump

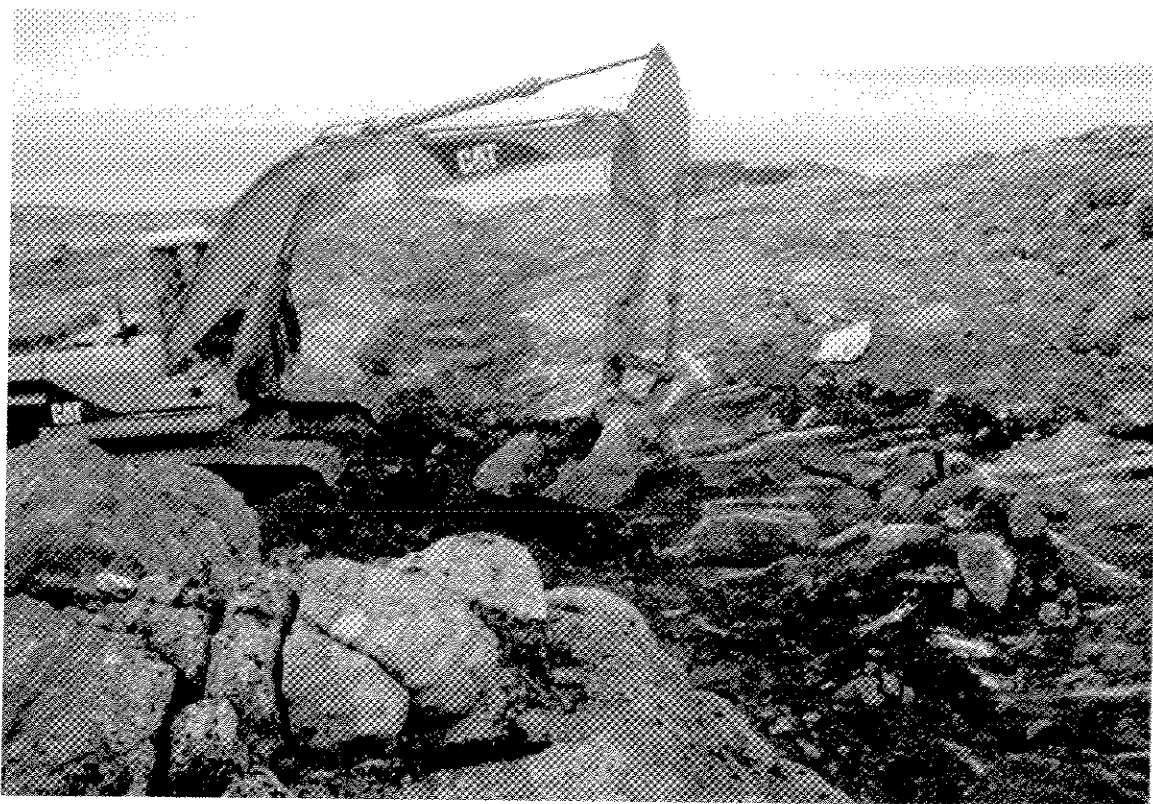
Photograph II-16: Excavating the Debris From the PCL Dump

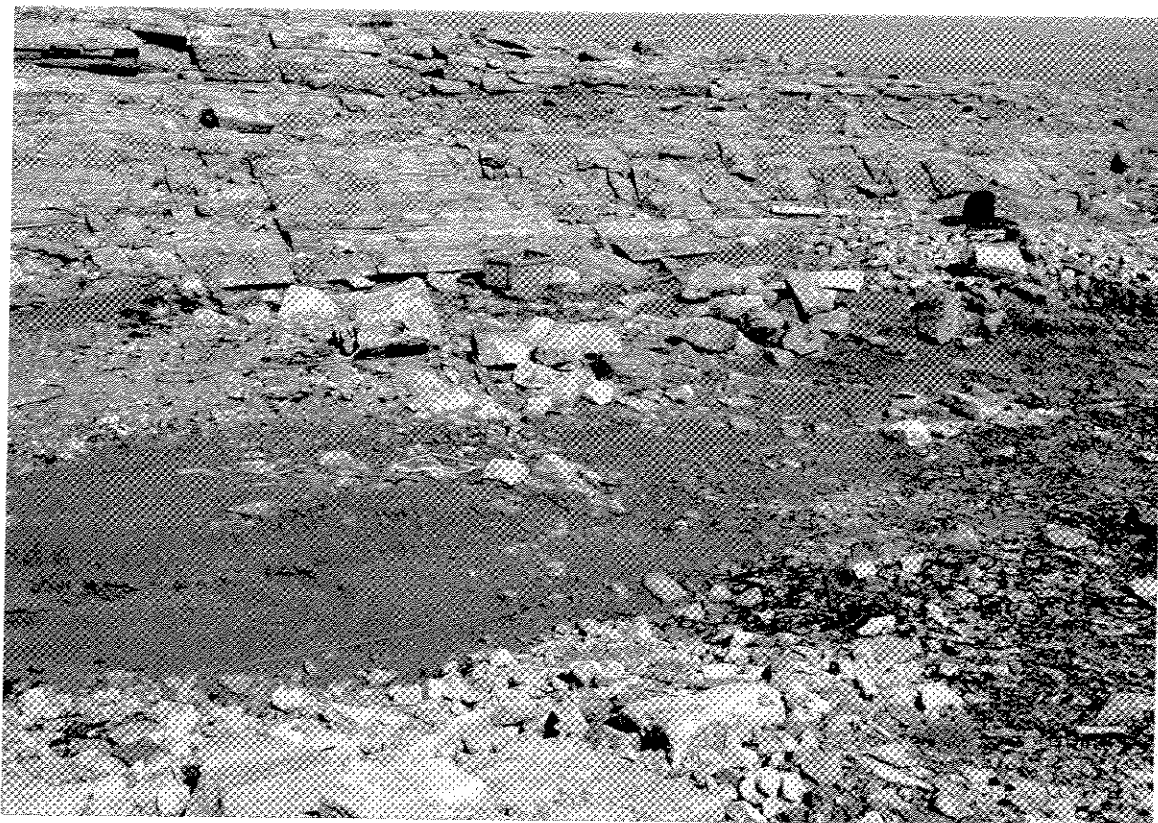
Photograph II-17: The Drainage Pathway of the PCL Dump Was Long and Narrow With Little Soil That Could be Excavated

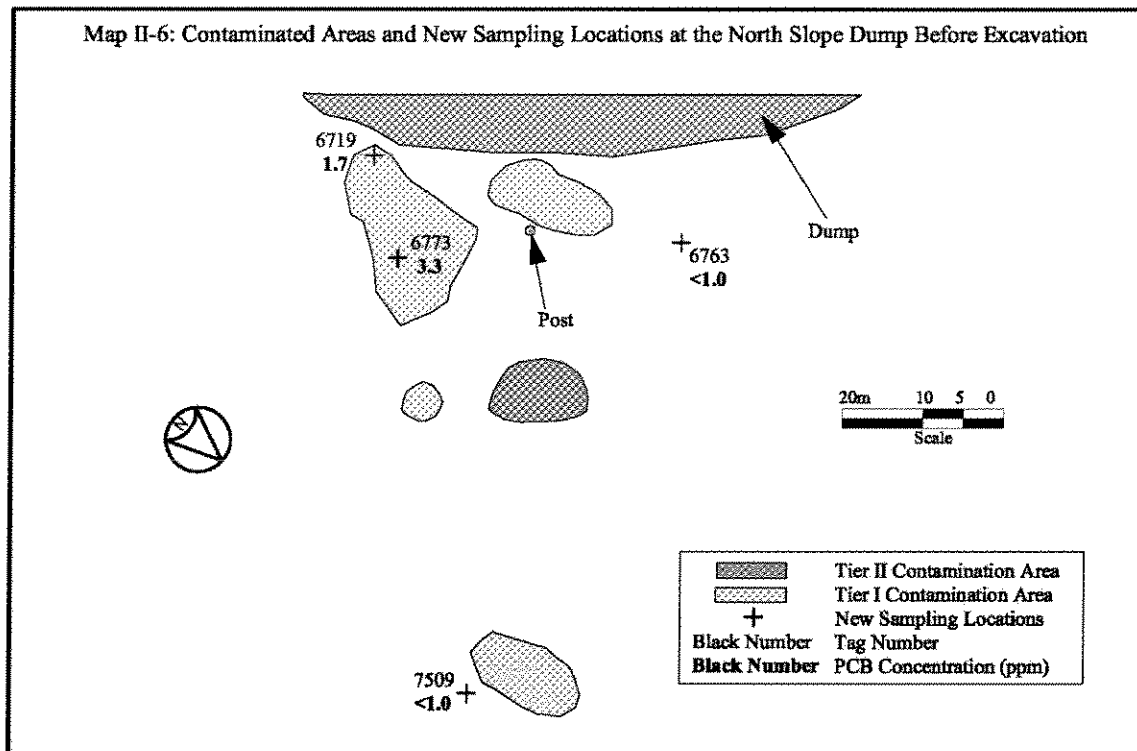
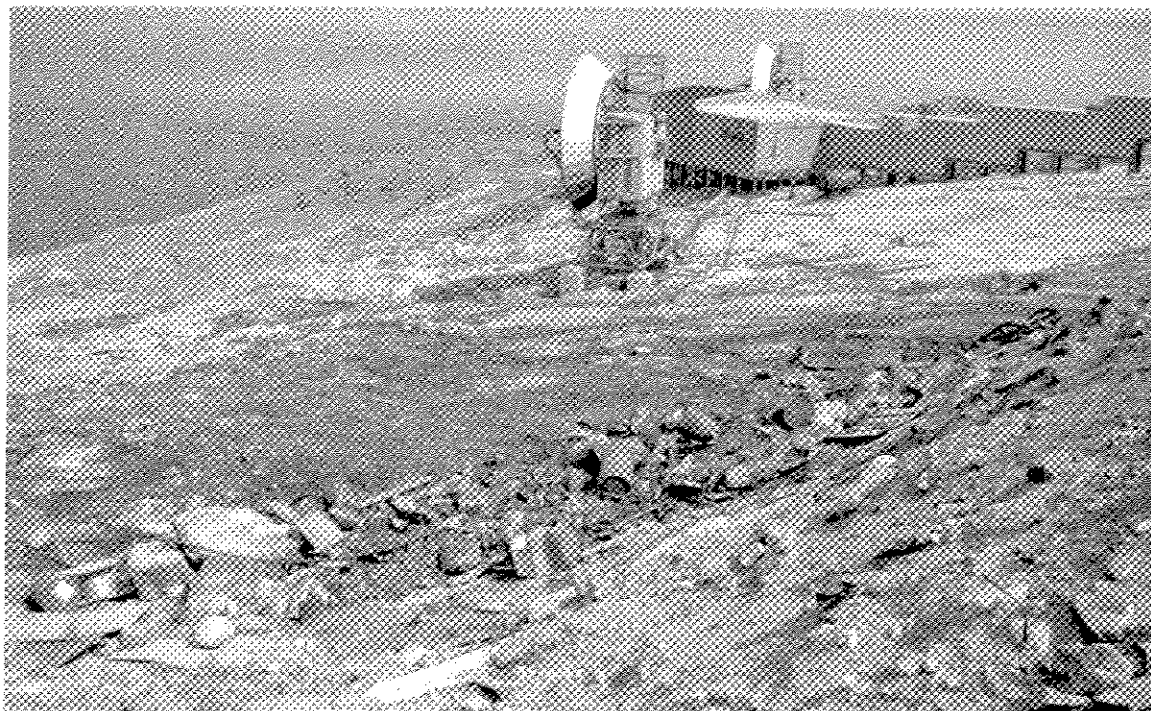
The small area contaminated with copper was excavated to bedrock and the resultant soil taken to the Tier II landfill. Four additional samples were taken in the PCB contaminated areas and these areas were then roped accordingly. Results given in Table II-4 and Map II-6 show low PCB levels which is consistent with the 1994 work. Any loose soil was then scraped and removed to the landfill. Remaining debris was scraped and placed at the toe of the dump (Photograph II-18). It was then covered with clean fill.

Photograph II-18: Debris in the North Slope Dump Was Scraped to the Toe Of the Dump After the Contaminated Soil Was Excavated and Removed

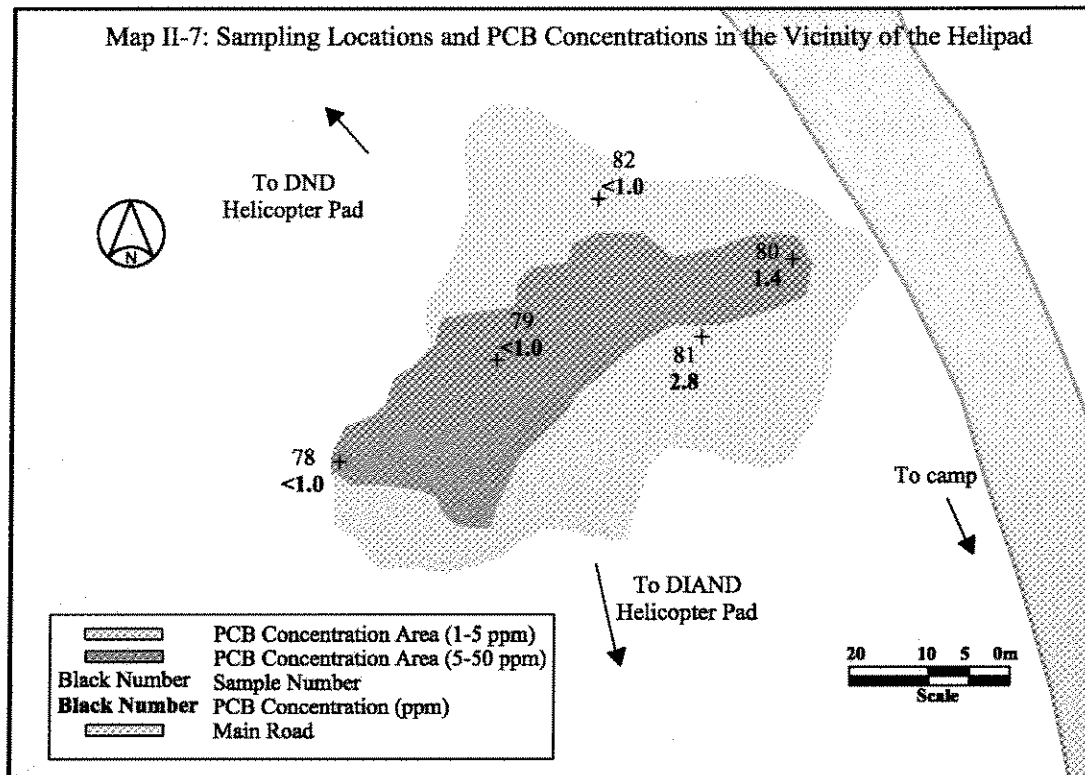
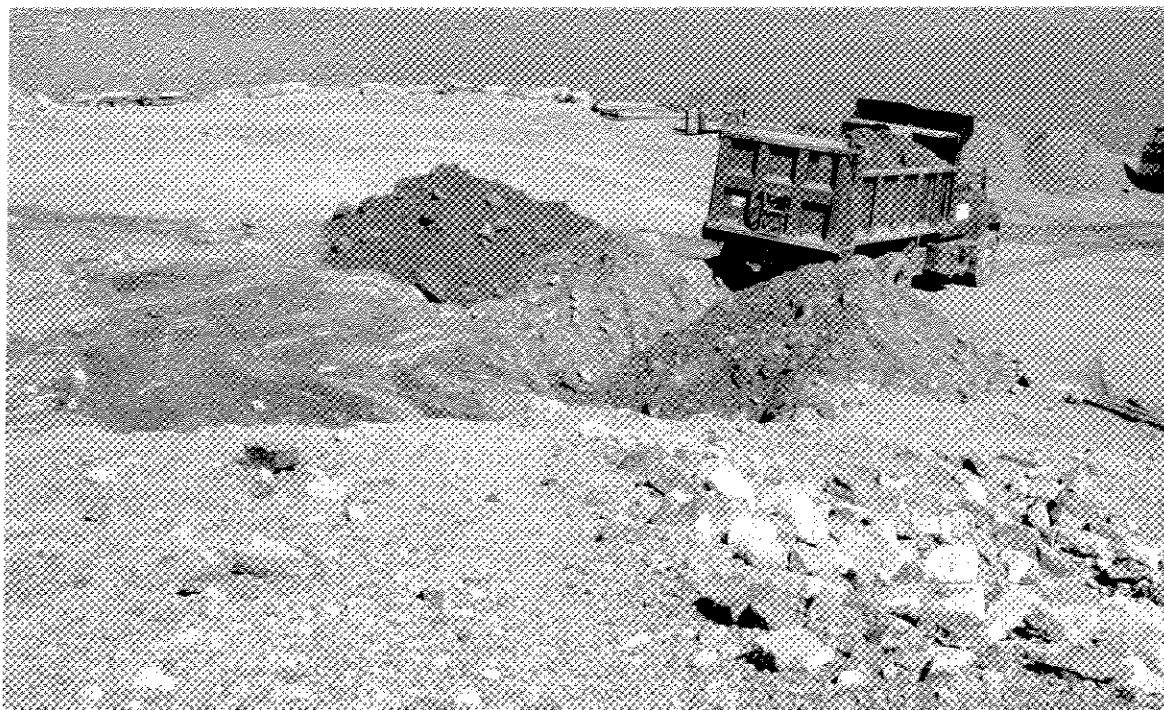
Initial work this year involved the roping off of the Tier I and Tier II areas and Tier 2 levels were roped off. Additional sampling was required to re-establish the Tier I and Tier II soils at this location. The locations of these sampling points have been superimposed on the map of the delineated areas established previously as shown on Map II-7. Analytical results are given in Table II-5. The DND helipad area was then excavated for Tier I and Tier II soils by scraping to bedrock (Photograph II-19); no confirmatory samples were necessary. Clean fill was then placed in the excavated area to allow vehicular access.

Photograph II-19: Excavating the PCB Contaminated Soil at the DND Helipad Site

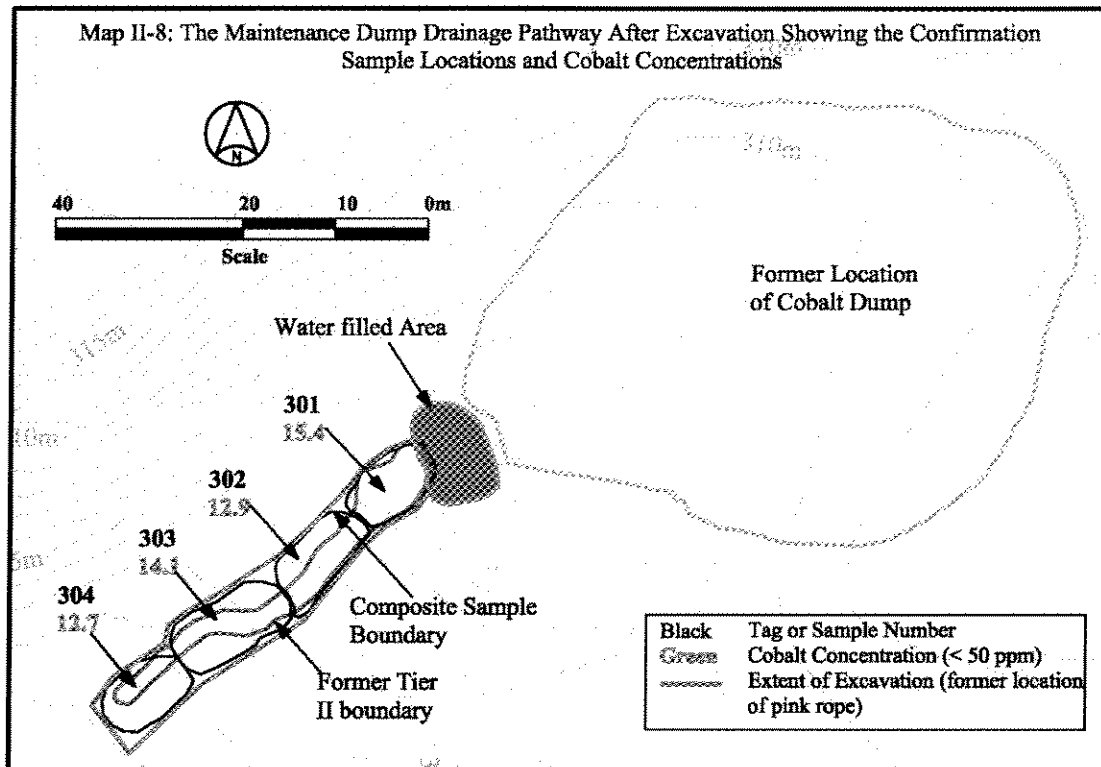
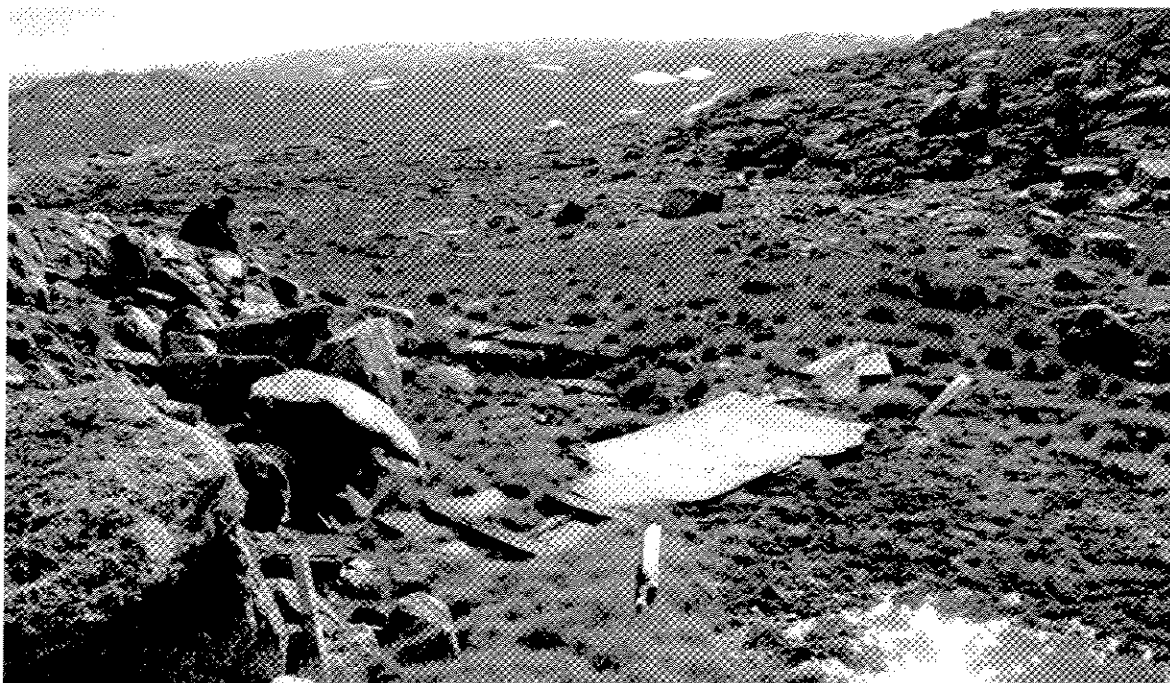
This dump contains a small well defined drainage pathway which is contaminated with cobalt at levels less than ten times the DEW Line Clean Up Criteria of 50 ppm. The drainage pathway is approximately 50 m long. The area was delineated in 1994 and additional samples taken in 1999. Exposed debris from the dump and near a small pond at its toe were removed in 2001.

As per the excavation protocol, 30 cm of cobalt contaminated soil was removed from the roped Tier II area comprising the drainage pathway from the maintenance dump (Photograph II-20). Samples from the excavated area were collected and sent to the ASU laboratory for analysis. Results of these confirmatory analyses are given in Table II-6 and Map II-8 and show that the excavation was complete. Two monitoring wells were installed as described in Chapter III, Section E.

Photograph II-20: The Maintenance Dump Drainage Pathway Roped Off For Excavation

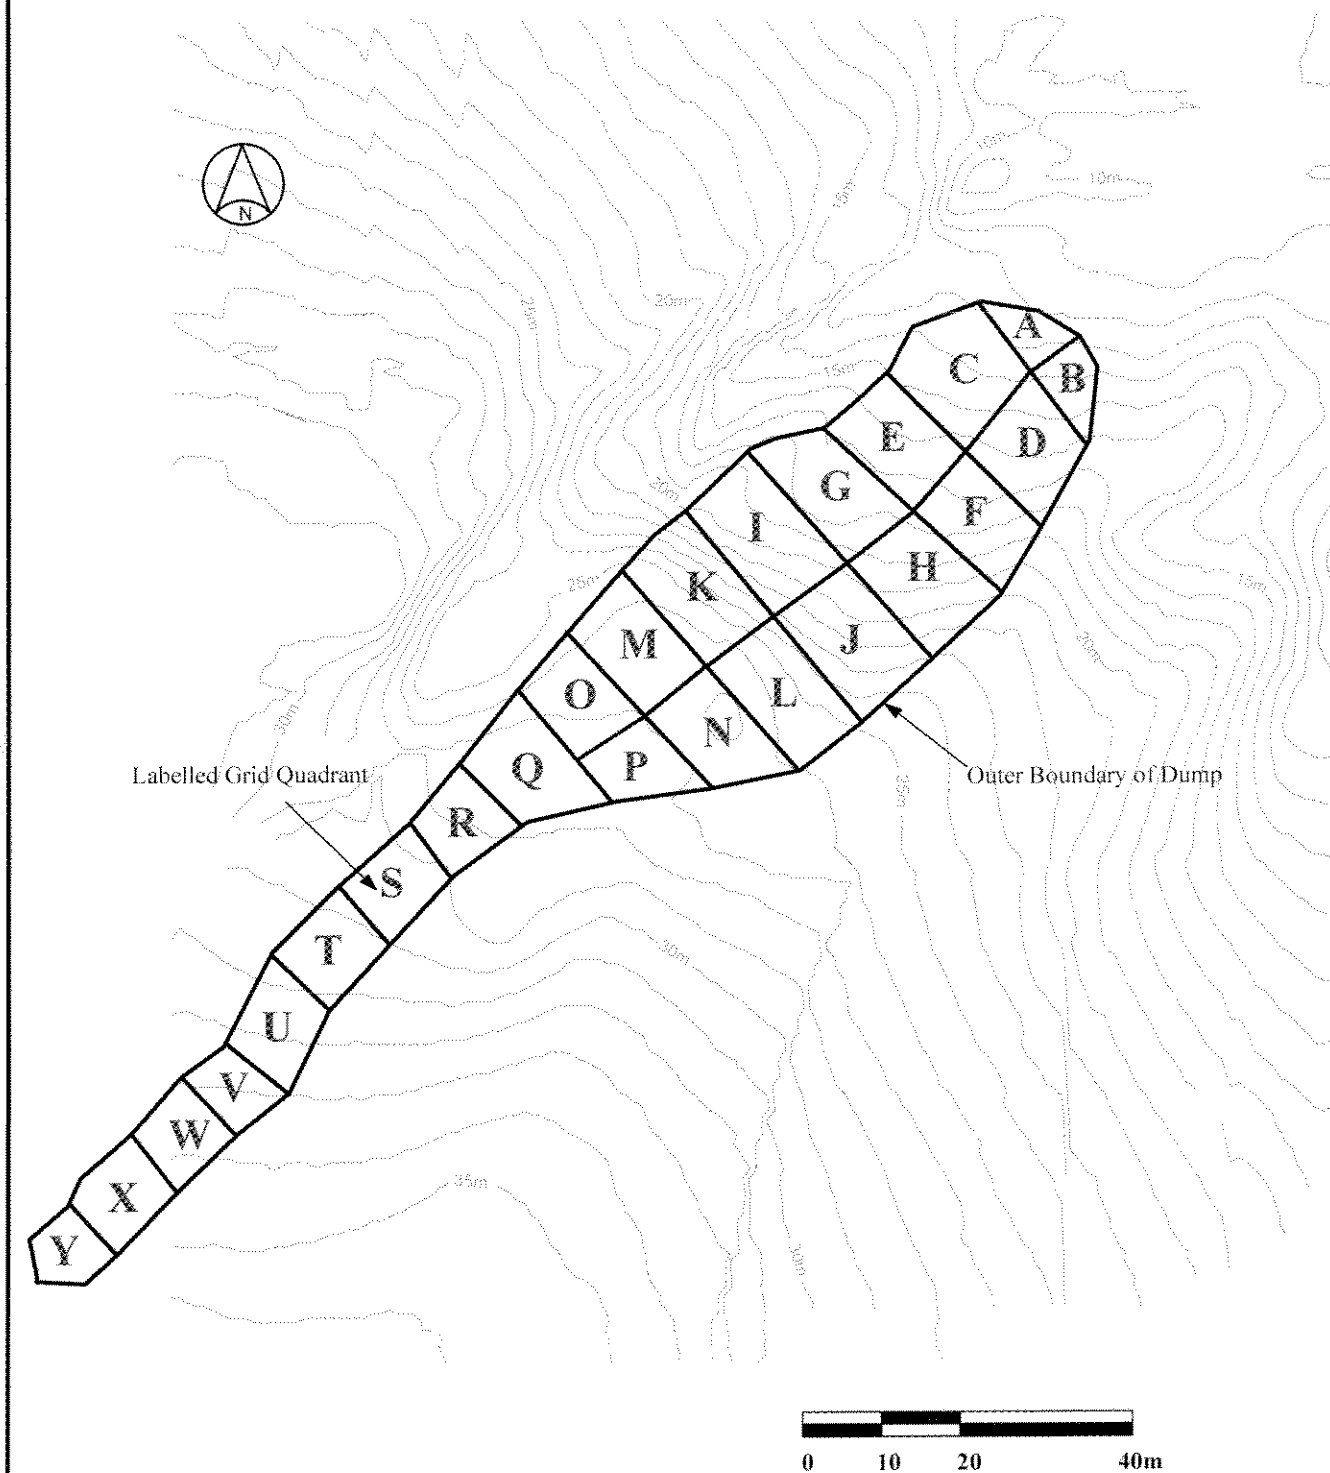
Map II-9: The Contaminated Areas in the Beach Dump Showing the Grid Zones Established for Sampling Before and During Excavation

The beach dump was excavated in 1999 and 2001. This involved the removal of a large volume of debris and many rusty barrels which contained waste oil. The soil remaining from these excavations was delineated in 2001 (Map II-9) and showed some areas where contamination was in the Tier II (copper, lead and zinc) and Tier I (PCBs) categories. Some debris was removed in 2002 but some remained partially buried frozen in the ground.

No work was carried out at the dump in 2004 and by 2005, debris within the area had become more exposed. Initial work therefore involved removal of all remaining physical debris from the area. Twelve soil samples were then taken to determine if the boundaries of the contaminated areas had altered; these analyses were conducted on site using a portable XRF instrument. Results given in Table II-7 showed that the contaminated area was largely unchanged. The area was then clearly roped around each contaminated zone. Excavation of the Tier II soil in the dump was then completed followed by excavation of the Tier I soils (Photograph II-21). All excavated soils were transported to the Tier II landfill. Table II-8 gives the analytical results taken during the excavation in order to determine when all the soil containing copper, lead and zinc above the DCC criteria had been removed. Much of the area was excavated to bedrock (Photograph II-22). Map II-9 shows the grid zones from which the samples were taken.
