Resolution Island 2008 Monitoring and Research

# Resolution Island 2008

*Monitoring and Research*

Analytical Services Unit  
Queen's University  
Kingston, Ontario

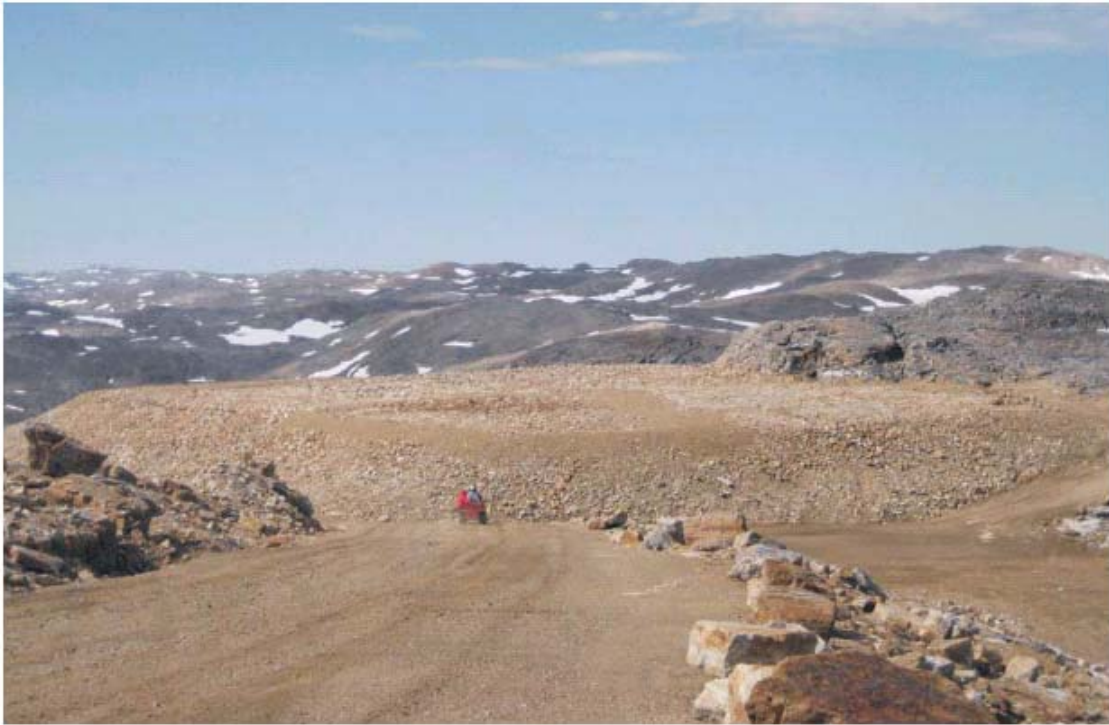
**Photograph 1: View of the Tier II Landfill from the Service Road**

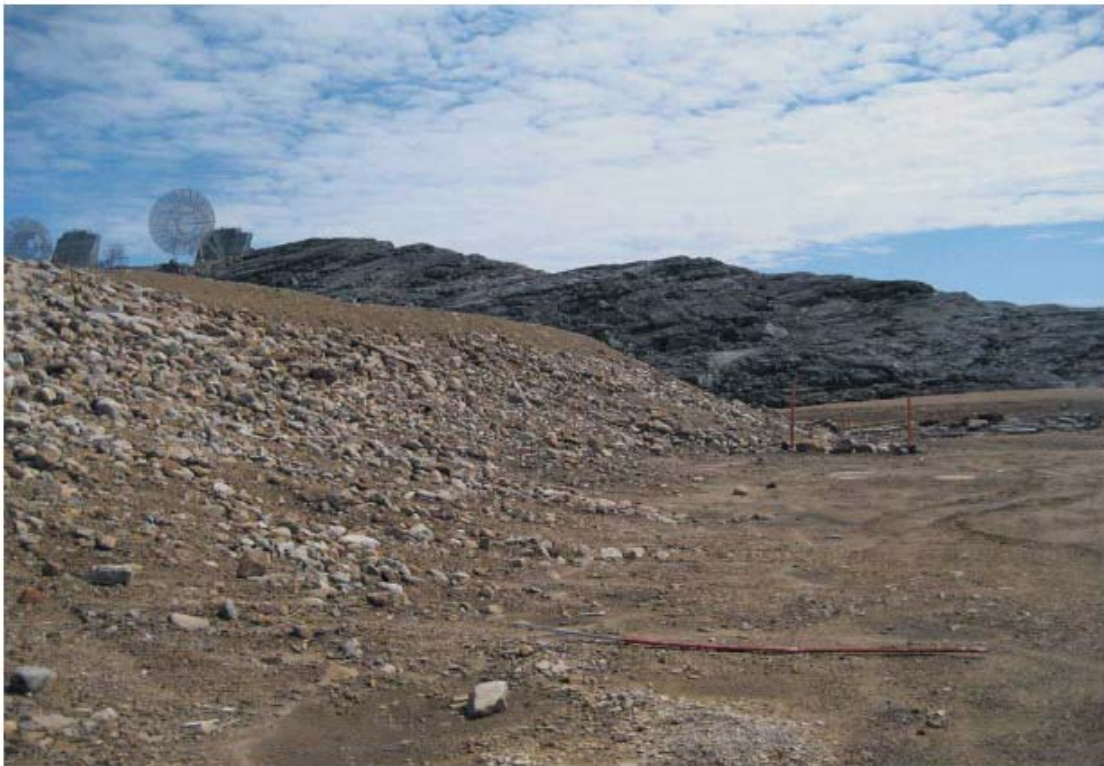
Previous observed areas of erosion E1-E3 did not appear to have increased in size. E4, a surface water runoff channel along the SW toe of landfill, has increased slightly in size. New areas of erosion were observed along east, west and south berms (Photograph 2); they were all about 8-10 m long, 1-15 m wide, but only 0.1-0.5 m deep and appear to be the result of surface water runoff. The stability of these numerous channels are in marginal condition and should be monitored in the future.

Three previously observed areas of ponded water, P1-P3, were assessed; no water was present this year. However, evidence of ponding of water earlier in the season still existed. Small amounts of water at P4 were observed along the south berm (Photograph 2). A large area of ponded water was still present, P5, 30 m from the east berm at MW-1 (Photograph 3). A new area of ponded water was observed 4 m from the north east berm of the landfill (Photograph 3). Surface water runoff from the access road drained into this pond. In general, ponds were drier than previous years and were graded as acceptable with the exception of P5 which was graded as marginal.

**Photograph 2: View of the South Berm Showing Areas of Erosion and Ponded Water**

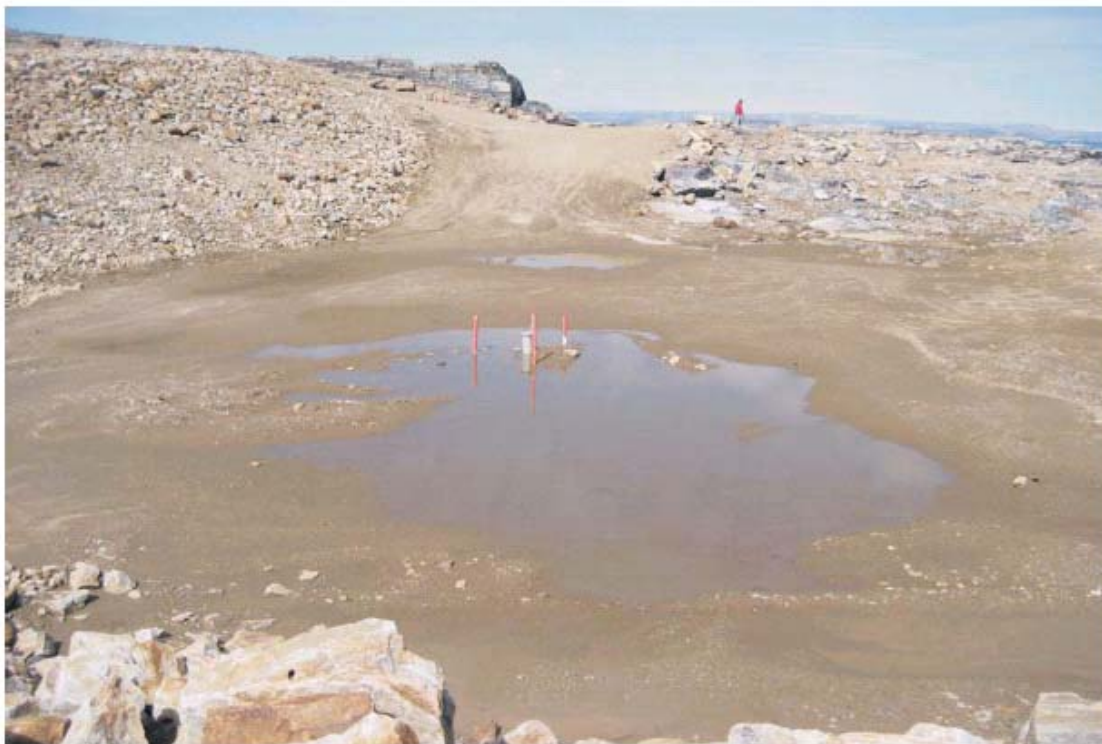
**Photograph 3: Ponded Water at the East Berm**

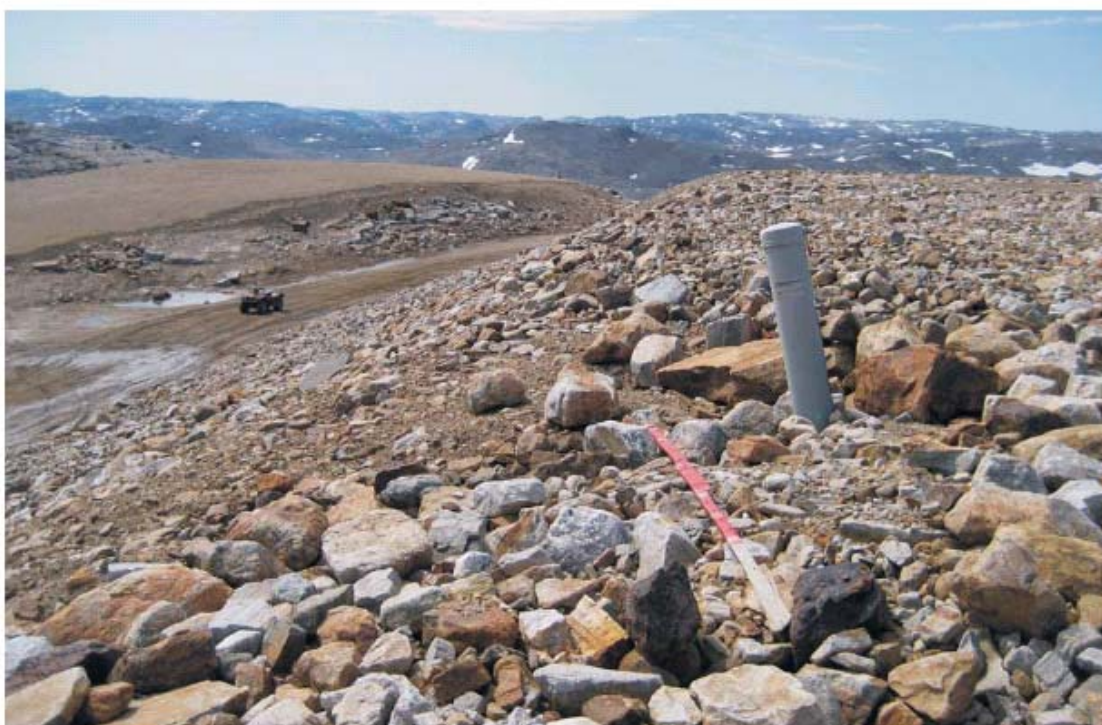
**Photograph 4: The Tube Containing the Thermister String in the South Berm was Tilted; The Main Hydrocarbon Landfarm is Visible Across the Service Road**

The locations of the four thermister strings is given in Map 3. All thermisters were in good working order. No 1311 was tilted slightly (Photograph 4), but it is unknown as to whether it has been like this since the time of construction. No 1318 was not downloaded last year, (the terminal was inverted in the housing) but results were obtained this year; data for last year was also obtained and this is reported, for completeness, as per last year's format at the end of the appendix. Batteries should have been replaced in August 2008 (as noted on the datalogger) however they were not. Memory of the data logger was 80 % full but the old data will erase to make room for new data automatically.

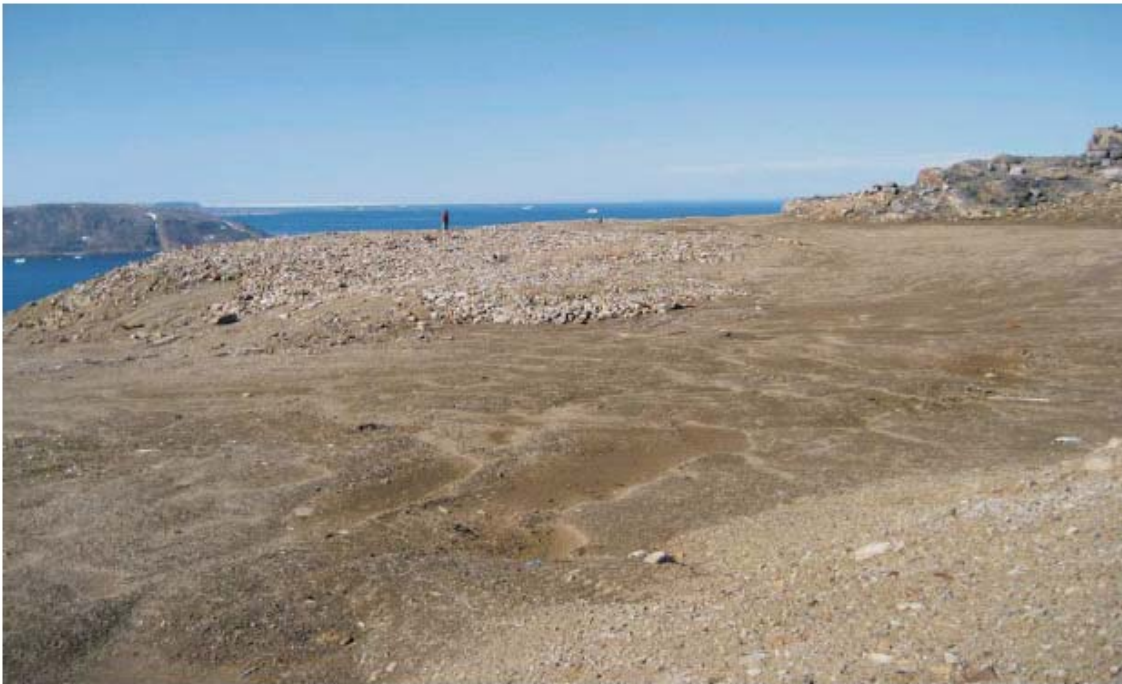
The surface of the main landfill is in good condition with minimal erosion. There was no ponding at the time of the site visit but there are small areas where water does accumulate as shown in Photograph 5. On the steep edge of the landfill between MW12 and MW13 there are several pockets of rusty debris which were never fully covered during the remediation of the site (Photograph 6). There are no visible signs of erosion on the steep edges of the landfill except in the main drainage pathway incorporation MW 14. There is a 2 m wide area of significant vegetation growth (Photograph 7) from the top of the edge of the landfill down to MW13 but this is not eroding.

**Photograph 5: The Airstrip Landfill Showing the Surface in Good Condition with Minimal Erosion Pathways**

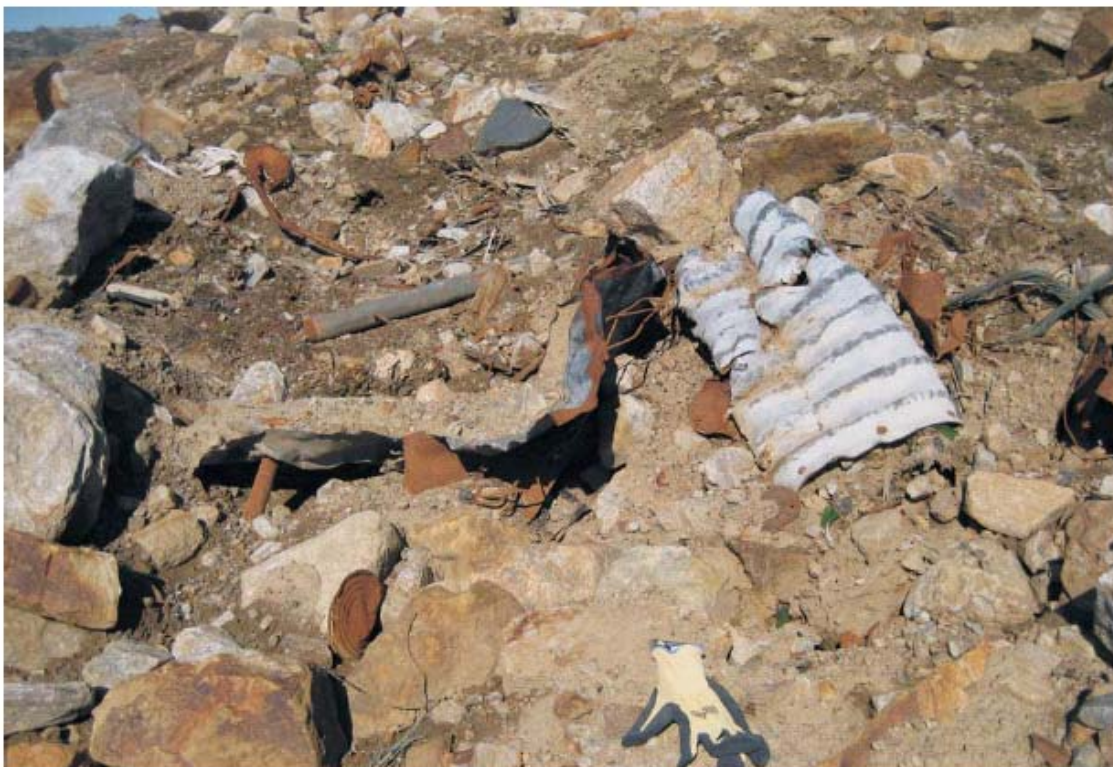
**Photograph 6: Some Visible Debris at the Steep Edge of the Airstrip Dump was Not Covered During the Remediation Program**

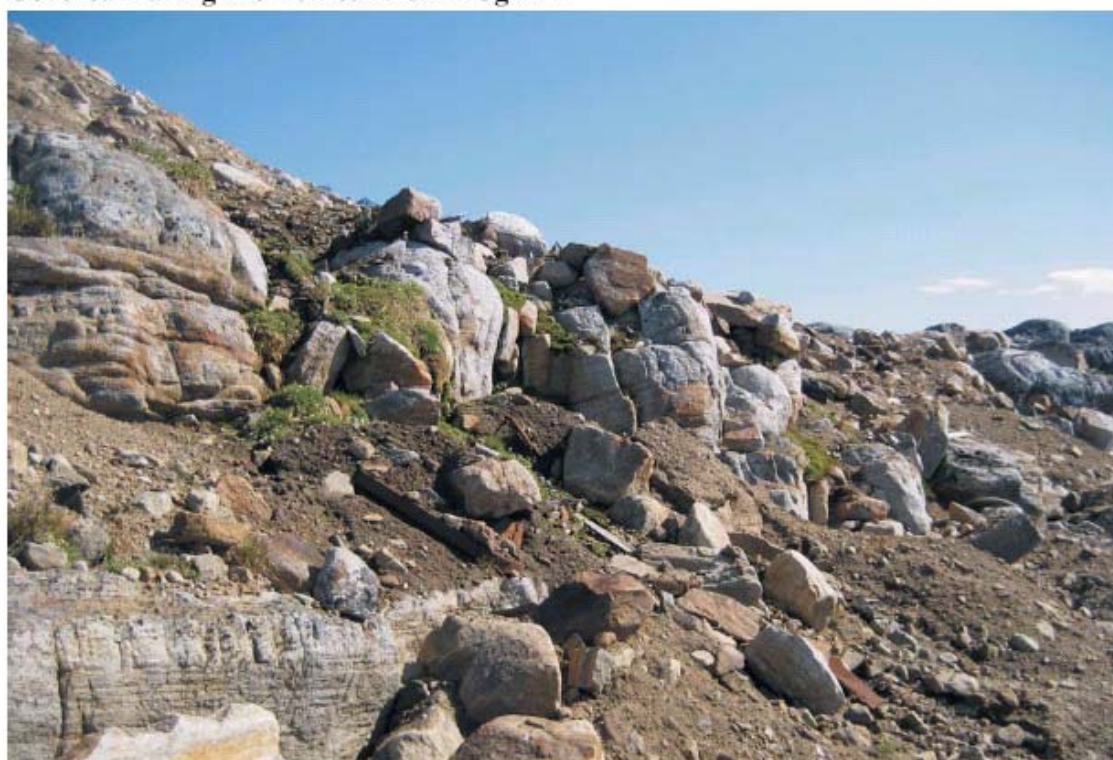
**Photograph 7: Vegetative Growth is Present in Some Areas at the Edge of the Airstrip Landfill**

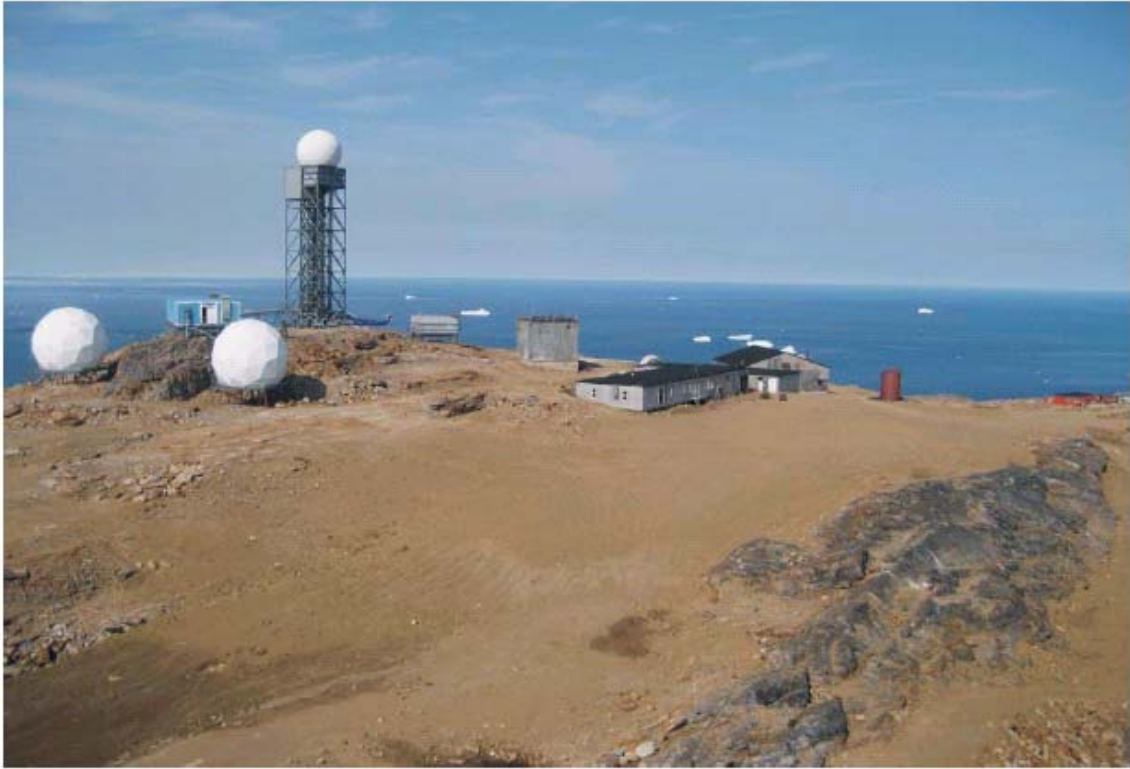
**Photograph 8: The Station Non-Hazardous Landfill was in Good condition**

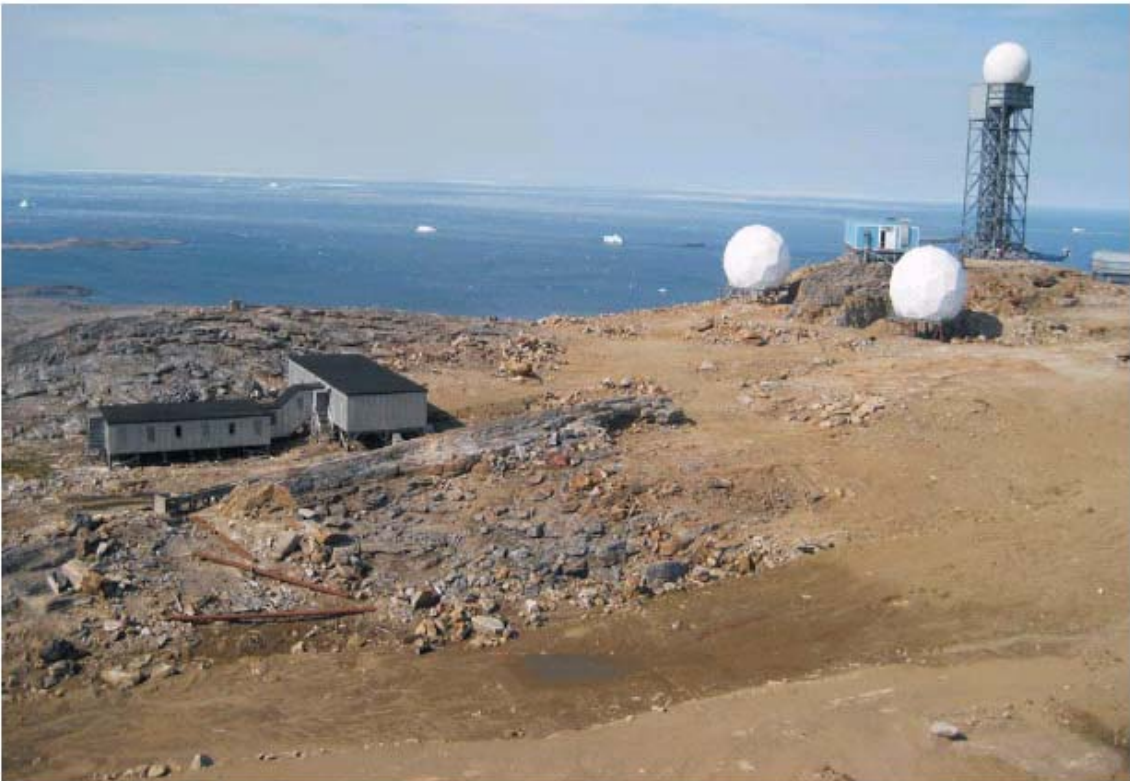
**Photograph 9: The Lower Edge of the Station Non-Hazardous Landfill Where a Small Pool of Water Was Present; Note the Officer's Mess Further Down Gradient**

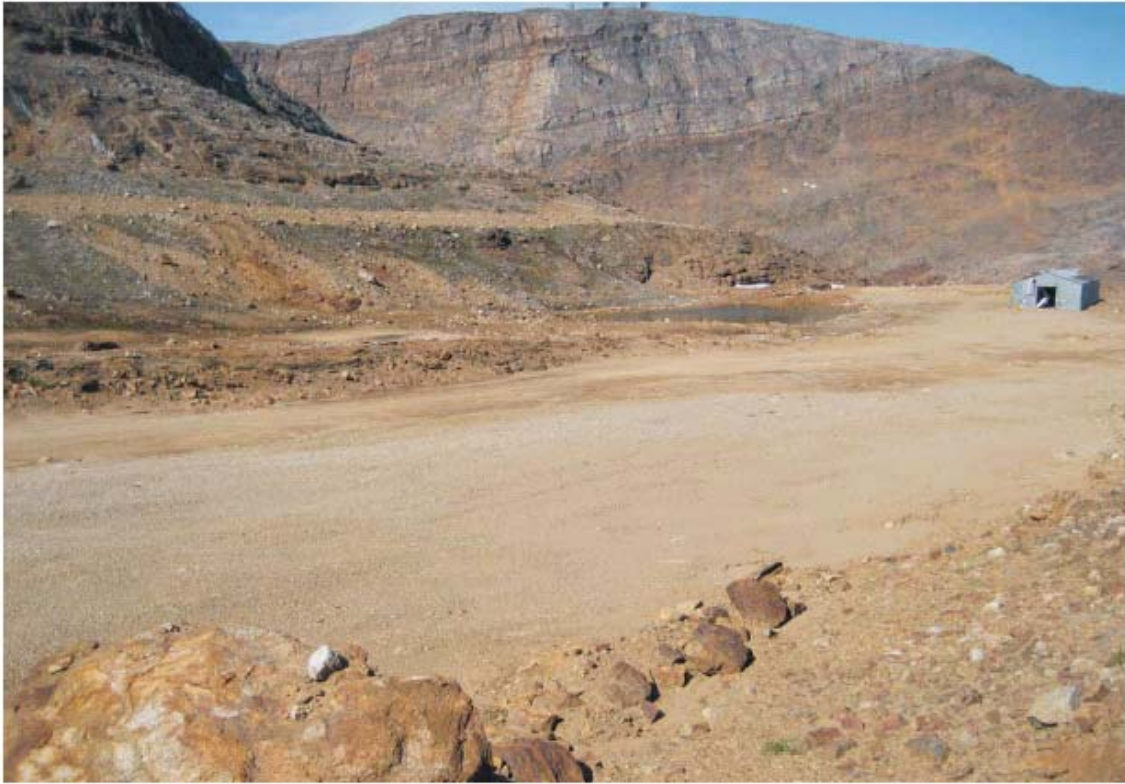
**Photograph 10: The Beach Non-Hazardous Landfill was in Good Condition**

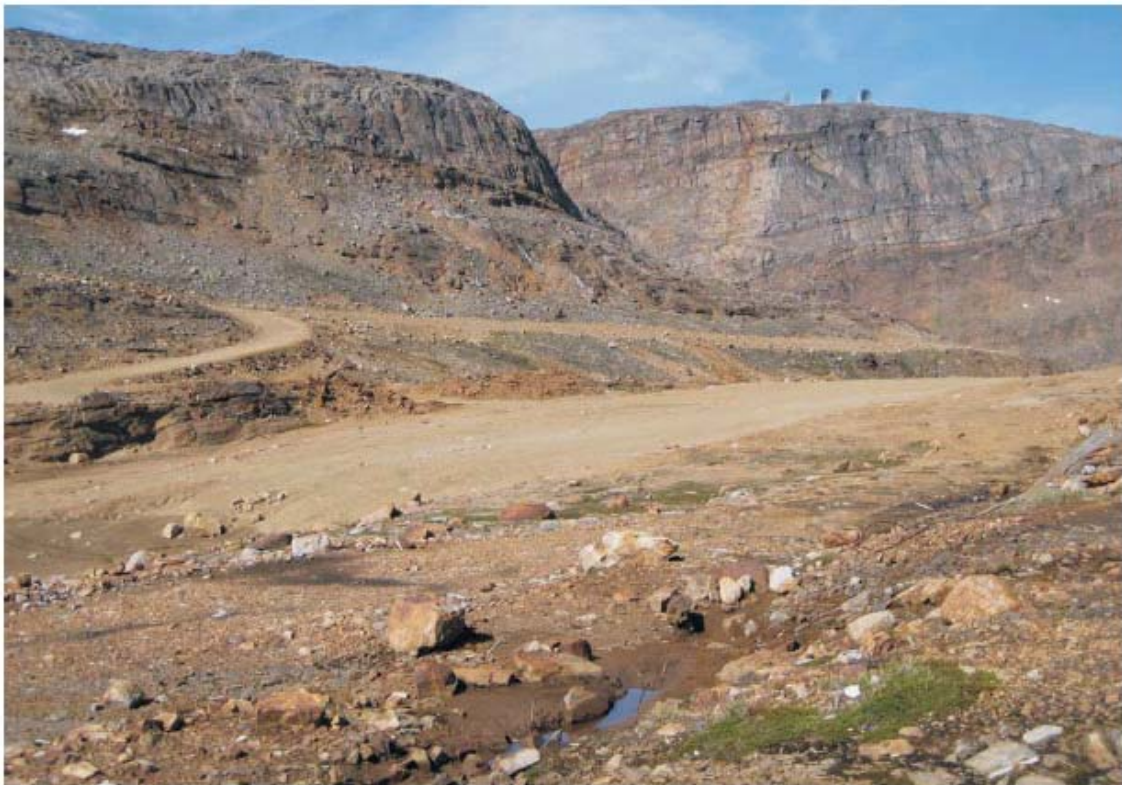
**Photograph 11: The Edge of the Beach Non-Hazardous Landfill Adjacent to the Barrel Cache Valley**

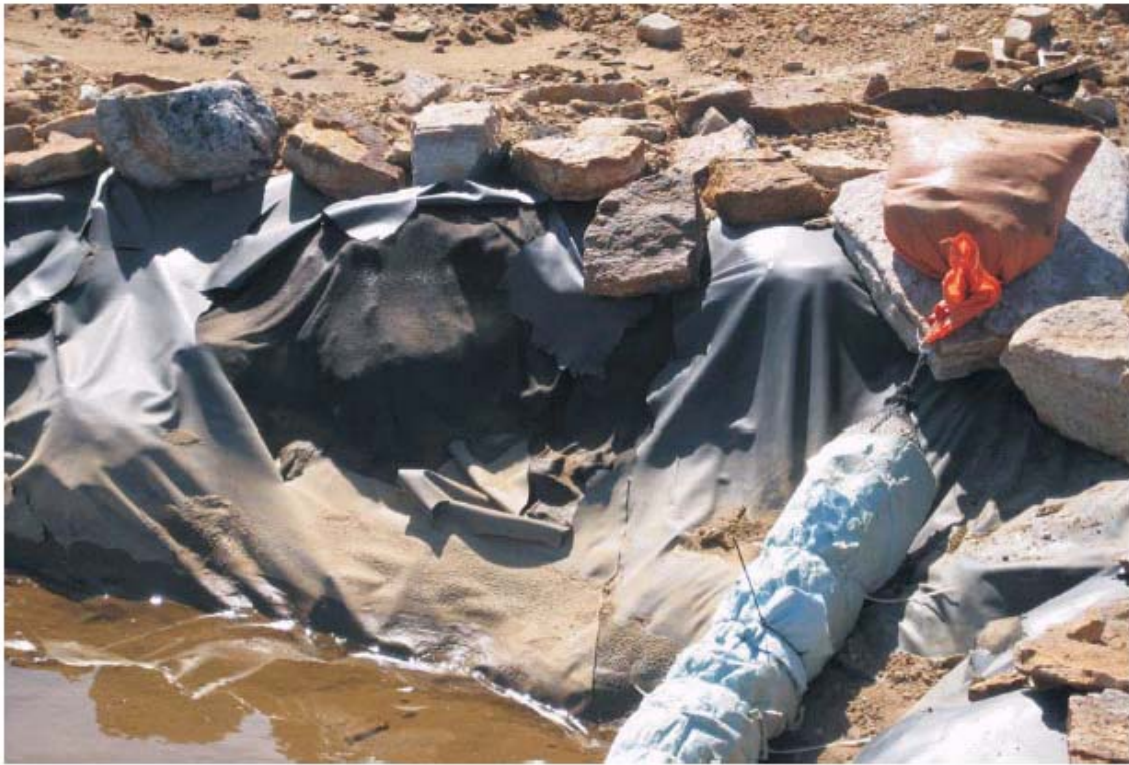
**Photograph 12: The PVC Pond Liner Did Not Survive the Arctic Winter Above the Pond Level: Note the Damage Due to UV-Radiation and Weather**

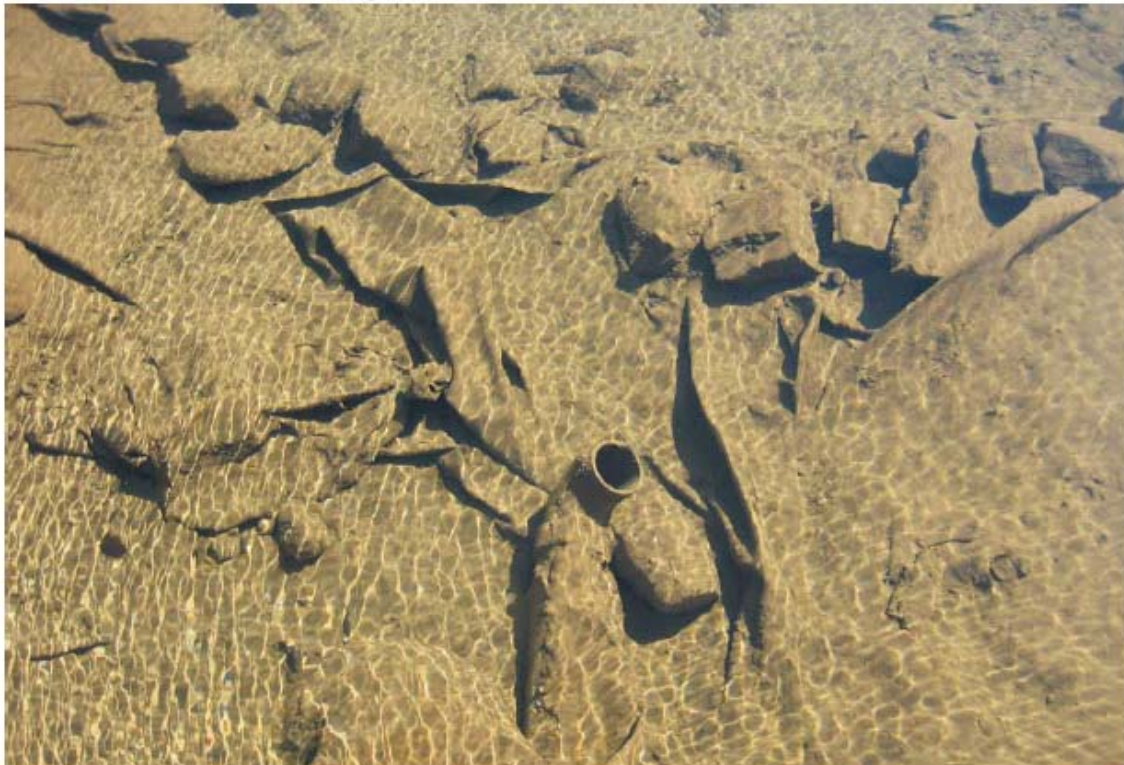
**Photograph 13: The PVC Pond Liner Was Intact Below the Water Line Where it Was Covered With a Layer of Sediment**

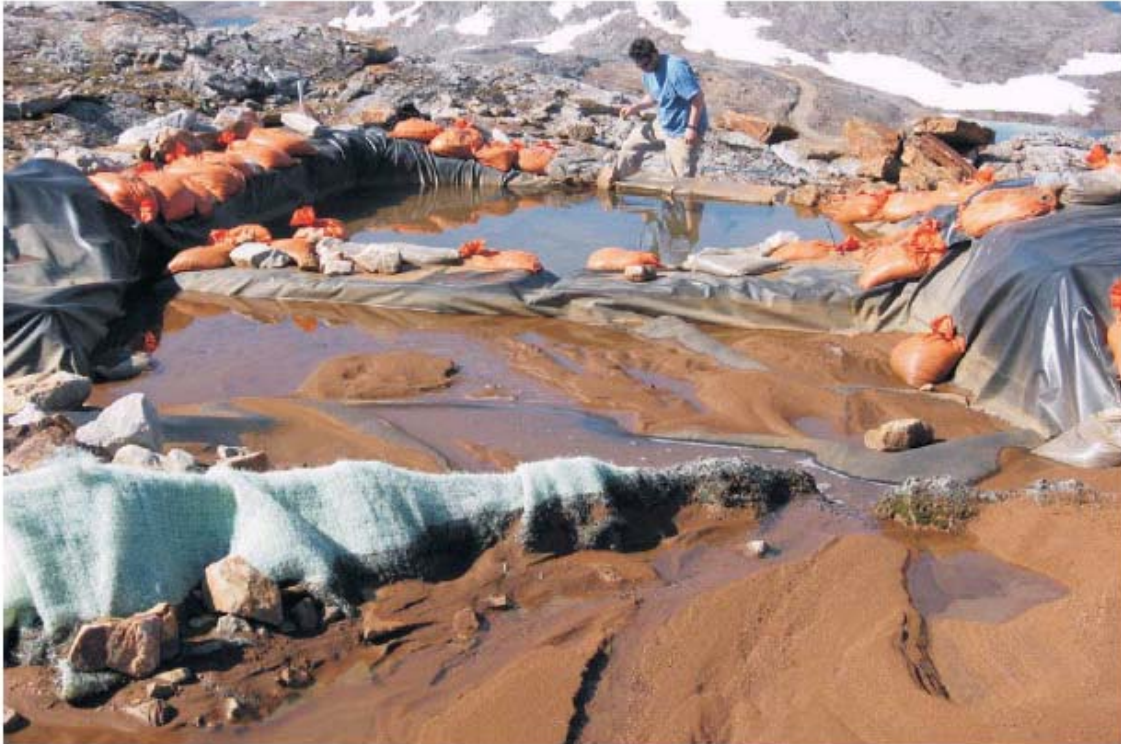
Upon preliminary inspection of the valley barrier it was noted that the sediment loading was greater than that of 2006. A decrease was expected again this year since the soil excavation in the valley had been completed in 2005 and therefore it was thought that the remaining soil would be stabilized to a greater degree. However, the barrier was clogged and water was up to about 80 % the height of the filters (Photograph 14). Initially all filters except the last GAC were removed and the barrier left for 2 days after which time the water level had dropped to about 20 % of the height of the filters. The uncontaminated sediment in the first clean cell had been mostly washed away but the second cell was in good condition. No repairs were necessary at the barrier.

**Photograph 14: The Valley Barrier at the Start of the Site Visit; Much More Sediment Was Present Than Last Year and the Filter Box was Clogged**

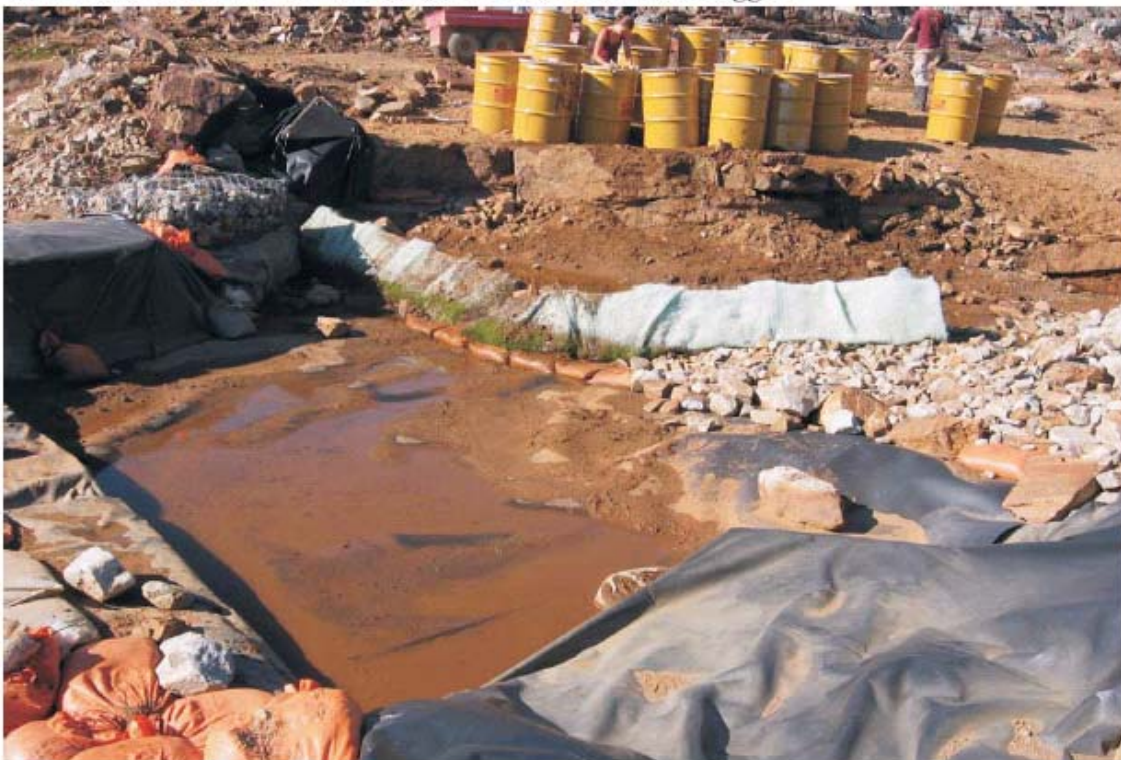
**Photograph 15: The Valley Barrier After the Sediment Was Shoveled Out Into Thirteen Overpack Drums:**

Sediment and water samples were taken from the various monitoring points around the barrier. Sediment was then shoveled out of the catchment areas within the barrier system into overpack drums (Photograph 15). Twelve drums were filled 7/8 full with sediment and labeled "Valley 2008 Barrel # PCBs". Filters were sampled and material from the old filters was placed into an overpack drum labeled #13 together with some additional sediment. The filter cassettes were filled with new gravel, GAC and geotextile 1200R. The valley barrier was charged with 2 gravel filters, 4 GAC filters and 4 geotextile filters as shown in Figure 7. Material from on site was used to regenerate both clean cells.

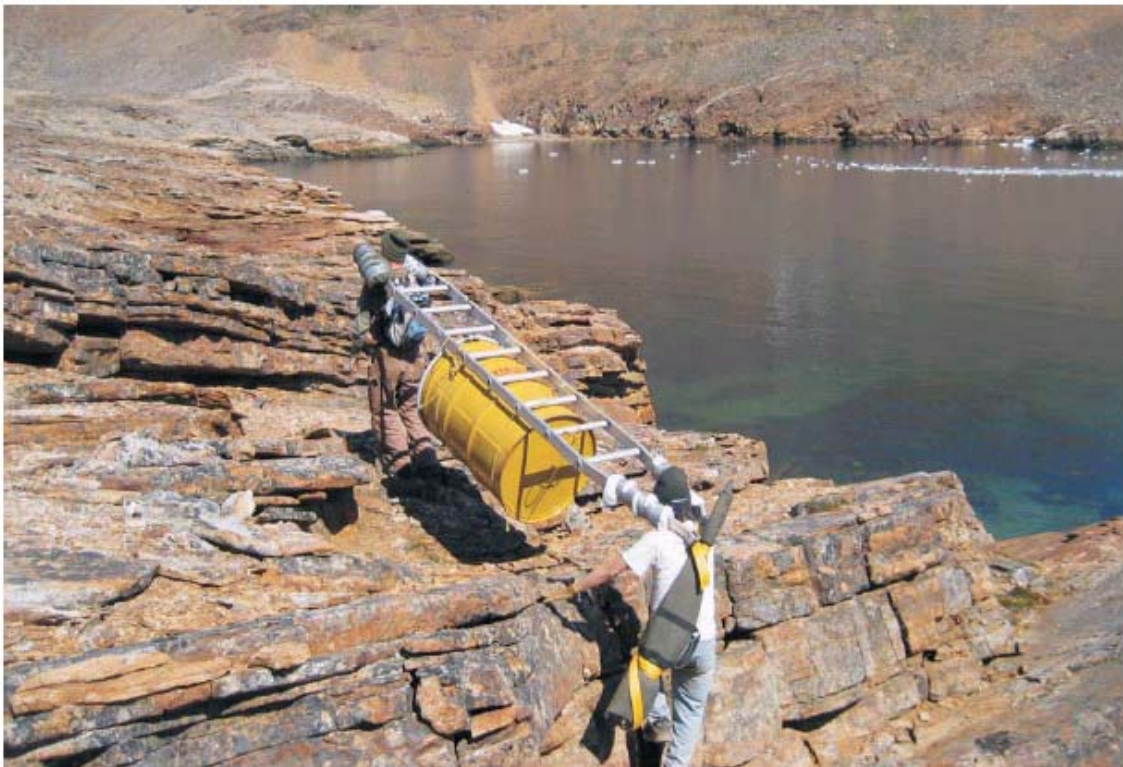
**Photograph 17: Carrying Empty Drums to the Beach Barrier From Building B2 Was Deemed to be Too Dangerous**
