Resolution Island 2009 Monitoring and Research

Analytical Services Unit Queen's University Kingston, Ontario

Indian and Northern Affairs Canada Affaires indiennes et du Nord Canada

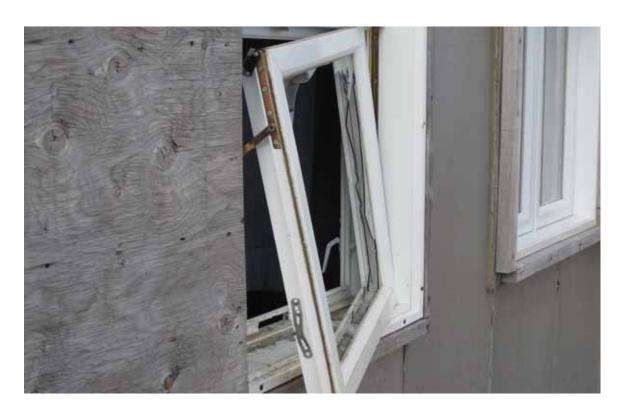
The ASU team was on site on 17, 18, 19 (½ day), 22 and 25 August 2009 and overnighted on the 17 August. Photographs 1-4 show the setup of the new overnight accommodation in the original cold food storage area that was used during the remediation project as the sleeping quarters and office area of the Qikiqtaaluk site supervisor. However since there was no power generation or heating available this approach was abandoned in favour of daily visits. The building is unlikely to have problems with mould as was the case with the training centre due to its structural design and therefore the area may be useable for site visits in the future. Doors to the new accommodation area were secured with plywood. A visit by INAC personnel on 5 September 2009 found that a bear had broken into the camp and scattered supplies around (Photographs 5 and 6). A pre-visit recce will be essential to assess the damage caused by the bear break in and the subsequent weather damage.

Photograph 5: The Window Broken by the Polar Bear

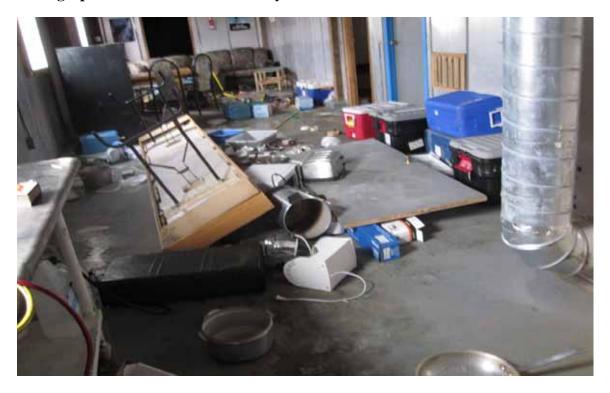
Photograph 6: Polar Bear Damage to the New Accommodation Facility as seen in Early September 2009

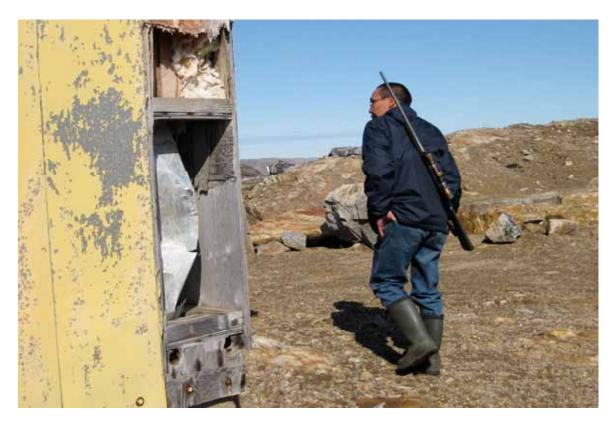
The old training center was also found to have some minor external bear damage as was the airstrip building (Photograph 7). The road system was satisfactory for ATV travel though a large hole (Photograph 8) was present near the old water lake. There were signs that vegetation was returning to some of the worked areas which should help to stabilize the loose soil and sediment. The ATVs were serviced by Frontec personnel on 19 August. Frontec personnel also made the necessary repairs to the ATV trailer damaged the previous year.

Photograph 7: Jamesie Josephee (JJ), One of Our Bear Monitors, Passing the Side of the Airstrip Building Where Polar Bear Damage was Cleary Visible

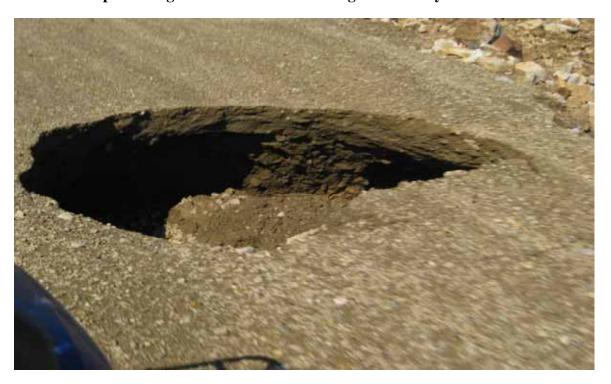
Photograph 8: A Hole in the Road Near the Old Water Lake

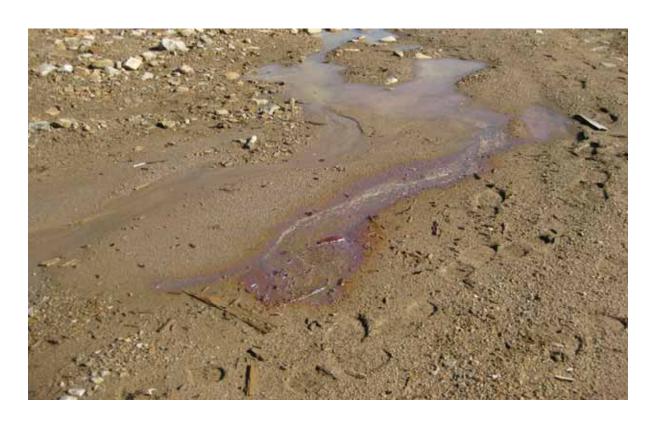
This year there was an area of standing water at the start of the stain (Photograph 9). The stain continues for 30 m towards the service road and this portion of the stain was dry. It was no larger than previous years and its severity is considered acceptable.

Photograph 9: The Start of the Stain ST1 near MW4

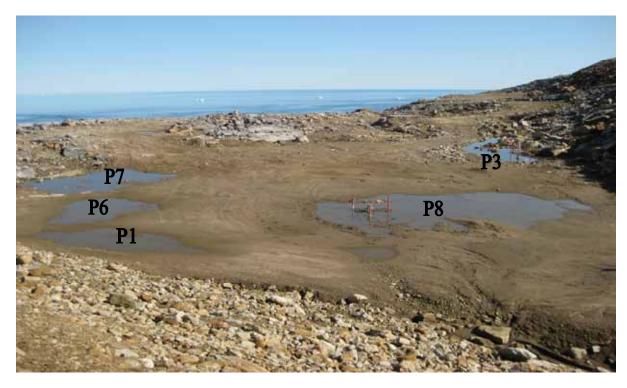
As noted above there was much more water above ground than in 2008 due to recent rain events. Previously noted ponded areas had generally increased in size. Four new ponded areas were observed. There are 5 ponded areas to the east of the landfill two of which two are new as shown in Photograph 10. The other 2 new areas are to the south of the landfill at locations shown on Map 2.

Photograph 10: The Area to the East of the Landfill by Monitoring Wells 1A and 1B Showing the Location of the Ponded Areas

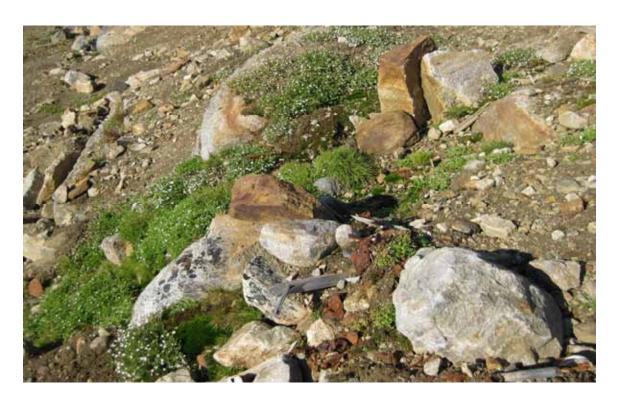
The surface of the airstrip landfill is in good condition with minimal erosion. There was no ponding at the time of the site visit despite the heavy rains and several areas showed signs of revegetation over and above the vegetation that remained after remediation (Photograph 11). On the north west berm, there is evidence of erosion. The gravel berm was built with large boulders on the top surface. Some of these boulders have recently migrated down the slope. Gravel is also migrating down the slope. Several large shallow gullies have formed from the erosion, 15-20m down the slope, 1-2m wide and 0.5m deep in some areas. The extent of the erosion is noted as marginal and should be investigated again next year. On the north berm, there is a local area of erosion and settling between MW12 and MW13, close to the vegetation and visible debris. There are several deep gullies in the sand/gravel that extend over an area 3m down the slope, 2m wide and 0.2m deep (Photograph 12). Some debris is located beside the gullies, including an old pipe. This area should be monitored for increasing erosion in future years. It is also deemed marginal because it is localized.

Photograph 11: Revegetation Was Visible at the Airstrip Landfill

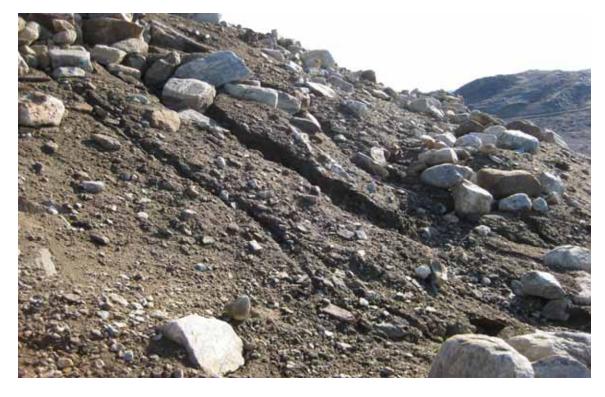
Photograph 12: Erosion Channels Have Developed in Some Areas of the Toe of the Airstrip Landfill

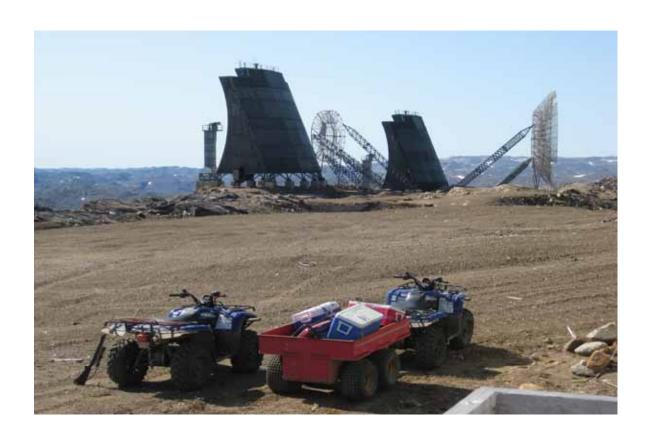
Photograph 13: The Station Non-Hazardous Landfill Was in Excellent Condition

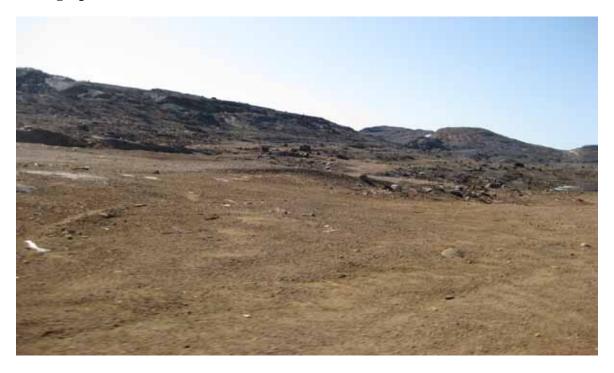
This landfill is situated near the junction of the road from the camp and the barrel cache valley. It was well graded and firmly packed. There were no signs of erosion, water ponding or any vegetative growth (Photograph 14).

Photograph 14: The Beach Non-Hazardous Landfill Was Also in Excellent Condition And Showed No Signs of Erosion, Settling or Ponding

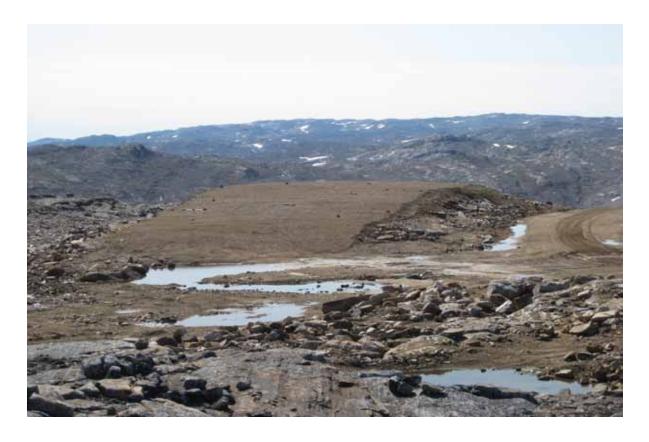
No sampling of any of the hydrocarbon remediation systems in place at the site were taken this year due to lack of time on site. The main landfarm (Photograph 15) was in good shape and showed no signs of erosion. The ponding and barrier system down gradient from this facility was also in excellent condition (Photograph 16) with water flowing freely through the filter system at the second ponded area (Photograph 17). The in situ landfarm experiment appeared unchanged from the previous year but there was no time to take samples.

Photograph 15: The Main Hydrocarbon Landfarm Showed No Signs of Erosion

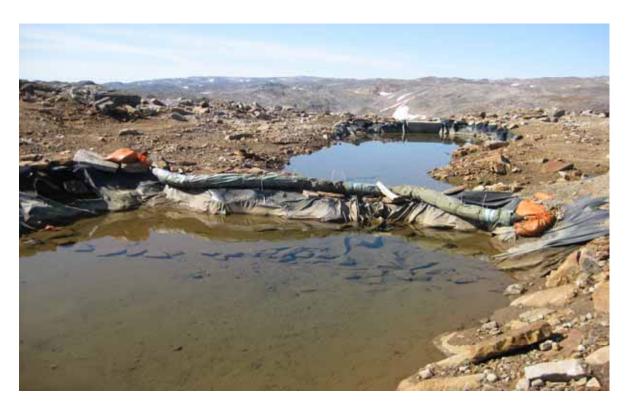
Photograph 16: The Ponding and Barrier System Put in Place to Remove Hydrocarbons From the Drainage Channel Leading From the Camp and Main Landfarm was in Excellent Condition

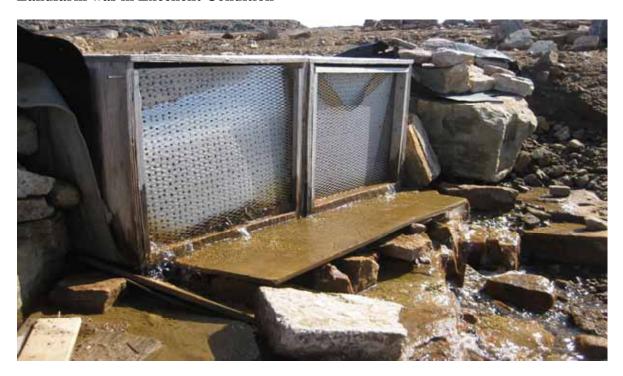
Photograph 17: Water Was Flowing Freely From the Base of the Filter Box

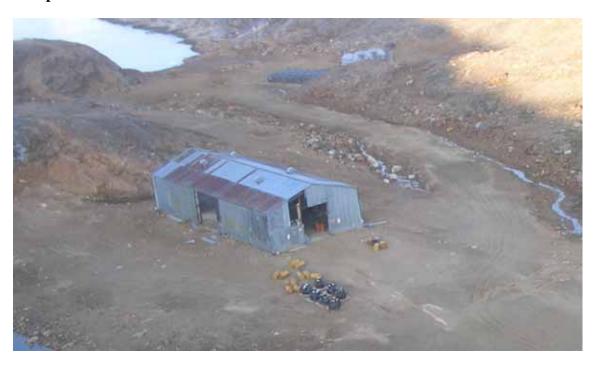
Photograph 19: Waste Wrangler Containers on Pallets and Overpack Drums Filled in 2007 and 2008 With PCB Contaminated Soil from the Barriers. This Photograph Was Taken When 15 of the 34 Drums Had Been Moved to the Area. Building B2 Lost an Additional Panel of Cladding by the Door Over the Past Winter

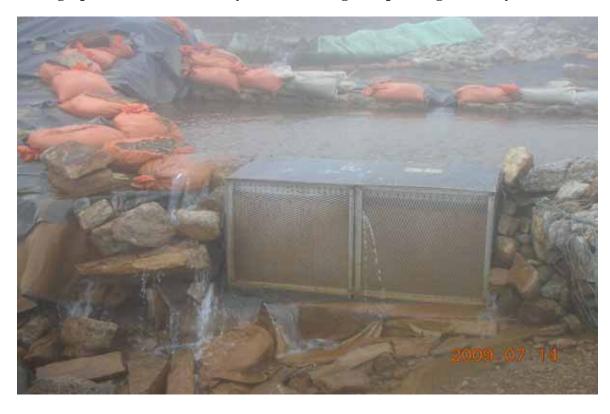
Photograph 21: The S1/S4 Valley Barrier on 14 July Overflowing Due to Snow Melt

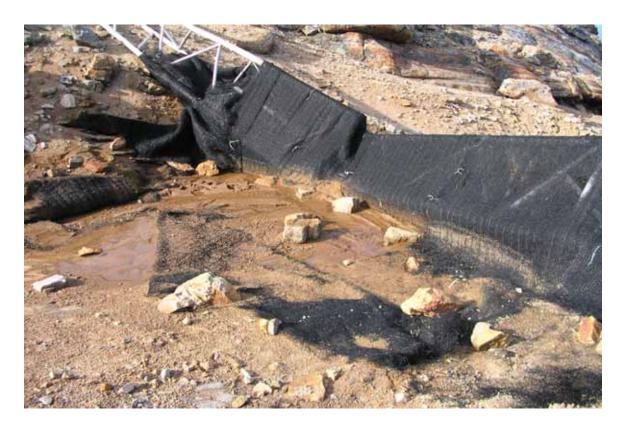
Photograph 26: Sediment Collected Above the Silt Fence at the Furniture Dump

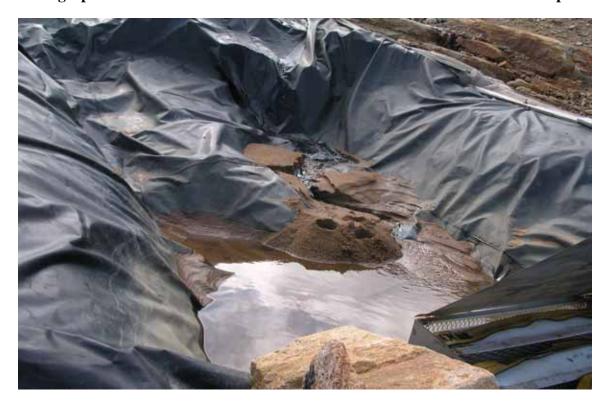
Photograph 27: Sediment Captured in the Furniture Dump Barrier
