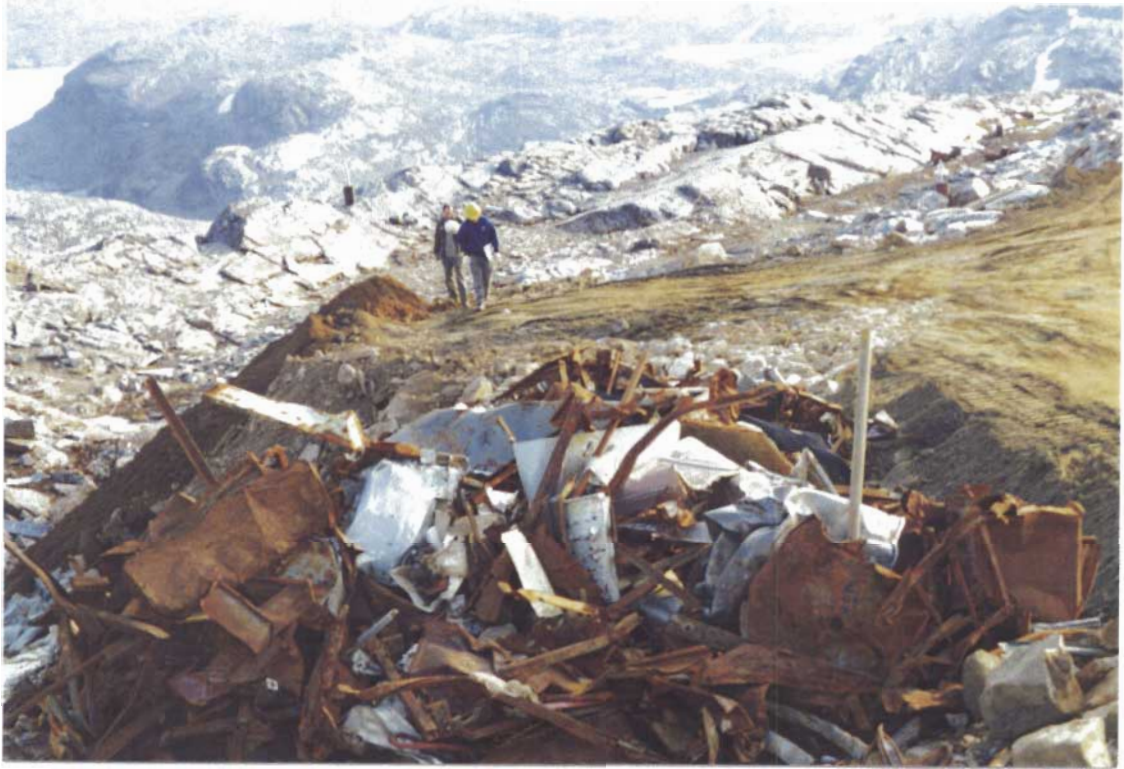
Photograph II-3: Metallic Debris and Tier II Soils from the Furniture Dump were Stockpiled on Tier II Soils in the S1/S4 Valley by the Road to S4.

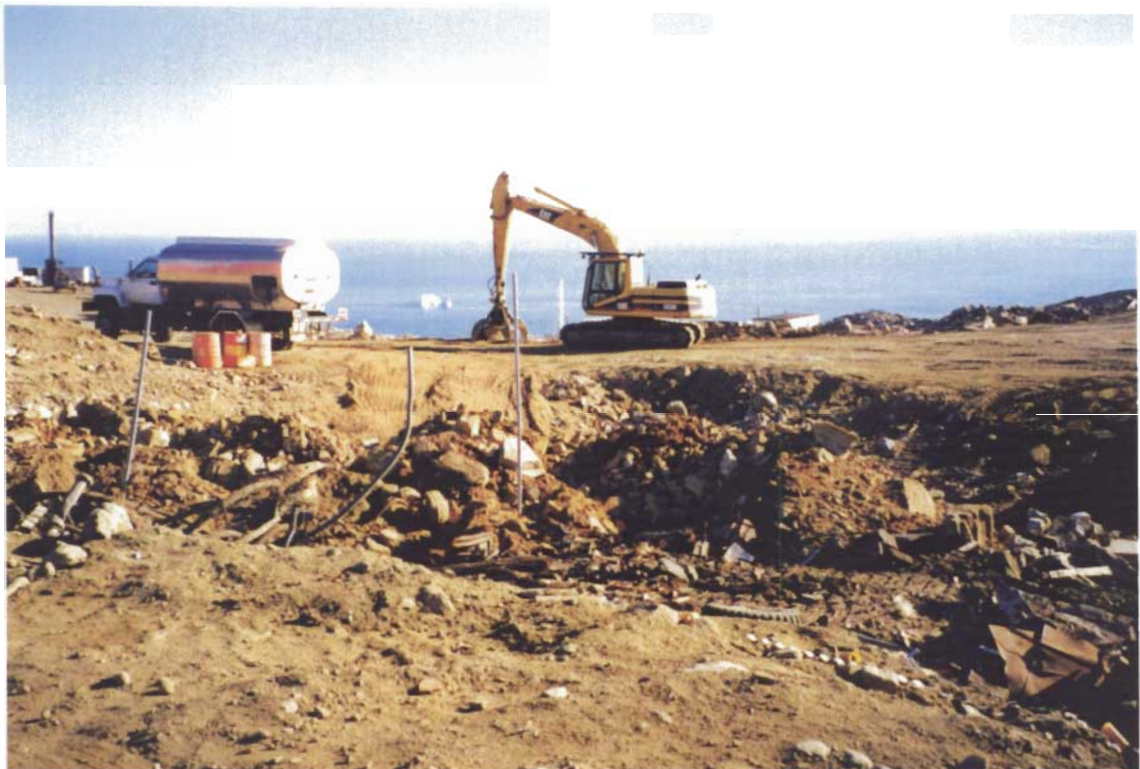
Photograph II-4: Tier I Soils from the Furniture Dump and Drainage Pathway Were Placed in a Separate Cell in the Landfill by the Core Camp

When all the CEPA soil had been removed from the drainage pathway, the rocks that did not pass through the screener were in a large pile below the unit. These rocks which were contaminated at the Tier I/II level were taken to the area in the S1/S4 valley next to where the metallic debris had been placed. Tier II soils from the drainage pathway were then excavated and placed with these rocks. Finally Tier I soils from the drainage pathway were excavated and placed in a separate cell in the landfill by the core camp (Photograph II-4).

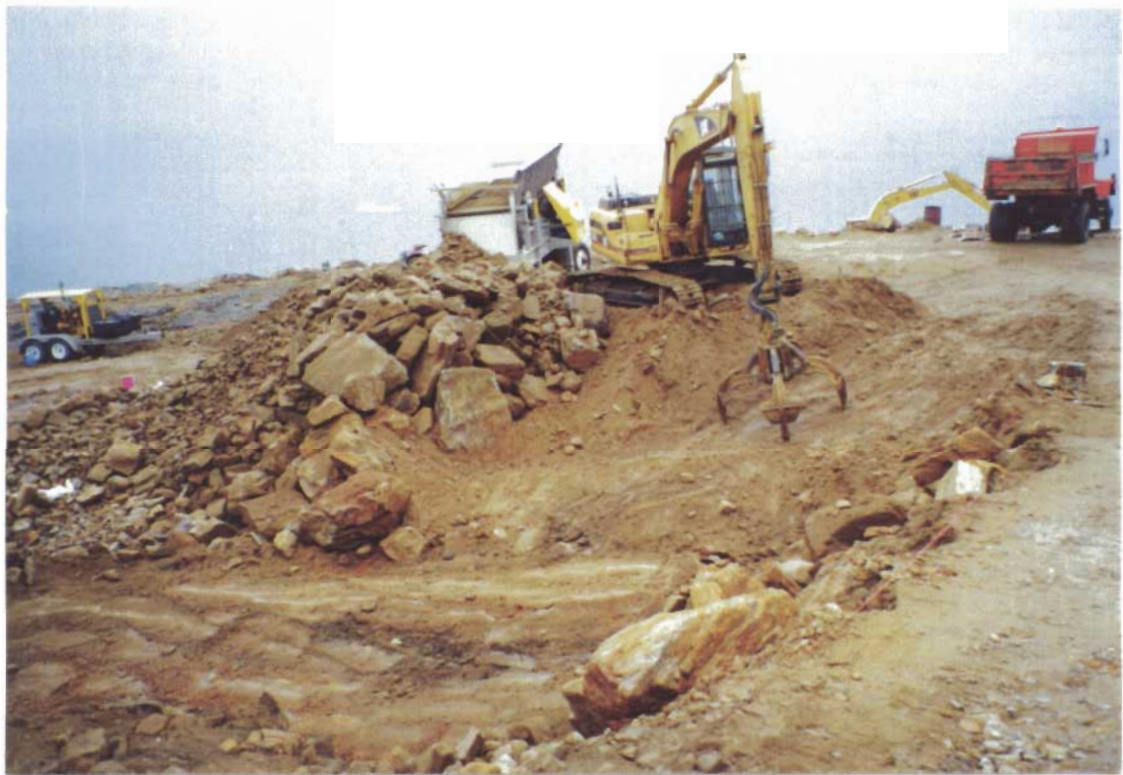
Photograph II-6: The Furniture Dump After Removing Most of the Buried Material: Note the Pile of Tier II Rocks Which Did Not Pass Through the Screener

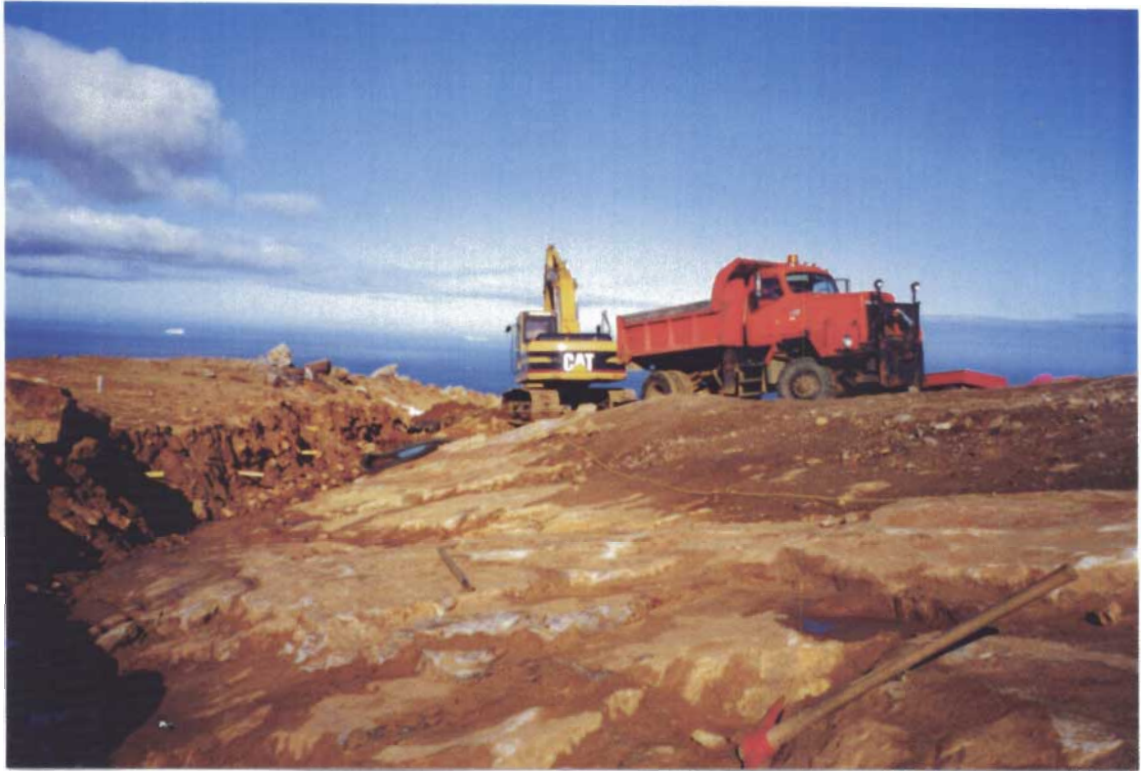
CEPA soils were then removed from the drainage pathway of the dump. The first straight section of this pathway contained much more soil than anticipated. The PCBs, which are more dense than water in the pure state appear to have traveled along the pathway in concentrated form and collected in a depression in the bedrock near the end of the first straight section. Soils in this location smelled very strongly of askarel. The bedrock sloped perpendicular to the drainage pathway and therefore the PCBs were found at depths up to about 1 meter. From this point onwards, the depth of the soils to bedrock was generally less than 30 cm and the soils were not stained with oil or PCBs. The initial excavation was generally carried out with heavy equipment, and hand shoveling and the vacuum truck were used to remove the soil left by the excavators. Water was used on the sloping bedrock with the vacuum truck sucking up this water at the end of the drainage channel. The upper interceptor barrier was removed and placed in two red steel vaults along with contaminated geotextile fabric. They were taken to the beach PCB storage facility.

Photograph II-7: Excavation of the Furniture Dump Drainage Pathway: Note the Sloping Bedrock and Posts in the Bank Marking Sampling Points

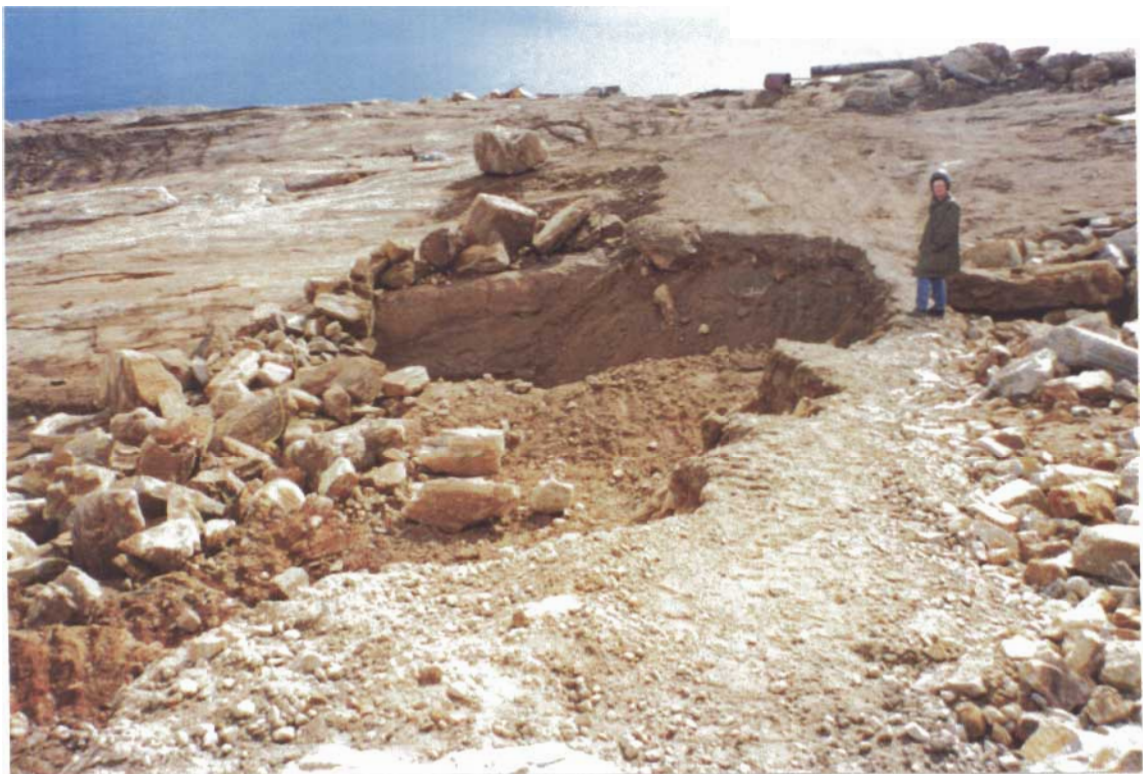
The last area to be excavated was the roadway and the area where the screener was located. The screener was decontaminated and moved to the S1/S4 area (see next section). The PCB contamination under the road was more extensive than had been anticipated. This was because the PCBs had leaked from the transformers and expanded the area of contamination in the soil beneath them in a pyramidal fashion. Unfortunately the bedrock under the road at this point had the form of a large depression and this further increased the zone of contamination.

Photograph II-10: The Furniture Dump After Excavation: the Road Which is Now Mostly Excavated Was Constructed to the Right of the Original Road

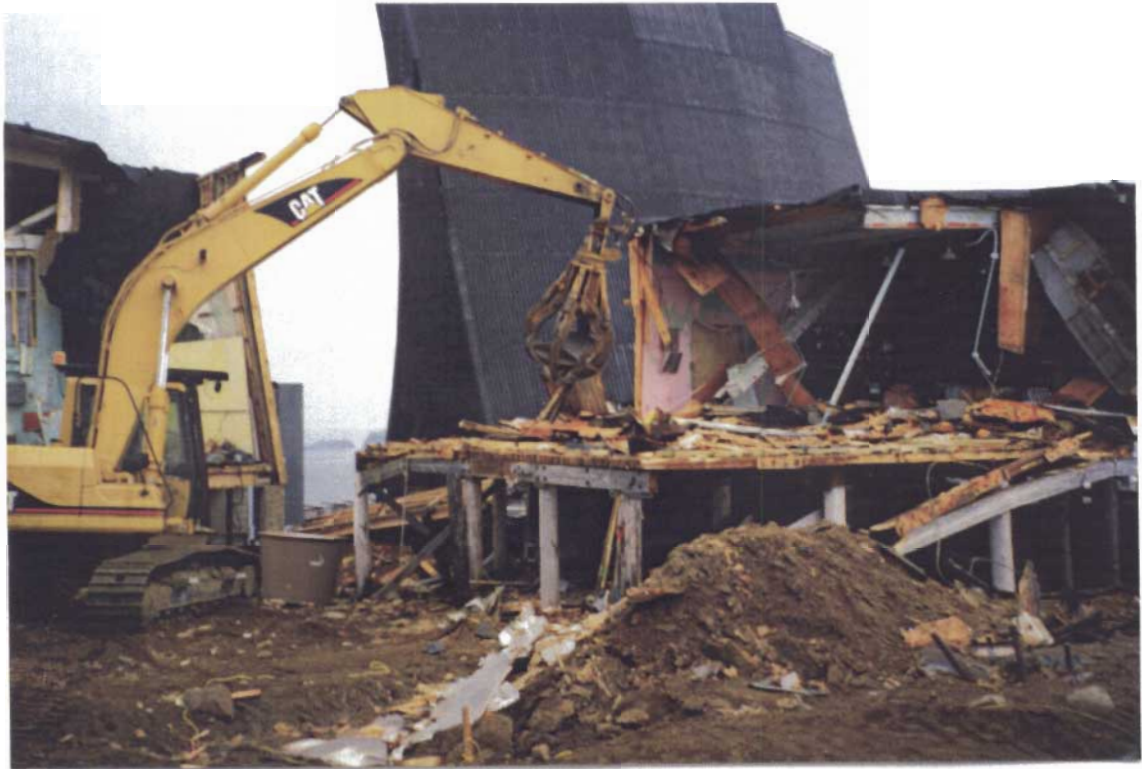
Photograph II-13: Demolishing Building S1; Note the Steel “Flower Pot” Used for Containerising > 2000 ppm PCB Soils

The buildings S1 and S3 were first dismantled to the floor level (Photograph II-13). Building S2 and all adjoining corridors were completely demolished. Floor tiles which could not be previously removed were placed in a Tier II stockpile. All non-hazardous material was placed in a new landfill in the area previously occupied by the old accommodation buildings. Most of the material was shredded into the landfill

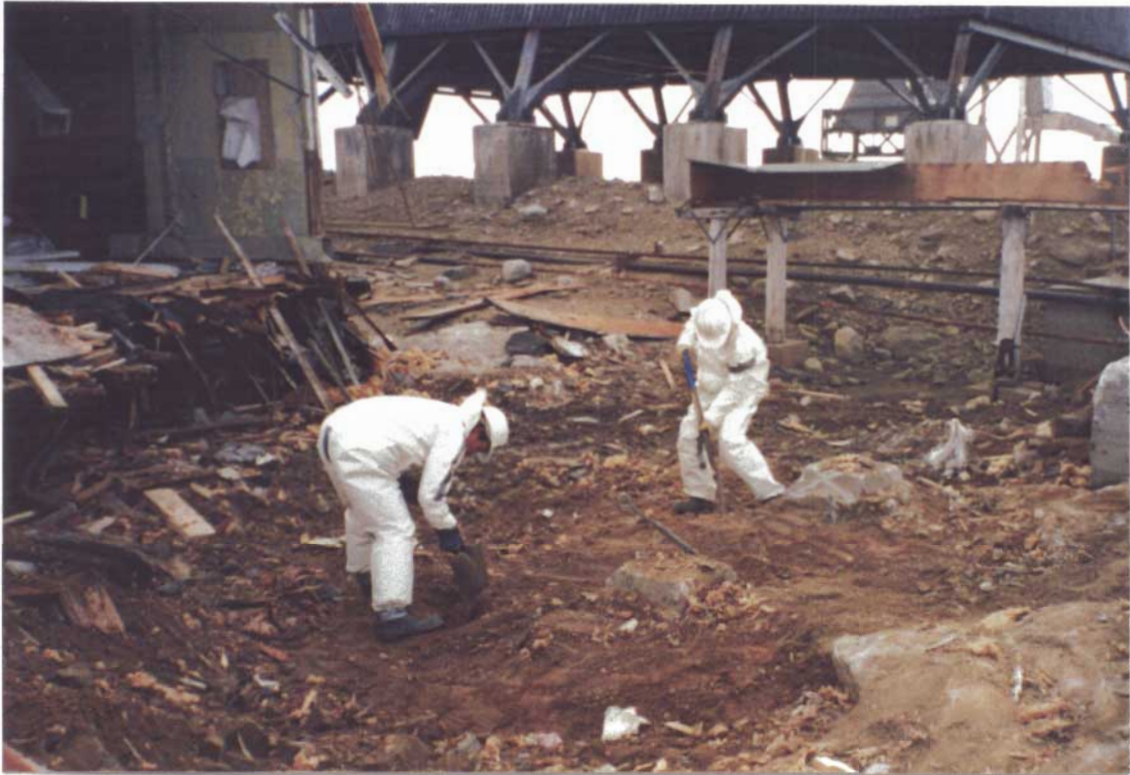
(Photograph II-14). There were some areas under buildings S1 and S3 which were highly contaminated (> 2000 ppm) with PCBs. During demolition, some of these areas were covered with tarps to minimize contamination of the non-hazardous debris. Other areas were excavated and the soil placed in steel “flower pots”. In order to allow the heavy equipment to reach the buildings and still remain on clean ground, CEPA soil had to be cleared. It was in these areas that the protocol for removing the soil using the excavator followed by shoveling and vacuuming was developed (Photograph II-15). Much of the floors of S1 and S3 were highly contaminated with PCBs (Photograph II-16). The affected sections were carefully removed using the clam attachment on the excavator and placed directly into steel containers. Tar paper was also added. Fourteen steel containers were filled and taken to the beach PCB storage facility. The remainder of the floors were taken and placed in a pile by the road on Tier II soil as they are slightly contaminated with PCBs.

Photograph II-15: Excavating the > 2000 ppm PCB Area by S3

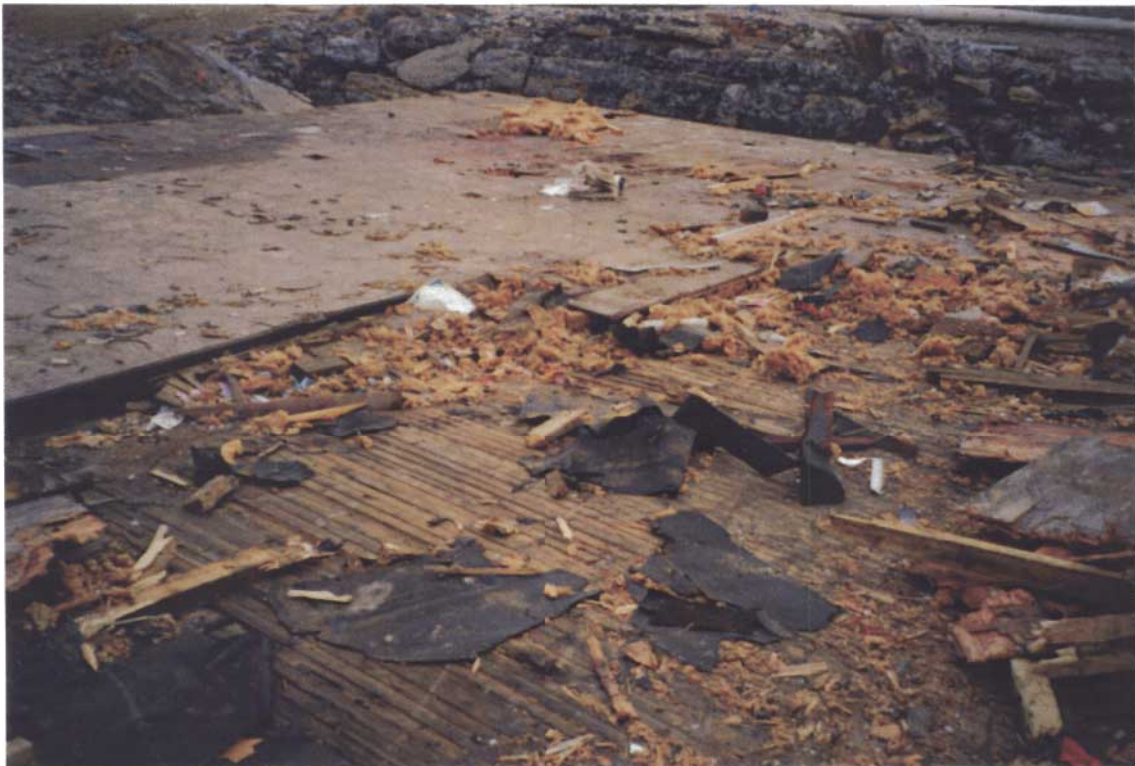
Photograph II-16: The PCB Contaminated Floor and Tar Paper; Note The Highly Contaminated Top Layer Which is Clearly Separated from the Lesser Contaminated Lower Layer of the Floor

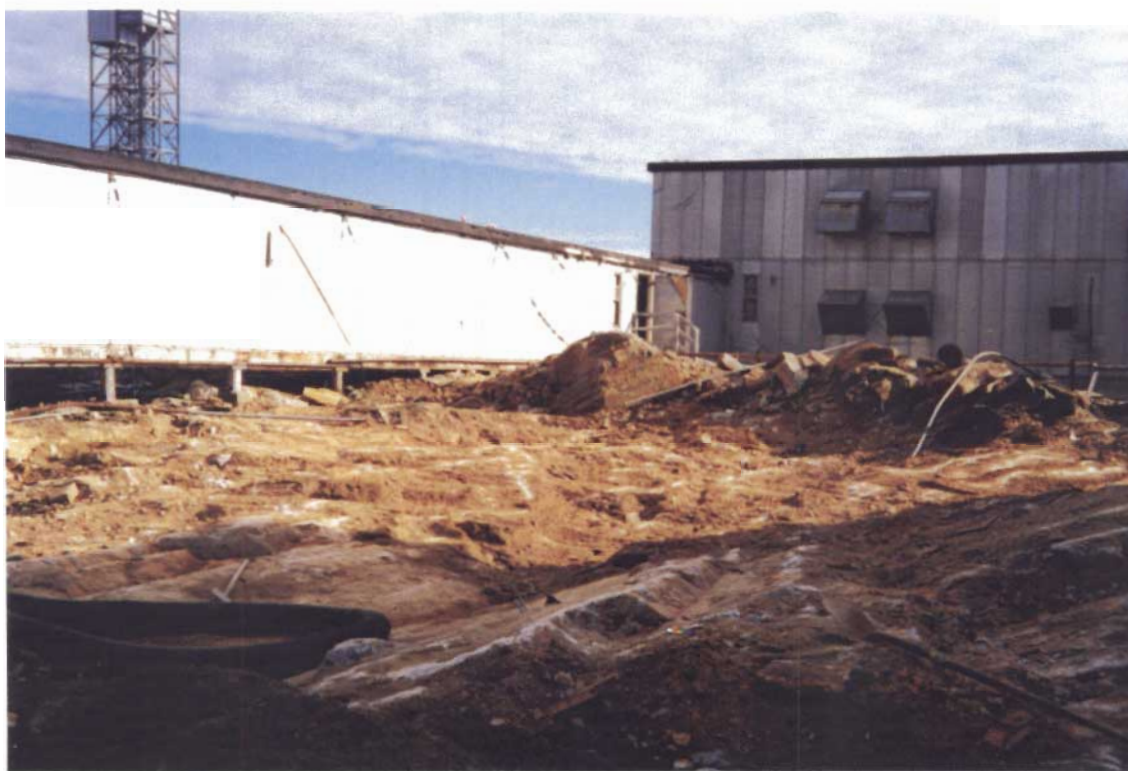
Photograph II-18: The Same Area After Excavation of the Contaminated Soil; The Clean Bedrock in the Foreground has been Vacuumed

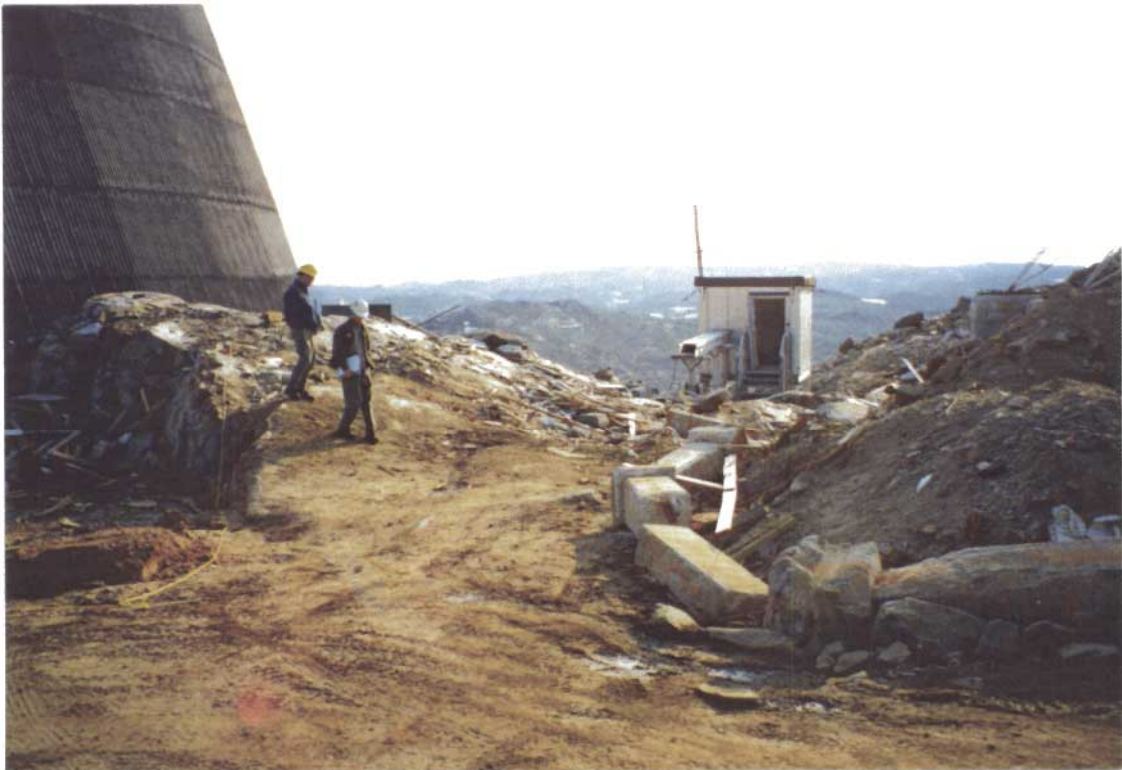
Photograph II-20: The Area Previously Occupied by S1; The Soil Pile to the Right Contained CEPA Soil Which Was Removed to the Screening Plant

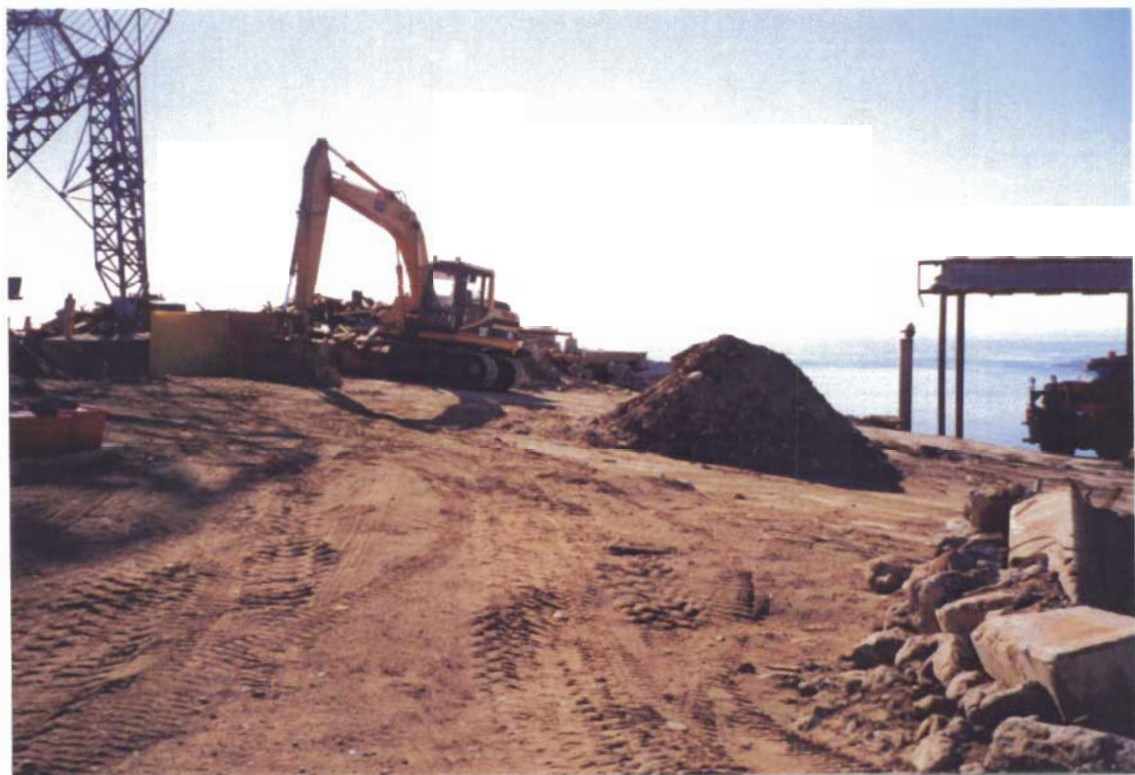
Photograph II-22: The Area Previously Occupied by S2 at the End of the Season; Note the Tier I/II Debris Pile Behind the Excavator

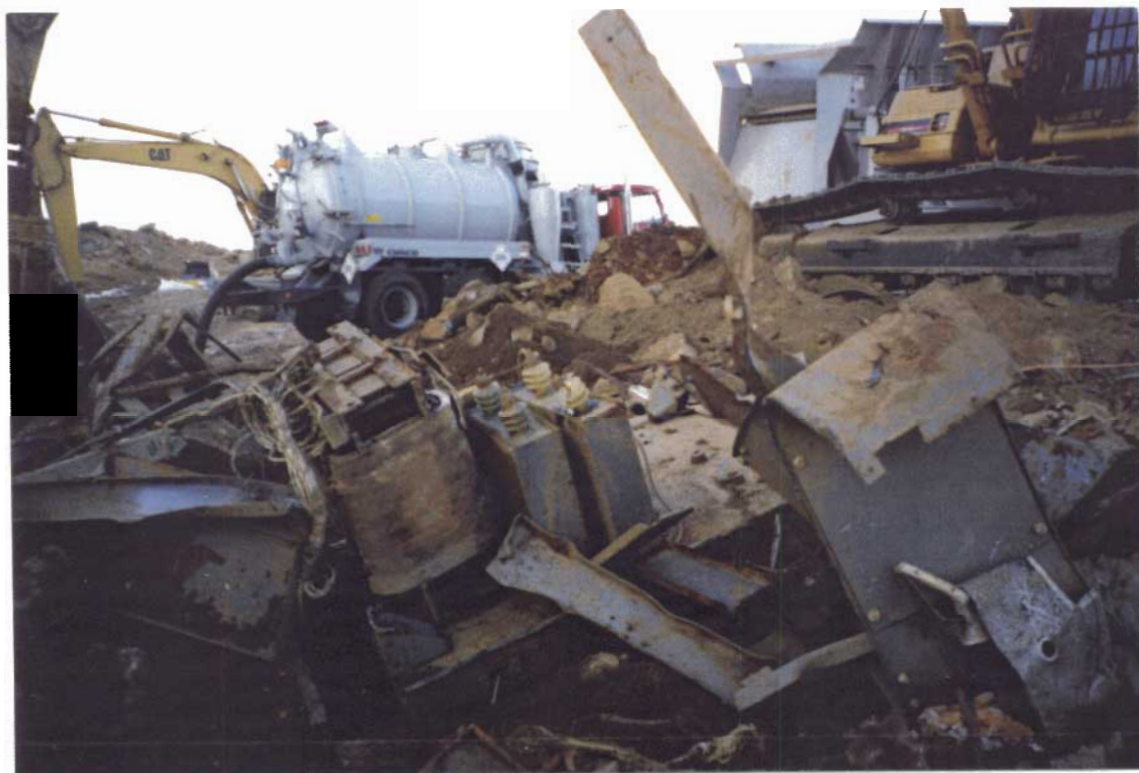
Photograph III-4: The Capacitors and Other Electrical Equipment Excavated From the Furniture Dump in 2000.

- Other barrels of capacitors in B2 were located and placed in sea-can #2. In addition the capacitors that were found during the excavation of the furniture dump (Photograph III-4) were placed in new plastic drums and PCB labels affixed to them. Small capacitors were removed from electrical racks (Photograph III-5) and added also.

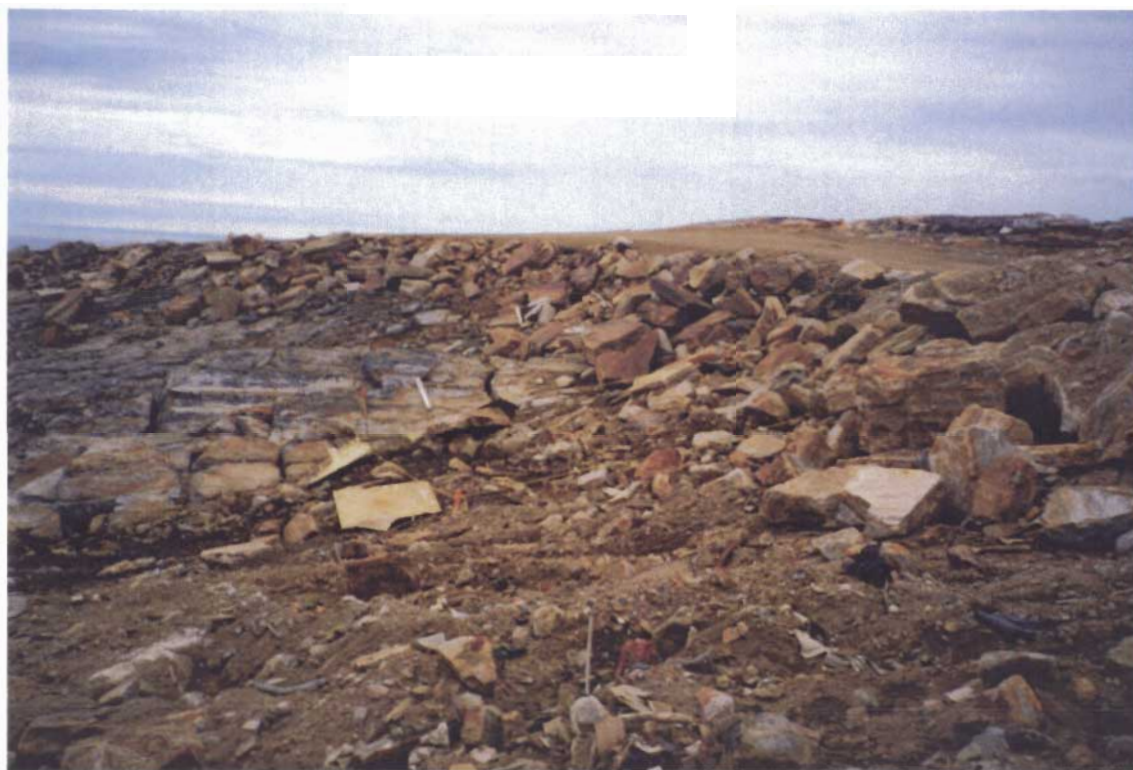
Thirteen samples were collected this year to determine the exact extent of the CEPA contamination. None of the samples taken this year contained > 50 ppm PCBs as shown in Table III-6. Map III-5 shows the PCB concentrations and tag numbers of samples taken in the area in 1994, 1999 and 2000. Ropes have been placed on the ground showing the extent of the CEPA contamination (yellow) (Photograph III-9) and the perimeter of the Tier I contamination (pink) near to the camp; the Tier I contamination extends for several hundred meters down the narrow drainage course away from the camp

Photograph III-9: The PCL Dump Showing the CEPA Area Marked with Yellow Rope.

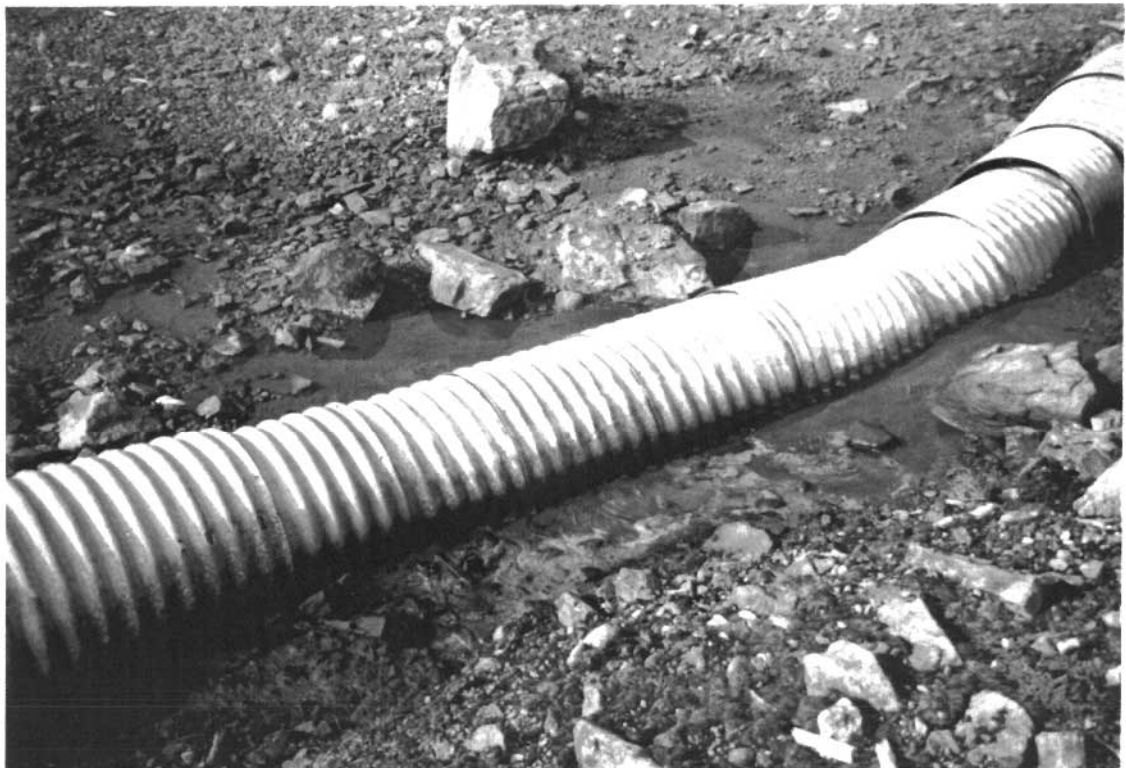
Photograph IV-1: The Barrier at the Barrel Cache Valley: Note the Oily Material on the High Side of the Barrier and Cleaned Water on the Other.

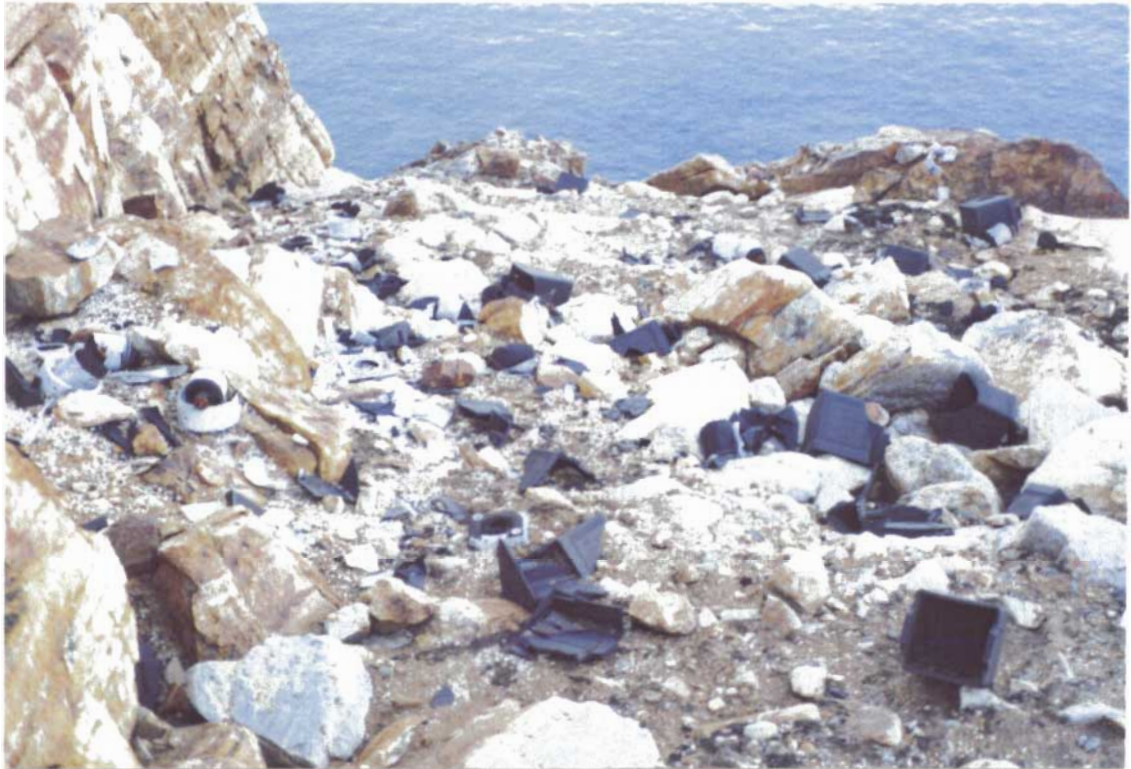
In 1999 a small area was found to the north of the furniture dump drainage pathway in which batteries had been disposed of. These batteries as shown in Photographs V-3 and V-4 were composed of a central metal electrode embedded in graphite and a whitish material which was previously housed in a black casing. Samples were collected of the graphite and white material and each was analysed for metals. The black graphite material was not found to contain any metals in significant amounts; manganese dioxide was expected to be present. The whitish material was found to contain a high level of zinc (35 %). Three soil samples were collected from the area and analyzed for their zinc content. The values found were 382, 335 and 5140 ppm. The high value was from a sample which contained a lot of the whitish material. It is therefore suggested that the visible pieces of the batteries plus the white solid and associated soil be placed in a lined wooden box and taken to the hazardous waste storage facility. Because of the remote location of the site, removal of the wooden box or boxes by helicopter is probably warranted.

Photograph V-3: The Battery Pile at the Edge of the Cliff near the Furniture Dump

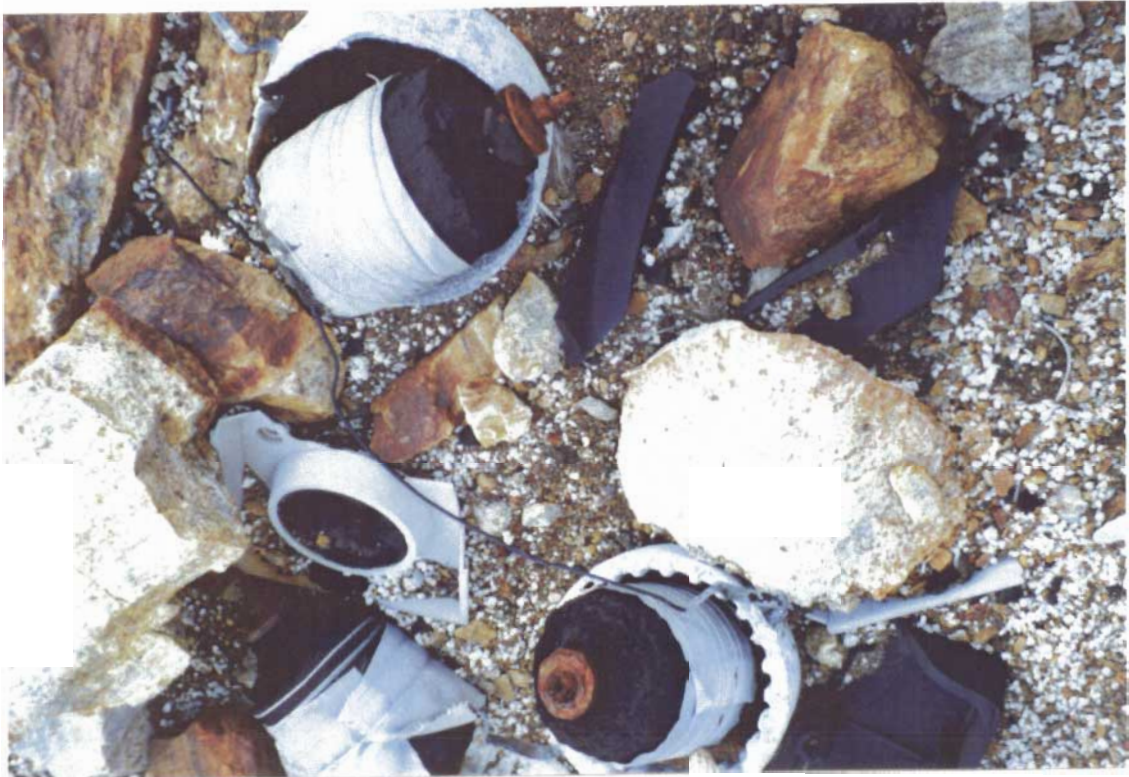
Photograph V-4: Close-up of Broken Batteries
