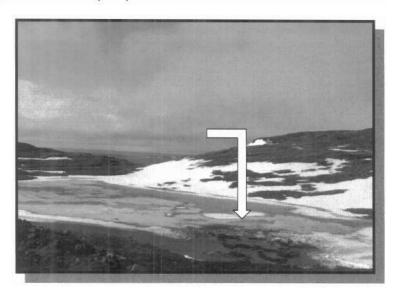
from the lakeshore. The last part of the access road was not completed (i.e., stream crossing) since quarrying operations were postponed to another season.

Photograph 7.2: Landslide at the Lake Borrow Pit

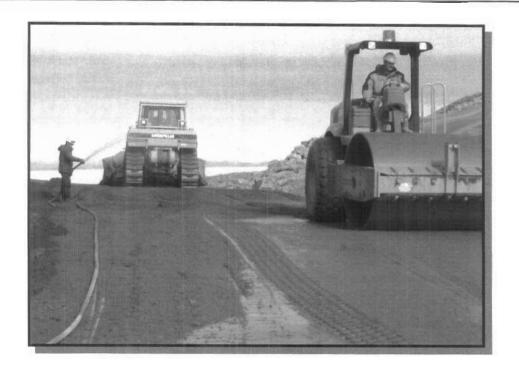
Photograph 7.3: Construction of the south berm core

Construction of the berm core was initiated on August 16. Work began in the north-east corner of the site and proceeded simultaneously on the east and south berms as well as on the north berm along the rock face. Type 3 soil was hauled from the borrow pits (mainly the Airstrip pit) and dumped directly in the berm footprint. Soil was placed in 1-foot lifts, evened out using a bulldozer, moisture conditioned, and then compacted using a roller-compactor. Boulders and rip-rap were placed along most of the core base to stabilize the over-90%-saturated soil.

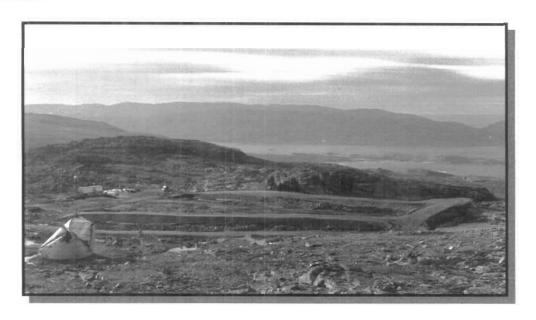
Photograph 7.4: Landfill site at the end of the 2003 season

Most of the north, east, and south berm cores were completed by the end of the season, however, the construction of the west berm could not be initiated because of the presence of hydrocarbon contaminated soil in the berm footprint. Despite this unexpected situation and the delays due to heavy rain, construction was completed to over 80% of the construction objective for the 2003 season (i.e., 3.5 of the 4 berms).

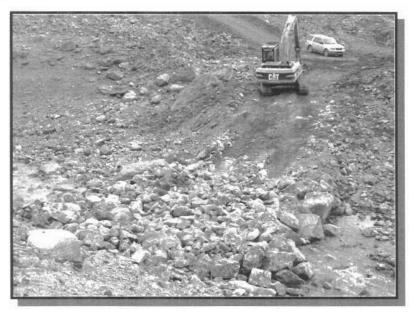
Photograph 8.1 Layer of boulders across streambed

Approximately halfway to the final destination, a stream had to be crossed. The option of installing culverts across the stream was rejected because of the risk of the culverts being damaged or even washed away during spring snow melt. Instead, boulders were placed in the streambed to allow water to flow through. Smaller rocks and gravel were placed atop the first layer to obtain a smoother driving surface. The final top layer of gravel will be placed in 2004, before regular dump truck traffic begins running across the stream. The road alignment is presented on the 2003 As-Built Drawings.

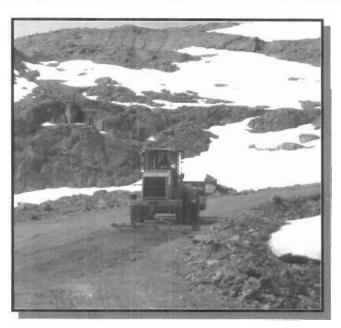
Spring time erosion caused by rainfall and snow melt had partly damaged some roads on site and therefore minor repairs were needed. Approximately two (2) weeks of road work (*i.e.*, from June 23 to July 5) was required to get the site roads in good condition for the season.

Photograph 8.2 Grading of main site road

After the heavy rainfall of August 22 to 24, most roads on site sustained major damage from erosion. A whole week of full time work was required to repair potholes, crevasses, and drainage ditches. Most of the heavy equipment available (i.e., loaders, dump trucks, and excavators) was used exclusively for this task. Over 1,000 m³ of granular material was required for road repairs following the downpour.
