**LANDFILL MONITORING REPORT –
BAF-5 RESOLUTION ISLAND**

Resolution Island, Nunavut

INDIAN AND NORTHERN AFFAIRS CANADA

March 2011

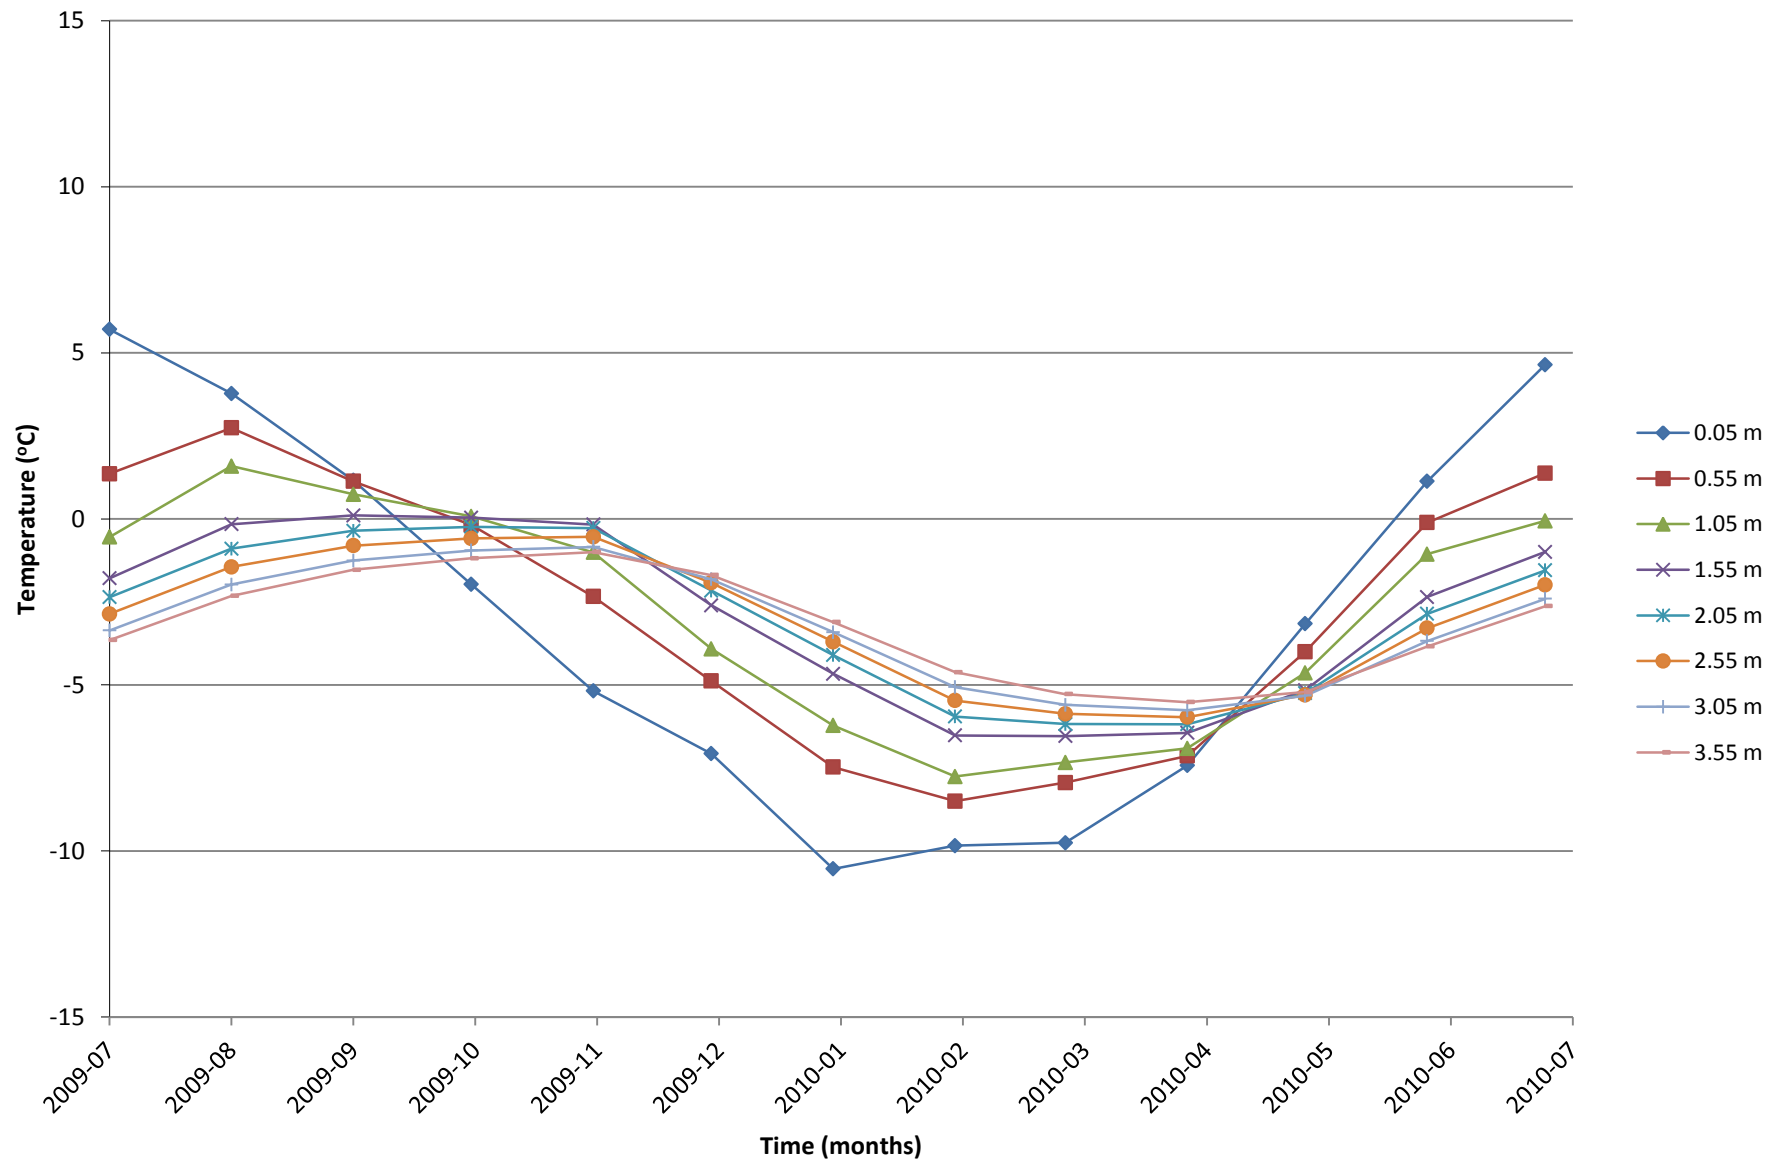
Graph 1: Thermistor Data From VT-1
Average Monthly Temperatures From July 2009 to July 2010

All thermistors at the Tier II Landfill were inspected and observed to be in good condition with no significant concerns identified. All analogues/thermocouples were observed to be functioning properly at the time of the inspection.
