2016 ENVIRONMENTAL MONITORING

Resolute Bay Airport Land Treatment Units

December 9, 2016

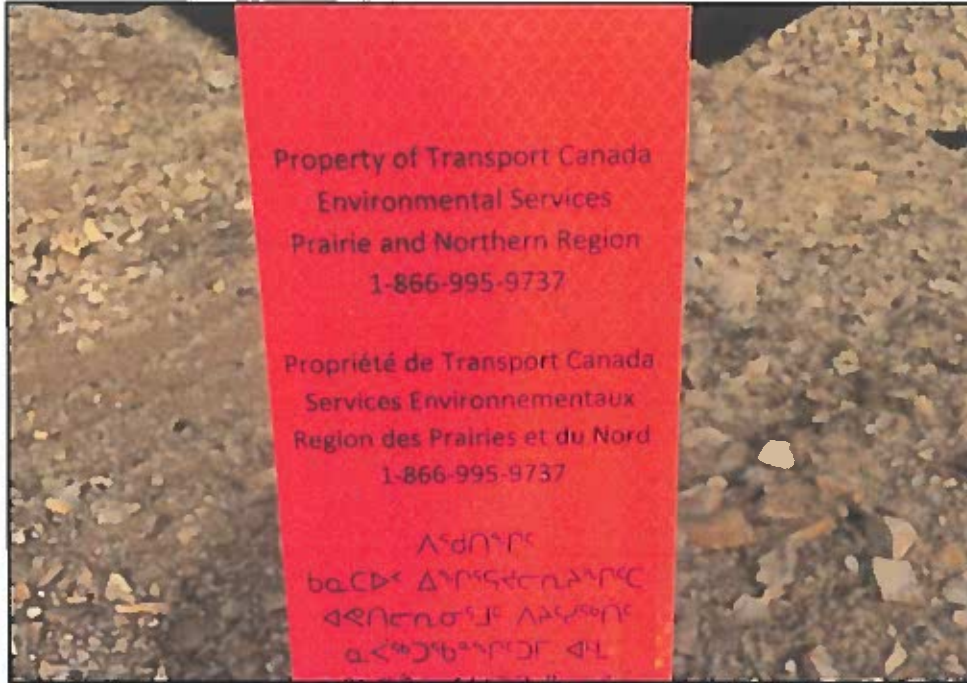
Photo: #1

Description:
Trilingual signage attached to wells.

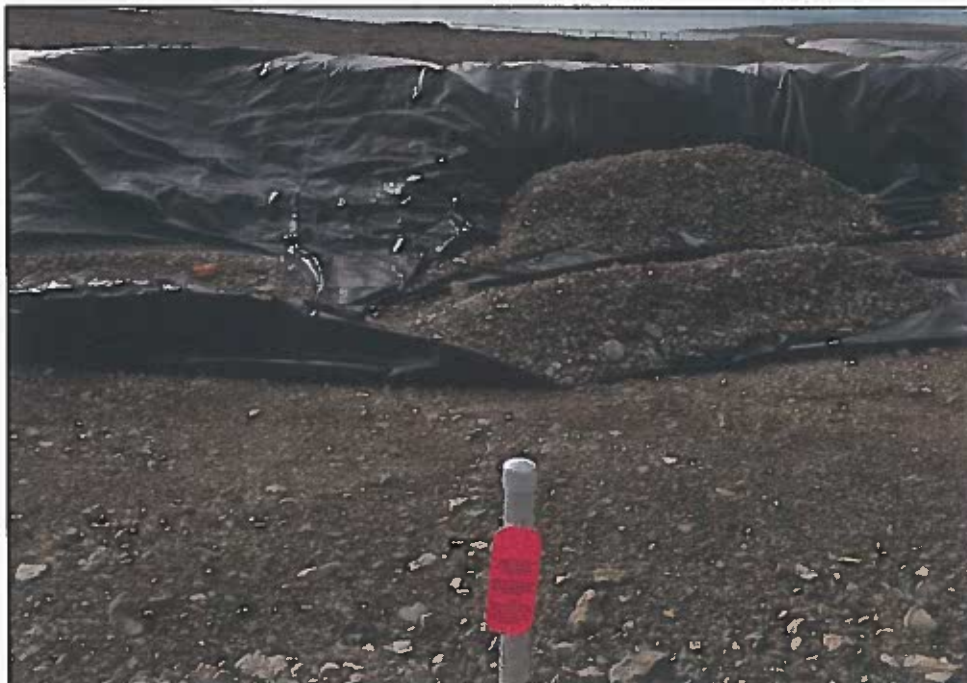
Photo: #2

Arcadis labelled the six monitoring wells according to NWB licensing requirements with tri-lingual signage (English, French, and Inuktitut). The Arcadis field technician appended the monitoring well signs to the PVC stick up using zip ties using extra caution not to damage the PVC riser. Monitoring well signage is shown in Photos 1 and 2 in Appendix A.

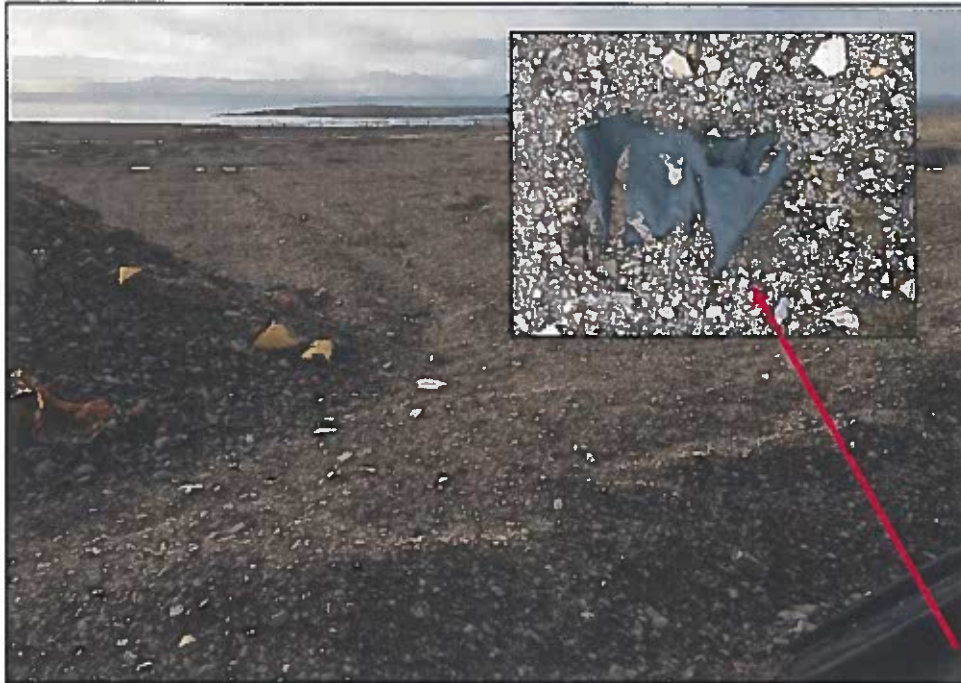
Photo: #7

The liner granular cover on LTU 1 was very shallow or non-existent along the majority of the berm walls, which resulted in exposure of the liner to atmospheric conditions and ultraviolet (UV) rays. Minor damage to the liner was observed at one location, the northeast corner. A small portion of the geomembrane liner was removed from the northwest corner and inspected closer (see Appendix A-Photos 7 and 8). After

inspection, Arcadis confirmed that the liner integrity has not been compromised as the weaving of the fibres was fully intact.

Exposure to ultraviolet (UV) rays generally degraded the condition of the geomembrane that was used to line the LTUs where it is exposed around the edges of the LTUs and not covered by soil in the typical manner. While minor degradation was observed at the northwest corner of LTU 1, this degradation is not necessarily the case for the liner below the LTU soil, as it has not been exposed to UV rays. The liner was reportedly made of 20 mil oil resistant polyethylene. Overall, the geomembrane liner was observed in good condition. Arcadis inspected a piece of the liner from the area of minor degradation and it was observed to be fully intact. The integrity of the liner at both LTU 1 and LTU 2 does not appear to be compromised and is containing soils as designed.

Description:
View of LTU1-the northeast corner. Minor damage to the liner was observed.
