# Roberts Bay and Ida Bay Abandoned Mine Sites Waste Audit Final Report

#### Prepared for:

Public Works & Government Services Canada Environmental Services, Western Region 5<sup>th</sup> Floor, 10025 Jasper Avenue Edmonton, Alberta, T5J 1S6

April 2006

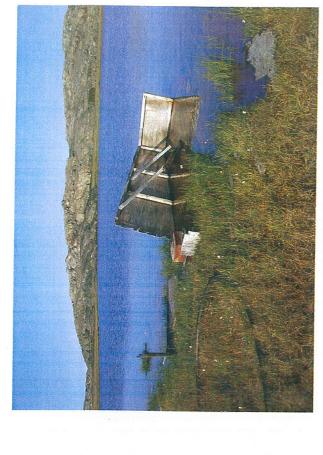
Photo 2: Remains of pumphouse at lake

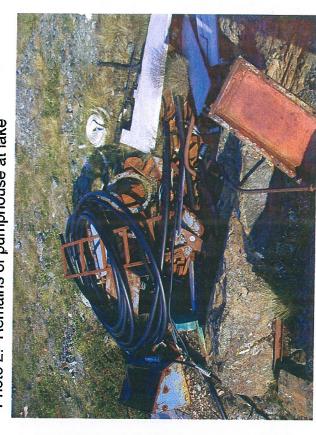
Photo 4 Debris pile near Mill

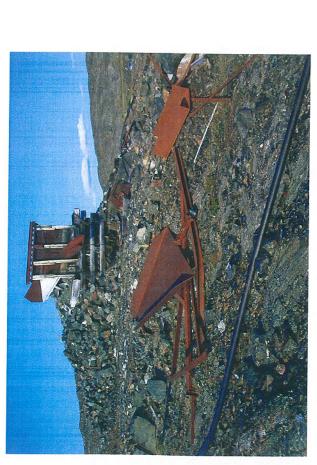
Photo 5: Debris around coarse ore hopper

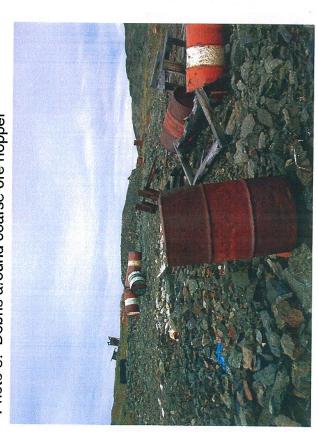
Photo 7: Barrels between Garage and Assay Building

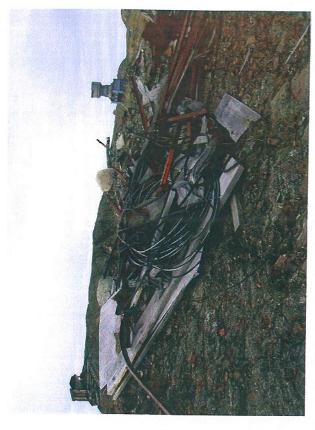
Photo 6: Debris near Assay Building, crusher in background

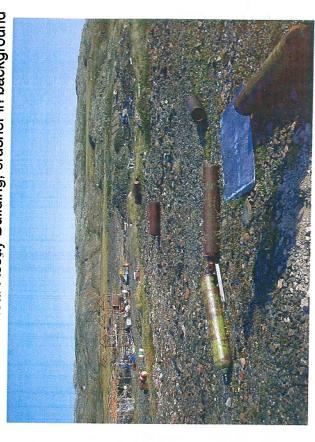
Photo 8: Gas cylinders near cone crusher

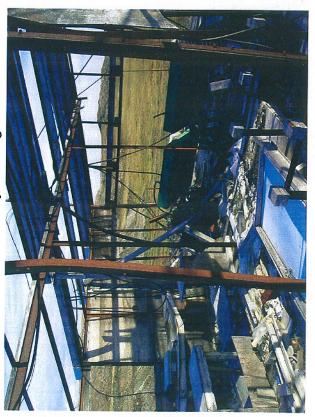
Photo 11: Equipment in Assay Building

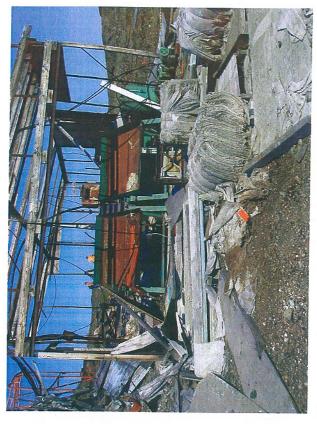
Photo 10: Concentration Tables and Equipment in Assay

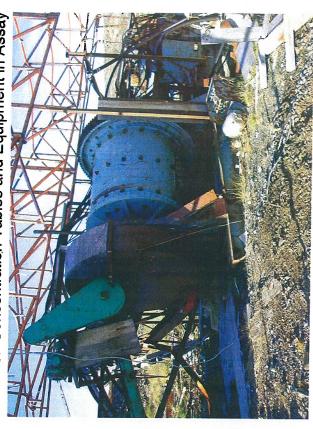
The steel mill equipment (cone crusher, ball mill, tanks and floatation cells, tables, etc.) are painted with a product containing very high levels of lead. The NWT Government Environmental Guideline for Waste Lead and Lead Paint indicates that all substances with lead levels greater than 500 ppm lead are considered hazardous and therefore require proper handling and disposal. Therefore based on the information in this document, it is recommended that the painted steel components be removed and hauled offsite for disposal or a lead abatement program be completed in order to remove the lead containing paint prior to disposal of the steel materials.

Photo 12: Ball mill and conveyor from hopper, Mill Building

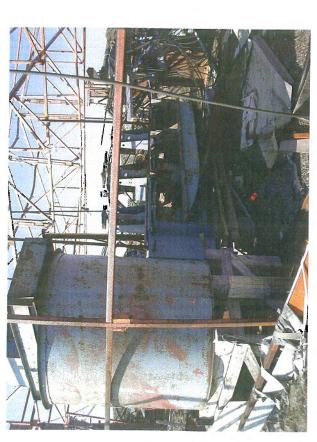
Photo 13: Thickener tank and flotation cells, Mill Building

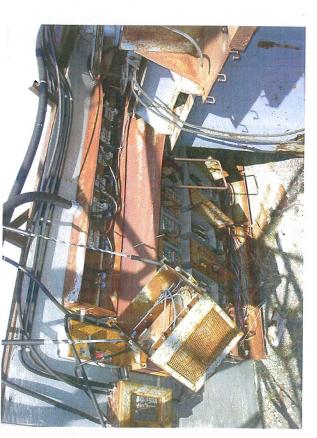
Photo 15: Main electrical panel in Mill

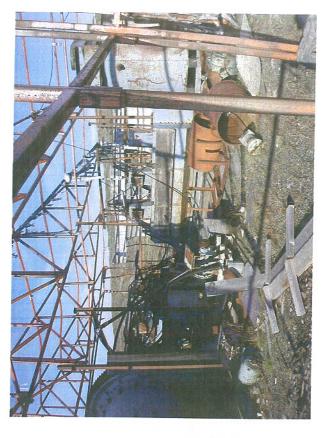
Photo 14 Debris and equipment in Mill

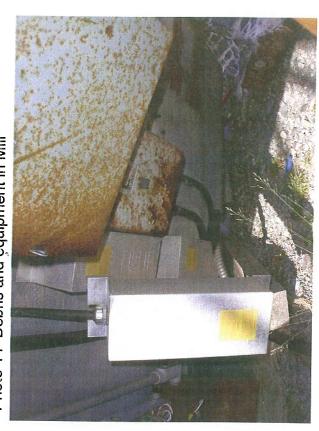
Photo 16: Three PCB containing capacitors in Mill

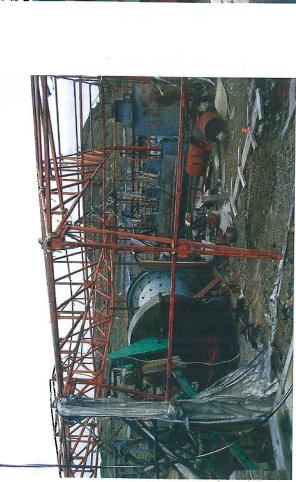
Photo 17: Looking east into Mill

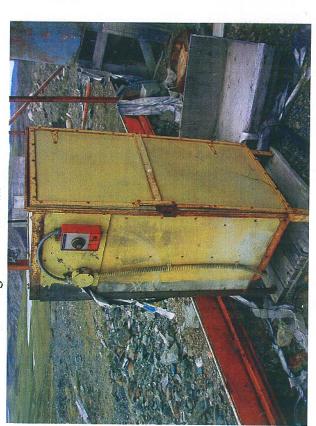
Asbestos materials on site were limited to a transite panel constructed heating cabinet in the mill (Photo 19). A sample of the transite panel was not submitted for analysis however transit panel materials typically contain between 2% and 10% chrysotile asbestos. The only other asbestos containing items that were observed was a couple of potentially asbestos containing brake pads located at both the Ida Bay and Roberts Bay sites.

Photo 19: Heated cabinet in Mill, asbestos materials

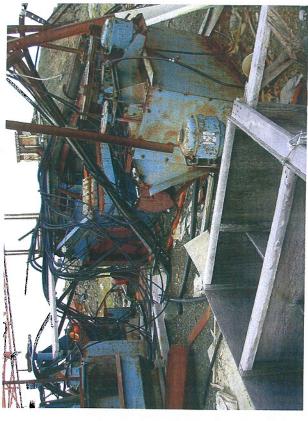
Photo 18: Floatation cells and debris in Mill

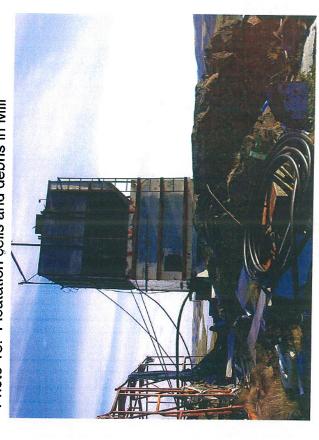
Photo 20: Fine ore hopper, west of Mill

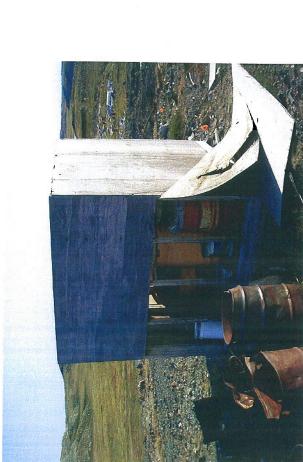
Photo 21: Barrel storage shed

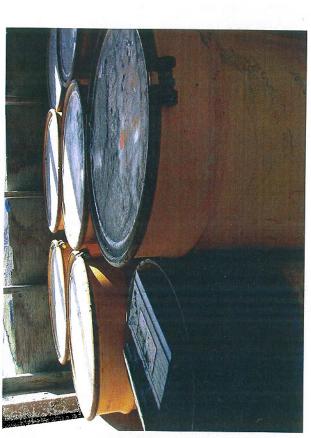
Photo 23: Overpack drums and lead acid batteries in shed

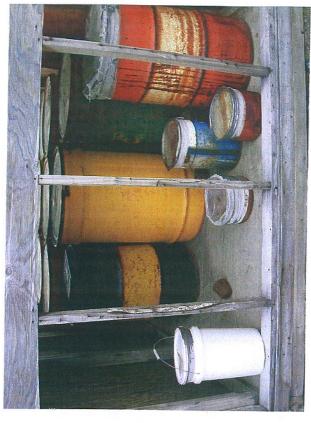
Photo 22: Overpack barrels and misc. containers in shed

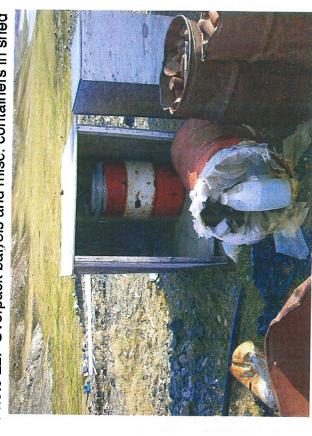
Photo 24: Drums containing recovered liquids and dry chemicals

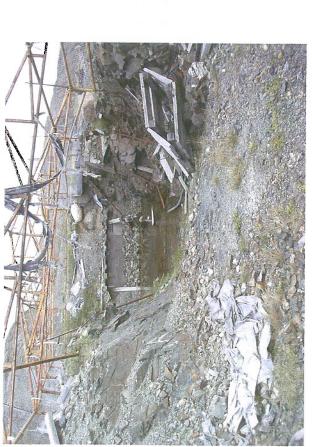
Photo 25: Fencing and debris around adit entrance

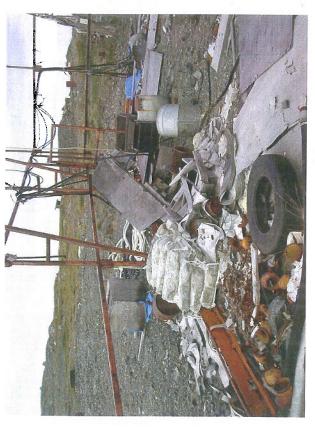
Photo 27: Equipment parts and concrete in Garage

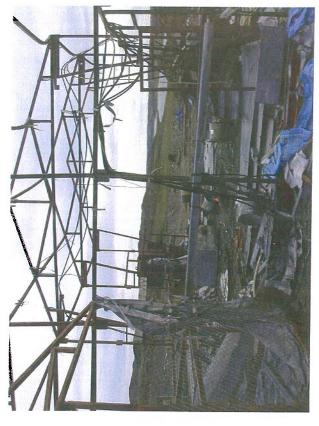
Photo 26: Looking south through Garage Building

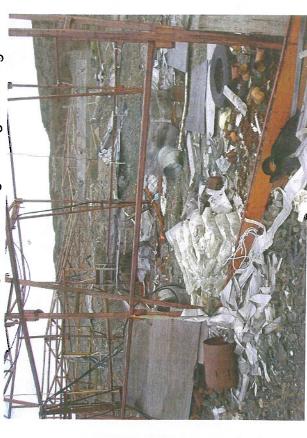
Photo 28: Looking east into Garage

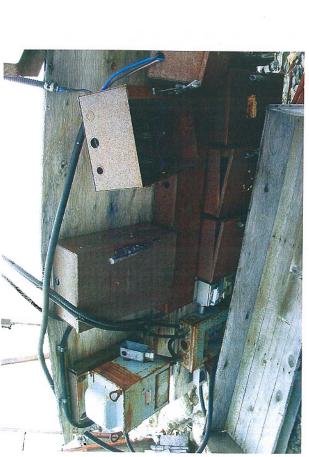
Photo 29: Dry transformer and electrical panel in Garage

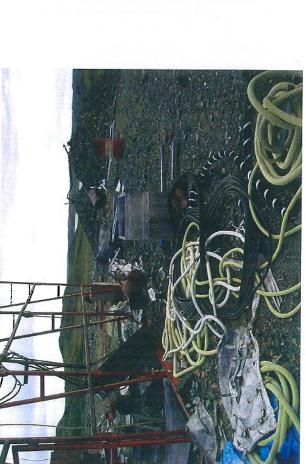
Photo 31: Hose products west of Garage

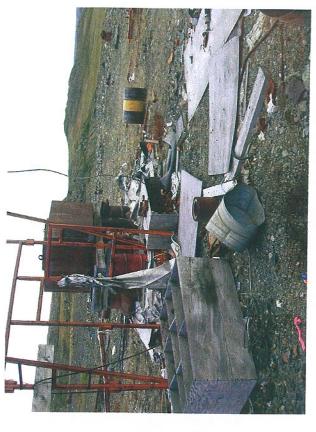
Photo 30: Debris and steel tank outside Garage

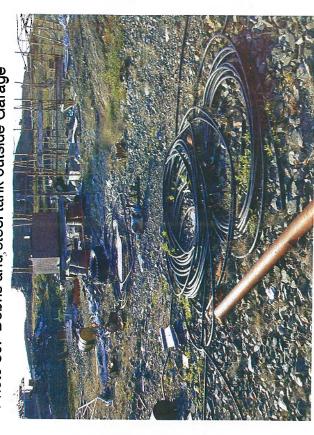
Photo 32: Debris east of Garage

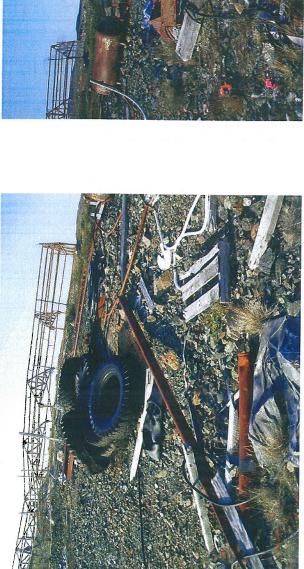
Photo 33: Waste materials east of Garage

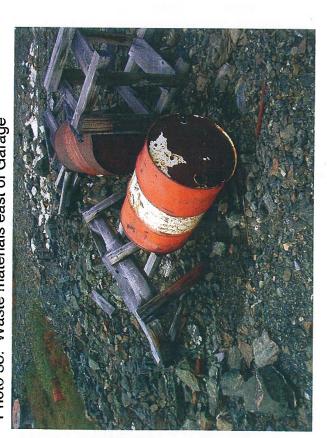
Photo 35: Drums near Garage

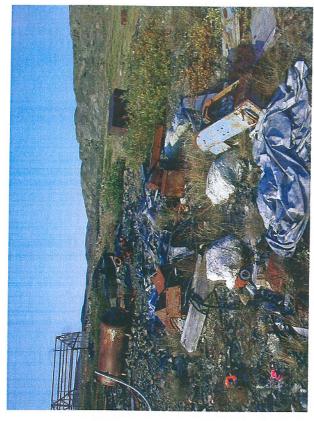
Photo 34: Waste materials east of Garage

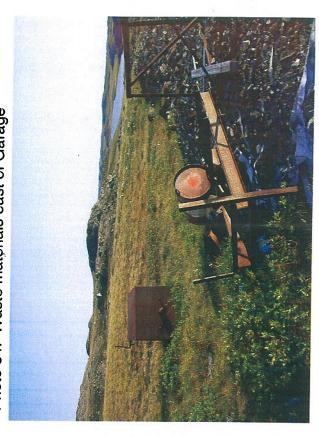
Photo 36: Waste materials east of Garage

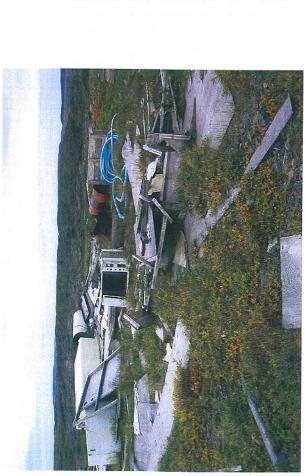
Photo 37: Buildings remains at former Camp site

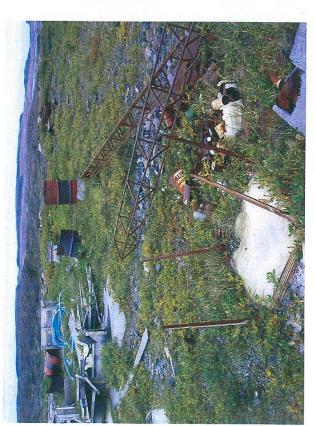
Photo 39: Waste debris at Camp site

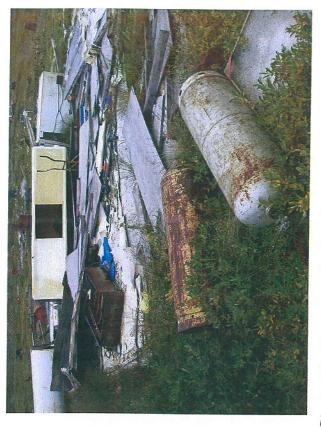
Photo 38: Propane cylinders and debris at former Camp site

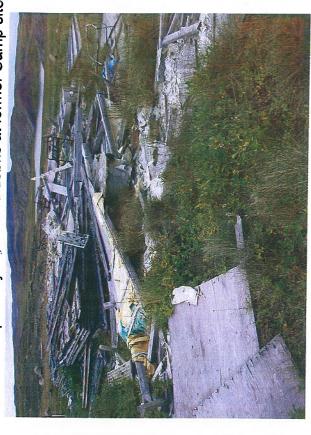
Photo 40: Core boxes and debris and former Camp site

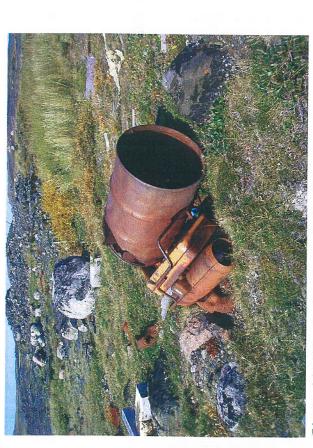
Photo 44: Waste debris west of adit

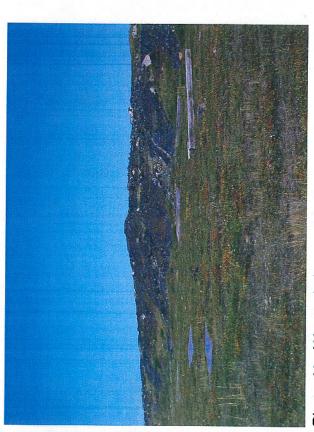
Photo 46: Waste timbers at Ida Bay

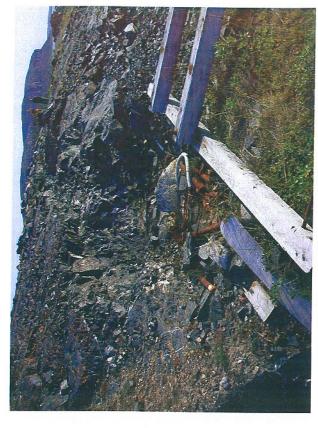
Photo 45: Waste debris at Ida Bay site

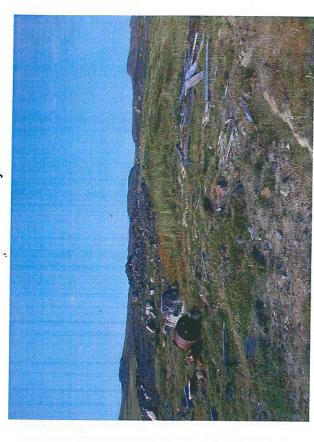
Photo 47: Scattered debris at Ida Bay site

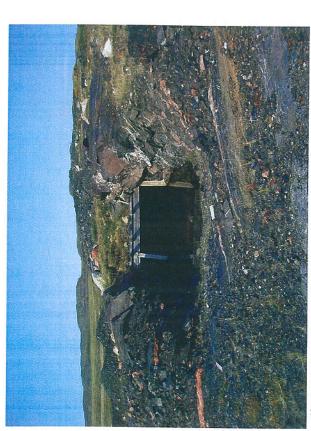
Photo 48: Adit entrance

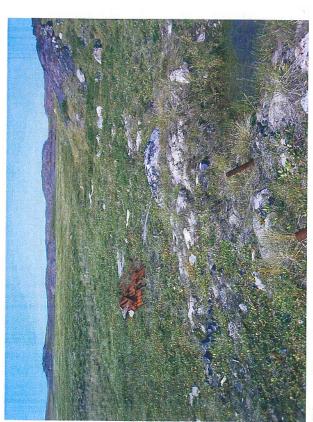
Photo 50: Waste debris at Ida Bay

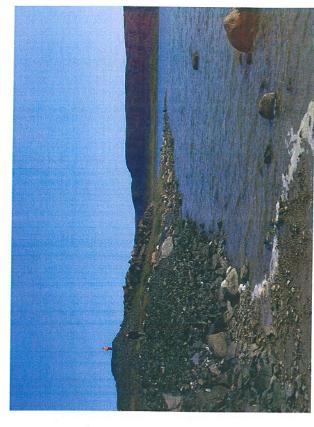
Photo 49: Waste rock along Ida Bay shoreline

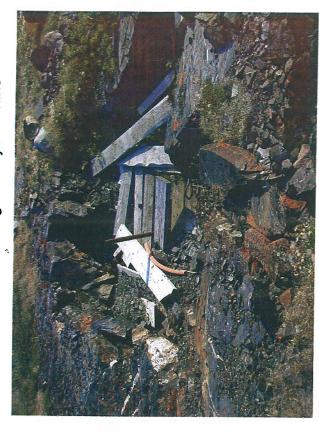
Photo 51: Covered raise at Ida Bay site

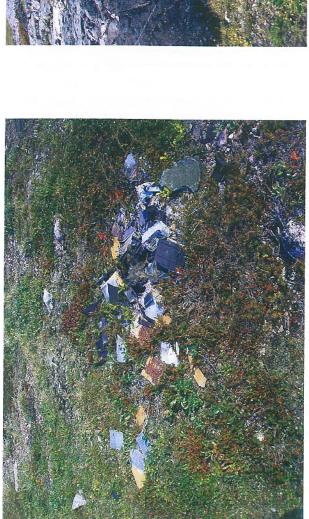
The only potentially hazardous material that was observed at the site consisted of a small number of broken open lead acid batteries also located in the former camp area.

Photo 52: Waste lead acid batteries at camp site

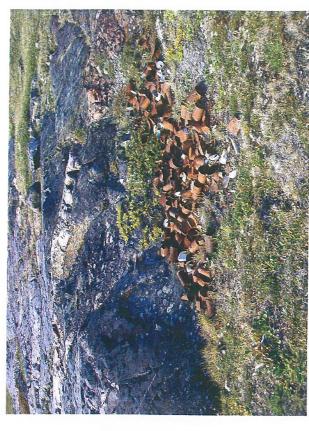
Photo 53: Pile of tin cans at former camp site
