**ROBERTS BAY AND IDA BAY
ABANDONED MINE SITES
GEOTECHNICAL ASSESSMENT IN SUPPORT OF
THE SITE REMEDIATION PROGRAM**

**Public Works and Government Services Canada
Environmental Services, Northern Contaminated Sites
Edmonton, AB**

**WX15131
January 2007**

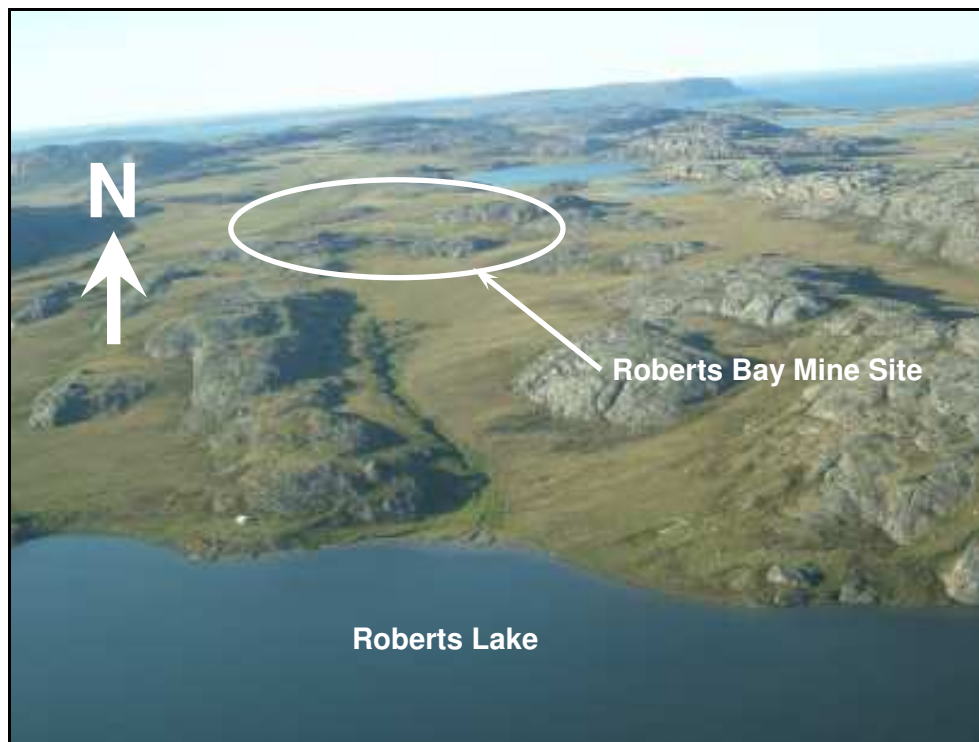
The Roberts Bay abandoned silver mine is located approximately 1 km north of Roberts Lake. (see Figure 1). A trail leads from the lakeshore of Roberts Lake to the mine site following the crest of a basaltic ridge. The mine site itself is located on and between two basaltic ridges, which run north-south. The site between the ridges occurs on a subtle crest primarily sloping southward and draining between the ridges into Roberts Lake. Parts of the mine site are located north of the crest, potentially draining to the north and subsequently westward into Melville Sound. The low areas between the basaltic ridges are underlain with a coarse textured glacial till with permafrost found about 1.2 to 1.5 m below surface.

Figure 1: Roberts Bay mine site with Roberts Lake in the forefront. Aerial view looking north.

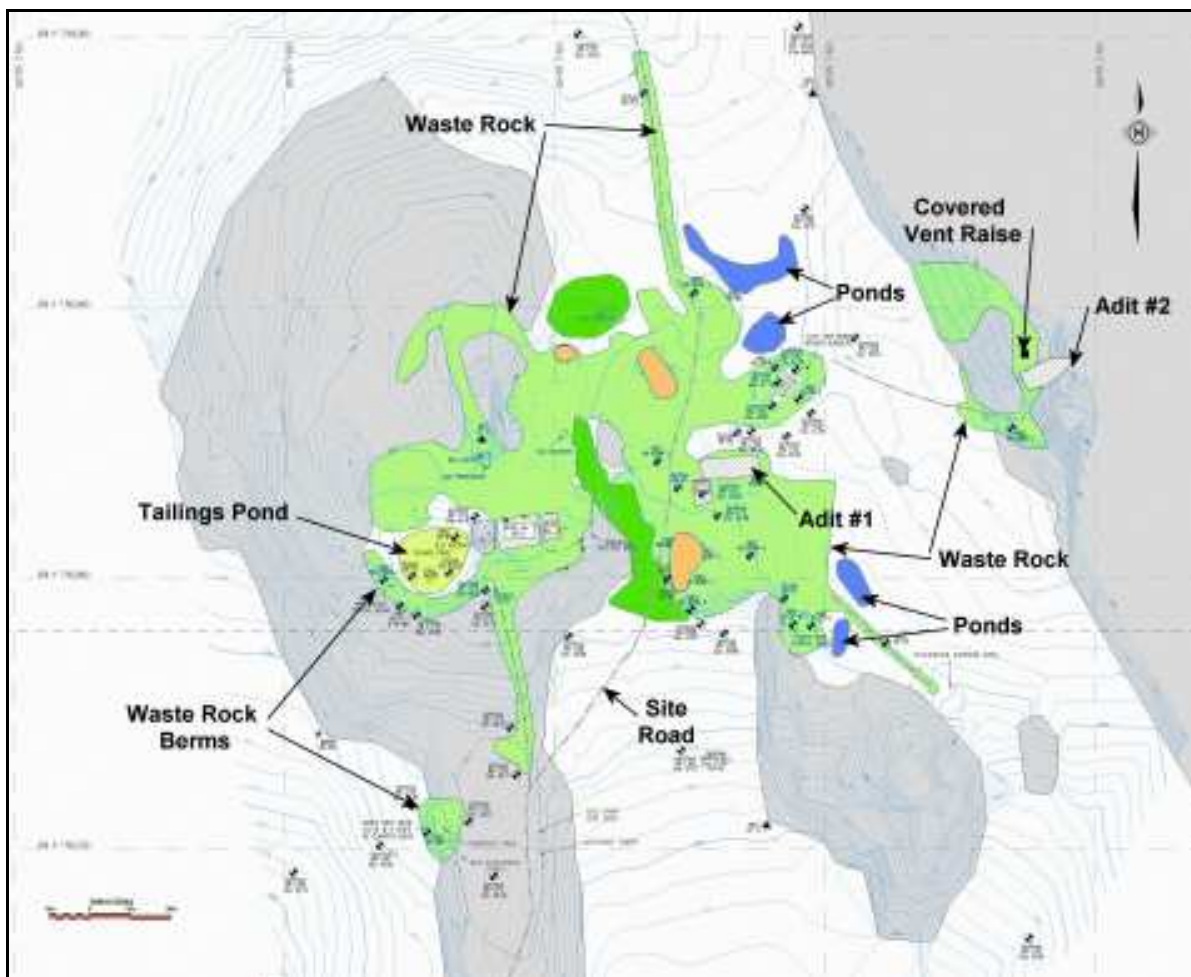
Due to the abandonment of the mine site, most of the infrastructure was left in place and could be observed around the site (Photo 2 and 3, Figure B2, Appendix B). Aside from the equipment and the remaining buildings (presented under a separate cover), the following main mine workings and features remaining at the site were identified (Figure 2):

- Mine openings. Two adits and a capped vent raise were identified at Roberts Bay mine site. Both adits were left open and partially blocked with waste rock (Photos 6 to 11, Figures B4 to B6, Appendix B). The vent raise appears to be recently concrete capped. Detailed information on the mine openings is presented in Section 5;

- Waste rock berms. Waste rock was used to provide containment and berm support for the landfill site, the fuel bladder, and the tailings pond (Photos 12 to 14, Figures B7 and B8, Appendix B). In general, berms were fairly small in height, low lying, and ranging from 0.5 m at the fuel bladder to 3 to 4 m at the tailings pond;

- Tailings pond. The tailings pond was observed to be fairly small in size, approximately 40 m in diameter (Photos 15 to 19, Figures B8 to B10, Appendix B). The pond was built on the west side of the site, using a wraparound rockfill berm against a ridge (hillside type of impoundment). The total volume of the tailings pond was estimated at approximately 1800 m³. The berm appears to have been built using local borrow material and rockfill. The presence of a thin polyethylene liner was observed on the upstream slope (Photo 17). The liner was fairly shallow, which suggests that the berm did not effectively contain the decant water. Furthermore, tailings were found downstream of the berm, approximately 20 m to the west of the containment berm. Samples were taken and the confirmation of tailings was based on geochemical testing (samples RBTP-08U and RBTP-08L). At the time of the site reconnaissance, the berm freeboard was measured to be approximately 1.5 m, but the extent of the decant water appears to have risen in the past to near crest level of the berm. From the information available, and noticing that two different types of materials were used for berm construction (local borrow and, on a small area, waste rock), it is most likely that more than one overtopping or a tailings spill occurred at the site, and that efforts had been made to repair the containment system. Tailings material contained over 91% fines fraction (silts and clays) to the south, while the areas to the west and east were classified as sandy materials with only 16% and 30% fines content, respectively. Five tailings samples (three of which were Shelby tubes) were collected from within the

Figure 2: Location of main geotechnical features at Roberts Bay mine site.

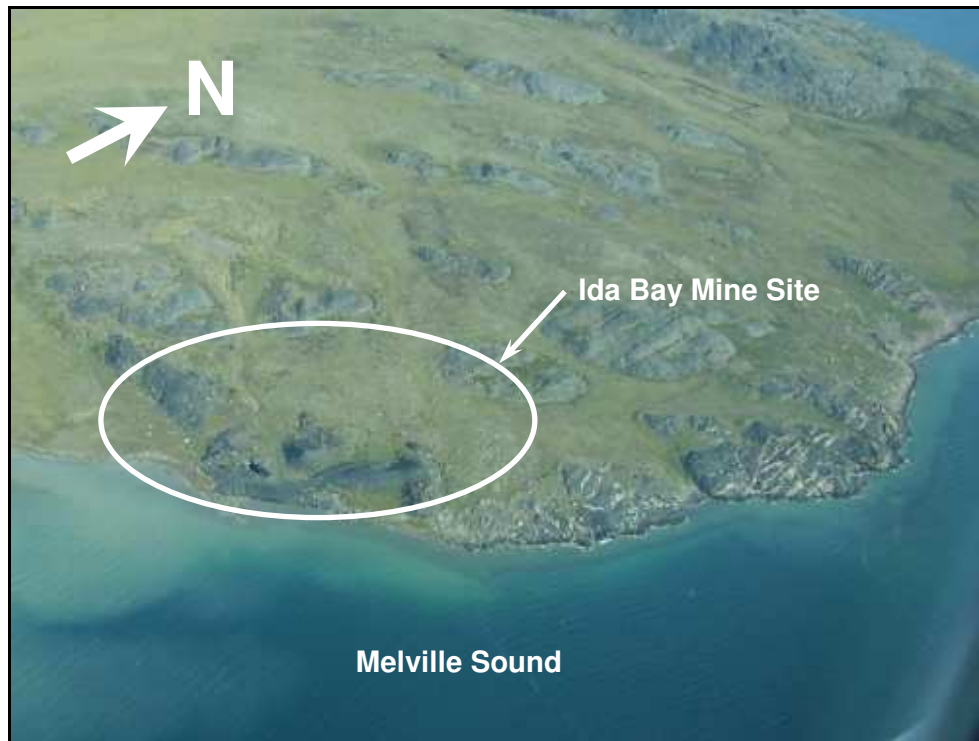
The Ida Bay mine site is located on the north shore of Ida Bay on the Melville Peninsula adjacent to Melville Sound about 6.2 km north of the Roberts Bay site (Figure 3; Sheet 1 of 4, Appendix A). The area is located on a basaltic outcrop with north/south striking ridges. Adjacent to the outcrop are low-lying marshes underlain by coarse textured glacial till. The site drains towards the southeast and east directly into the Melville Sound, which is part of the Arctic Ocean water system.

Figure 3: Ida Bay mine site. Aerial view looking northwest.

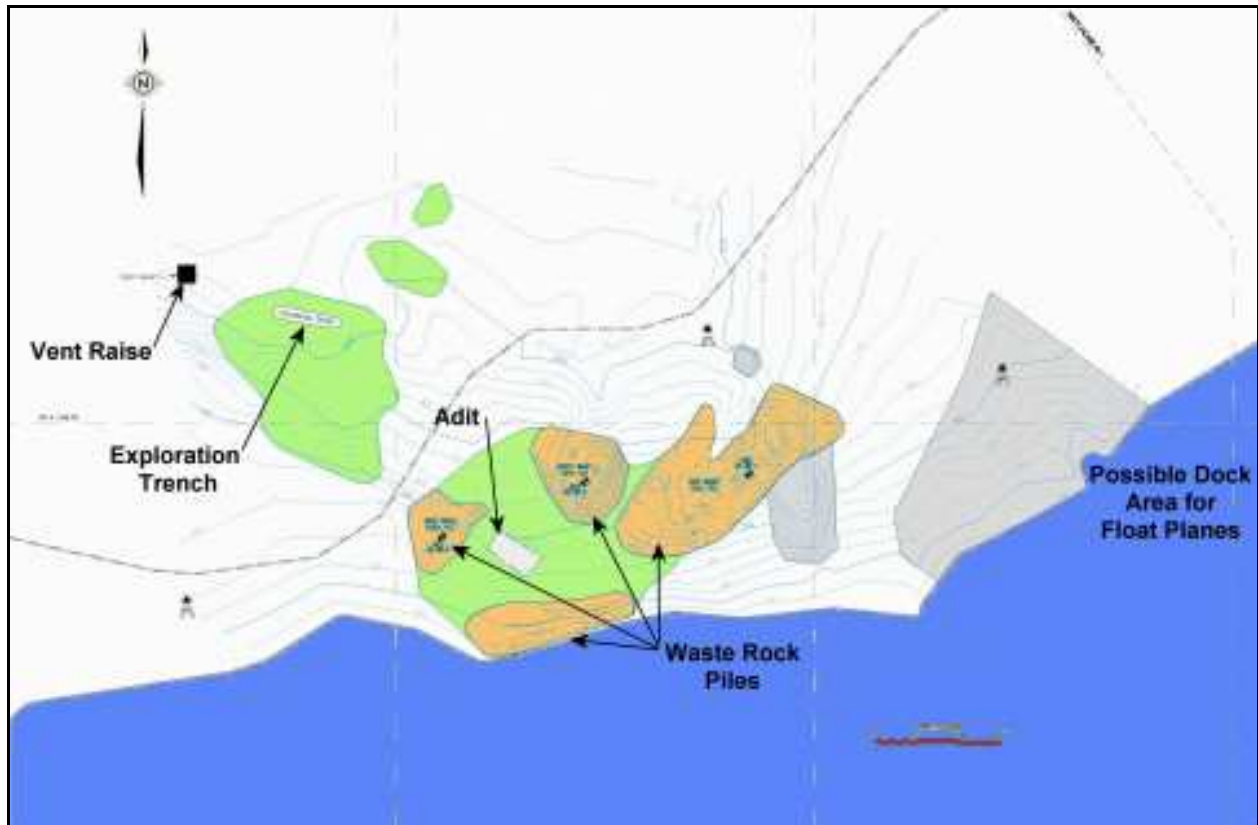
- Waste rock piles. Four main waste rock piles were identified at Ida Bay, having a total estimated volume of 2,500 m³ (Photos 24 and 25, Figure B13, Appendix B). The waste rock piles are all located in the vicinity of the adit, and is dominated by black fine-grained basalt containing small amounts of pyrite in fractures and thin veins of quartz and pink granite (Photos 26 and 27, Figure B14, Appendix B). The composition of the waste rock from across the site was essentially similar. There is no visible oxidation staining, and all waste rock materials are well consolidated with stable slopes. The waste rock pile closer to the north shore extends into the marine waters and could be partially covered by seawater at high tide. The waste rock piles were of small size, with a maximum height of 4 m, and slopes at the angle of repose were observed to be fairly stable;

- Mine openings. There was only one adit, a vent raise and an exploration trench at Ida Bay. The adit was not fenced and was partly submerged. The vent raise was small in size but open. The exploration trench was approximately 1 m deep and 5 to 8 m long. These features are shown in Photos 28 to 31, Figures B15 and B16, in Appendix B. Detailed information on the mine openings is presented in Section 5.

Figure 4: Location of main geotechnical features at Ida Bay mine site.

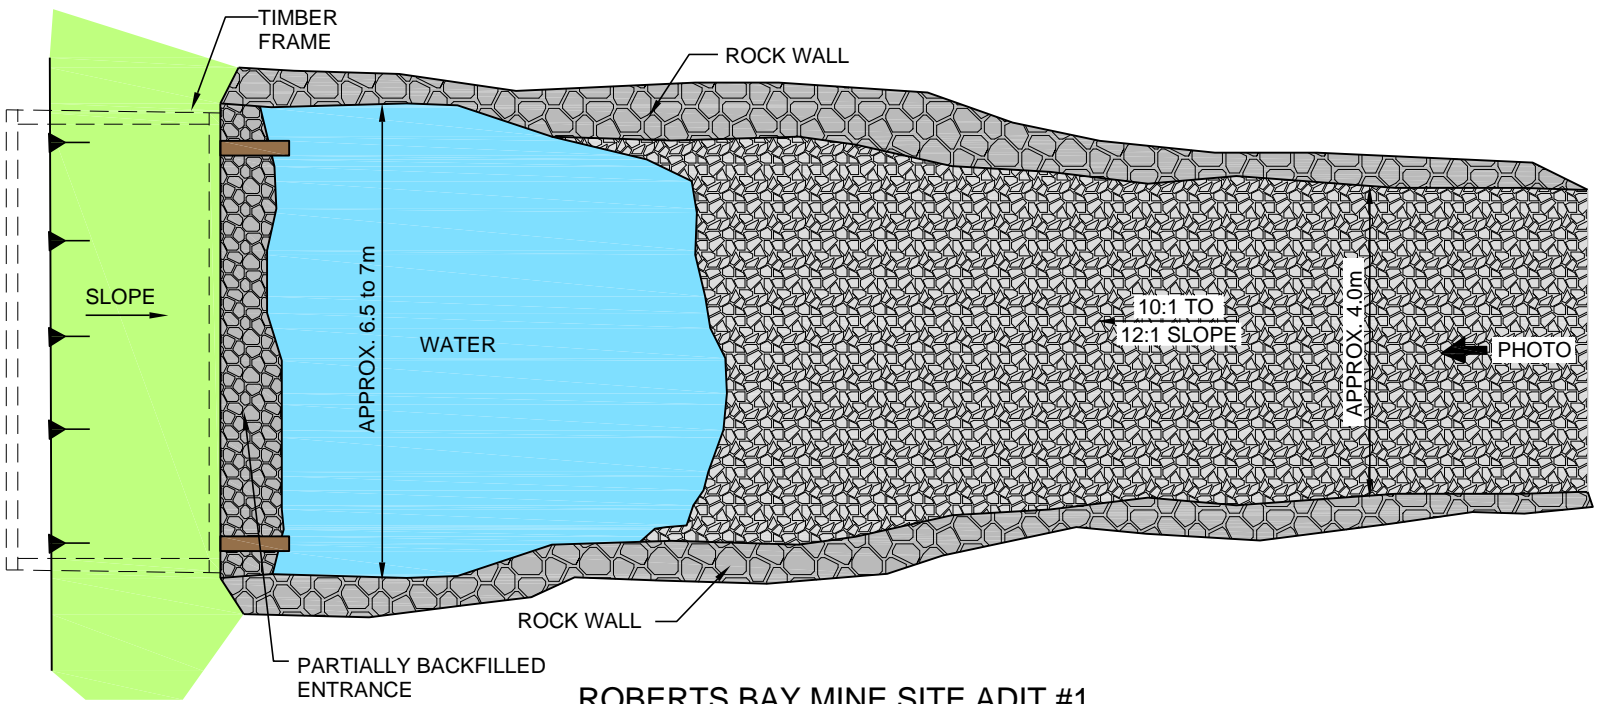
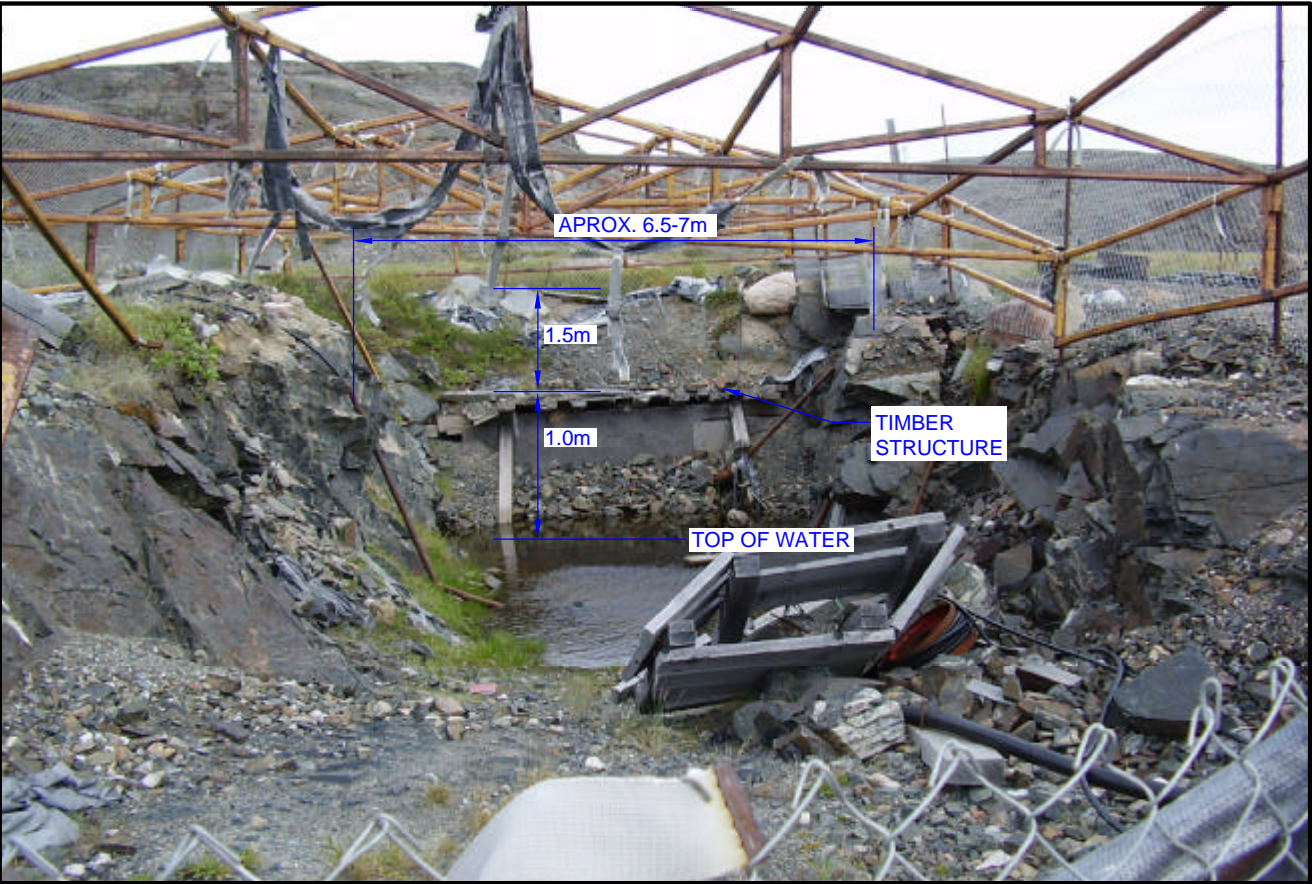
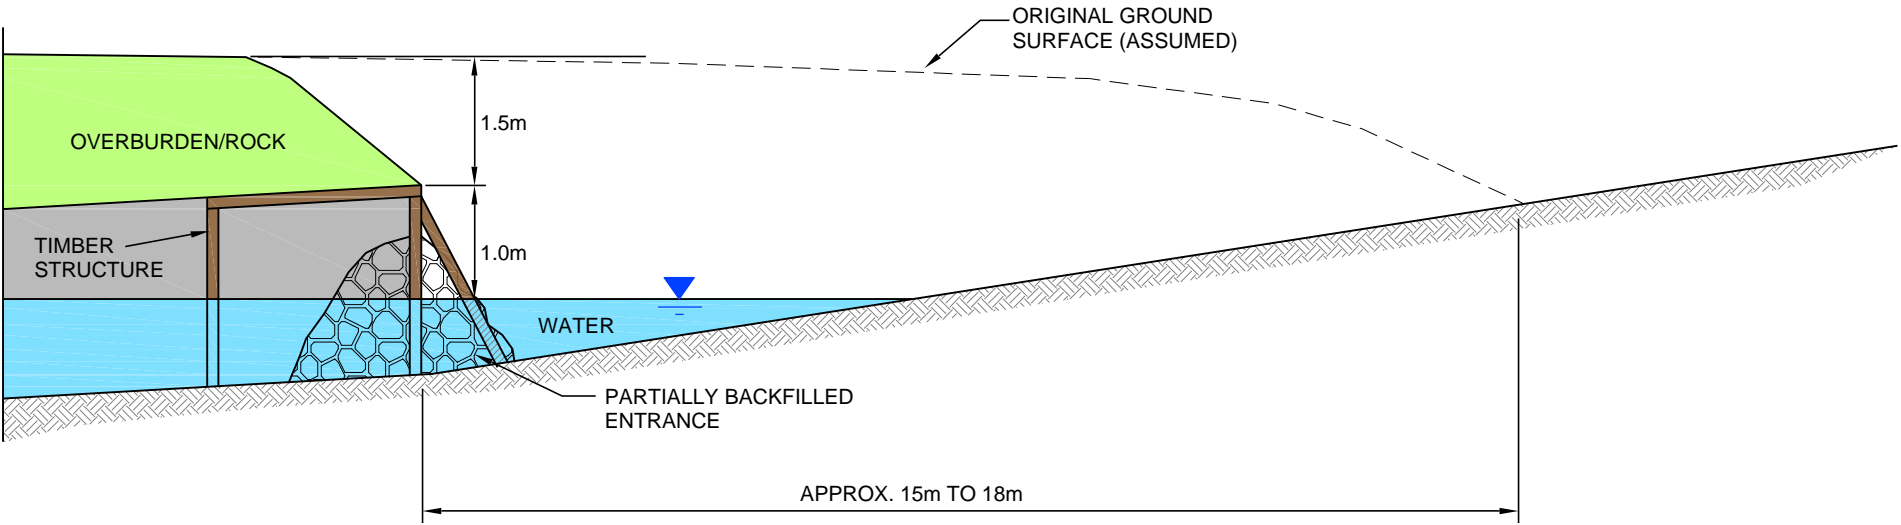
ROBERTS BAY MINE SITE ADIT #1

Adit #1 is centrally located at the Roberts Bay mine site (Figure 2, and sheet 2 of 4, Appendix A) and is oriented in an east-west direction. Figure 5 presents a plan view, a front view of the entrance, and a longitudinal cross section through the adit and the ramp. The ramp is approximately 5 to 7 m wide, 15 to 18 m long and slopes at 5H:1V.

At the time of the site reconnaissance, the adit was 1/3 filled with water and the access ramp was partly blocked by debris. A portion of the adit entrance was boarded and backfilled. A timber structure supported the back of the adit, which was measured to be approximately 1.5 m thick. The adit back appeared to be overburden material supported by the timber structure within the adit. The adit entrance (the opening) was estimated to measure approximately 2.2 to 2.5 m in height.

Adit #1 was at one time covered by a tubular tent-like steel structure, anchored in the rock, and left in place. Textile cover material has been destroyed over time. The adit entrance was observed to have rock slopes that were fairly steep, blocky in nature, and relatively stable. Rock joints were observed to follow an orthogonal pattern, with the main joint set dipping at 20 to 30 degrees to the west. Several blocks of rock, 0.6 by 0.4 by 0.5 m in size, were found to be in an unstable position. The north wall of the ramp was partly covered by fine grained (overburden) material.

- The mine openings were all partly flooded. Some were partly backfilled. Side walls were found to be stable, however back collapse could become a potential problem if not properly addressed. Controlled blasting of the adit backs, followed by backfilling with non-acid generating materials are the preferred alternative for a safe remediation of all three main mine openings;

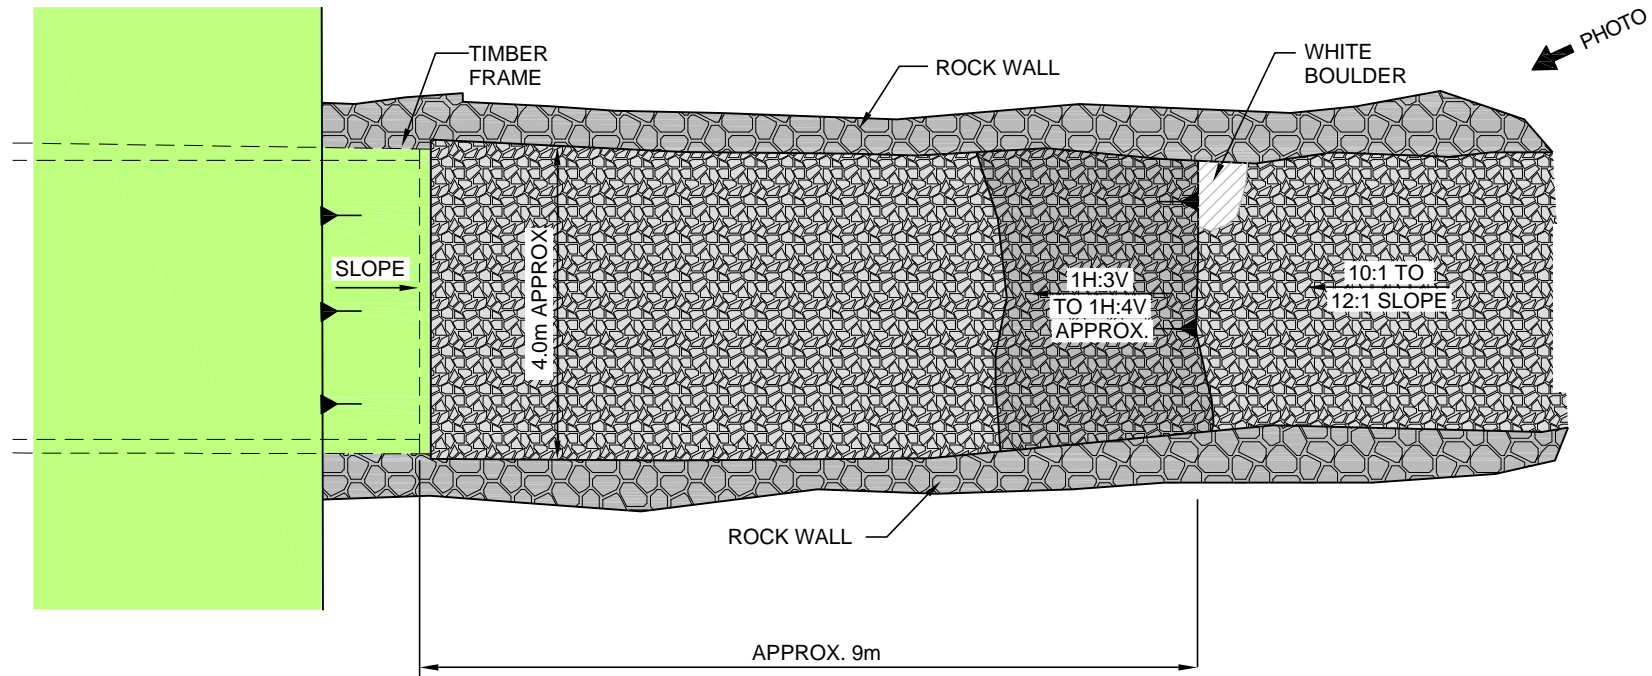
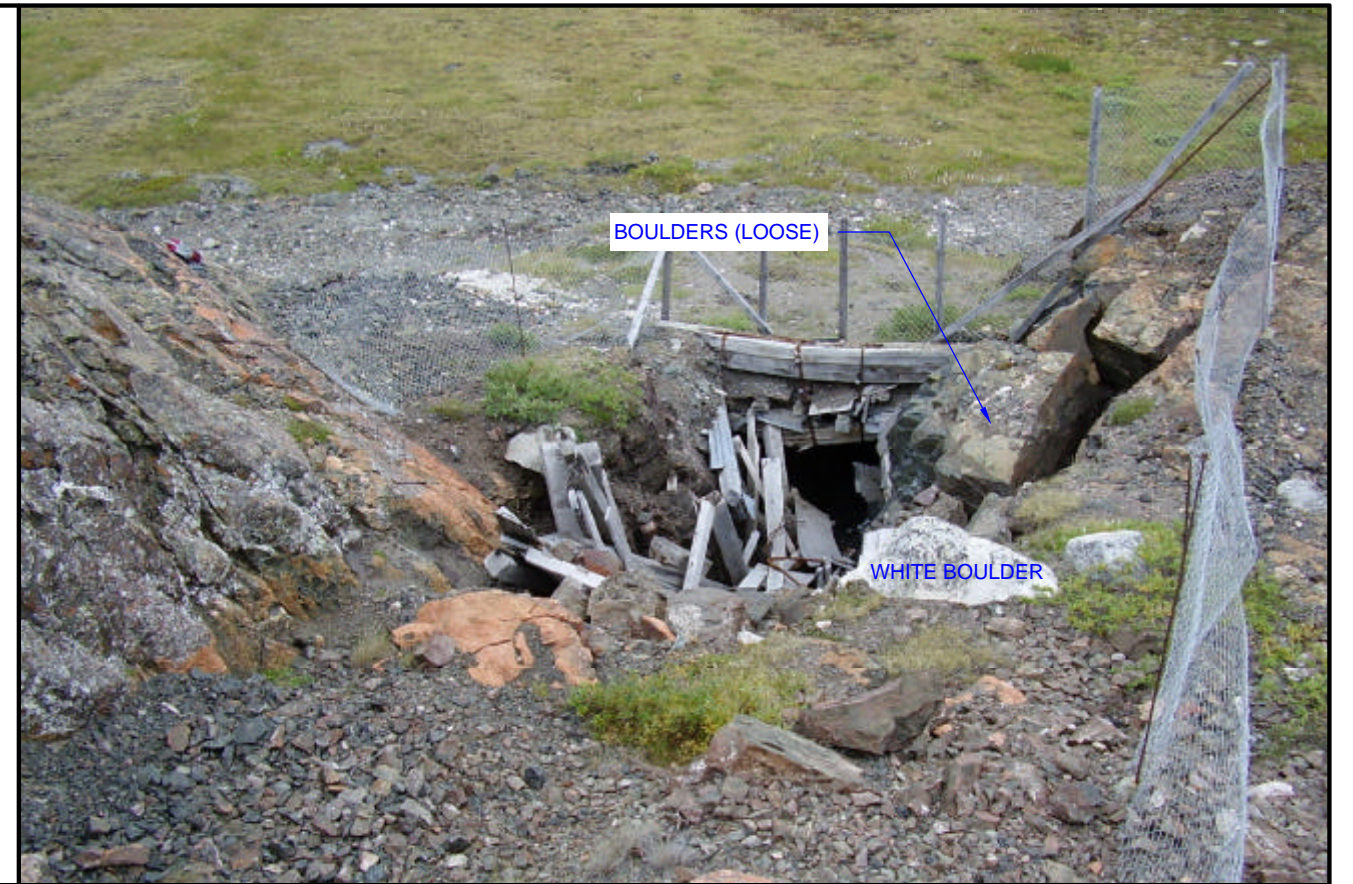
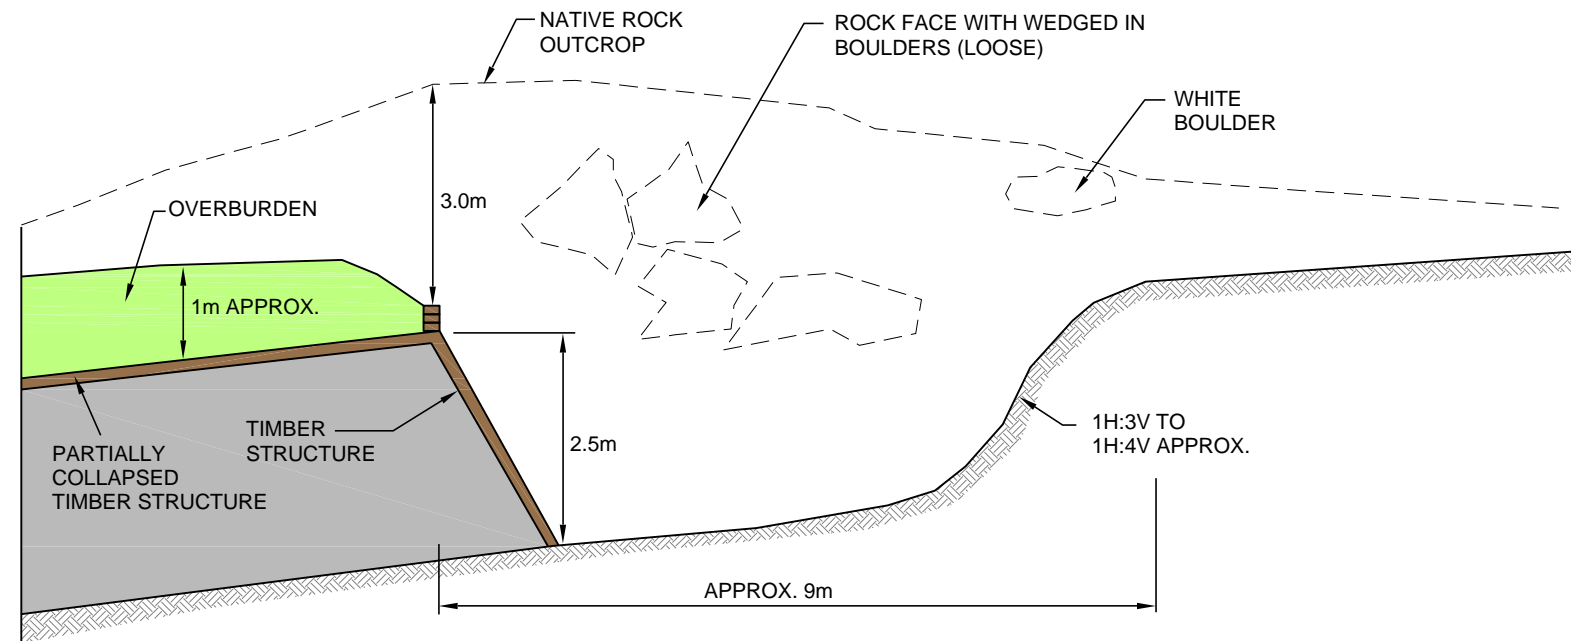
ROBERTS BAY MINE SITE ADIT #2

Adit #2 is located on a ridge on the east side of the Roberts Bay mine site (Sheet 2 of 4, Appendix A) and is oriented in an east-west direction, similar to Adit #1. Figure 6 presents a plan view, a front view of the entrance, and a longitudinal cross section through Adit #2 and the ramp. Adit #2 is not a true adit but rather an adit – shaft combination. The entrance is fairly steep, measuring approximately 9 to 10 m in length, 4 m wide, and sloping at 10H:1V at the far end, and 1H:4V closer to the entrance.

At the time of the site reconnaissance, the adit was not filled with water. The steep portion of the ramp was partly blocked by debris, the entrance was partly backfilled, and a deformed and unstable timber structure was supporting the adit back. The adit structure, approximately 1 m thick, appeared to be made of overburden material supported by the timber structure farther inside the adit. Stability problems with the entrance to the adit and cave-ins of the rock and overburden surrounding the shaft were observed. The adit entrance (the opening) was estimated to measure approximately 2.5 m in height.

The adit entrance was observed to consist of fairly steep side slopes up to 6 m above the floor of the entrance and comprised of rock with a blocky structure. Rock joints were observed to have variable orientations. Several blocks of rock up to 1 m by 1m in dimension were noted to

be in an unstable position, mainly on the north side wall. Adit #2 was partly fenced, but is still accessible to wildlife and the public.

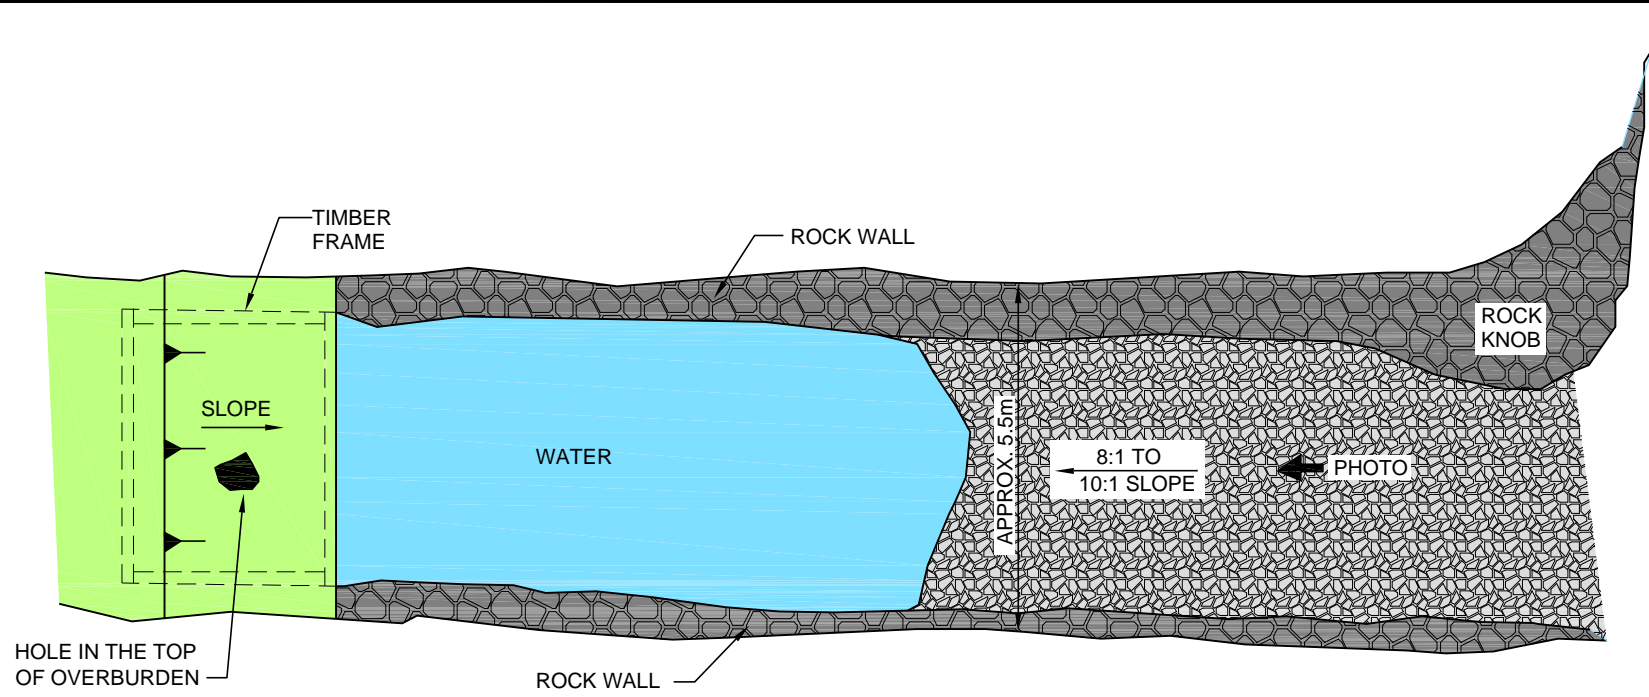
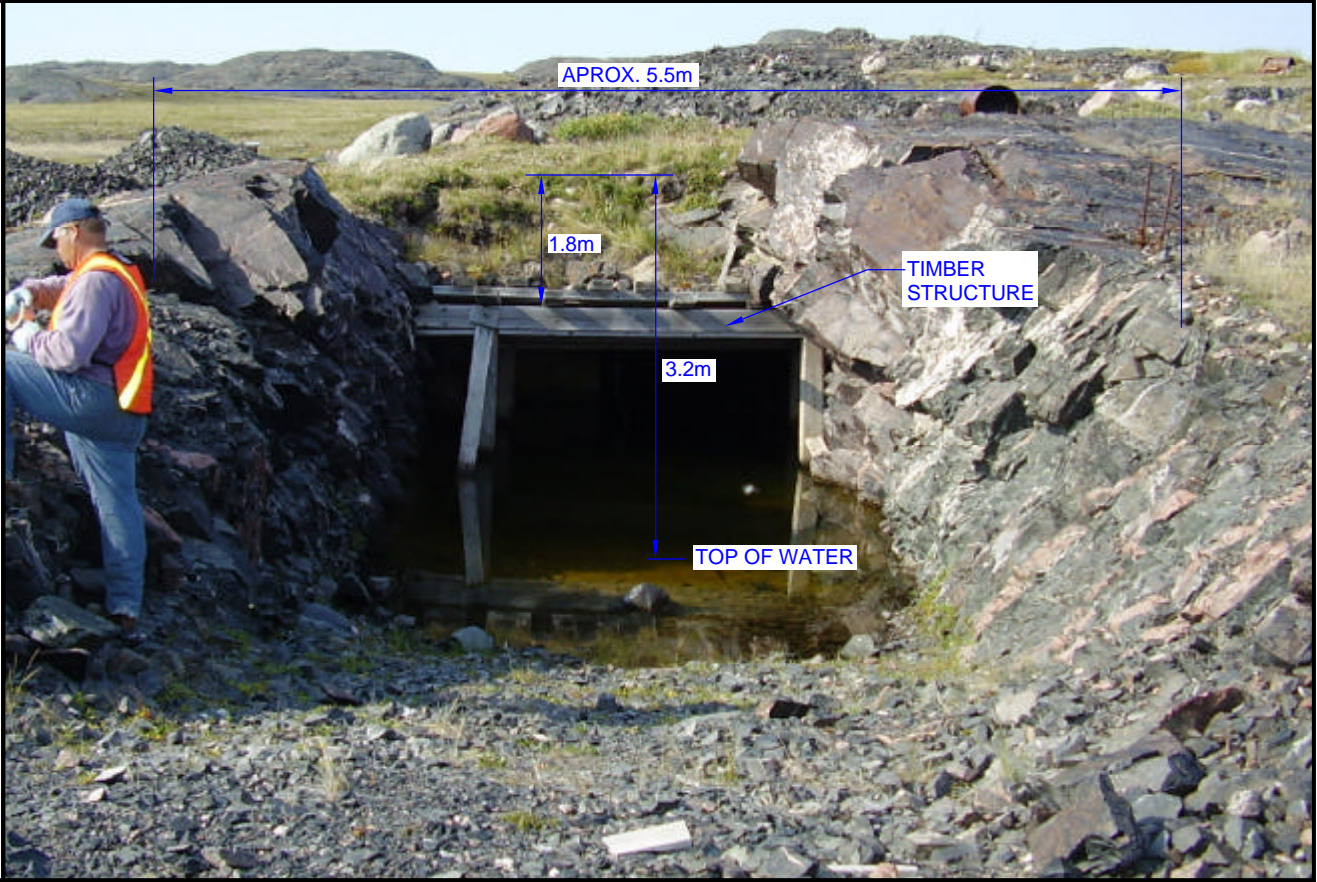
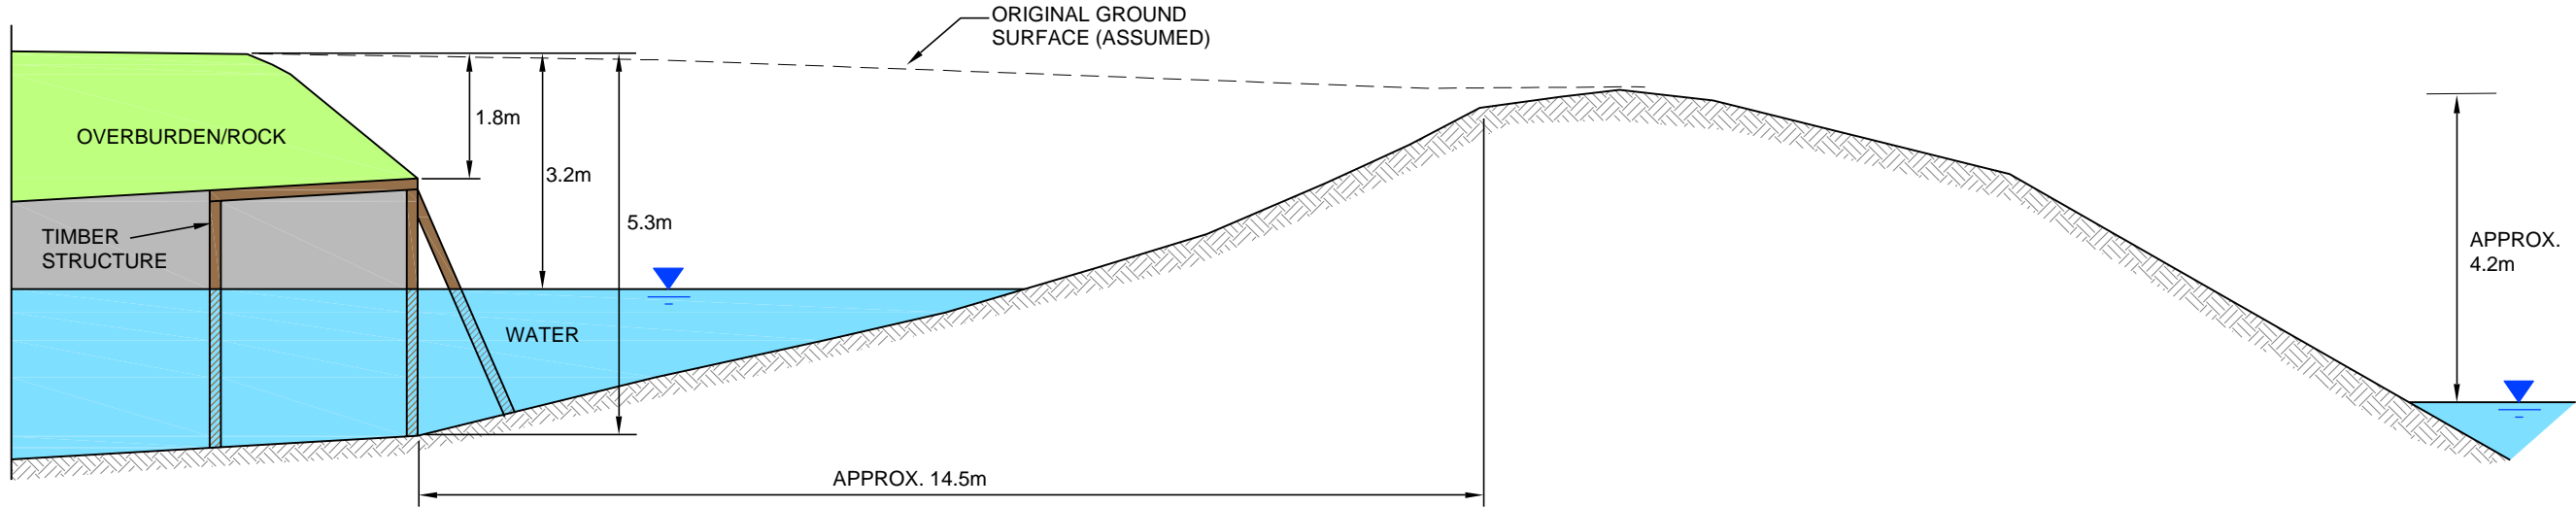
IDA BAY MINE SITE ADIT PLAN

Ida Bay Adit is located approximately 30 m away from the north shore of Ida Bay mine at Melville sound (Sheet 4 of 4, Appendix A) and is oriented in a north-south direction. Figure 7 presents a plan view, a front view of the entrance, and a longitudinal cross section through the adit and the ramp. The ramp is approximately 5.5 m wide, 15 m long and slopes at 2.5H:1V (overall slope).

At the time of the site reconnaissance, the adit was half filled with water. The adit entrance was not backfilled and a timber structure supported the adit back, which was measured to be approximately 1.8 m thick and comprised of overburden. A hole was observed in the back of the adit, and it appeared unstable.

The adit entrance (the opening) was estimated to measure approximately 3.0 to 3.5 m in height with side slopes that were observed to be comprised of fairly steep, blocky and stable rock. Rock joints were observed to dip around 32° and strike 68° to the north. Thick veins (8 to 9 cm) of quartz and reddish pink granites alternating with green and gray coloured granitic rocks were observed on the rock faces of the side walls. Overhanging boulders were noted at the entrance.

Ida Bay Adit was neither fenced nor backfilled or blocked.
