**RE: Roberts Bay and Ida Bay Project: 2009 Annual Report for Water
Licence No: 1BR-ROB0813**

NWB Annual Report

Project Name: Roberts Bay and Ida Bay Mine Site Remediation Project

SOME SELECT PHOTOS OF BEFORE AND AFTER REMEDIATION

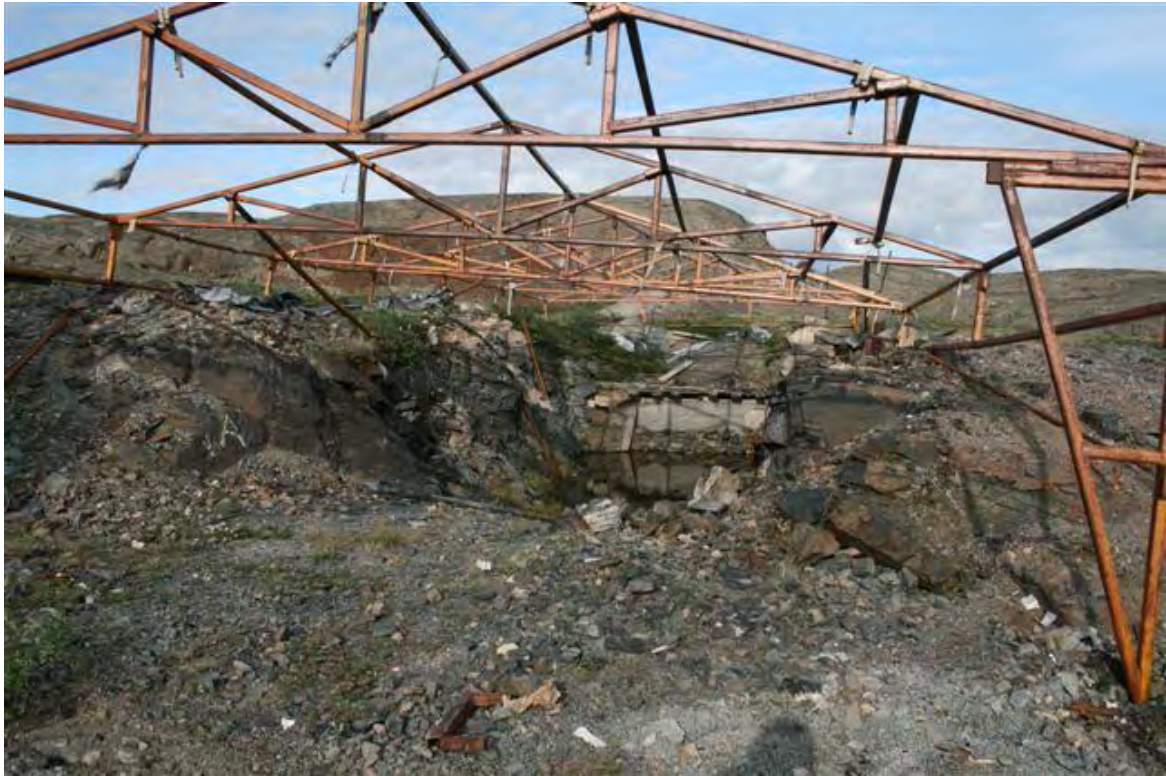
Adit #1 at Roberts Bay prior to remediation

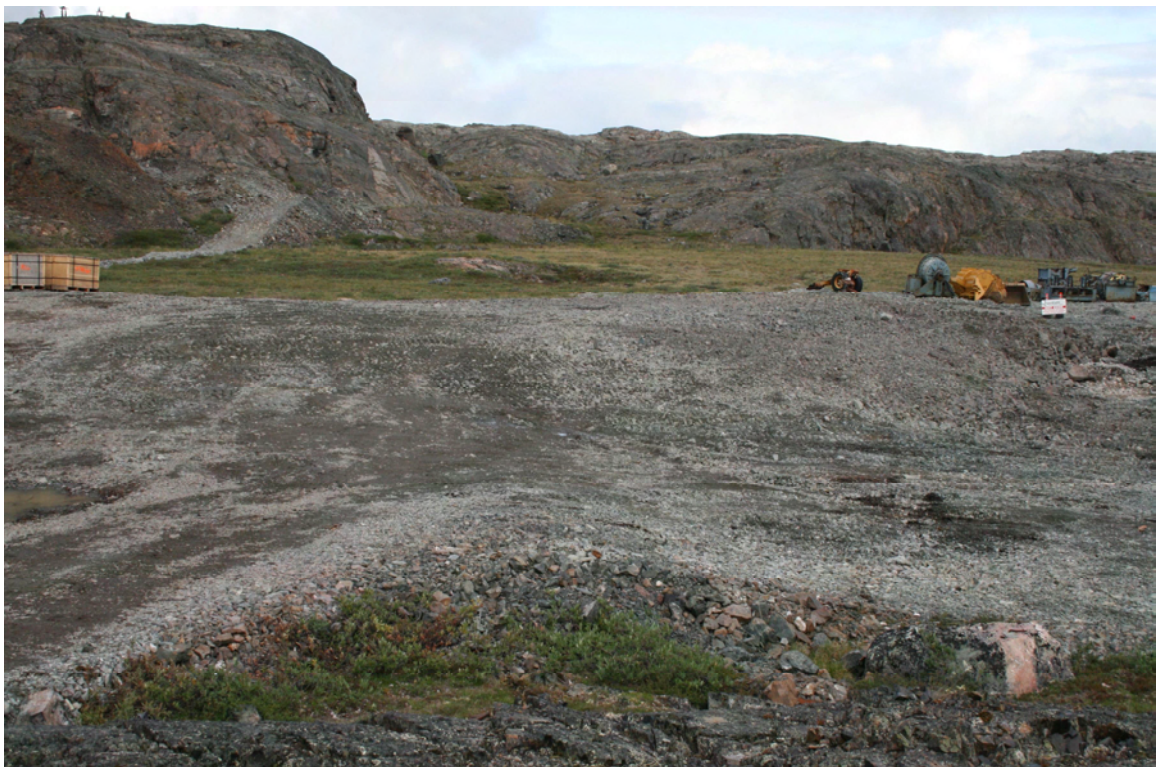
Adit #1 at Roberts Bay post remediation

- ☐ Relocation of equipment and materials by winter mobilization to Roberts Bay;
- ☐ Closure of the two adits at Roberts Bay;
- ☐ Reinforcing the concrete capped vent raise at Roberts Bay by covering with waste rock and grading;

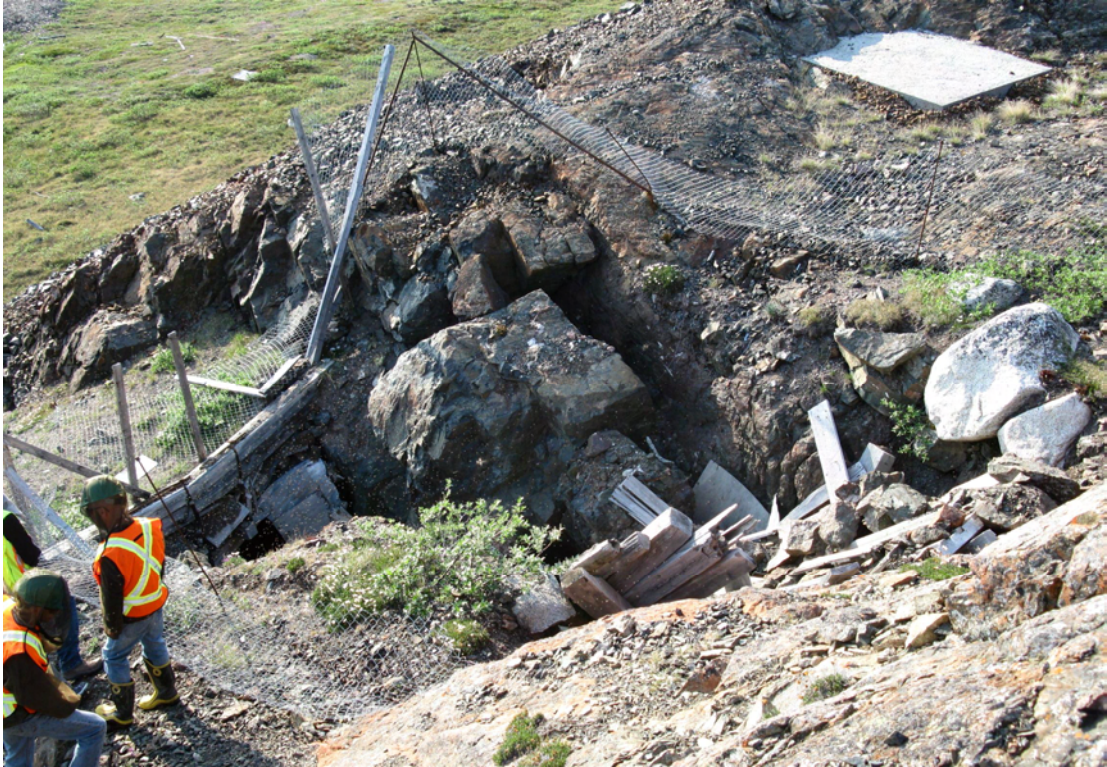
Adit #2 and Vent Raise at Roberts Bay prior to remediation

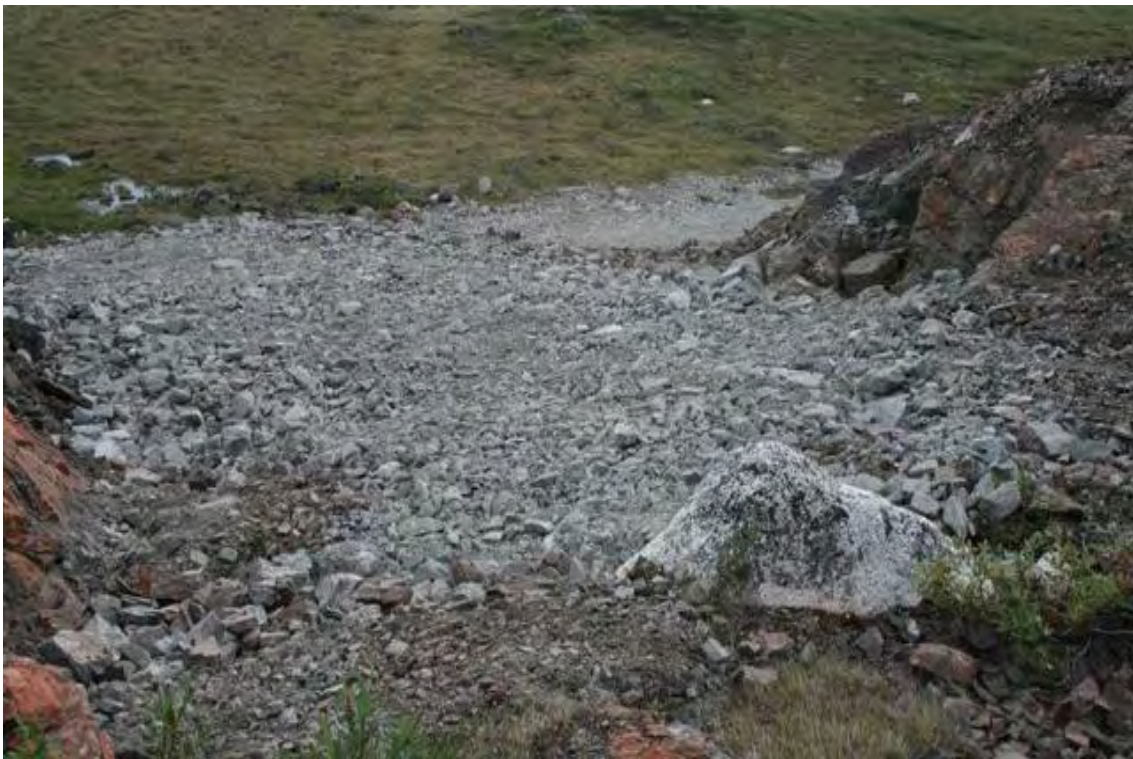
Adit #2 at Roberts Bay post remediation (13 August 2009)

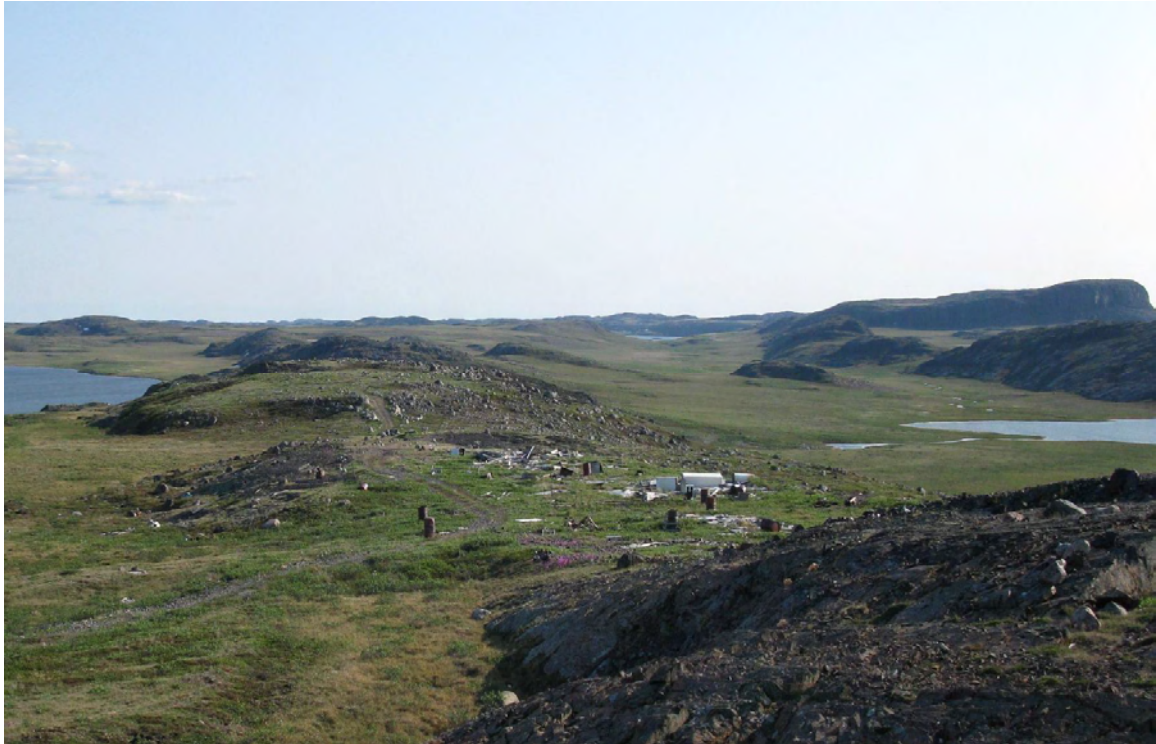
Former Camp Area prior to remediation

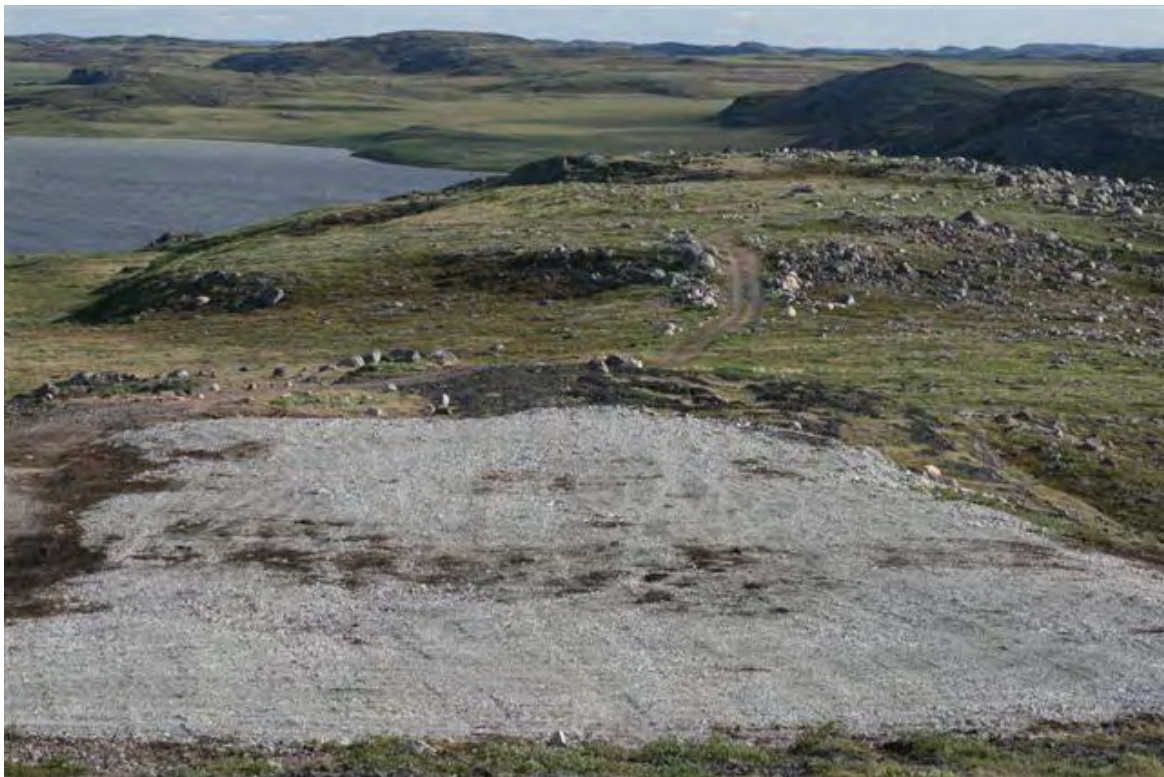
Former Camp Area post remediation

- ☐ Demolition of all site infrastructure (garage, mill structure, former camp area);
- ☐ Collection and disposal of non-hazardous demolition and surface debris in the NHWL;

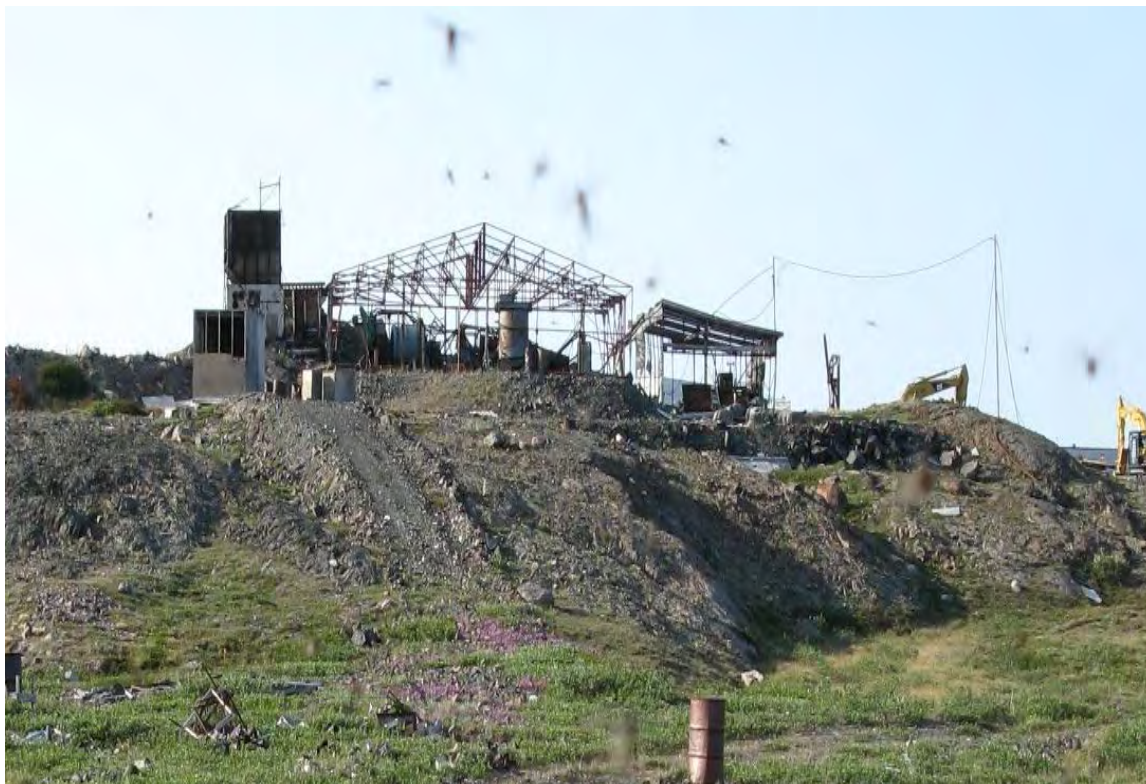
Mill Area prior to remediation

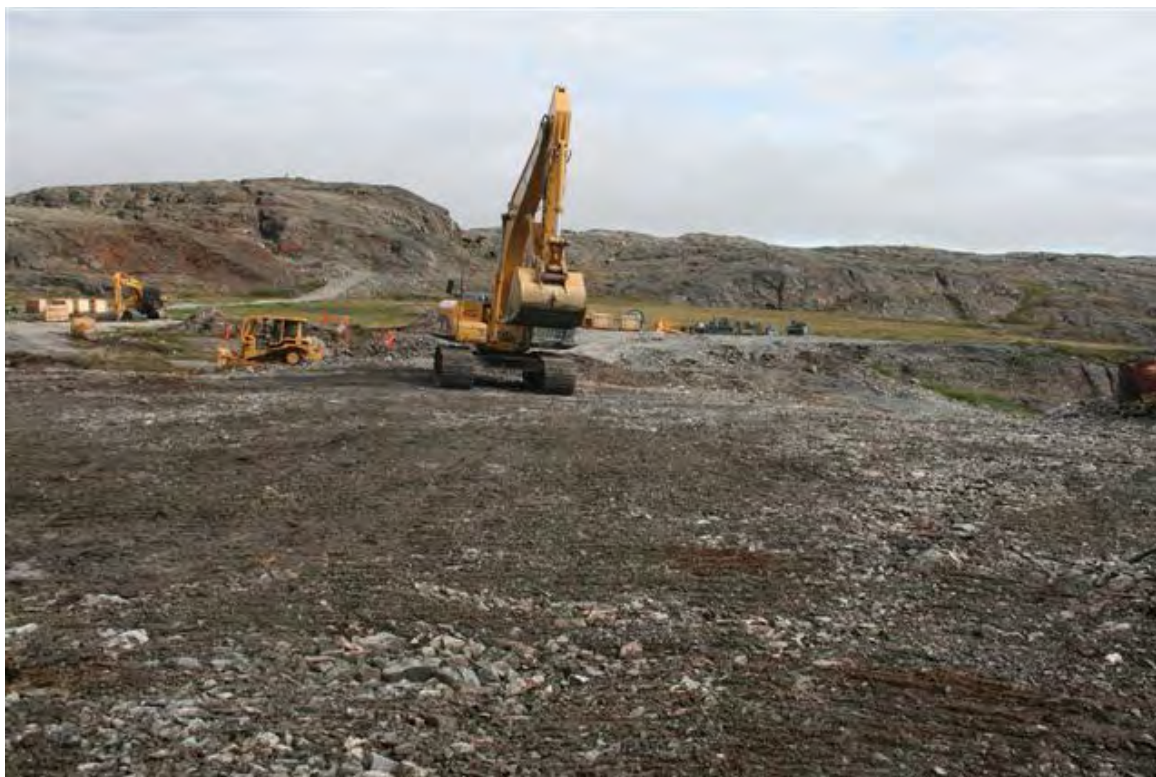
Mill Area post remediation

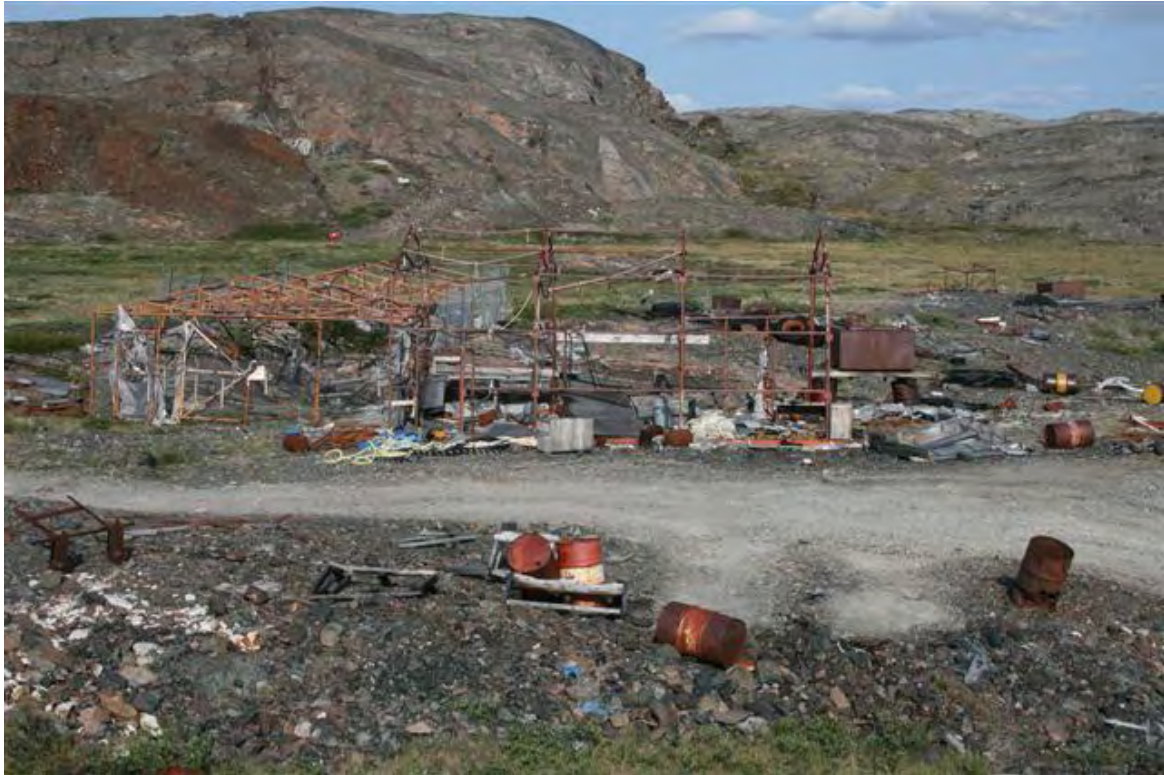
Garage/Machine Shop Area prior to remediation

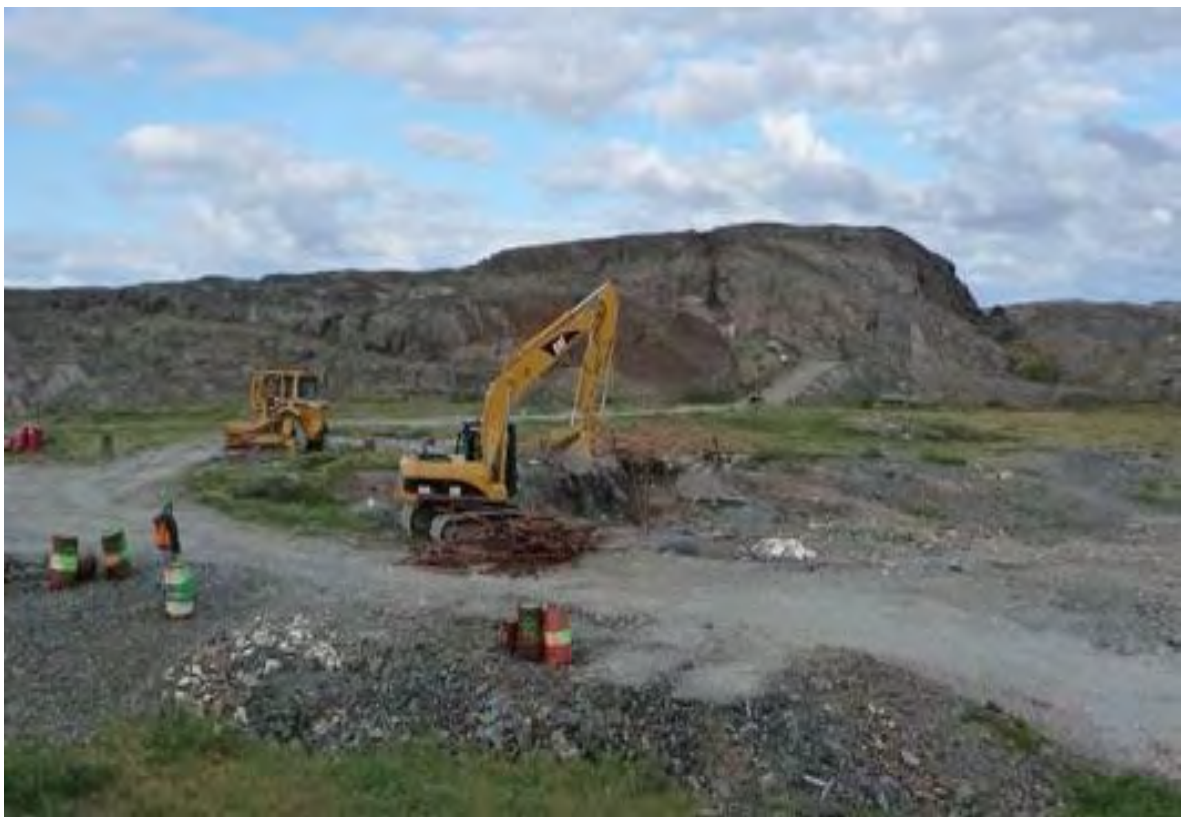
Garage/Machine Shop Area post remediation

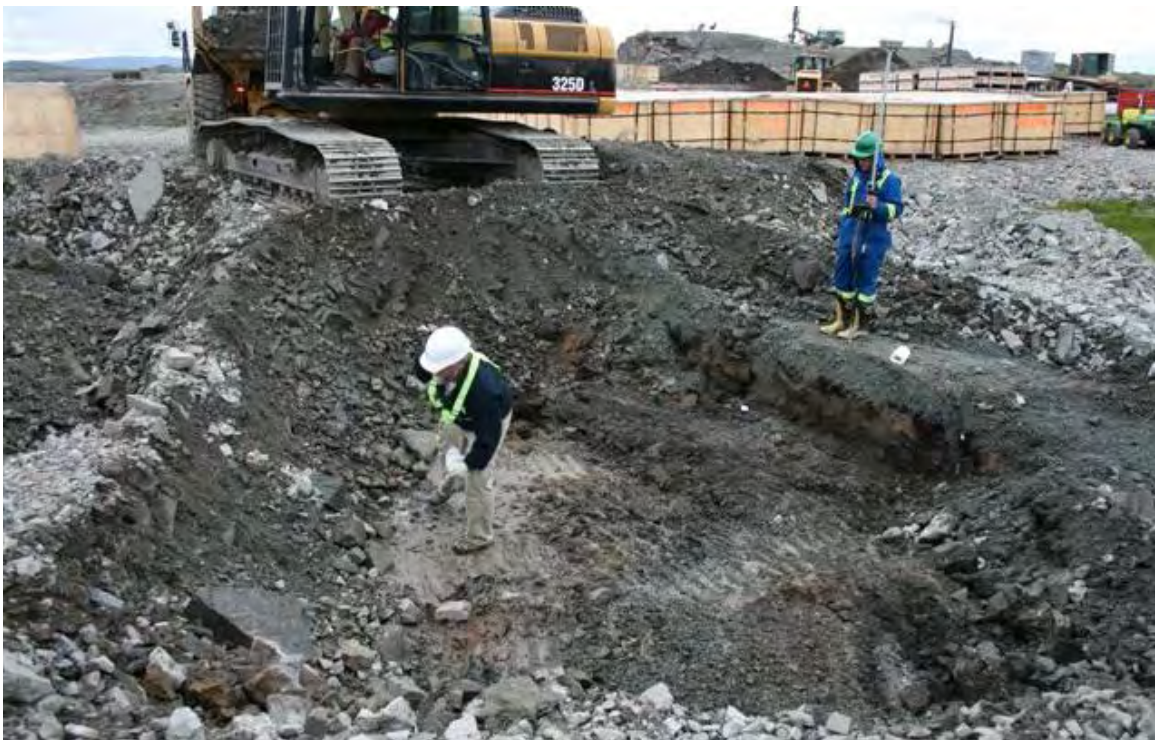
Petroleum Hydrocarbon remediation at the POL Area of Roberts Bay

- ☐ Collection and packaging of 319 m3 of petroleum Hydrocarbon (PHC) impacted soils; and 38 m3 of metal/PHC impacted soils;
- ☐ Tailings pond remediation / Non-hazardous waste landfill (NHWL) construction at tailings pond area (tailings capped in place) as per the Engineer's design;

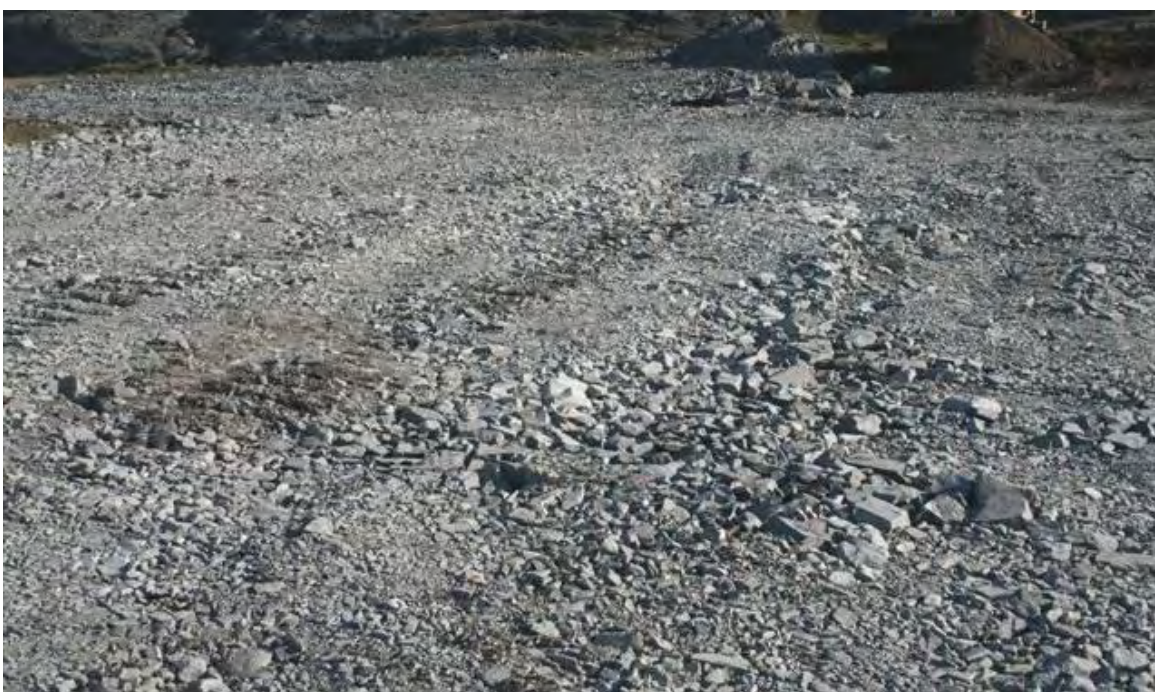
Petroleum Hydrocarbon remediation at the POL Area of Roberts Bay

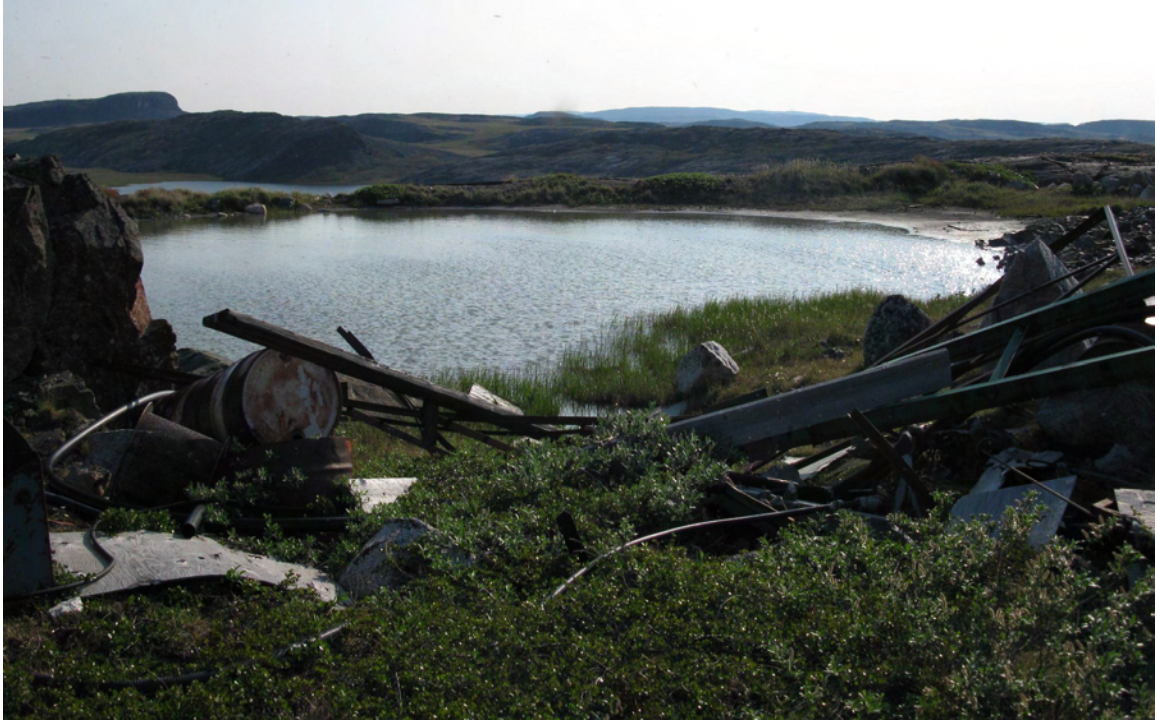
Tailings Containment Area prior to remediation

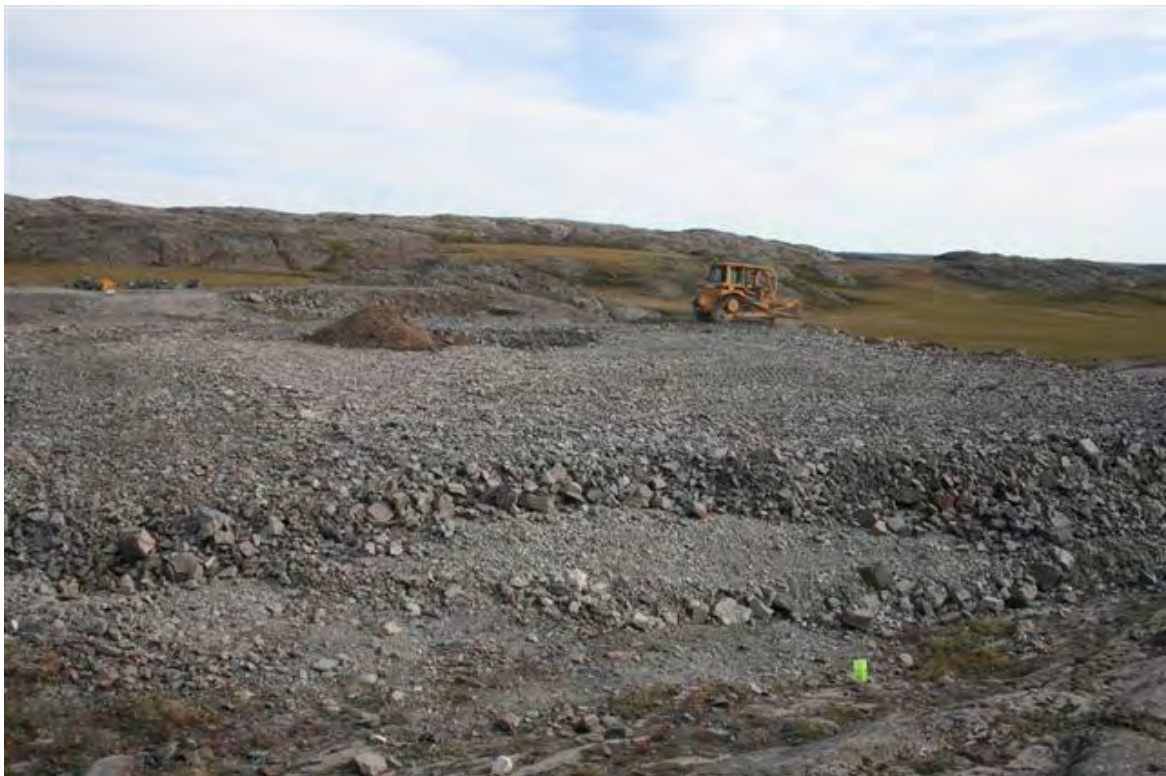
Placement of final cover on Solid Waste Disposal Facility (at the former tailings containment area) – post remediation

- ☐ Non-hazardous waste landfill closure;
- ☐ Collection and packaging of hazardous demolition and surface debris; and
- ☐ Other activities are:
 - Workers orientation seminar;
