NWB Annual Report

Project Name: CAM-F Sarcpa Lake Long-Term Monitoring

APPENDIX 2: LONG-TERM MONITORING 2008 CAM-F DEW LINE SITE, NU

Executive Summary

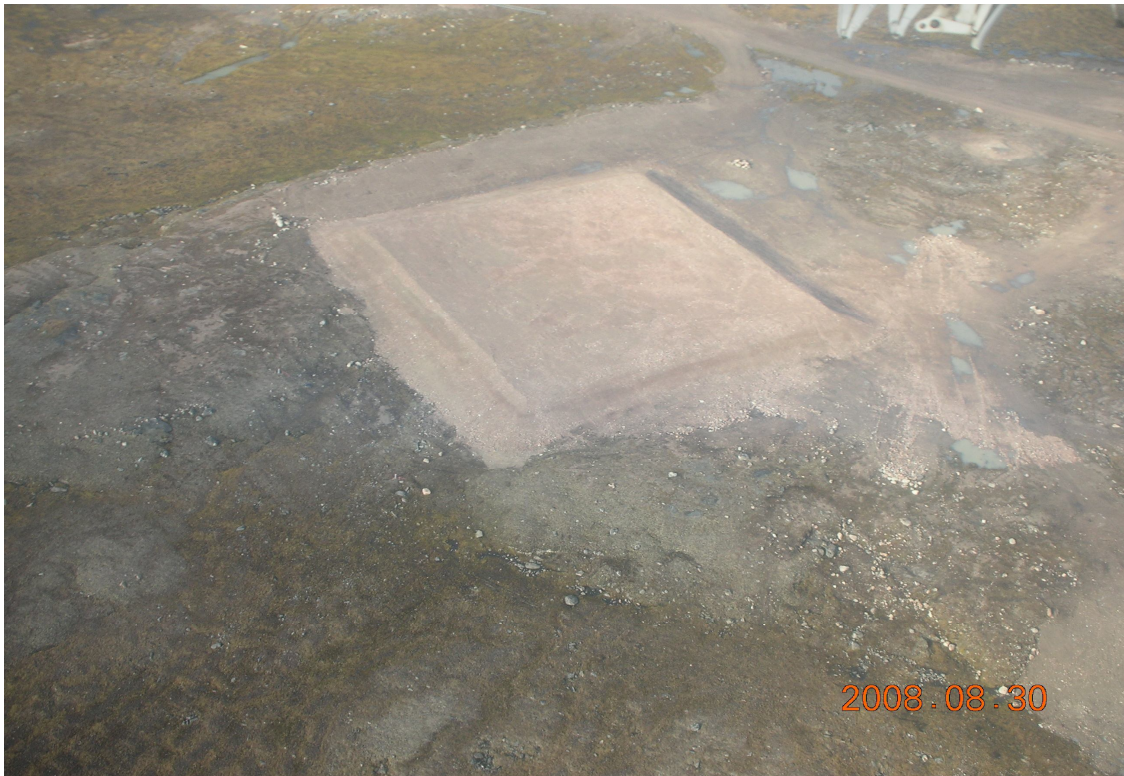
Non-Hazardous Waste Landfill

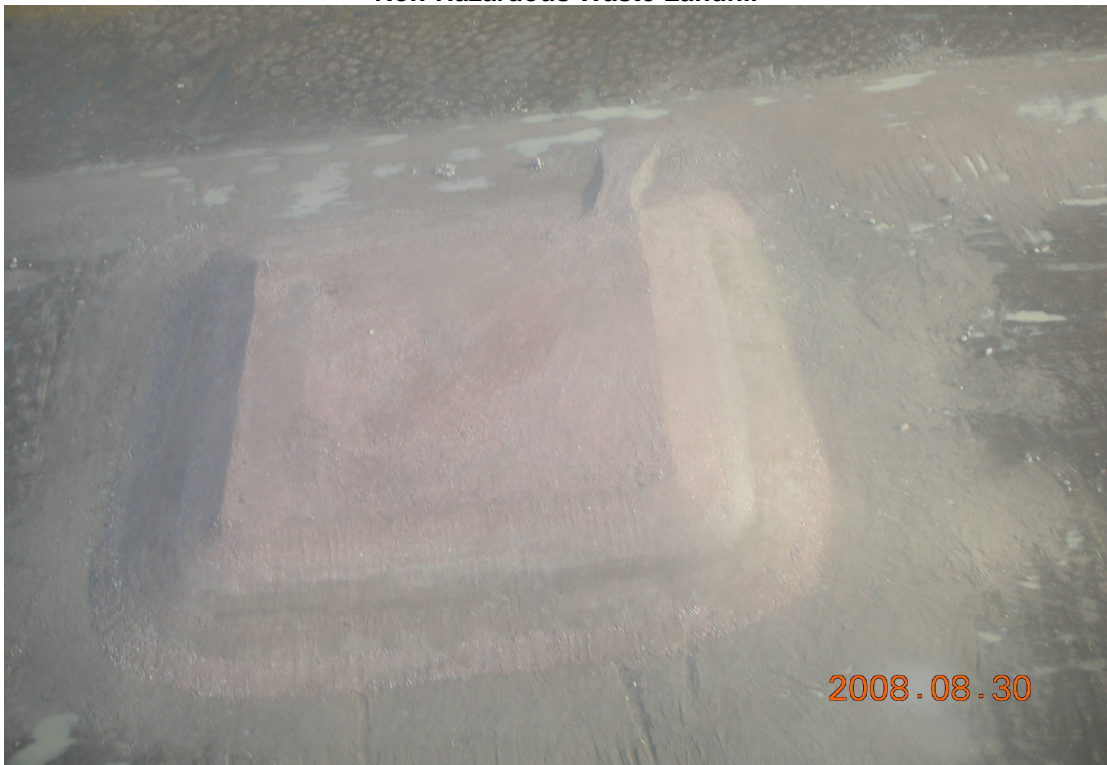
Secure Soil Disposal Facility

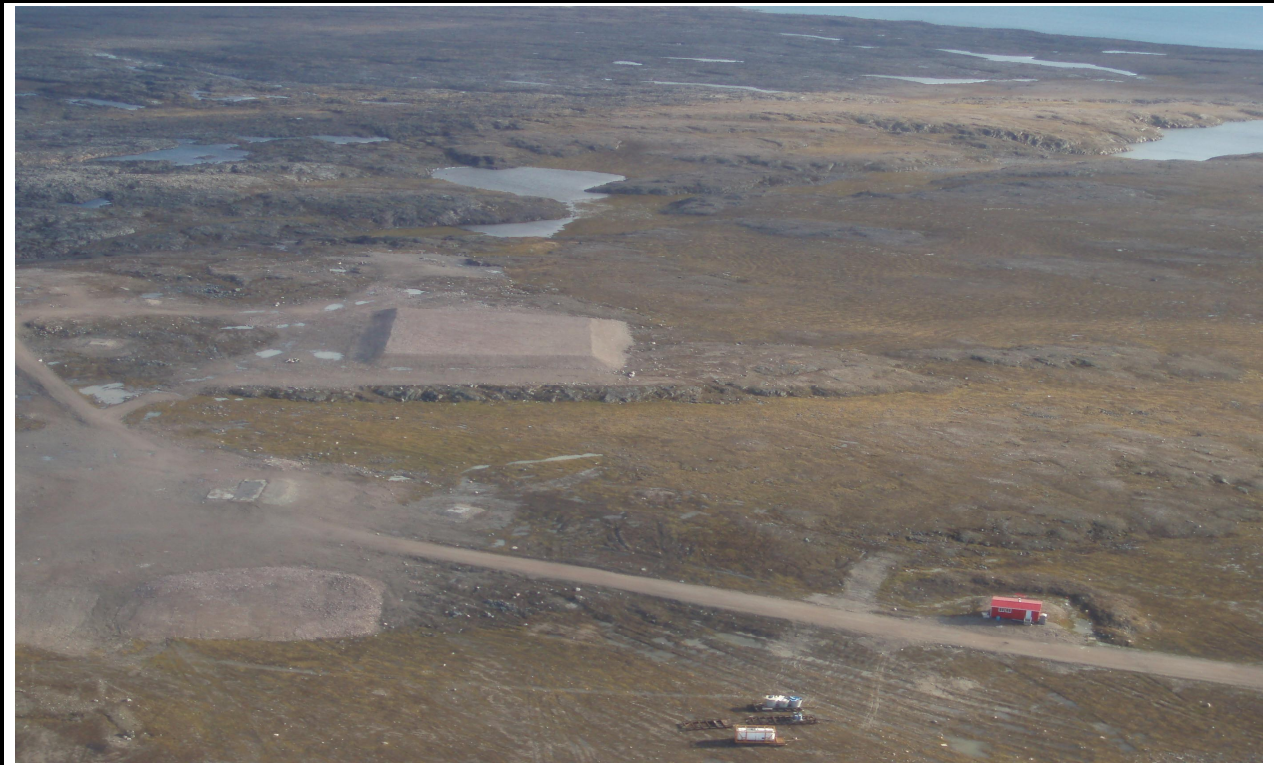
Photo 1: Picture 59 NHWLF – Aerial View of the Landfill, Minor Ponding near the NW Corner

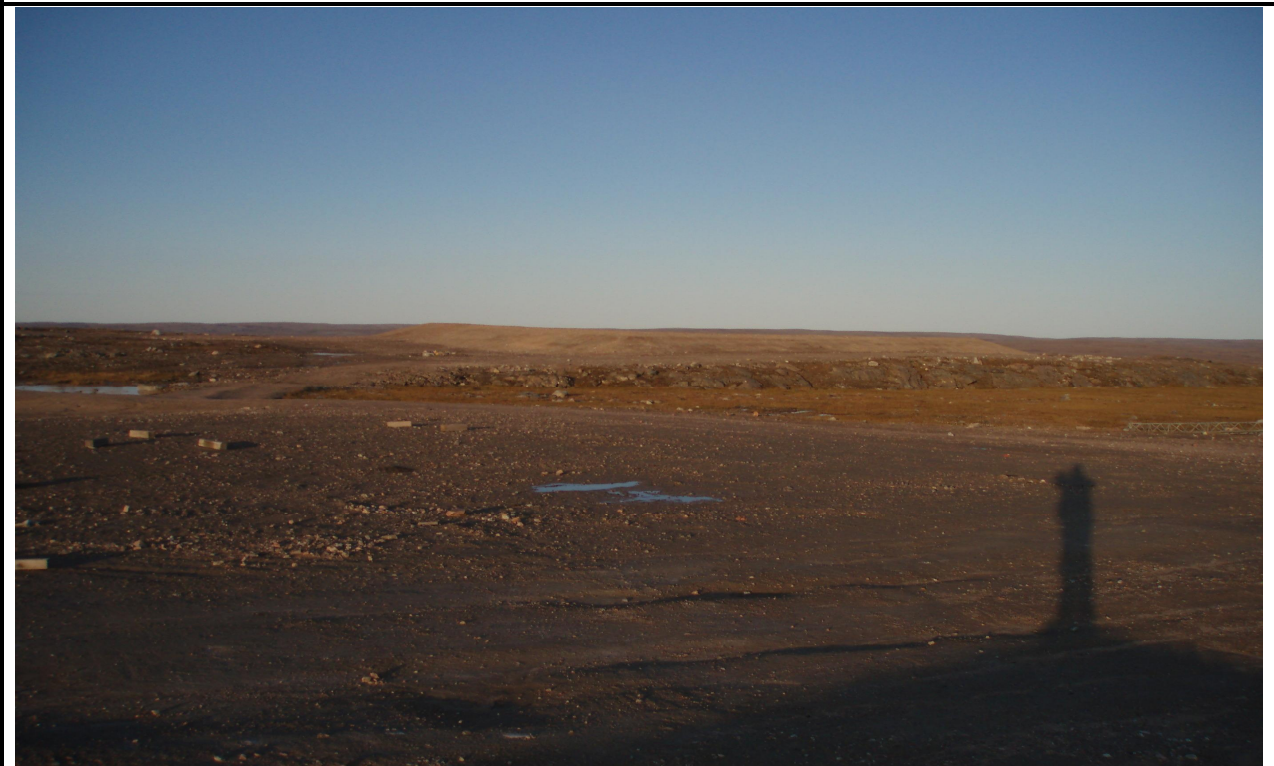
Photo 2: Picture 57 NHWLF – Panoramic View Looking Southeast

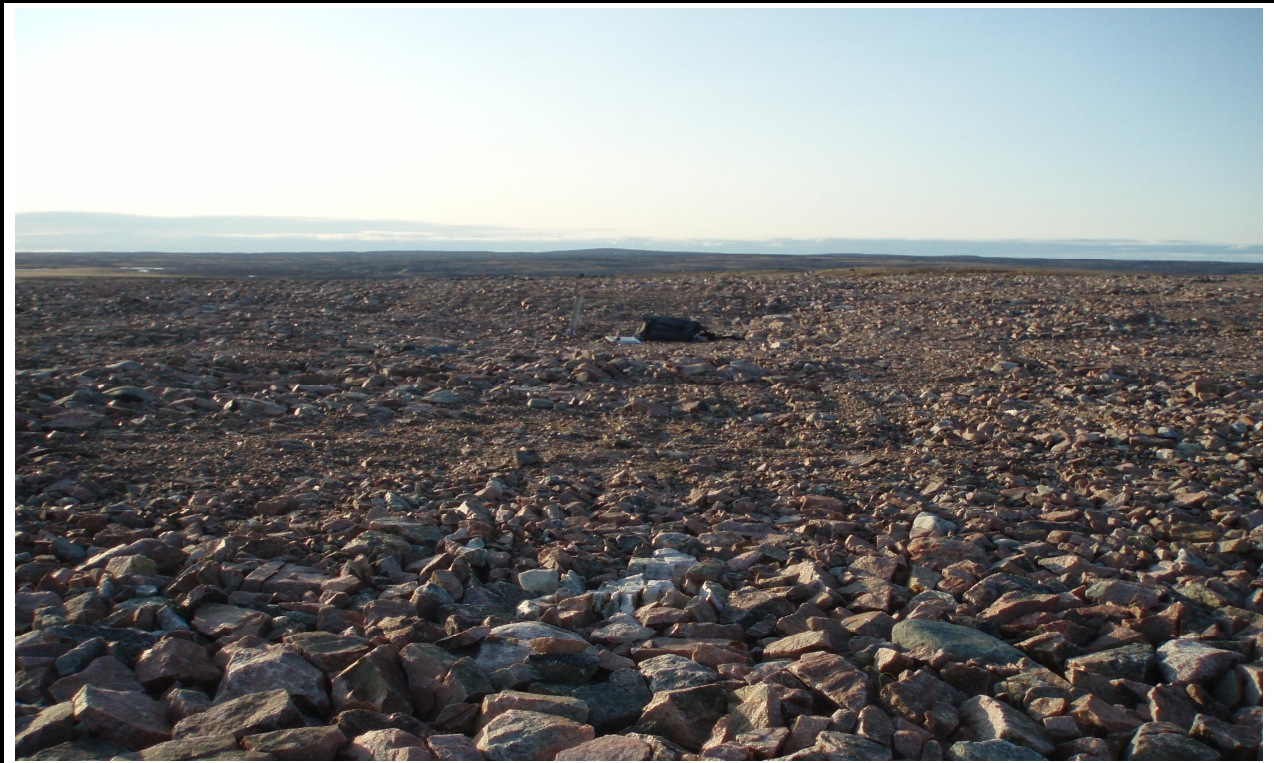
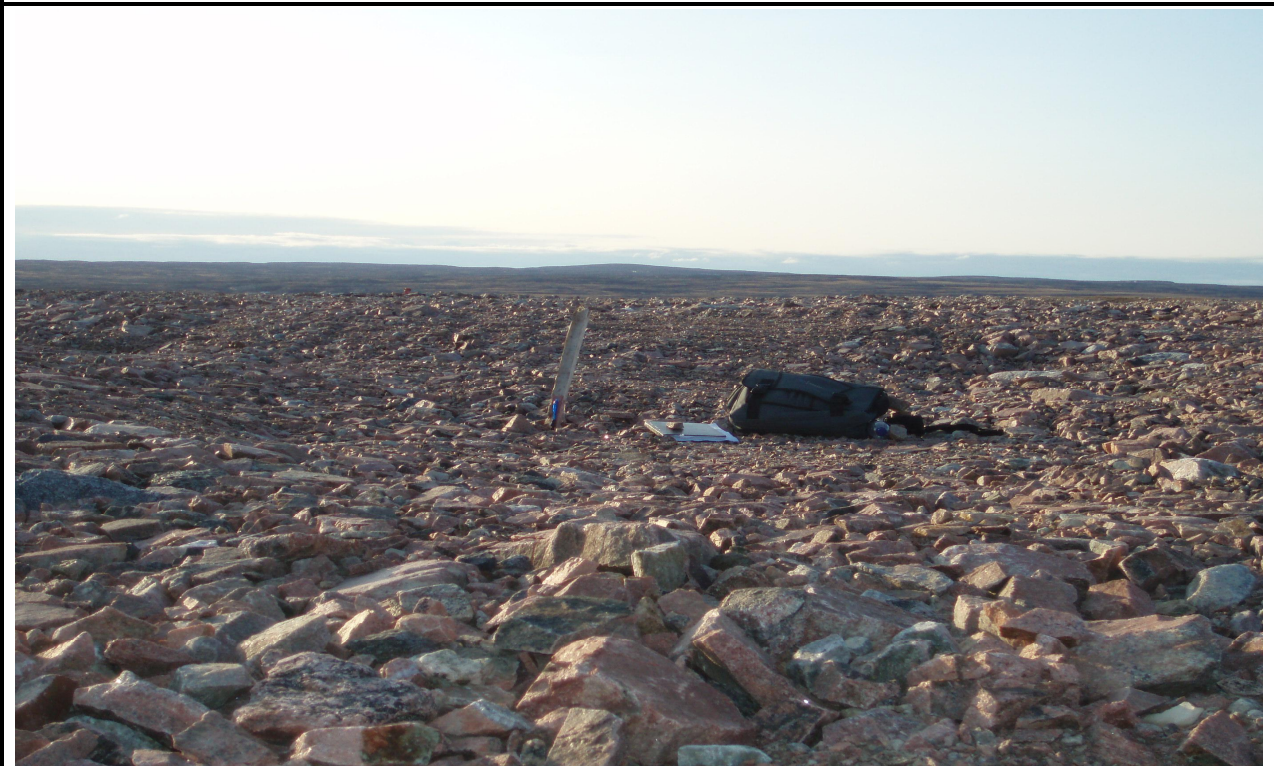
Settlement was noted at two locations on the landfill surface as shown on Figure A1 and Photos 3 to 6. Ponding of water was not observed in the settled areas during site inspection. Due to porous cover material the surface runoff likely infiltrates into the cover material and seeps along the frozen/unfrozen soil contact until it appears on the sideslopes. Seepage on sideslopes was not observed during inspection, but appeared to have occurred on the berm (Pictures 017, 019, 021 on Data CD).

c) Where is the settlement occurring? See Figure A2 and Photos 3 to 6	
d) Explanation: Settlement was noted at two locations (8mx8m and 4mx2m, 0.1 to 0.3 m deep) as shown on Figure A2. Ponding was not noted at the time of inspection. Due to cover material containing cobbles and boulders, the surface water infiltrates through the cover material, and seeps along the frozen/unfrozen soil contact through the landfill body and the side slopes.

Photo 3: Picture 35 NHWLF –Settlement (8mx8m) on Landfill Surface in Northwest Corner (Figure A2)

Photo 4: Picture 35 NHWLF –Settlement (8mx8m) on Landfill Surface in Northwest Corner (Figure A2)

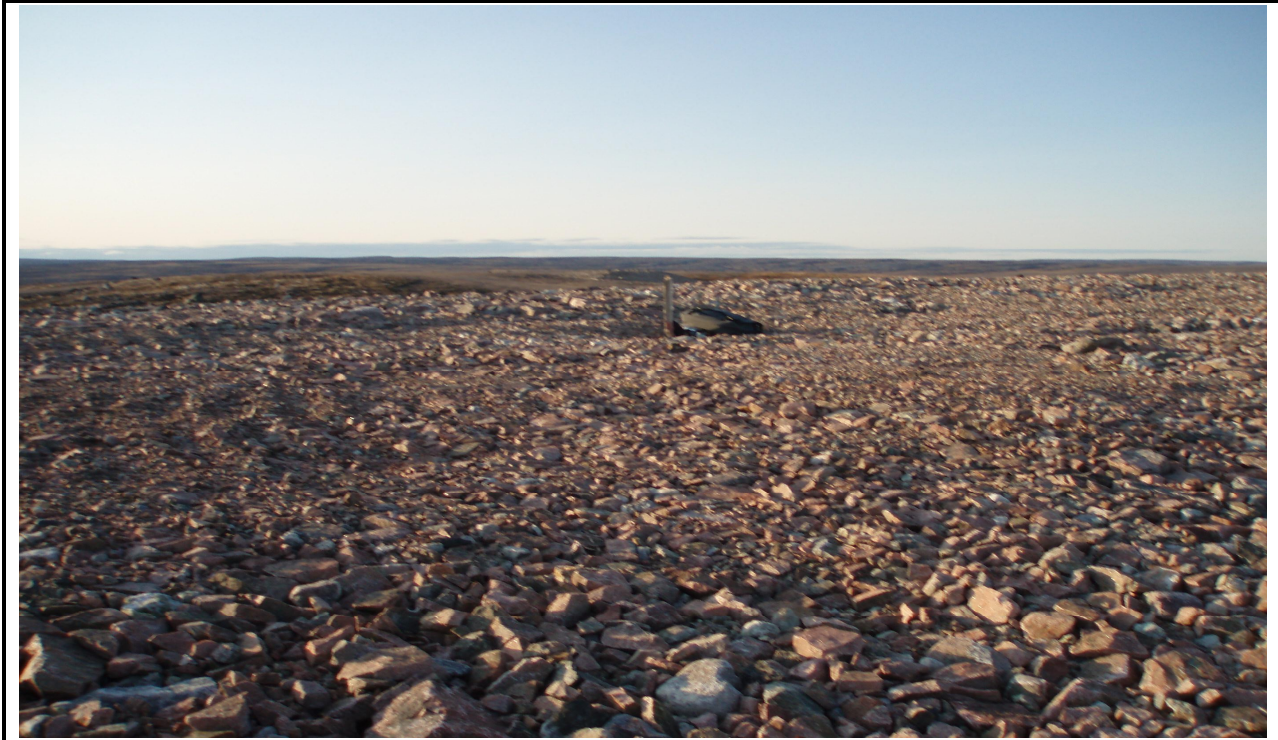
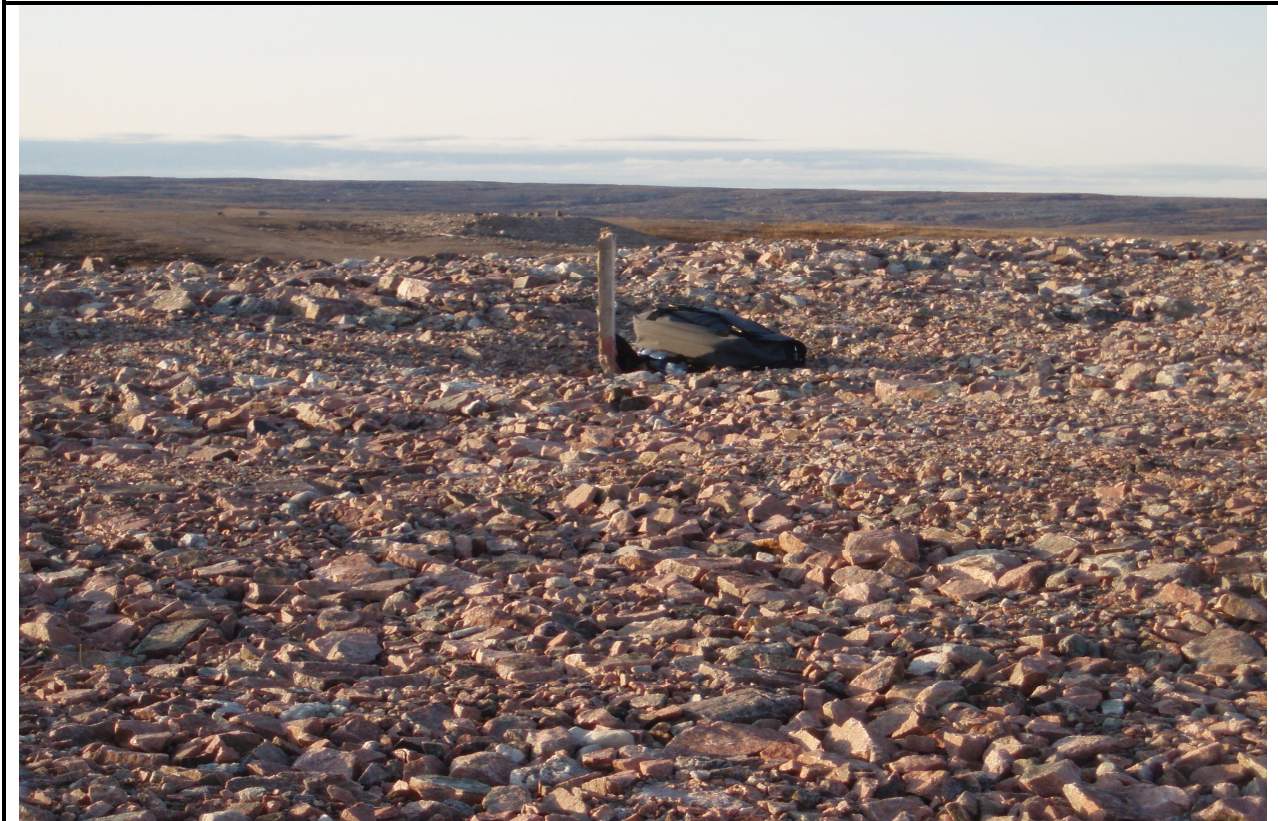
Photo 5: Picture 39 NHWLF – Settlement (4mx2m) on the Landfill Surface (Figure A2)

Photo 6: Picture 40 NHWLF – Settlement (4mx2m) on the Landfill Surface, (Figure A2)

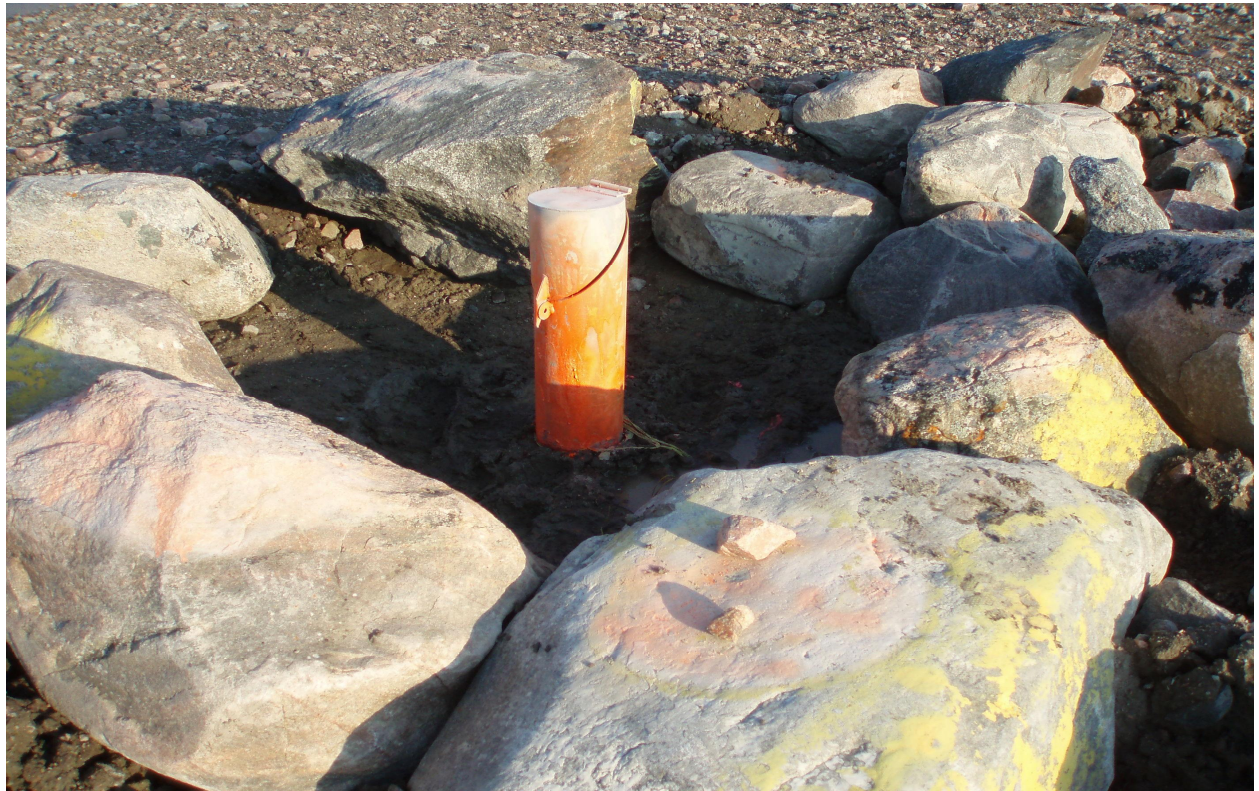
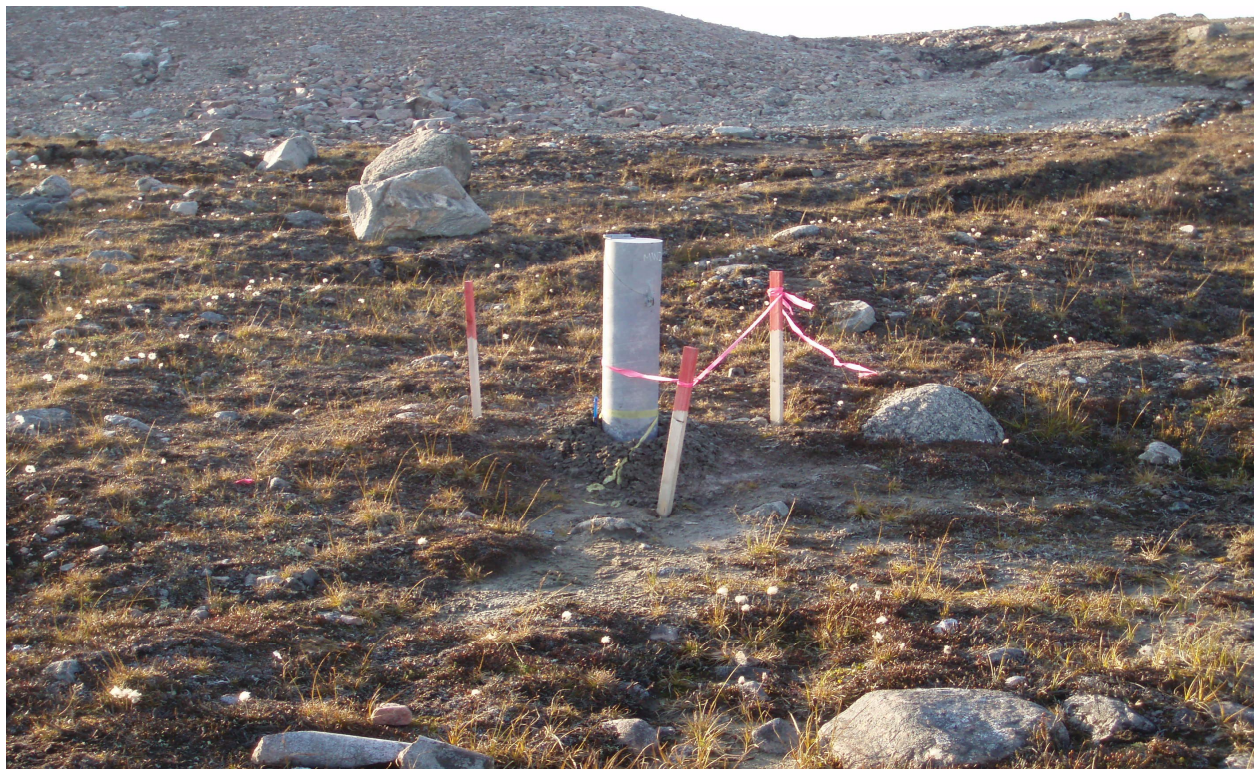
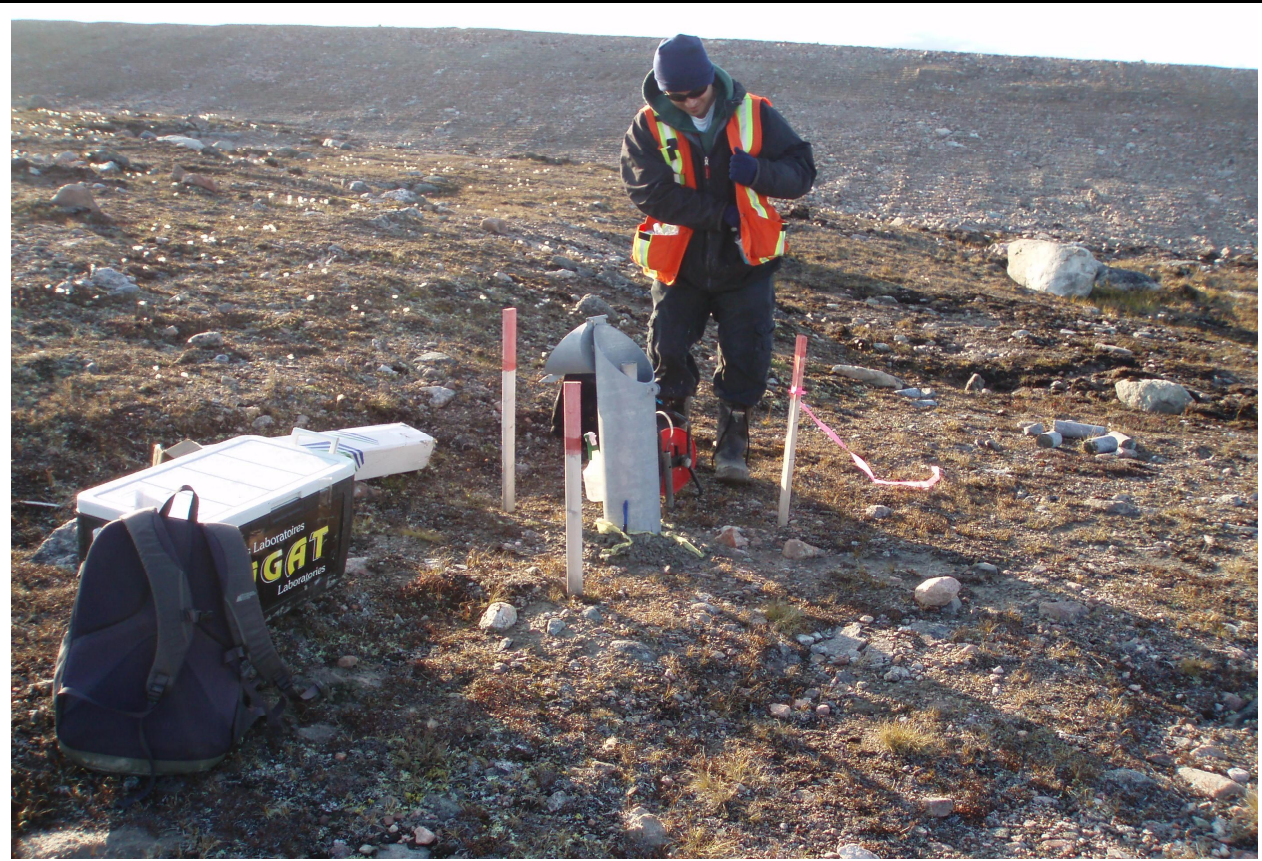
Photos 7 to 9 show the condition of groundwater monitoring wells at the NHWLF. The monitoring wells were leaning slightly towards the protective casing possibly because of frost jacking. The monitoring wells were generally in good conditions and no damage to the monitoring wells was noted.

d) Explanation:	
4. Monitoring Instruments	
a) What is the condition of the monitoring wells and thermistor strings? All monitoring wells (MW06-01 to 03) were in good condition. No damage to the monitoring wells was observed (Photos 7 to 9).

Photo 7: Picture 15 NHWLF – MW06-01 Looking Southeast

Photo 8: Picture 2 NHWLF – MW06-02 Looking Northwest

Photo 9: Picture 3 NHWLF – MW06-03 Looking Northwest

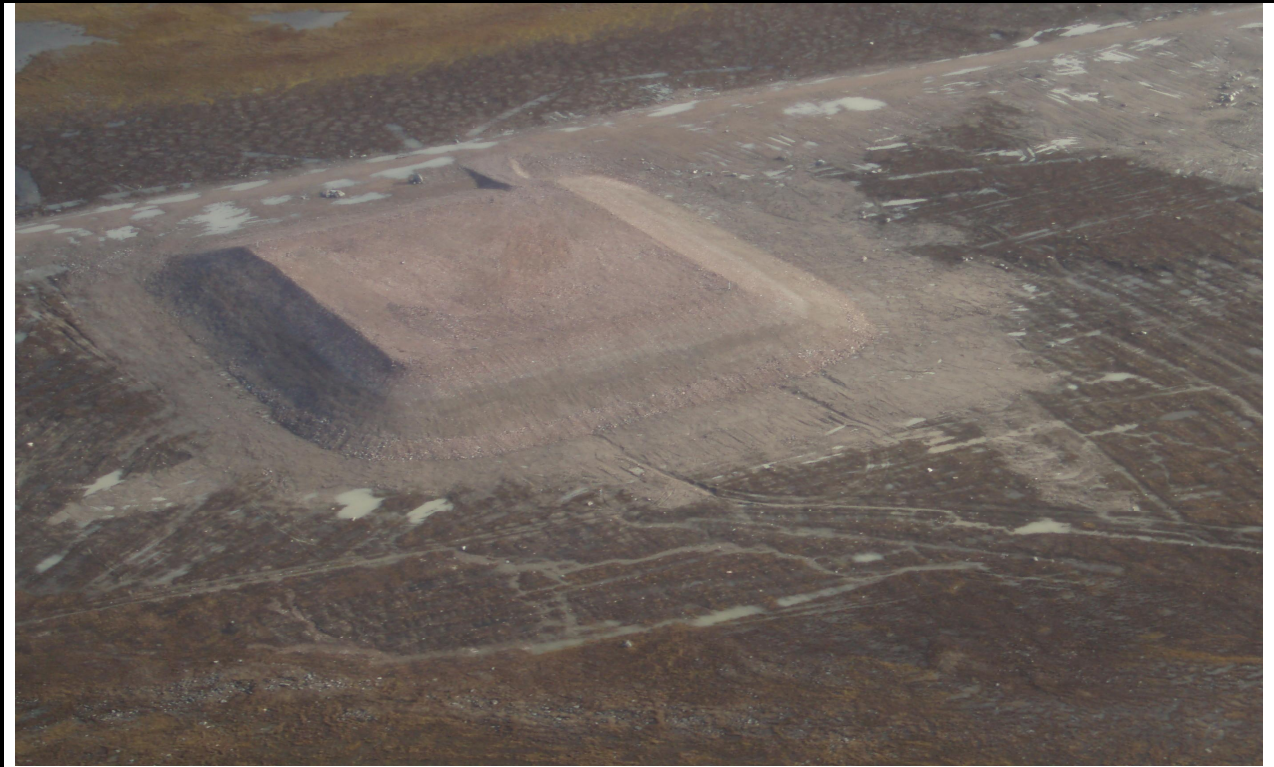
Seepage was noted on all berms during site inspection as shown on the panoramic view of the landfill on Photos 1 and 2. The seepage was occurring approximately 2 to 2.5 m below the landfill top surface and was likely due to a rainfall on August 29, 2008. It appears that some surface water infiltrates through the porous cover material and seeps along the frozen/unfrozen soil contact until it appears on berms. The seepage and surface runoff have created a few erosion rills and small potholes containing water on the south and west facing slopes as shown on Photos 3 to 6. The seepage is expected to occur in the future at the frozen/unfrozen soil contact; however, frozen/unfrozen soil contact will move up as permafrost aggrades with time.

Photo 1: Picture 66 SSDF – Aerial View of the Landfill; Seepage on Sideslopes, Ponding Near the Landfill and Erosion Channels Near the South Facing Slope

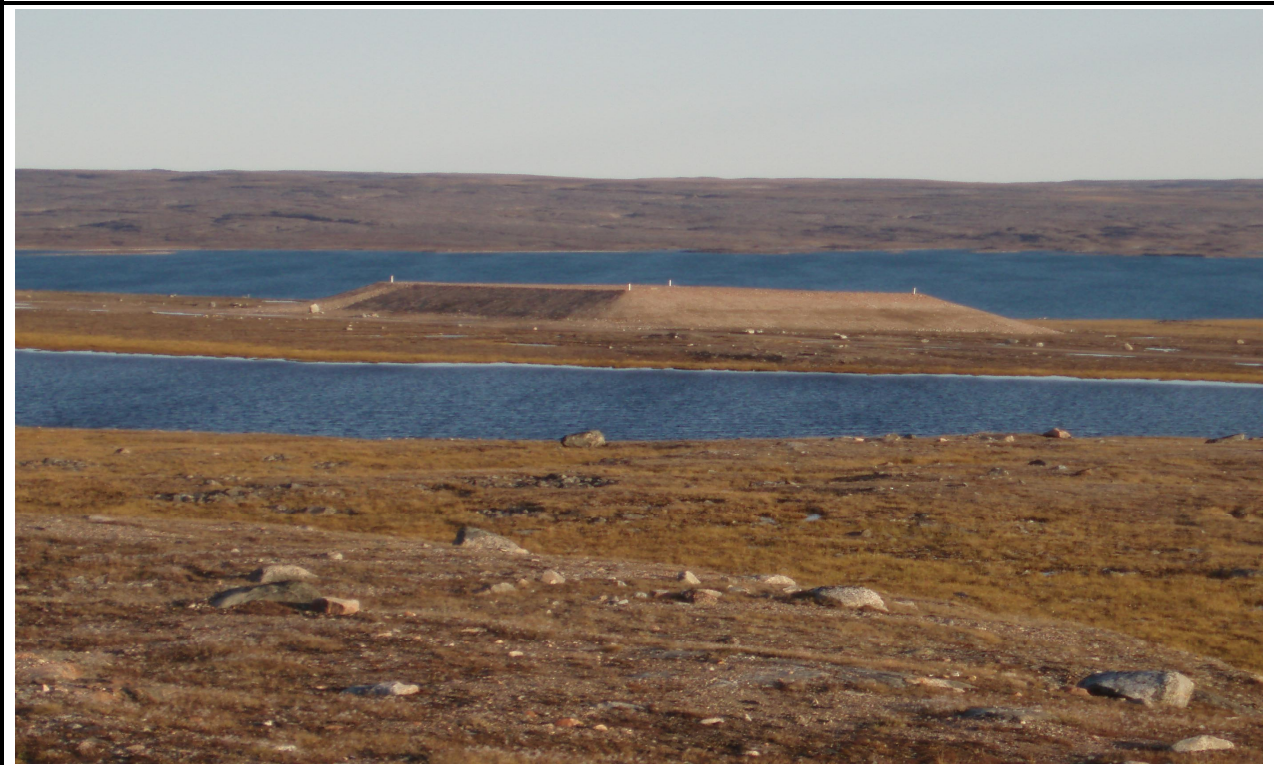
Photo 2: Picture 73 SSDF – Panorama of the Landfill Looking SE

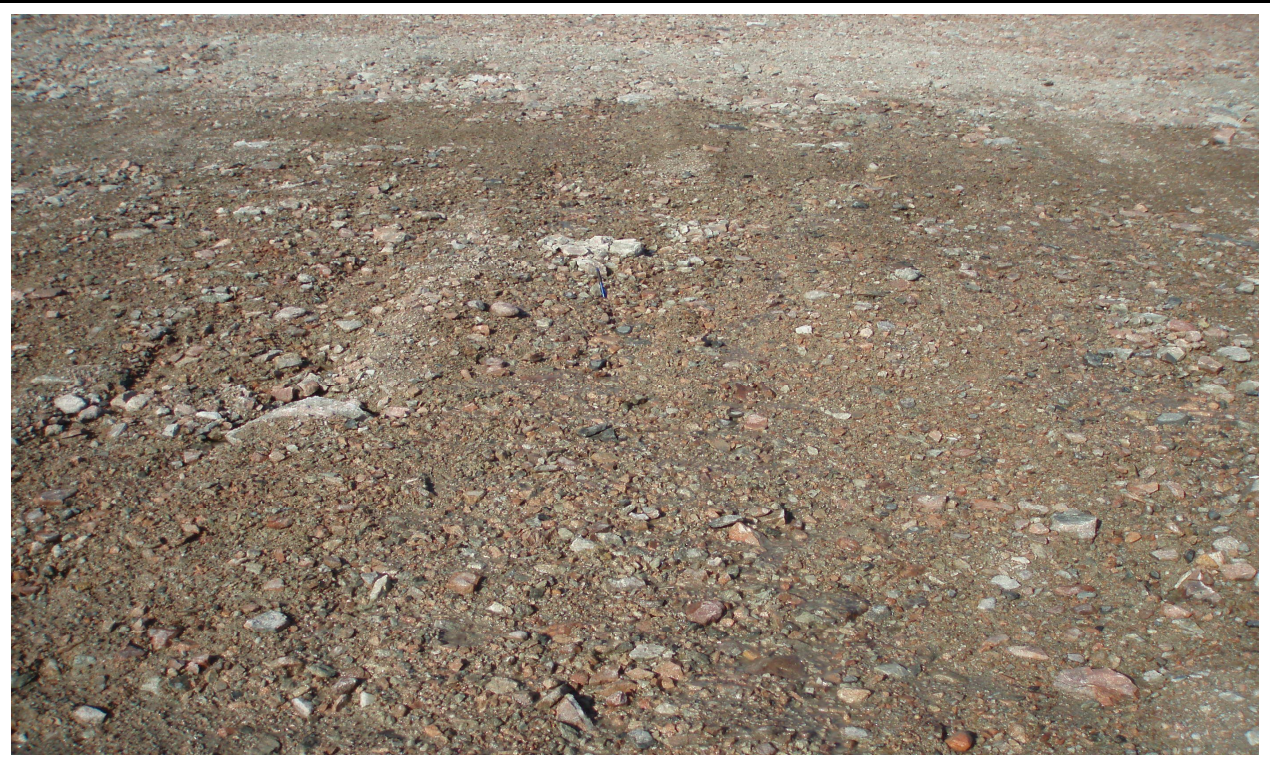
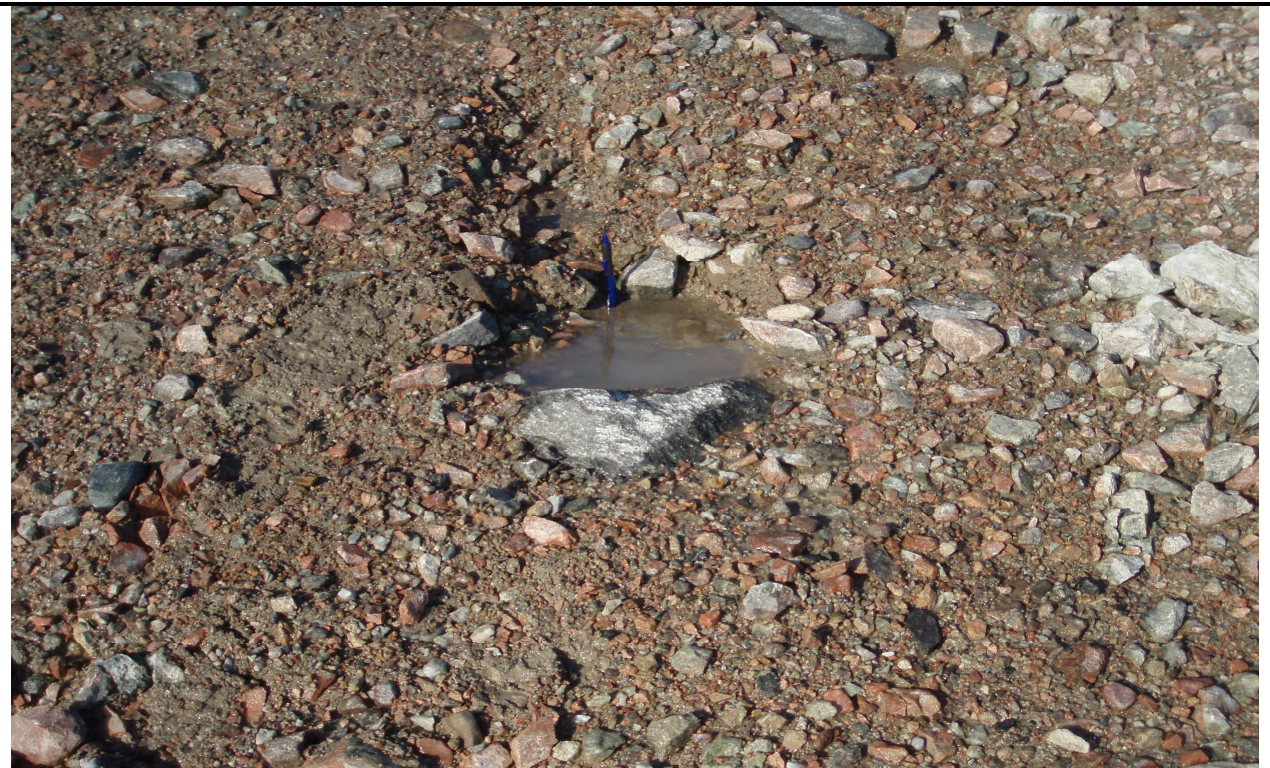
The minor erosion that has occurred on all sideslopes is a result of downslope washing of fine-grained particles between cobbles and boulders. The landfill is covered with erosion resistant material and will naturally resist further erosion. Surface runoff has also eroded small channels in the silty soil near the south facing slope as shown on Figure A1 and Photos 7 to 10. The erosion channels are not in direct contact with the landfill and are not affecting the landfill structure. Minor ponding was also noted near the toe of all berms.

Photo 3: Picture 20 SSDF – Seepage/Erosion on South Facing Slope (Figure A1)

Photo 4: Picture 20 SSDF – Seepage/Erosion on South Facing Slope (Figure A1)

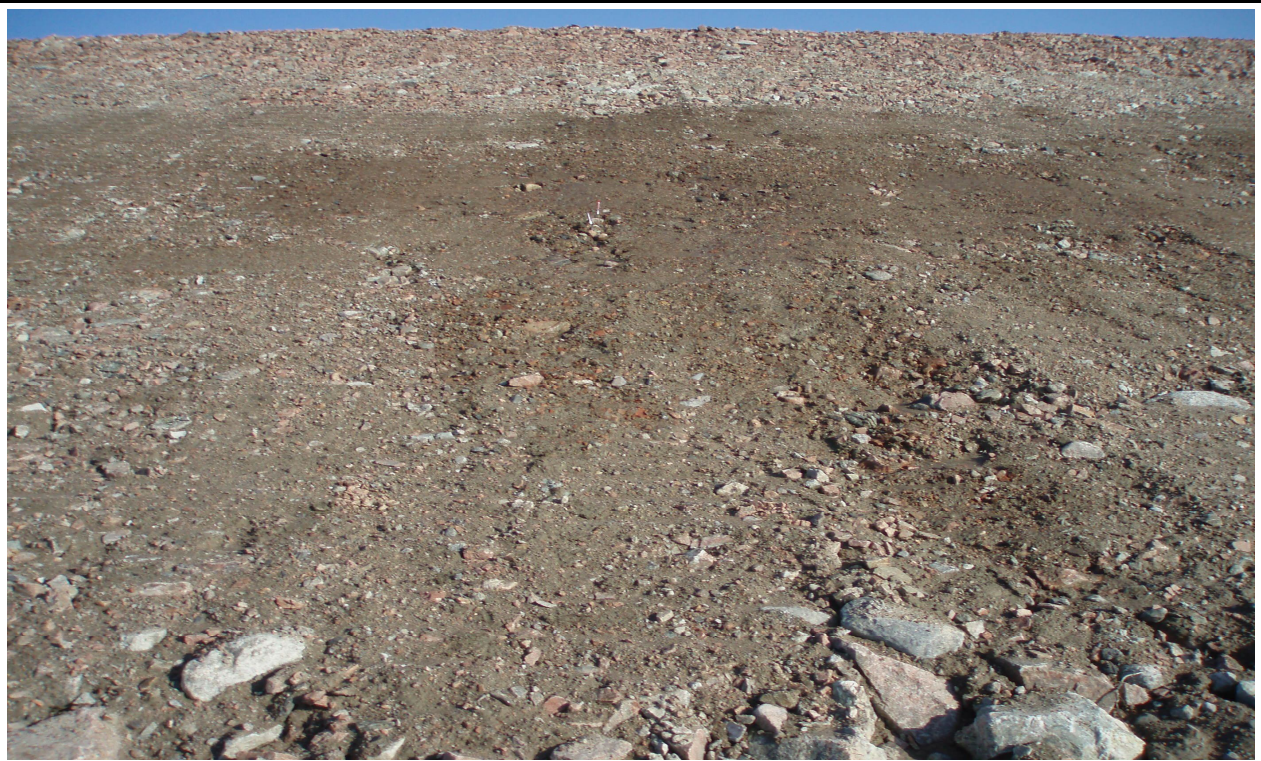
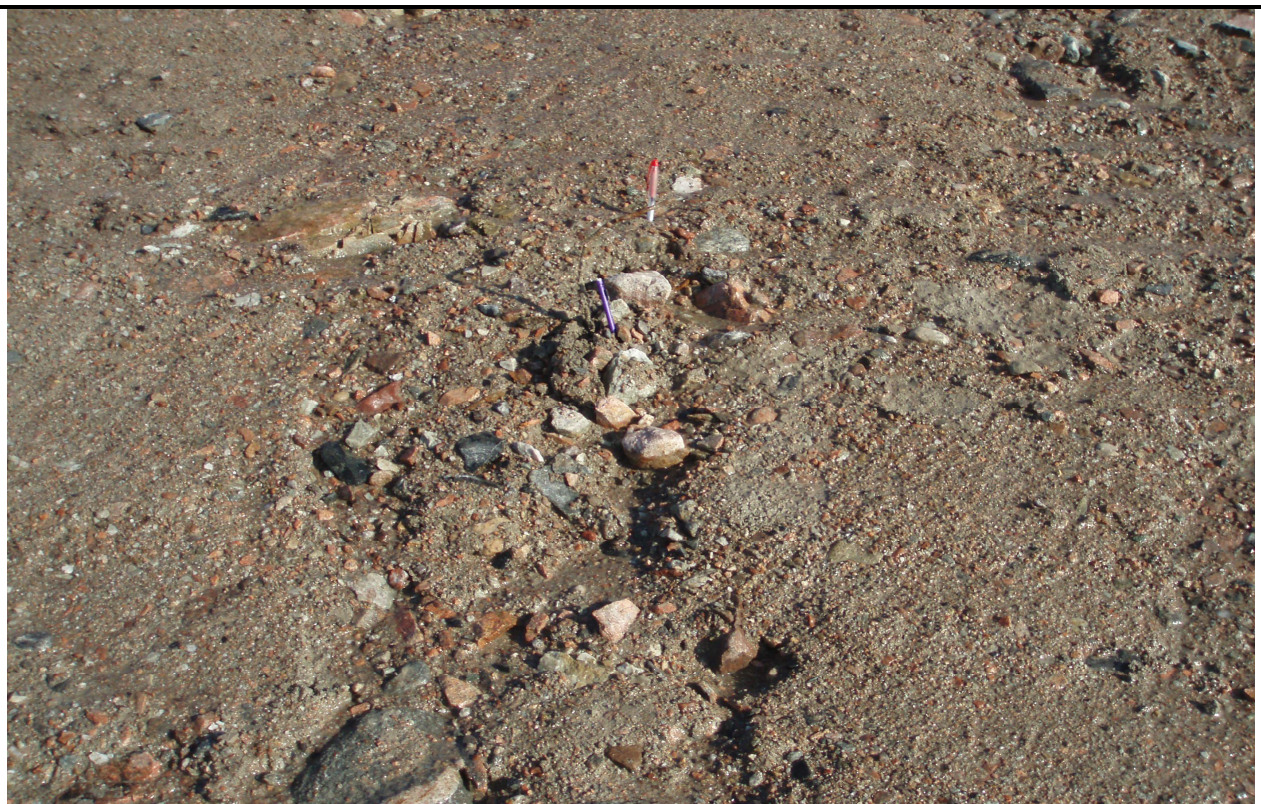
Photo 5: Picture 9 SSDF – Seepage/Erosion on West Facing Slope (Figure A1)

Photo 6: Picture 10 SSDF – Seepage/Erosion on West Facing Slope (Figure A1)

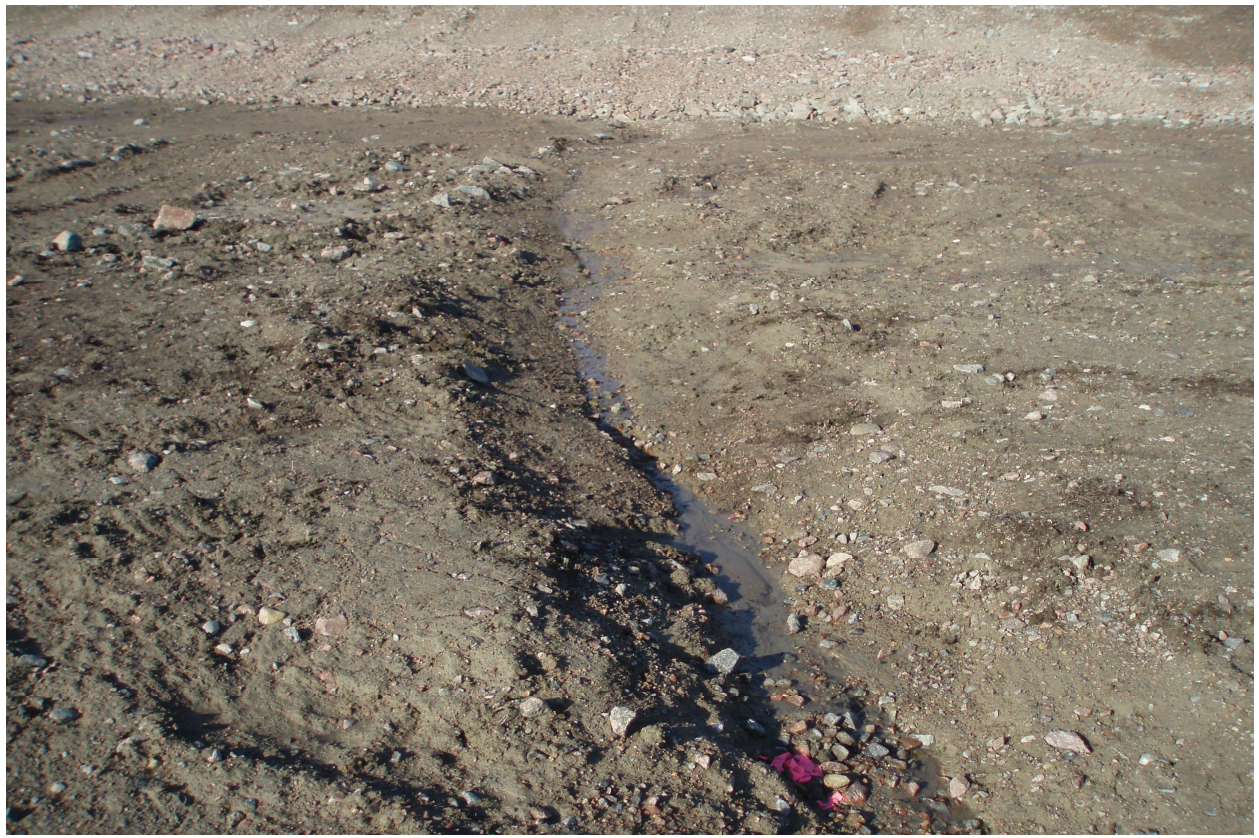
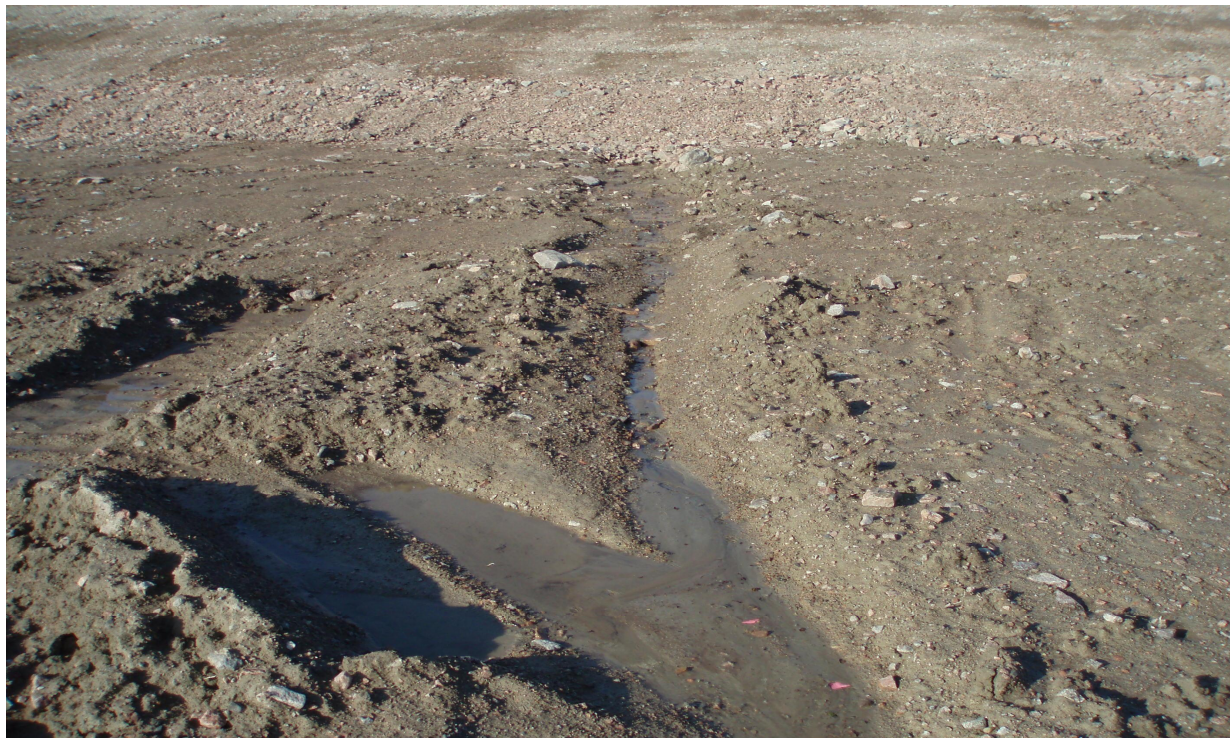
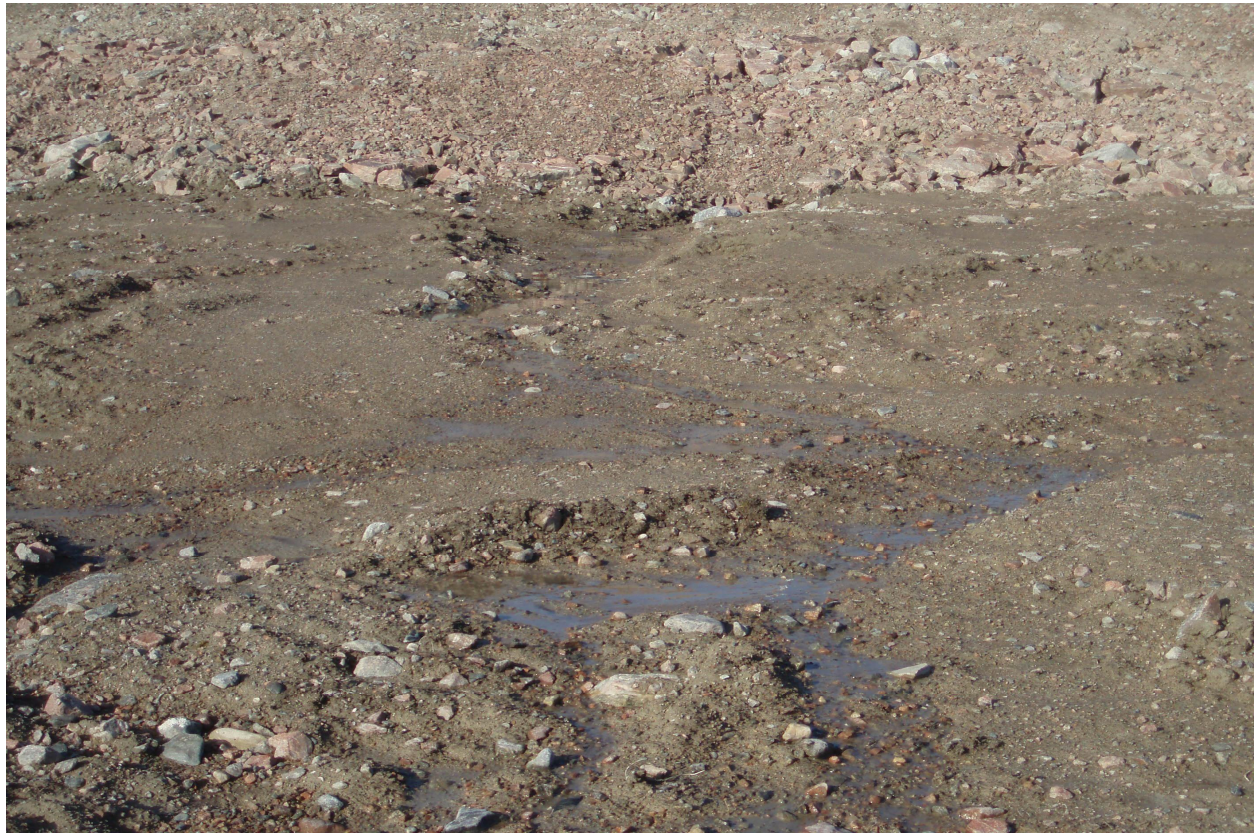
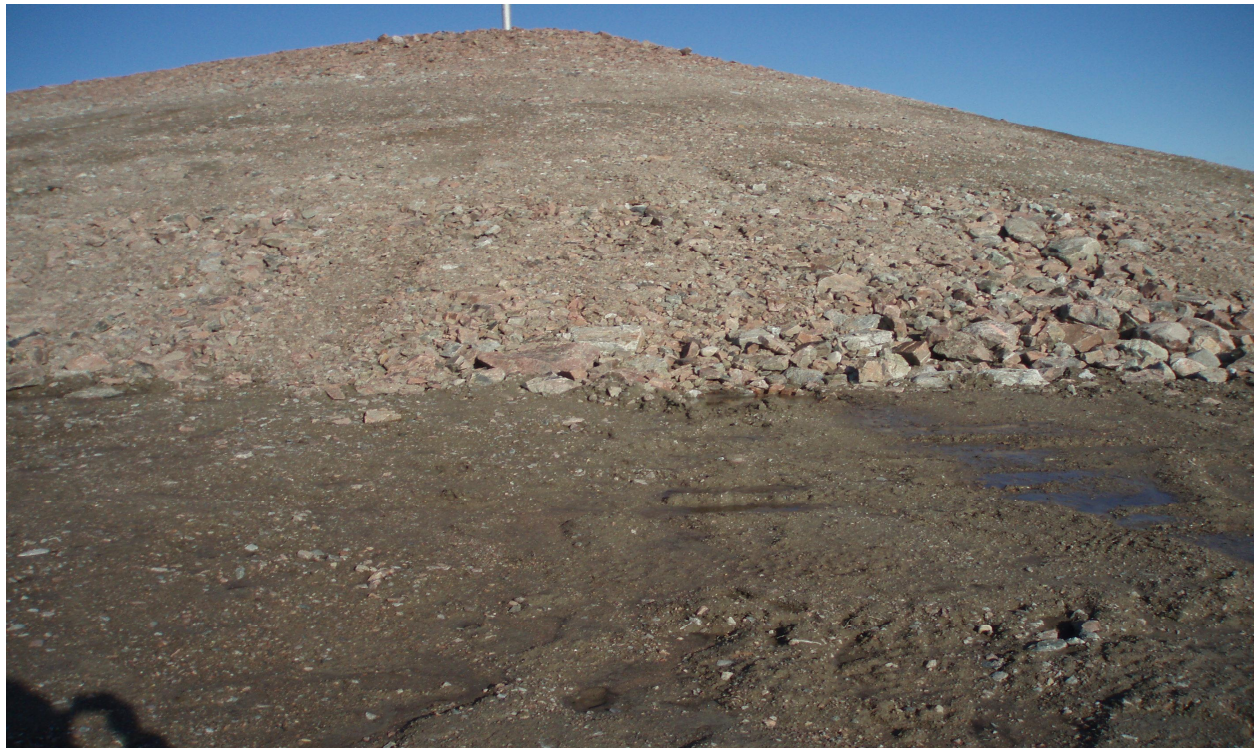
i) Is it localized or continuous?	Localized
c) Where is the erosion occurring? South and West Facing Slopes	
<p>d) Explanation: Minor erosion was noted on the south and west facing slopes. The slope is surfaced with granular material containing cobbles and boulders that are erosion resistant and stable. Minor erosion is due to seepage of water from the side slopes washing fines from the erosion resistant cover material. Few erosion rills and small pot holes trapping seepage water were noted on the south and west facing slopes (Photos 3,4,5,6, Figure A1).</p> <p>Seepage was occurring on all side slopes approximately 2 to 2.5 m below the landfill top surface (Photos 1, 2, Figure A1). It appeared that water infiltrates through the porous cover material and seeps along frozen/unfrozen soil contact through the landfill body and on the side slopes. The seepage at the time of inspection was likely due to rainfall on August 29, 2008.</p> <p>The surface runoff and seepage from the landfill surface has eroded small erosion channels near the toe of the south facing slope (Photos 1, 7 to 10, Figure A1). The erosion channels are not in direct contact with the landfill.</p>

Photo 7: Picture 23 SSDF – Erosion Channel at the Toe of South Facing Slope (Figure A1)

Photo 8: Picture 24a SSDF – Erosion Channel at the Toe of South Facing Slope (Figure A1)

Photo 9: Picture 24b SSDF – Erosion Channel at the Toe of South Facing Slope (Figure A1)

Photo 10: Picture 15 SSDF – Erosion Channel at the Toe of South Facing Slope (Figure A1)

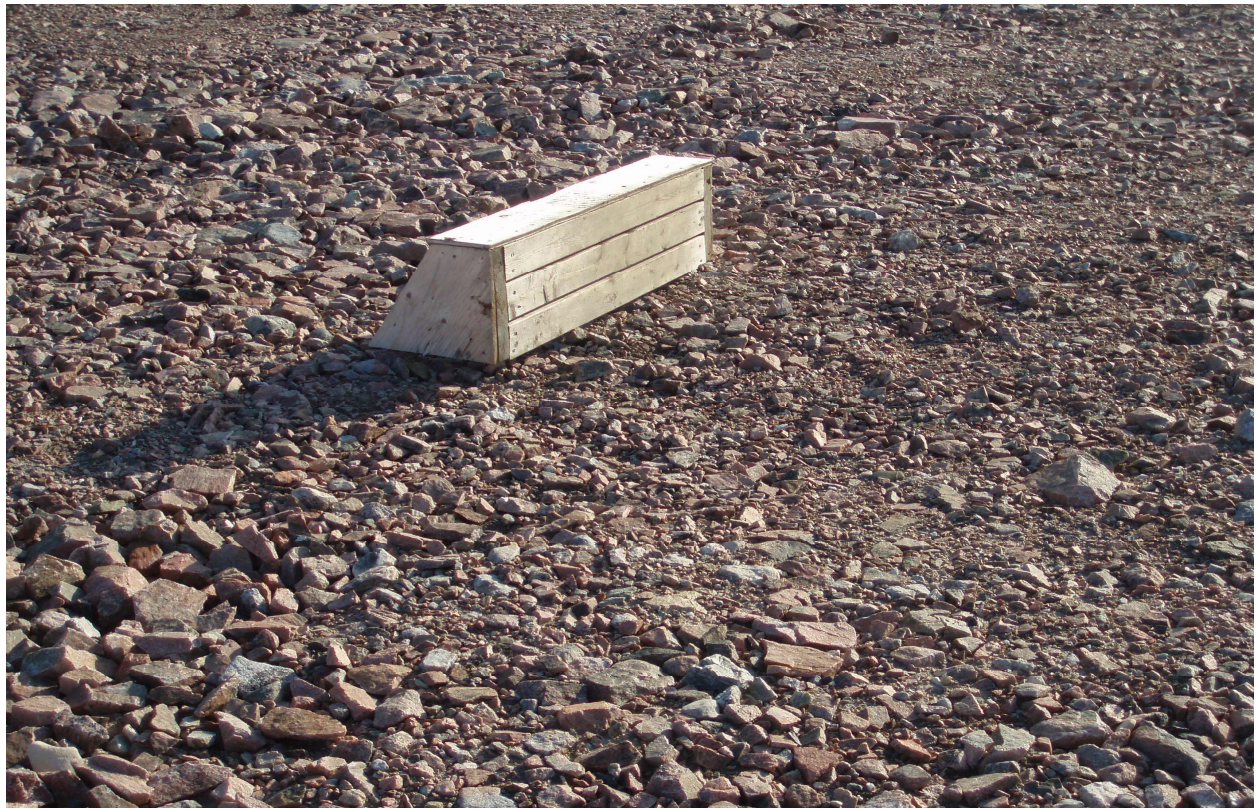
Photo 11: Picture 62 SSDF – Left Over Debris on Landfill Surface (Figure A1)
