NWB Annual Report

Project Name: CAM-F Sarcpa Lake Long-Term Monitoring

APPENDIX 2: LONG-TERM MONITORING 2008 CAM-F DEW LINE SITE, NU

Executive Summary

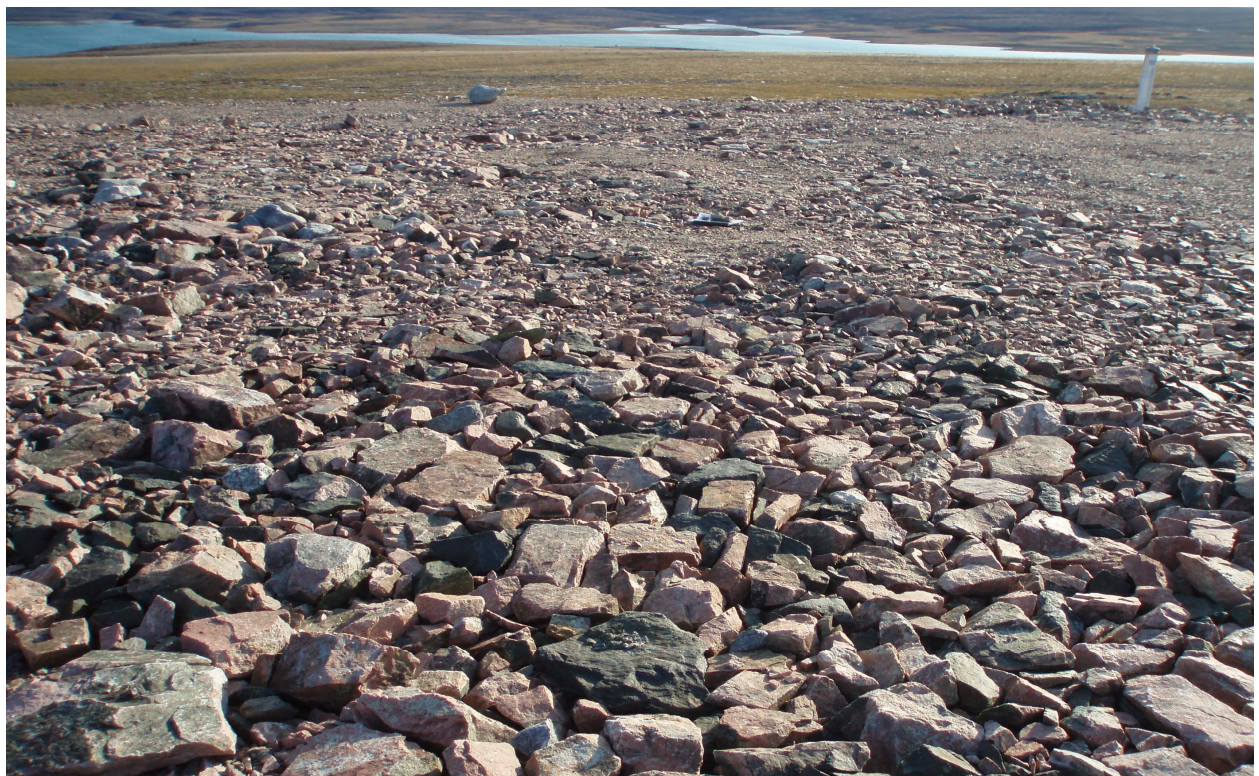
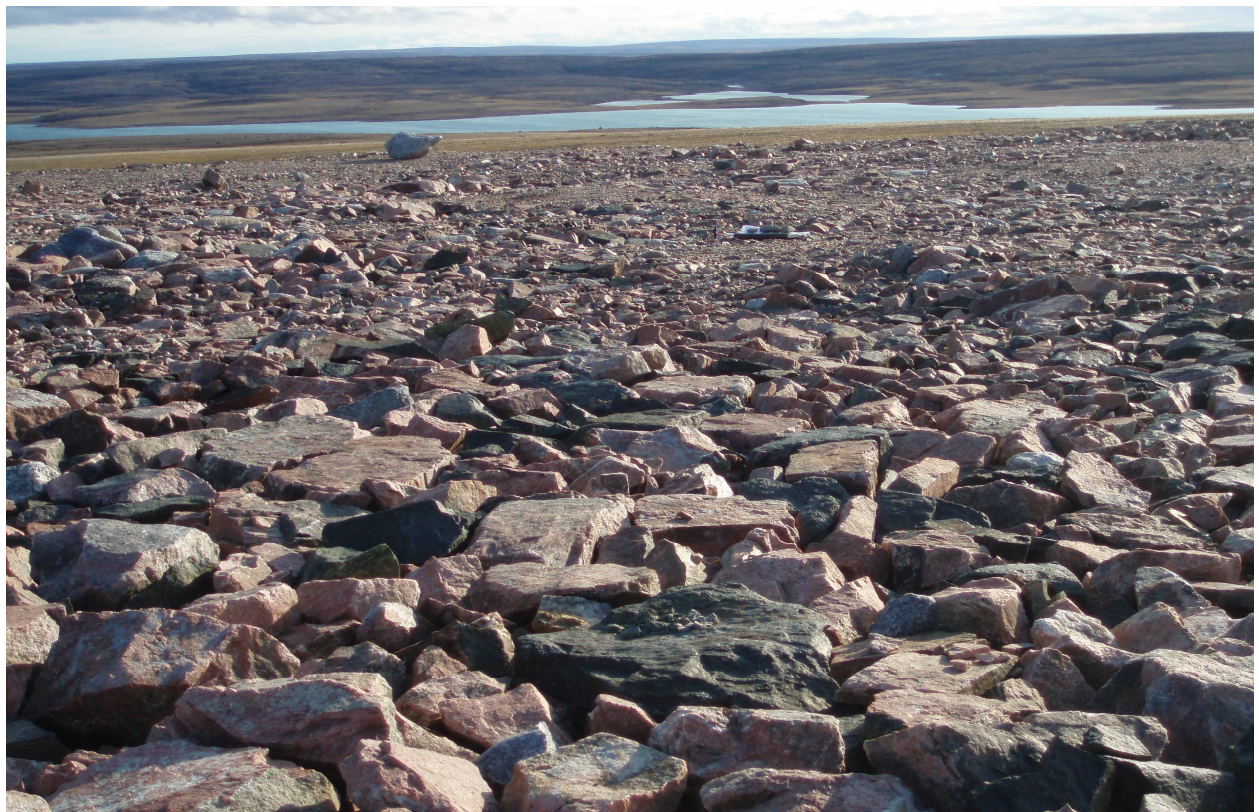
A subtle depression was noted on the surface of the landfill as shown on Figure A2 and Photos 12 and 13. Ponding was not noted in the depression during site inspection. There is potential for additional settlement to occur as the landfill settles over time and this settlement could express itself as an area of water ponding.

b) What is the extent of the settlement? (percentage of surface area)	~ 3 %
i) Is it localized or continuous?	Localized
ii) How deep is it?	0.1–0.15 m
c) Where is the settlement occurring? See Figure A1 and Photos 12 and 13	
<p>d) Explanation: Minor settlement, approximately 15mx15m and 0.1 to 0.15 m deep, was observed on the landfill surface as shown on Figure A1. Ponding was not noted at the time of inspection likely because surface water infiltrates through the cover material.</p>

Photo 12: Picture 63 SSDF – Minor Settlement (15mx15mx0.10-0.15m) on Landfill Surface (Figure A1)

Photo 13: Picture 64 SSDF – Minor Settlement (15mx15mx0.10-0.15m) on Landfill Surface (Figure A1)

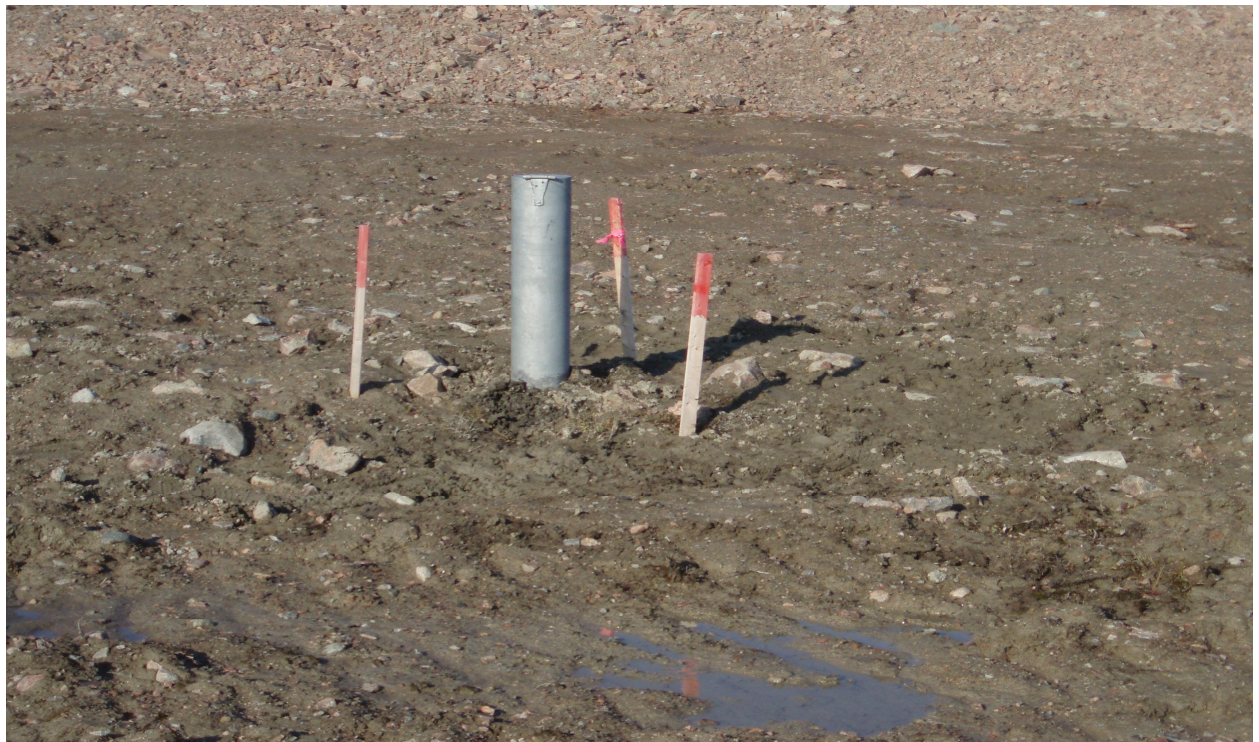
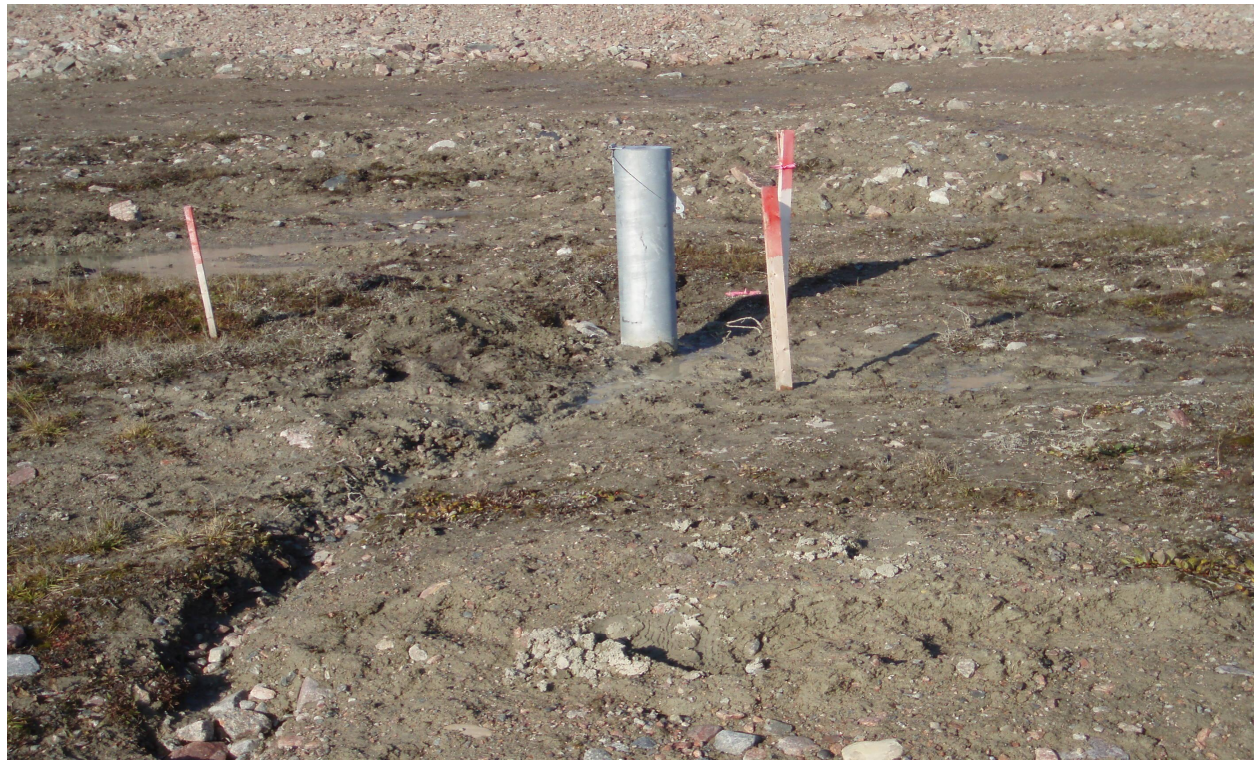
The monitoring wells were generally in good condition and no damage to the monitoring wells was noted (Photos 14 and 15). The ground temperature cables, data loggers and protective casing were all in good condition and no damage was observed to any of the installation (Photos 16 to 19).

a) What is the condition of the monitoring wells and thermistor strings? All monitoring wells (MW06-04 to 06) were in good condition. No damage to the monitoring wells was observed (Photos 14 and 15).

Photo 14: Picture 22 SSDF – MW06-05 (Figure A1)

Photo 15: Picture 22 SSDF – MW06-06 (Figure A1)

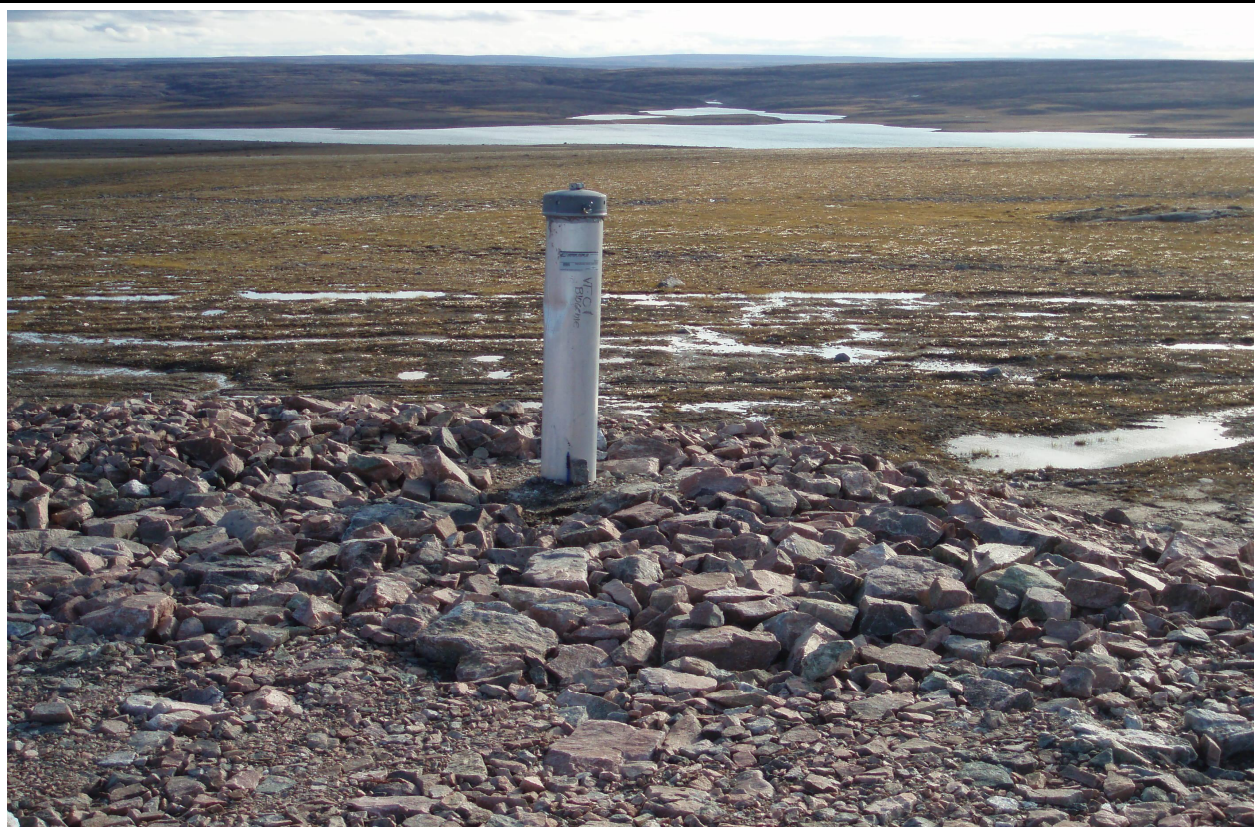
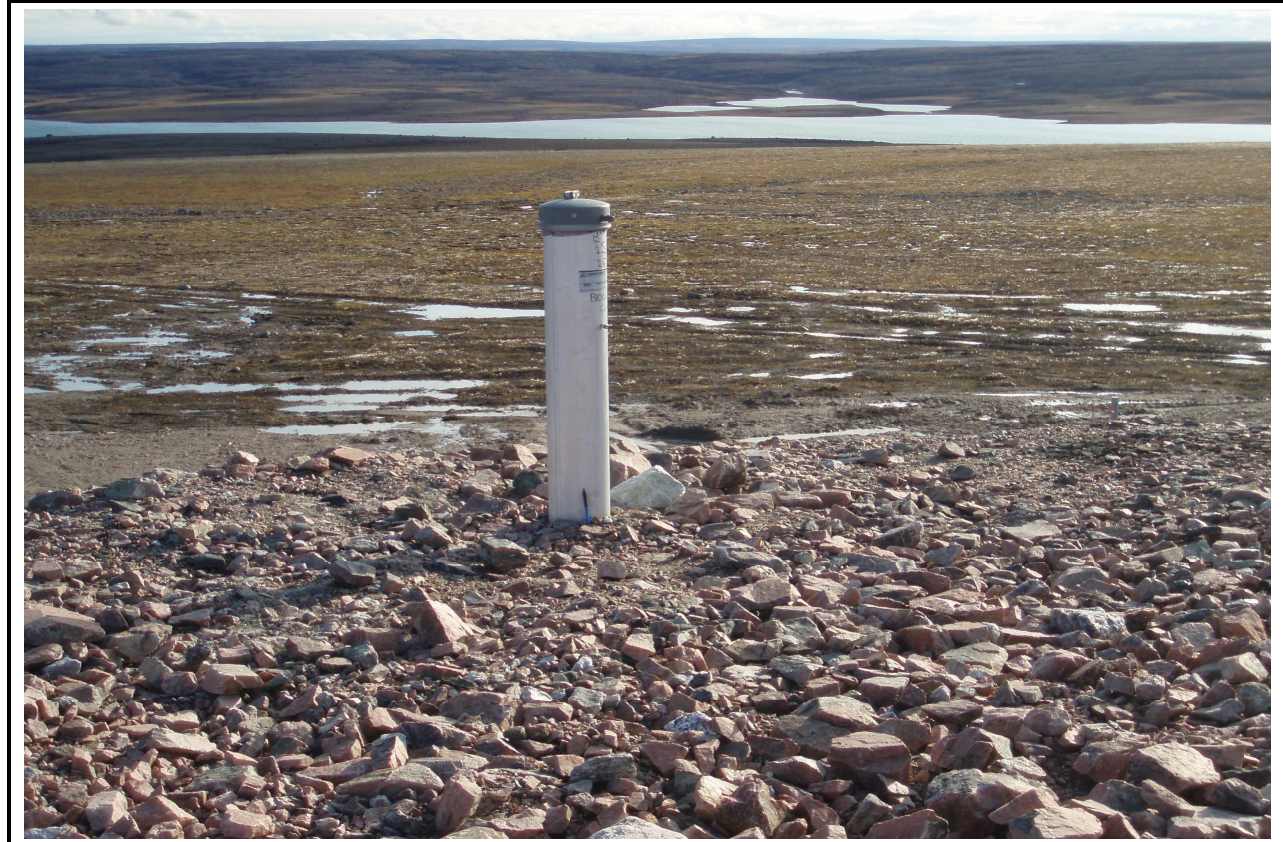
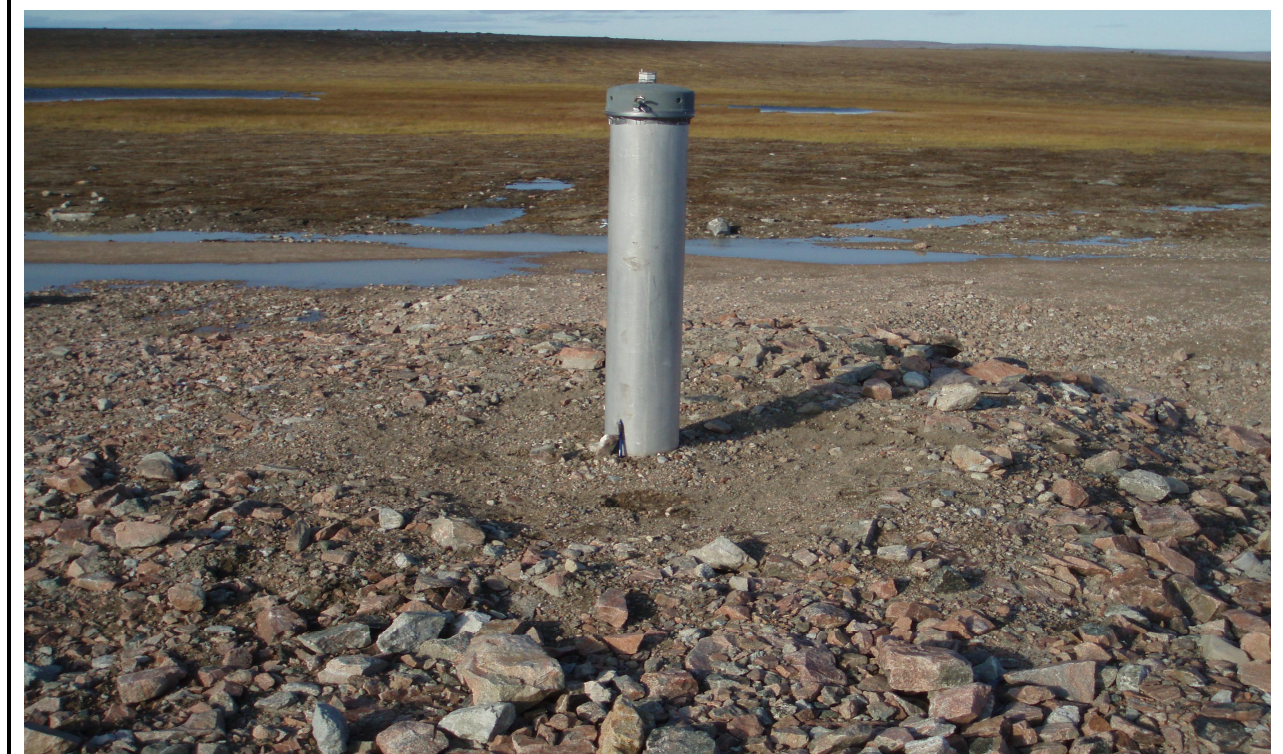
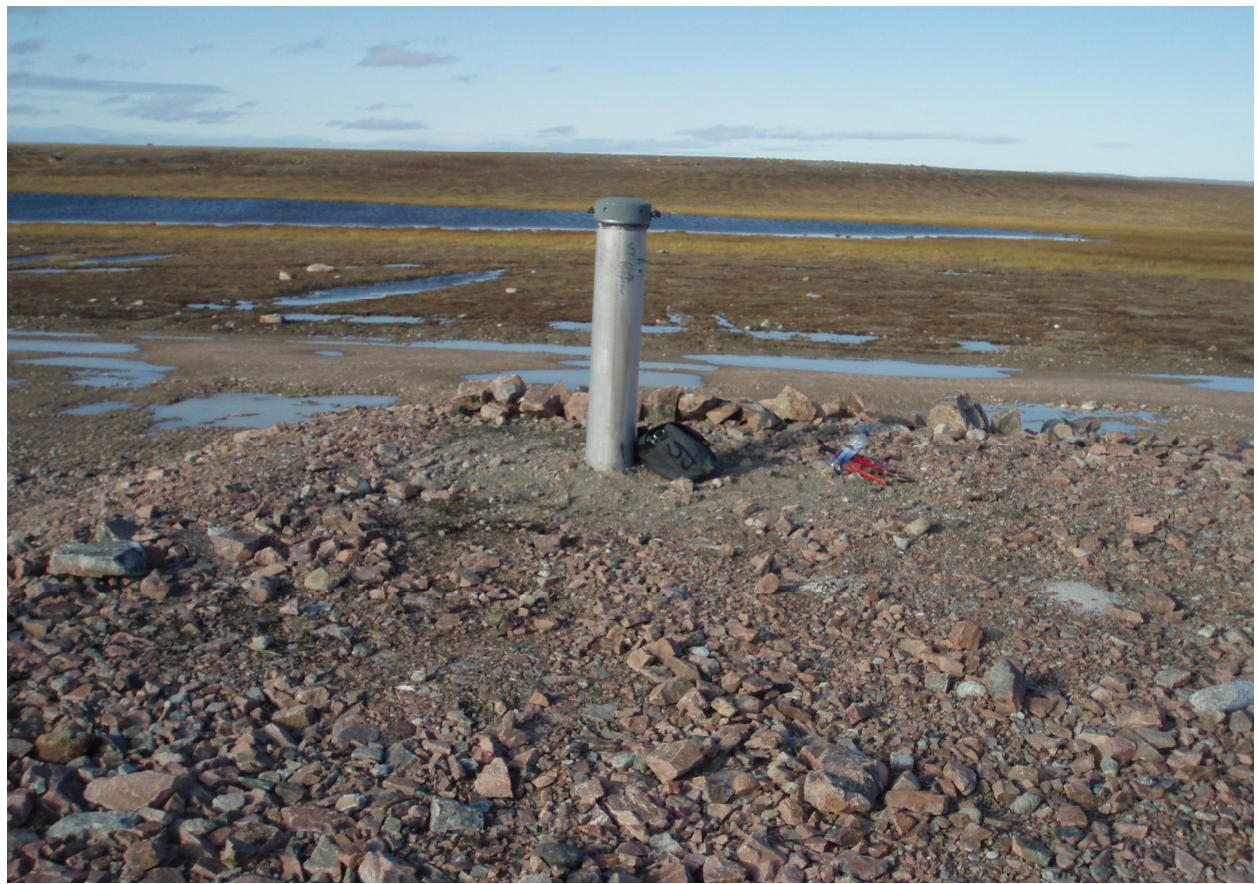
Manual readings were taken from all four thermistor strings (CAMF 01-VT to 04-VT) and ground temperature data was checked with that recorded by the data loggers. All thermistor strings, data loggers and protective casings were in good condition (Photos 16 to 19). The keys for casing locks (01-VT to 04-VT) was lost due to which the locks were broken. The casing cover was secured with duct tape and broken lock. The locks need to be replaced during 2009 inspection.

Photo 16: Picture 45 SSDF – VT-1 (Figure A1)

Photo 17: Picture 45 SSDF – VT-2 (Figure A1)

Photo 18: Picture 43 SSDF – VT-3 (Figure A1)

Photo 19: Picture 43 SSDF – VT-4 (Figure A1)
