## **APPENDIX F**

### **Site Photographs**

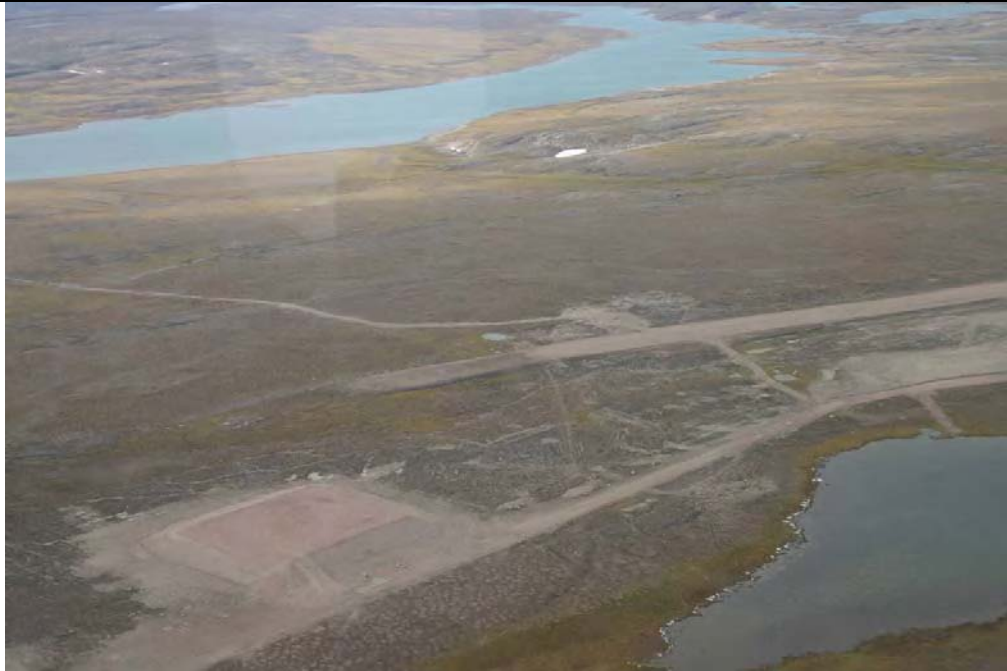
Photo 3. SSDF. Ponding areas can be seen on the southern side, near the corners, and on the northern side, near the access ramp. Direction photo taken: SW. Photo provided by INAC.

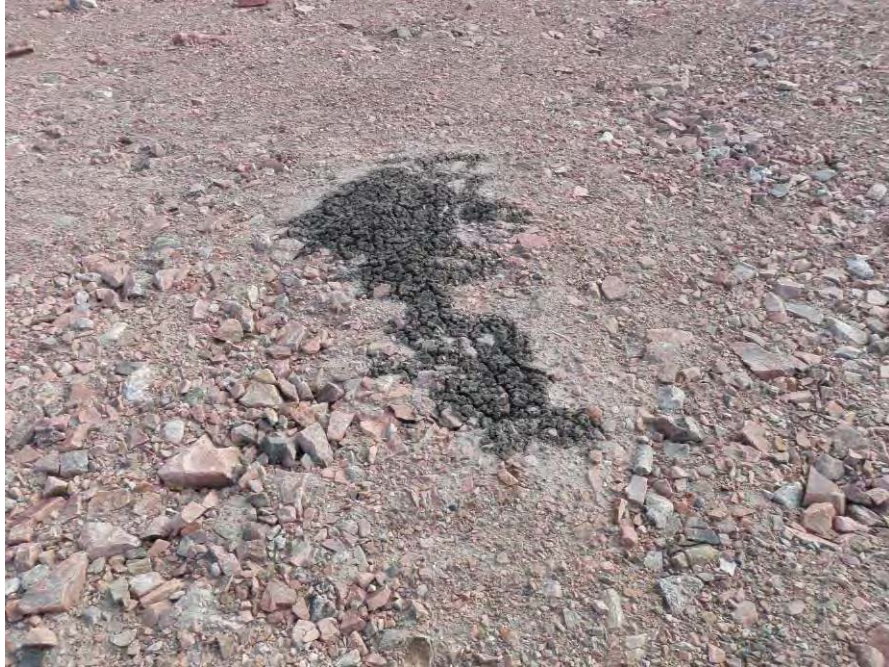
Photo 5. Stain on top of the SSDF (picture # P8250187).

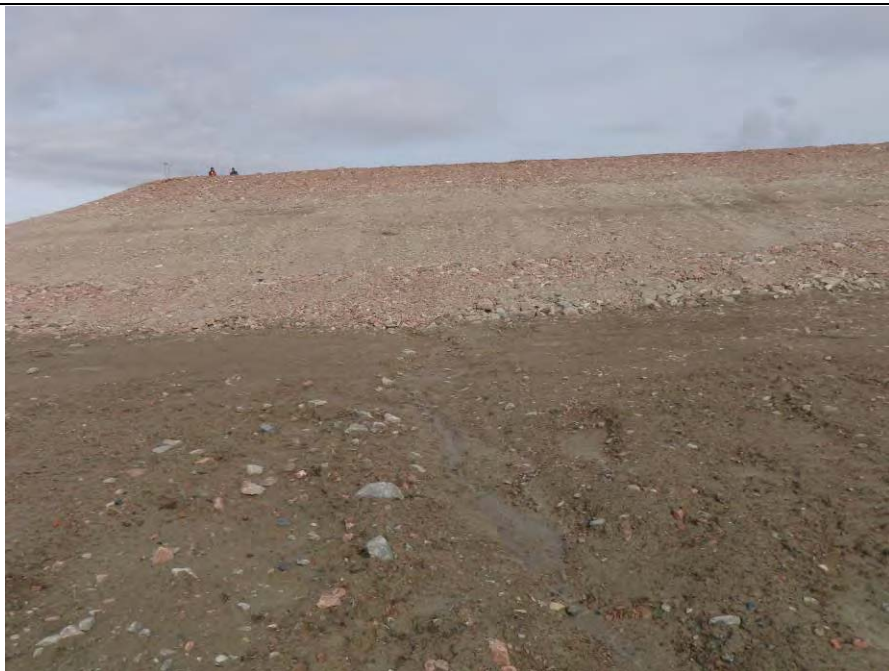
Photo 6. Rivulet (erosion channel) on south side of SSDF; picture viewpoint number 23 (Figure A-1, Appendix A).  
Direction photo taken: N (picture # P8240081).

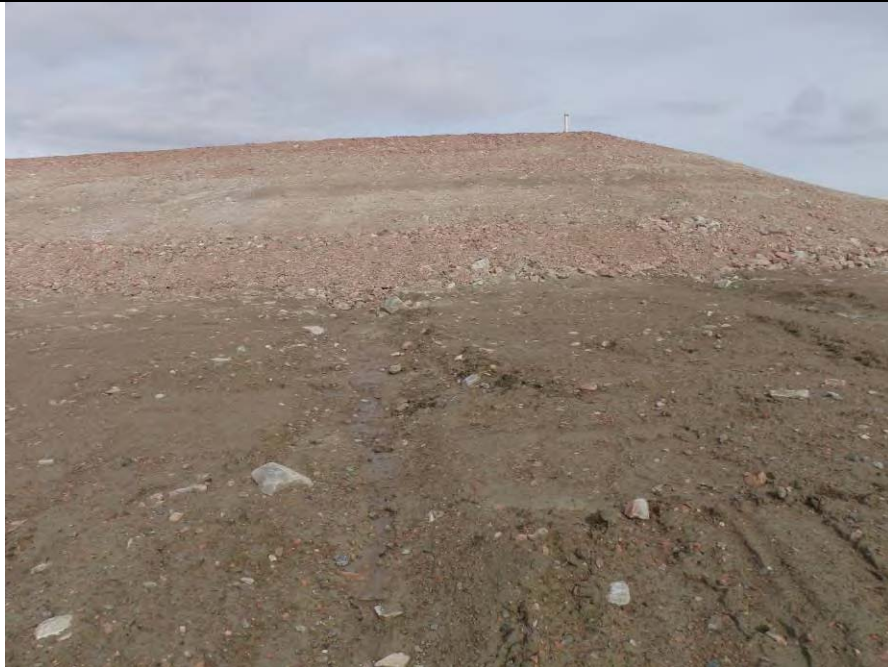
Photo 7. Rivulet (erosion channel) on south side of SSDF; picture viewpoint number 24a (Figure A-1, Appendix A).  
Direction photo taken: N (picture # P8240086).

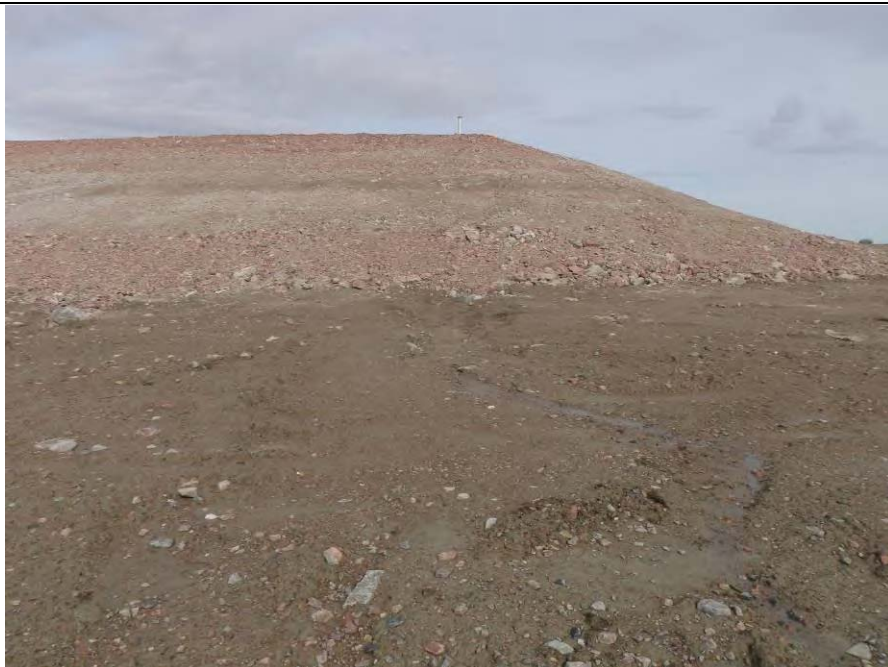
Photo 8. Rivulet (erosion channel) on south side of SSDF; picture viewpoint number 24b (Figure A-1, Appendix A).  
Direction photo taken: N (picture # P8240087).

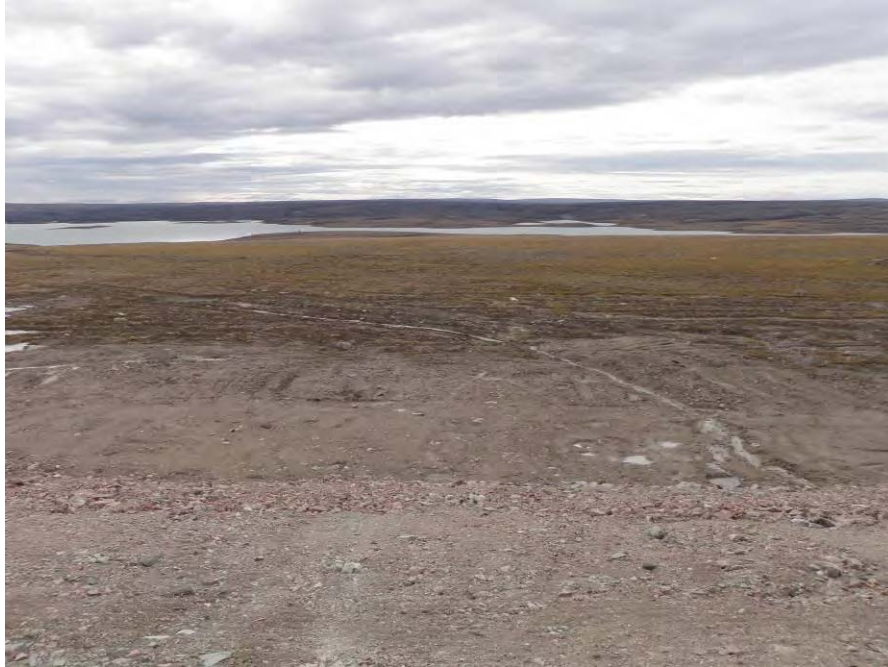
Photo 9. Rivulet (erosion channel) on south side of SSDF; picture viewpoint number 47 (Figure A-1,Appendix A).  
Direction photo taken: S (picture # P8240110).

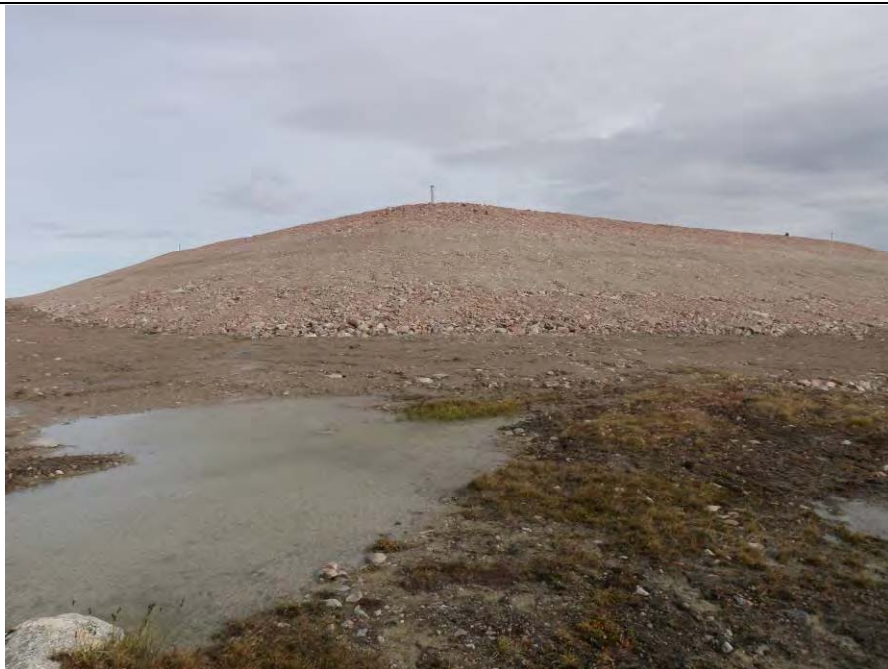
Photo 10. Ponding at the SW corner of the SSDF. A small rivulet (erosion channel) is also seen coming from the SSDF. Picture viewpoint number 15 (Figure A-1,Appendix A). Direction photo taken: NE (picture # P8240073).

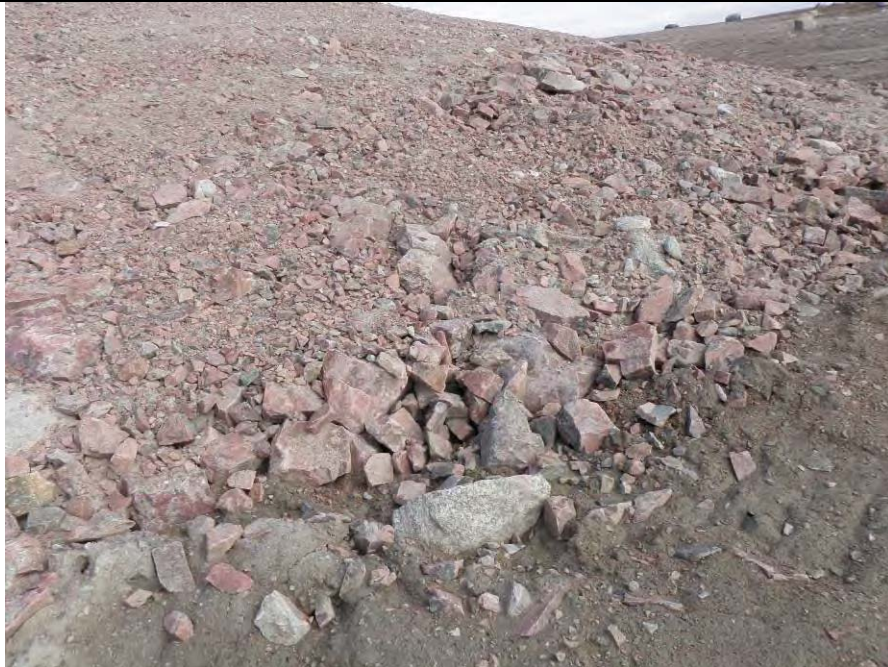
Photo 11. Exposed riprap on southern corner of the SSDF. Direction photo taken: E (picture # P8250170).

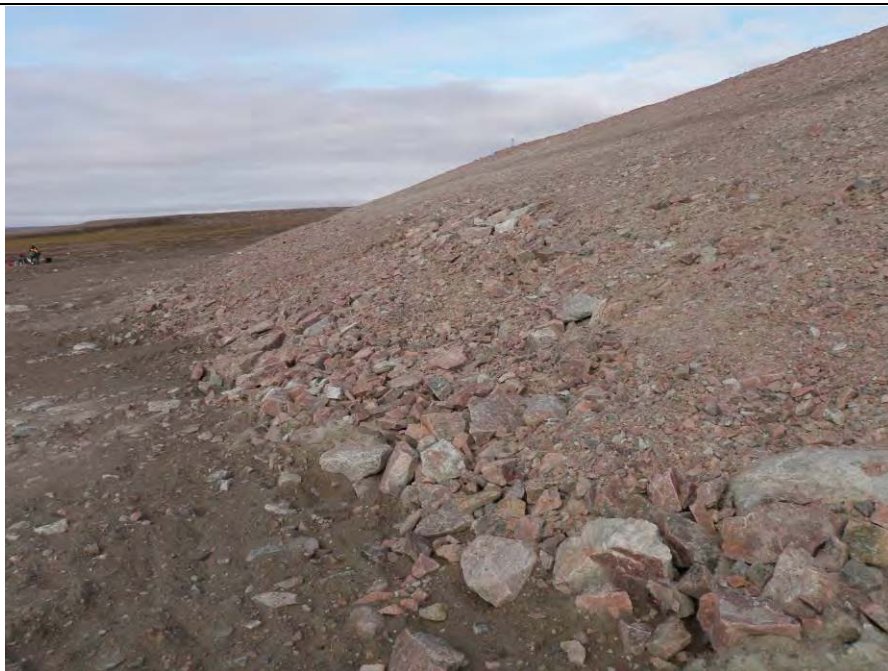
Photo 12. Exposed riprap on southern side slope of the SSDF. Direction photo taken: W (picture # P8250171).

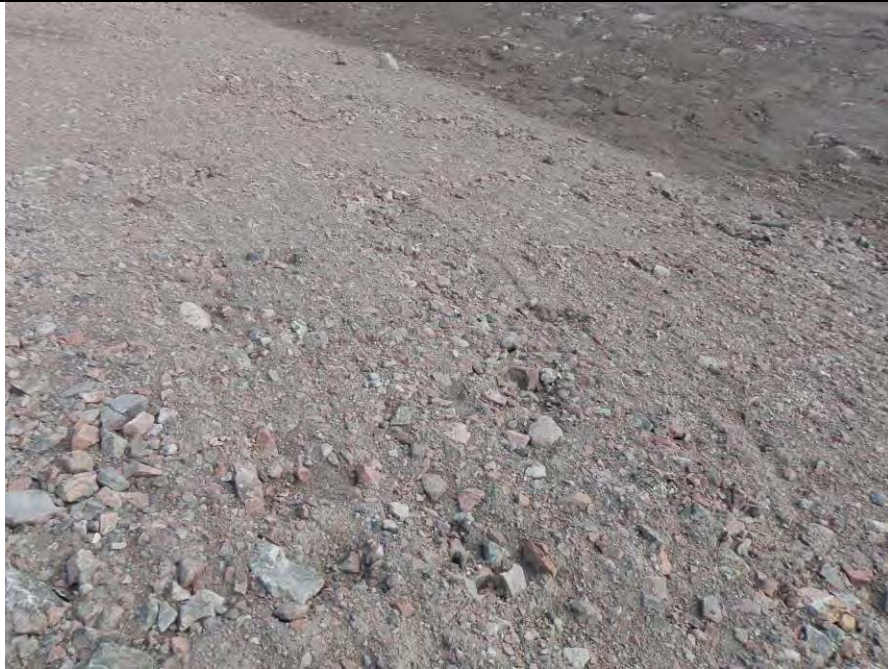
Photo 13. Small potholes on the south-western sideslope of the SSDF. (picture # P8250178).

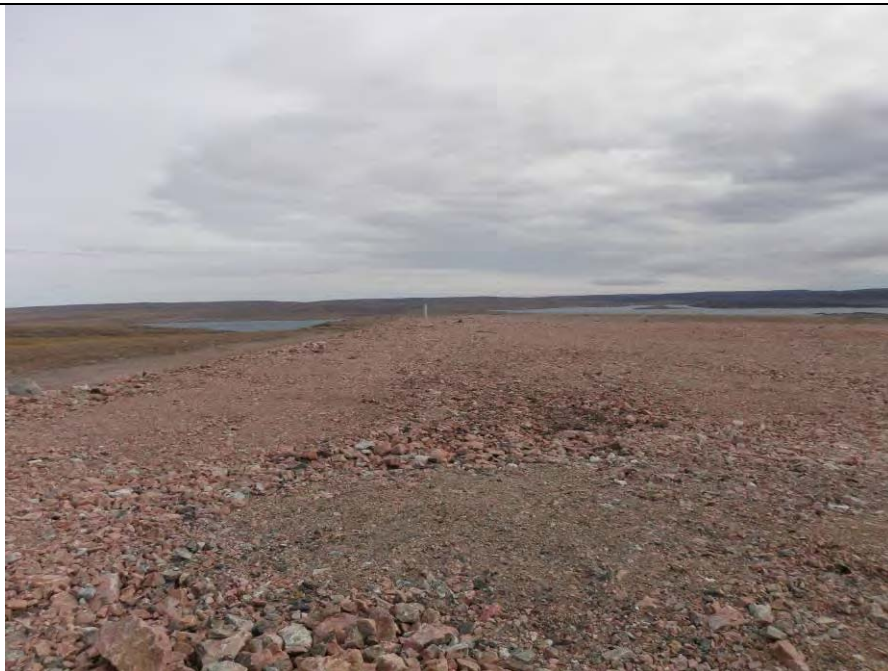
Photo 14. Minor erosion of fines and very slight depression on the top of the SSDF; picture viewpoint number 56 (Figure A-1, Appendix A). Direction photo taken: SE (picture # P8240119).

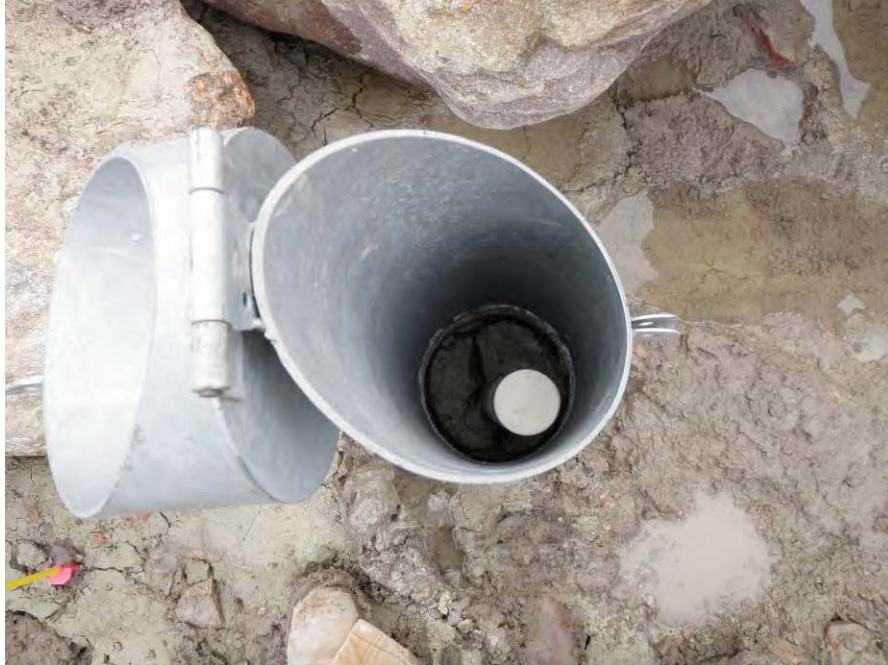
Photo 15. MW0604 on the north side of the SSDF showing bentonite upwelling and slight cracking. Ponding is also evident (picture # P8250155).

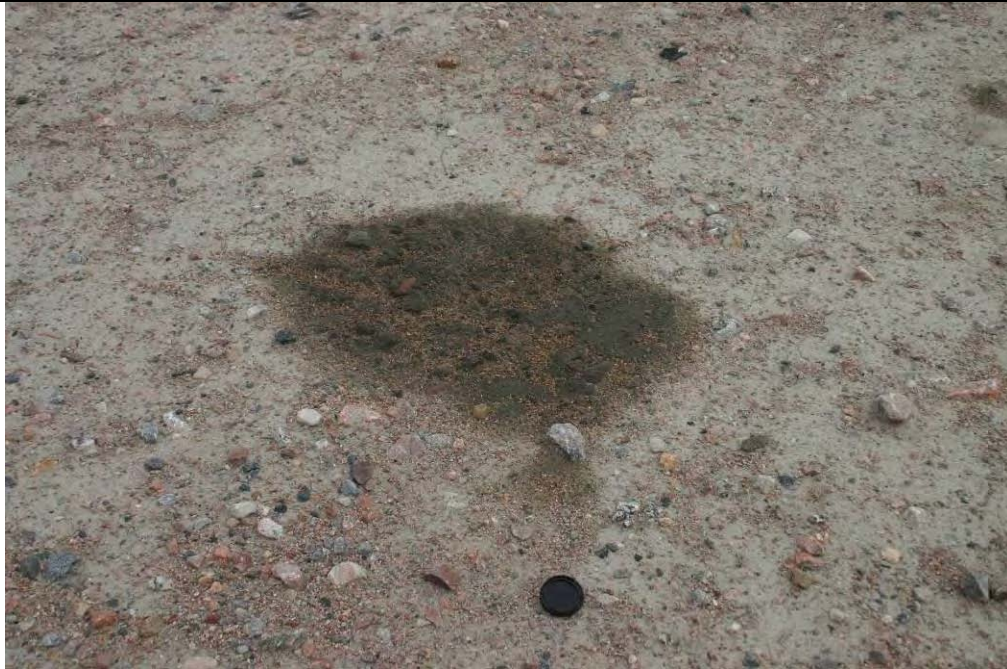
Photo 17. Stain on the road between the cabin and the NHWL. Lens cap shown for scale. Photo provided by INAC.

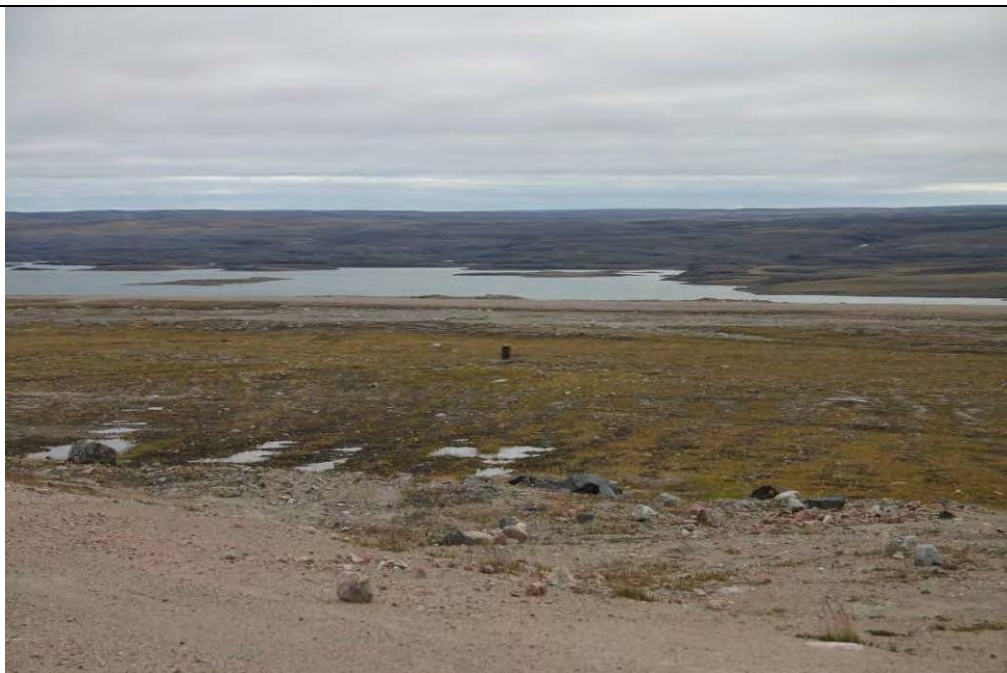
Photo 18. Stray debris (empty barrel) south of the cabin. Direction photo taken: S to SE. Photo provided by INAC.

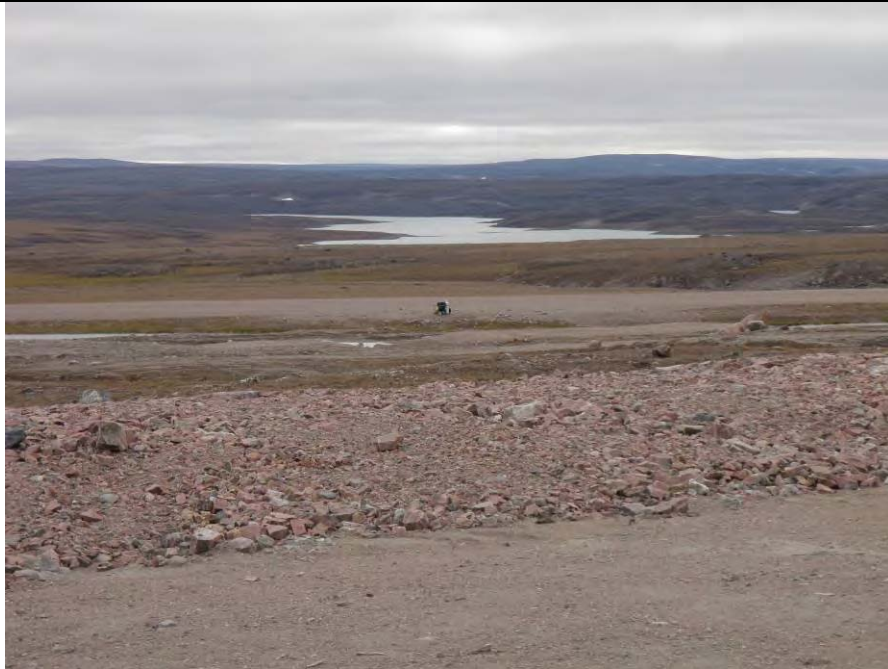
Photo 19. Stray debris (barbeque) south of the cabin. Direction photo taken: S to SW (picture # P8250233).

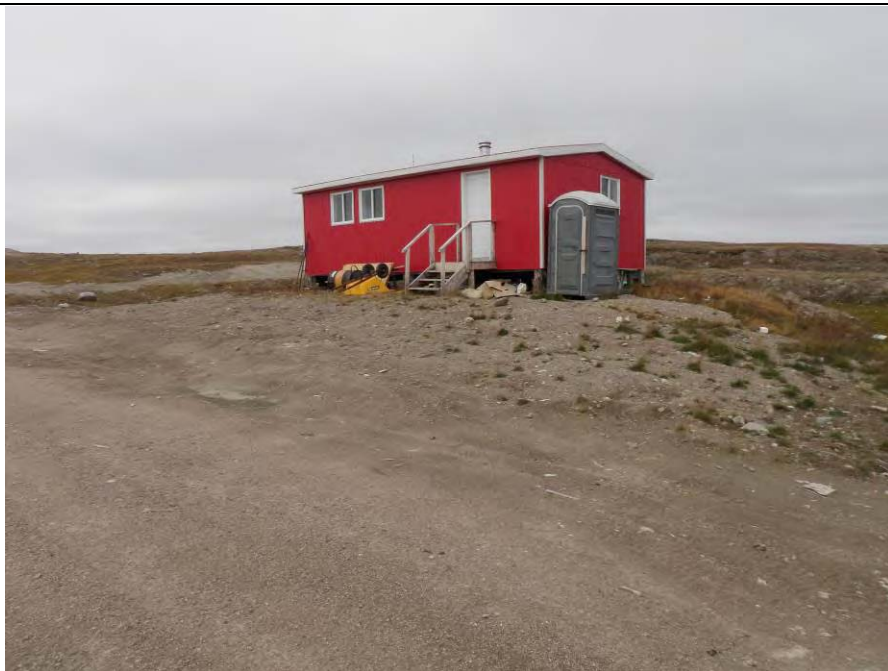
Photo 20. Cabin located between the SSDF and the NHL showing surrounding debris. Direction photo taken: N (picture # P8250229).

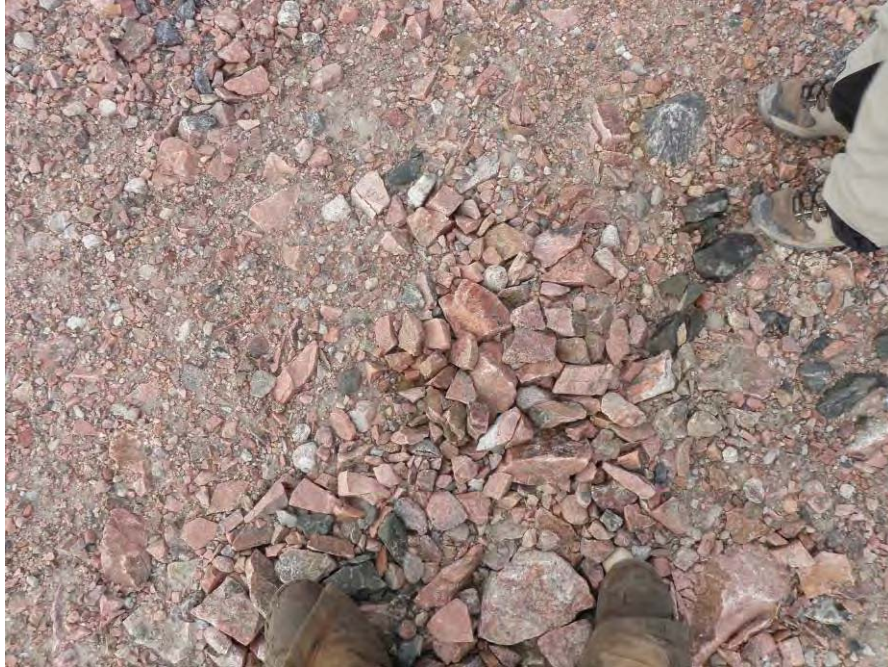
Photo 21. Top of NHWL showing minor erosion of fines revealing gravel and cobbles; picture viewpoint number 38 (Figure A-1, Appendix A); picture # P8250273.

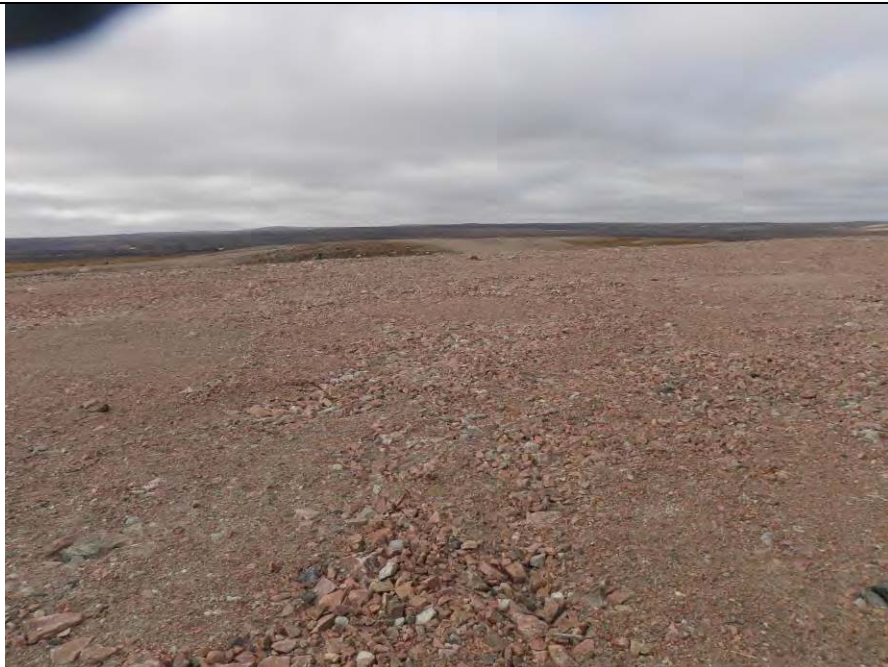
Photo 22. Top of NHWL showing minor erosion of fines revealing gravel and cobbles; picture viewpoint number 39 (Figure A-1, Appendix A). Direction photo taken: NW (picture # P8250274).

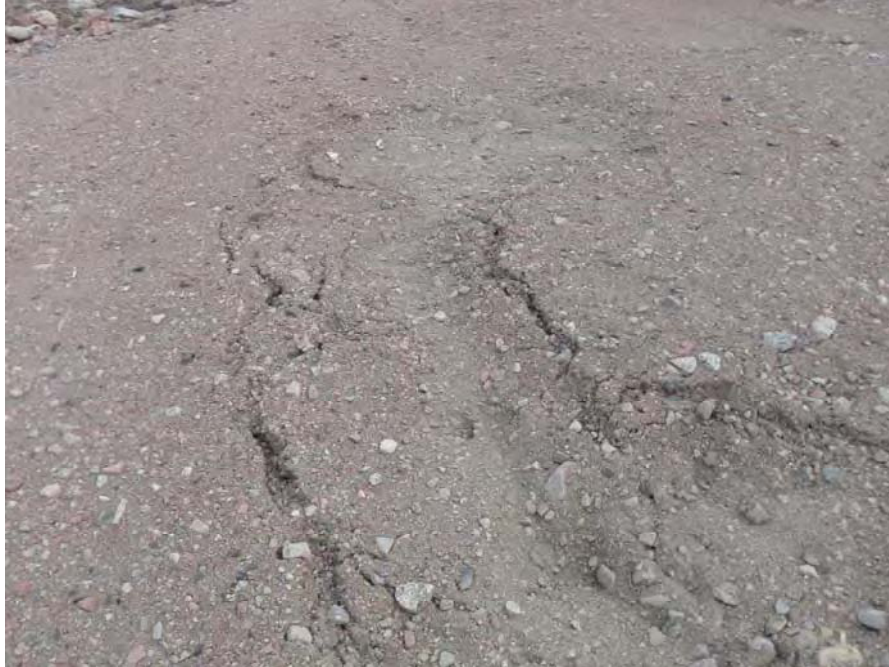
Photo 23. Close-up of depression, approximately 5 m long, to the western side of the southern corner of the NHL (picture # P8250302). Refer to Figure A-1, Appendix A, for exact location.

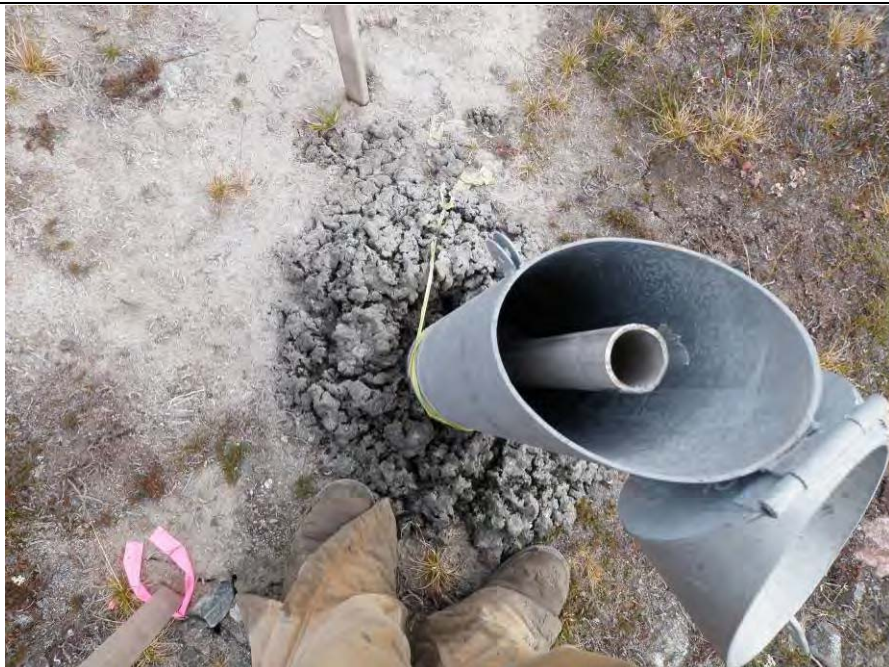
Photo 24. MW06-02 near the NHL with signs of a deteriorating bentonite surface seal (picture # P8250298).
