Indigenous and Northern Affairs Canada

LONG TERM MONITORING 2017

CAM-F, Sarcpa Lake, Nunavut

25 January 2018

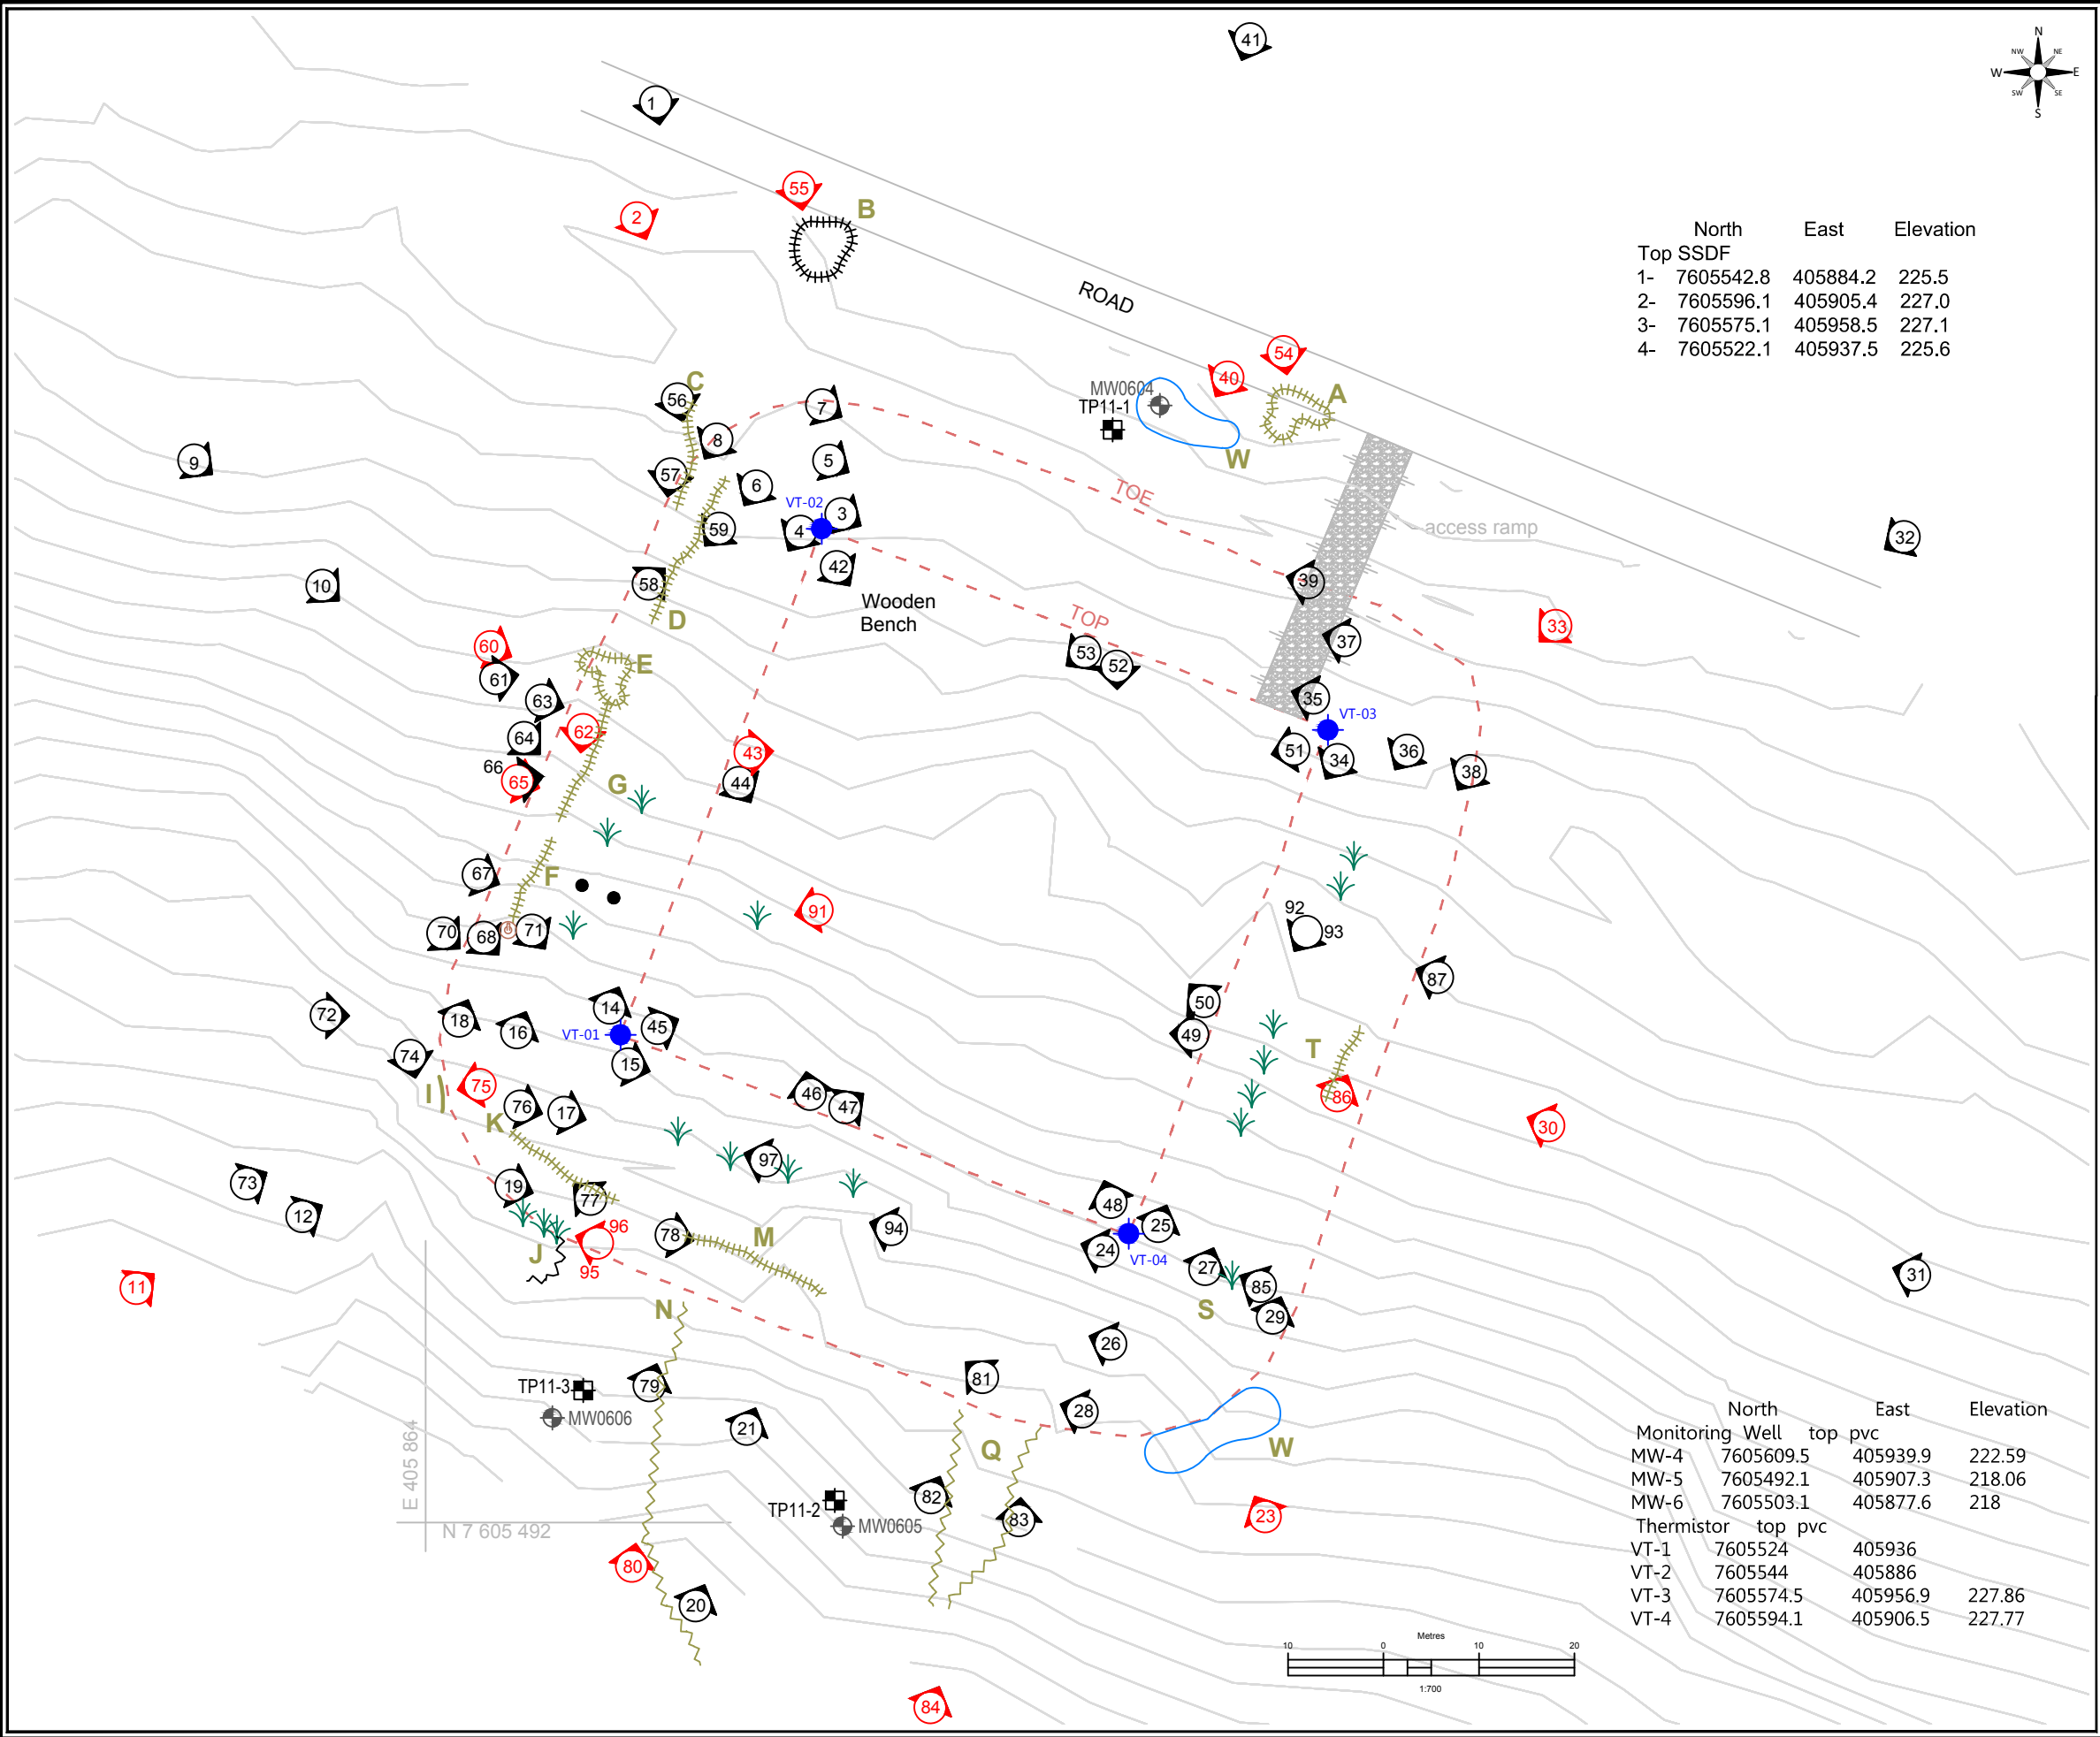
Project:	CAM-F Sarcpa Lake, NU 100570-002
	Client:	Indigenous and Northern Affairs Canada
Date:	December 2017	
Scale:	Scale as shown	
		Figure 2

Settlement Features A and B were observed to the north of the landfill, with no significant change from previous monitoring events (see Photographs 7 and 8, Appendix A-1). Other settlement depressions depicted on Figure 2, Features E (Photo 9, Appendix A-1), G (Photo 11, Appendix A-1) were observed to be minor and not significantly changed from the previous year. Former Feature U was not observed and was removed from Figure 2, refer to Table 5-2 for more details. These settlement features do not pose any risk to the landfill integrity. The minor settlement cracking that was observed along the landfill's perimeter and located approximately 4 m up the face of the berm from the toe (see Features C, D, F, K, M, and T; Figure 2) was less evident in 2017 than that observed in 2014.

The small preferred-drainage channels observed in previous years at the toe on the southwest side of the SSDF are still apparent (see Features I (Photo 12), J (Photo 17), N (Photo 14), and Q (Photo 13); Figure 2; Appendix A-1). Based on a comparison with photo documentation from 2008 to 2014, there does not appear to be an appreciable increase in the length or depth of these channels. The channels associated with Features I and J were observed to be dry during the 2017 monitoring event; however, there was running water in Features N and Q. No staining and no areas of ponded water were observed.

Four seepage points (see Features I, J, N, and Q; Figure 2) were observed along the southern toe of the landfill in 2011 and 2012. During the 2011 and 2012 LTM events, two of the seepage points (Features J and I; Figure 2, Photos 12 and 17, Appendix A-1) exhibited flowing water. Two of the seepage points (Features I and Q; Figure 2, Photos 12 and 13; Appendix A-1) terminated at standing ponded water. No flowing seepage was observed in 2014. Flowing seepage water was observed at Feature I and Feature Q during the 2017 site visit, consistent with some previous investigations (2011 and 2012).

Four passive seepage points (formerly labelled as features H, L, P, and V) were identified in 2011; however, these features were not observed during subsequent monitoring events. These seepage features are most likely directly related to heavy precipitation events. No rivulets or erosion channels associated with these passive seepage points were observed. As these features have not been observed in the past three LTM events, they have been removed from Figure 2.

These seepage features directly correlate with the observations of erosion noted above. These features should be monitored closely, as they may present a pathway for landfill content exposure should the seepages worsen in the future.

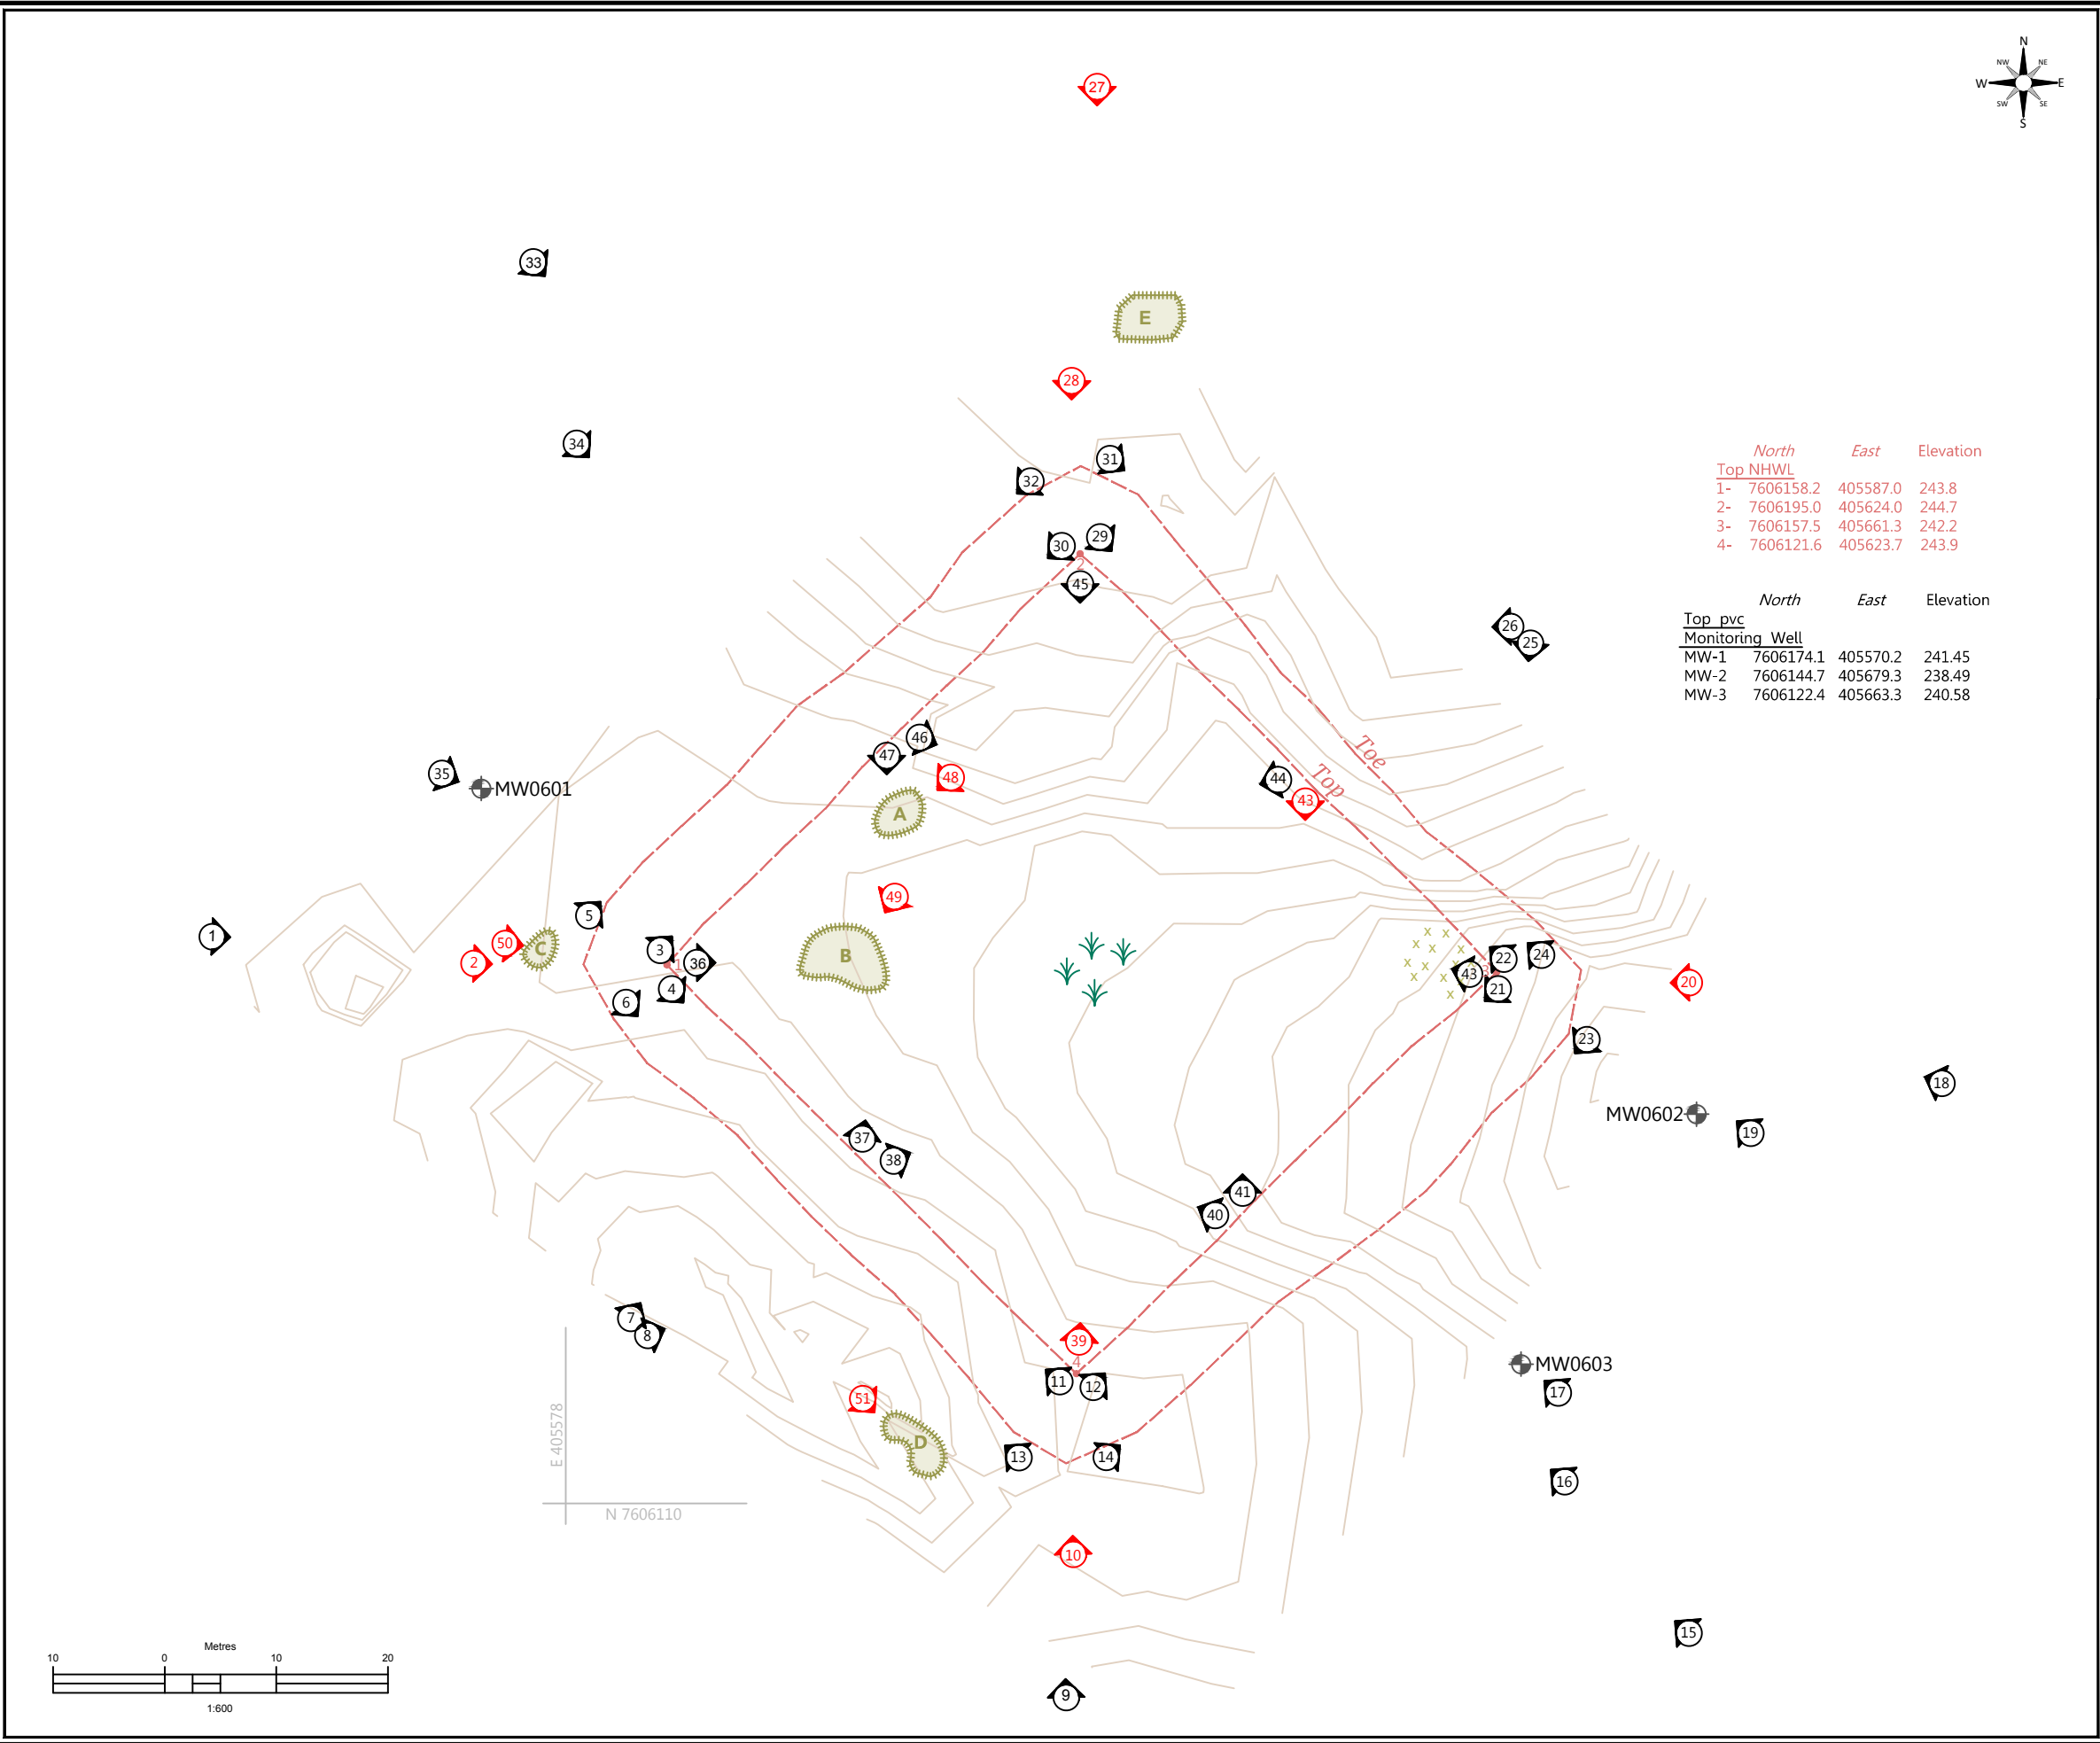
Settlement on the landfill top (see Features A and B, Photos 8 and 9; Appendix A-2) is similar to that described in previous years (two small locations on the northwest sector; refer to Figure 3). There is no obvious cause to this settlement, which is considered minor. There is no evidence of significant water infiltration and no ponding was observed at or around the NHWL.

The same settlement areas (see Features C and D, Photos 10 and 11; Appendix A-2) were also observed beyond the toe of the NHWL between the northwest corner and the southwest side (see Figure 3) where a maximum depth of settlement of 0.3 to 0.4 m was reached. A new area of minor settlement located approximately 25 m north of the NHWL was documented as Feature E in 2012, which showed no significant change in subsequent years (see Figure 3 and Photo 4; Appendix A-2) including 2017.
