Long Term Monitoring, 2017 CAM-F Sarcpa Lake, Nunavut

APPENDIX A-2

Site Photographs - NHWL

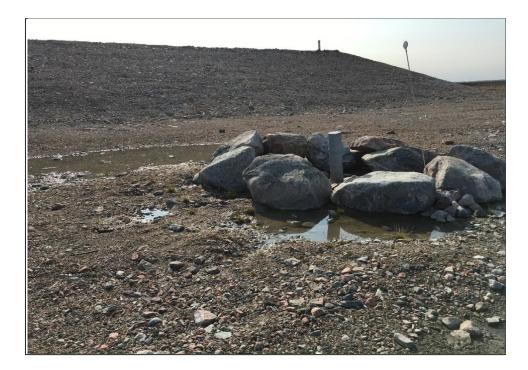
Photo: 5

View of ponded water surrounding MW0604. SSDF northern edge.

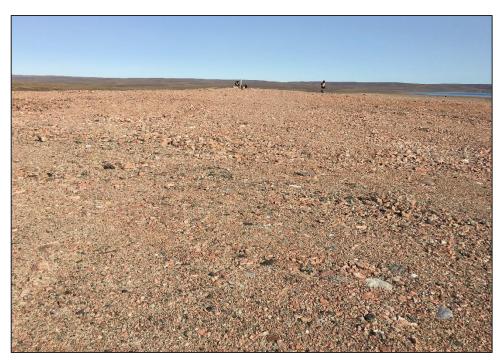
Photo: 6

Landfill cap view of SSDF. Thermistor Number 3 in background.

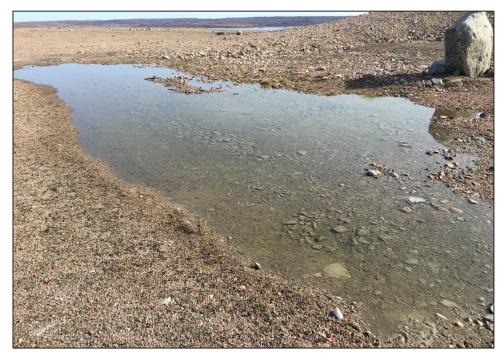
Photo: 7

Northeast side of the SSDF. Monitoring Well MW0604 in top right corner or photo.

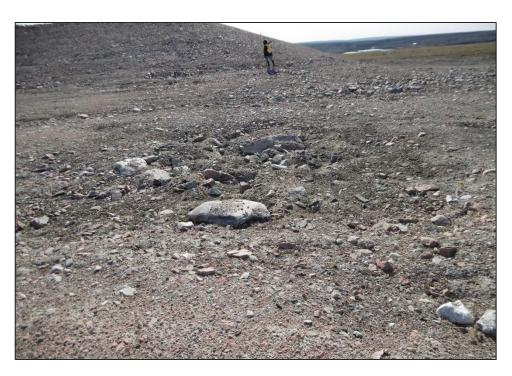
Photo: 8

Northwest corner of landfill, Settlement Feature B.

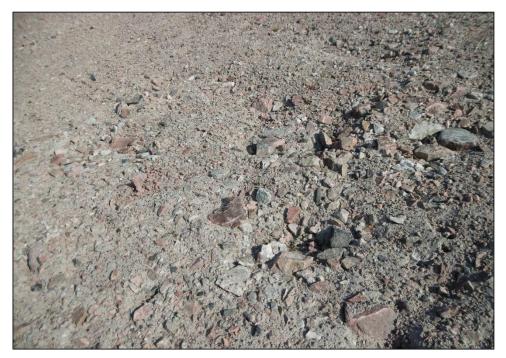
Photo: 9

West side of the SSDF. Feature E.

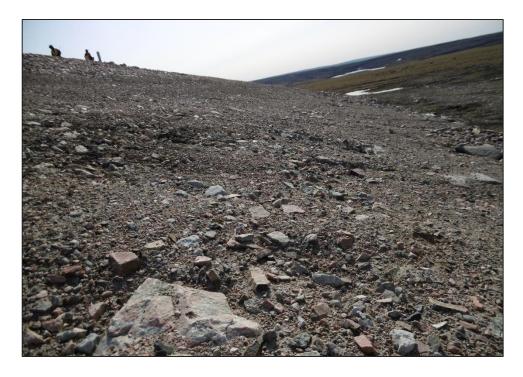
Photo: 10

Western side of SSDF. Thermistor Number 1 in top left corner of photo.

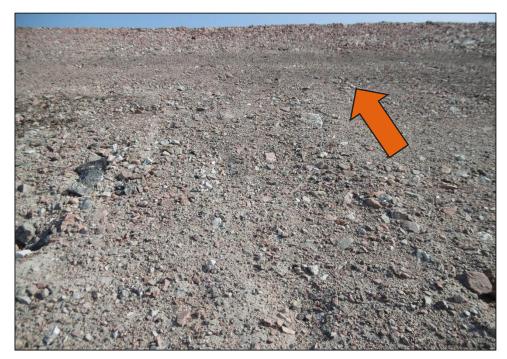
Photo: 11

Western side of SSDF. View of Feature G in middle of photo (line feature)

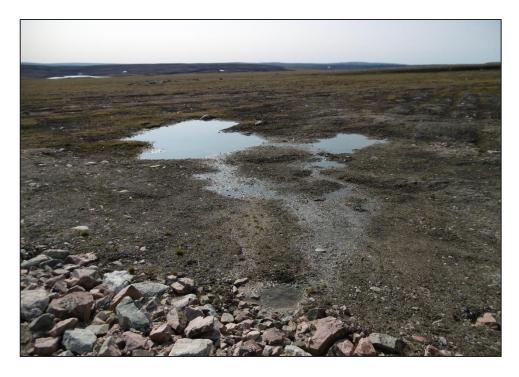
Photo: 12

View out from landfill southwest corner. Feature I in photo.

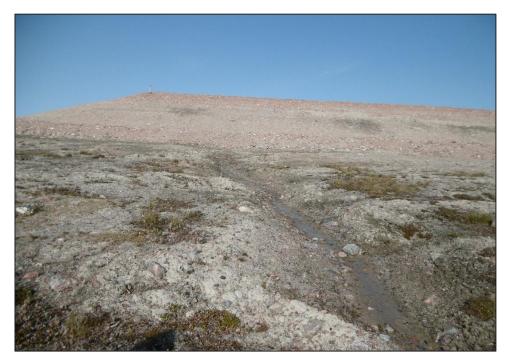
Photo: 13

View of SSDF southeastern corner in background, Feature Q in foreground.

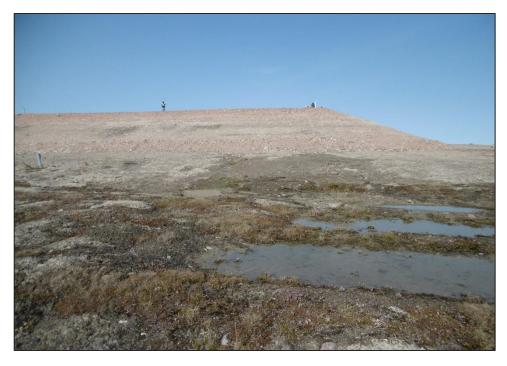
Photo: 14

Southern edge of the SSDF in background, Feature N in foreground.

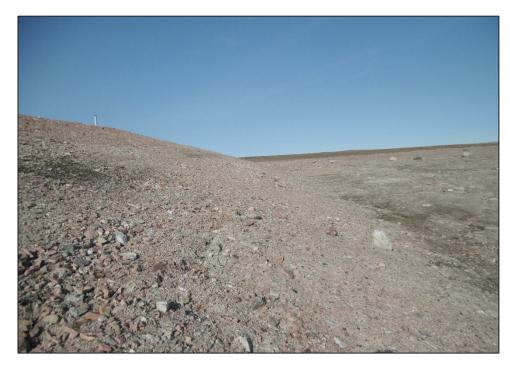
Photo: 15

View of Feature T, SSDF eastern side.

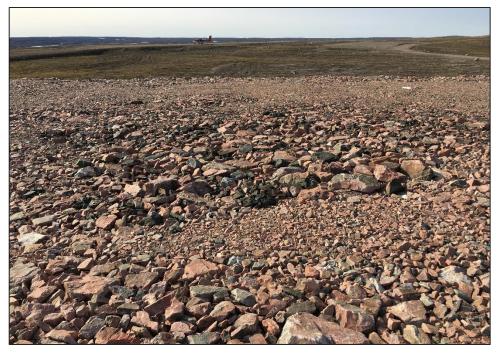
Photo: 16

View of revegetated area on landfill cap.

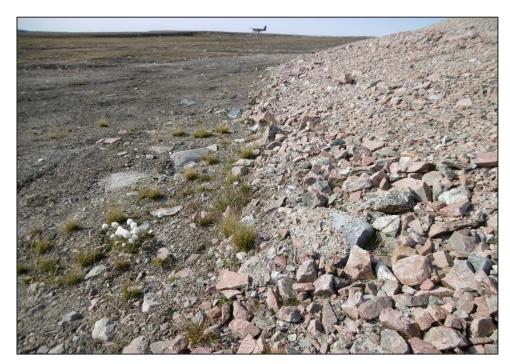
Photo: 17

View of revegetated area (Feature J), southwest corner of SSDF.

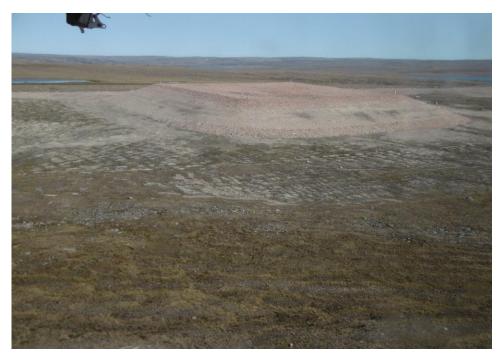
Photo: 18

Aerial view of SSDF.

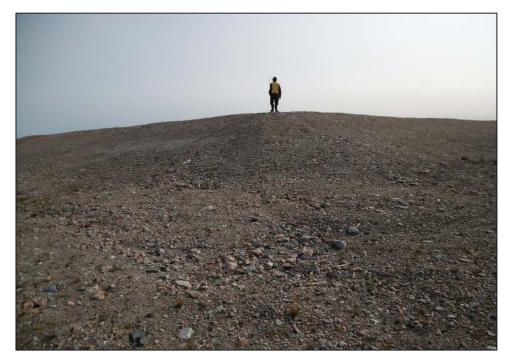
Photo: 1

Western corner of the landfill. Feature C can be seen in the foreground.

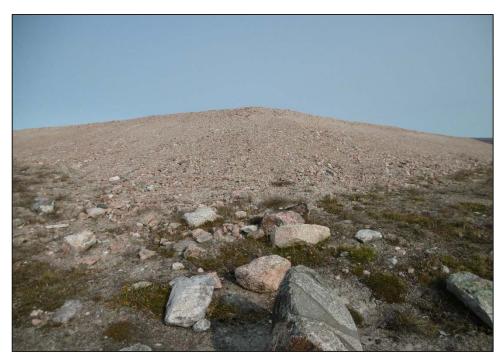
Photo: 2

Southern corner of the NHWL.

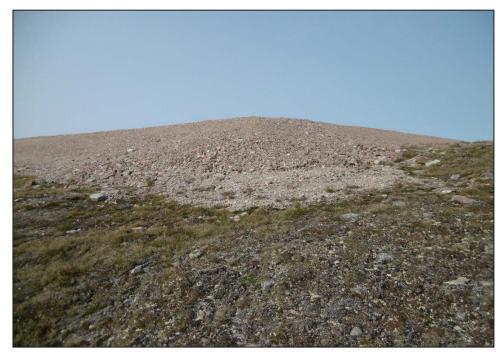
Photo: 3

Eastern corner of the NHWL.

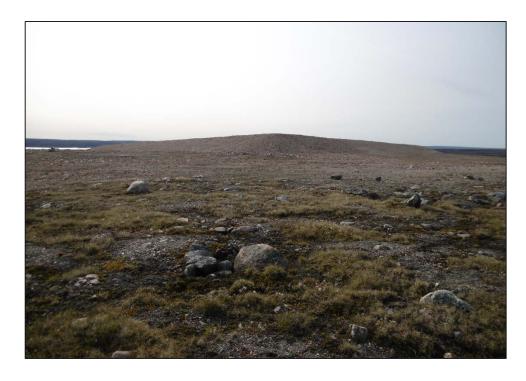
Photo: 4

Northern corner of the NHWL. Feature E in the

foreground.

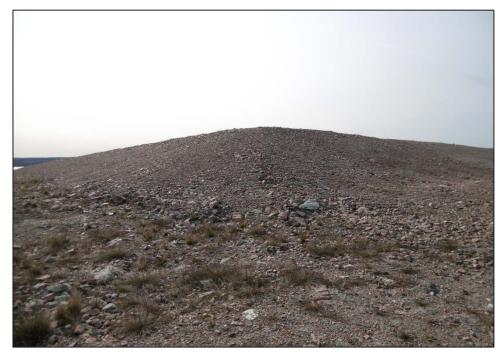
Photo: 5

View of northern corner of NHWL.

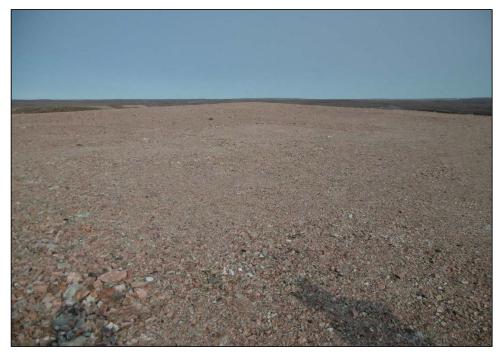
Photo: 6

View of grading of cap on south side of NHWL.
