## **Long Term Monitoring, 2014 CAM-F, Sarcpa Lake, Nunavut**

### **FINAL REPORT**

Prepared for:

Aboriginal Affairs and Northern Development Canada  
Nunavut Regional Office  
P.O. Box 2200  
Iqaluit, Nunavut  
X0A 0H0

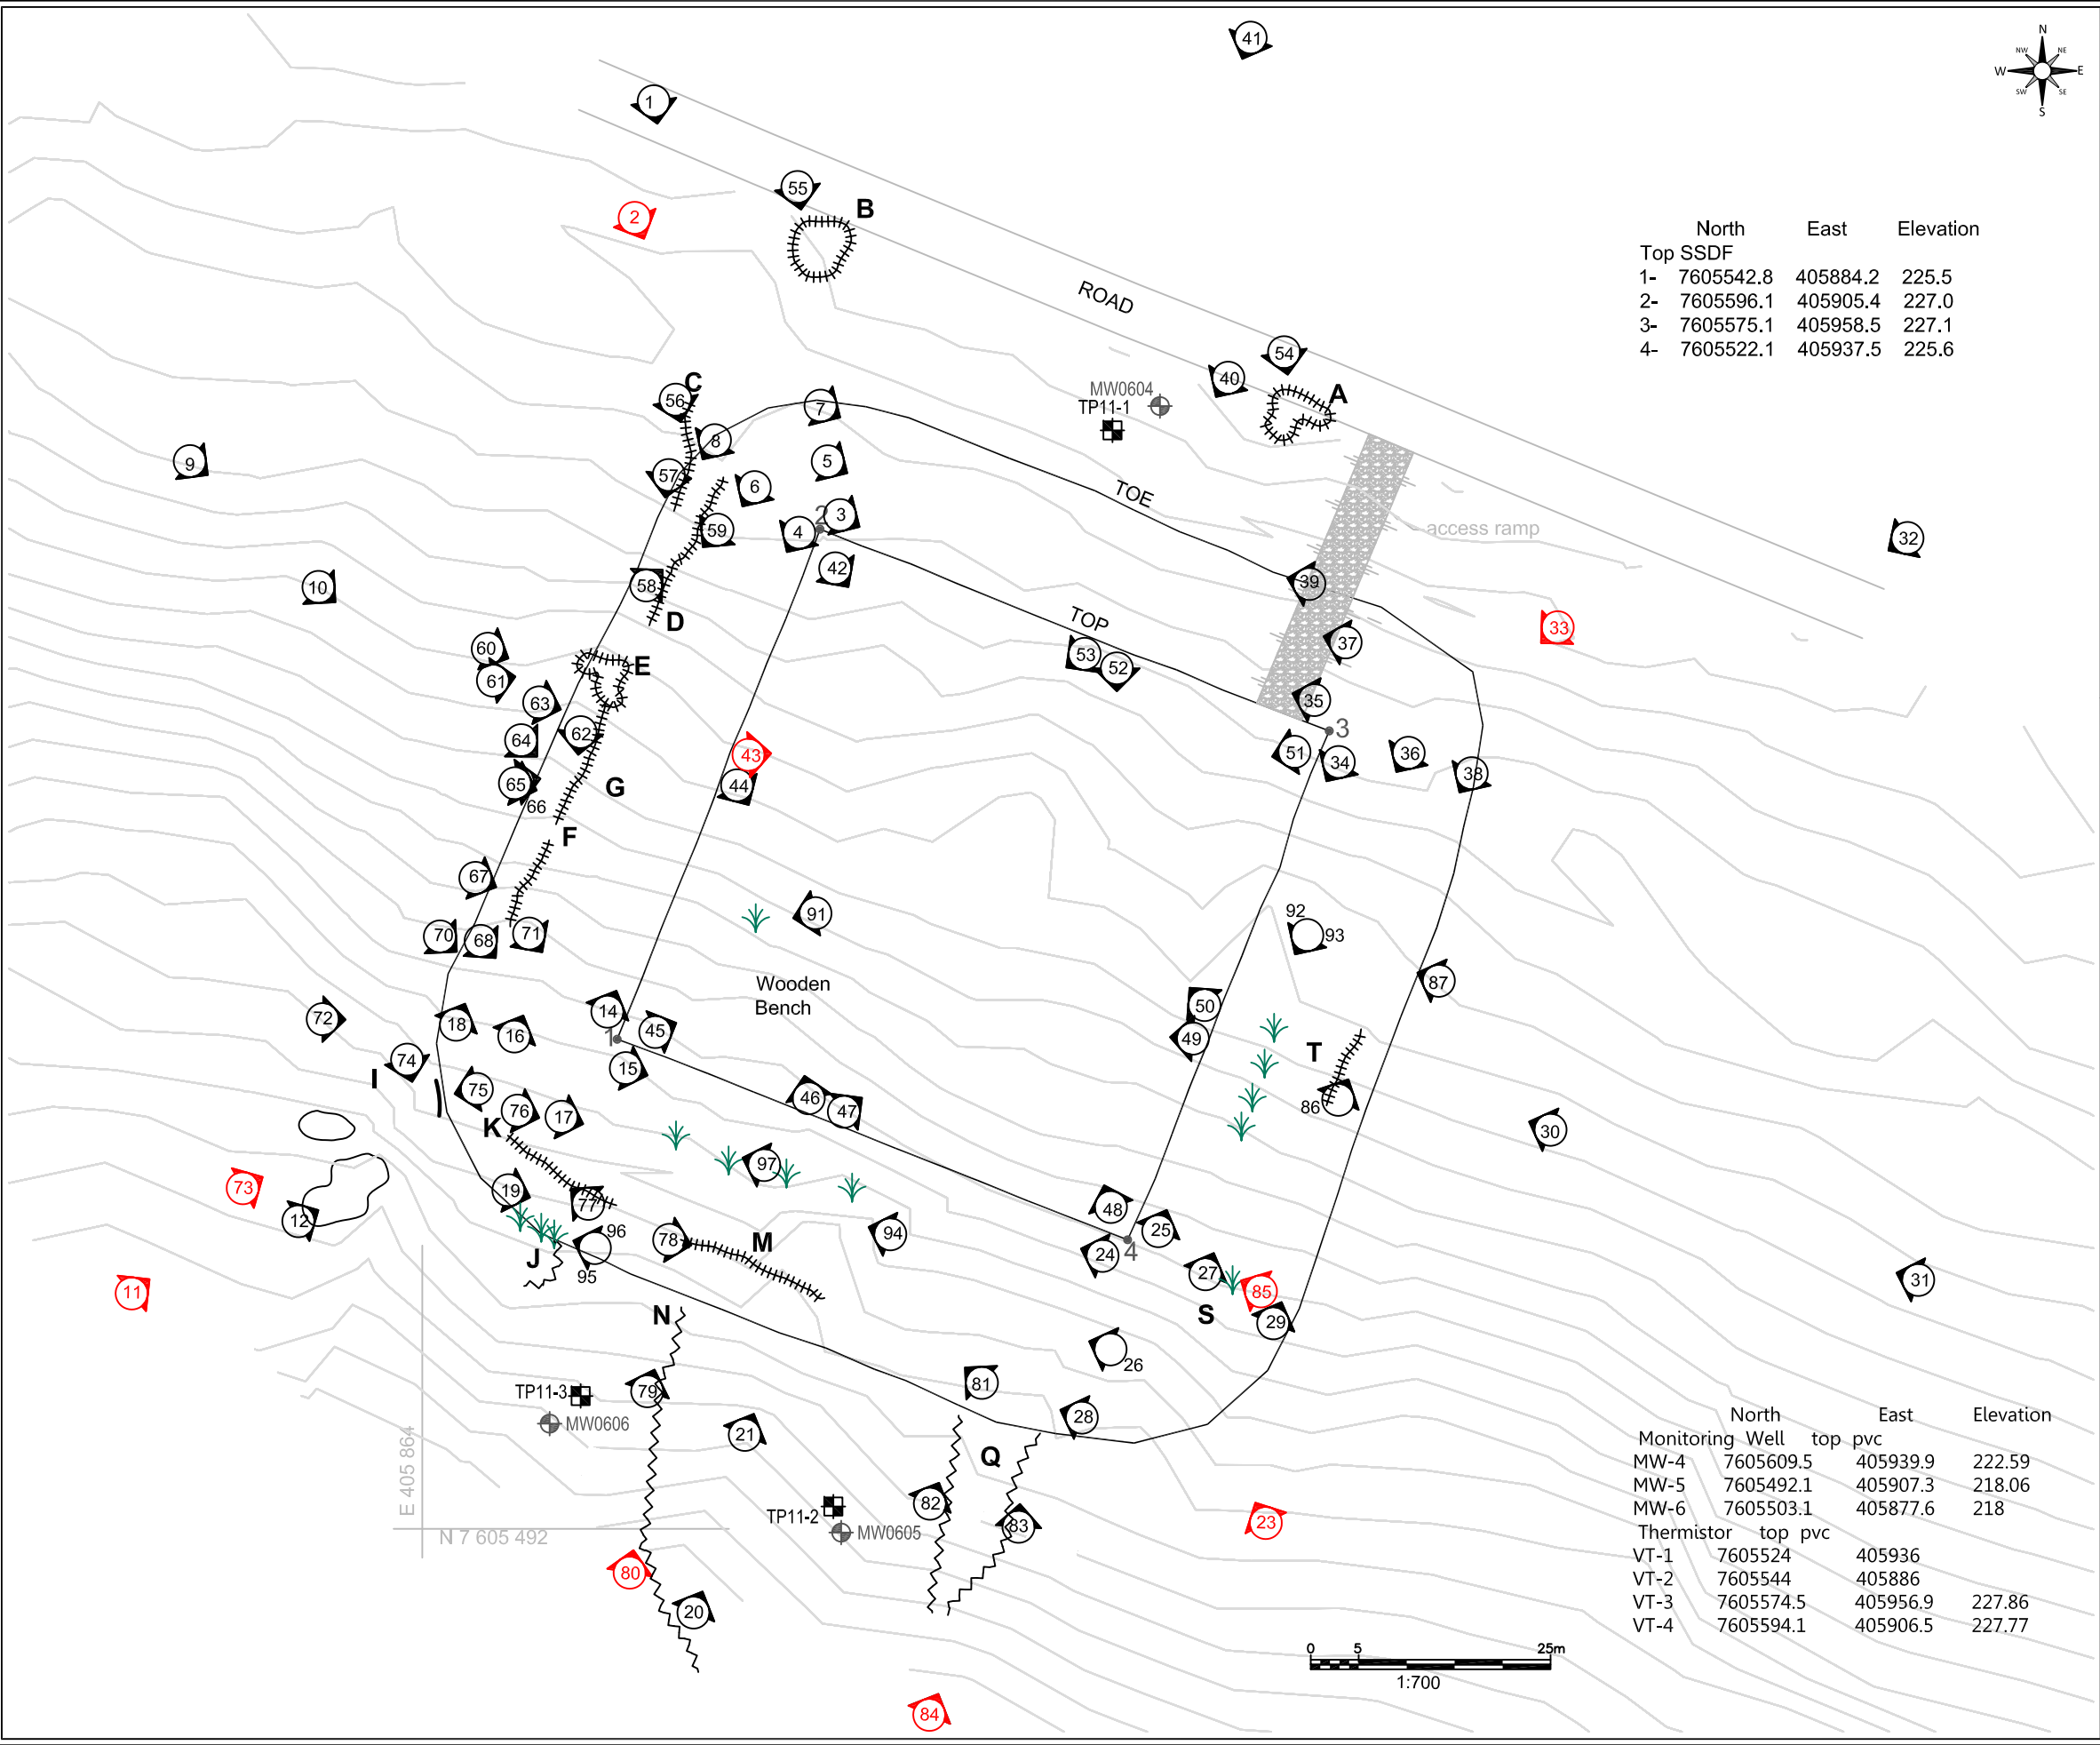
CONSULTING • ENGINEERING • TECHNOLOGIES	Project: <b>CAM-F Sarcpa Lake, NU 1697-1401</b>	
	Date: <b>December 2014</b>	Client: <b>Aboriginal Affairs and Northern Development Canada</b>
Scale: <b>Scale as shown</b>		<b>Figure A-2</b>

Settlement depression features A and B were observed to the north and northeast of the landfill extents, with no significant change from previous monitoring events (see Picture Viewpoint Numbers (VP) 54 and 55 Figure A-2; Appendix A). Other settlement depressions depicted on

Figure A-2, features E (VP 60-61), G (VP 65-66) and U (VP 87) were observed to be very minor and not significantly changed from the previous year. These settlement features do not pose any risk to the landfill integrity. The minor settlement cracking that was observed along the landfill's perimeter and located approximately 4 m up the face of the berm from the toe (see features C, D, F, K, M, and T; Figure A-2; Appendix A) was not significantly changed, with the exception that the cracking observed in previous years was less evident in 2014 than that observed in 2012.

The small preferred-drainage channels observed in previous years at the toe on the southwest side of the SSDF are still apparent (see features I (VP 73-75), J (VP 95-96), N (VP 79-80), and Q (VP 82-84); Figure A-2; Appendix A). Based on a comparison with photo documentation from 2008-2012, there does not appear to be an appreciable increase in the length or depth of these channels. These channels were observed to be dry during the 2014 inspections.

Five seepage points (see features I, J, N, and Q; Figure A-2; Appendix A) were observed along the southern toe of the landfill in 2011 and 2012. During the 2011 and 2012 inspections events, two of the active seepage points (I and J; Figure A-2; Appendix A) exhibited active flowing water. Two of the seepage points (I and Q; Figure A-2; Appendix A) terminated at standing ponded water. In comparison to previous site visits, no active seepage was observed during the 2014 site inspection.

These active seepage features directly correlate with the observations of erosion noted above. These features should be monitored closely, as they may present a pathway for landfill contents should the seepages worsen in subsequent years. Consideration could be given to collecting a soil sample in one of these locations should the seepage or erosion increase.

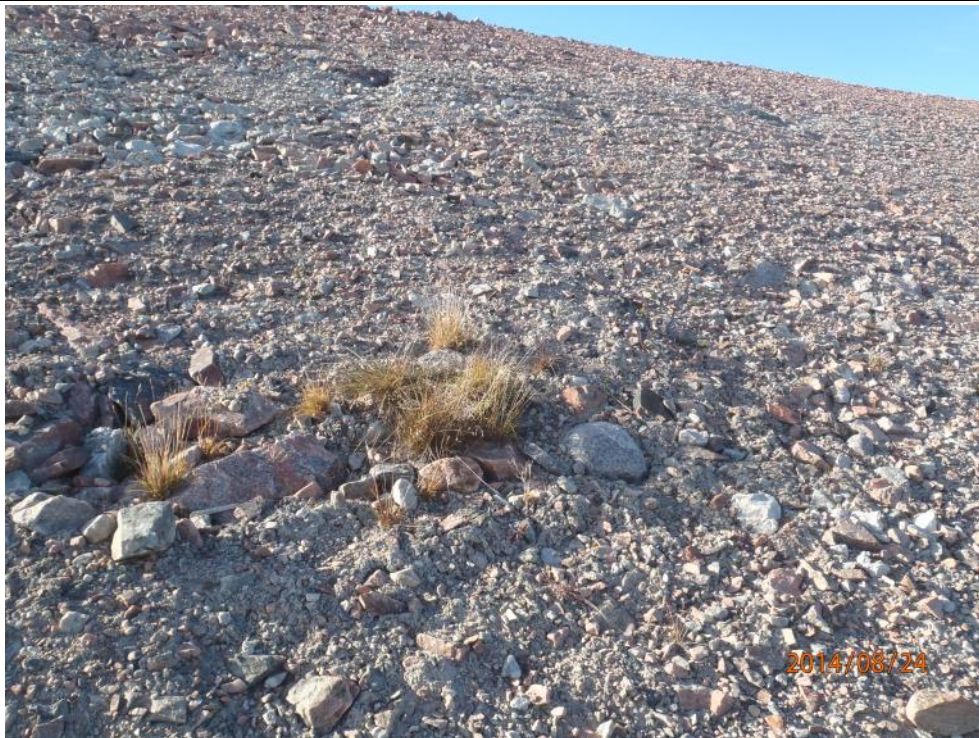
Vegetative re-growth was observed mainly in one location (see feature S; Figure A-2; Appendix A) on the southeast corner of the SSDF berm. Additional indications of vegetative re-growth observed in 2011 and 2012 were confirmed in 2014. New growth was observed on the top of the landfill and mid-way up the south and east facing slopes of the landfill, the new growth is shown in Figure A-2; Appendix A, near previously identified features J, and T (VP 95-96, 94 and 97, and 92-93, respectively). It is believed that the previously identified passive seepage points may be contributing to the re-vegetation.

Vegetation on south slope of SSDF. Viewpoint 85 (Figure A-2; Appendix A). Photograph reference P8240085 (CD-ROM). Direction photo taken: E

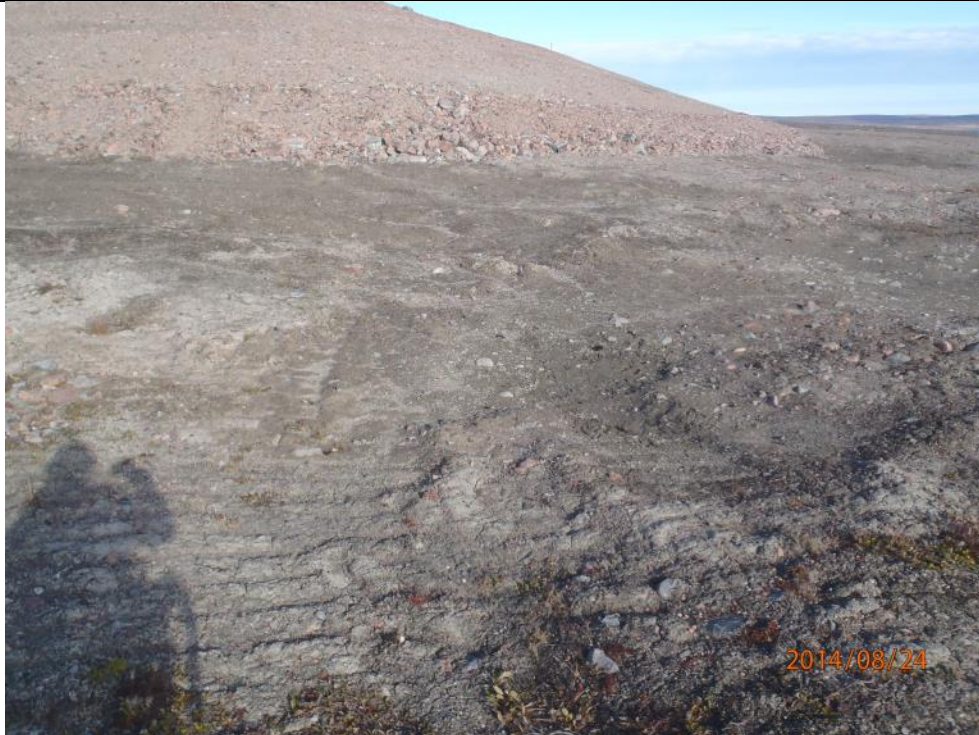
Active seepage identified in 2012 at the southwest corner. Dry in 2014. Viewpoint 73 (Figure A-2; Appendix A).  
Photograph reference P8240073 (CD-ROM). Direction photo taken: NE

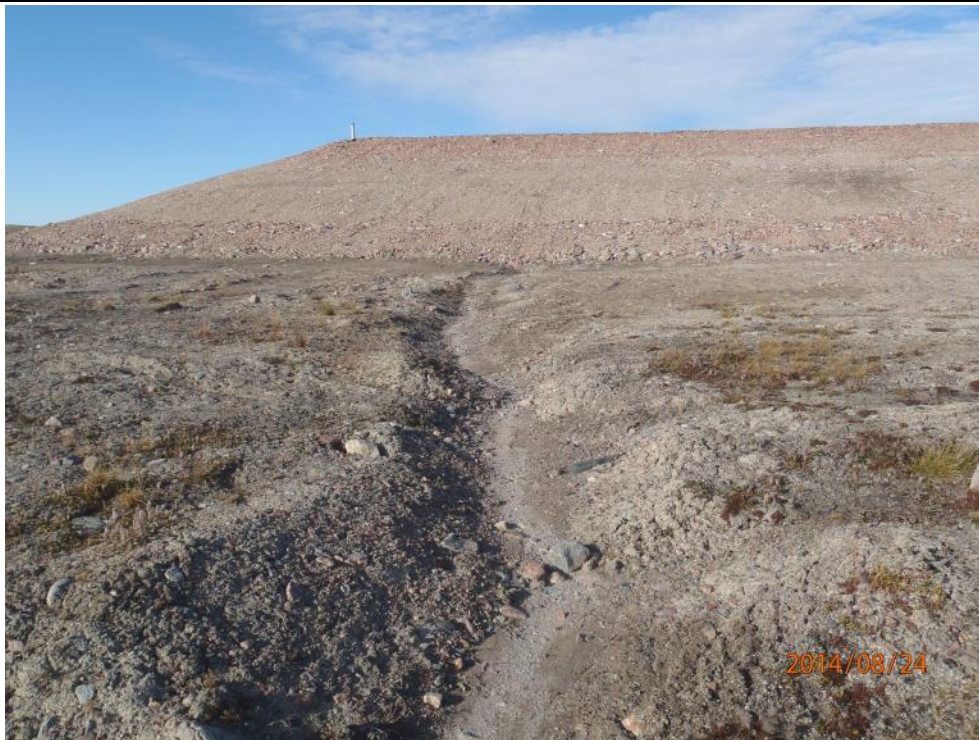
Active erosion from active seepage along the south toe of the SSDF. Dry in 2014. Viewpoint 80 (Figure A-2; Appendix A). Photograph reference P8240080 (CD-ROM). Direction photo taken: N

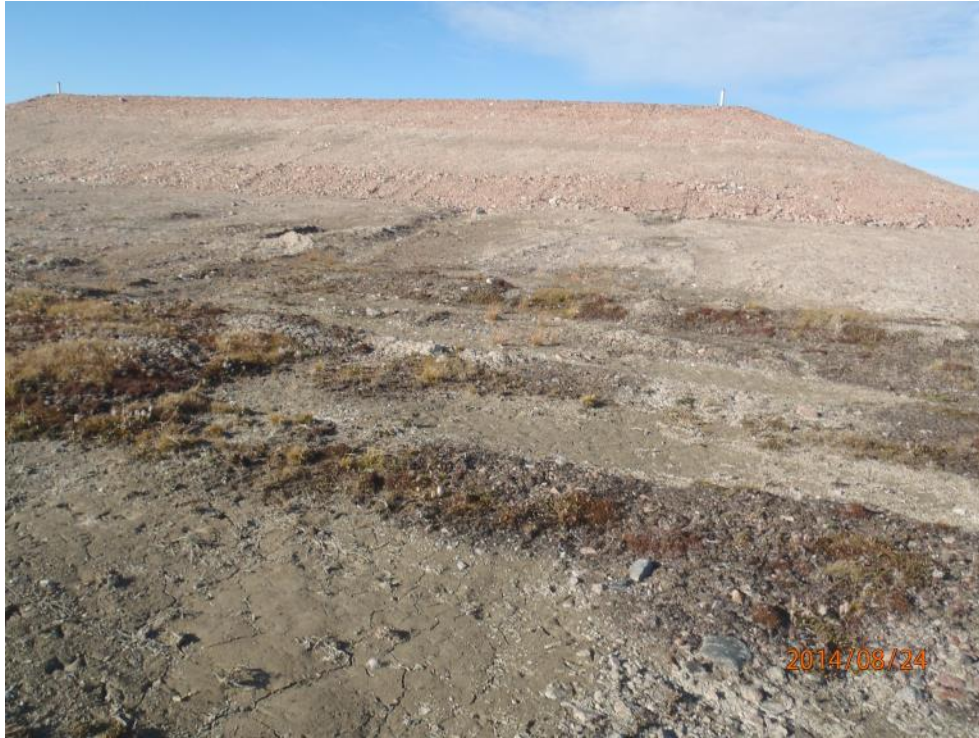
Ponded water from the active seep near the southeast corner of the SSDF. Dry in 2014. Viewpoint 84 (Figure A-2; Appendix A). Photograph reference P8240084 (CD-ROM). Direction photo taken: SE

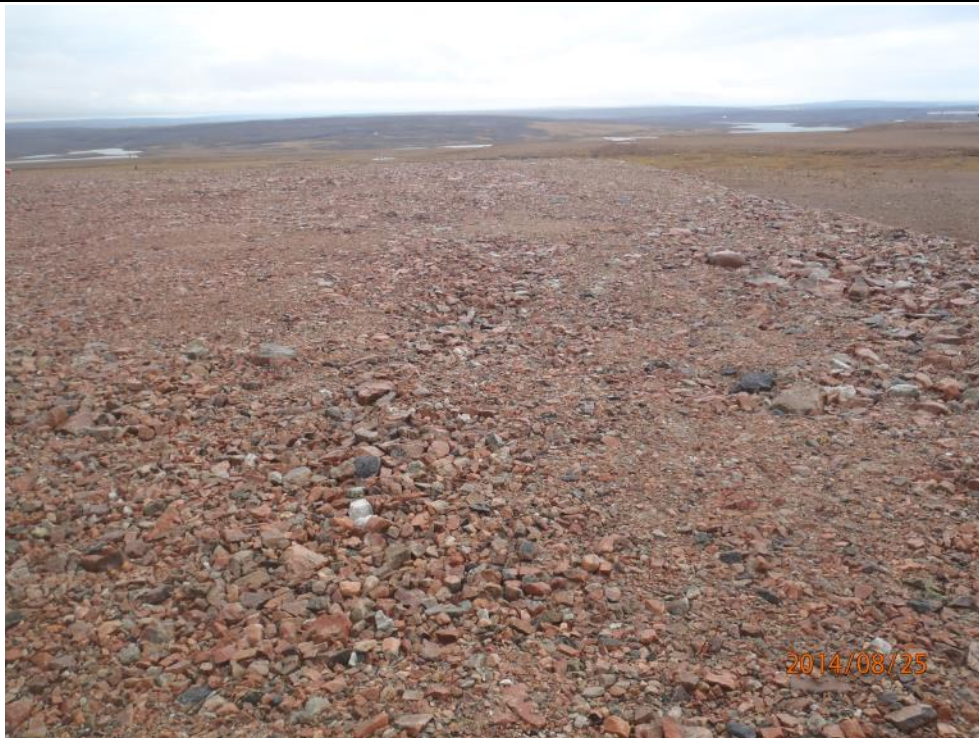
Feature A – small depression on top of the NHWL. Viewpoint 48 (Figure A-3; Appendix A). Photograph reference P8250048 (CD-ROM). Direction photo taken: SW

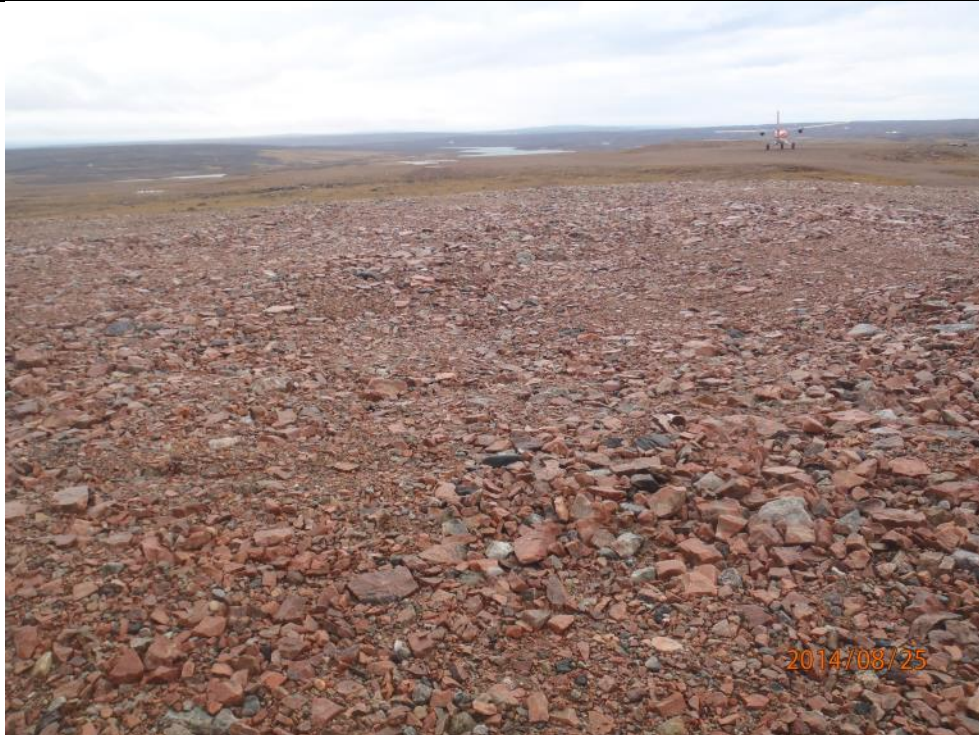
Feature B – large depression on top of the NHL. Viewpoint 49 (Figure A-3; Appendix A). Photograph reference P8250049 (CD-ROM). Direction photo taken: S

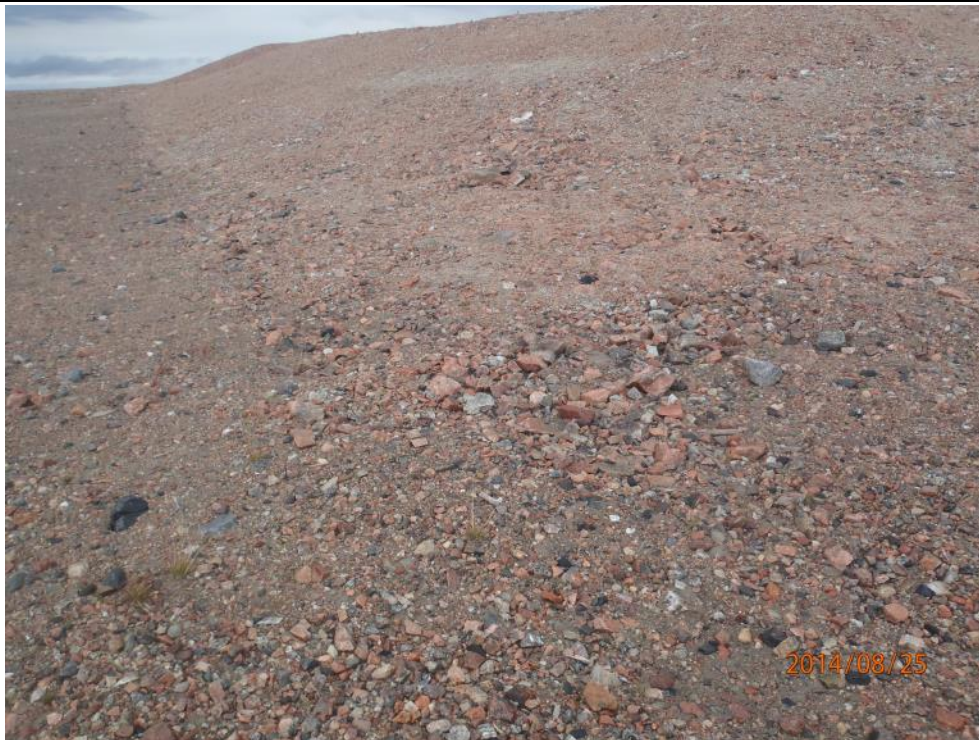
Feature C –Slight low area near the west corner of the NHL. Viewpoint 50 (Figure A-3; Appendix A). Photograph reference P8250050 (CD-ROM). Direction photo taken: W
