Directorate of Contaminated and Legacy Sites Project Delivery  
National Capital Region  
Ottawa, ON K1A 0K2

INAC File: CIDM #1176224  
NWB File: 1BR-SHE1016

**Re: Response to INAC's Letter Dated September 18, 2017, Titled "Indigenous and Northern Affairs Canada's (INAC) Review of Defence Construction Canada's Renewal Application for Water Licence #1BR-SHE1016"**

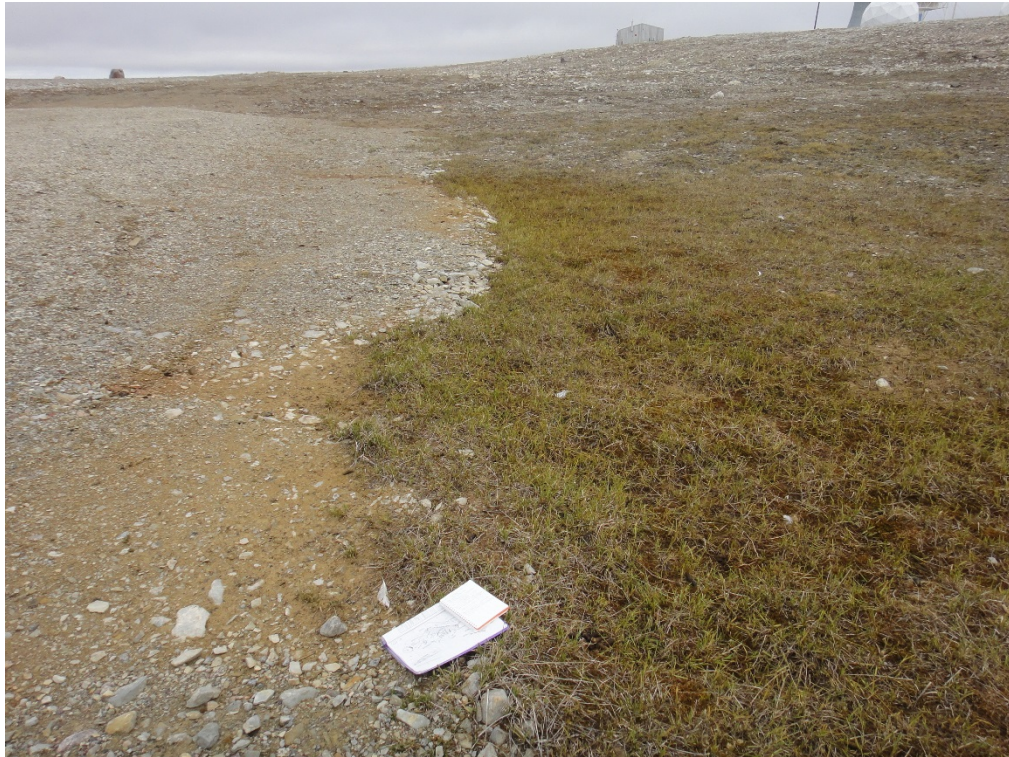
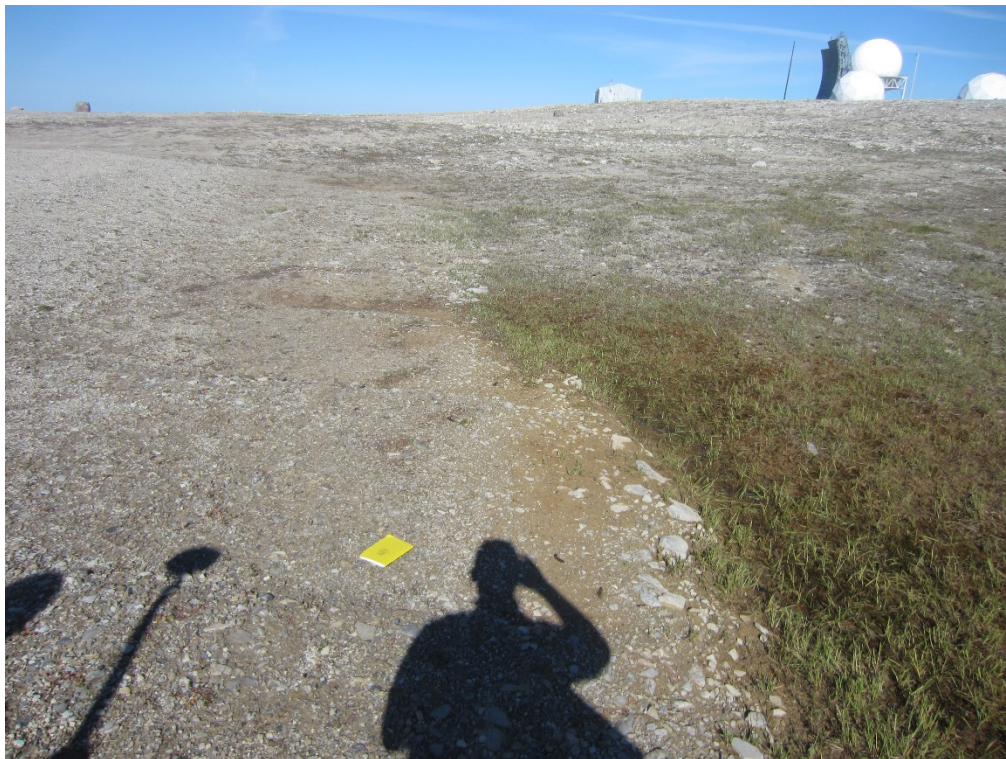
**Attachment 1: CAM-3 Station Landfill Staining Feature J**

The staining identified in both 2014 and 2016 at the toe of Lobe A of the Station Landfill (Feature J) was described as “rust coloured” (Biogénie, 2015 and Arcadis, 2017); the photos corroborate this characterization. The staining is also very small in extent (6.0 m<sup>2</sup>). This is most likely iron oxide staining.

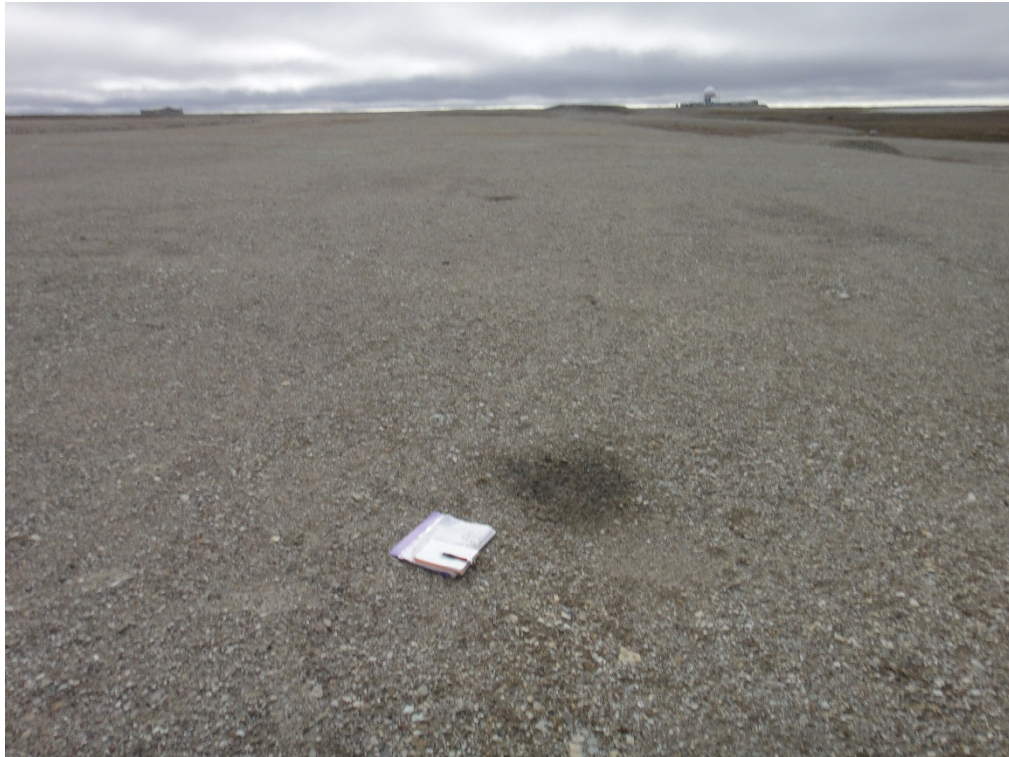
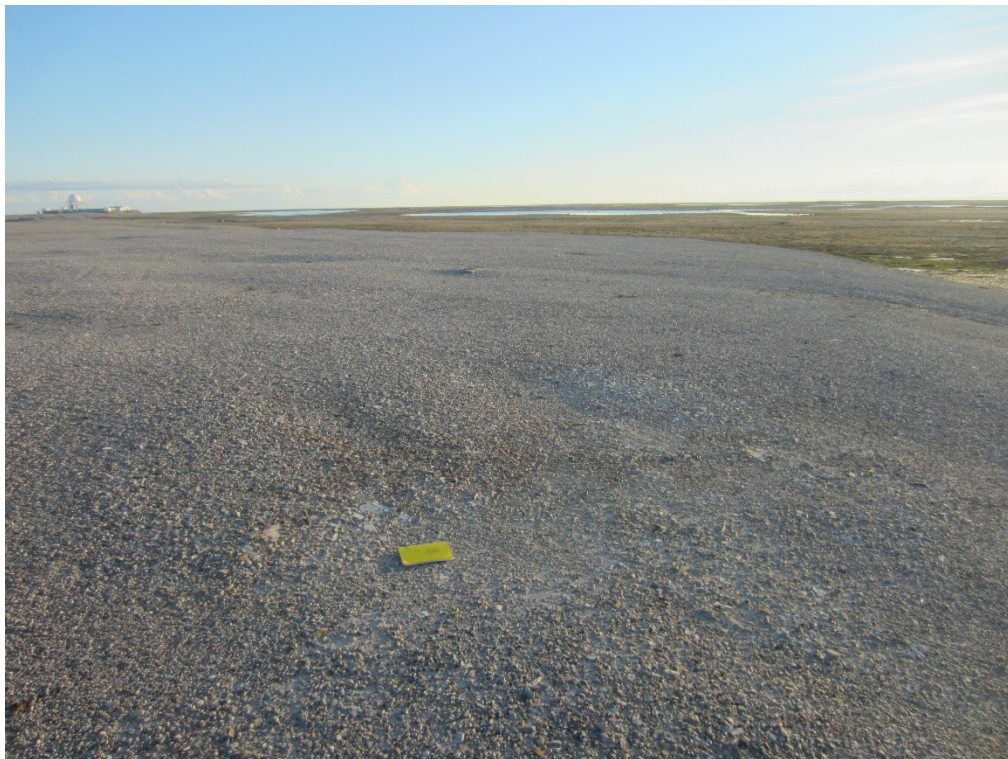
**Attachment 2: CAM-3 Northeast Landfill Staining Feature U**

The staining identified in both 2014 and 2016 on the cover of Lobe D of the Northeast Landfill (Feature U) was described as “dark” in 2014 (Biogénie, 2015). The associated photo corroborates this characterization. A review of the 2014 photograph of Feature U suggests that the small dark stains on top of the landfill cover look like the surficial release of limited quantities of fuel, likely from a vehicle. Feature U is later described as “reddish oxidation staining” in 2016 (Arcadis, 2017). The colouring is difficult to distinguish on the 2016 photo, and it does not appear to show the same dark stain that was in the foreground of the 2014 photo (note the angles in the photographs are slightly different). Based on the position (on the top of the landfill cover) and extent (small area of 0.09 m<sup>2</sup>) of this feature, surficial deposition of a stain-producing material such as fuel or a naturally occurring iron oxidation would be the most plausible explanations.

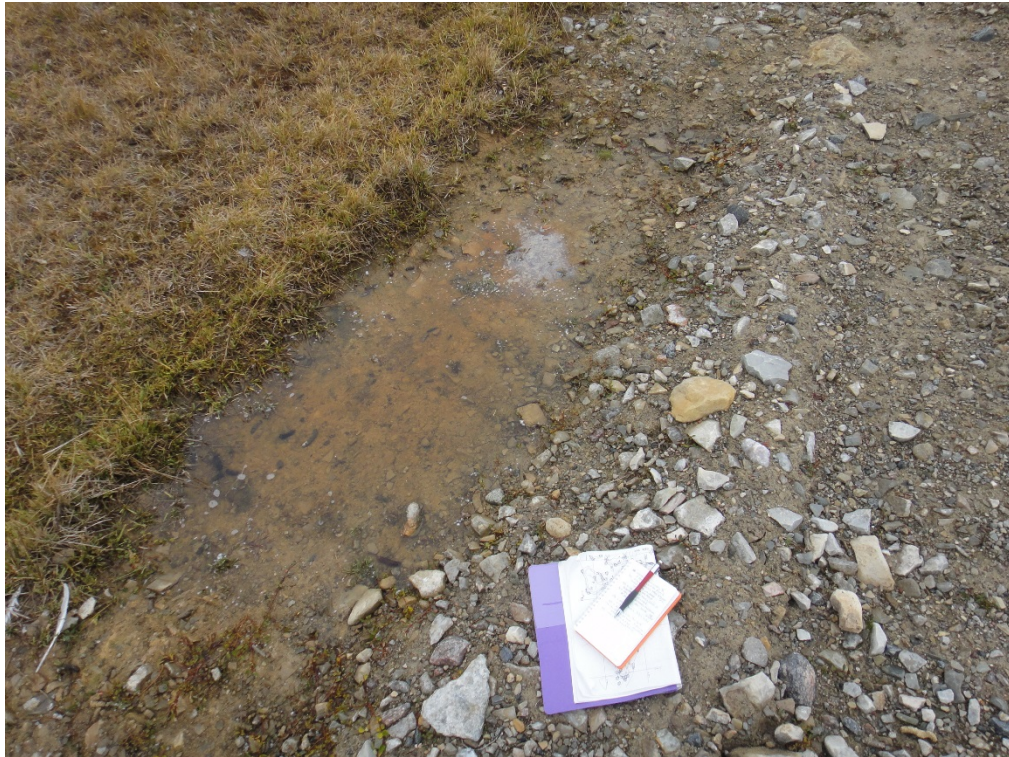
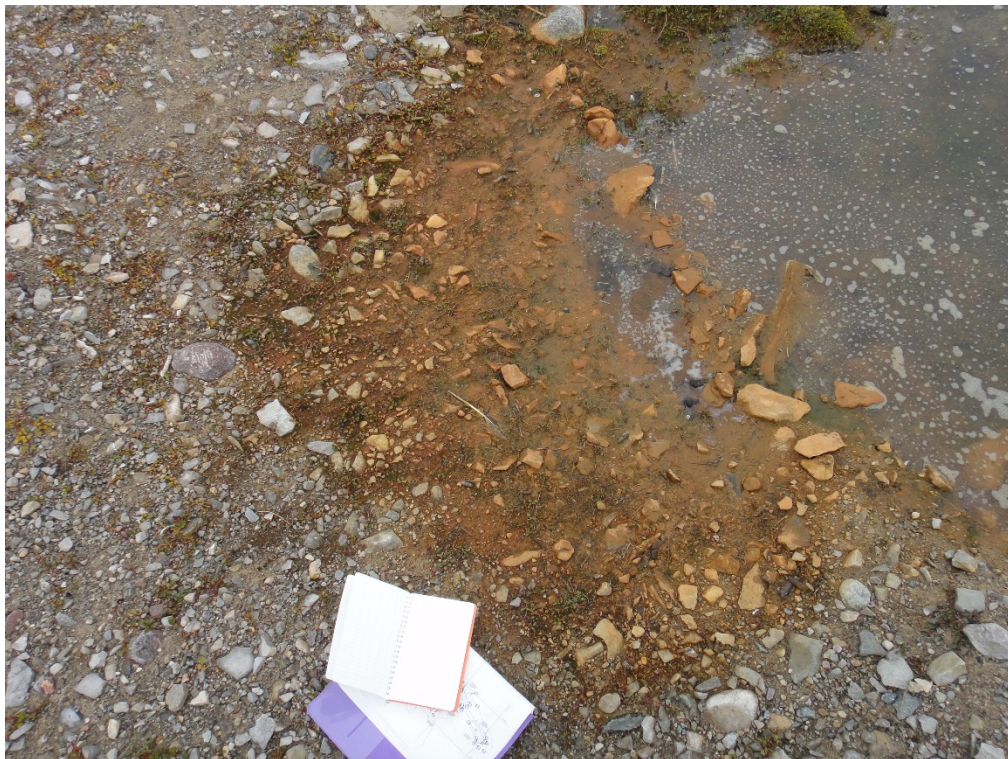
**Attachment 3: CAM-3 Northeast Landfill Staining Feature V (Two Locations)**

The staining identified in 2014 at the toe of Lobe G of the Northeast Landfill (Feature V) was described as “rust coloured” (Biogénie, 2015); the associated photos corroborate this characterization. Feature V was not observed in 2016 (Arcadis, 2017).

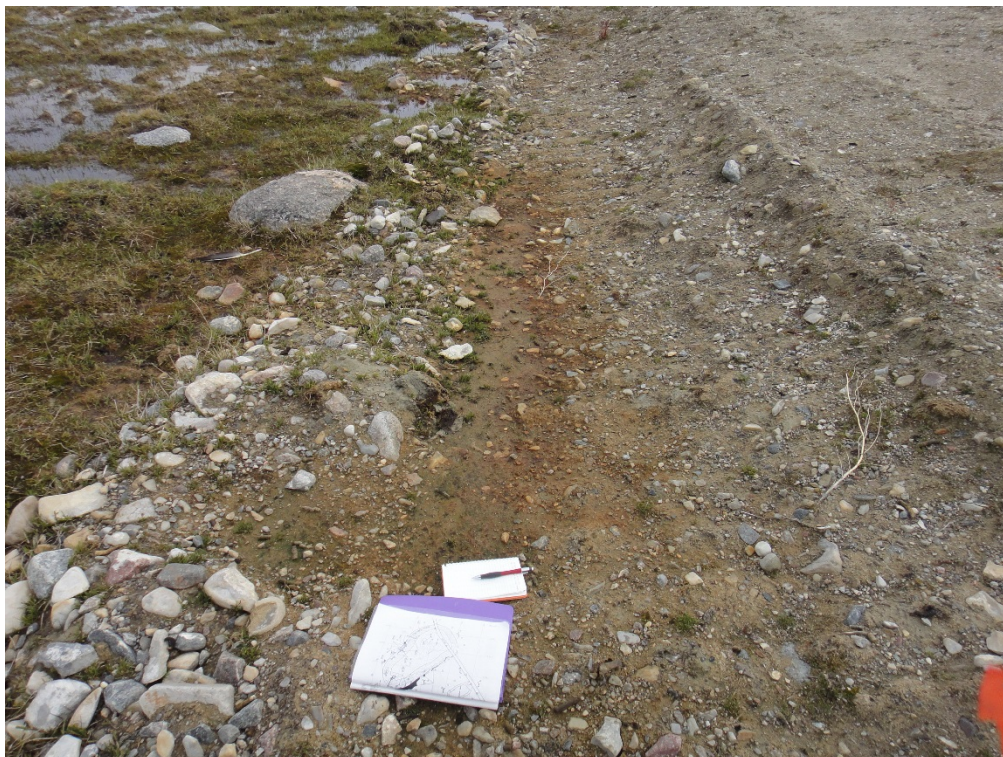
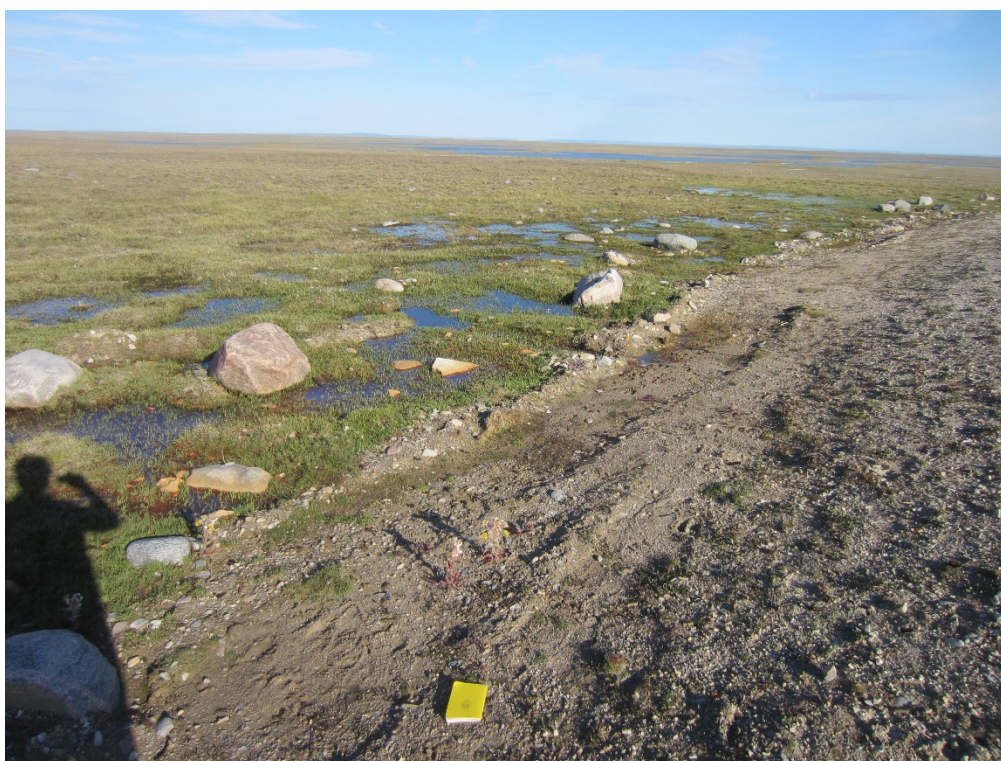
**Attachment 4: CAM-3 USAF Landfill Staining Feature G**

The staining identified in both 2014 and 2016 at the toe of the USAF Landfill (Feature G) was described as “rust coloured” (Biogénie, 2015 and Arcadis, 2017), indicative of a likely iron oxide stain. The photos corroborate this characterization. The staining is also very small in extent (5.0 m<sup>2</sup>).
