WATER LICENCE INSPECTION FORM

Licensee		Licensee Representative	
DND/DCC		Don Beattie	
Licence No. / Expiry		Representative's Title	
1BR-SHE1016		Environmental Officer	
Land / Other Authorizations		Land / Other Authorizations	
Date of Inspection		Inspector	
July 6, 2017		Baba Pedersen	
Activities Inspected			
<input type="checkbox"/> Camp	<input type="checkbox"/> Drilling	<input type="checkbox"/> Mining	<input type="checkbox"/> Construction
<input type="checkbox"/> Roads/Hauling	<input checked="" type="checkbox"/> Other: Long Term Monitoring		<input checked="" type="checkbox"/> Reclamation
			<input type="checkbox"/> Fuel Storage

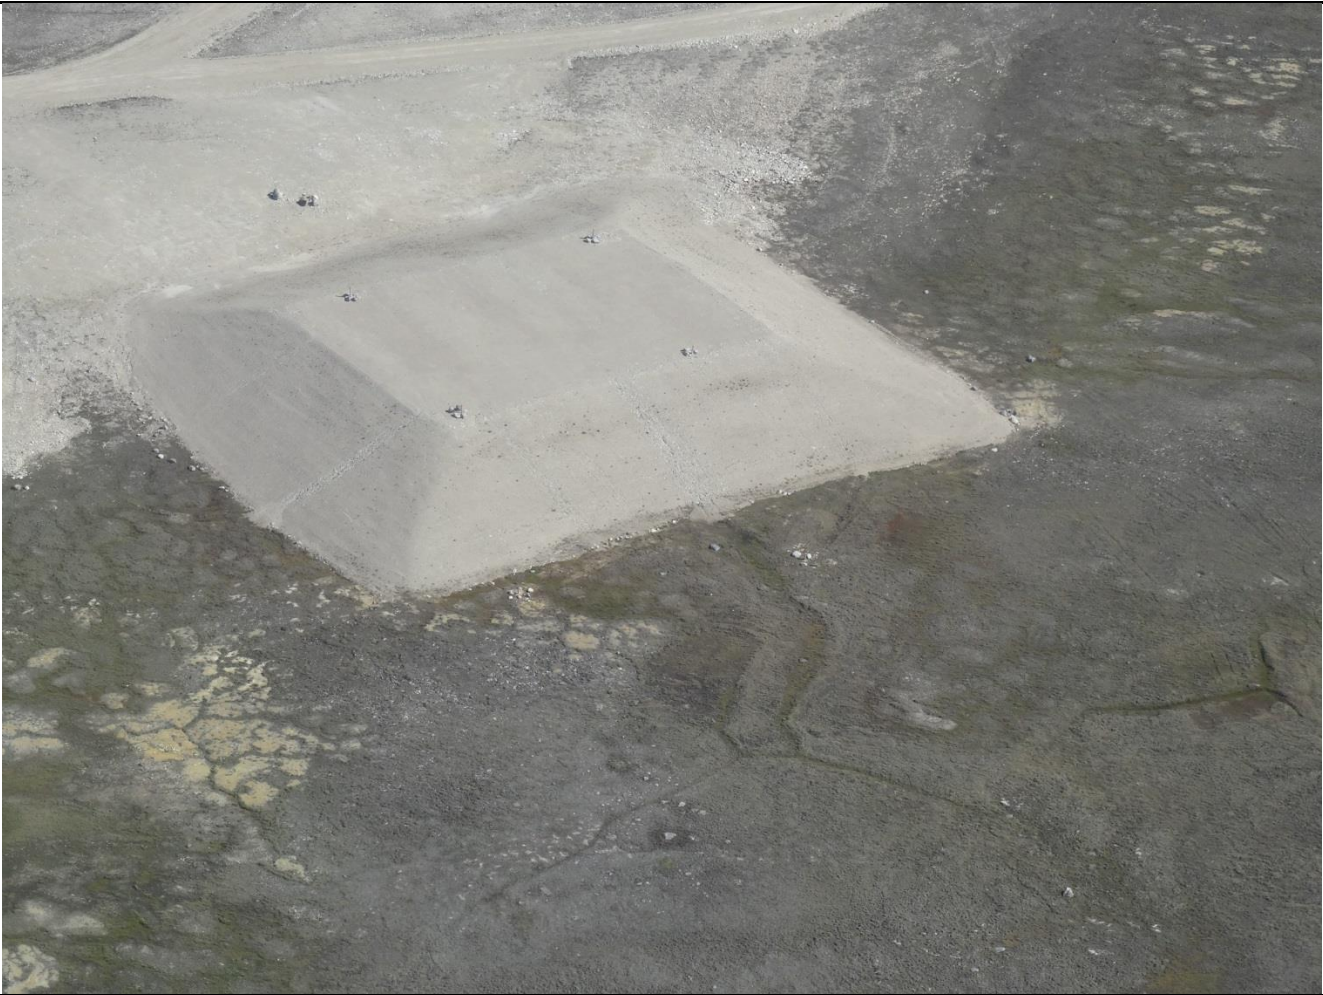
Photo 1

1. The Tier II Hazardous Waste Site (Photos 1 to 4) was all covered and there were no signs of any leakage. There was no Visible Signage indicating the Site Location and/or it's contents. 2. The Non-Hazardous Waste Site (Photos 5 to 8) was all covered and there were no signs of any leakage. There was no Visible Signage indicating the Site Location and/or it's contents. 3. The Asbestos Burial Site (Photos 9 & 10) was all covered and there were no signs of any leakage. There was very nice long lasting Signage indicating the location of, and contents of, the site.			
SECTION 3	<input type="checkbox"/> Comments	<input type="checkbox"/> Non-Compliance with Act or Licence	<input checked="" type="checkbox"/> Action Required

Description: CAM-3 Tier II Haz Waste Site

1. Some sort of Signage that will last for a long time in the outdoors indicating the Location and Identifying the Site as the Tier II Hazardous Waste Site needs to be installed. 2. Some sort of Signage that will last for a long time in the outdoors indicating the Location and Identifying the Site as the Non-Hazardous Waste Site needs to be installed.

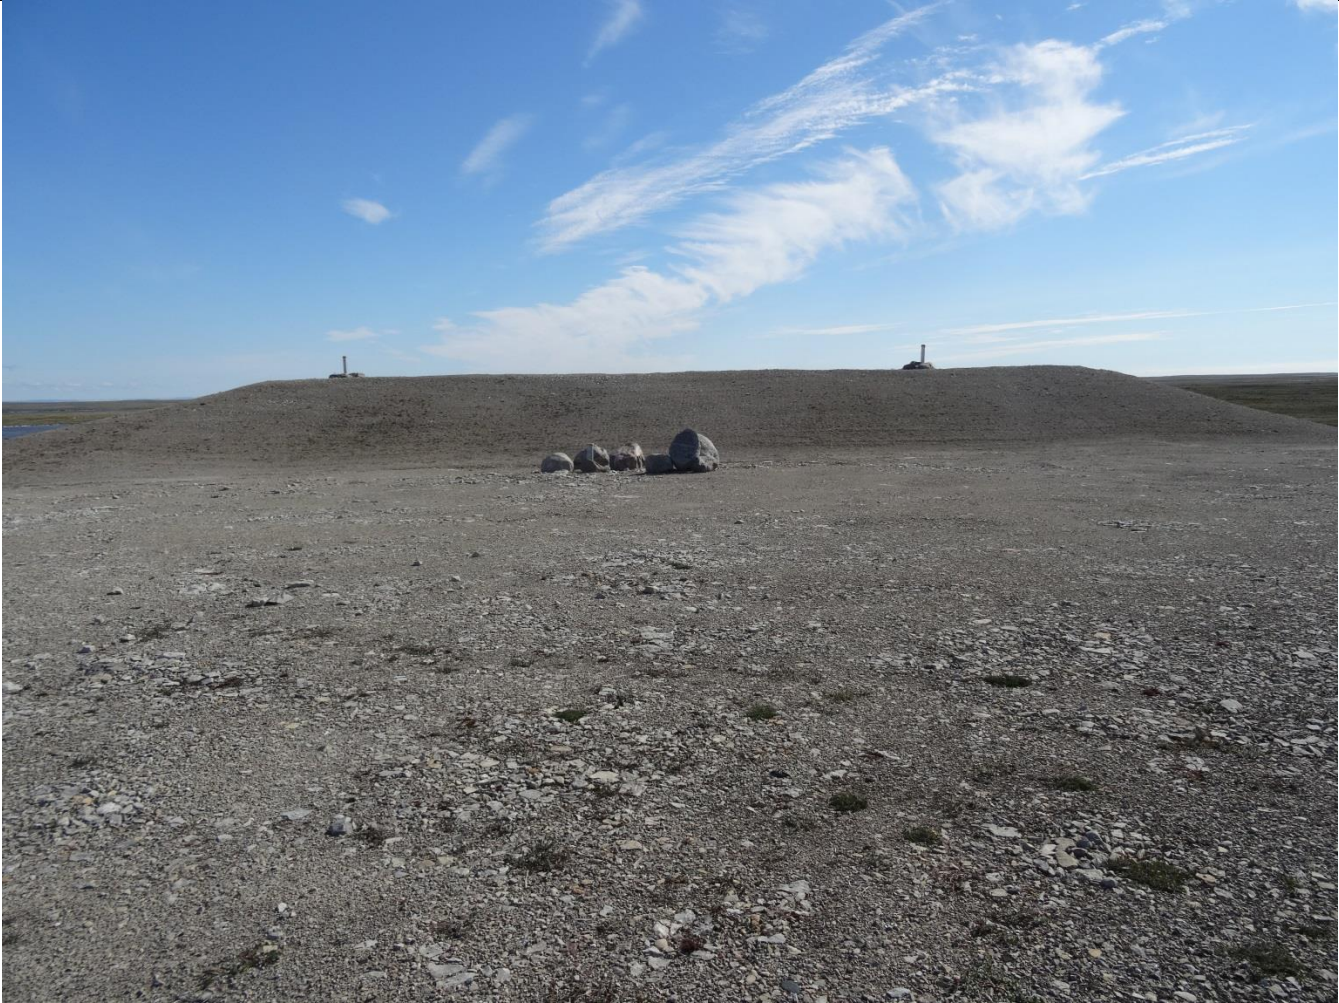
Photo 2

Description: CAM-3 Tier II Haz Waste Site

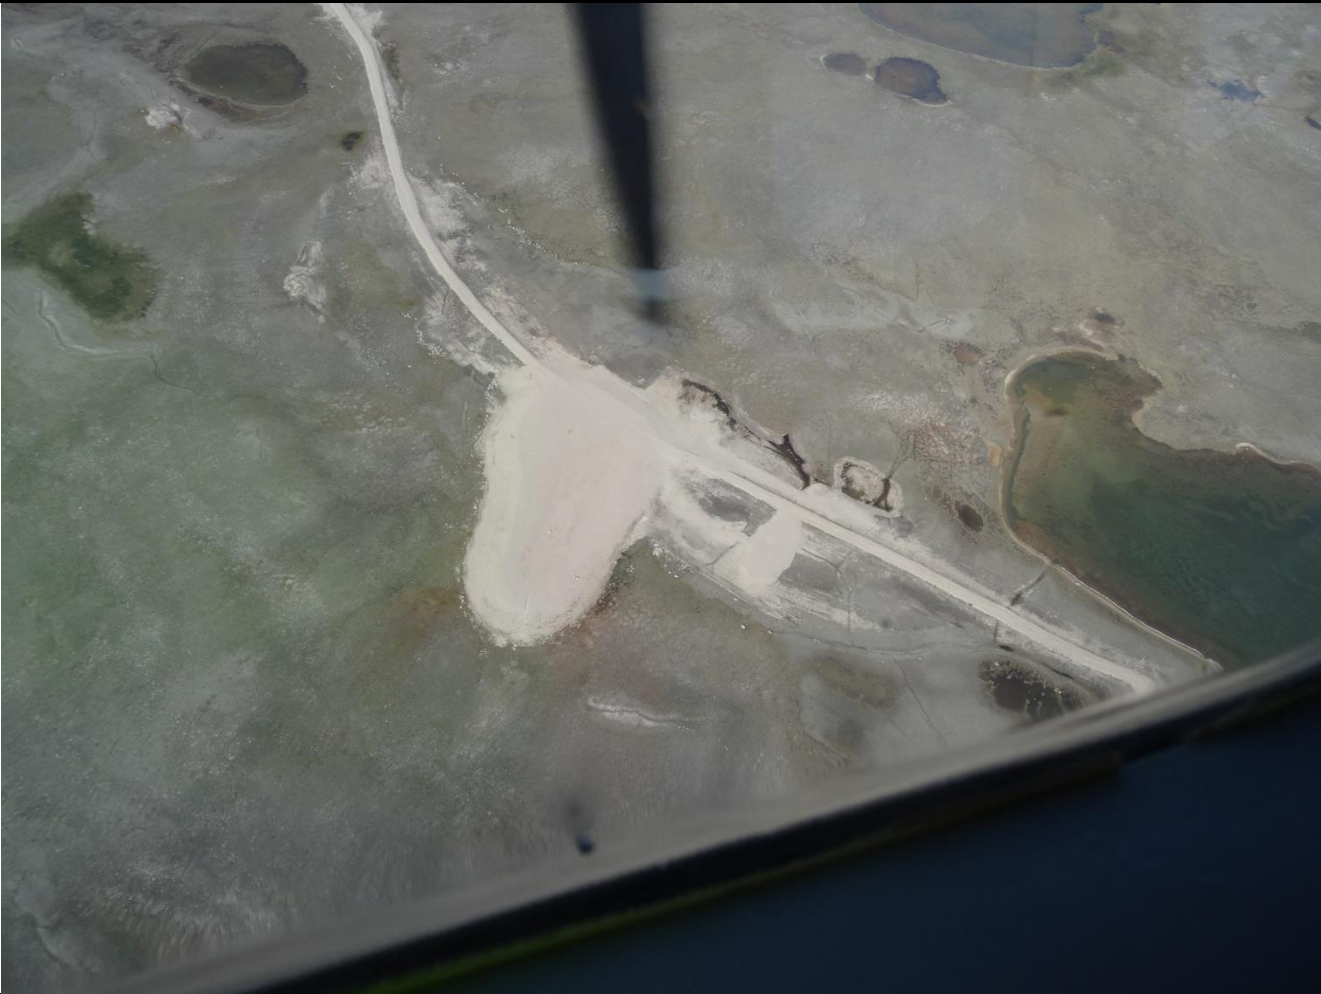
Photo 5

Description: CAM-3 Non-Haz Waste Site

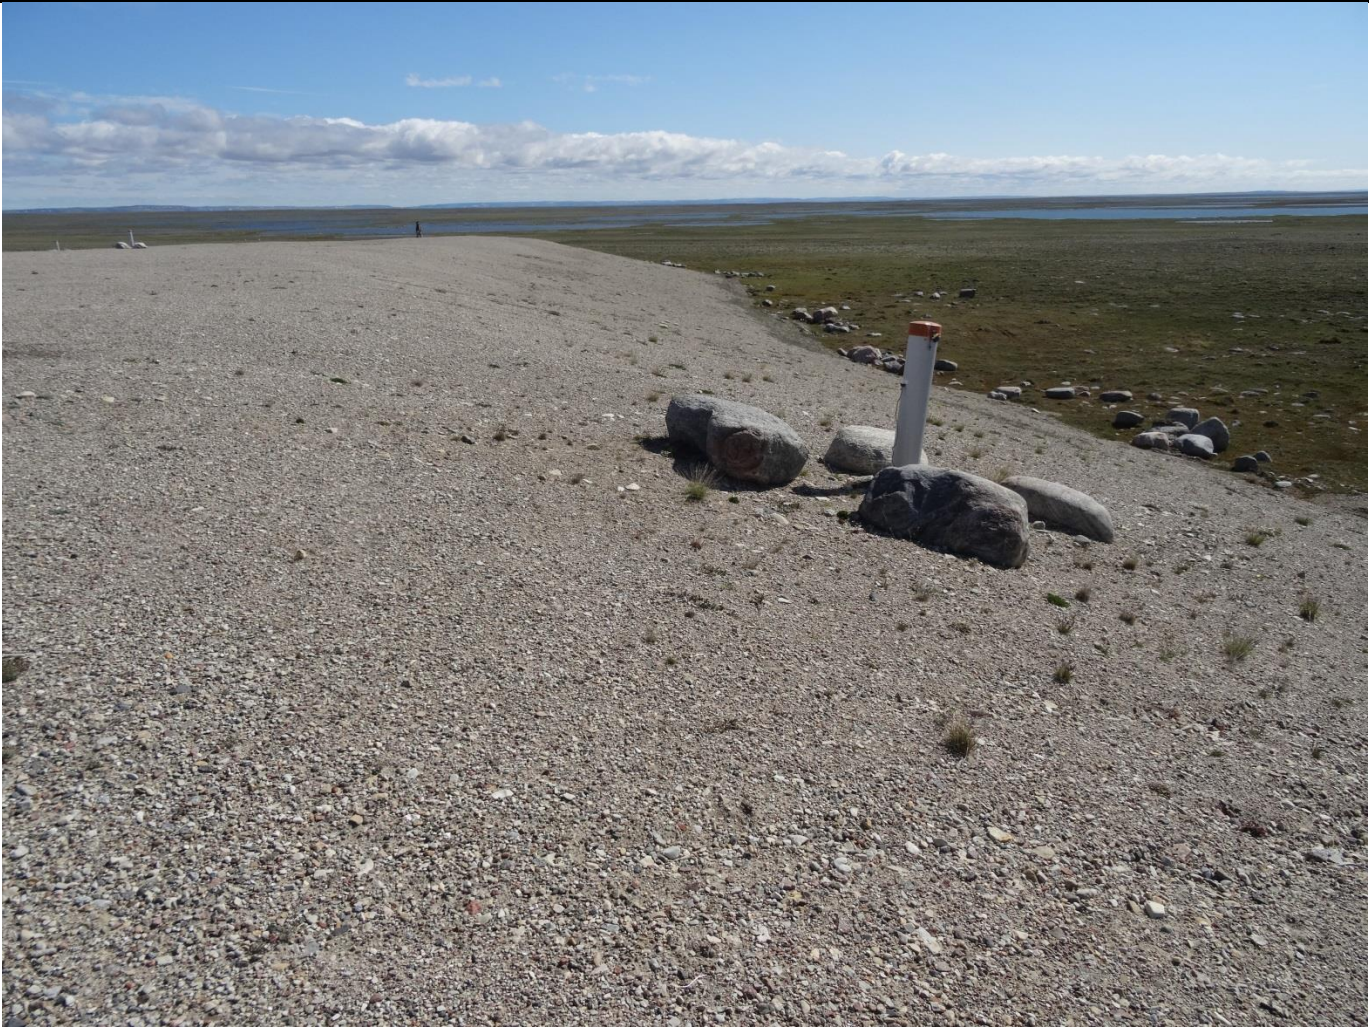
Photo 6

Description: CAM-3 Non-Haz Waste Site

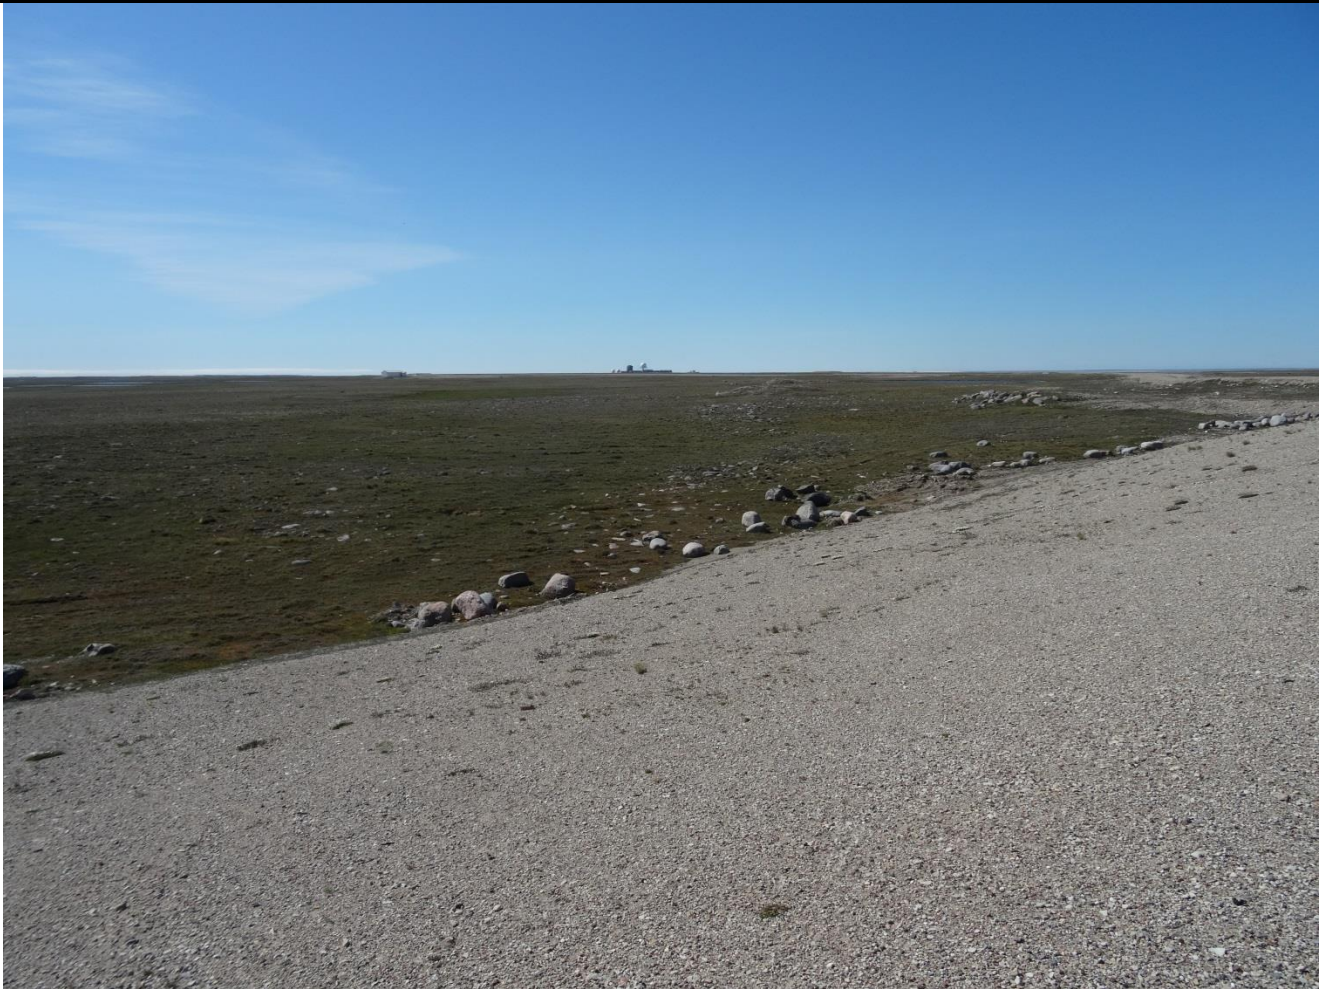
Photo 7

Description: CAM-3 Non-Haz Waste Site

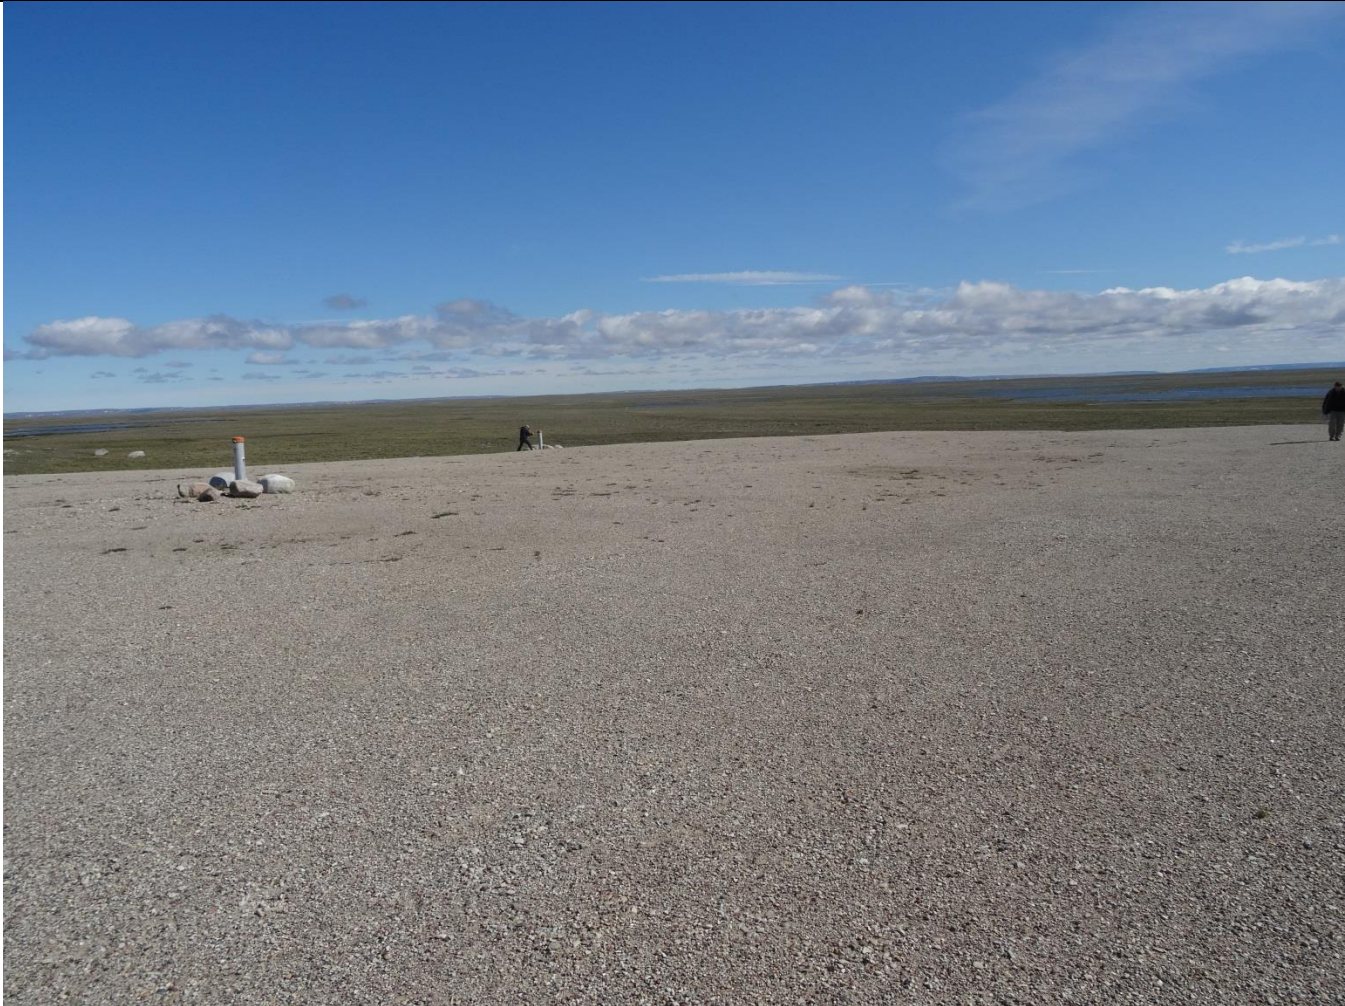
Photo 8

Description: CAM-3 Non-Haz Waste Site

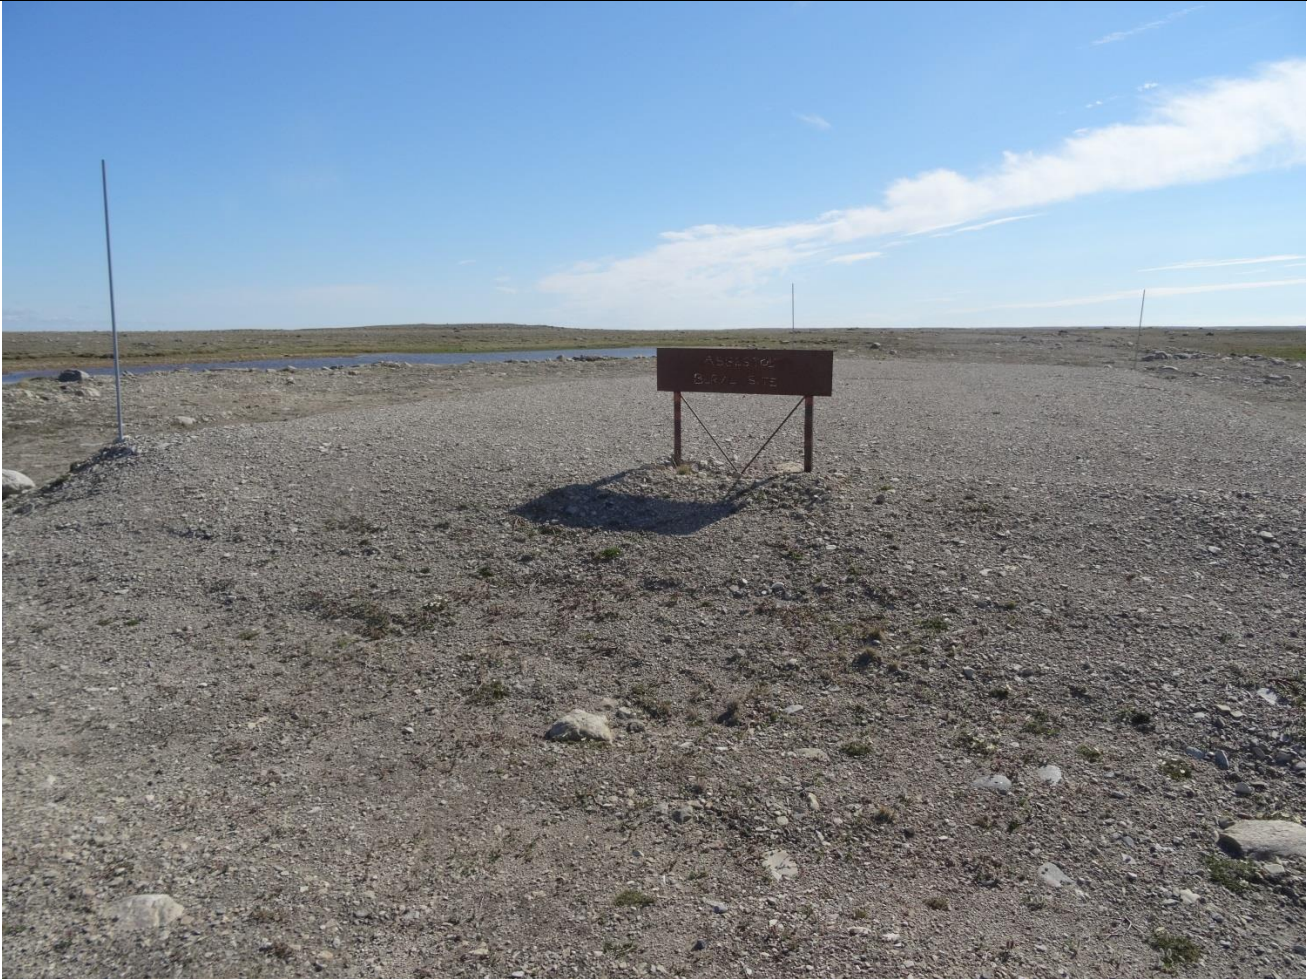
Photo 9

Description: CAM-3 Asbestos Burial Site

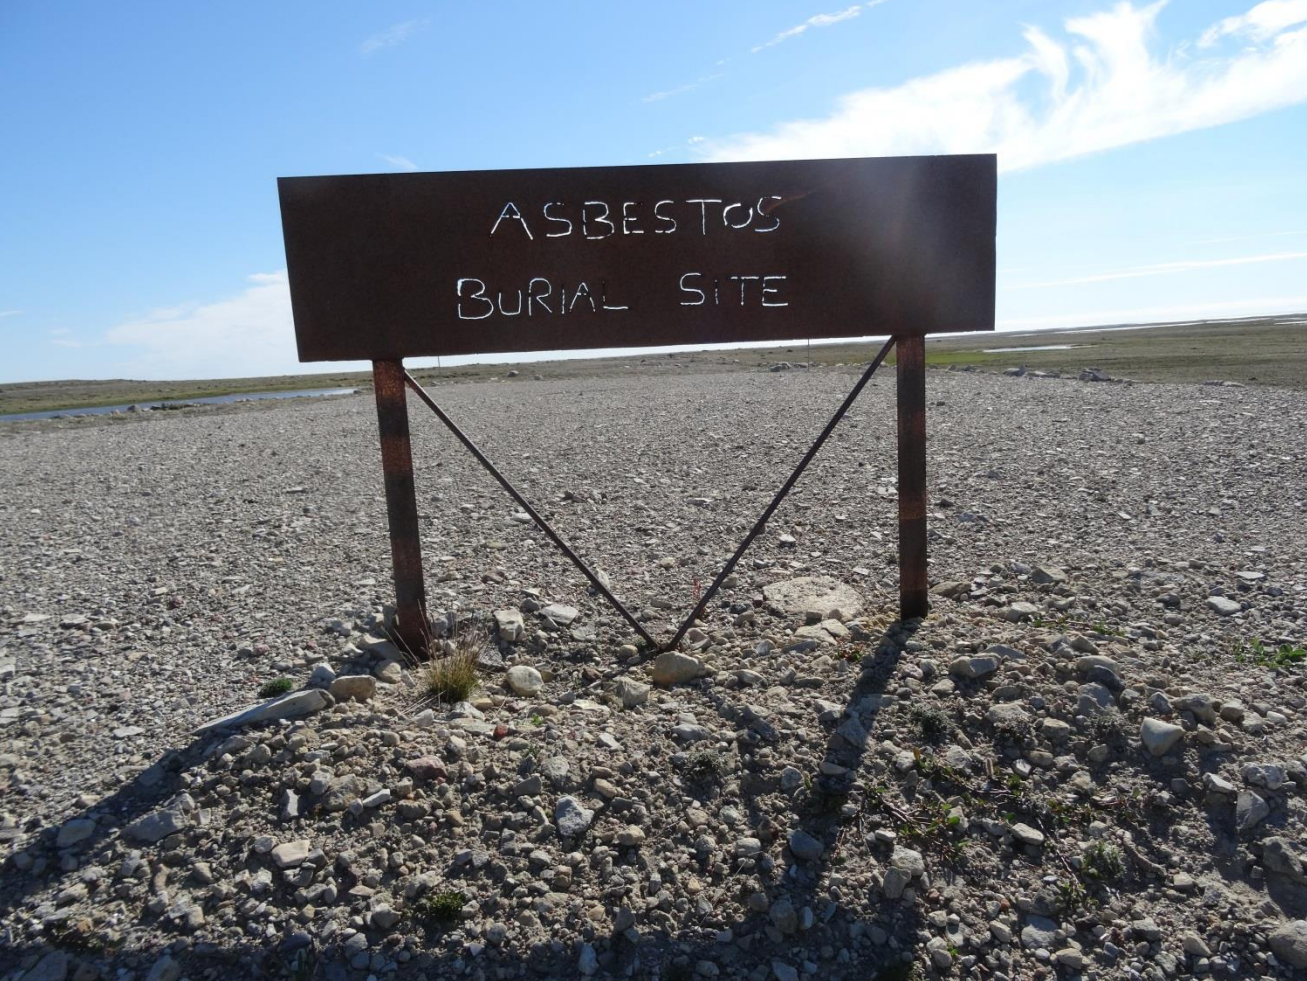
Photo 10

Description: CAM-3 Asbestos Burial Site
