**THE COLLECTION OF LANDFILL  
MONITORING DATA AT THE FORMER  
CAM-3 DEW LINE SITE**

Shepherd Bay, Nunavut

**FINAL REPORT– 2009 SEASON**

**DEFENCE CONSTRUCTION CANADA**

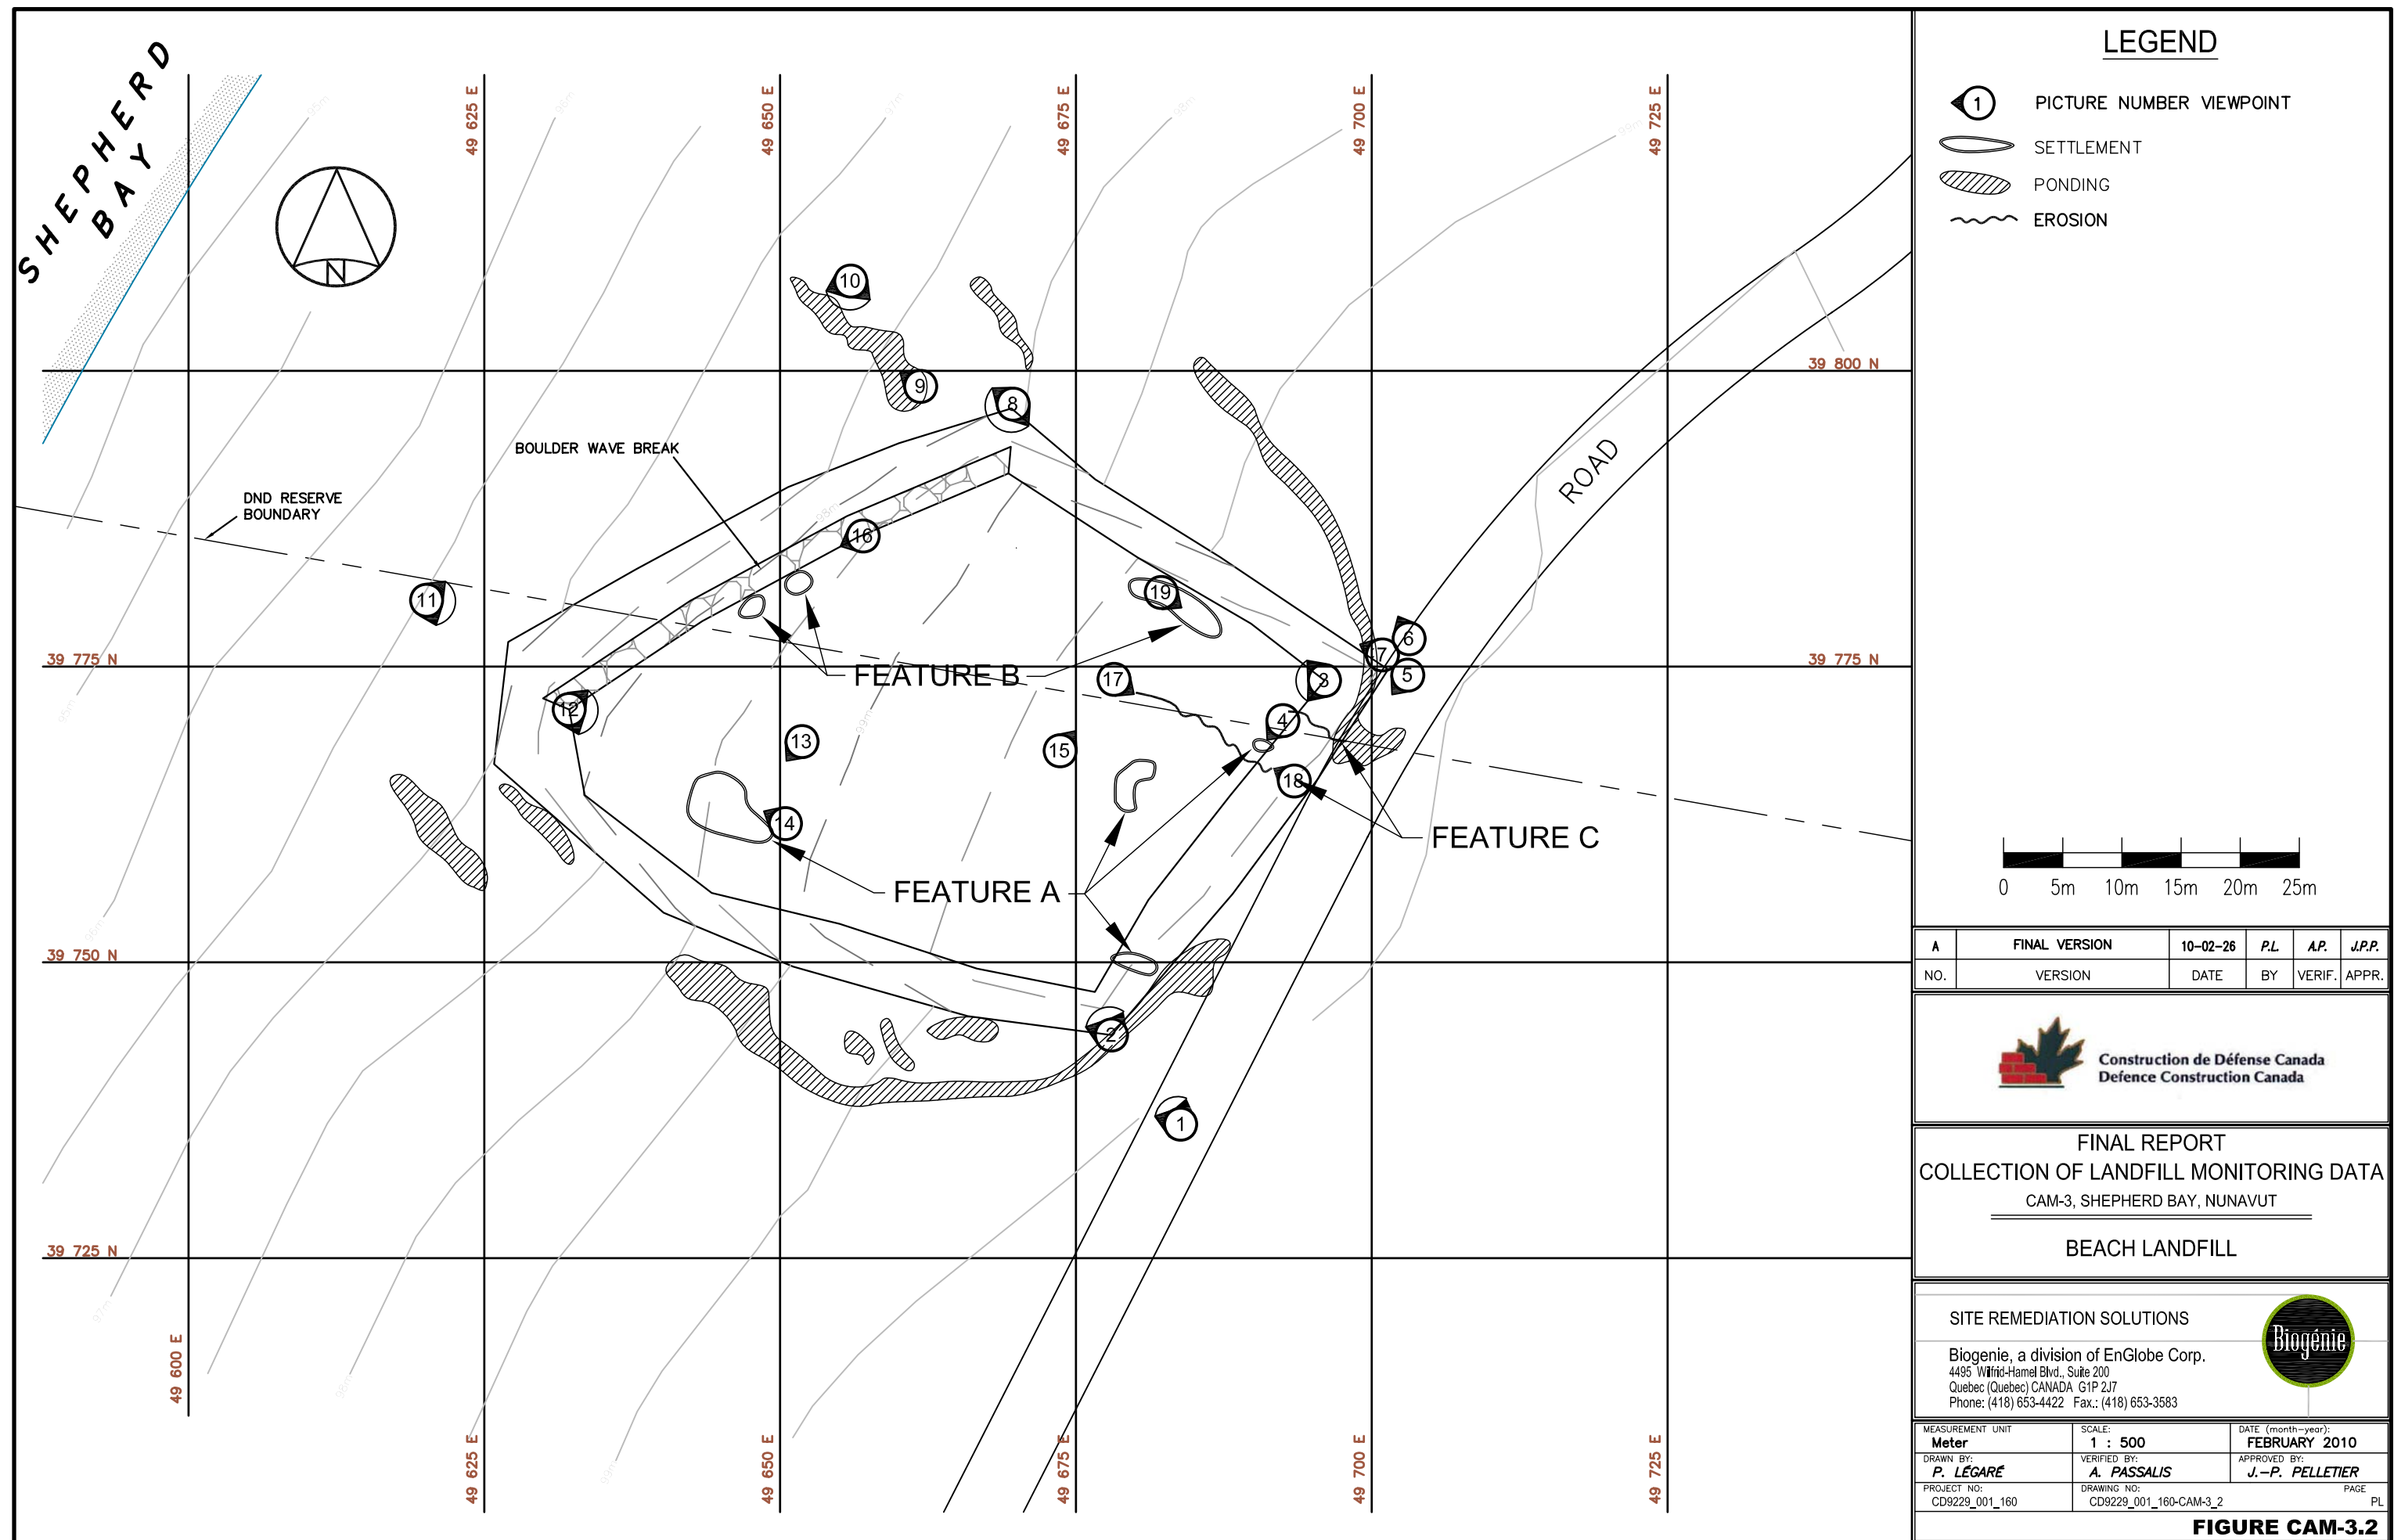
The Location Plan for the Beach Landfill has been completed as per the ToR and is presented in Figure CAM-3.2.

Indications of minor settlement were noted at several locations, including one sizeable (9 x 7 m) depression situated on the northwest area of the landfill surface (Feature A). Several smaller depressions were also noted along the north, east and south sides of the landfill surface (Feature A and B). These features have an acceptable severity rating.

Two areas of erosion were noted on the southeast side of the Beach Landfill (Feature C), including one elongated feature extending across the southeast corner and one relatively localized area on the side slope to the northeast. Both areas appear to be associated with possible minor settlement that has resulted in directed runoff and washing of fines from the landfill cover. Both features appear to be self-armouring and have an acceptable severity rating.

Minor erosion was also noted along the constructed drainage channel extending around the northeast side of the landfill and appears consistent with planned remedial measures to direct flow around the landfill. The erosion is not in direct contact with the landfill. Minor runoff flow was observed in the channel at the time of the inspection.

It was noted that surface runoff has resulted in minor erosional features on the southeast side of the landfill surface. These features appear to be consistent with findings from the 2008 inspection and appear to be self armouring along the downgradient slope.

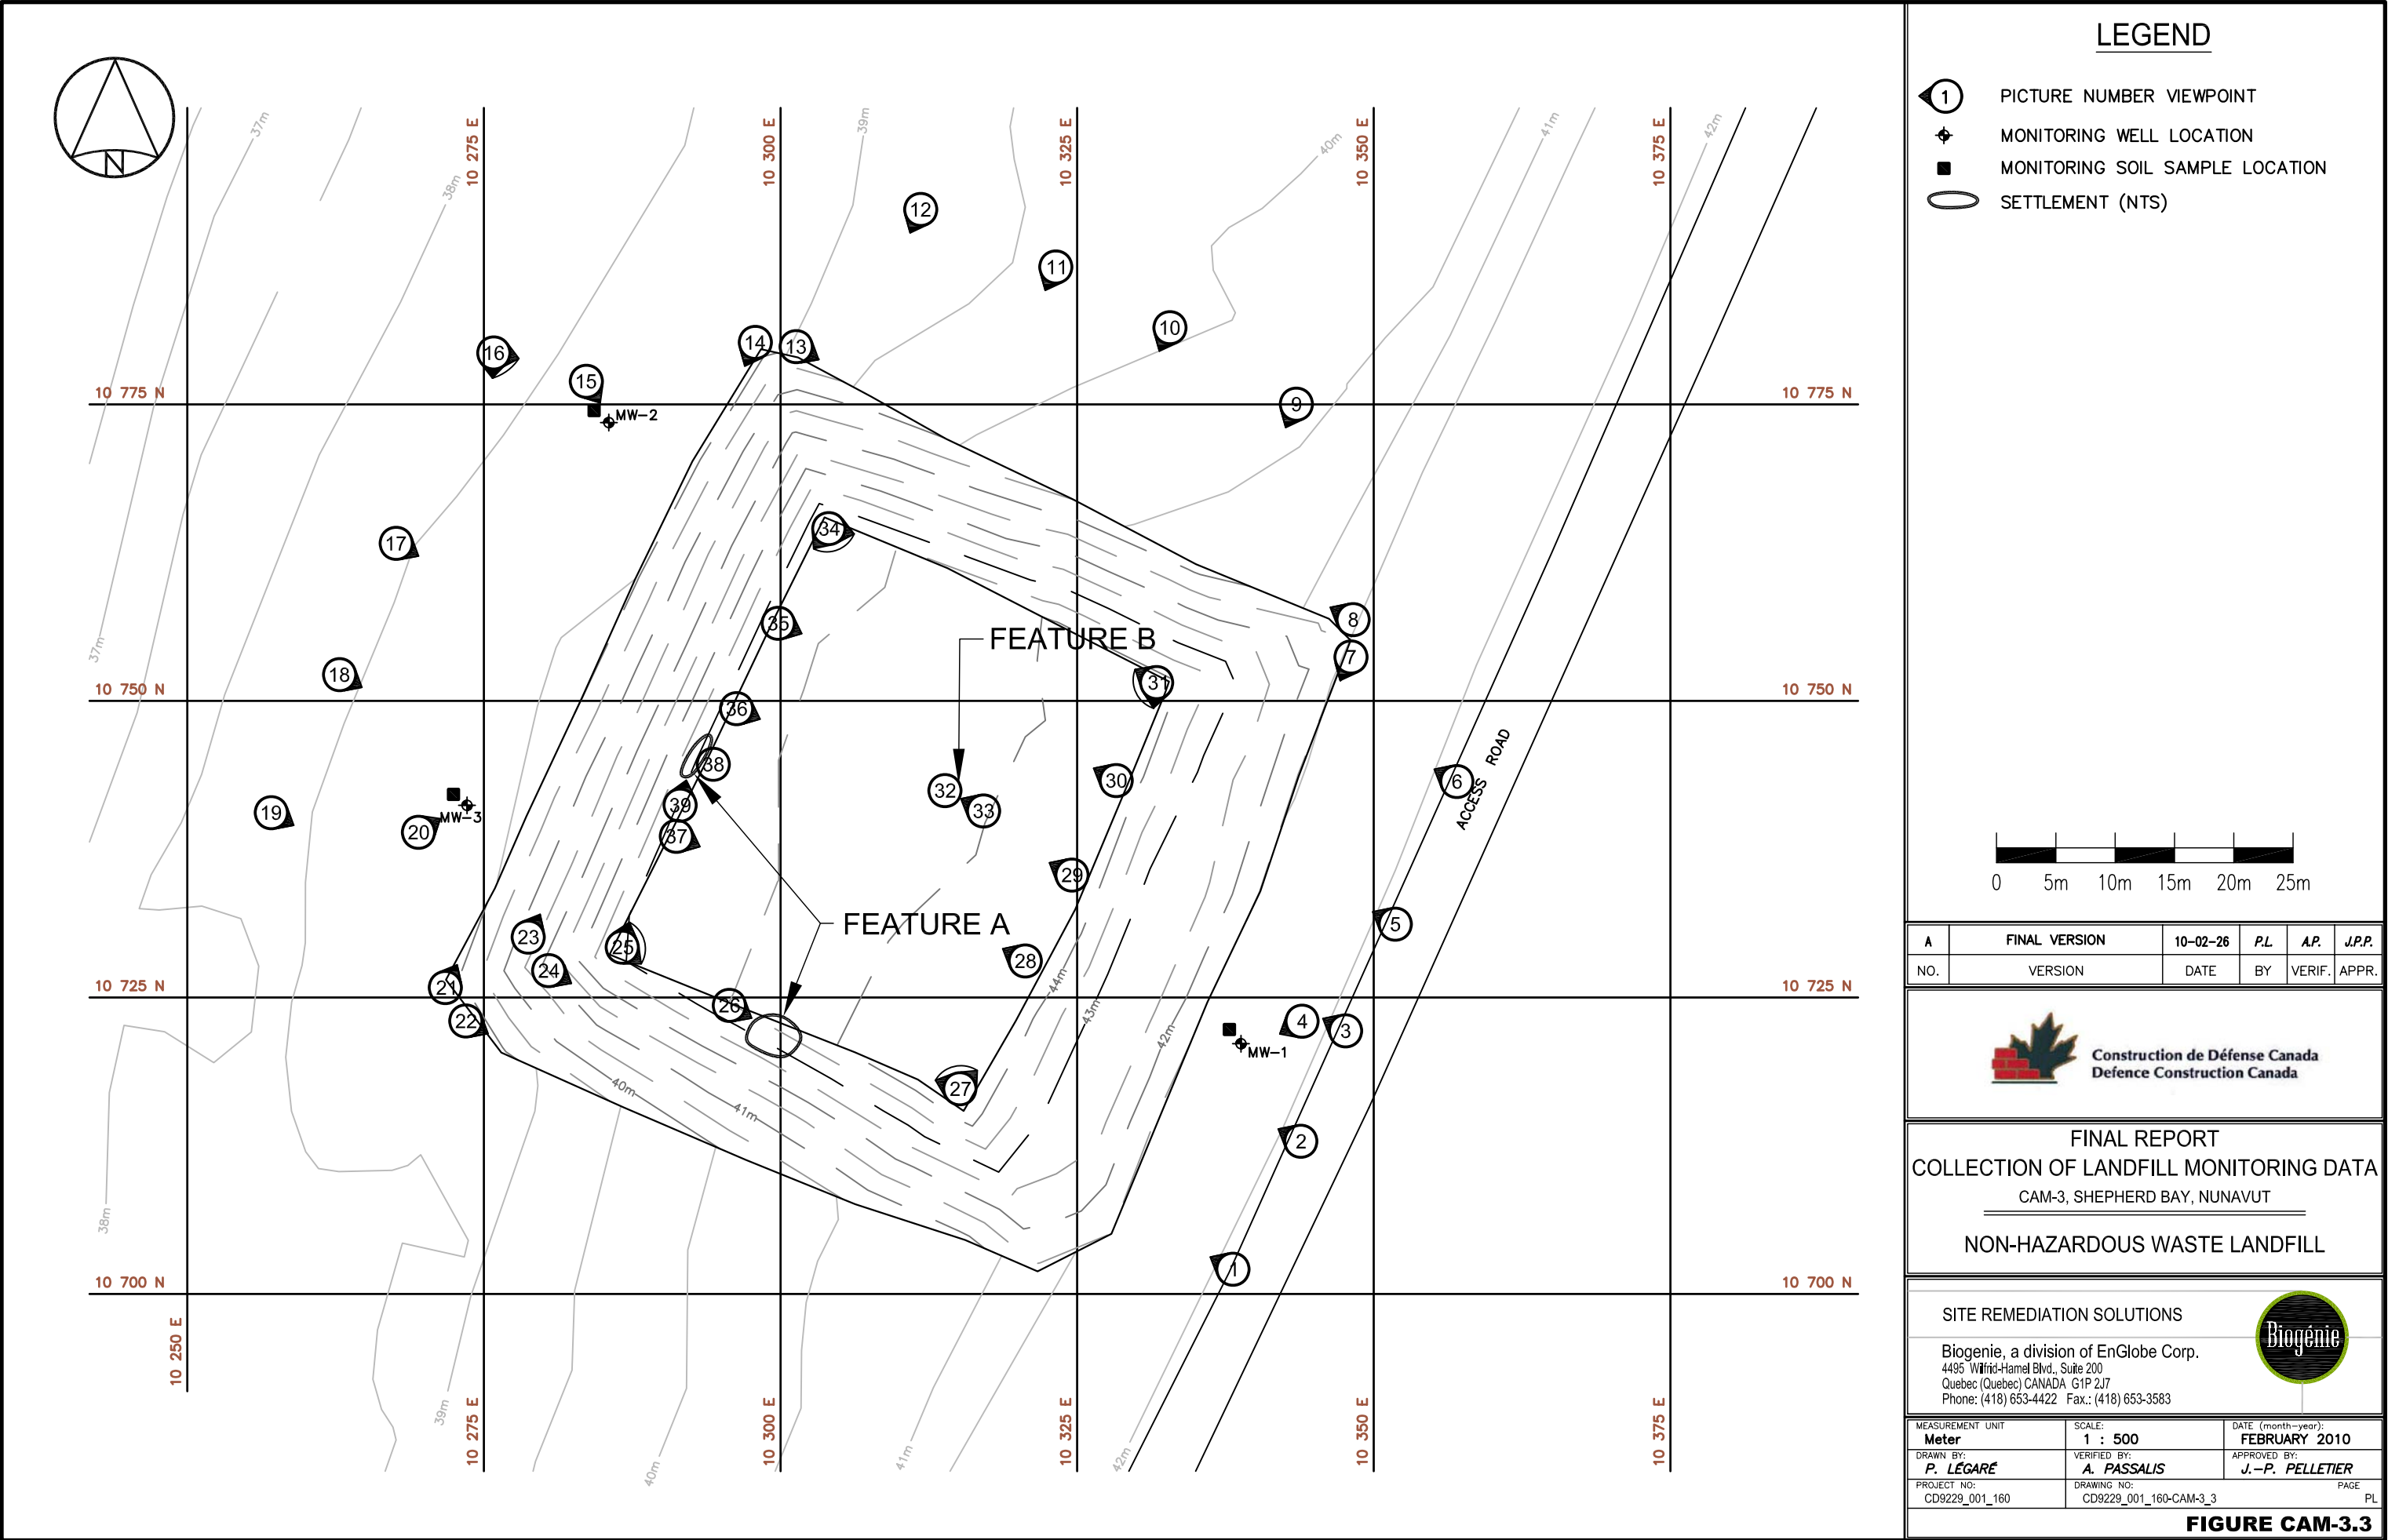
The Location Plan for the NHWLF has been completed as per the ToR and is presented in Figure CAM-3.3.

Indications of localized settlement were noted at two areas (Feature A) on the landfill surface, including: one circular depression below the crest at the top of the southwest facing slope; and one elongated shallow depression near the crest on the northwest facing slope. These features appear consistent with the 2008 inspection and have an acceptable severity rating.

One partially exposed piece of metal debris was noted on the landfill surface (Feature B), consisting of a 15 x 5 cm exposed piece of angular metal (bed rail). There was no other indication of debris at the landfill.

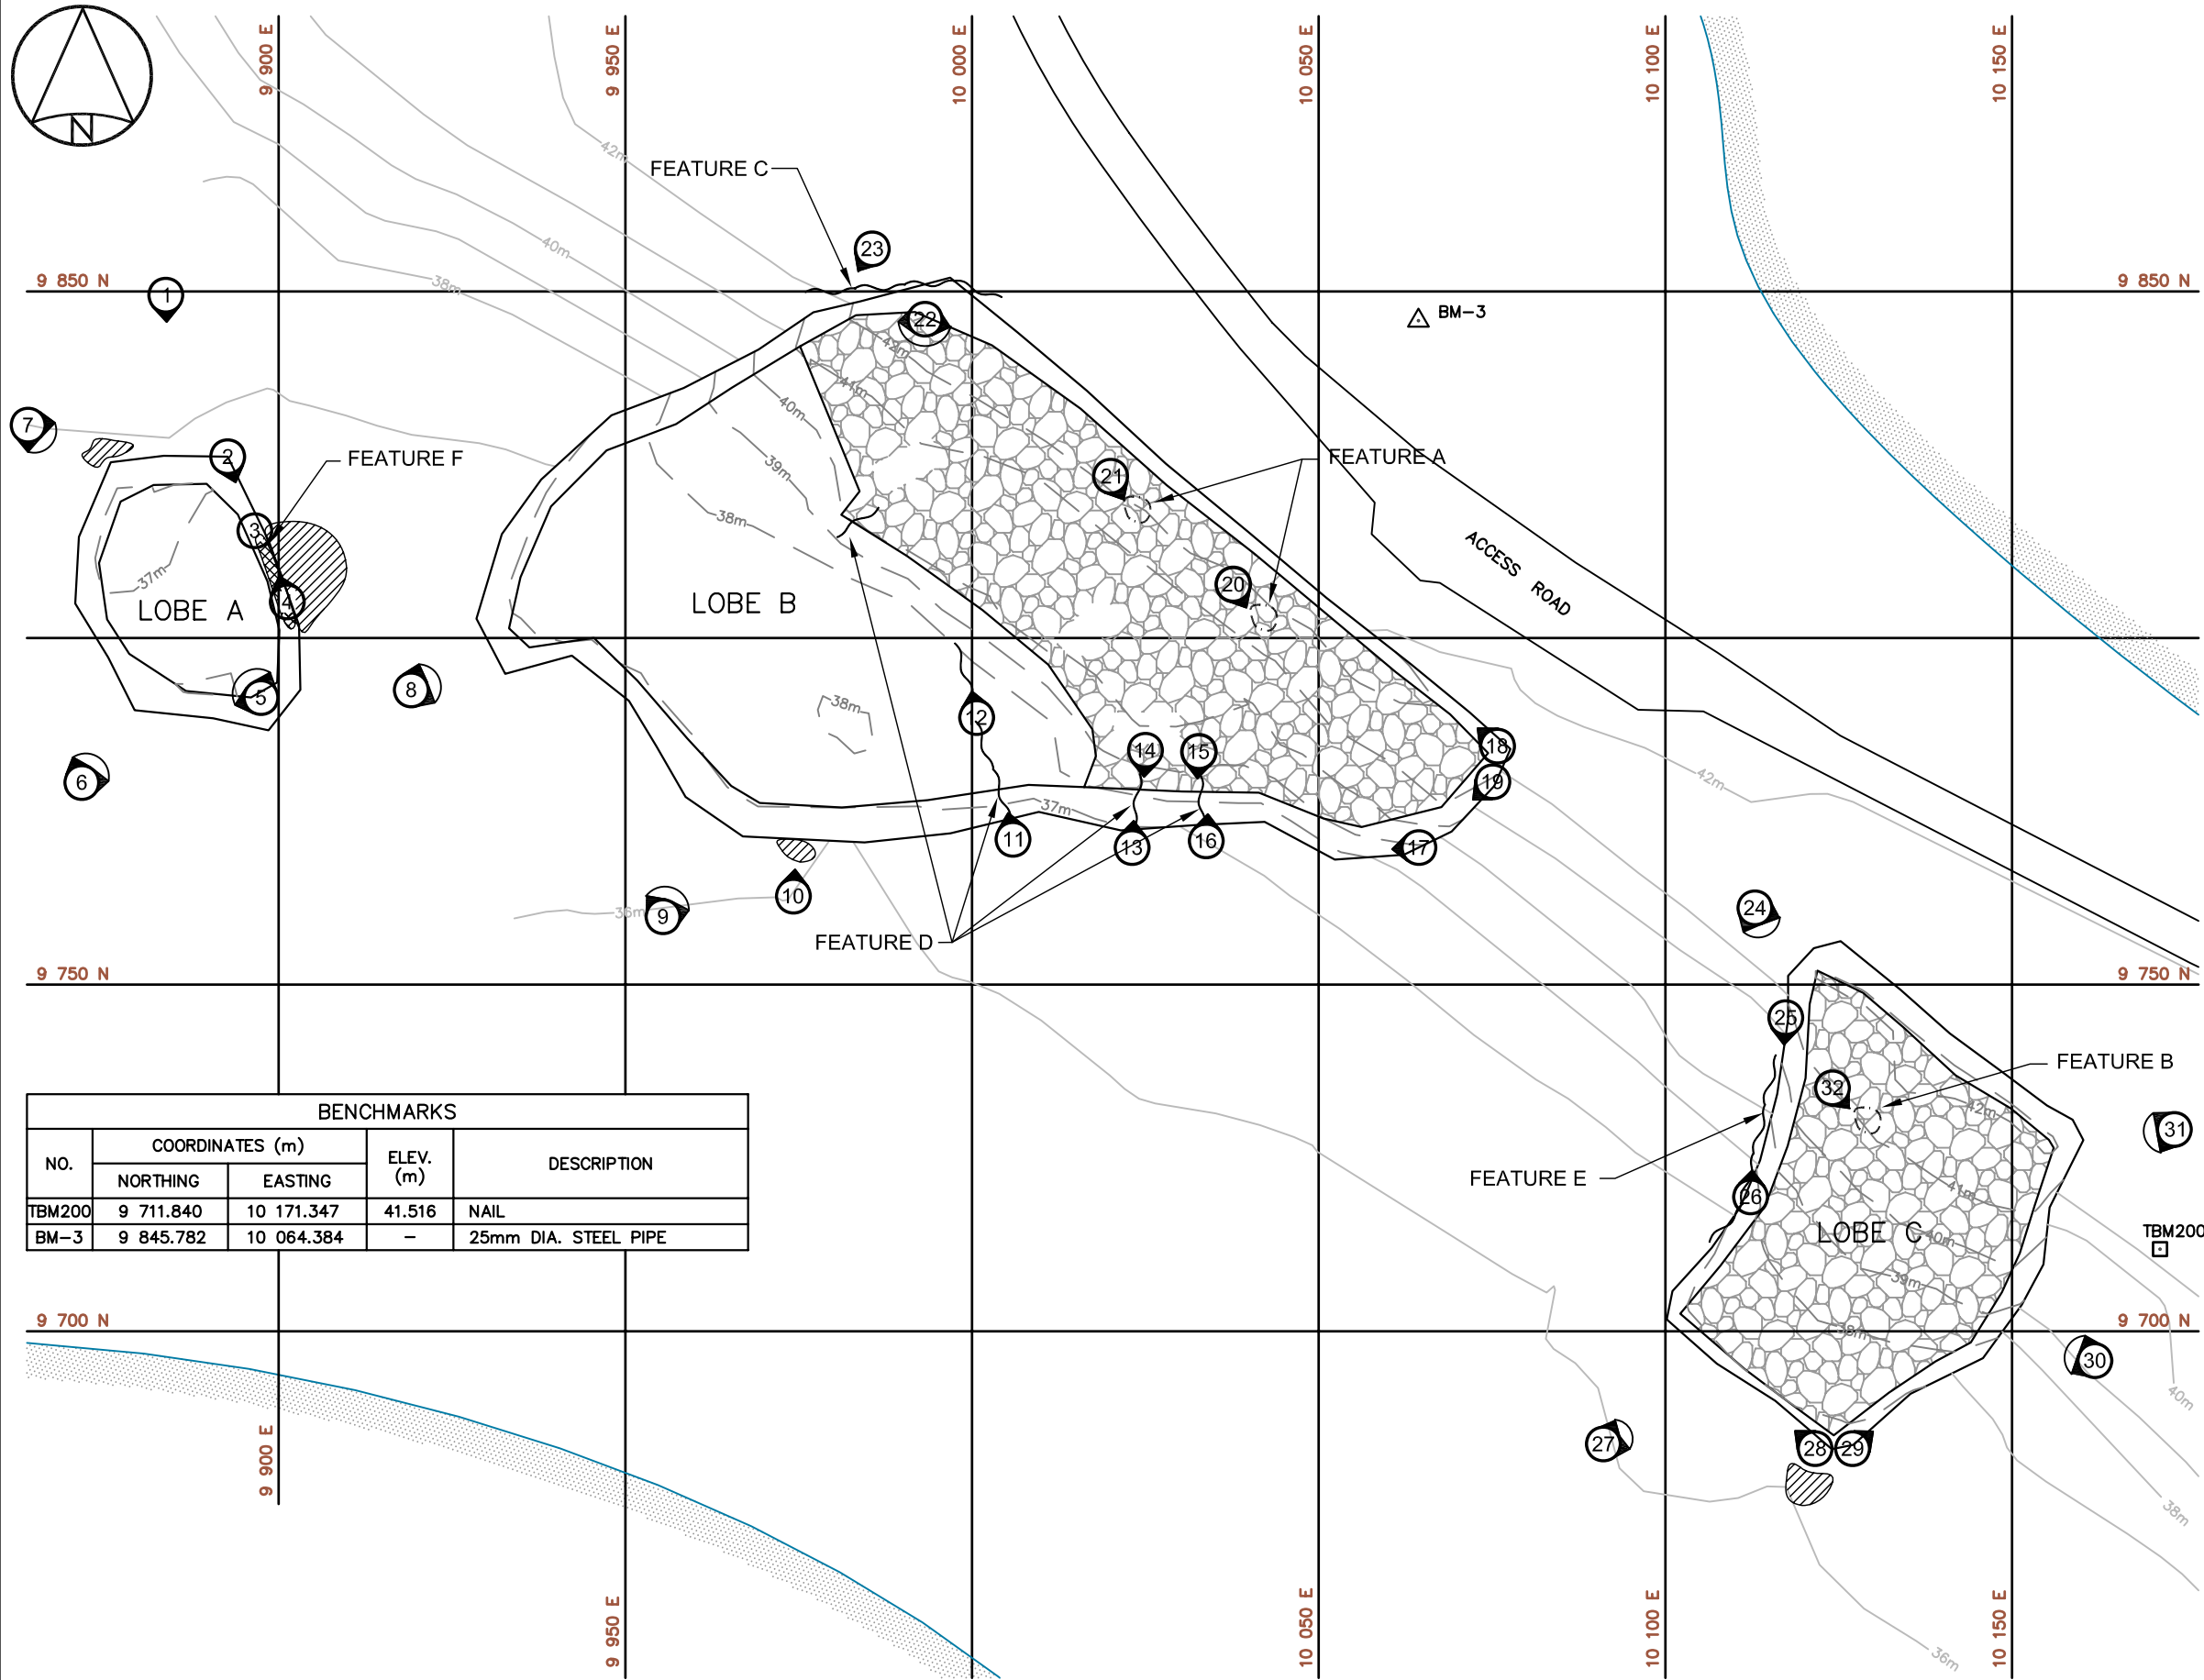
The Location Plan for the Station Landfill has been completed as per the ToR and is presented in Figure CAM-3.4.

Indications of settlement were noted at two locations (Feature A) on the north side of Lobe B and a single location (Feature B) on the northwest surface of Lobe C. All three areas consisted of relatively small localized depressions on the landfill surface. The features have an acceptable severity rating.

Three general areas of erosion were noted on the surface or sides of the Station Landfill, including one within a constructed erosion channel extending along the north end of Lobe B (Feature C), several localized areas of shallow erosion on the south cover and south facing slope of Lobe B (Feature D); and surface runoff resulting in erosion along the west toe of Lobe C (Feature E). Surface runoff in each area has resulted in the washing of fines from the more resistant gravel and cobble matrix. All features appear to be self-armouring and have an acceptable severity rating.

Three relatively small and localized areas of rust-coloured staining (Feature F) were noted along the east toe of Lobe A. The staining was associated with a large area of ponded water bordering the east side of the lobe. The staining appears consistent with findings from the 2008 inspection. There was no sheen associated with the staining at the time of the inspection.

Minor settlement features were noted in isolated areas on the surface of Lobes B and C. It was noted that surface runoff has resulted in minor erosional features on the south side of Lobe B and along the west side of Lobe C. Surface runoff upgradient of Lobe B is directed along a drainage channel that extends around the north end of the lobe. These features appear to be consistent with findings from the 2008 inspection and appear to be self armouring along the cross and downgradient slopes. Rust-coloured staining and adjacent ponding on the east side of Lobe A also appear consistent with 2008 observations.
