**RE: CAM-D Simpson Lake Remediation Project: 2010 Annual Report
for Water Licence No: 1BR-SIM0813**

CAM-D, Simpson Lake NWB Licence No. 1BR-SIM0813

Executive Summary of all Plans, Reports, or Studies Conducted under Water Licence No. 1BR-SIM0813

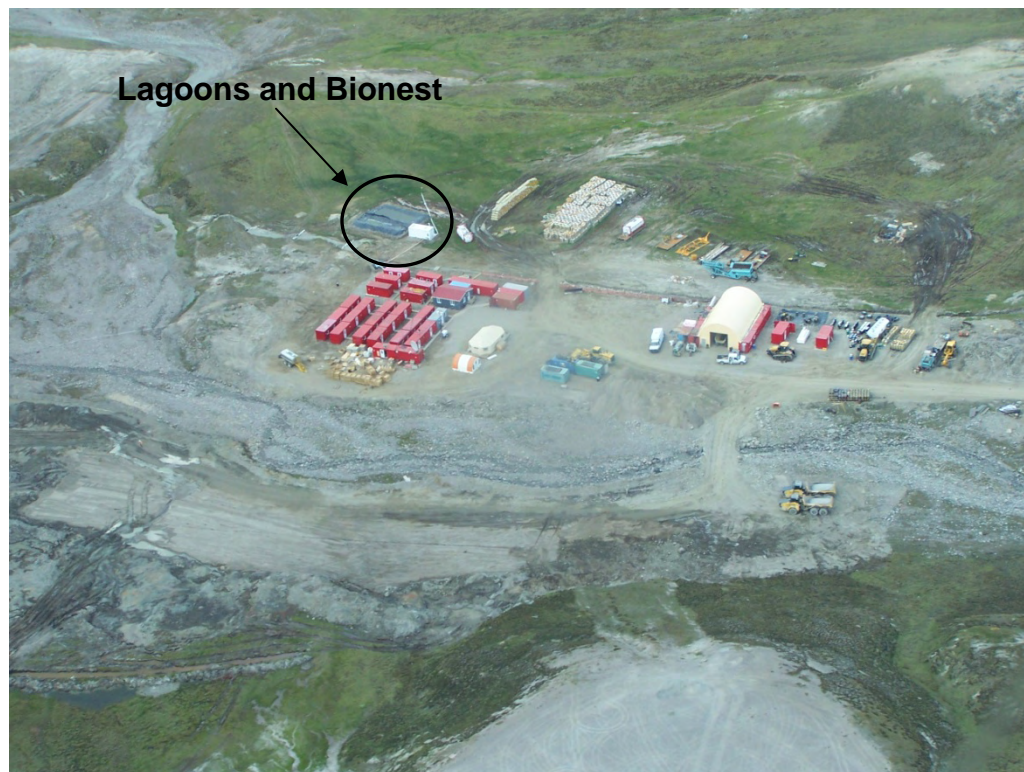
- e. During the initial stages of construction, two temporary sewage waste lagoons were constructed with a liner. The lagoons were used to temporarily store sewage while the Bionest treatment system was constructed. Once the Bionest system was operational, the lagoon waste was passed through the treatment system and, once confirmatory samples were collected, the treated effluent was discharged to ground at the approved discharge location.

The photo below shows the CAM-D camp area, with the temporary sewage lagoons and the Bionest treatment system located in the northwest (top left of the photo) corner of the camp.

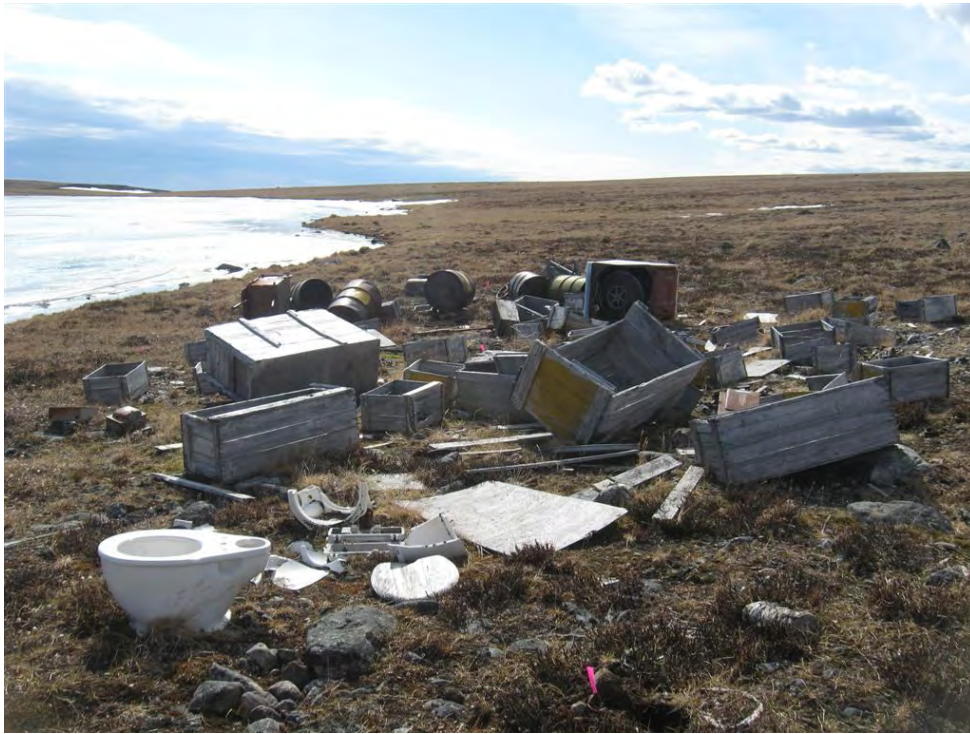
Photograph 1. Before: View of Plumber's Dump prior to surface debris removal. ↑

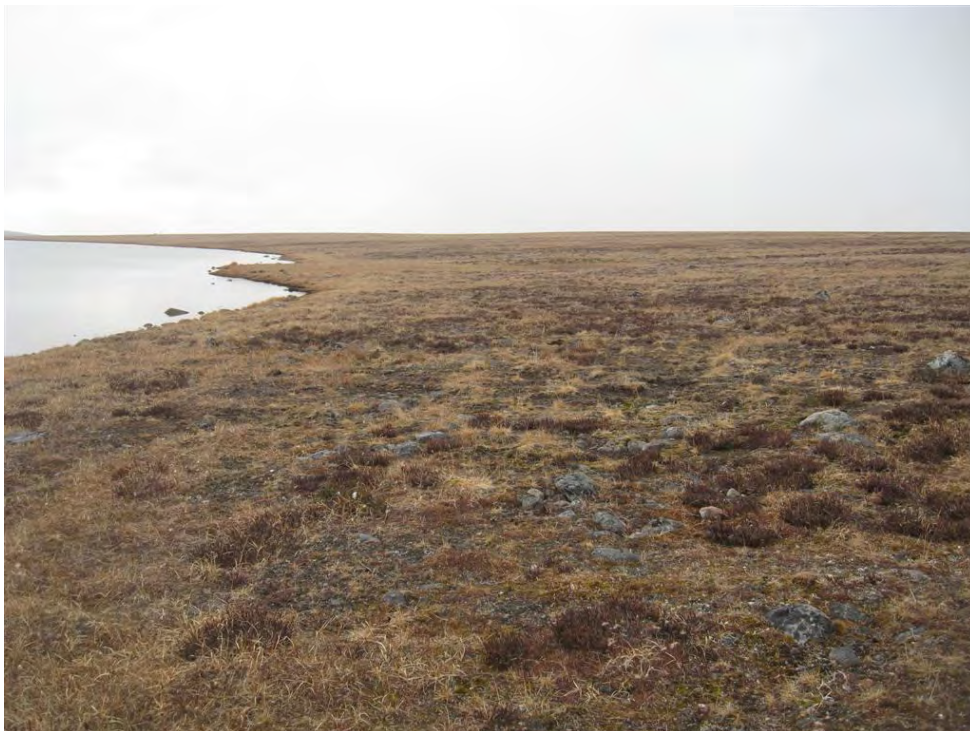
Photograph 2. After: View of Plumber's Dump subsequent to surface debris removal. ↑

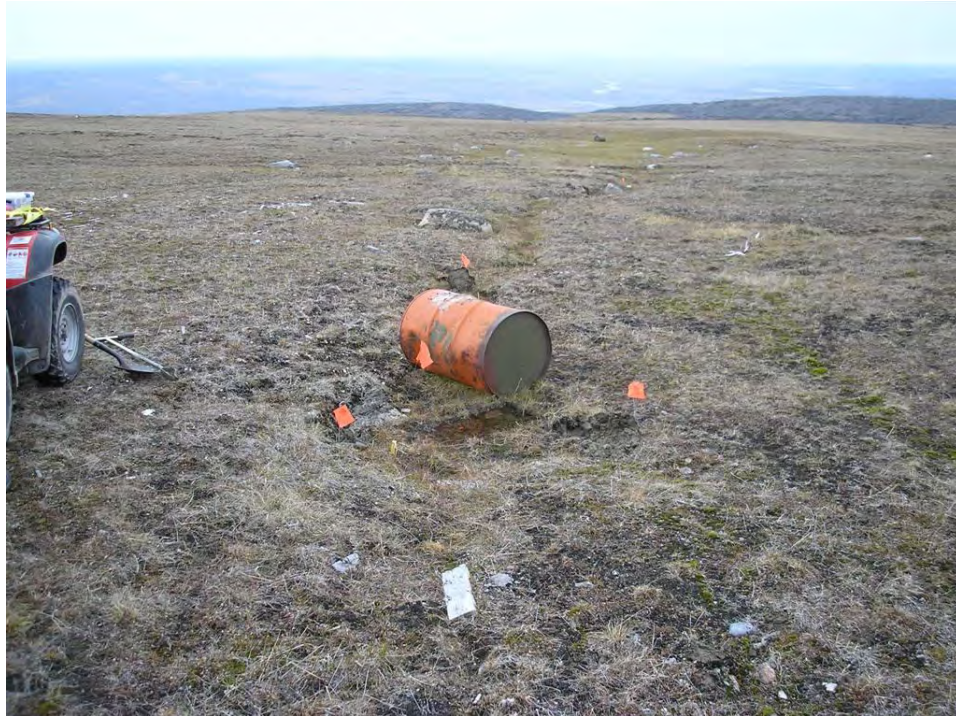
Photograph 3. Before: View Outfall – Contaminated prior to excavation of contaminated soil. ↑

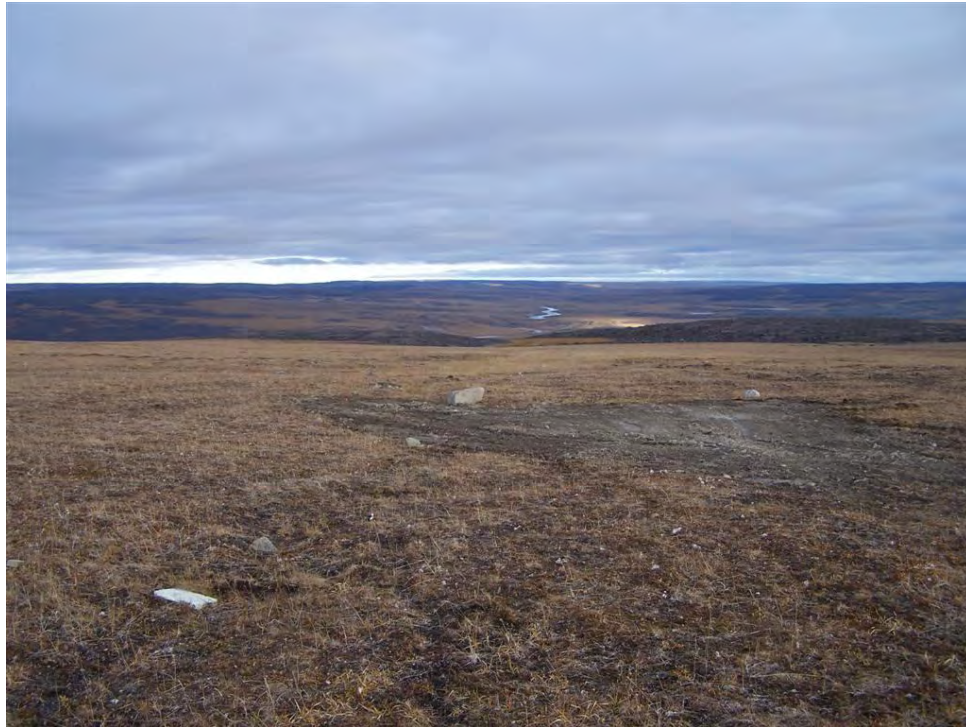
Photograph 4. After: View of Outfall - Contaminated subsequent to excavation and backfilling activities. ↑

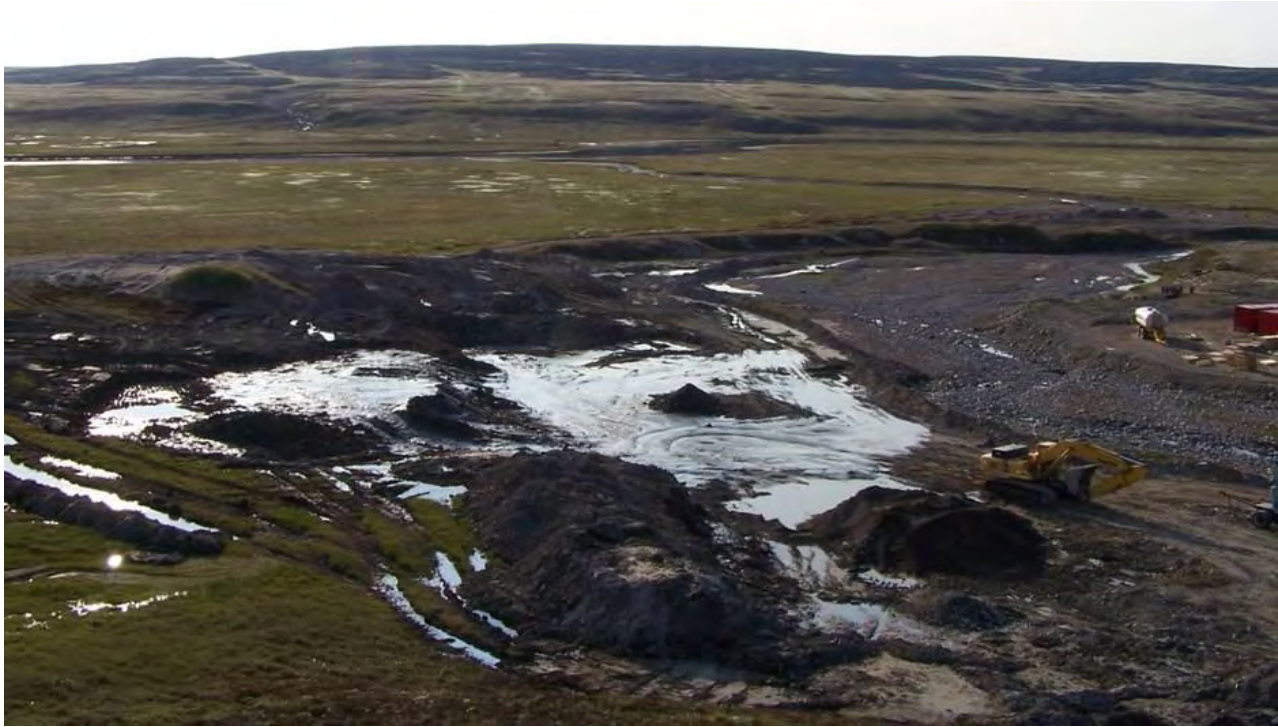
**Photograph 5.**

Before: Borrow Area No. 2 during borrow material development. ↑

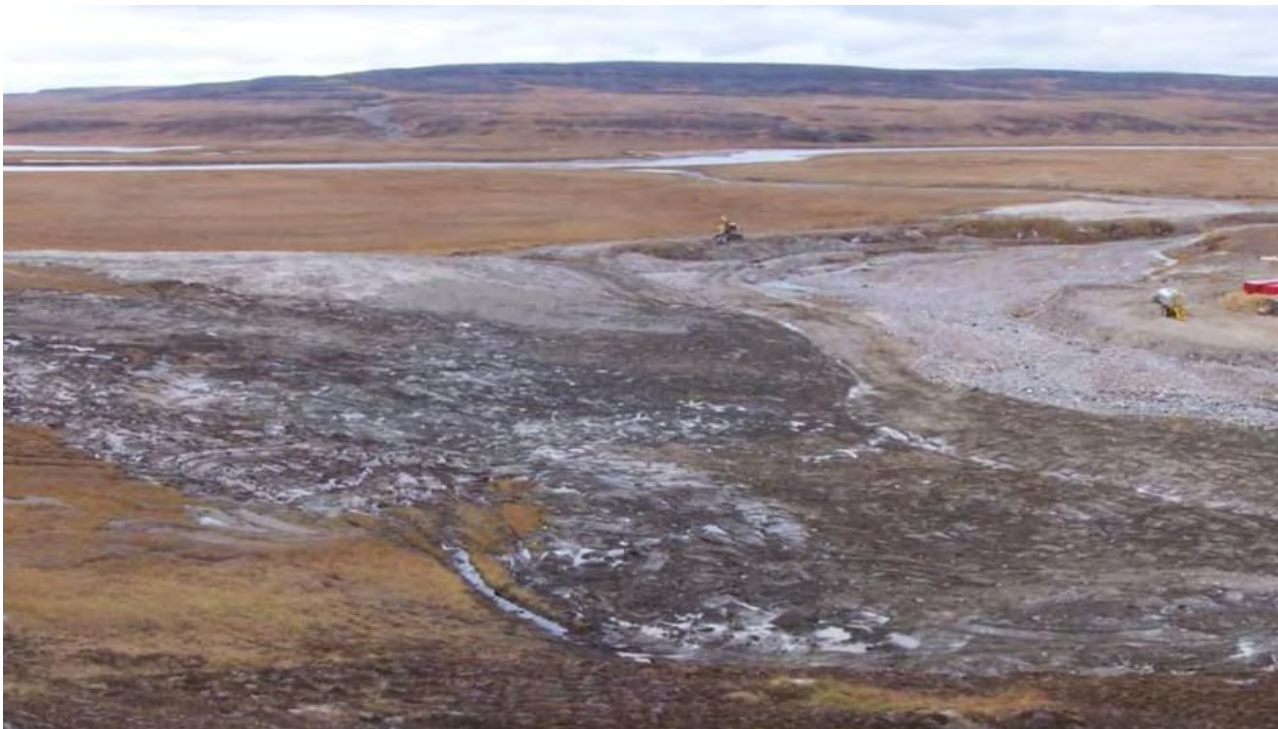
**Photograph 6.**

After: Borrow Area No. 2 subsequent to restoration program. ↑

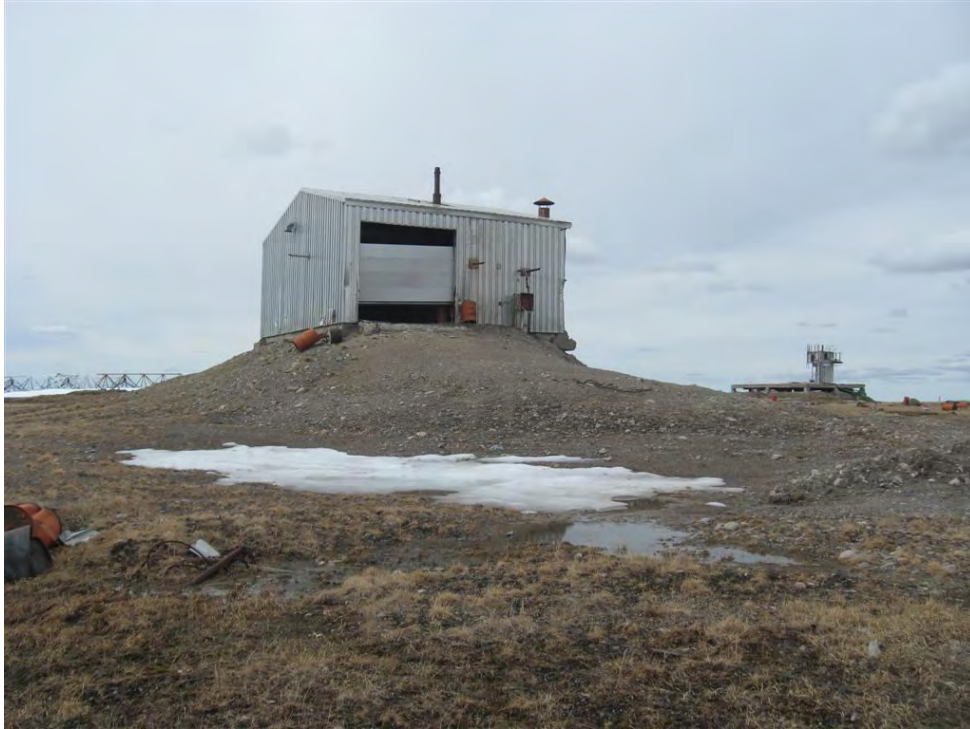
Photograph 7. Before: View of Garage prior to demolition. ↑

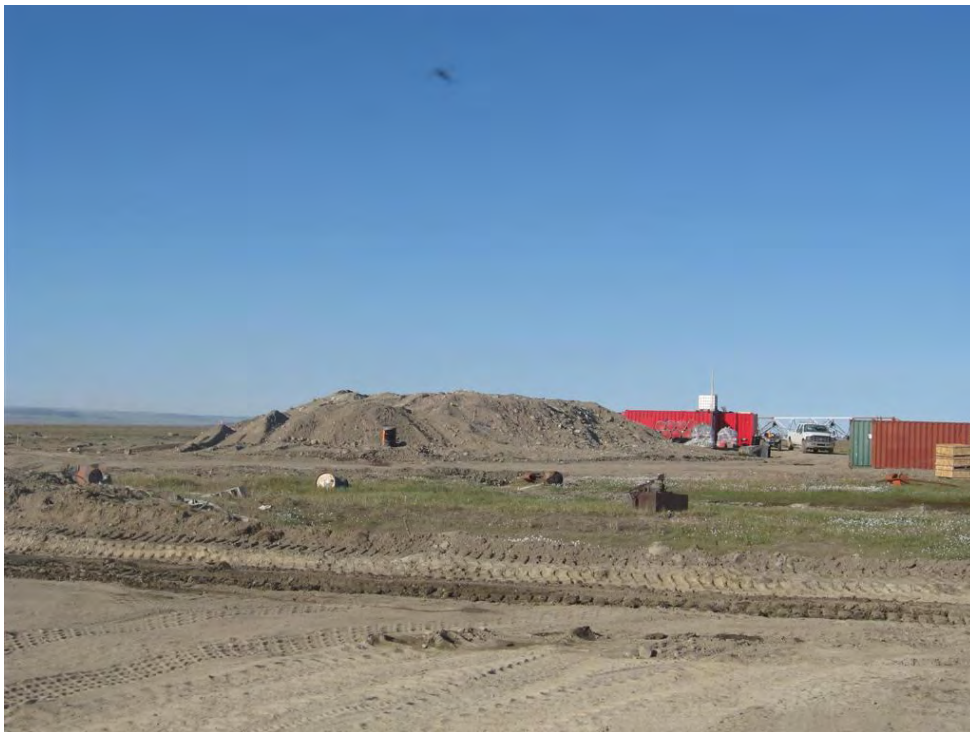
Photograph 8. After: View of Garage Pad following the completion of demolition activities. ↑

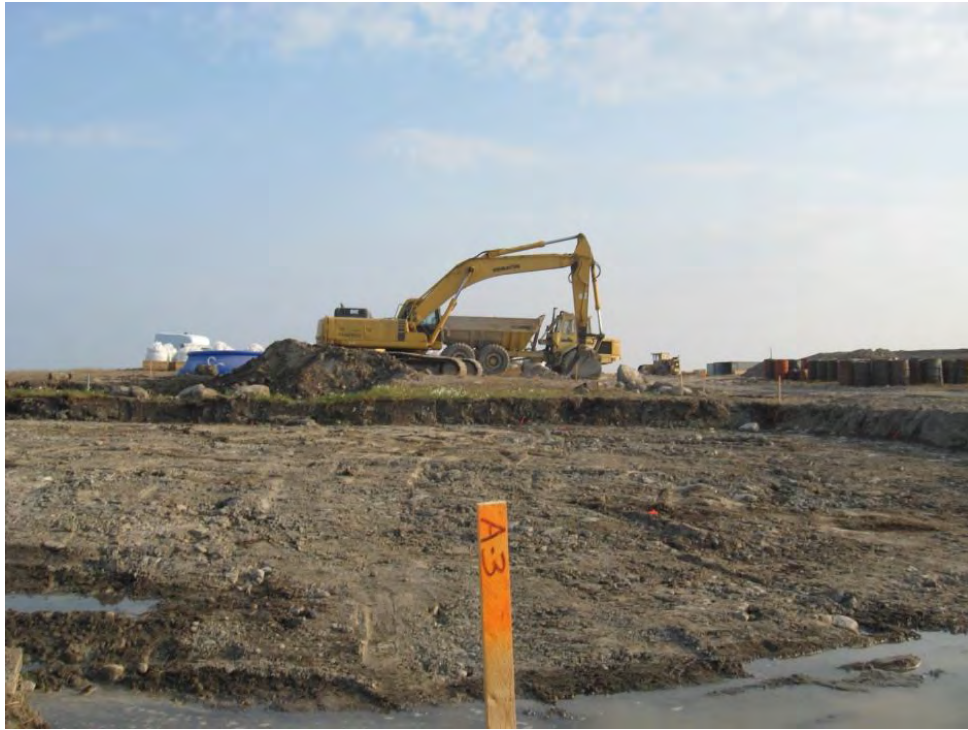
Photograph 9. Before: View of Pallet Line – Contaminated during excavation of contaminated soil. ↑

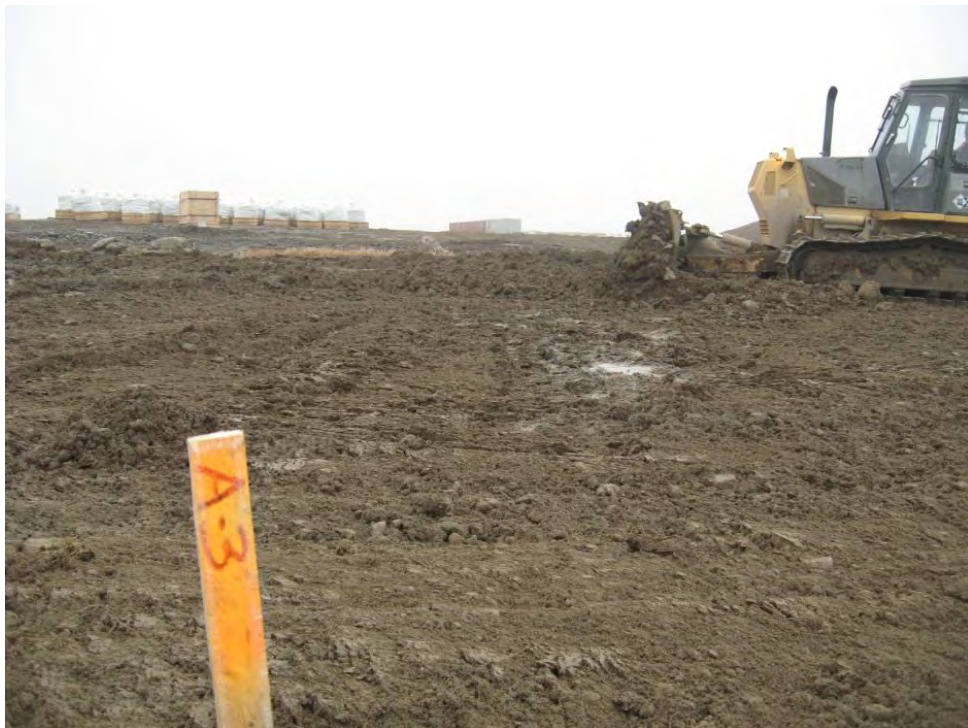
Photograph 10. After: Pallet Line – Contaminated during backfilling/reshaping. ↑
