**Project No: 60149115**

**Regarding: CAM-D DEW Line Environmental Remediation –CAM-D Camp Final Inspection**

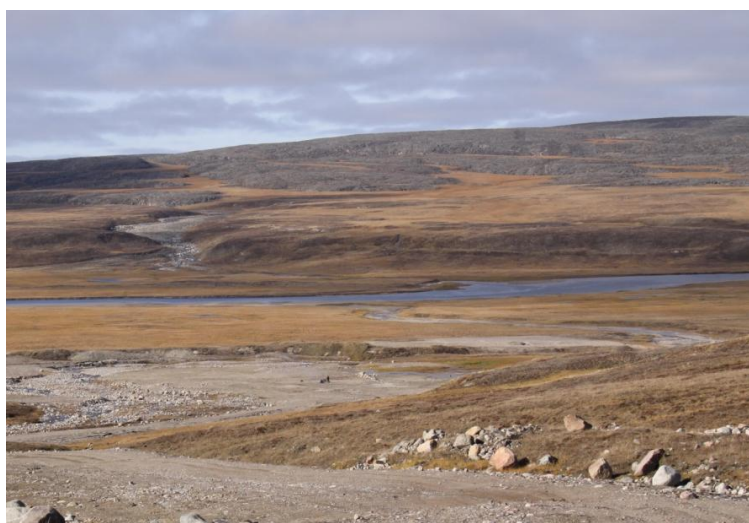
A visual assessment of the former construction camp identified a small amount of wood, remaining from pallets, chocks and other miscellaneous wood waste, was found scattered around the camp area. There was also a minor amount of metal and plastic debris within the former camp area. All wood debris was collected, stockpiled and incinerated. The waste unsuitable for incineration (i.e. anything other than unpainted, untreated wood) was collected and removed from the site, to be disposed of at the dump in Kugaaruk. In addition, a small privy, used for grey water disposal for the temporary camp in place during the March 2012 CAT train required backfilling. Large boulders were

used to fill the majority of the hole, which were then covered using surrounding soil. Aside from the minor amount of debris and the pit that required backfilling, the CAM-D camp area was found to be in very good condition, with no erosion channels, slope instabilities, spills, or other significant issues observed.

**Photograph 3 – CAM-D Camp, facing West (September 5, 2012). ↑**

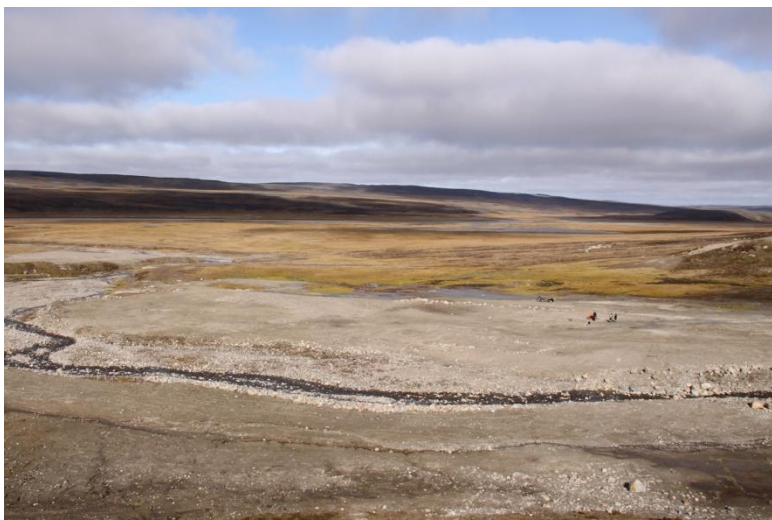
**Photograph 6 – CAM-D Camp, facing Northwest (September 5, 2012). ↑**

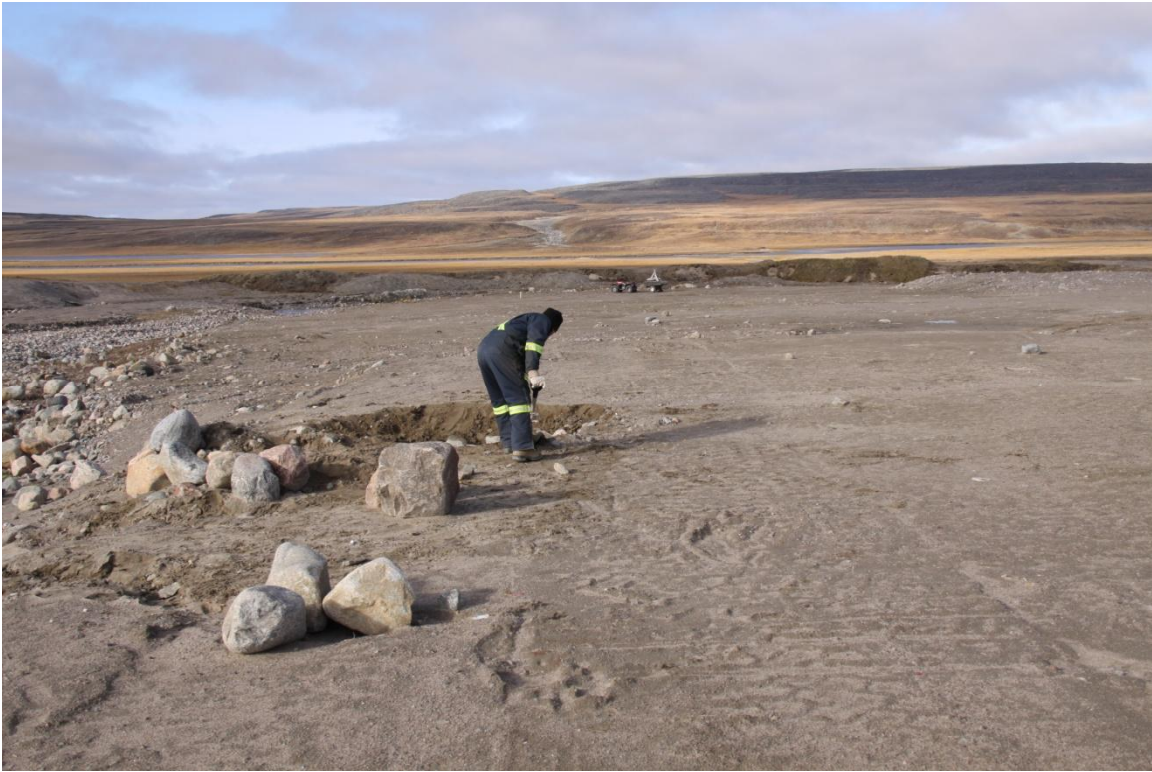
**Photograph 7 – Backfilling the winter camp greywater privy (September 5, 2012). ↑**

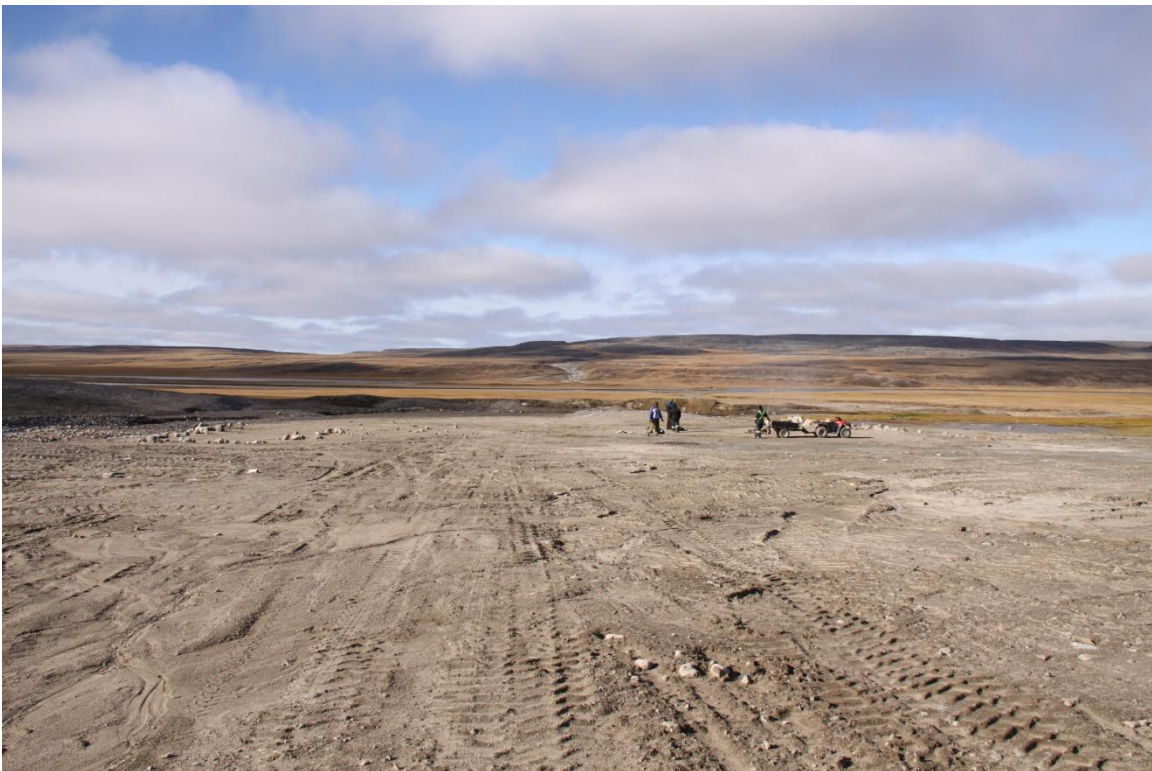
**Photograph 8– View of former camp area (September 5, 2012). ↑**

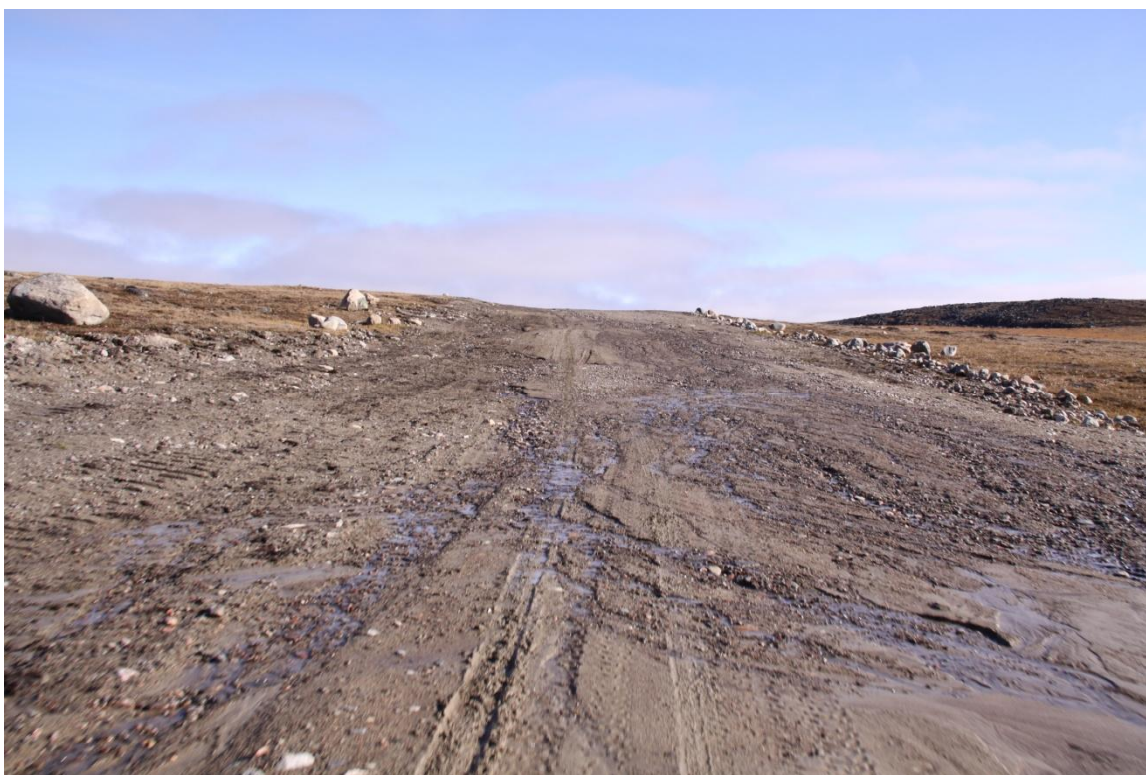
Visual observations of the performance of constructed features at the CAM-D site itself, including the non-hazardous waste landfill (NHWL), reshaping of the haul road, regrades, and backfilled excavations were also conducted; however, time for visual inspection of the CAM-D site was limited. The following observations are generalized and not intended to be a complete record of conditions on site, as it was understood that the long term monitoring and inspection was completed separately, by another consultant. Backfilled excavations, regraded dump areas and the NHWL were inspected and found to be in very good condition and performing as intended. Equipment cleat marks are still prominent on constructed surfaces and no erosion channels or slope instability features were observed. Drainage courses along the haul road, between the camp area and the CAM-D site, have been adequately restored and the road itself is not impeding drainage in any way.

**Photograph 9 – Former haul road (September 5, 2012). ↑**

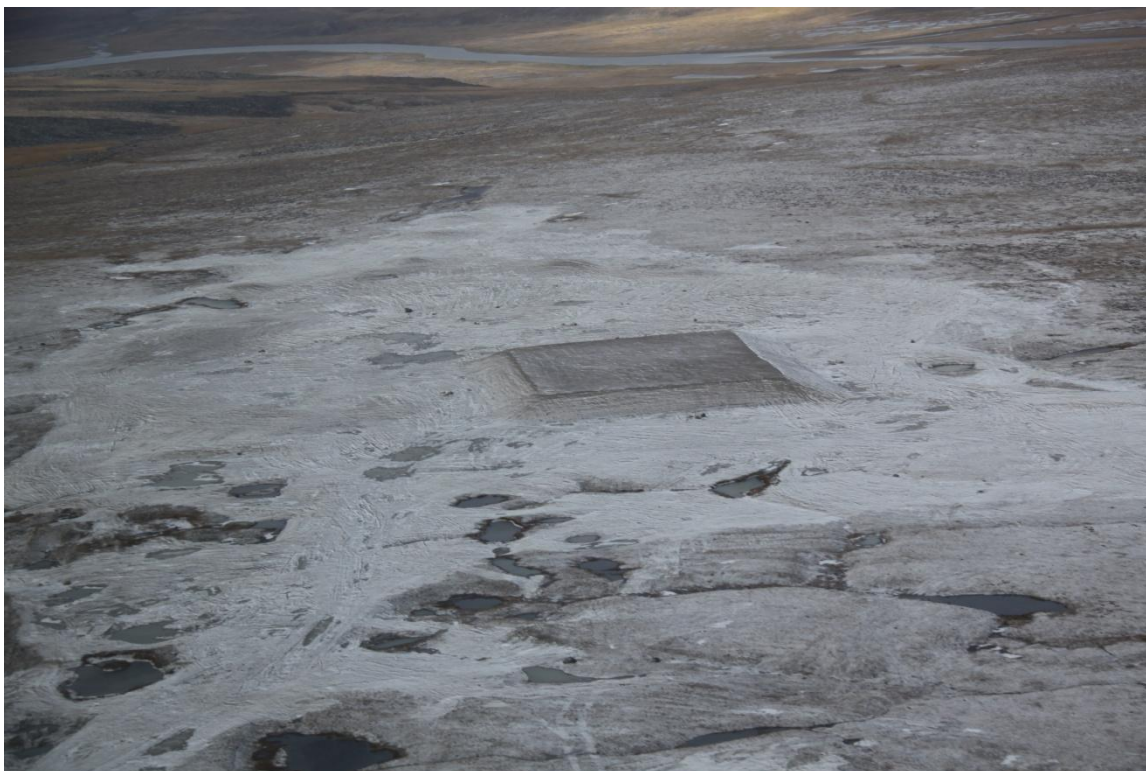
**Photograph 10– CAM-D Site, facing West (September 5, 2012). ↑**

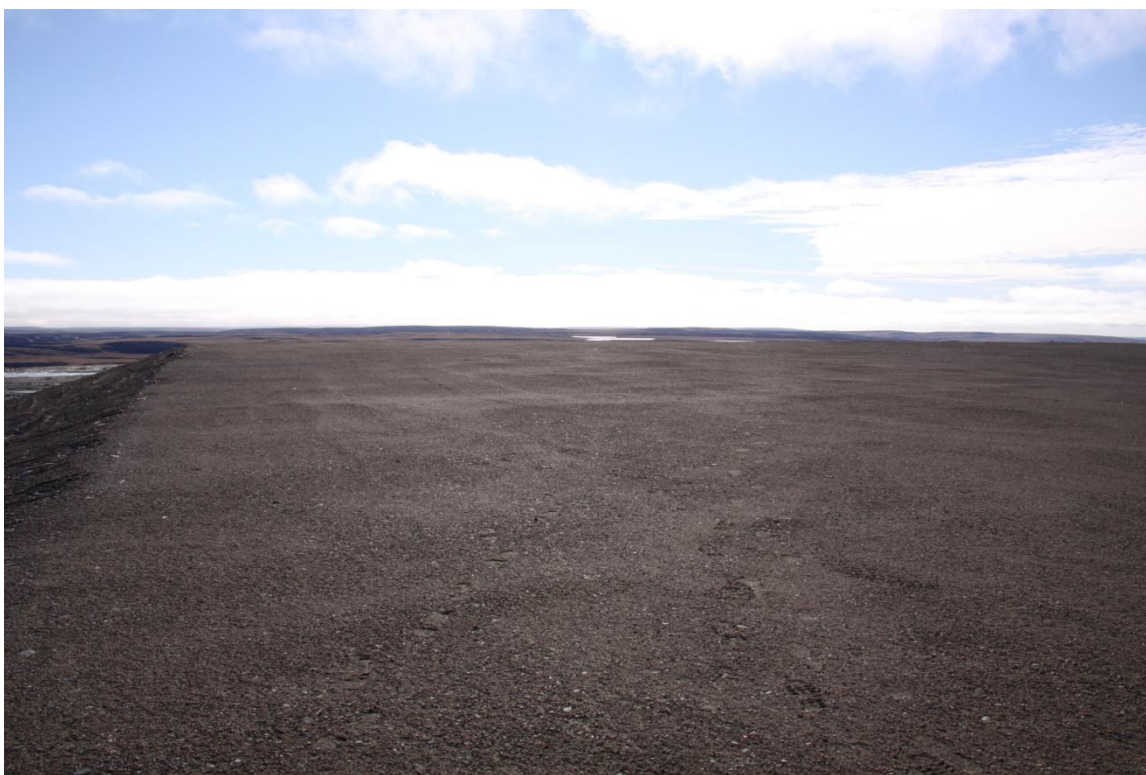
**Photograph 11 – NHWL, facing South (September 5, 2012). ↑**

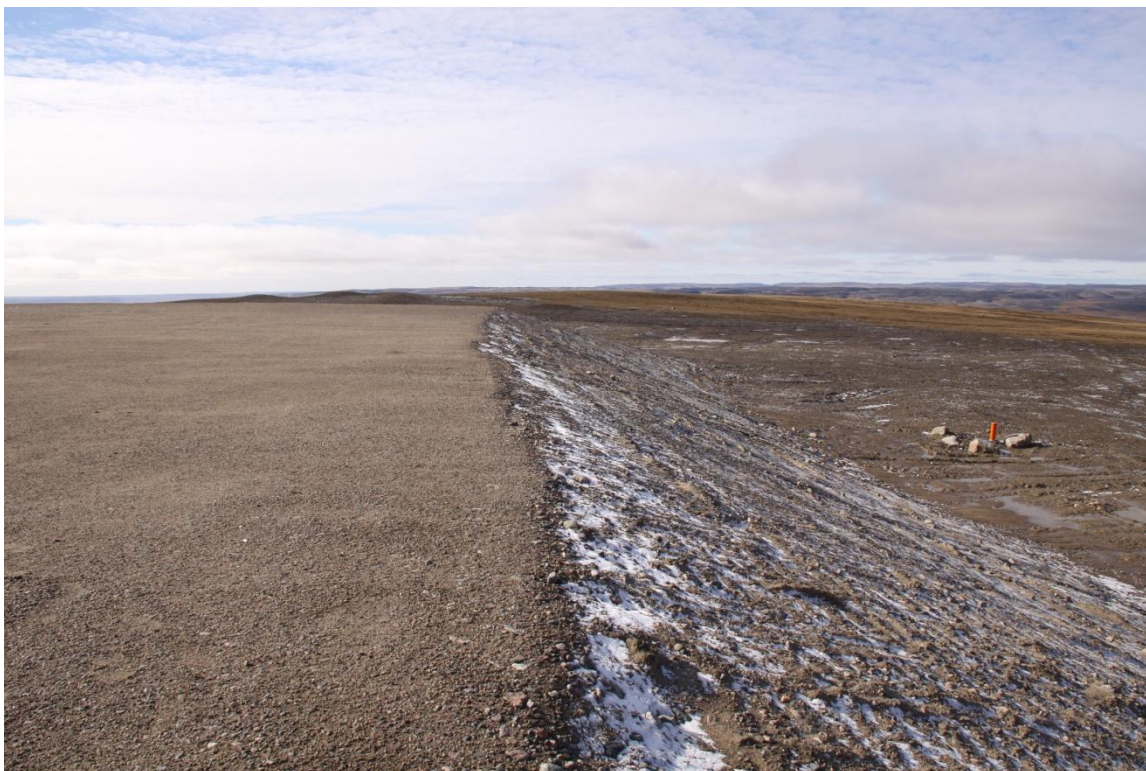
**Photograph 12– NHWL, facing West (September 5, 2012). ↑**
