**NWB Annual Report**

**License No:** 1BR-SIM0813

**Project Name:** CAM-D Simpson Lake Remediation Project

**Licensee:** Indian and Northern Affairs Canada Contaminated Sites program

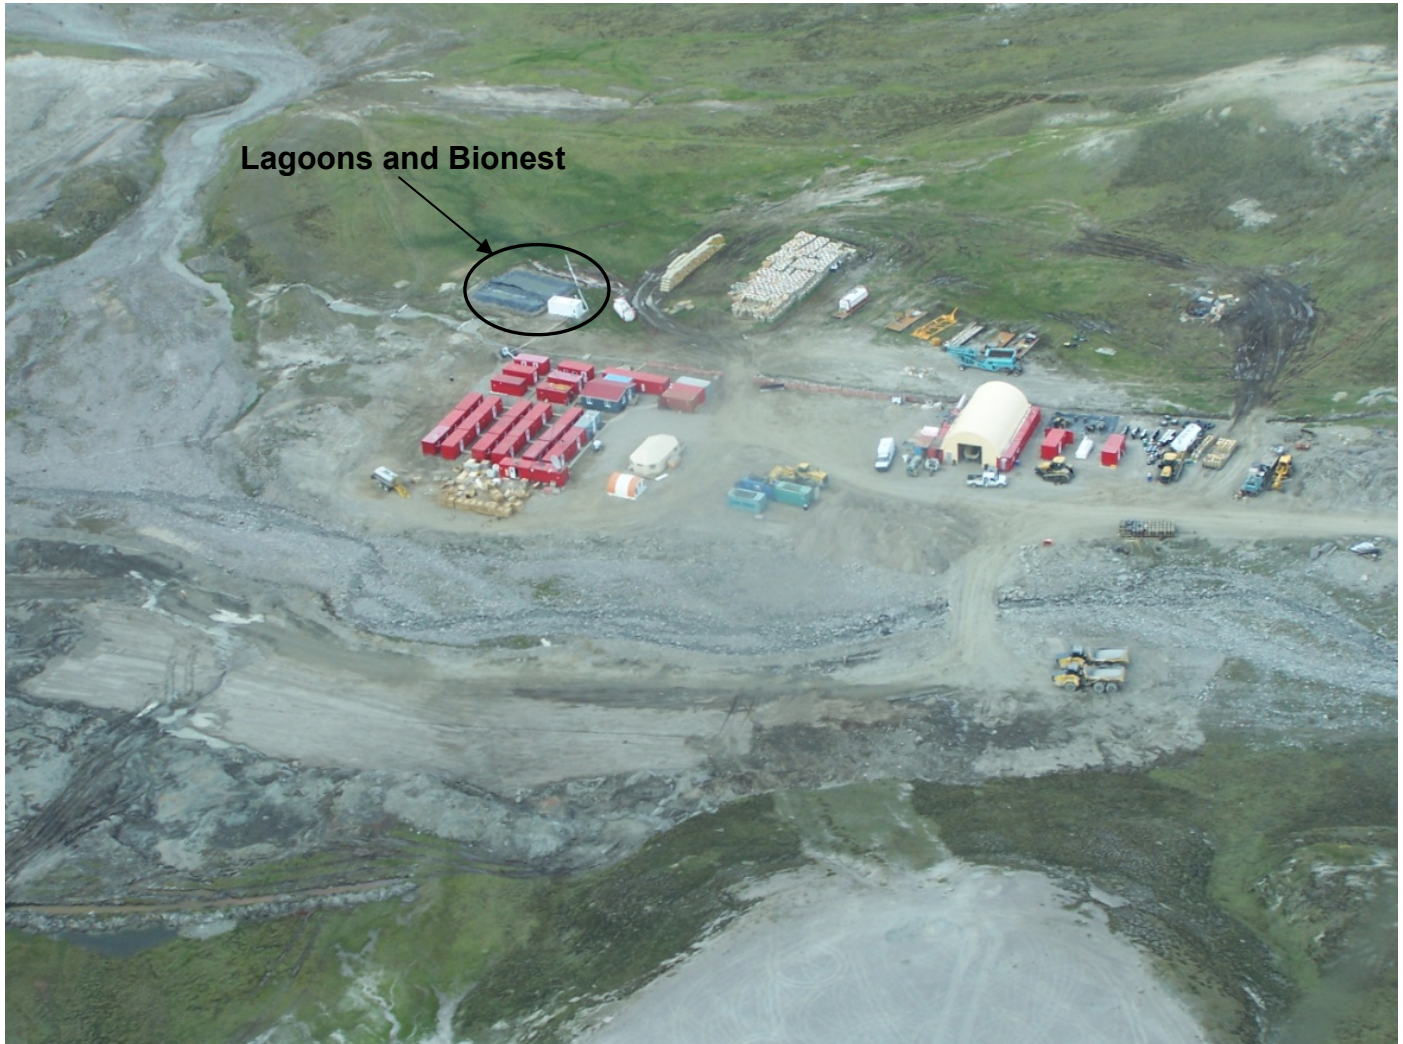
At the completion of the 2011 construction season, the sediment in the lagoons was sampled, tested and packaged together with the liners for shipment off site. The area was then reshaped to match the surrounding terrain.

The following photograph shows the CAM-D camp area. The temporary sewage lagoons and the “Bionest” treatment system are located in the northwest (top left of the photo) corner of the camp.

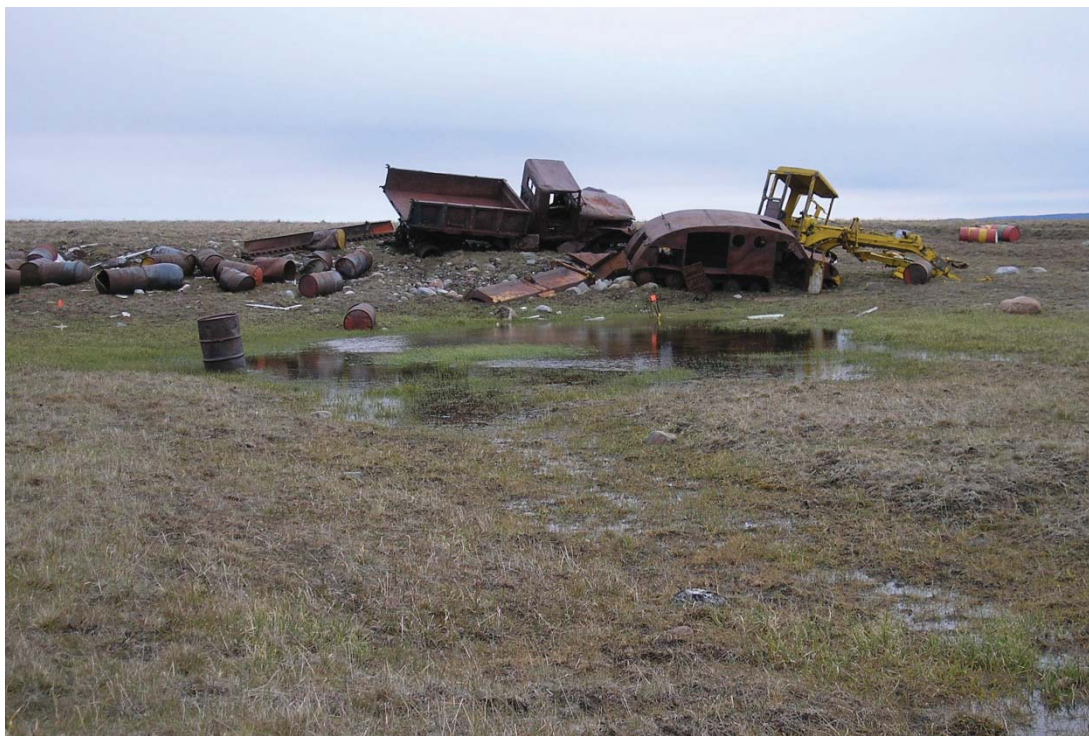
**Photograph 3.** Before: View of Site Debris Area 6 (Airstrip) prior to surface debris removal. ↑

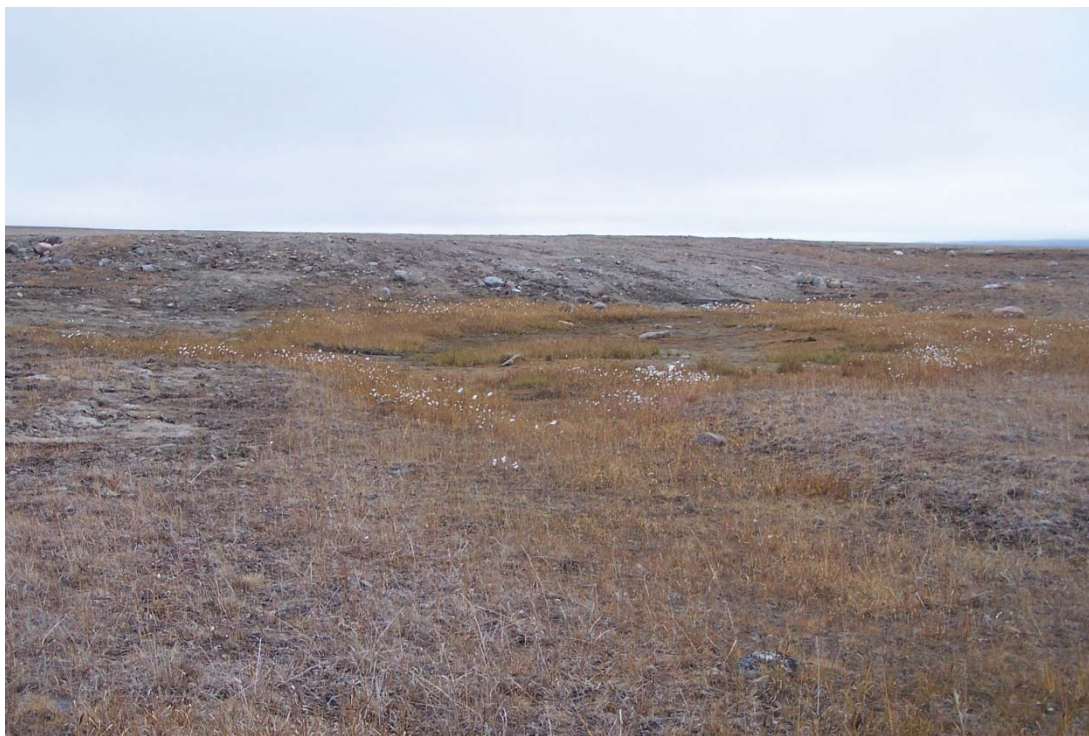
**Photograph 4.** After: View of Airstrip subsequent to surface debris removal. ↑

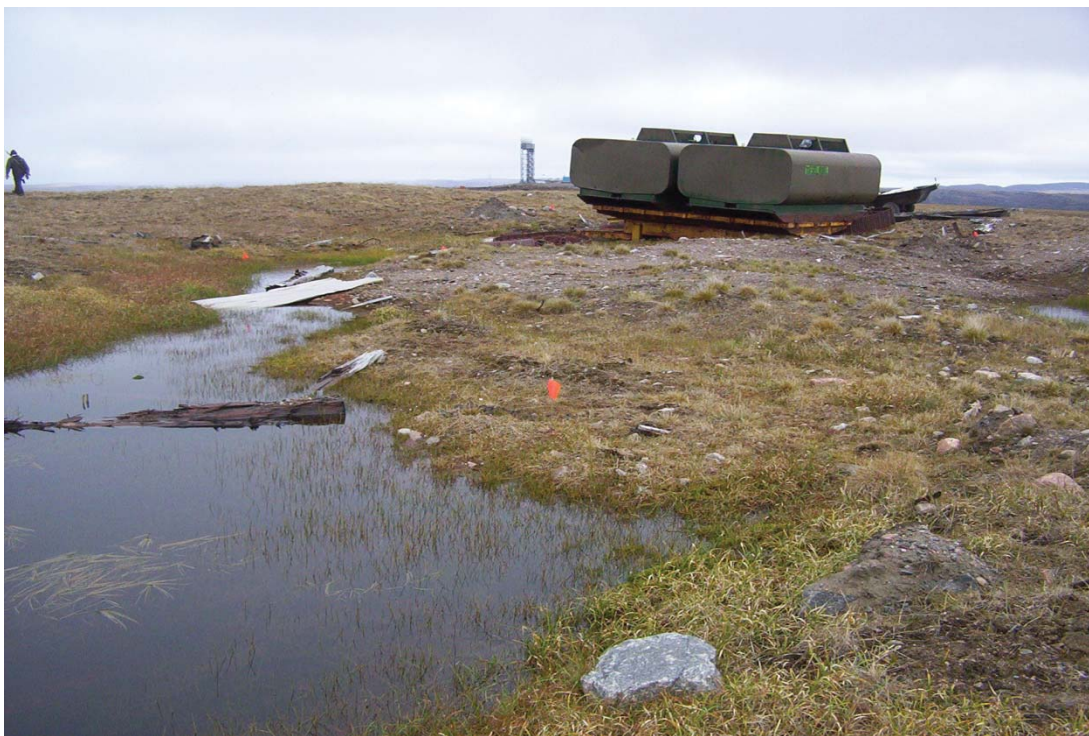
**Photograph 9.** Before: View of Portable Fuel Tanks – Impacted prior to impacted soil excavation. ↑

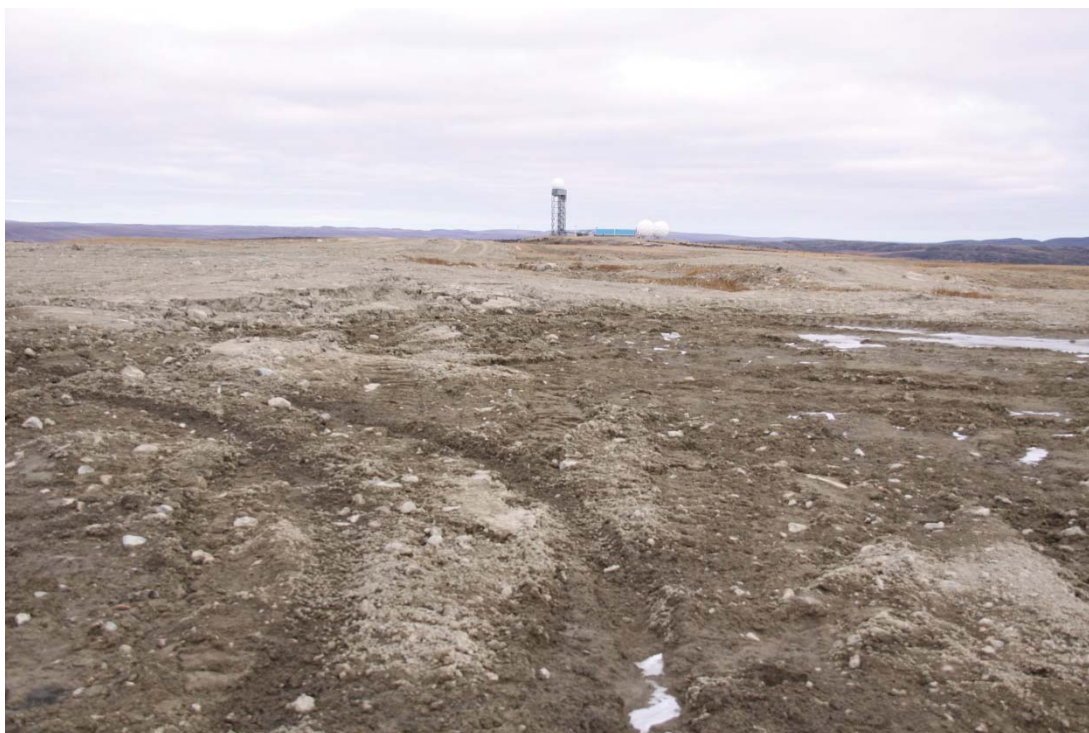
**Photograph 10.** After: Excavation complete; reshaped to match surrounding terrain. ↑
