RESIDENT ENGINEER'S LETTER REPORT:

May 30, 2012

**Regarding: Water Licence Reporting Requested Information
CAM-D DEW Line Site, Simpson Lake, Nunavut**

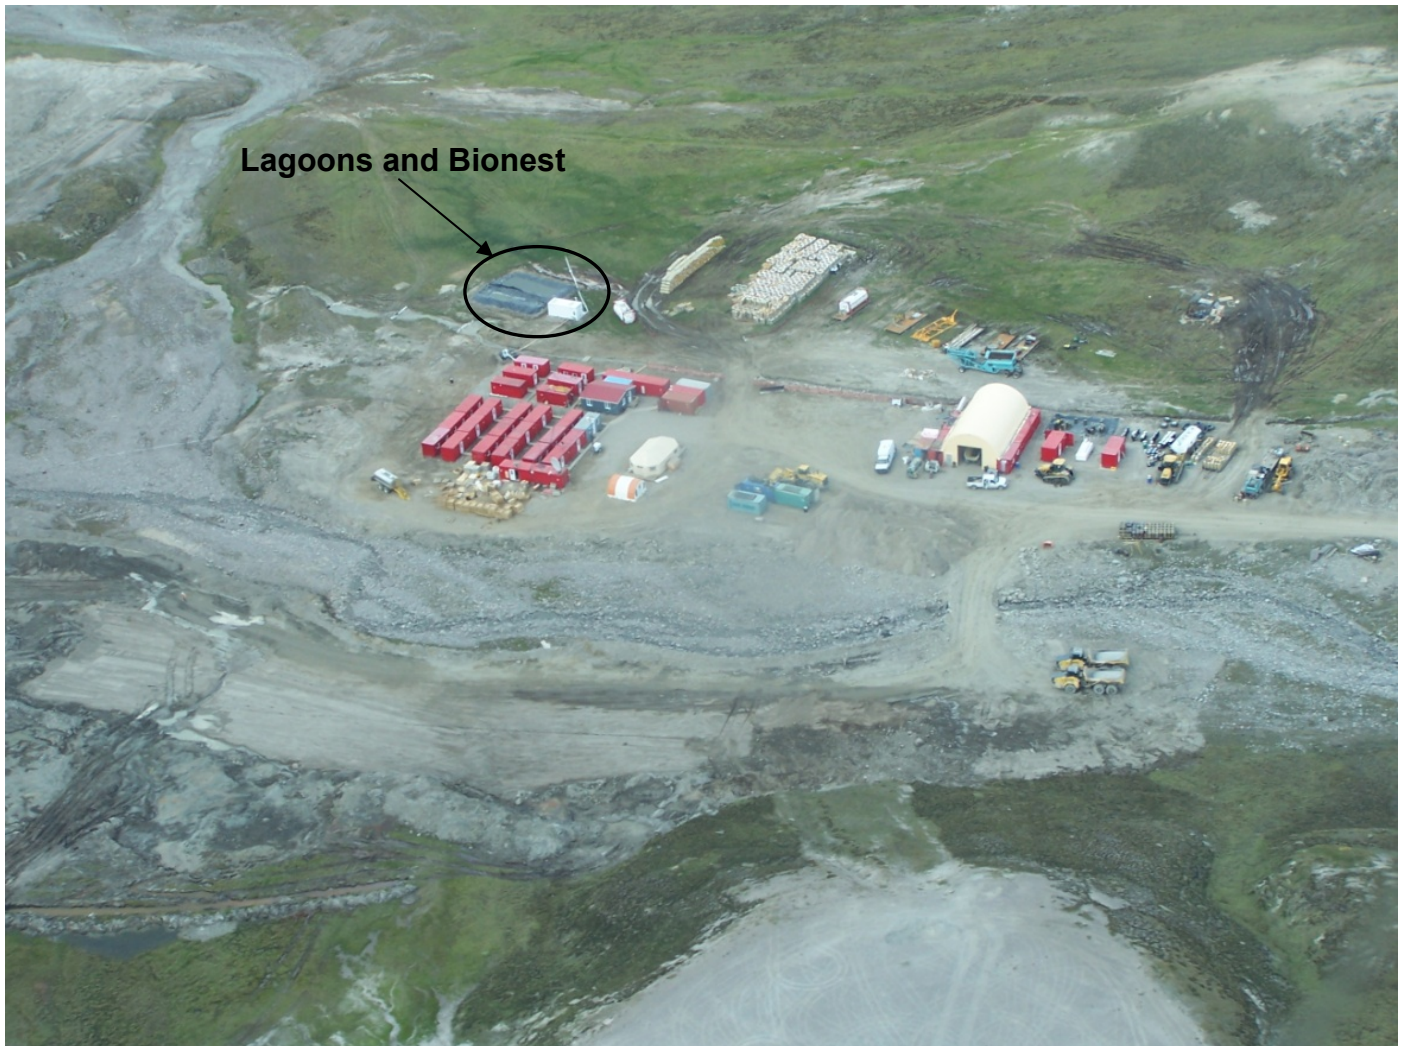
The following photograph shows the CAM-D camp area. The temporary sewage lagoons and the “Bionest” treatment system are located in the northwest (top left of the photo) corner of the camp.
