**RE: CAM-D Simpson Lake Remediation Project: 2012 Annual Report  
for Water Licence No: 1BR-SIM0813**

# **CAM-D, Simpson Lake, Nunavut NWB Licence No. 1BR-SIM0813**

## **RESIDENT ENGINEER'S LETTER REPORT:**

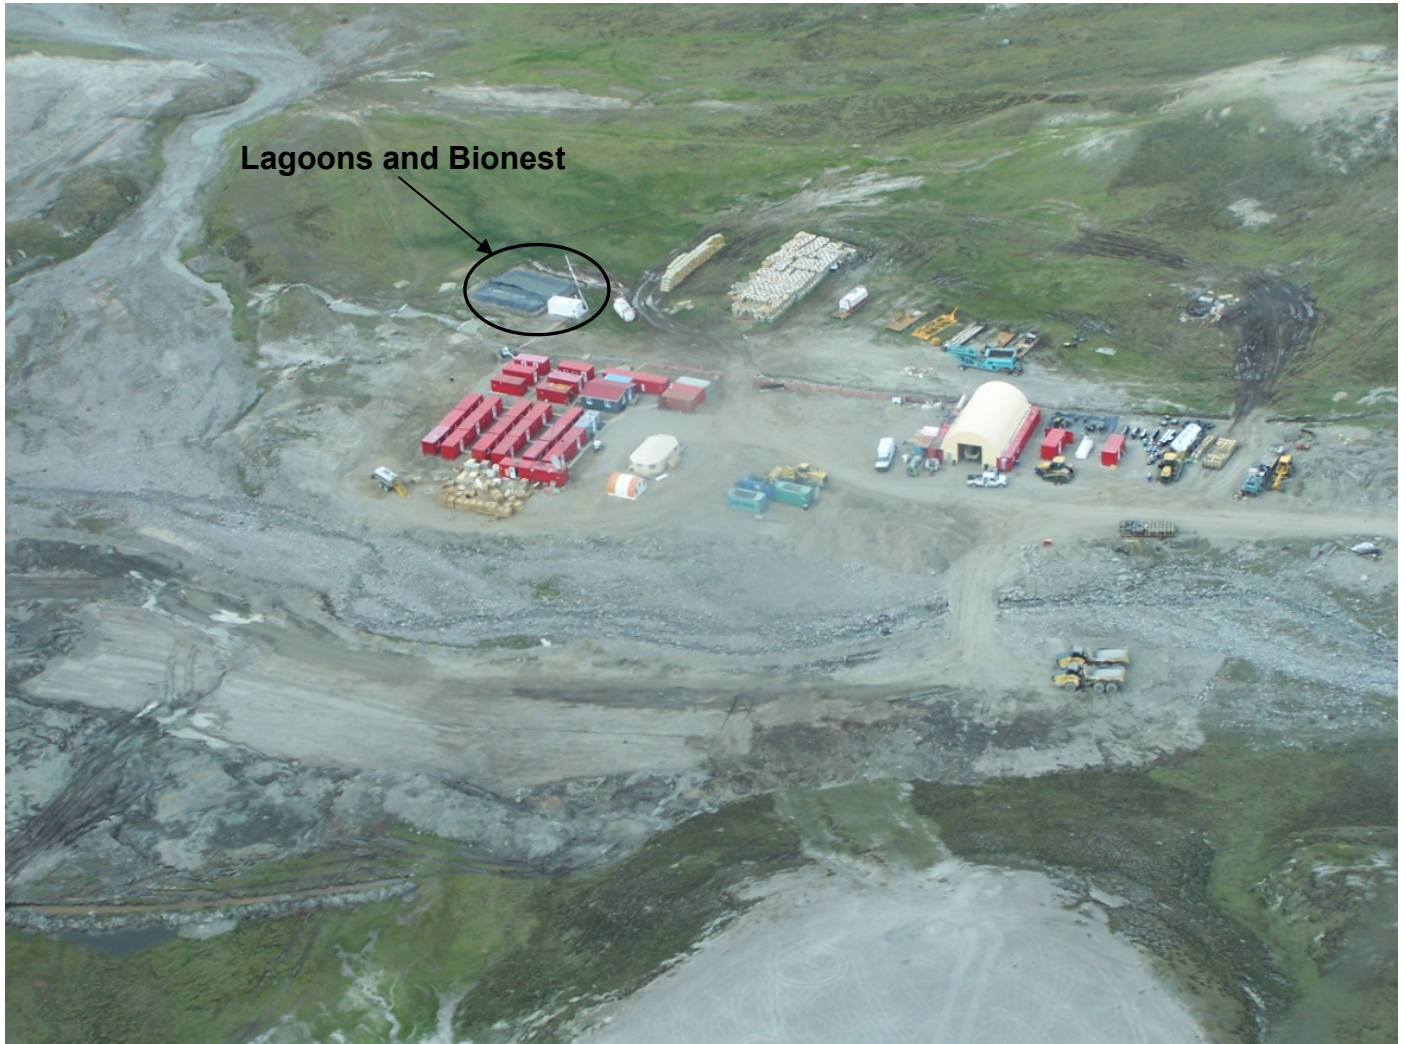
The following photograph shows the CAM-D camp area. The temporary sewage lagoons and the “Bionest” treatment system are located in the northwest (top left of the photo) corner of the camp.

At the completion of the 2011 construction season, the sediment in the lagoons was sampled, tested and packaged together with the liners for shipment off site. The area was then reshaped to match the surrounding terrain.

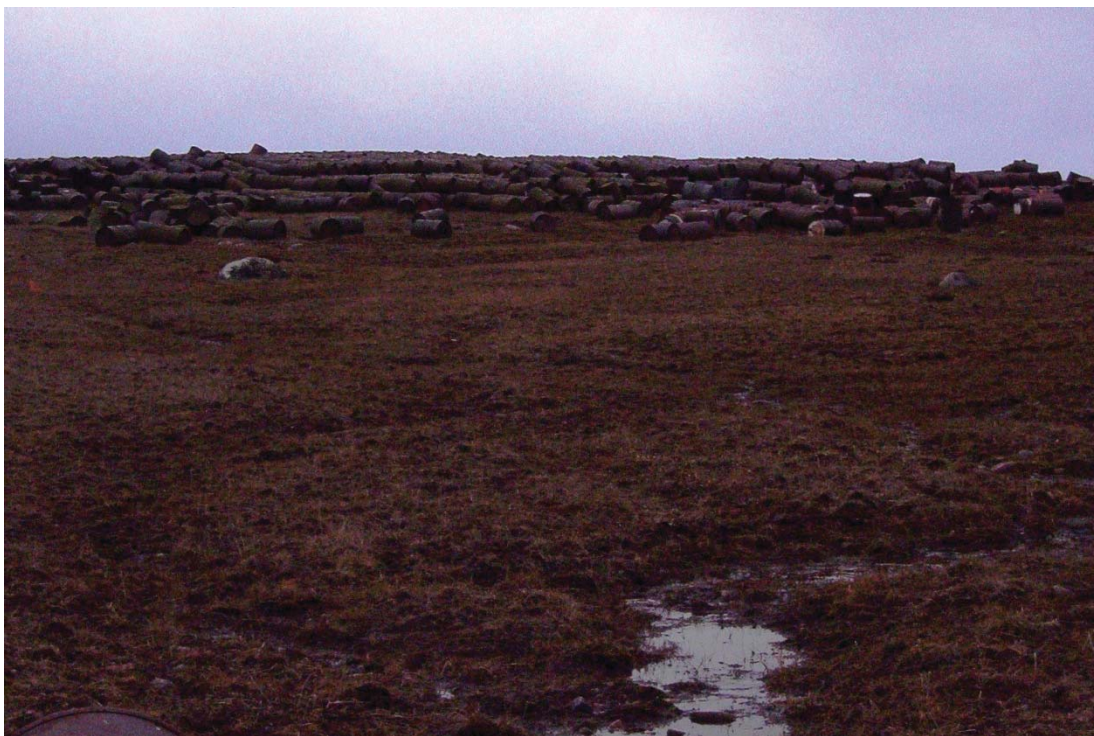
**Photograph 1.** Before: View of Site Debris Area 4 (Main Barrel Cache) prior to surface debris removal. ↑

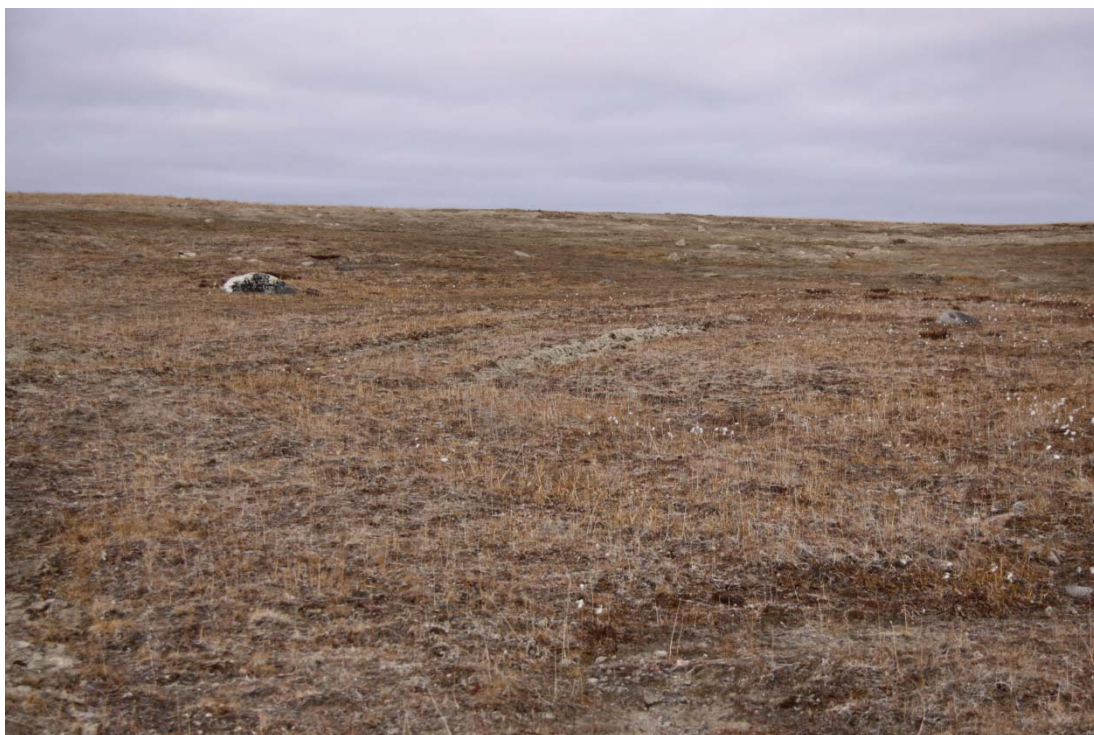
**Photograph 2.** After: View of Main Barrel Cache subsequent to surface debris removal. ↑

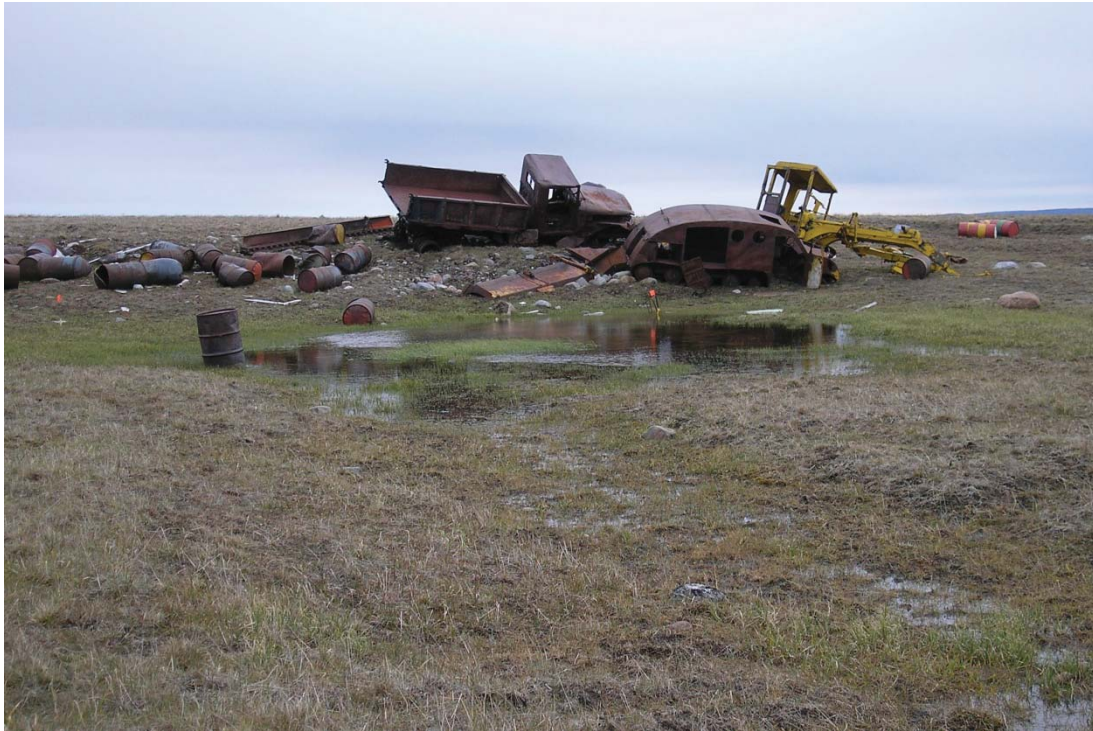
**Photograph 3.** Before: View of Site Debris Area 6 (Airstrip) prior to surface debris removal. ↑

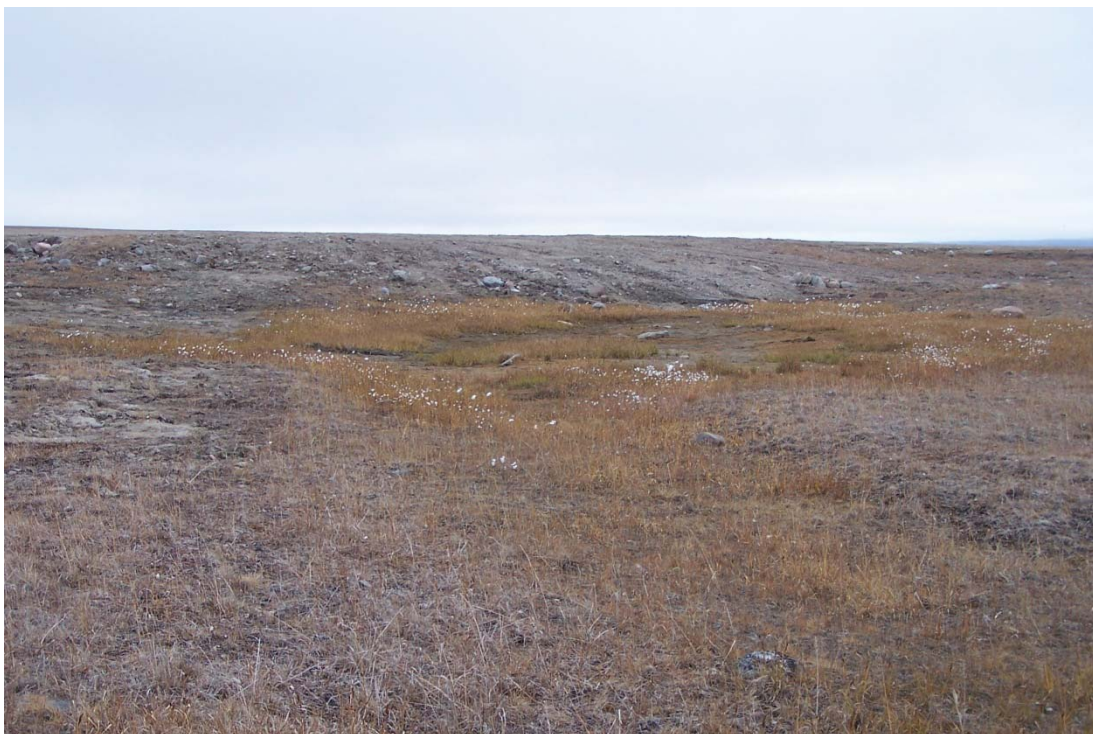
**Photograph 4.** After: View of Airstrip subsequent to surface debris removal. ↑

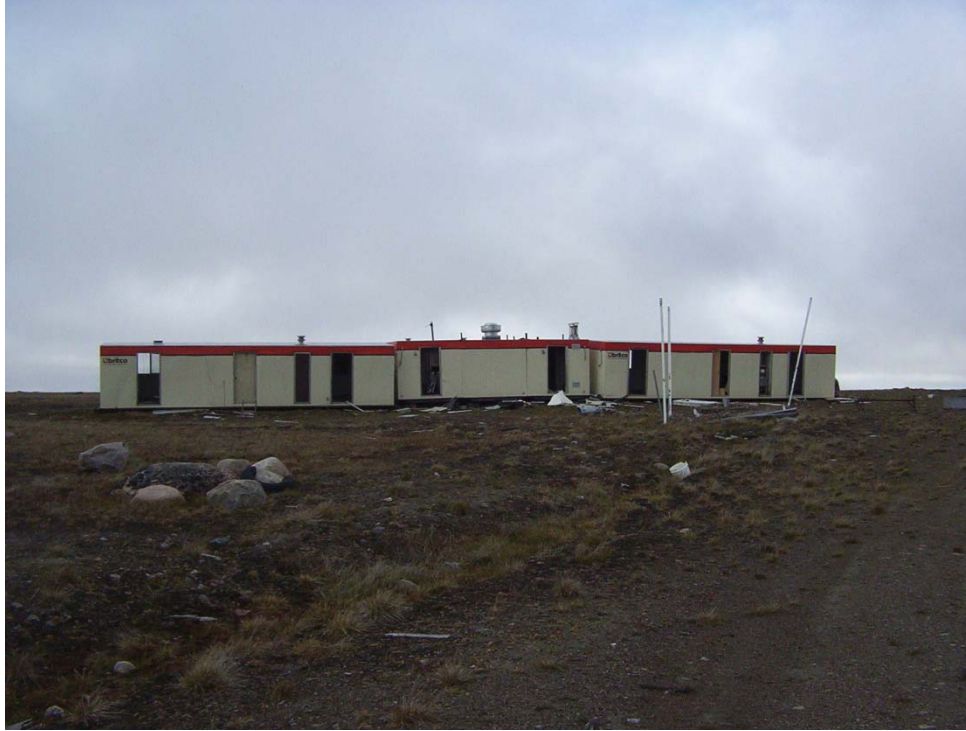
**Photograph 5.** Before: Short Range Radar Camp prior to removal and demolition. ↑

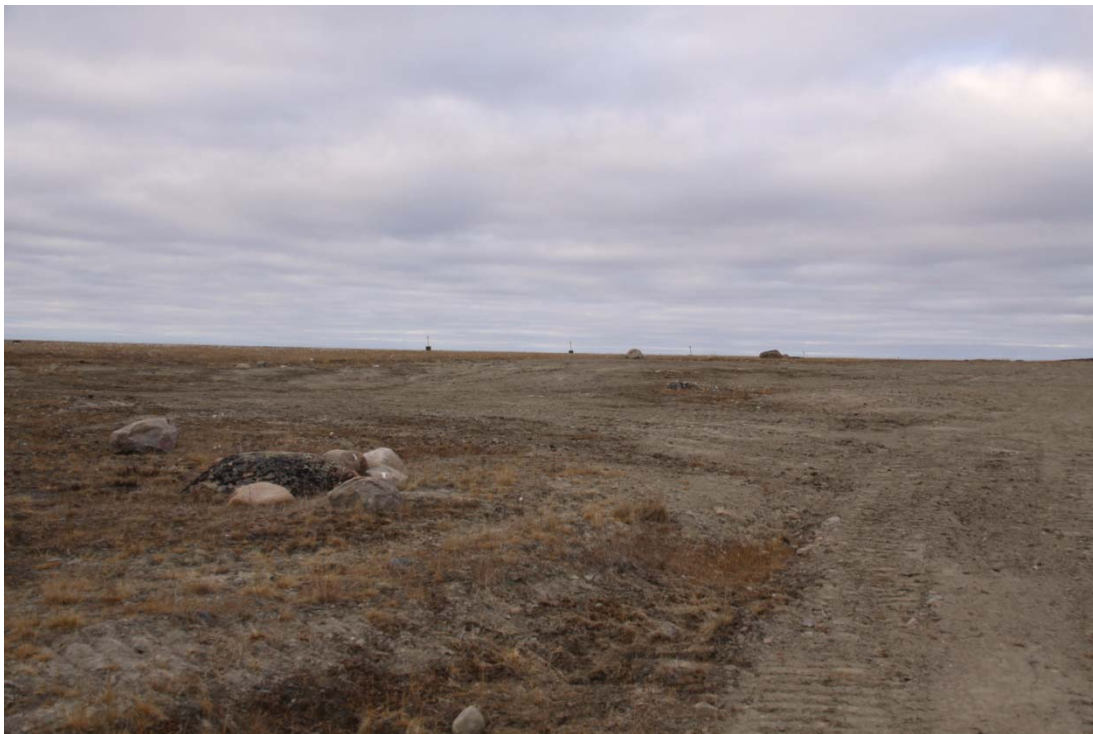
**Photograph 6.** After: Short Range Radar Camp removed; area reshaped to match surrounding terrain. ↑

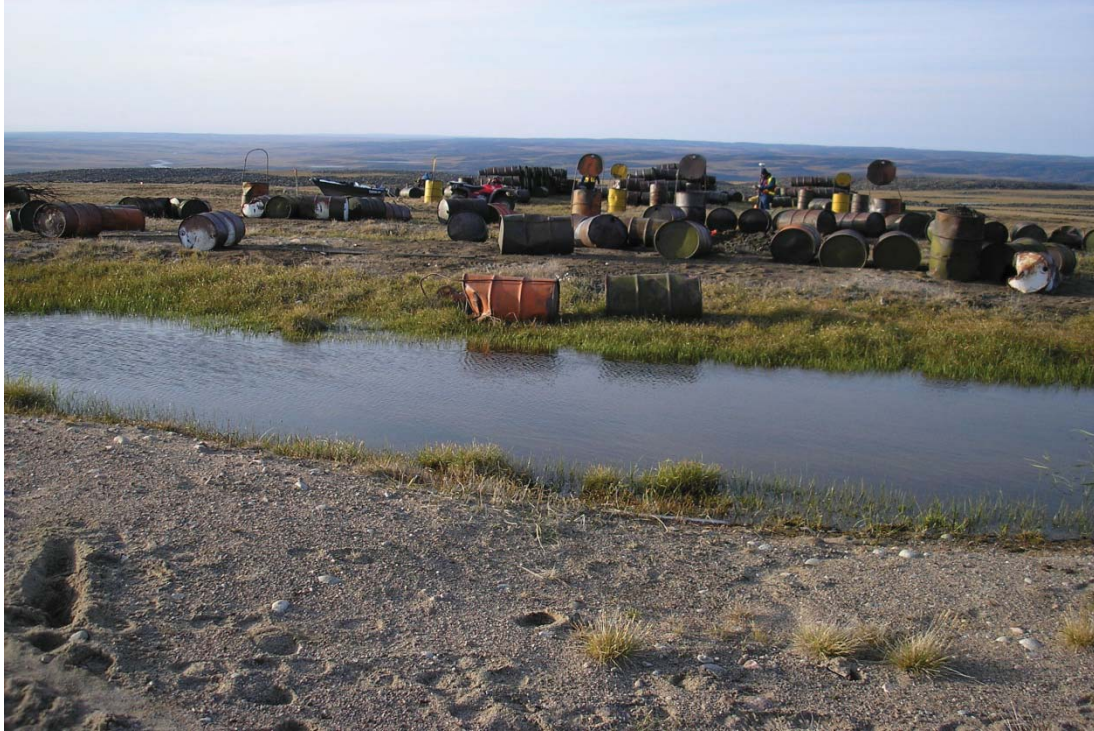
**Photograph 7.** Before: View of Pallet Line looking north prior to surface debris removal and contaminated soil excavation. ↑

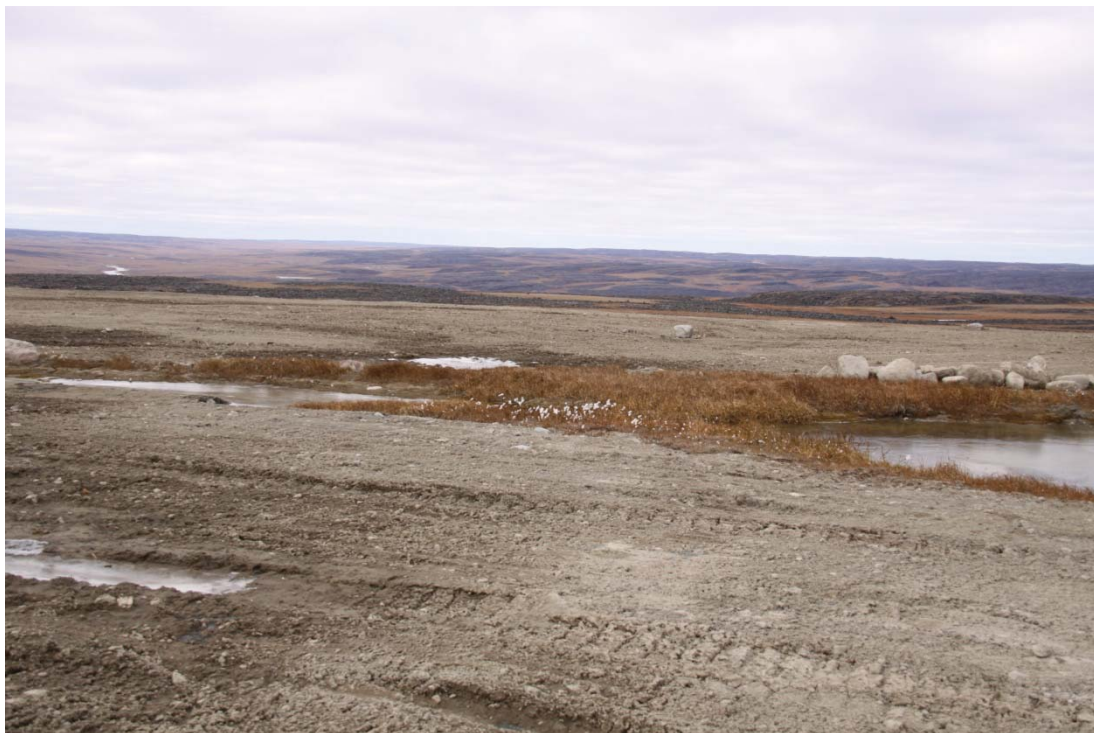
**Photograph 8.** After: View of Pallet Line after the completion of debris removal and soil excavation. ↑

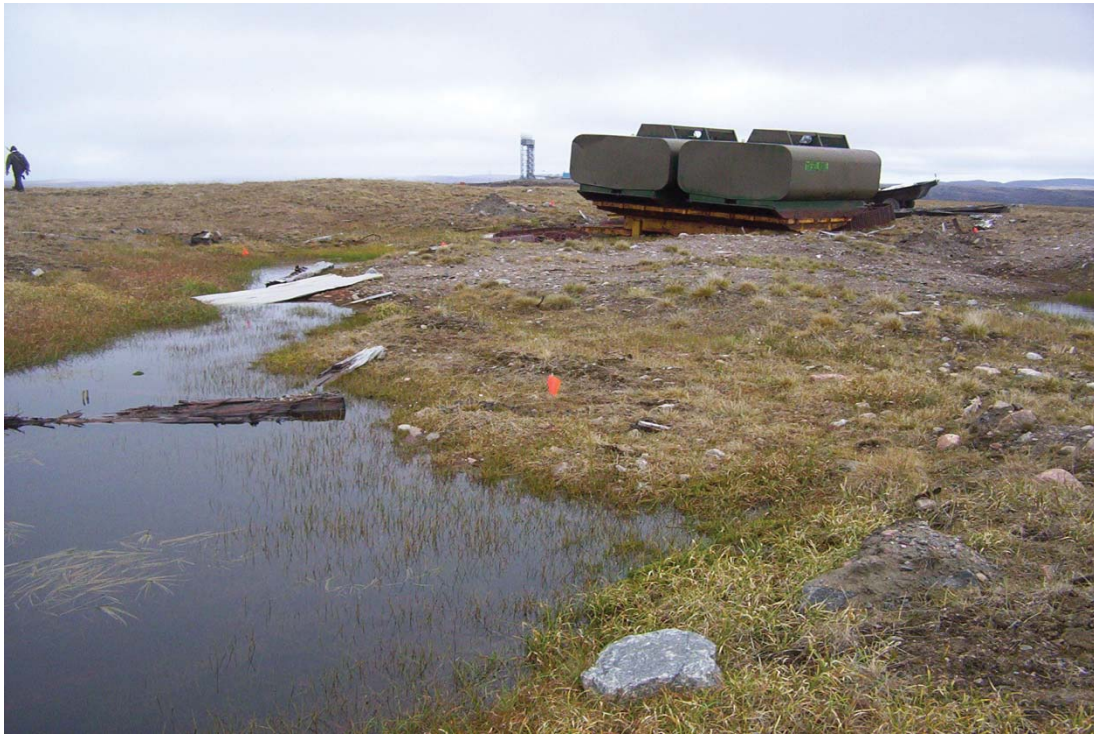
**Photograph 9.** Before: View of Portable Fuel Tanks – Impacted prior to impacted soil excavation. ↑

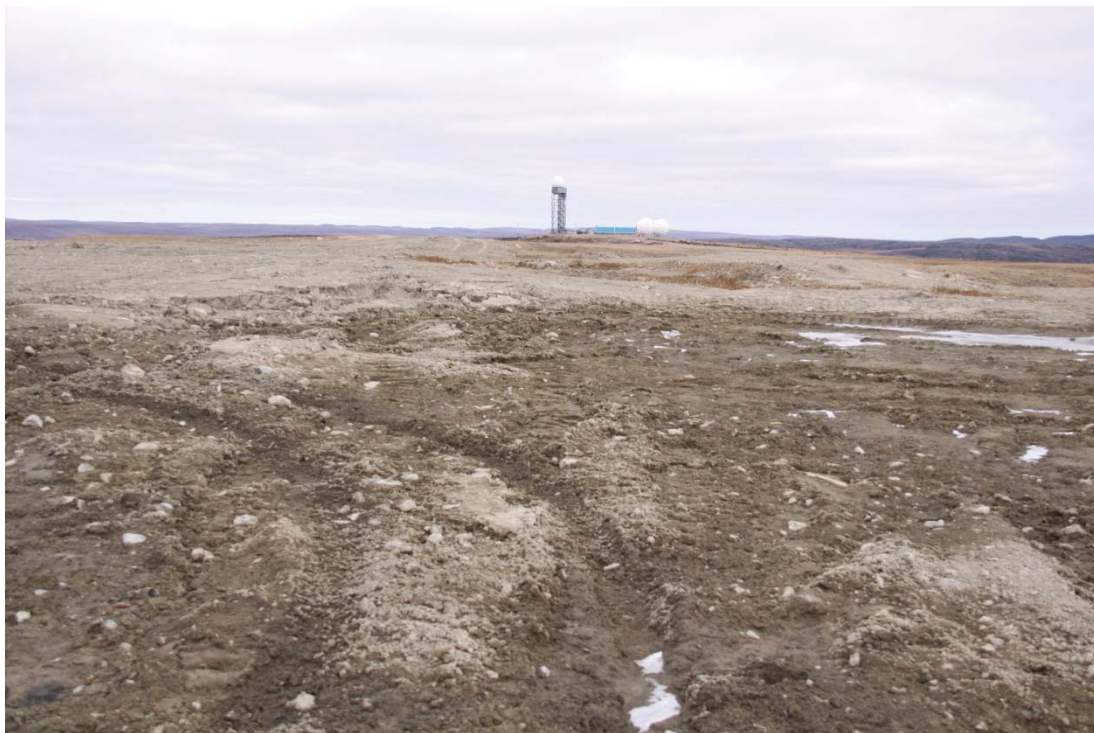
**Photograph 10.** After: Excavation complete; reshaped to match surrounding terrain. ↑
