CAM-D Simpson Lake Long-Term Monitoring Report

Year 13

Project number: 60736036

March 31, 2025

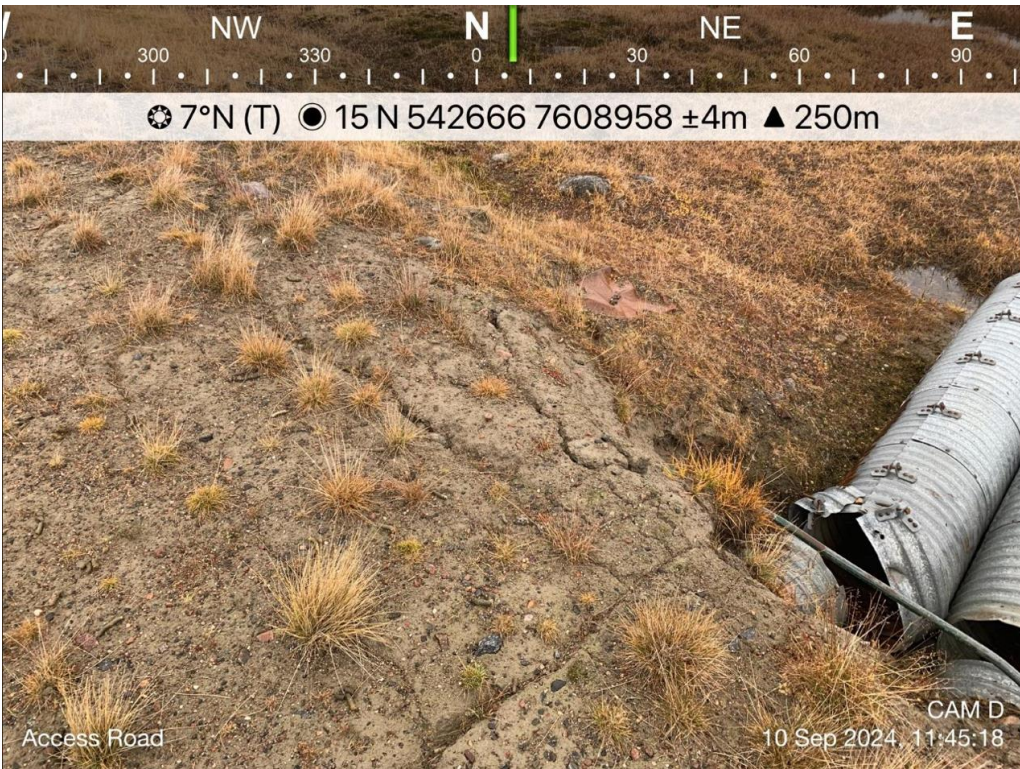
9	9/10/2024	
Direction Photo Taken		
North		
Area		
Access Road		
Description		
Close up of cracking and slumping on east portion of culvert settlement.		
Numerous tufts of vegetation.

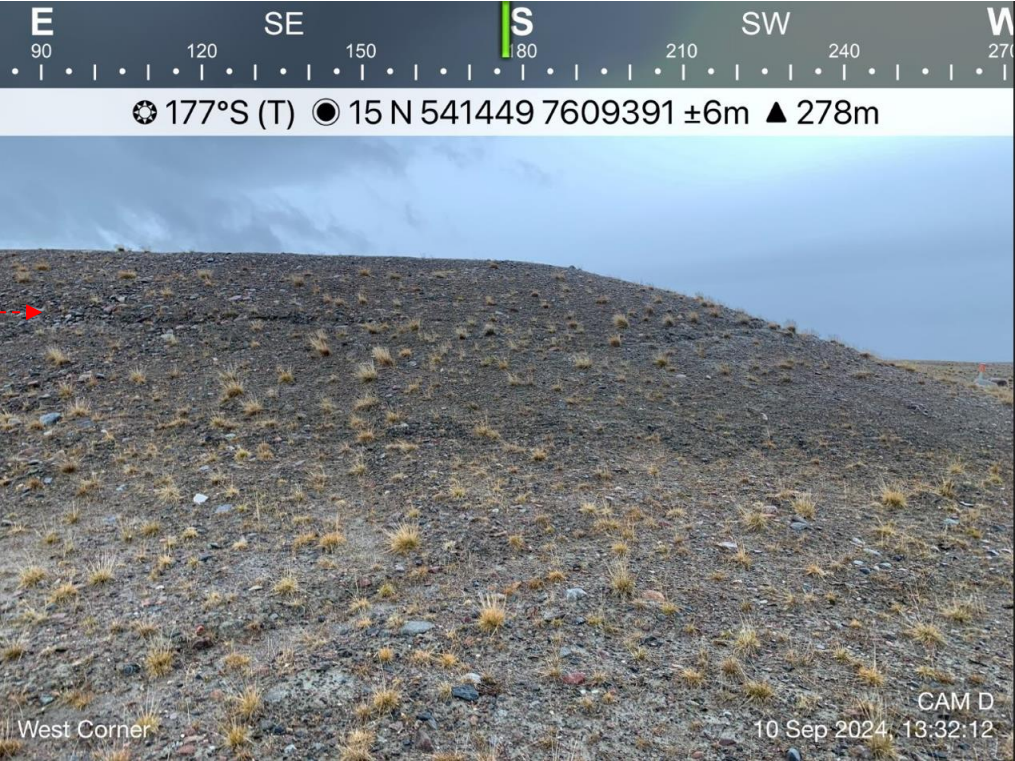
Photo No. 49	Date 9/10/2024

Direction Photo Taken S		
Area NHWL		
Description South portion of northwest slope approaching west corner.		
<p>Tension cracks visible traversing from the northwest slope and around the west corner (dashed arrow).</p> <p>Numerous tufts of vegetation.</p>

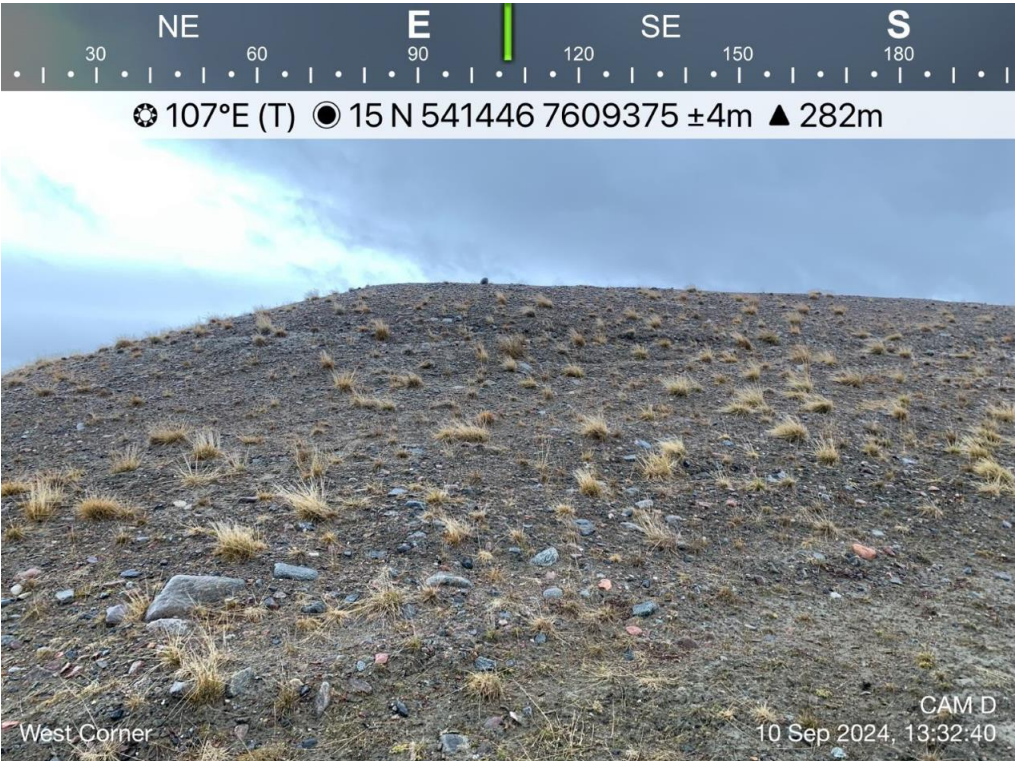
Photo No. 50	Date 9/10/2024

Direction Photo Taken E		
Area NHWL		
Description North portion of southwest slope, west corner to the left.		
<p>Some boulders exposed at the toe of the west corner.</p>

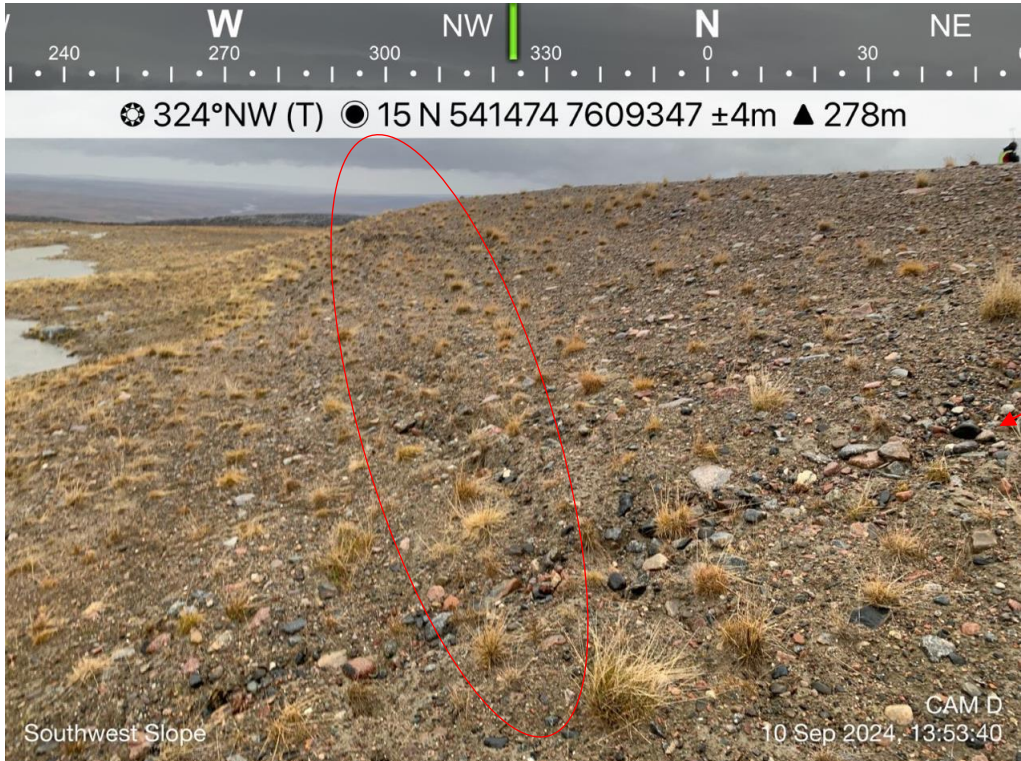
61	9/10/2024	
Direction Photo Taken		
NW		
Area		
NHWL		
Description		
Cross view of erosion channel down southwest slope (arrow).		
Washout of fines observed within the erosion channel.		
Horizontal tension cracks intersecting erosion channel (circled).

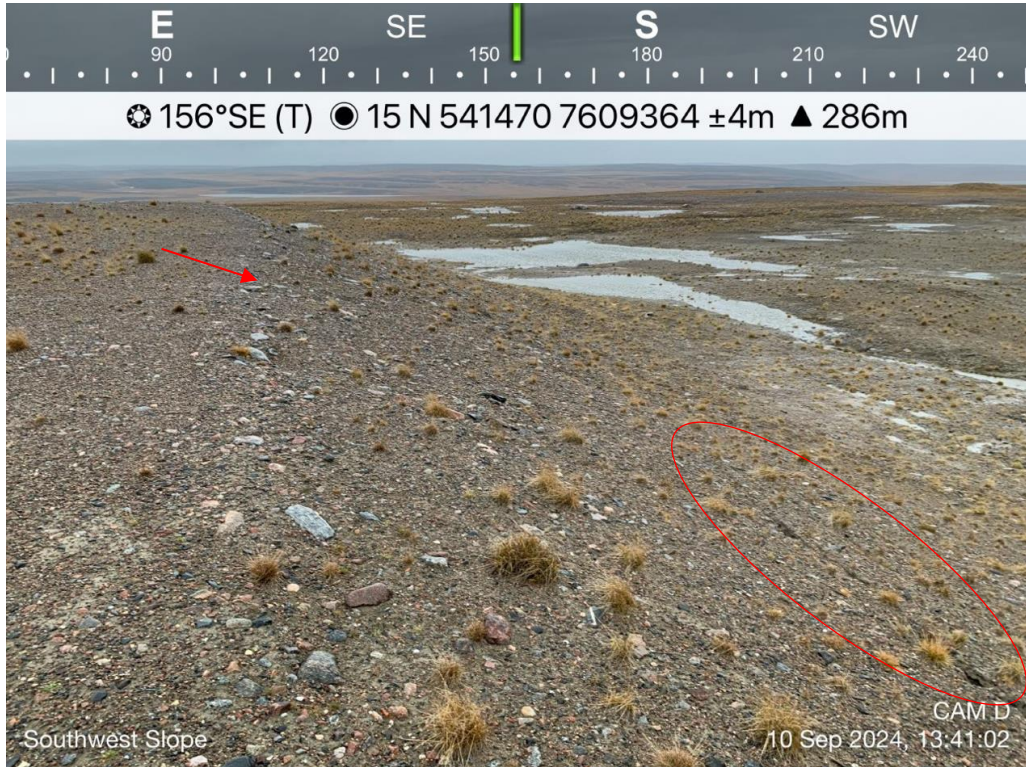
62	9/10/2024	
Direction Photo Taken	S	
Area	NHWL	
Description	<p>Top of landfill looking down southwest slope.</p> <p>Erosion channel (arrow).</p> <p>Tension crack (circled).</p> <p>Ponding water at base of slope and toward south corner.</p>

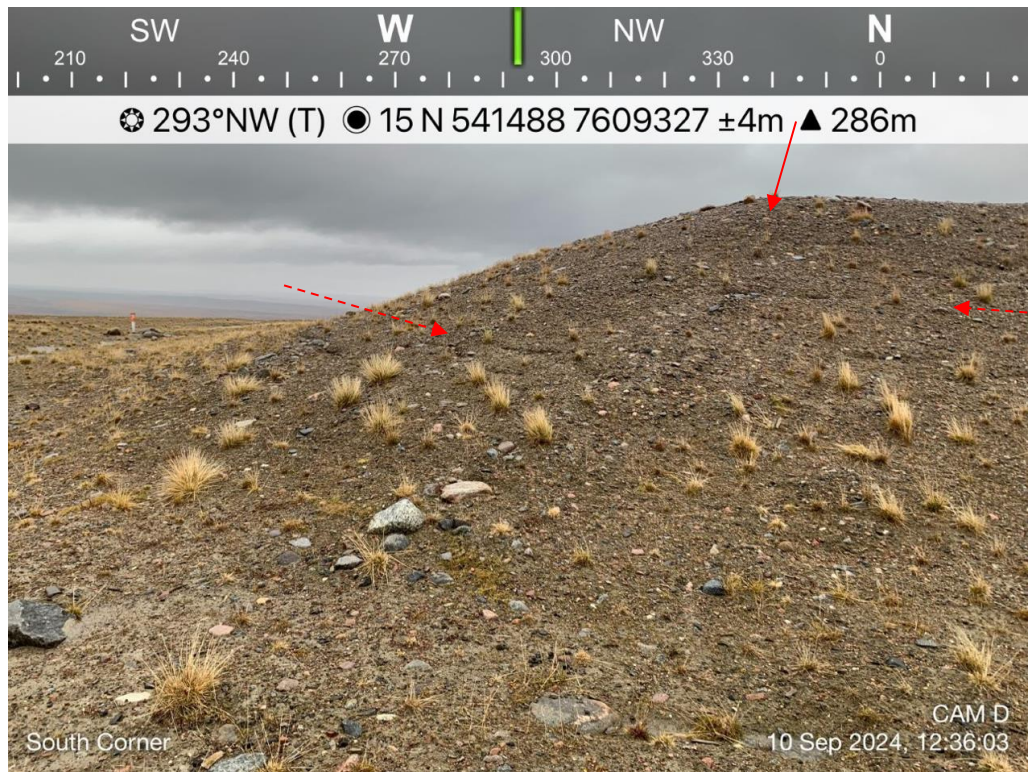
Photo No. 66	Date 9/10/2024

Direction Photo Taken N-NW		
Area NHWL		
Description Looking up south corner of NHWL. Various horizontal tension cracks (dashed arrows) and a vertical erosion channel down corner (solid arrow). Occasional tufts of vegetation. MW04 to the left. Note: compass header error, direction is N-NW.

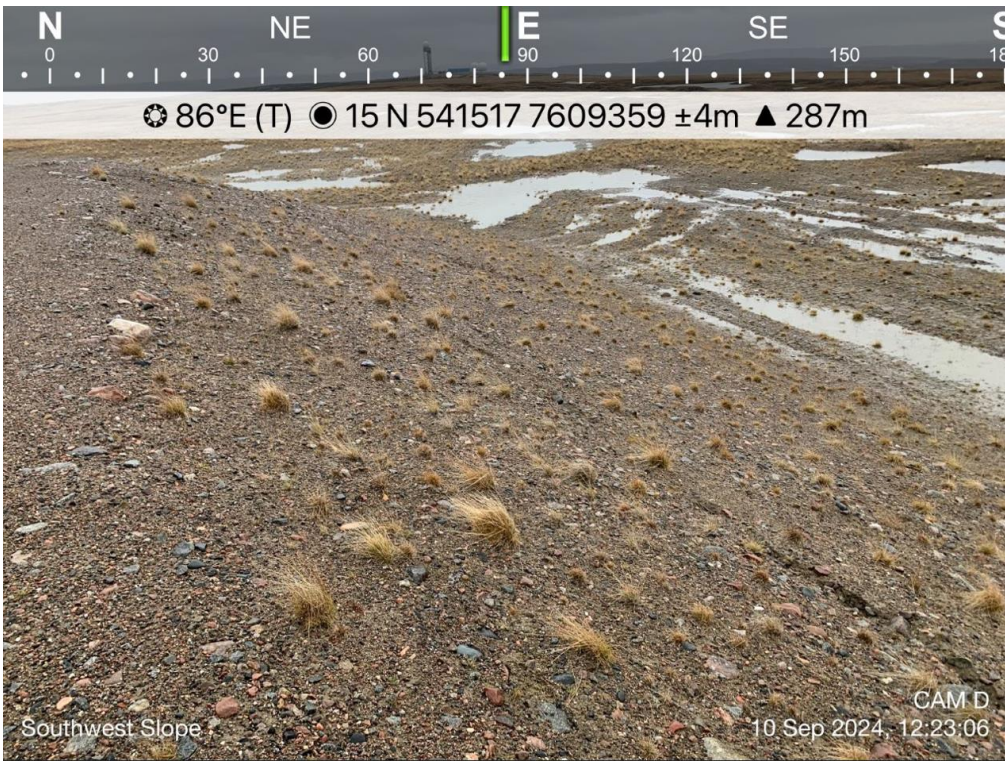
75	9/10/2024	
Direction Photo Taken		
E		
Area		
NHWL		
Description		
Looking down north portion of southeast slope. East corner of landfill at the top.		
Tension cracks located approx. 4 to 5 m from the crest of the slope.		
Ponded water and drainage channels parallel to base of landfill.

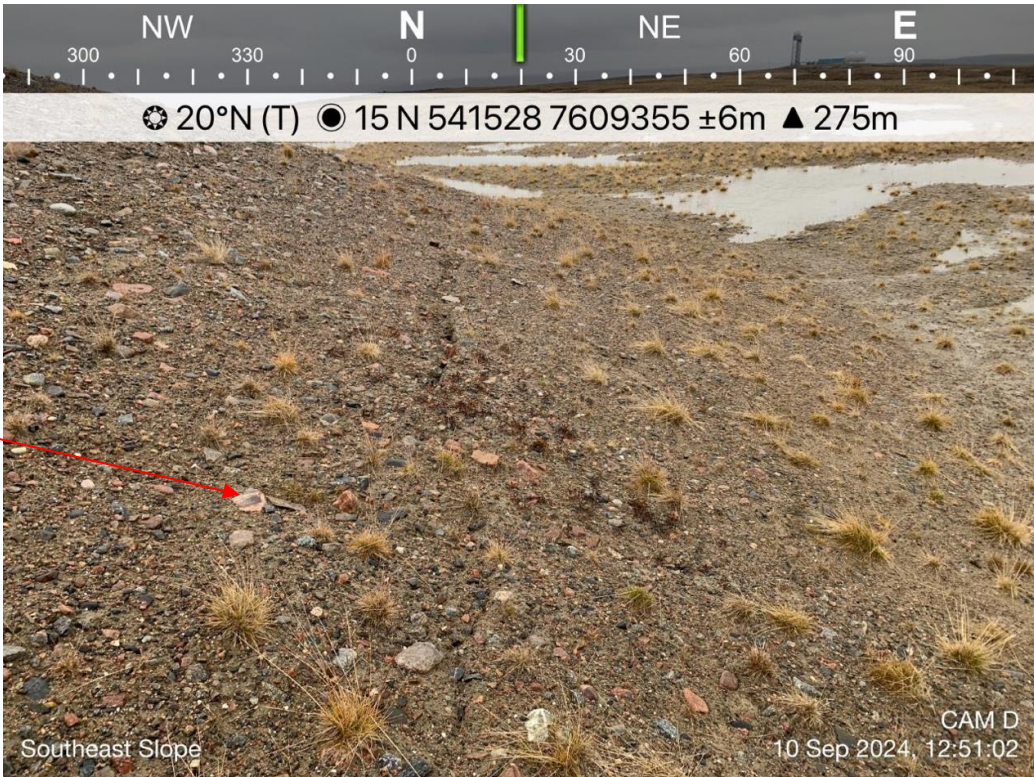
77	9/10/2024	
Direction Photo Taken		
N-NE		
Area		
NHWL		
Description		
Looking along southeast slope toward east corner of landfill (top).		
Tension cracks located approx. 4 to 5 m from the crest of the slope.		
Erosion channel (arrow) intersecting tension crack.		
Numerous tufts of vegetation.		
Ponded water at base of landfill.

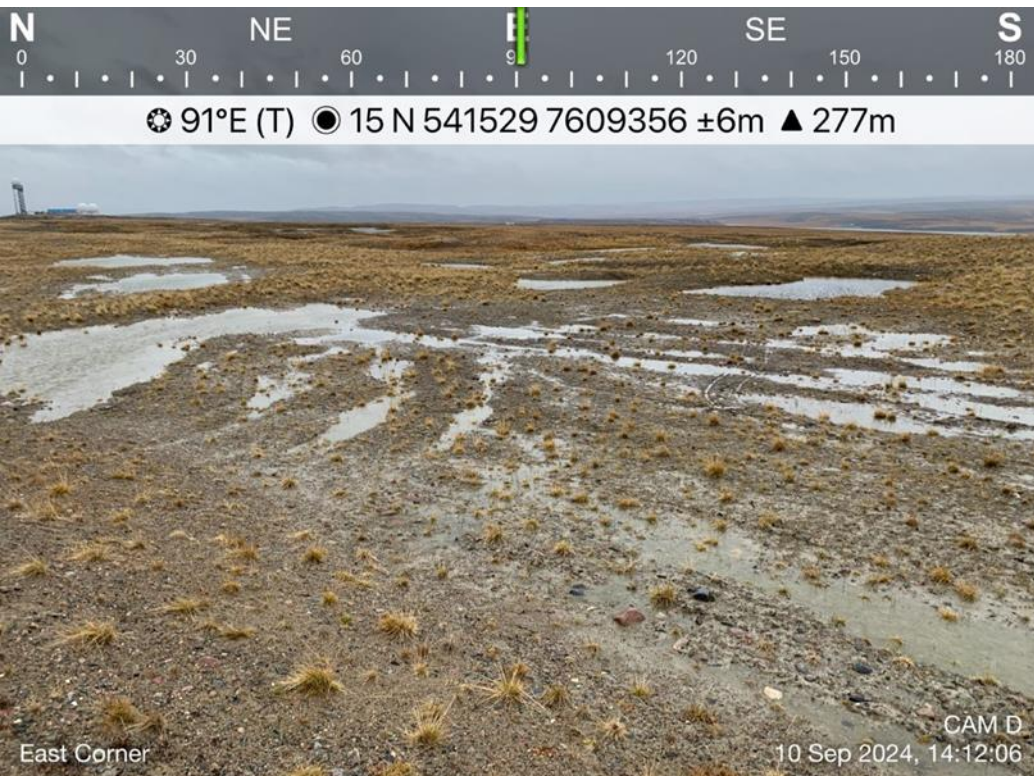
78	9/10/2024	
Direction Photo Taken		
E		
Area		
NHWL		
Description		
Ponding water and flow channels off east portion of southeast slope approaching east corner (left).		
Flow channels both parallel to slope and perpendicular off corner, converging at larger pond.		
Short Range Radar station in background (top left).

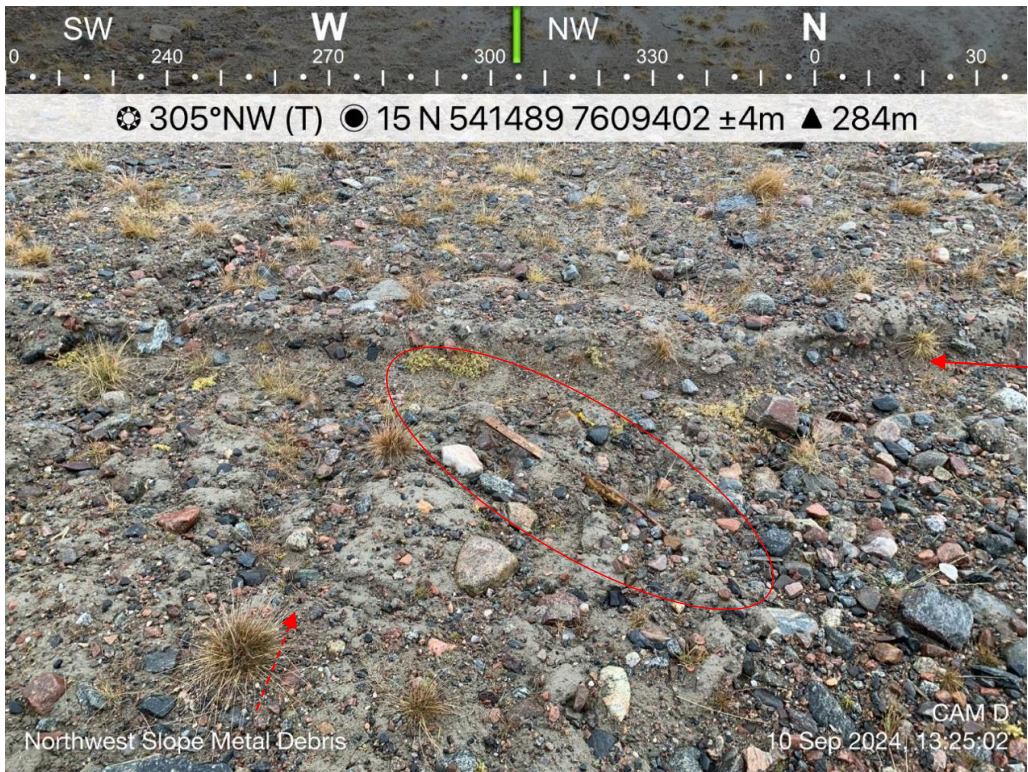
95	9/10/2024	
Direction Photo Taken		
N/A		
Area		
NHWL		
Description		
Exposed metal debris (circled) mid northwest slope near tension crack (solid arrow) and erosion channel (dashed arrow).

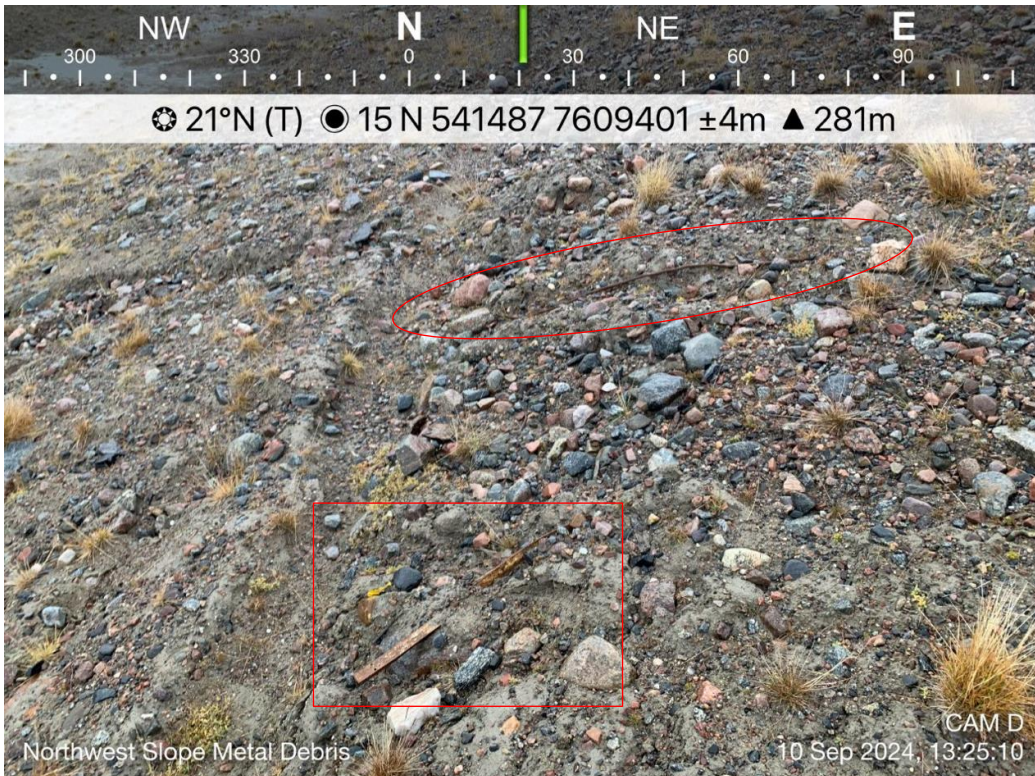
96	9/10/2024	
Direction Photo Taken	N/A	
Area	NHWL	
Description	Exposed metal debris from Photo 94 (circled) and Photo 95 (boxed) on northwest slope, previously observed.

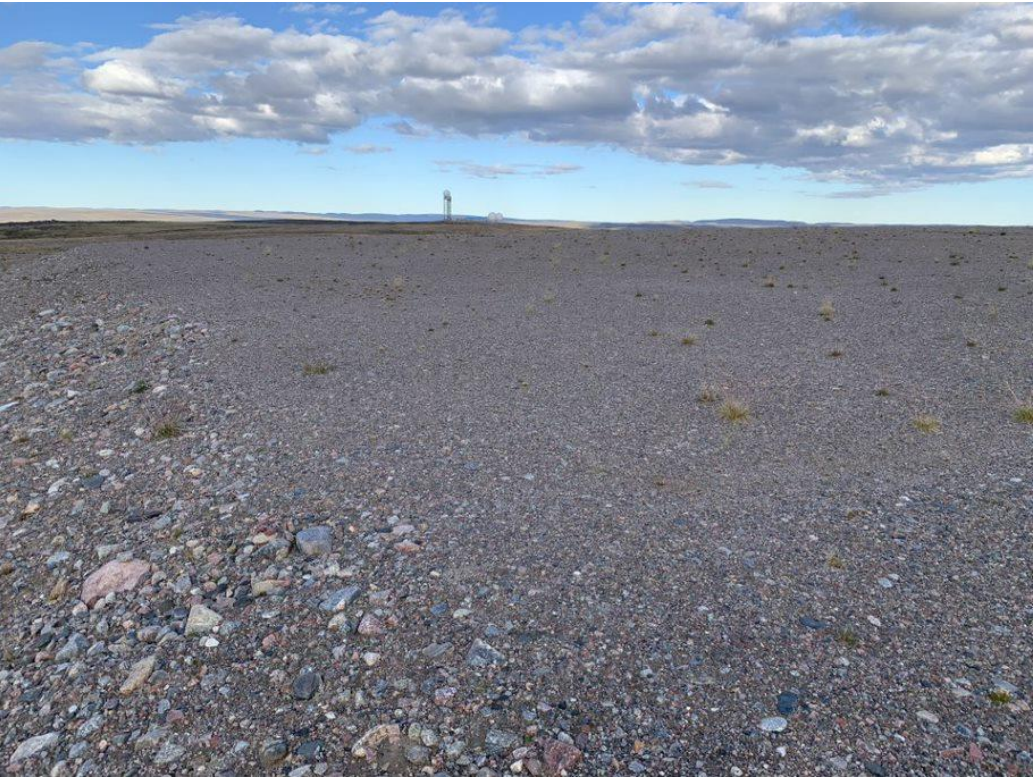
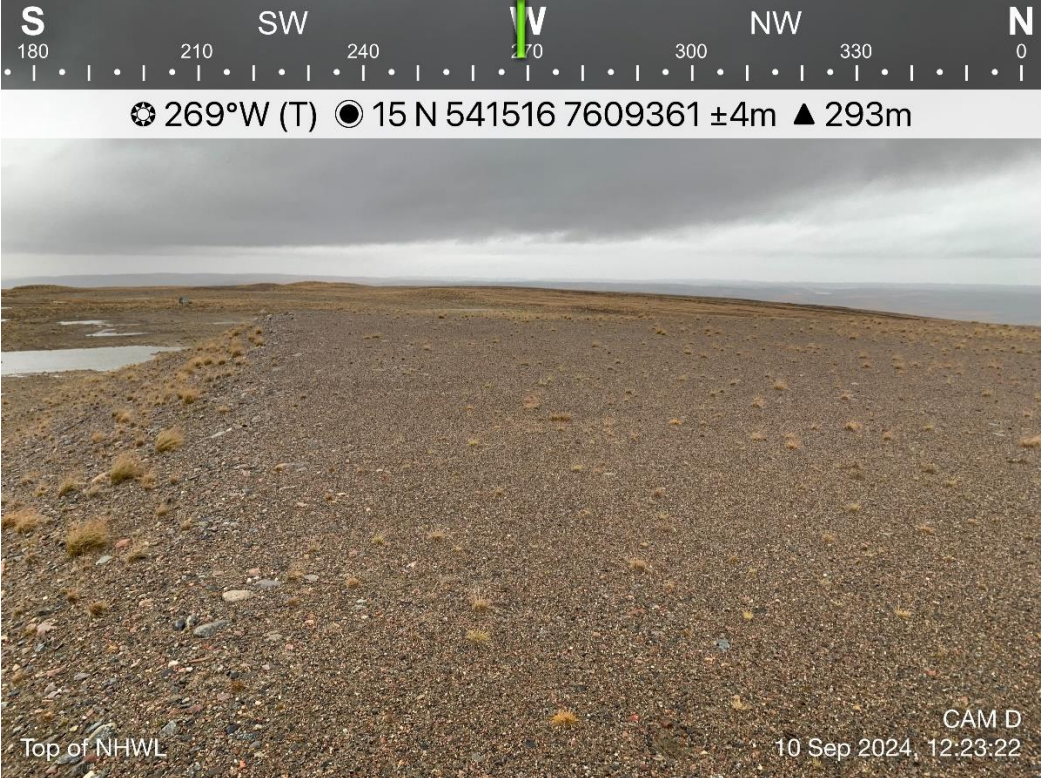
Comparison No. 1	Previous Condition	Date 8/6/2022	Current Condition	Date 9/10/2024
		Direction Photo Taken West		Direction Photo Taken (see photo header)
Description Top of NHWL. Slight increase in vegetation across landfill cover. Surface still in good condition. Relatively flat, no significant undulations.

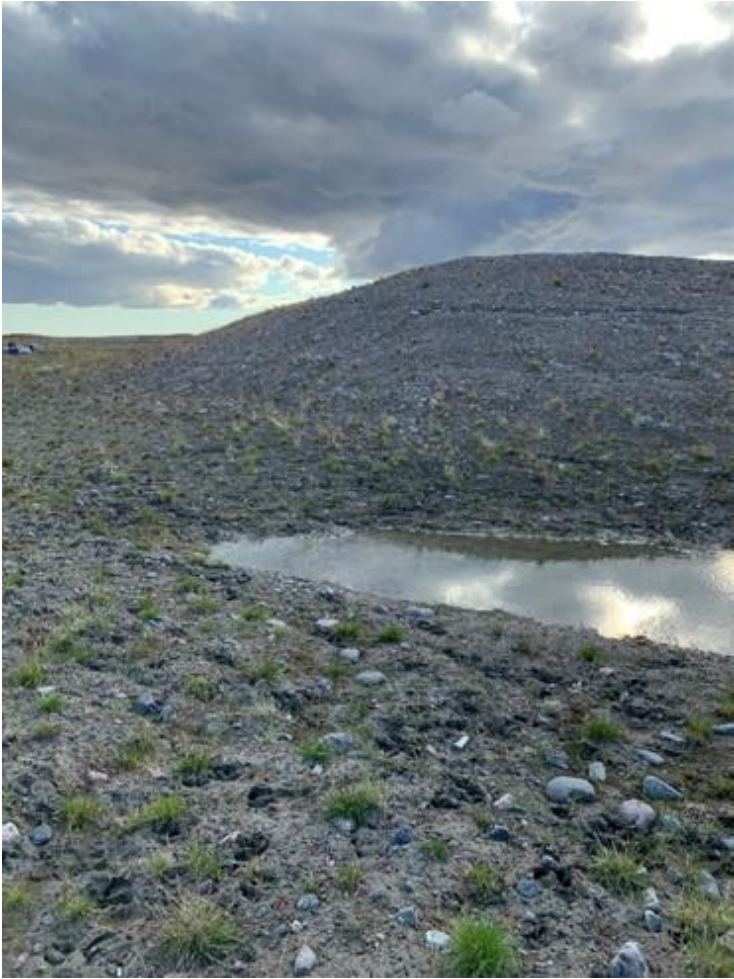
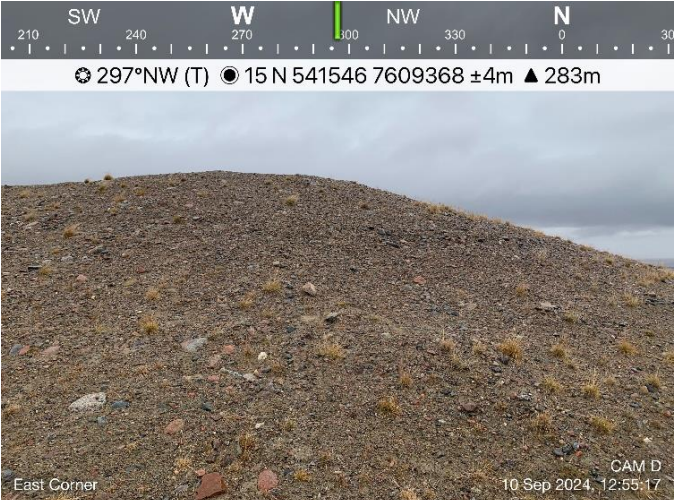
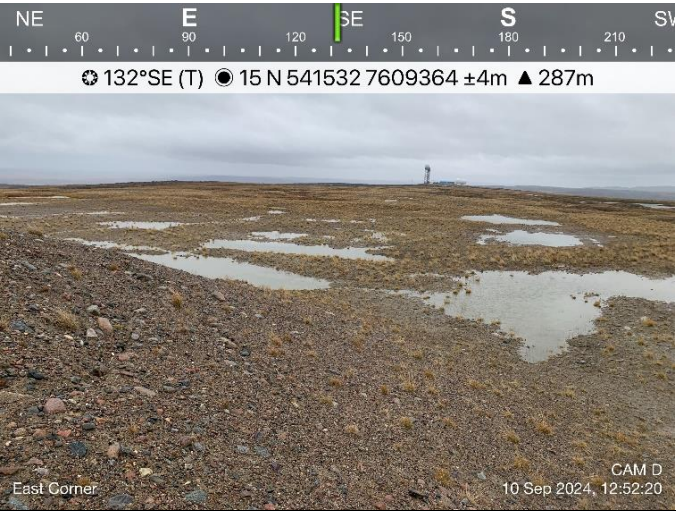
Comparison No. 2	Previous Condition	Date 8/6/2022	Current Condition	Date 9/10/2024
		Direction Photo Taken West		Direction Photo Taken (see photo header)
Description East corner of NHWL. Large horizontal settlement crack still present around the east corner. Similar to slightly progressed condition relative to previous visit in 2022. Water continues to pool at base of landfill.

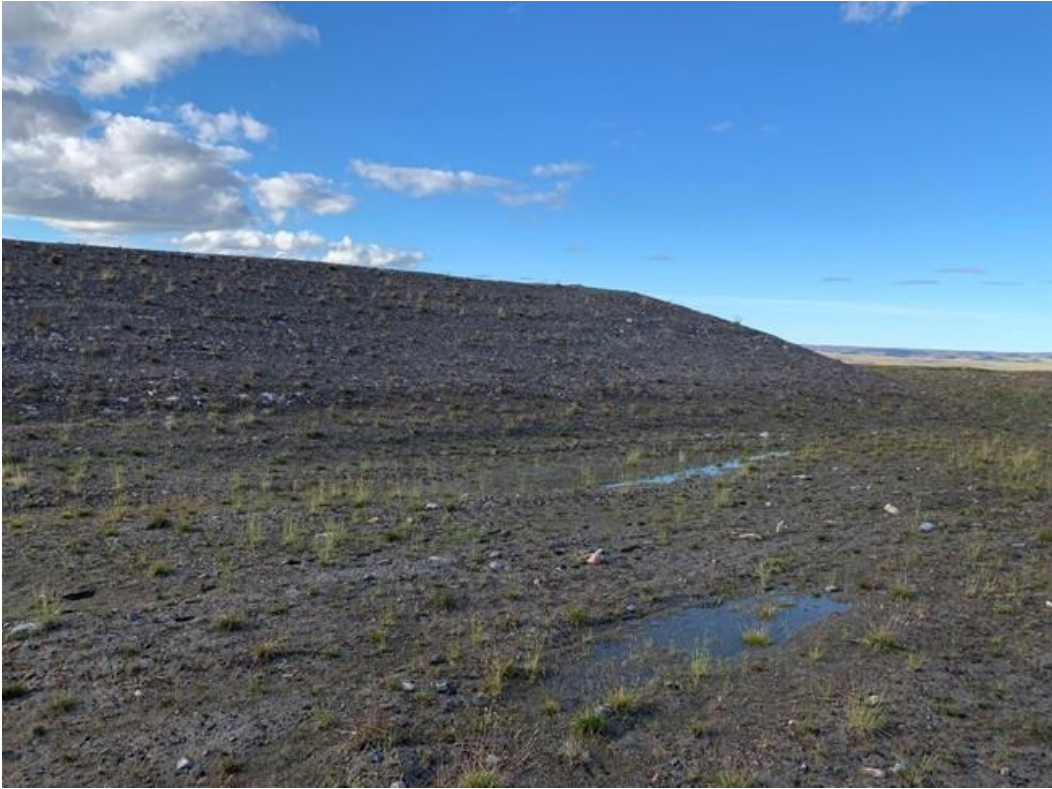
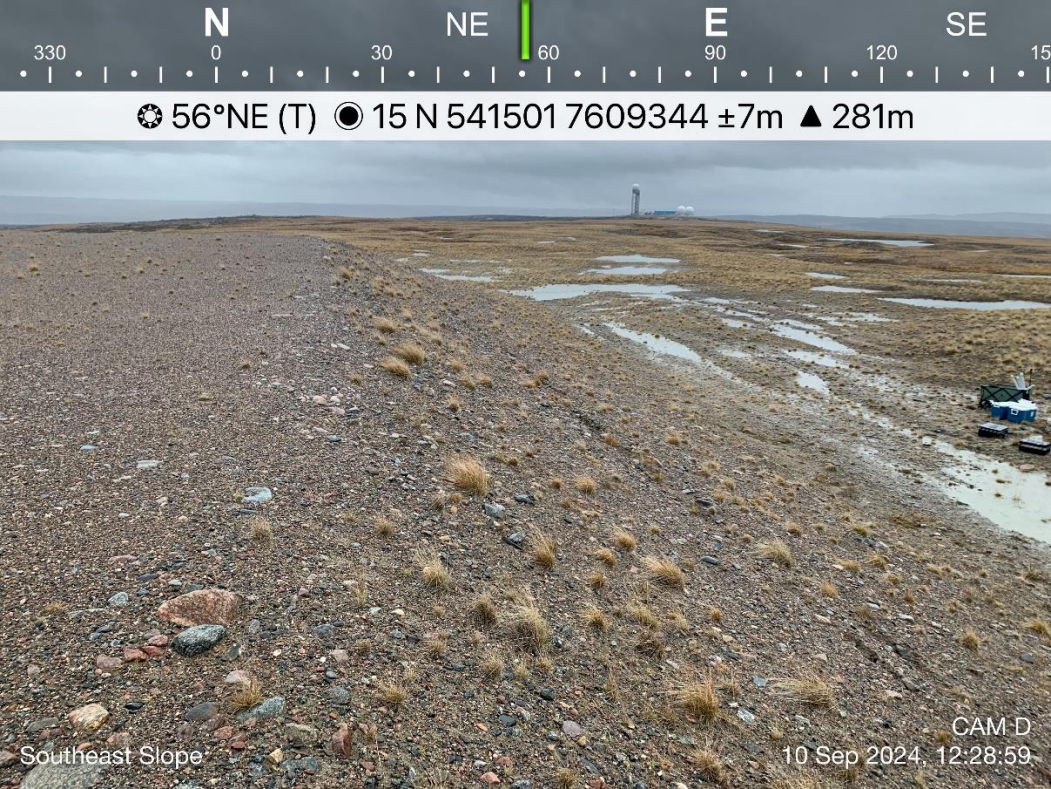
Comparison No. 3	Previous Condition	Date 8/6/2022	Current Condition	Date 9/10/2024
		Direction Photo Taken Northeast		Direction Photo Taken (see photo header)
<p>Description</p> <p>Southeast slope of NHWL.</p> <p>Settlement cracks of varying width present near crest of the southeast slope. Similar to slightly progressed condition relative to 2022 condition.</p> <p>Water continues to pond at base of landfill.</p> <p>Increasing revegetation of slope.</p>

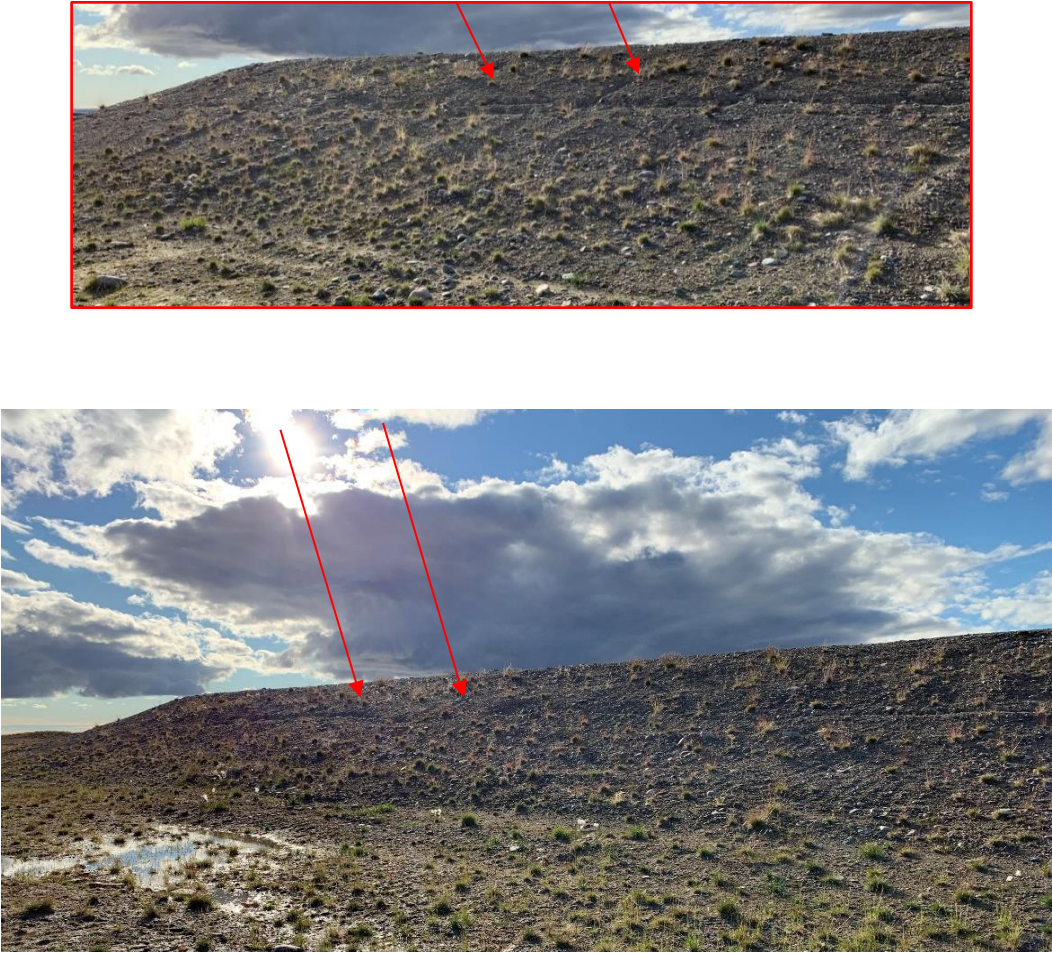
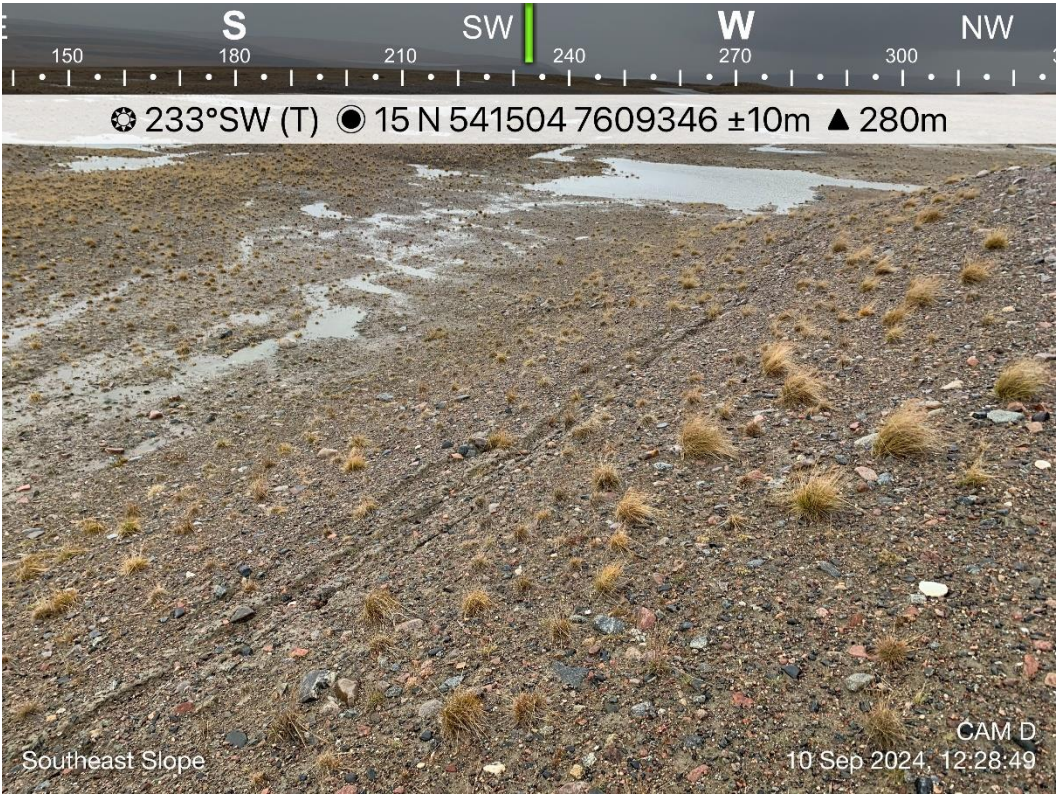
Comparison No. 4	Previous Condition	Date 8/6/2022	Current Condition	Date 9/10/2024
		Direction Photo Taken West		Direction Photo Taken (see photo header)
<p>Description</p> <p>Southeast slope of NHWL.</p> <p>Settlement cracks of varying width present near crest of the southeast slope. Similar to slightly progressed condition relative to 2022 condition.</p> <p>Water continues to pond at base of landfill.</p> <p>Increasing revegetation of slope.</p> <p>Vertical cracks observed in 2022 were not found in 2024 visit. Erosional channels were found in the approximate locations of the 2022 vertical cracks.</p>

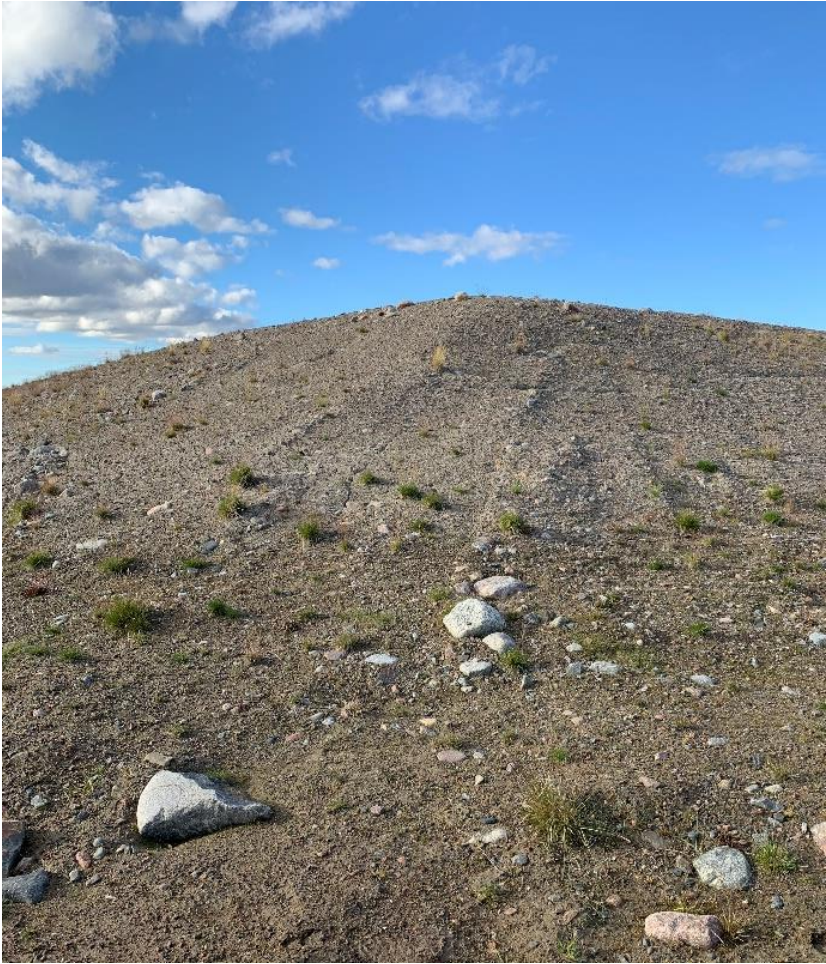
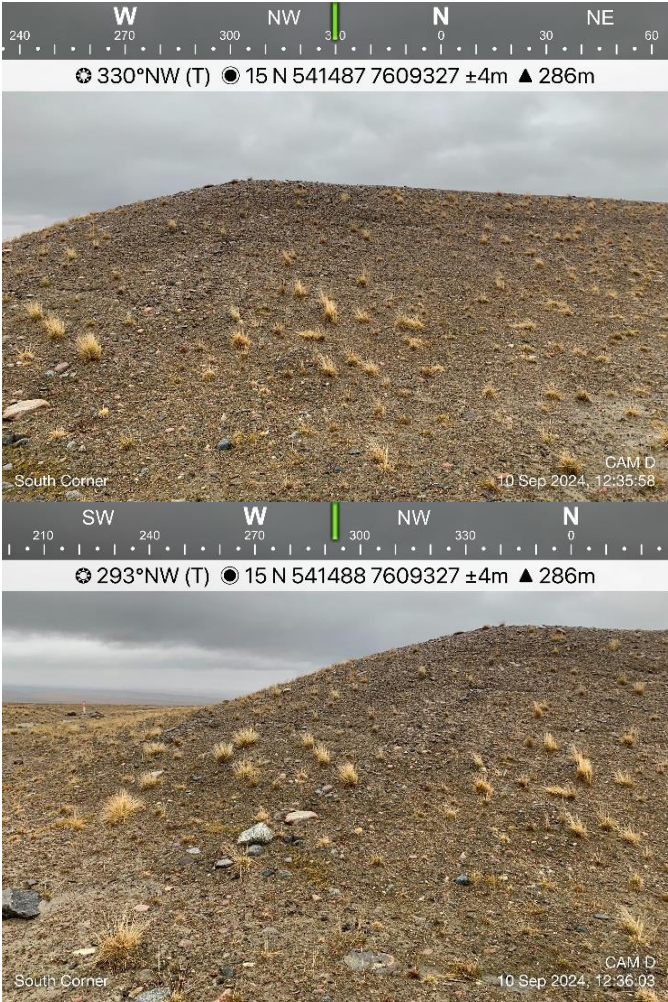
Comparison No. 5	Previous Condition	Date 8/6/2022	Current Condition	Date 9/10/2024
		Direction Photo Taken North		Direction Photo Taken (see photo header)
Description South corner of NHWL. Erosion channel appears to be self-armouring. No significant increase in channel depth observed. Increasing revegetation of slopes. Settlement cracks of varying width present near crest of the south corner.

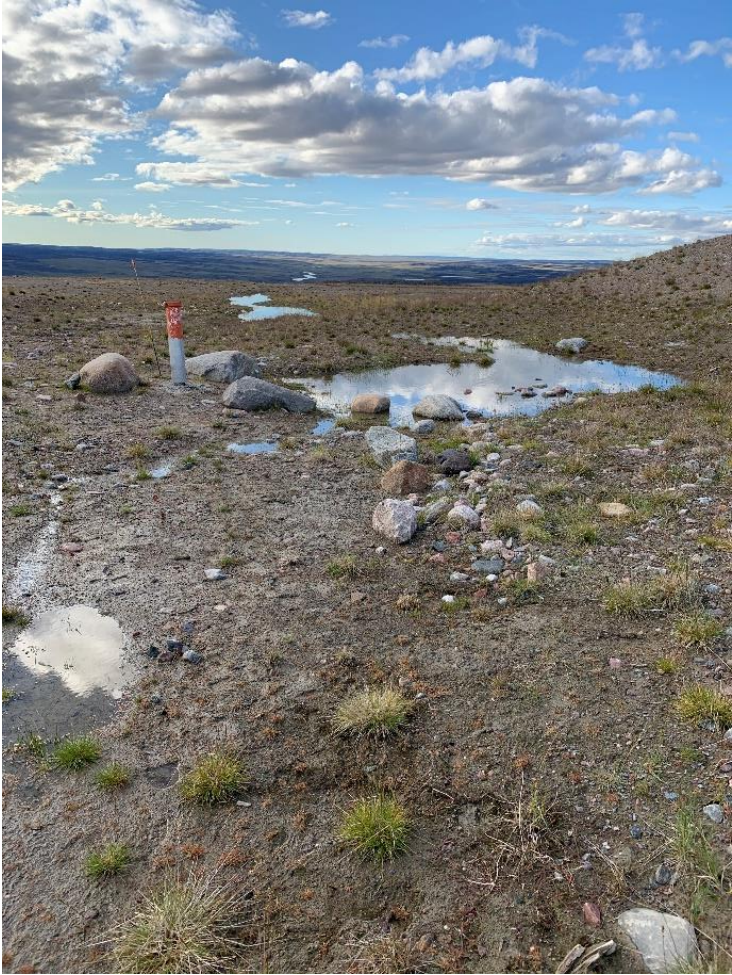
Comparison No. 6	Previous Condition	Date 8/6/2022	Current Condition	Date 9/10/2024
		Direction Photo Taken Northwest		Direction Photo Taken (see photo header)
<div>Description</div> <div>MW04 off southwest side of landfill.</div> <div>Water continues to pond at base of landfill and around MW04. Extent of larger ponds has increased.</div> <div>Increased revegetation throughout surrounding area.</div> <div>MW04 casing has heaved and bentonite seal is now exposed at the ground surface.</div>

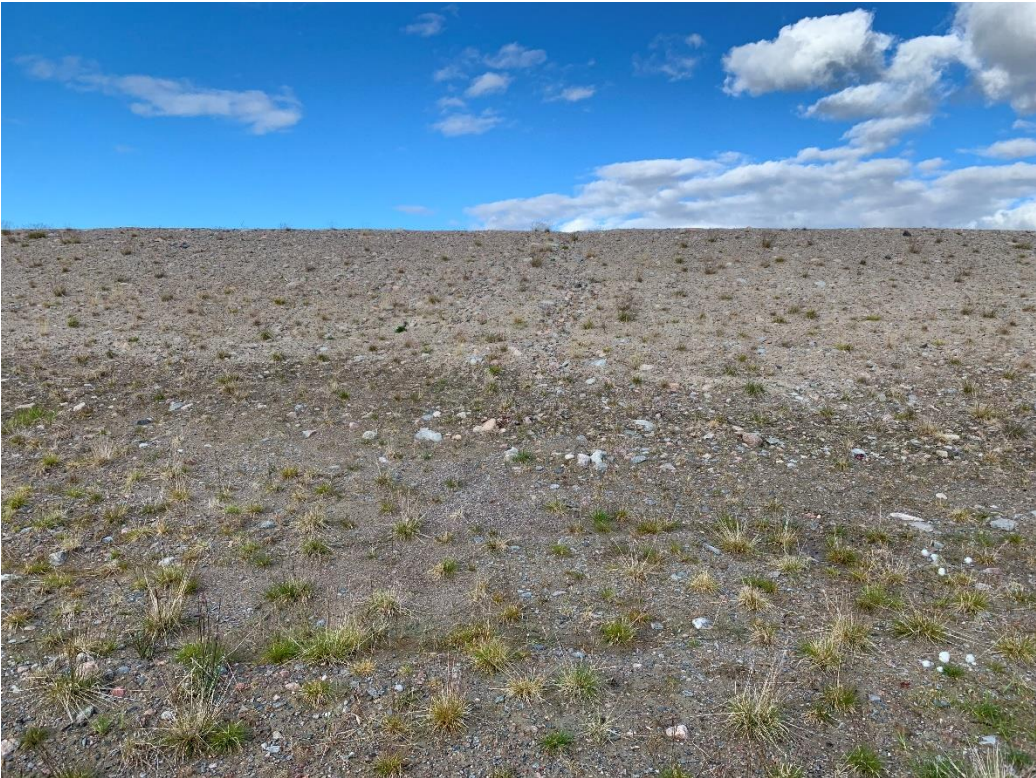
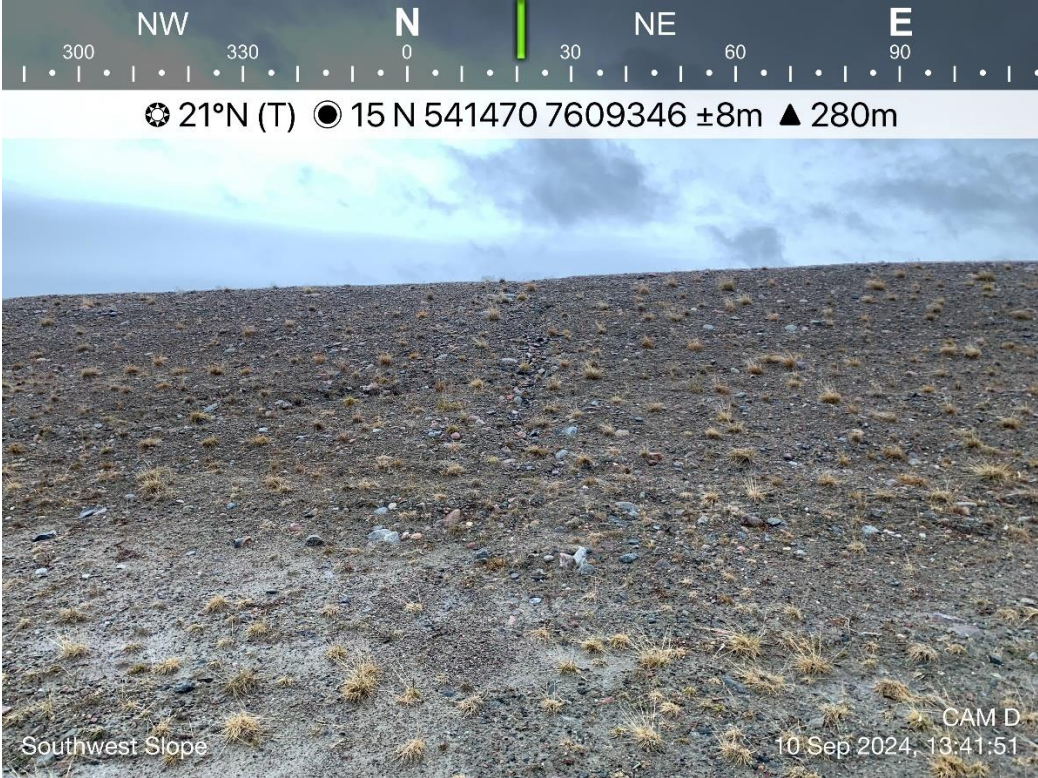
Comparison No. 7	Previous Condition	Date 8/6/2022	Current Condition	Date 9/10/2024
		Direction Photo Taken Northeast		Direction Photo Taken (see photo header)
<p>Description</p> <p>Southwest slope of landfill.</p> <p>Erosion channel appears to be self-armouring. No significant increase in channel depth was observed.</p> <p>Increasing revegetation of slope.</p>

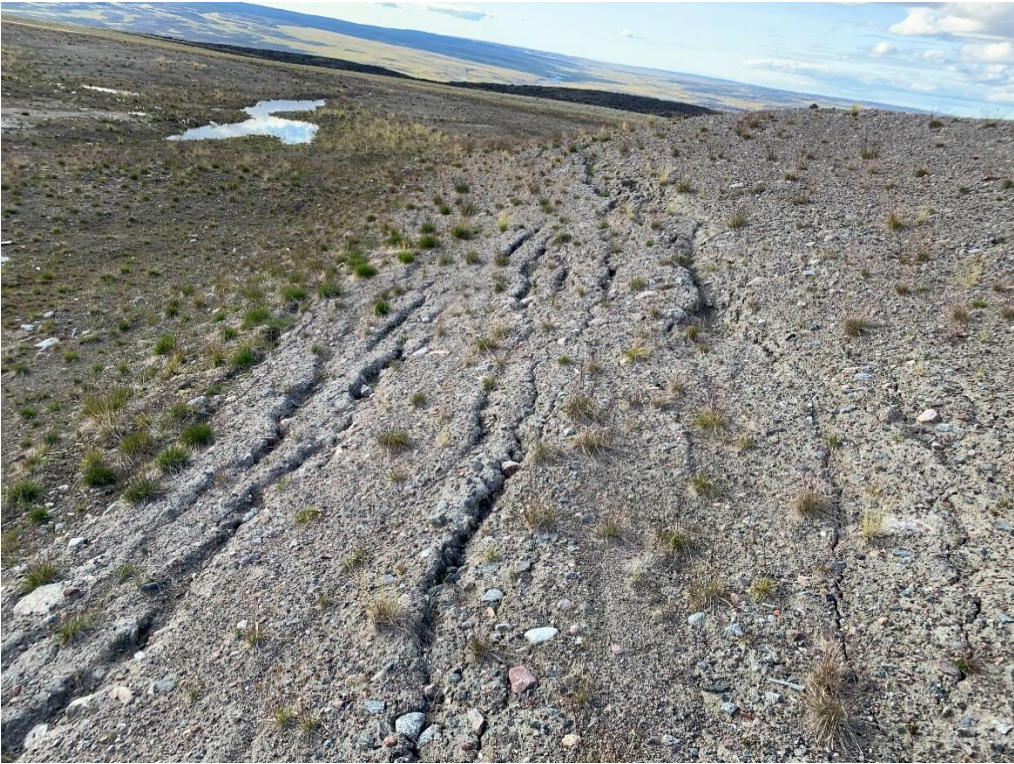
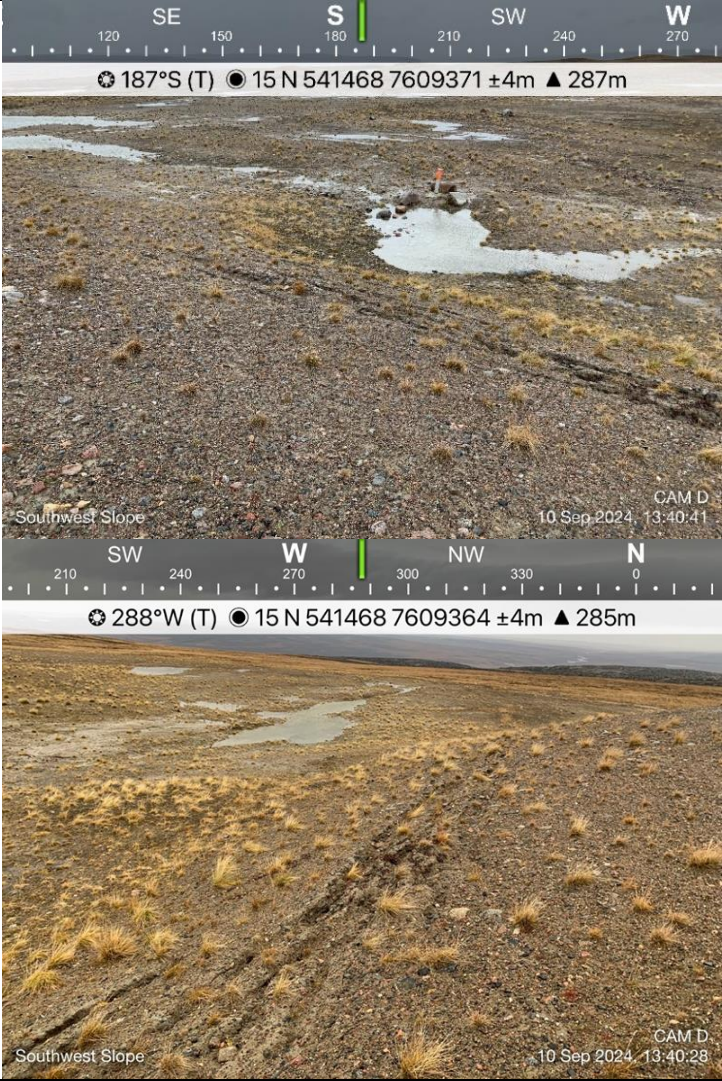
Comparison No. 8	Previous Condition	Date 8/6/2022	Current Condition	Date 9/10/2024
		Direction Photo Taken Northwest		Direction Photo Taken (see photo header)
<p>Description</p> <p>Southwest slope of landfill.</p> <p>Shallow slough on southwest slope has progressed.</p> <p>Tension cracks appear to be more severe in 2022 compared to the condition observed during 2024. Site conditions in 2022 were relatively dry, compared to the wet, saturated ground conditions encountered in 2024 and suggests the establishment of a wet-dry cycle serving to infill the cracks (see Report Section 5.2.1.1).</p> <p>Slight increase in revegetation of the slope.</p> <p>Water continues to pond at base of landfill.</p>
