CAM-D Simpson Lake Long-Term Monitoring Report

Year 13

Project number: 60736036

March 31, 2025

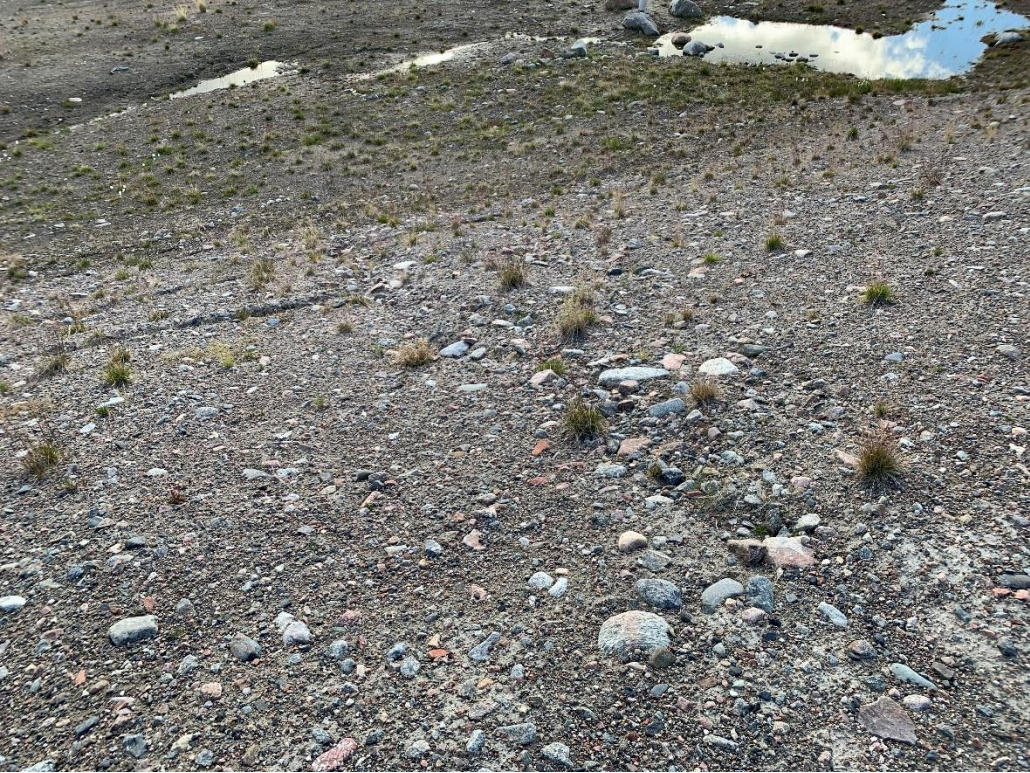
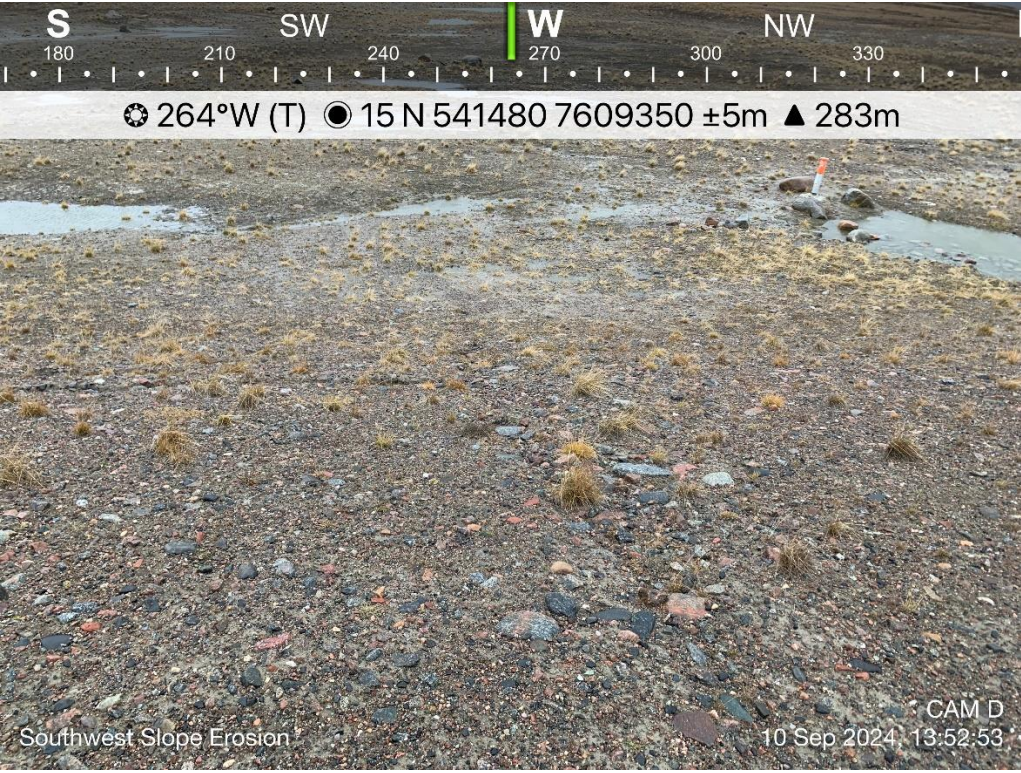
Comparison No. 9	Previous Condition	Date 8/6/2022	Current Condition	Date 9/10/2024
		Direction Photo Taken West		Direction Photo Taken (see photo header)
<p>Description</p> <p>Southwest slope near MW04.</p> <p>Erosion channel appears to be self-armouring. No significant increase in channel depth observed.</p> <p>Increasing revegetation of the slope and landfill toe.</p> <p>Water continues to pond at base of landfill.</p>

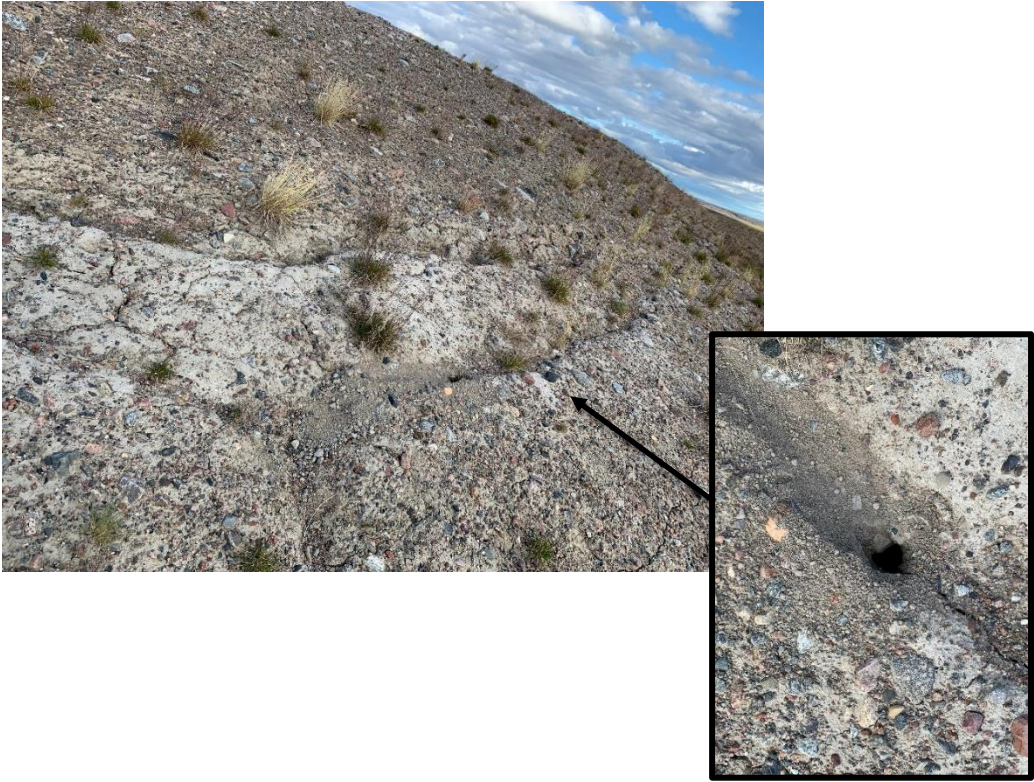
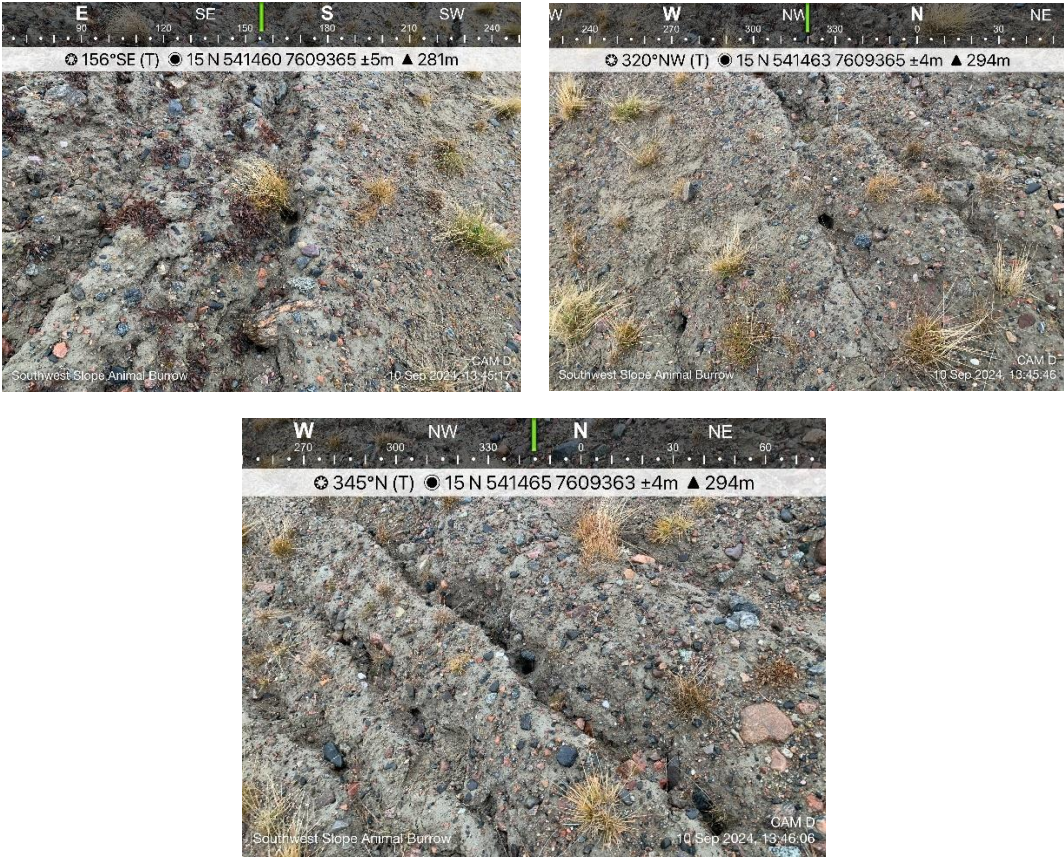
Comparison No. 10	Previous Condition	Date 8/6/2022	Current Condition	Date 9/10/2024
		Direction Photo Taken Southeast		Direction Photo Taken (see photo header)
Description Increase in animal burrows: one (1) animal burrow noted on west landfill corner in 2022, four (4) animal burrows noted on southwest slope in 2024.

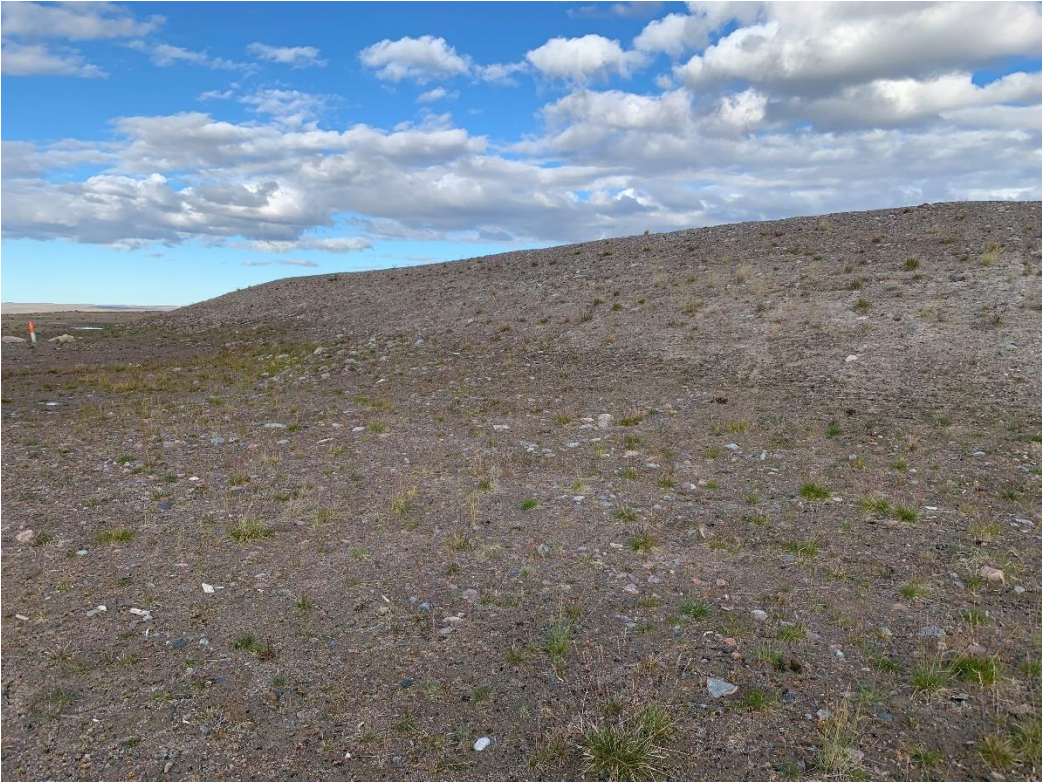
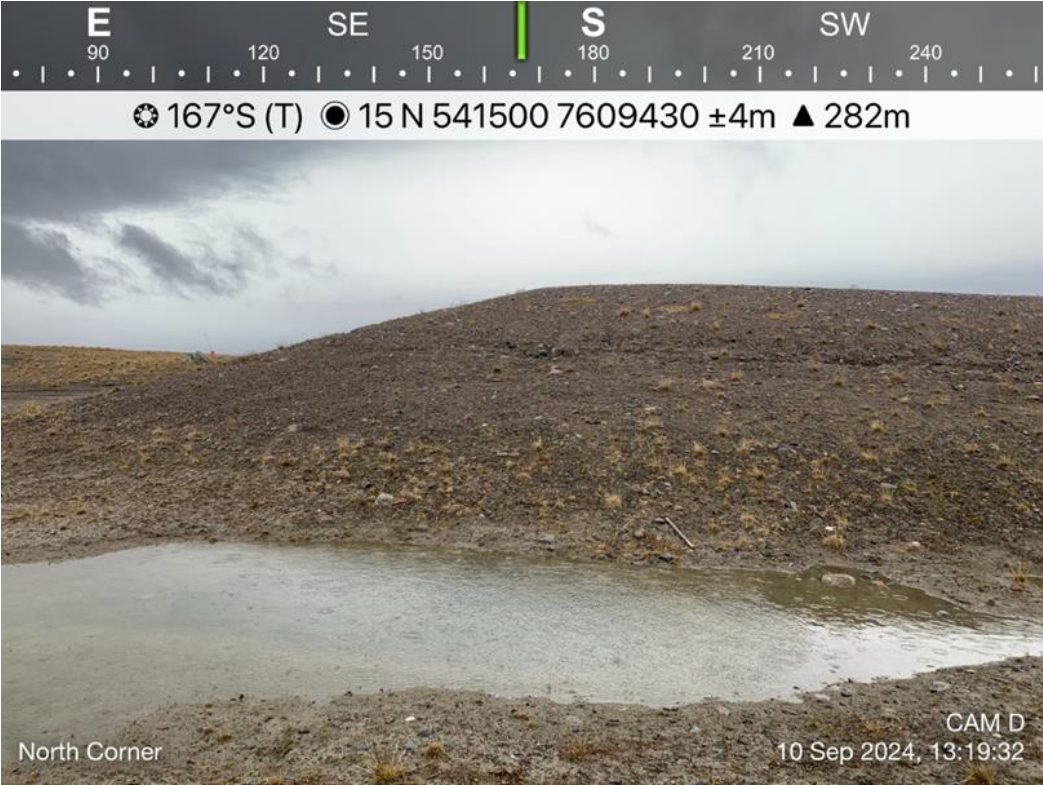
Comparison No. 11	Previous Condition	Date 8/6/2022	Current Condition	Date 9/10/2024
		Direction Photo Taken Northeast		Direction Photo Taken (see photo header)
<p>Description</p> <p>Northwest slope of landfill.</p> <p>Erosion channels continue to develop along northwest slope, increasing in size and frequency from 2022.</p> <p>Increase in ponded water at base of landfill.</p> <p>Settlement cracks of varying width present near crest of the northwest slope.</p>

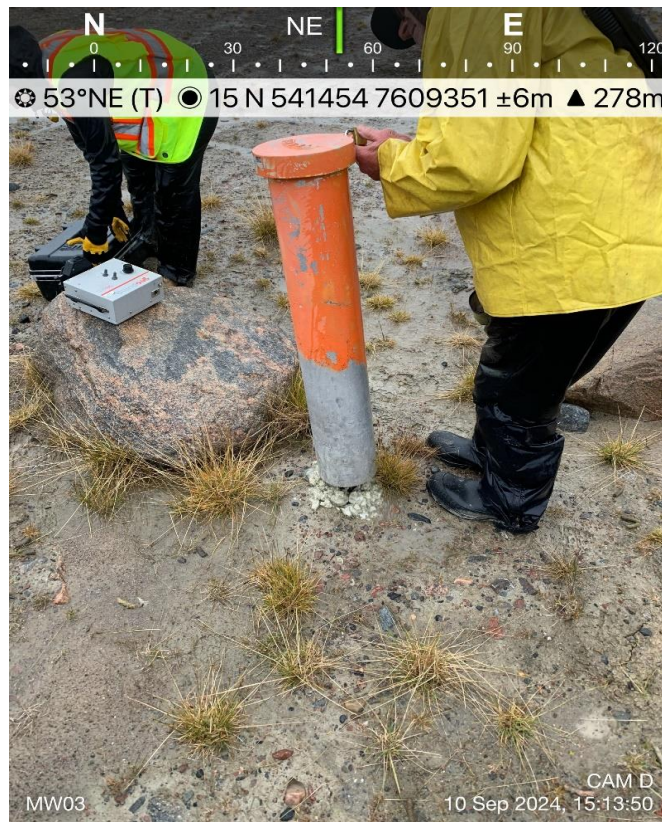
Photograph 2: Heaving at MW#3, exposed bentonite at base, casing on angle.

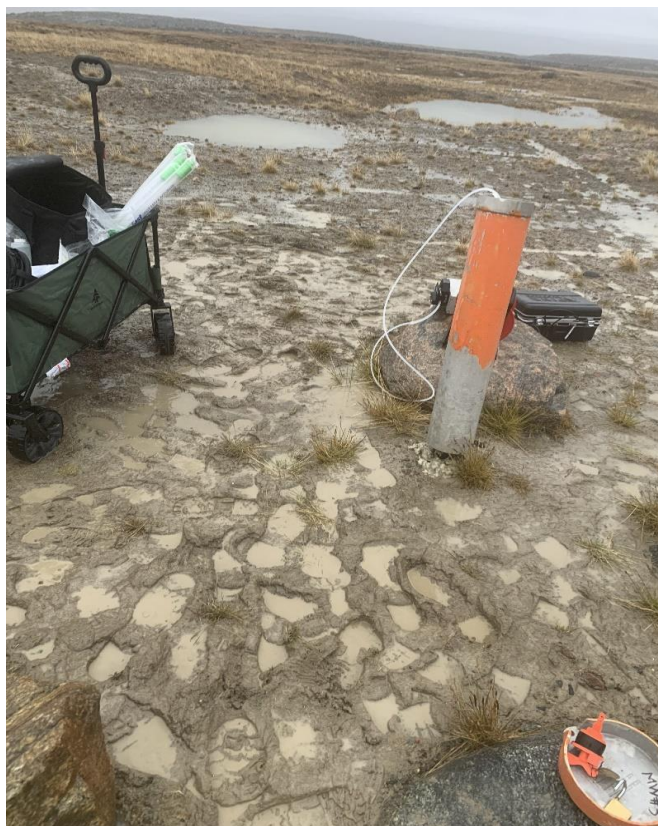
Photograph 5: Ground very soft and muddy, field team sunk deeper as work continued around MW#3, boots often stuck.
