WATER LICENCE INSPECTION FORM

Licensee		Licensee Representative	
Oikiqtaaluk Environmental Inc.		Olivier Simard	
Licence No. / Expiry		Representative's Title	
1BR-THI1722		Project Manager	
Land / Other Authorizations		Land / Other Authorizations	
Date of Inspection		Inspector	
June 4, 2018		Jonathan Mesher	
Activities Inspected			
<input type="checkbox"/> Camp	<input type="checkbox"/> Drilling	<input type="checkbox"/> Mining	<input type="checkbox"/> Construction
<input type="checkbox"/> Roads/Hauling	<input checked="" type="checkbox"/> Other: Land Farm	<input type="checkbox"/> Reclamation	<input type="checkbox"/> Fuel Storage
<input type="checkbox"/> Other:

A water licence inspection was conducted on June 4, 2018 by Jonathan Mesher and Joseph Monteith Water Resource Officers of CIRNAC, The purpose of this inspection was to ensure compliance with the terms and conditions of the Water Licence 1BR-THI1722.

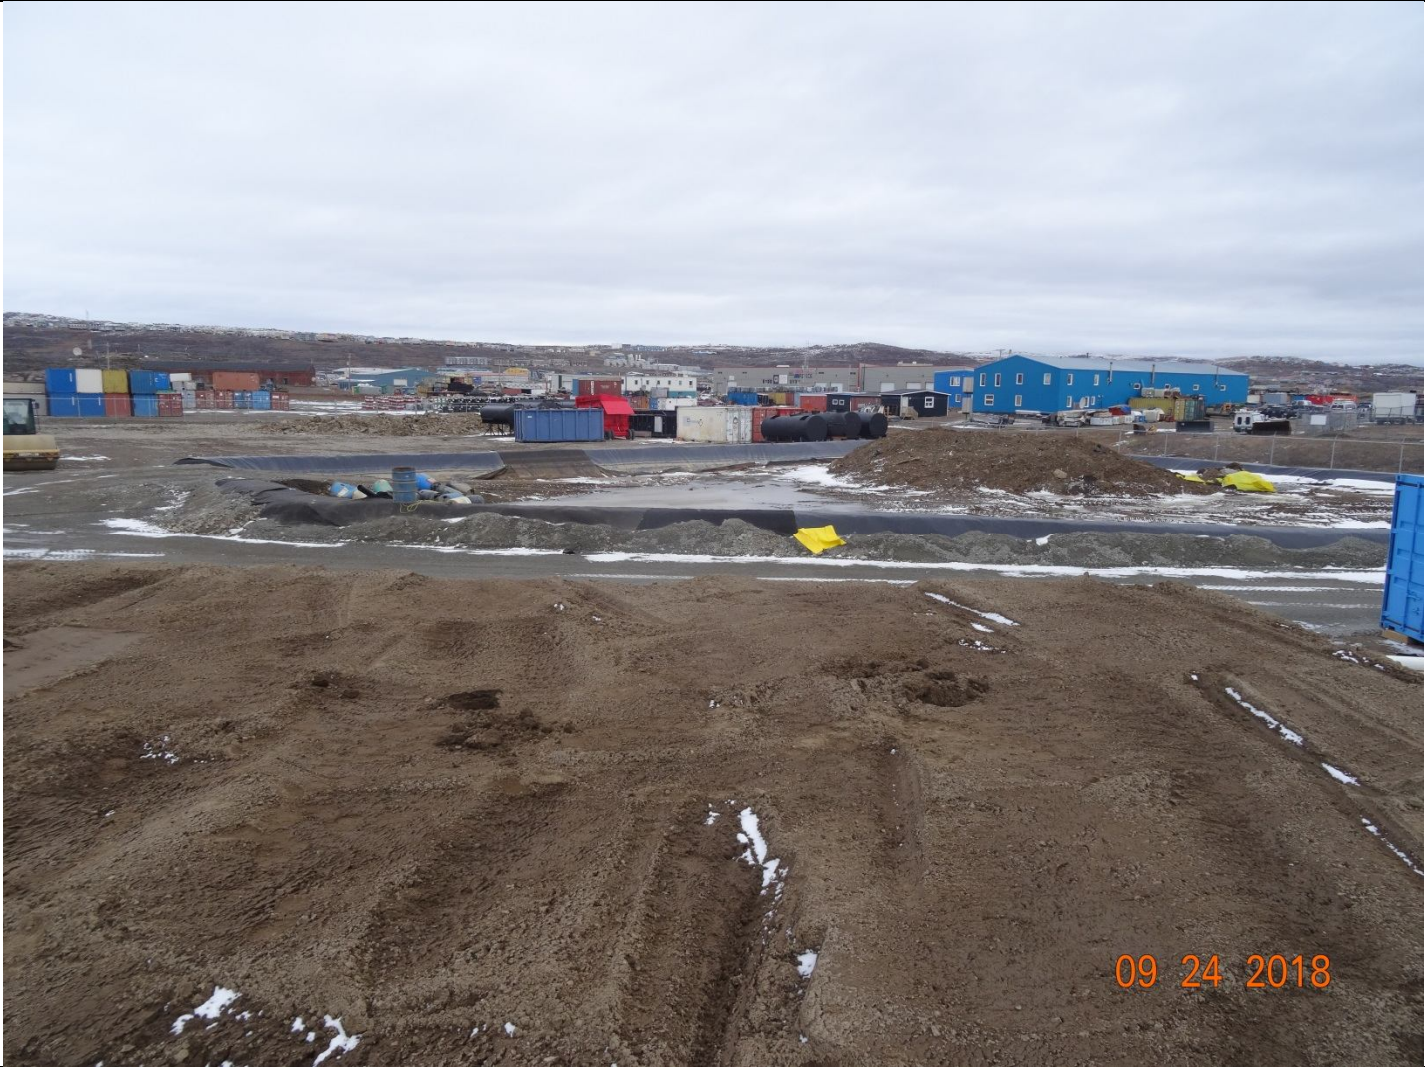
Photo 3

II. Constructed another containment area to deal with the over topping of the initial containment area. See photo #2 for the new containment area constructed. It is required that the licensee follows the requirements set out in Part F: Conditions Applying to Modifications while making modifications to Waste Disposal Facilities.

Description: Recently constructed Containment Area

III. The licensee has committed to submitting the appropriate documentation to seek approval for this modification prior to March 31, 2019.
