WATER LICENCE INSPECTION FORM

Licensee	Licensee Representative
Qikiqtaaluk Environmental Inc.	Catalin Cenan
Licence No. / Expiry	Representative's Title
1BR-THI2027	Project Manager
Land / Other Authorizations	Land / Other Authorizations
	--
Date of Inspection	Inspector
6/3/2021	Jonathan MESHER
Activities Inspected	
<input type="checkbox"/> Camp	<input type="checkbox"/> Drilling
<input type="checkbox"/> Roads/Hauling	<input type="checkbox"/> Other:
<input type="checkbox"/> Mining	<input type="checkbox"/> Construction
	<input type="checkbox"/> Other: Land Farm
<input type="checkbox"/> Reclamation	<input type="checkbox"/> Fuel Storage

On Wednesday June 3rd, 2021 I Jonathan Mesher, Crown Indigenous Affairs and Northern Relations Canada Inspector, did perform an inspection of the Water Licence 1BR-THI2027 located in Iqaluit, Nunavut, the below observations were noted.

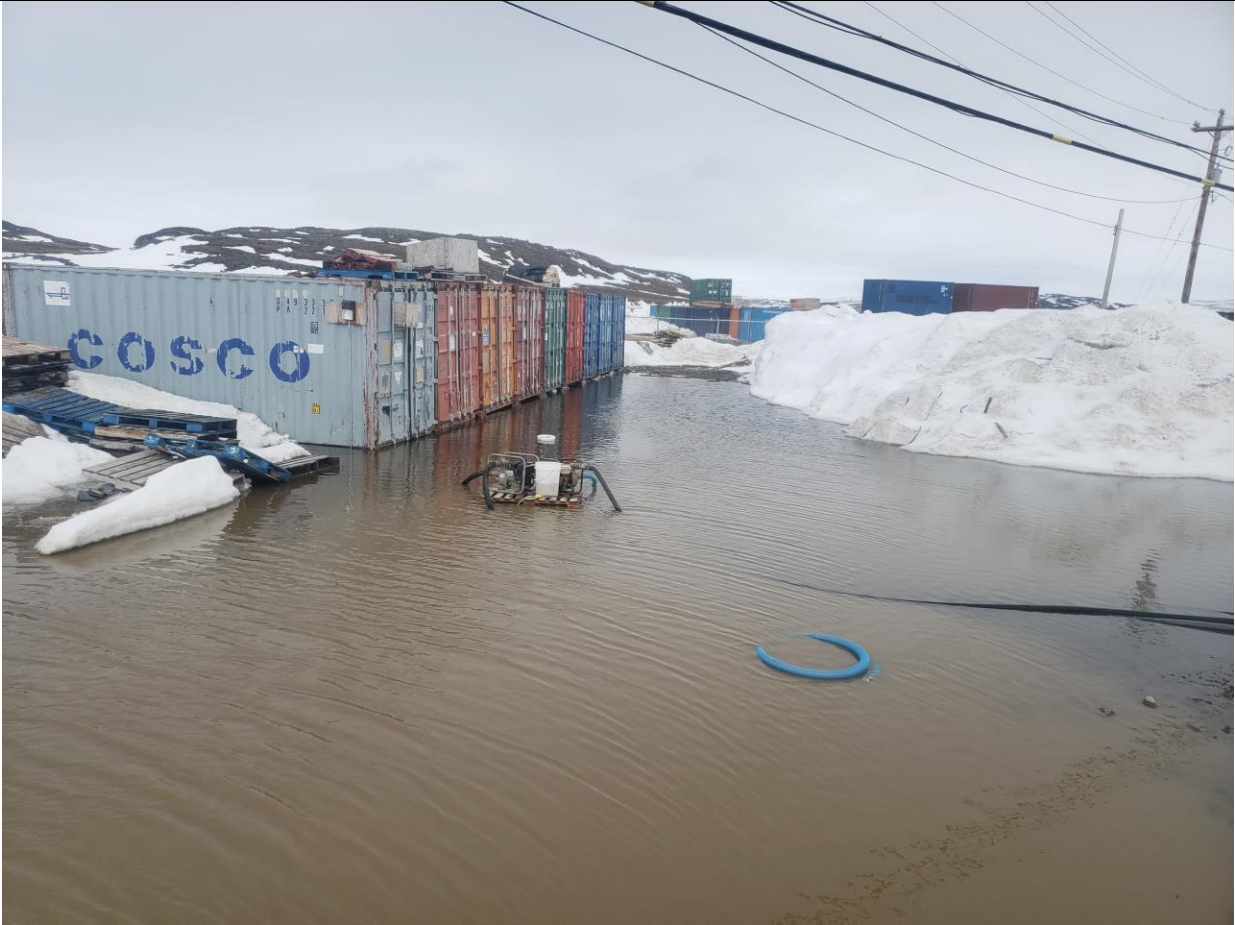
Date	Camera	Inspector	Authorization
	Samgsung S9 (work cell phone)	J.Mesher	1BR-THI
Photo Log			
Photo 1

1. During the inspection the licensee was managing a flood of the pad, the licensee was attempting to temporarily manage the flood by pumping the water from one side of the pad to ditches on the other side of the pad. This flood appears to be caused by ditches surrounding the facility being blocked with snow and ice, the inspector is requesting the licensee ensure the diversion ditches are cleared prior to freshet. see photo 1 for the flood and photo 2 for the ditch behind the facility.

Description: flooding of the pad.

1. The inspector is requesting the licensee clear the ditches surrounding the facility prior to freshet to ensure the water management structures are not blocked and operating as intended.
2. The licensee is to move the waste identified in photo 3 and ensure the following condition of their licensee is adhered to, Part H, item 7, of the licenece 1BR-THI2027 states that; “The Licensee shall provide secondary containment for fuel, chemical and contaminated Water storage as required by applicable standards and acceptable industry practice.”
3. The licensee is to organize the waste in Cell A in the approved manner and the licensee is to ensure all waste management facility’s are operated and managed as stated in the approved operations and management plan.
