***Former Navigational Aid and
Weather Station, Radio Island,
Nunavut***

***Environmental Site Delineation
and Material Inventory***

Earth Tech Canada Inc.
17203-103rd Ave.,
Edmonton, Alberta, T5S 1J4
(780) 488-6800

November 2001

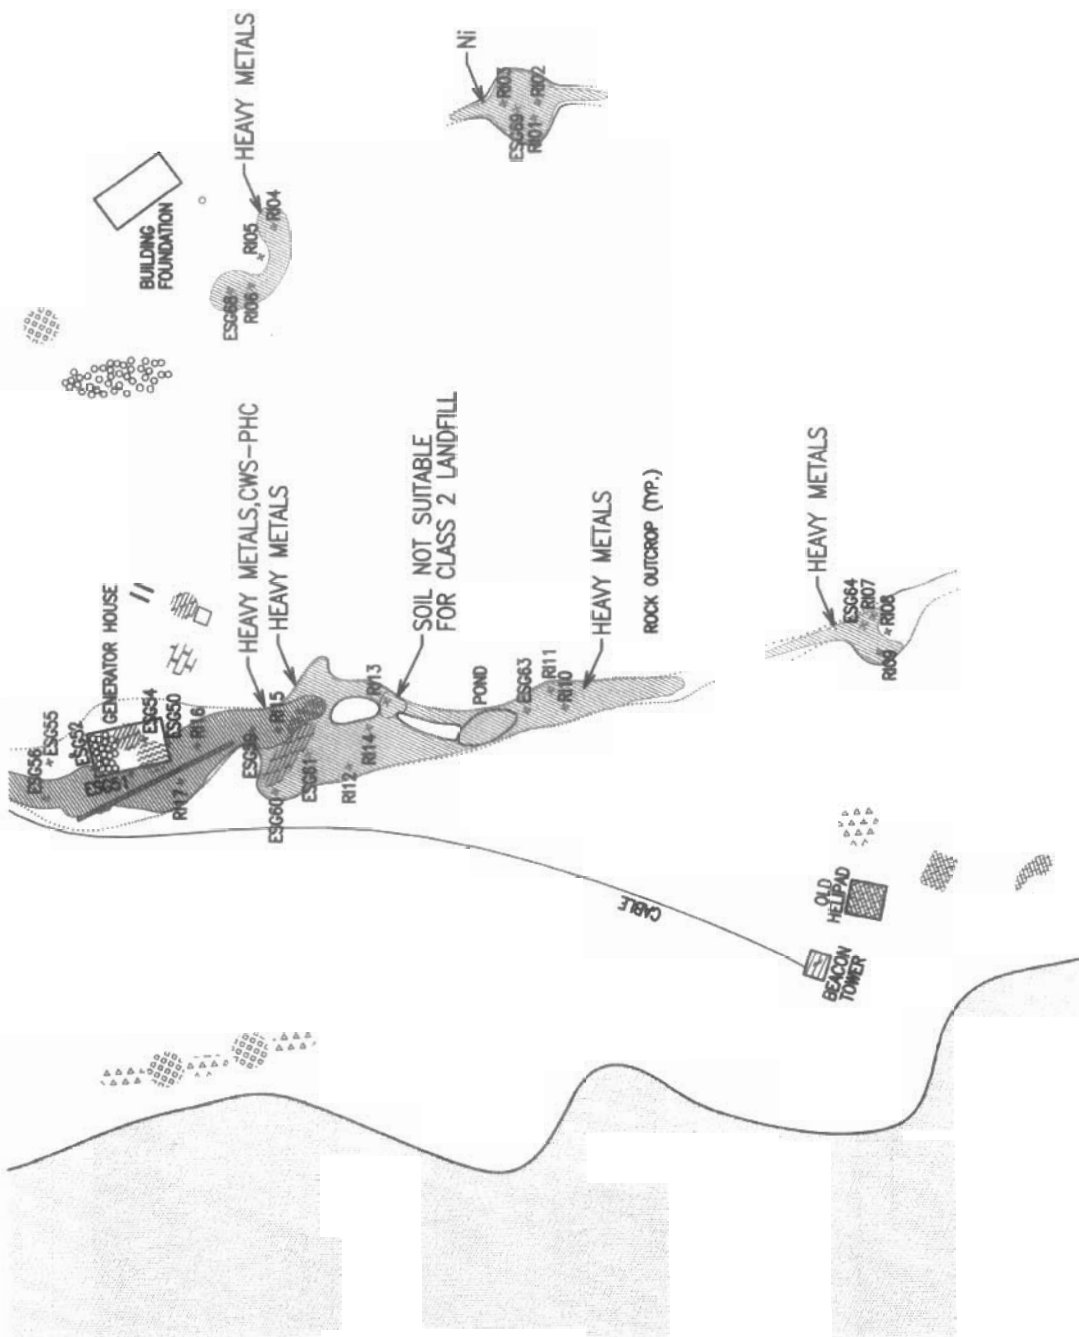
RADIO ISLAND
MAIN STATION AREA SOUTH
SAMPLE LOCATIONS AND EXCEEDANCES
OCTOBER, 2001
SCALE: 1:750
FIGURE 2.0

The ESG sample locations were assigned a four-digit number with a letter prefix and the sample point(s) for the location were identified with an ESG tag number. (i.e. G7508, Tag #9) Where possible, the ESG tags were located in the field and correlated to the site/location description in the report. Where the tags could not be located or there was no tag, the description provided in Appendix C of the ESG report was used to locate the sample area. The location of identified areas having exceedances and requiring delineation in the vicinity of the main station area is presented in Figure 2.0 (south half of site), and Figure 2.1 (north half of site).

The data presented in Table 2.1.1 indicates that there are exceedances outside of the ESG sampled areas and that delineation has been achieved in some areas. Table 2.1.2 briefly describes each site in the vicinity of the station area, and presents the results of the investigations conducted. Table 2.1.2 also provides an estimate as to the volume of impacted soil at each location. The sites are identified for location and delineation on Figures 2.0 and 2.1.

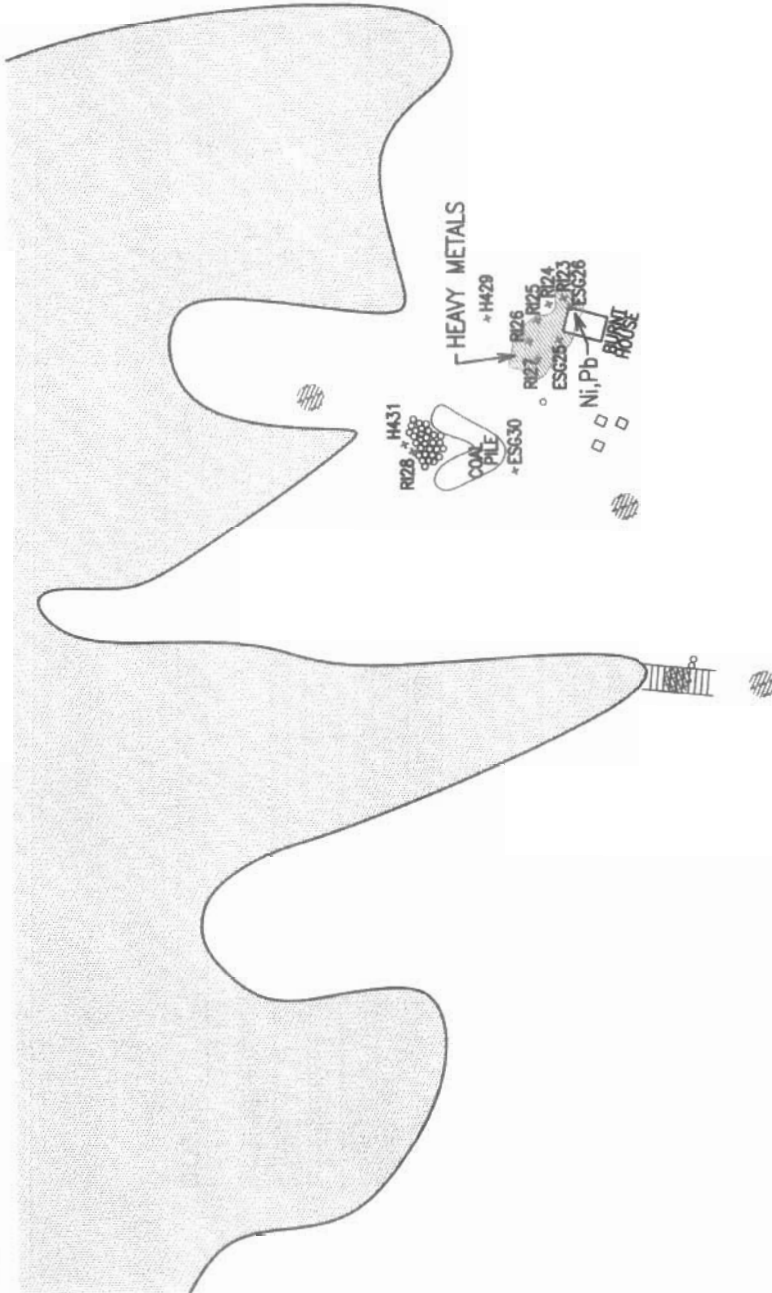
OCTOBER, 2001
SCALE: 1:750
FIGURE 2.2

RADIO ISLAND
BEACH AREA AND COAL OFF-LOADING SITE
SAMPLE LOCATIONS AND EXCEEDANCES
